YAKIMA MILL SITE
 CITY OF YAKIMA, YAKIMA COUNTY, WASHINGTON

Photograph Locations at the Boise
Cascade Mill Site (aka Yakima Mill
Site) and East of Interstate 82

Fulcrum Environmental Consulting, Inc.
406 N 2nd St, Yakima, WA 98901
509.574.0839 | www.efulcrum.net
YMS East of I-82 . 11.13.2023 . RKM

Attachment B
Site Photographs

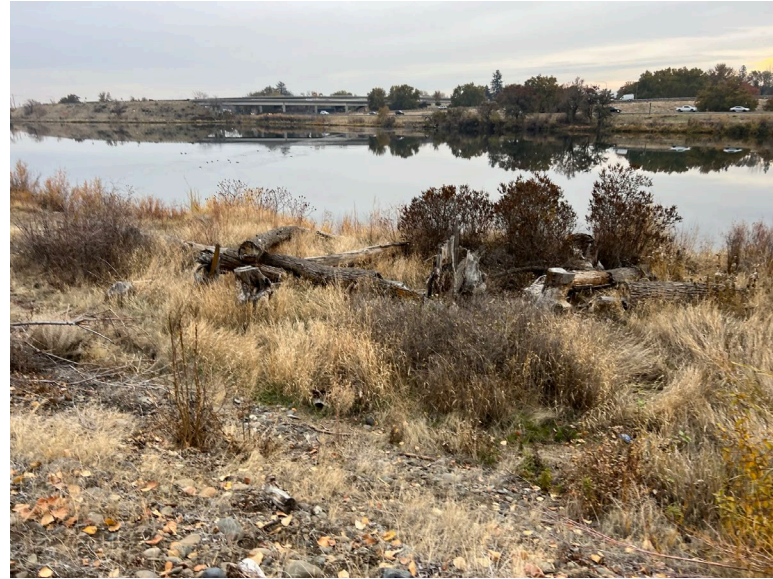
B1.1 Parcel F – The approximate west extent of the parcel.

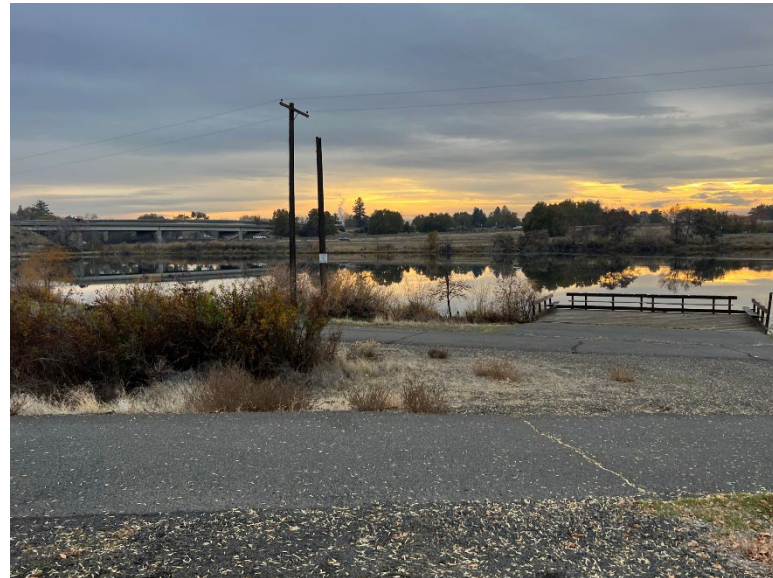
B1.3 Offsite, immediately north of Parcel A, the former head gate for the River Water Intake.

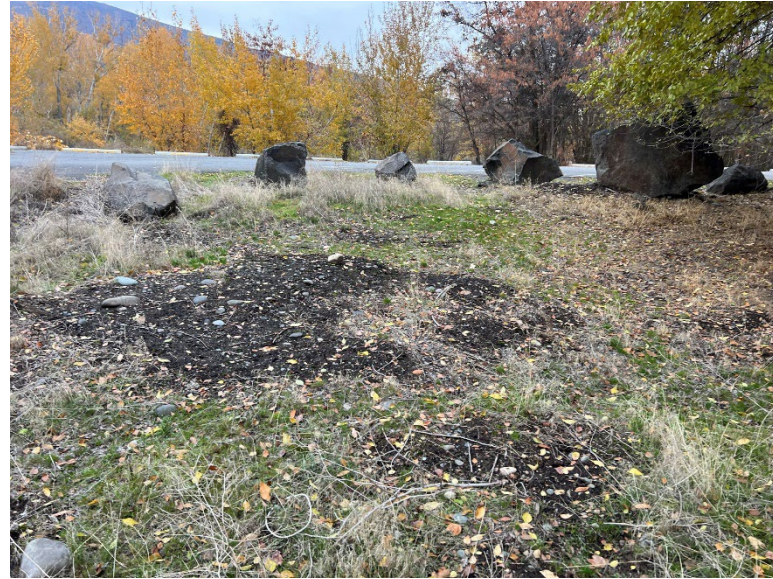
B4.2 Parcel B – Log yard material was present in the center of the parking lot.

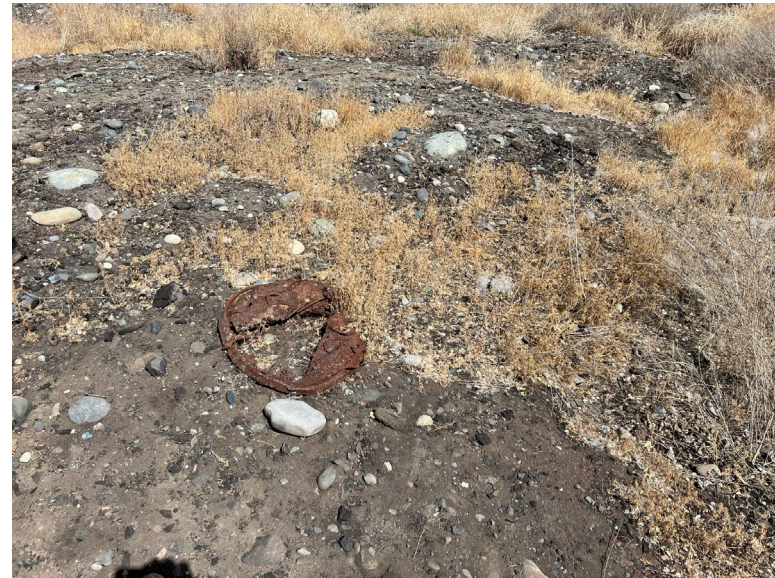
B8.4 Parcel C1 – Metal scrap debris was observed with the log yard materials.

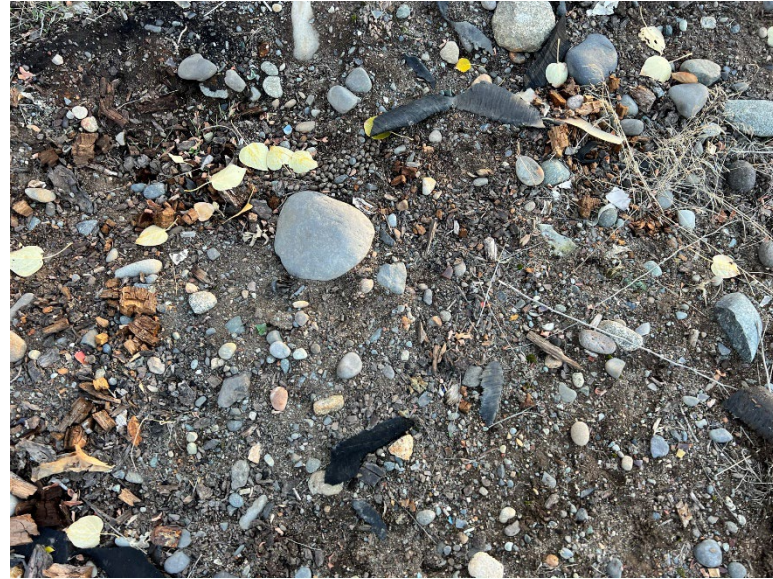
B9.2 Parcel C1 – Tire debris was observed mixed in the log yard materials.

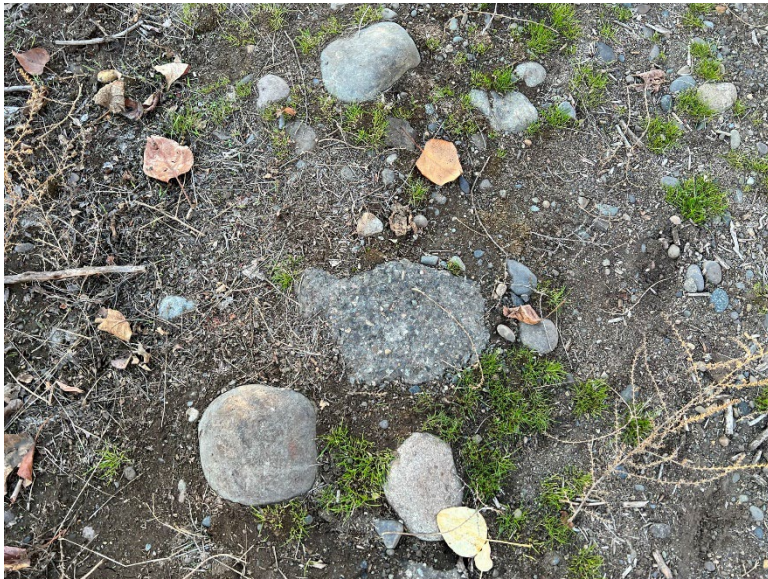
B10.1 Parcel C1 – Asphalt and concrete debris was observed in some locations.

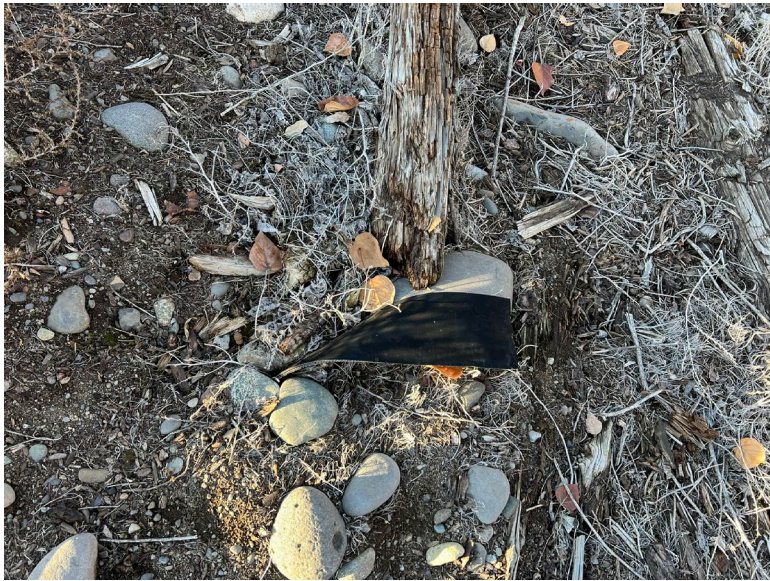
B12.1 Parcel D – A belt scrap was observed in the log yard material.

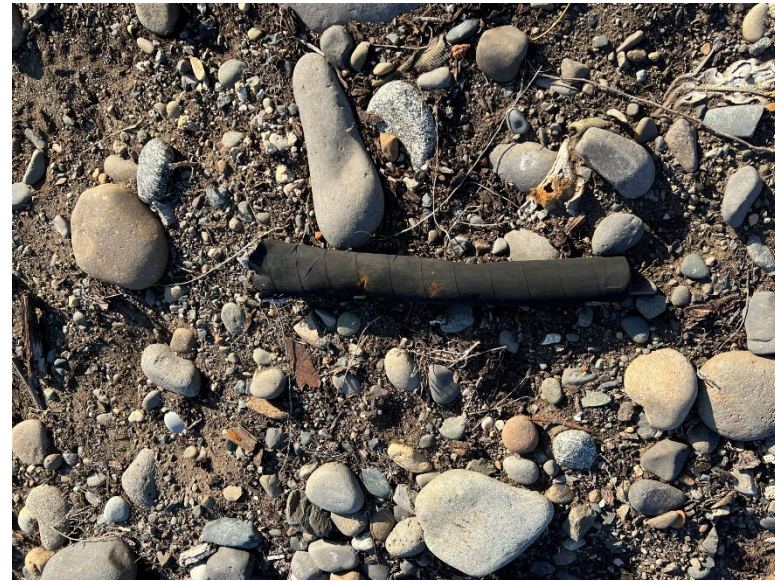
B12.2 Parcel D – A black equipment hose was observed.

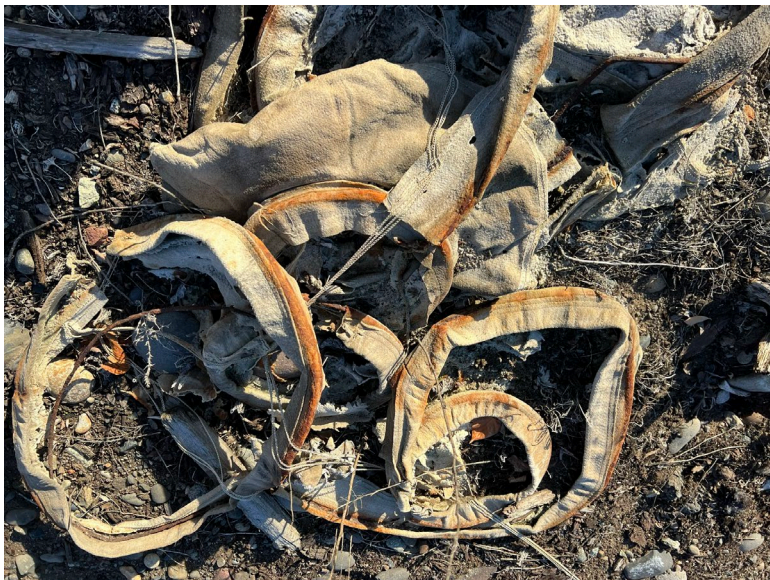
B12.3 Parcel D – A metal frame and fabric component discarded in the log yard material.

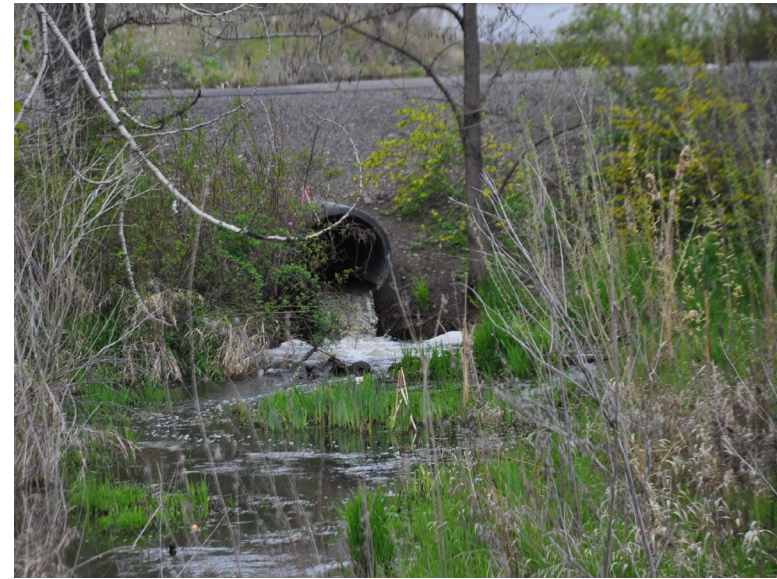
B16.2 Parcel D – Water overflow from Cascade Mill Pond (April 2017).

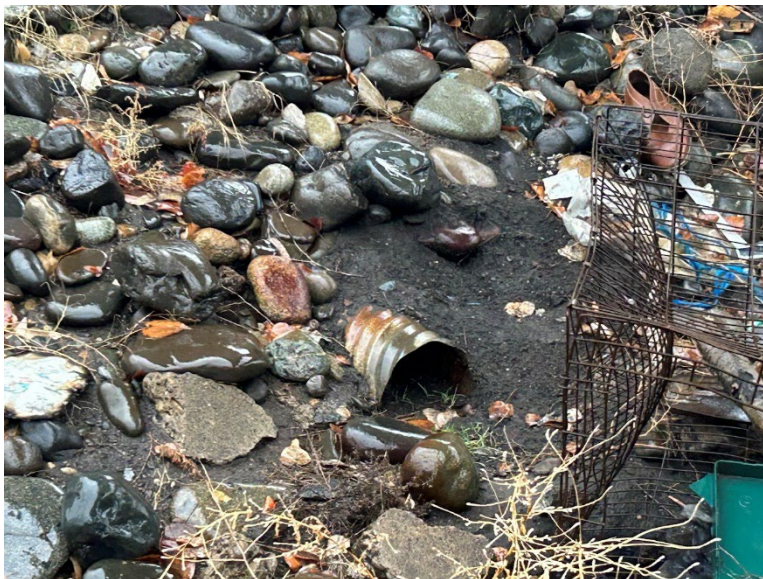
B21.2 Parcel E – A connective elbow is missing on the downspouts. Water discharges to the ground surface.

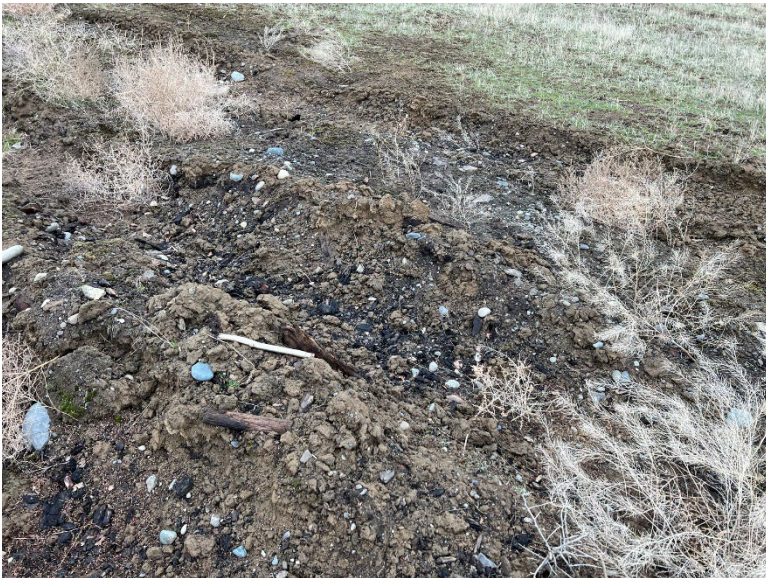
B24.2 Parcel E – Metal debris, including a crushed drum, was observed in the excavated area of log yard material.

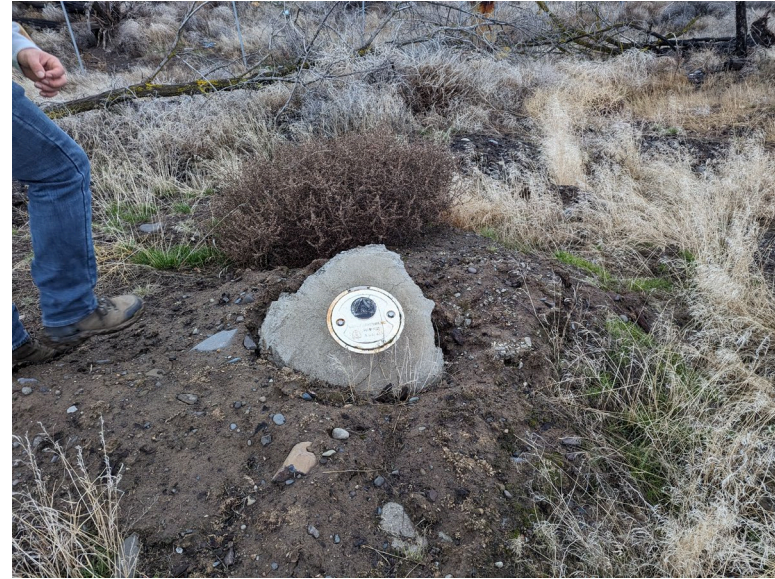
B26.2 Parcel E – The well monument appears to have been pulled from the ground.
