APPENDIX L (continued)
Field Report – Environmental

FIELD REPORT

Project:
Kite Hill Soil Cover Project

Location:
Gas Works Park, Seattle, WA

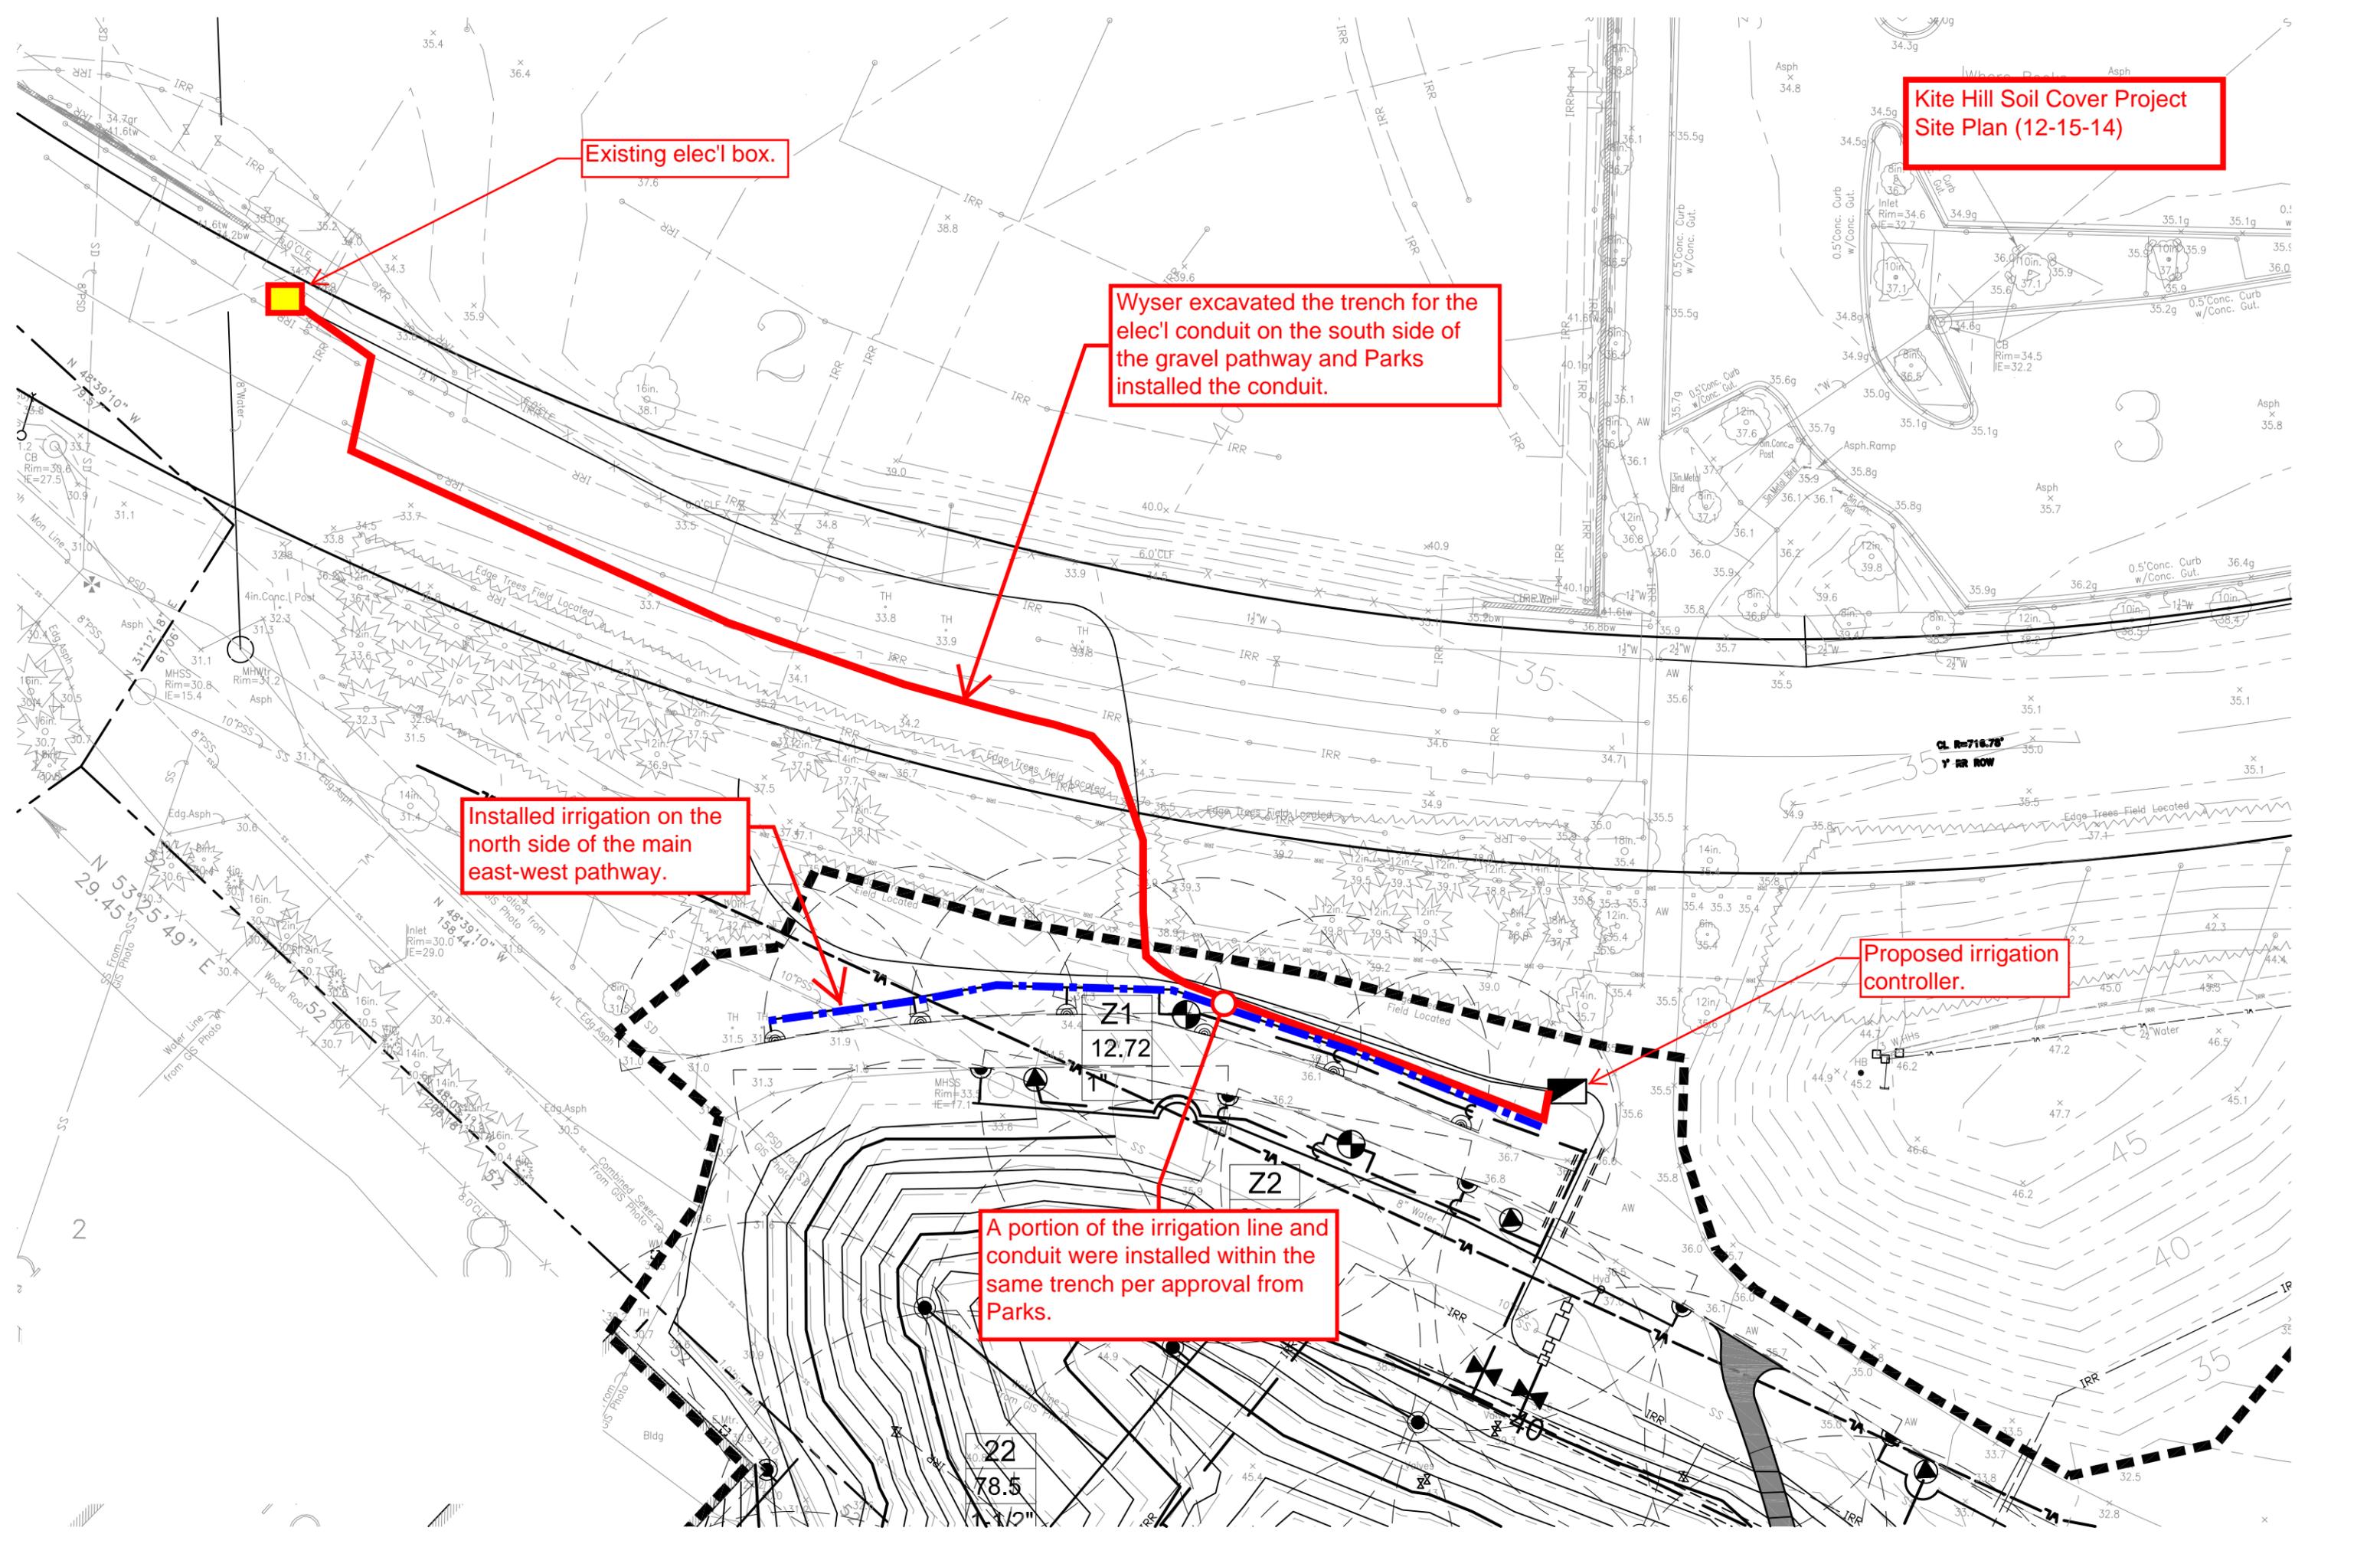
A portion of the irrigation line and conduit were installed within the same trench per approval from Parks.

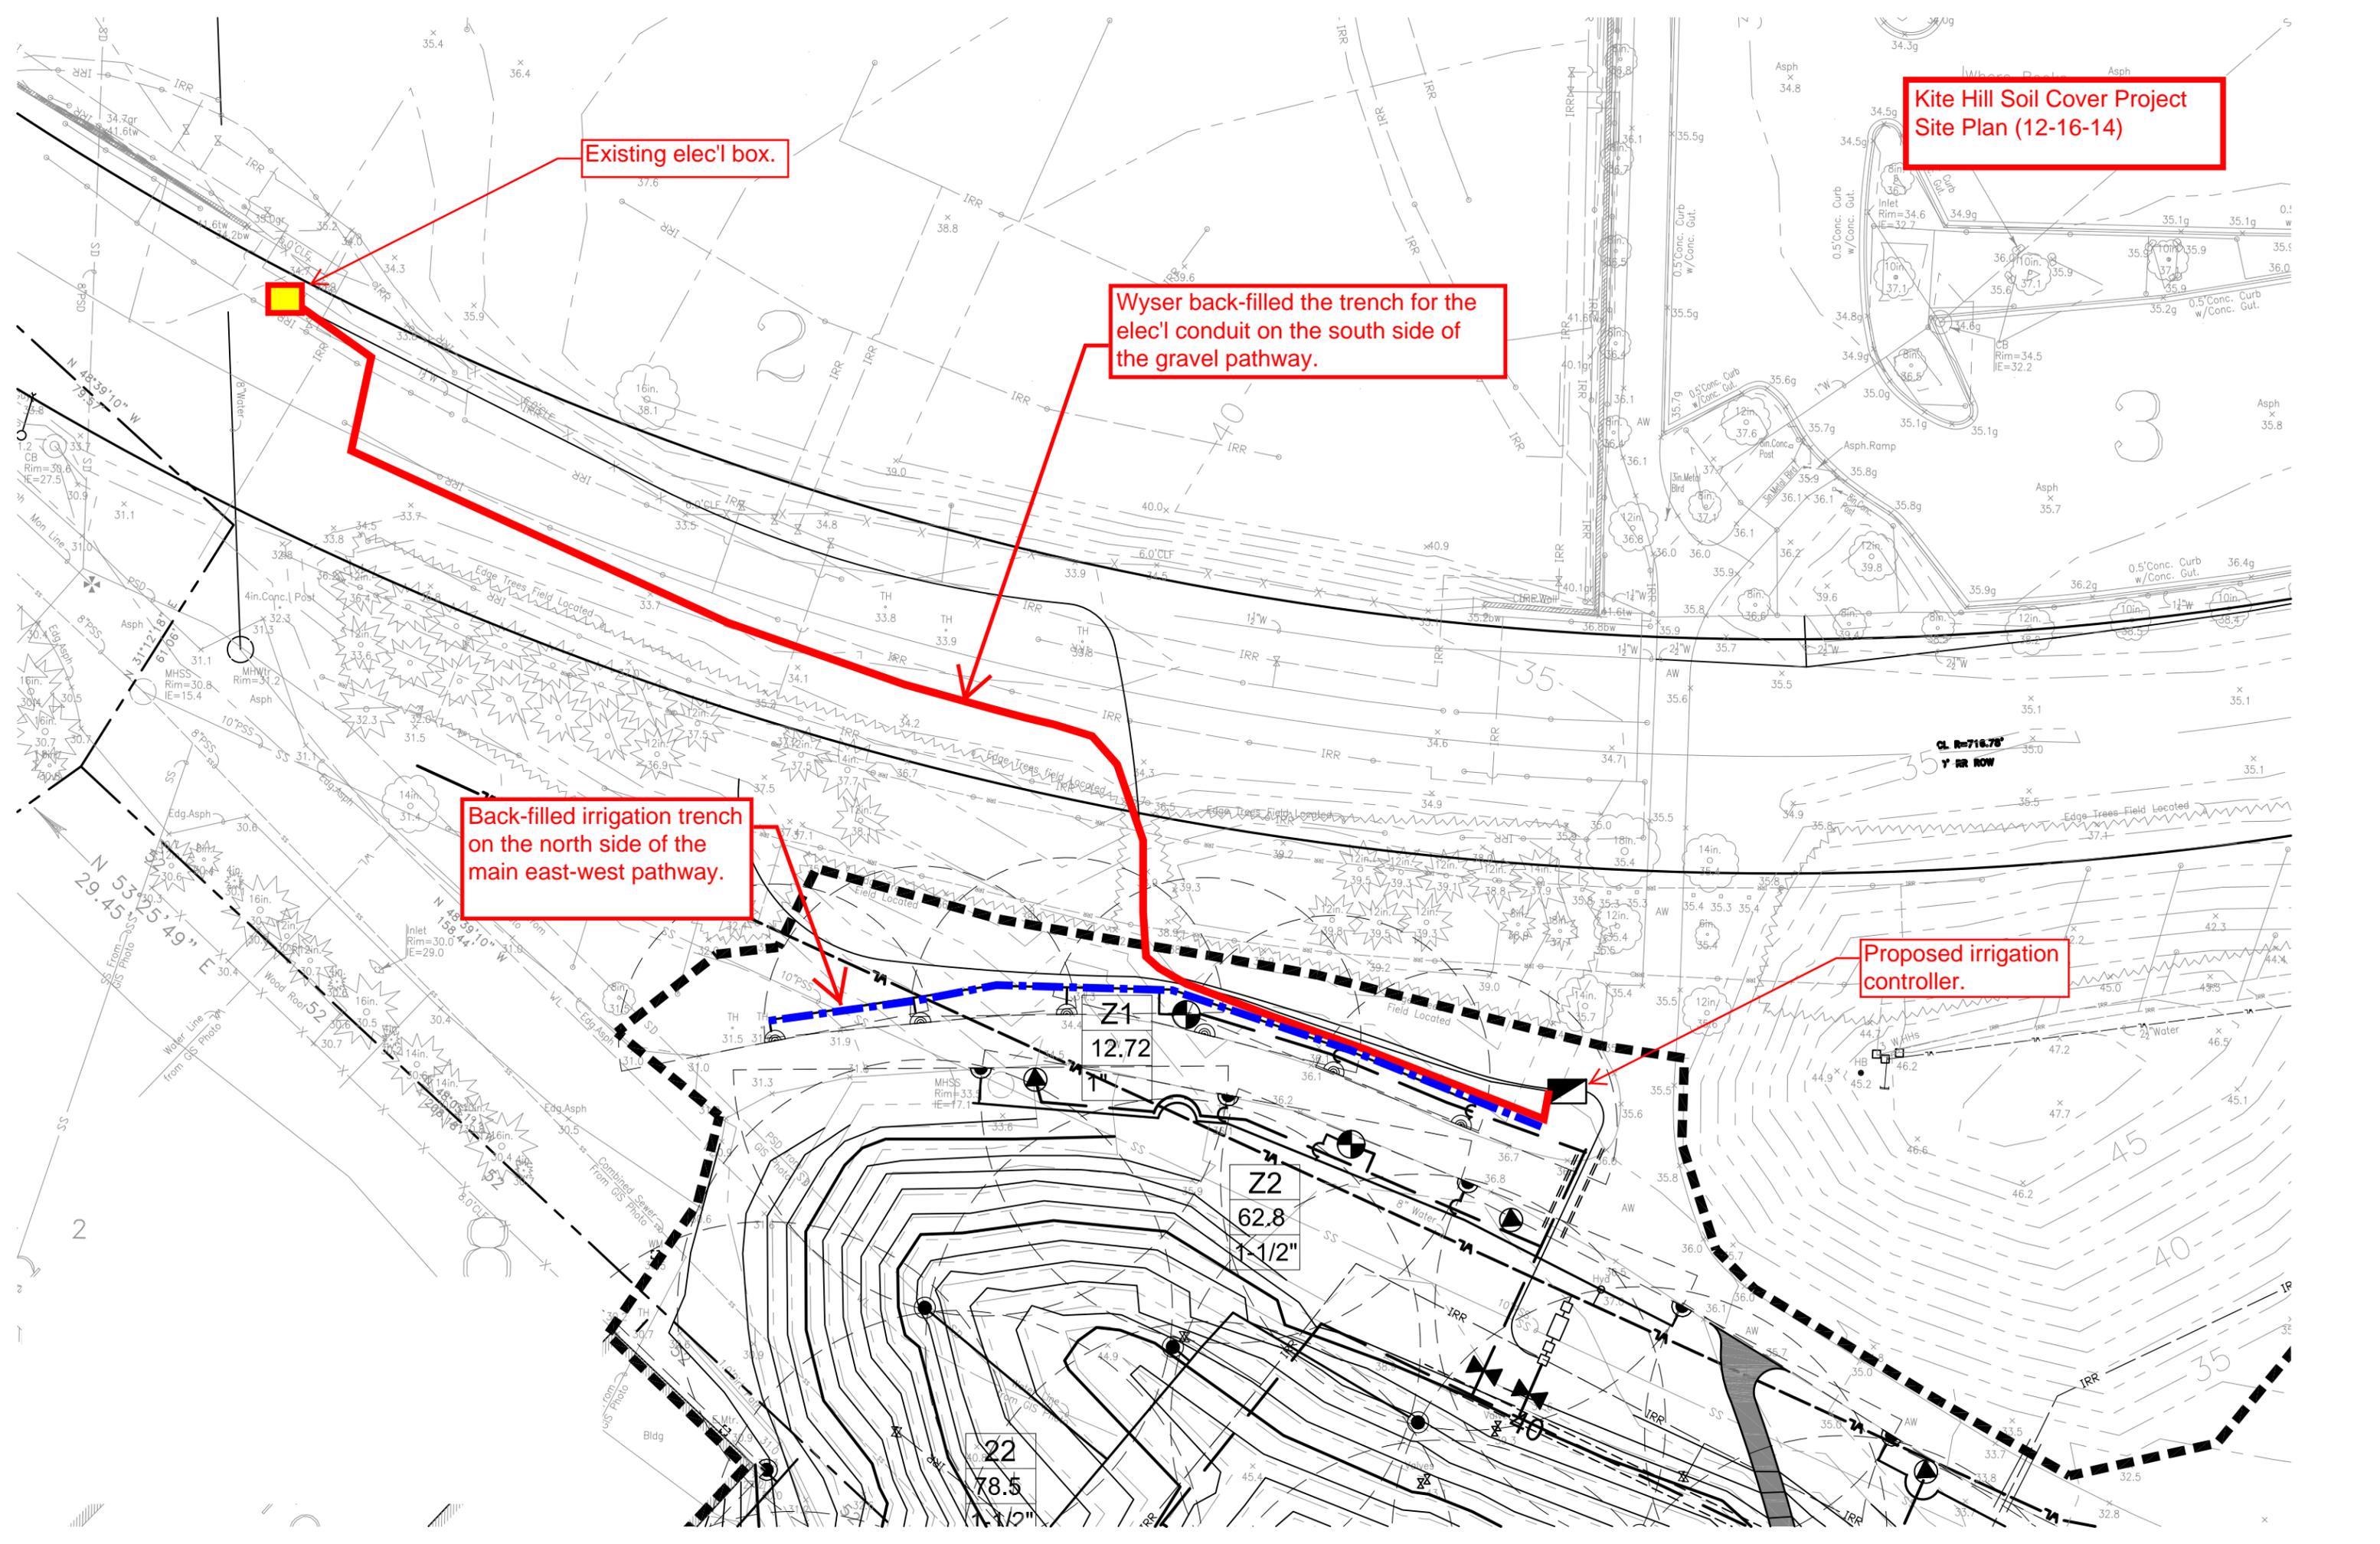
Proposed irrigation controller.

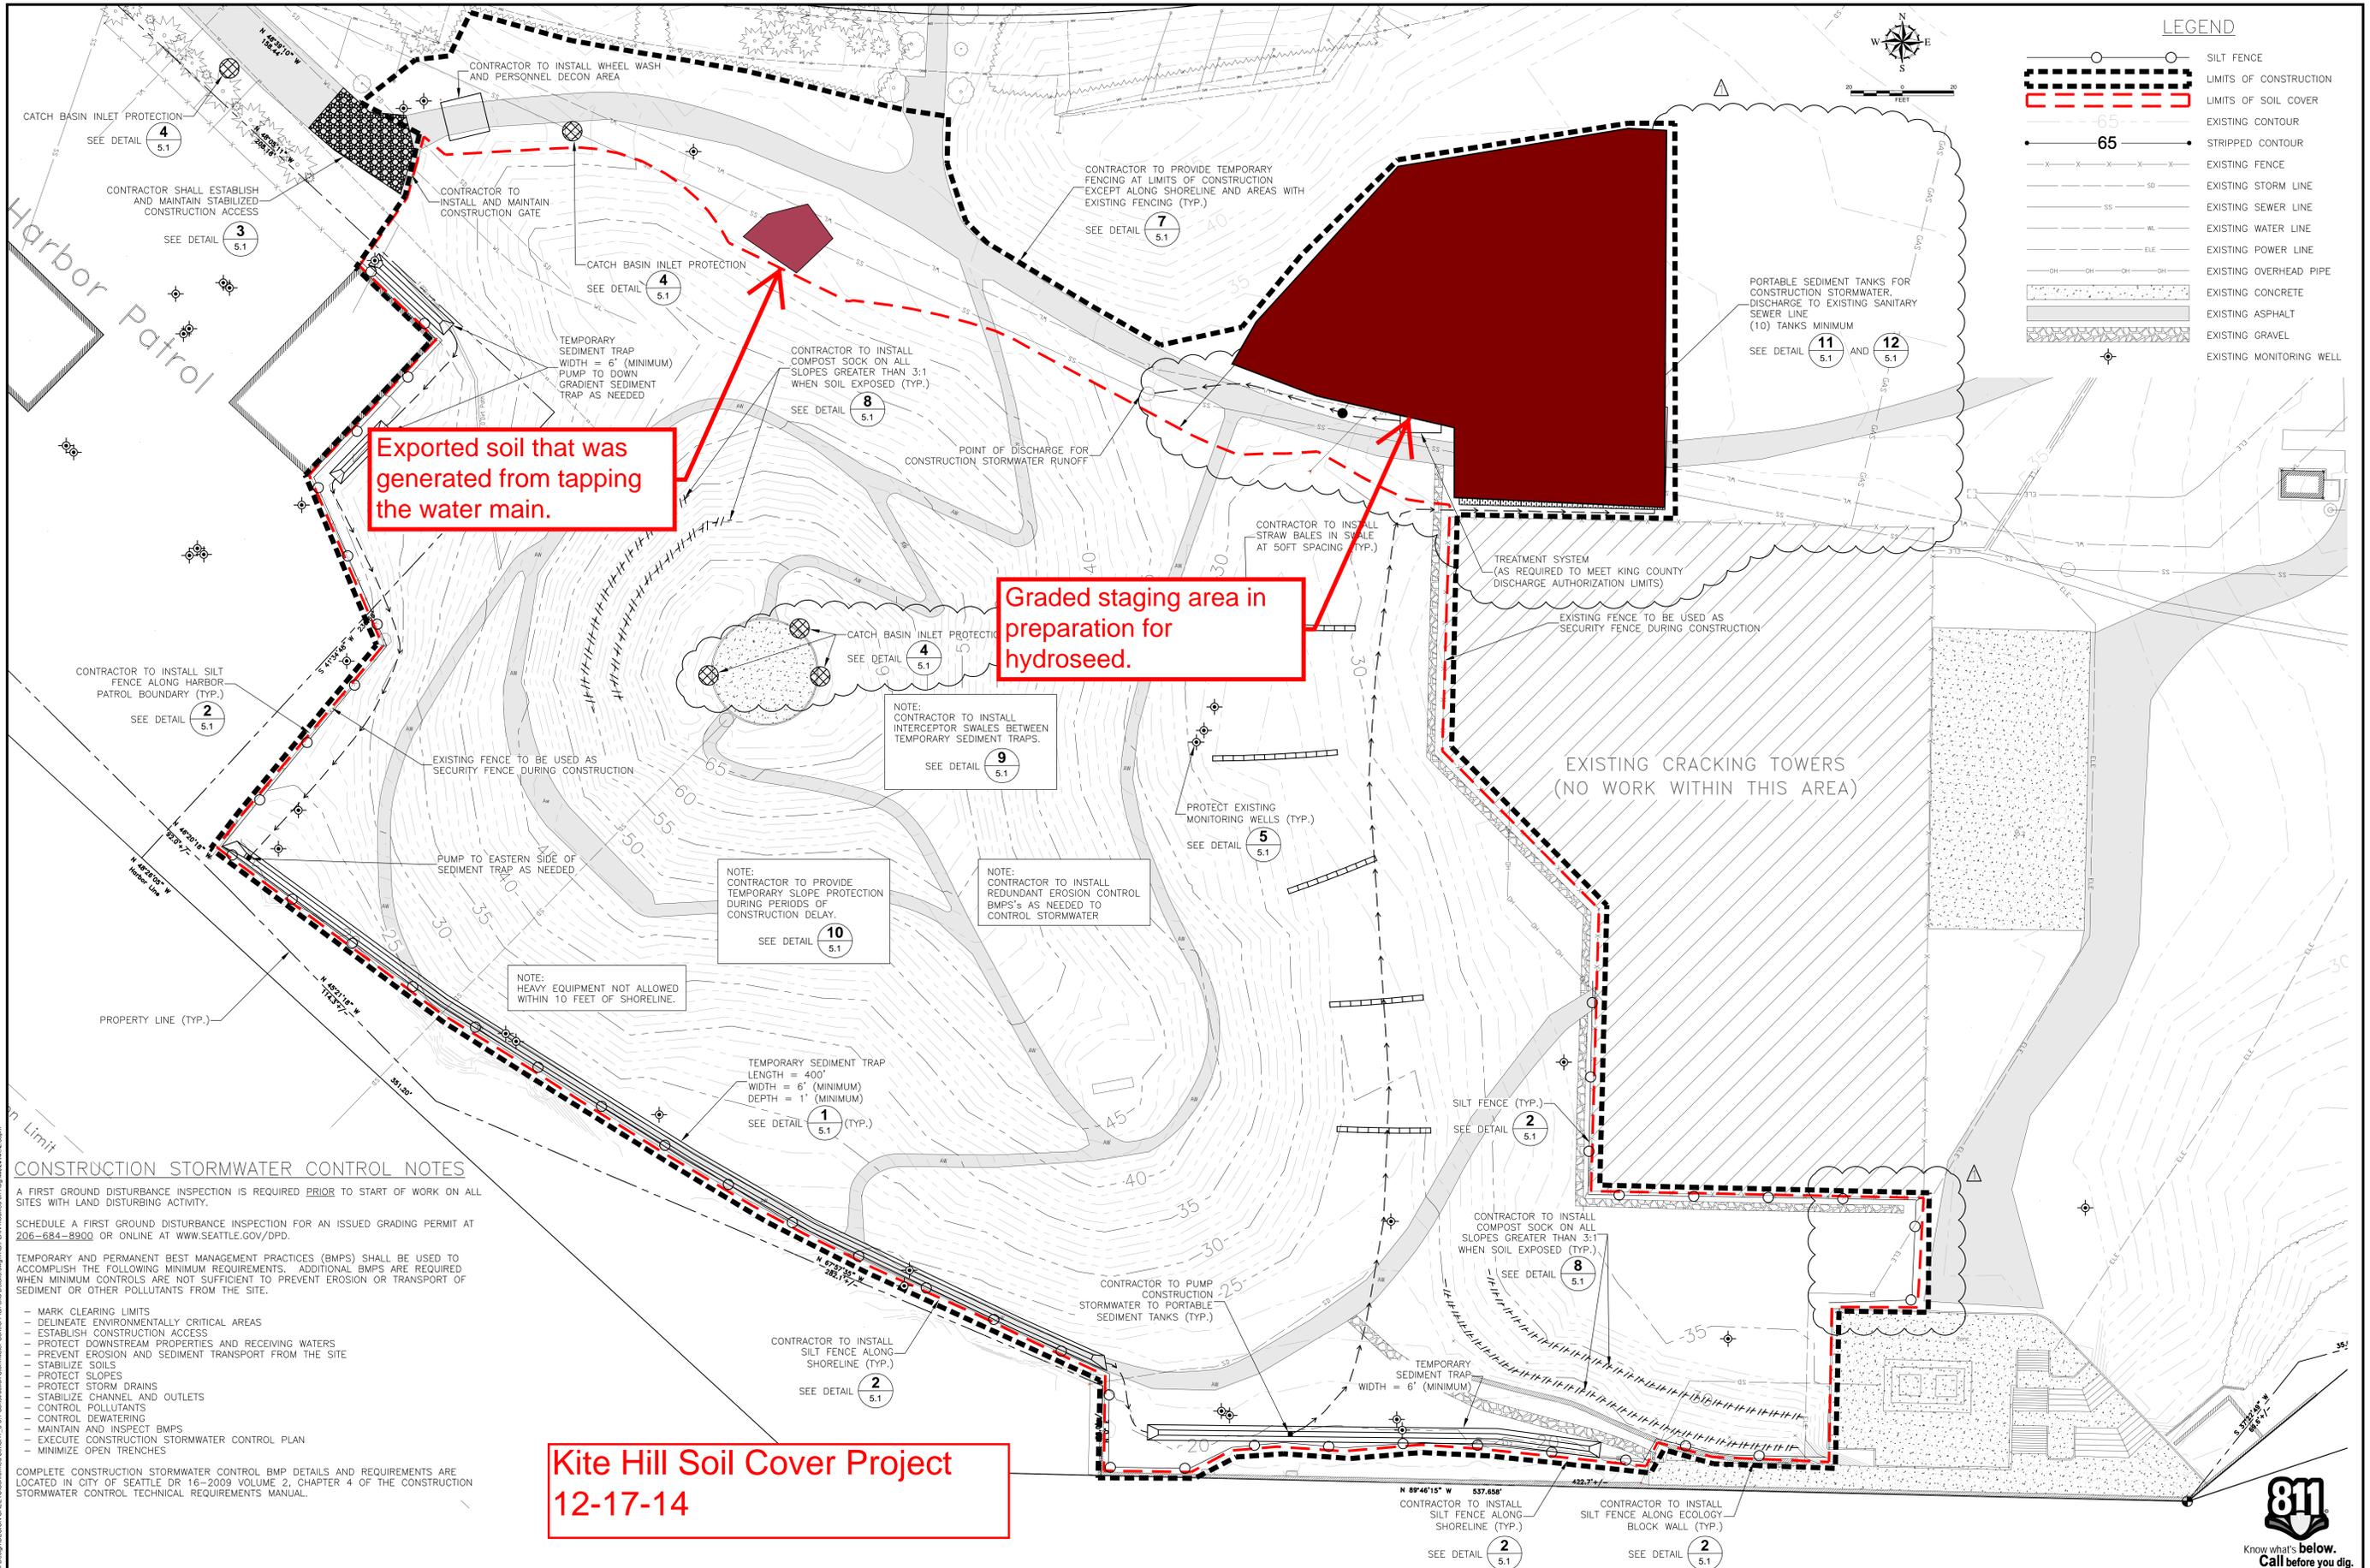
Exported soil that was generated from tapping the water main.

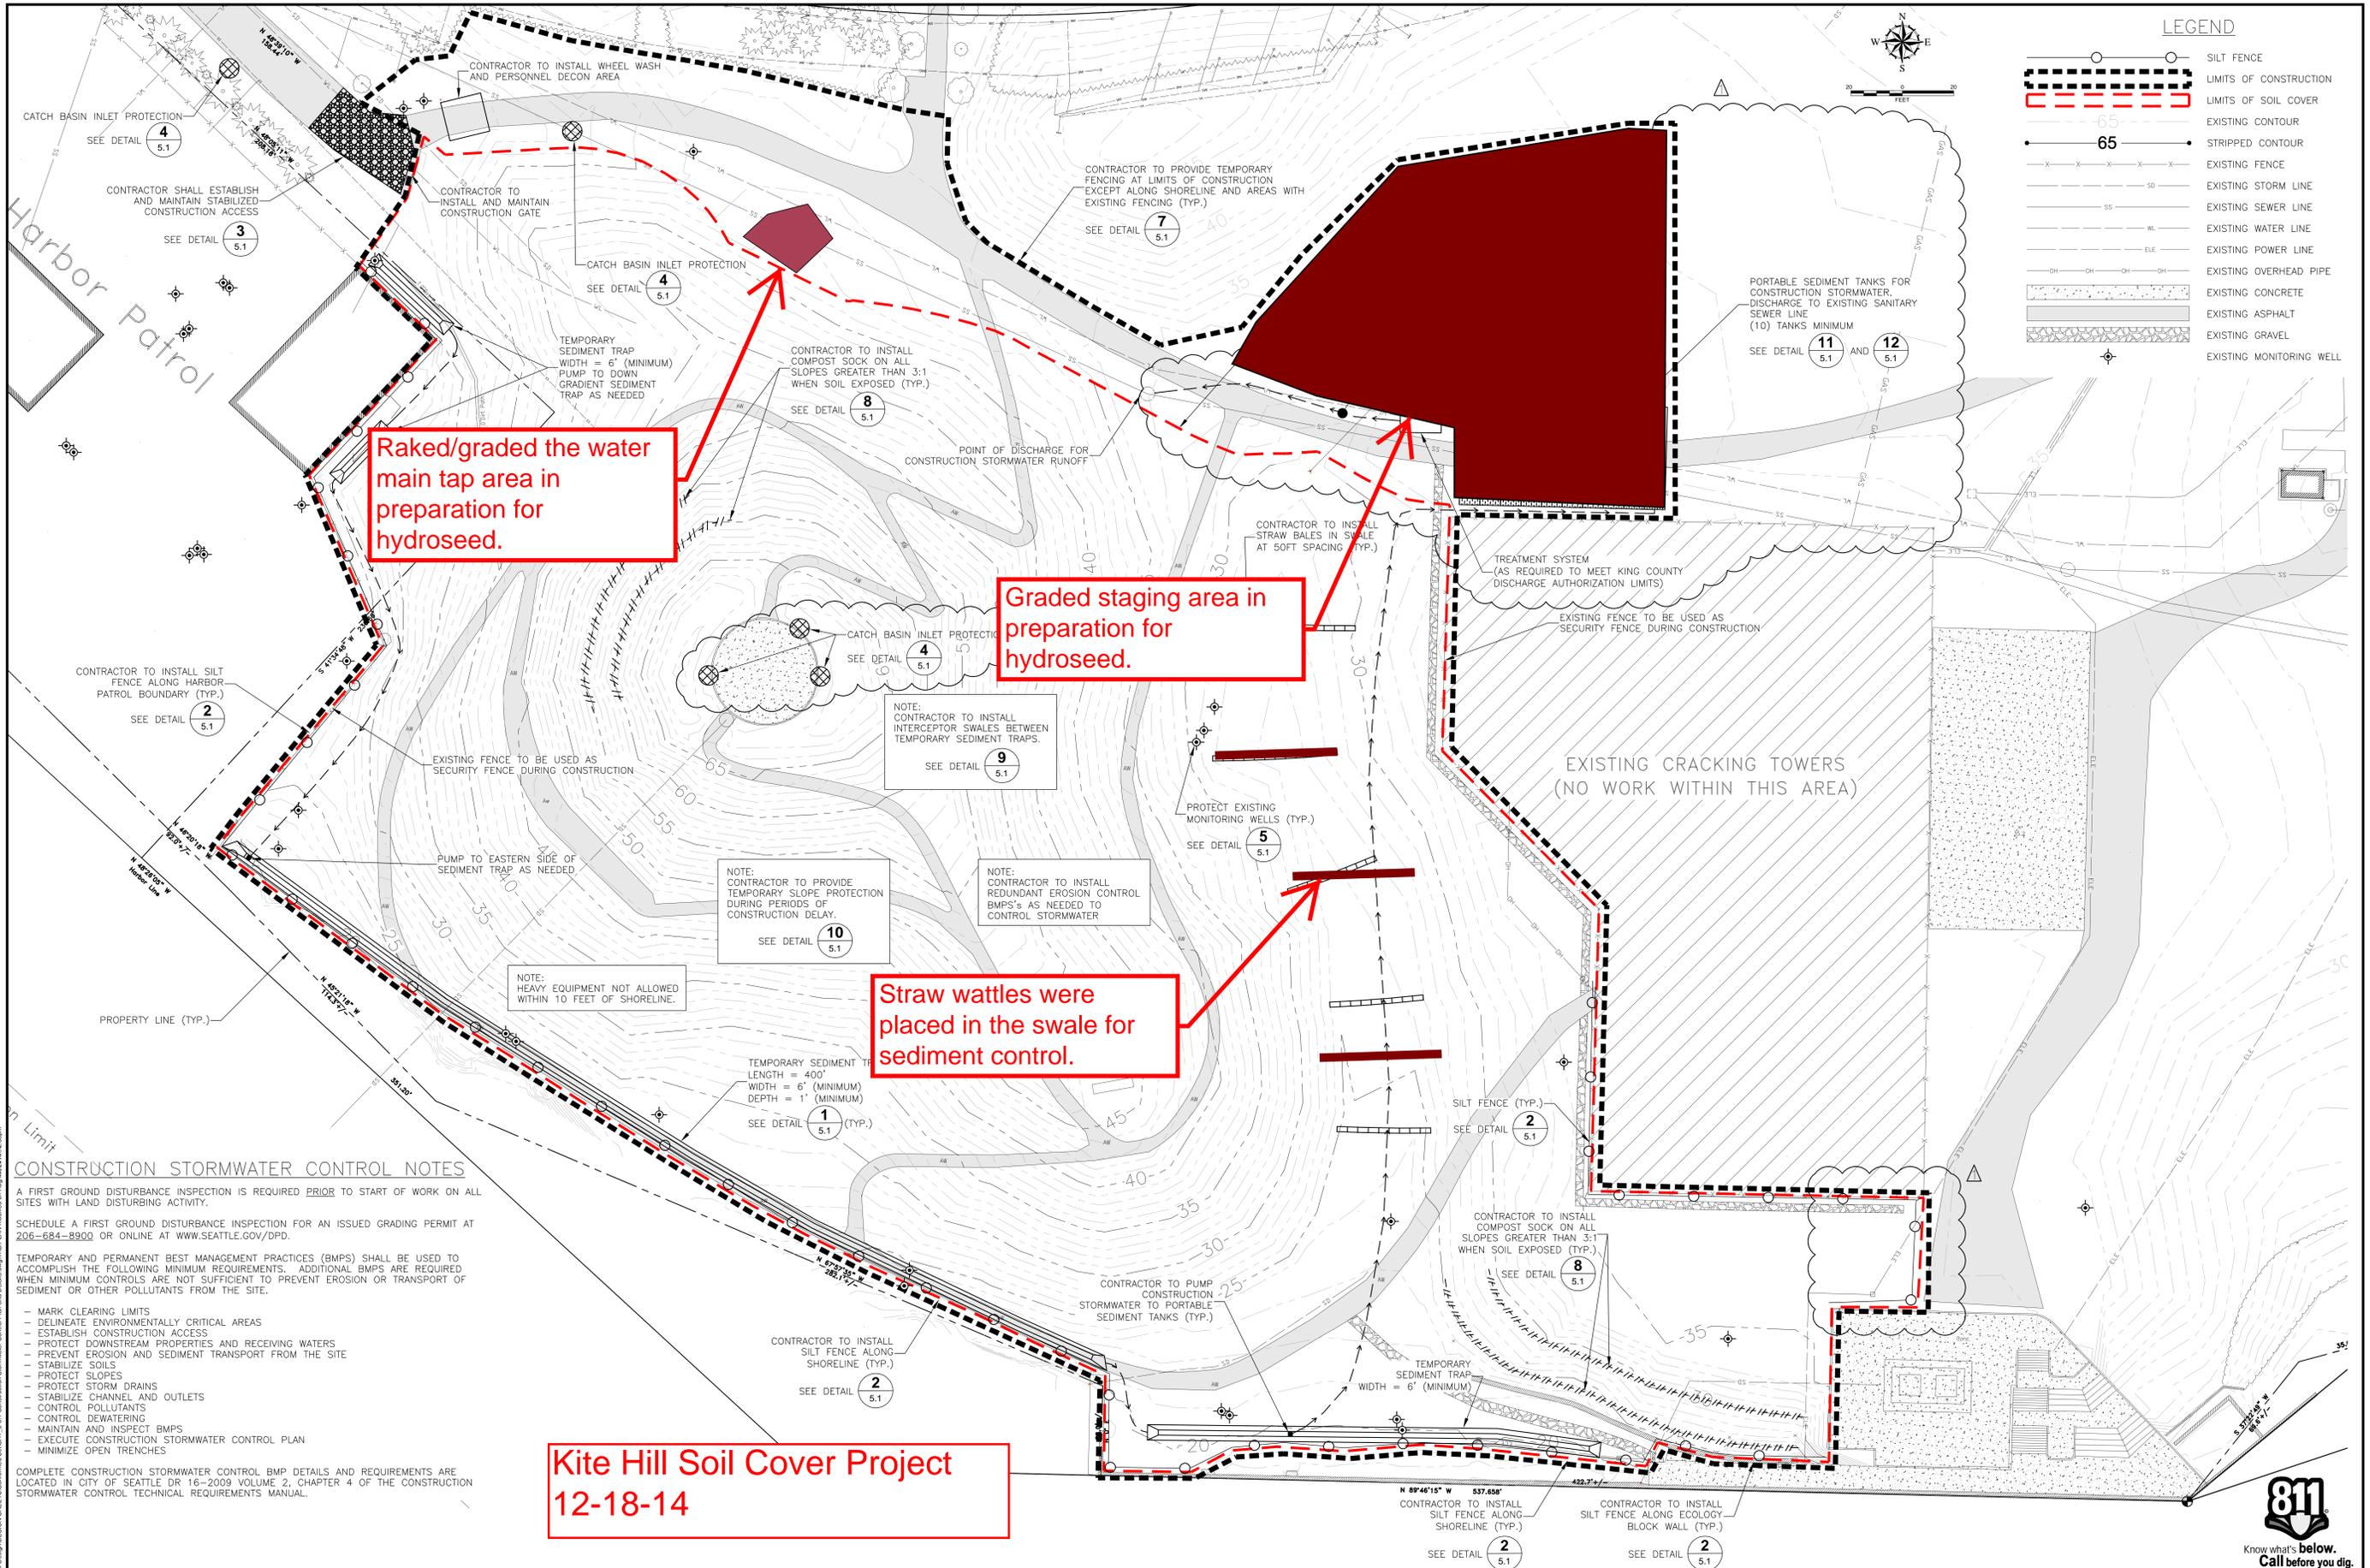
Raked/graded the water main tap area in preparation for hydroseed.

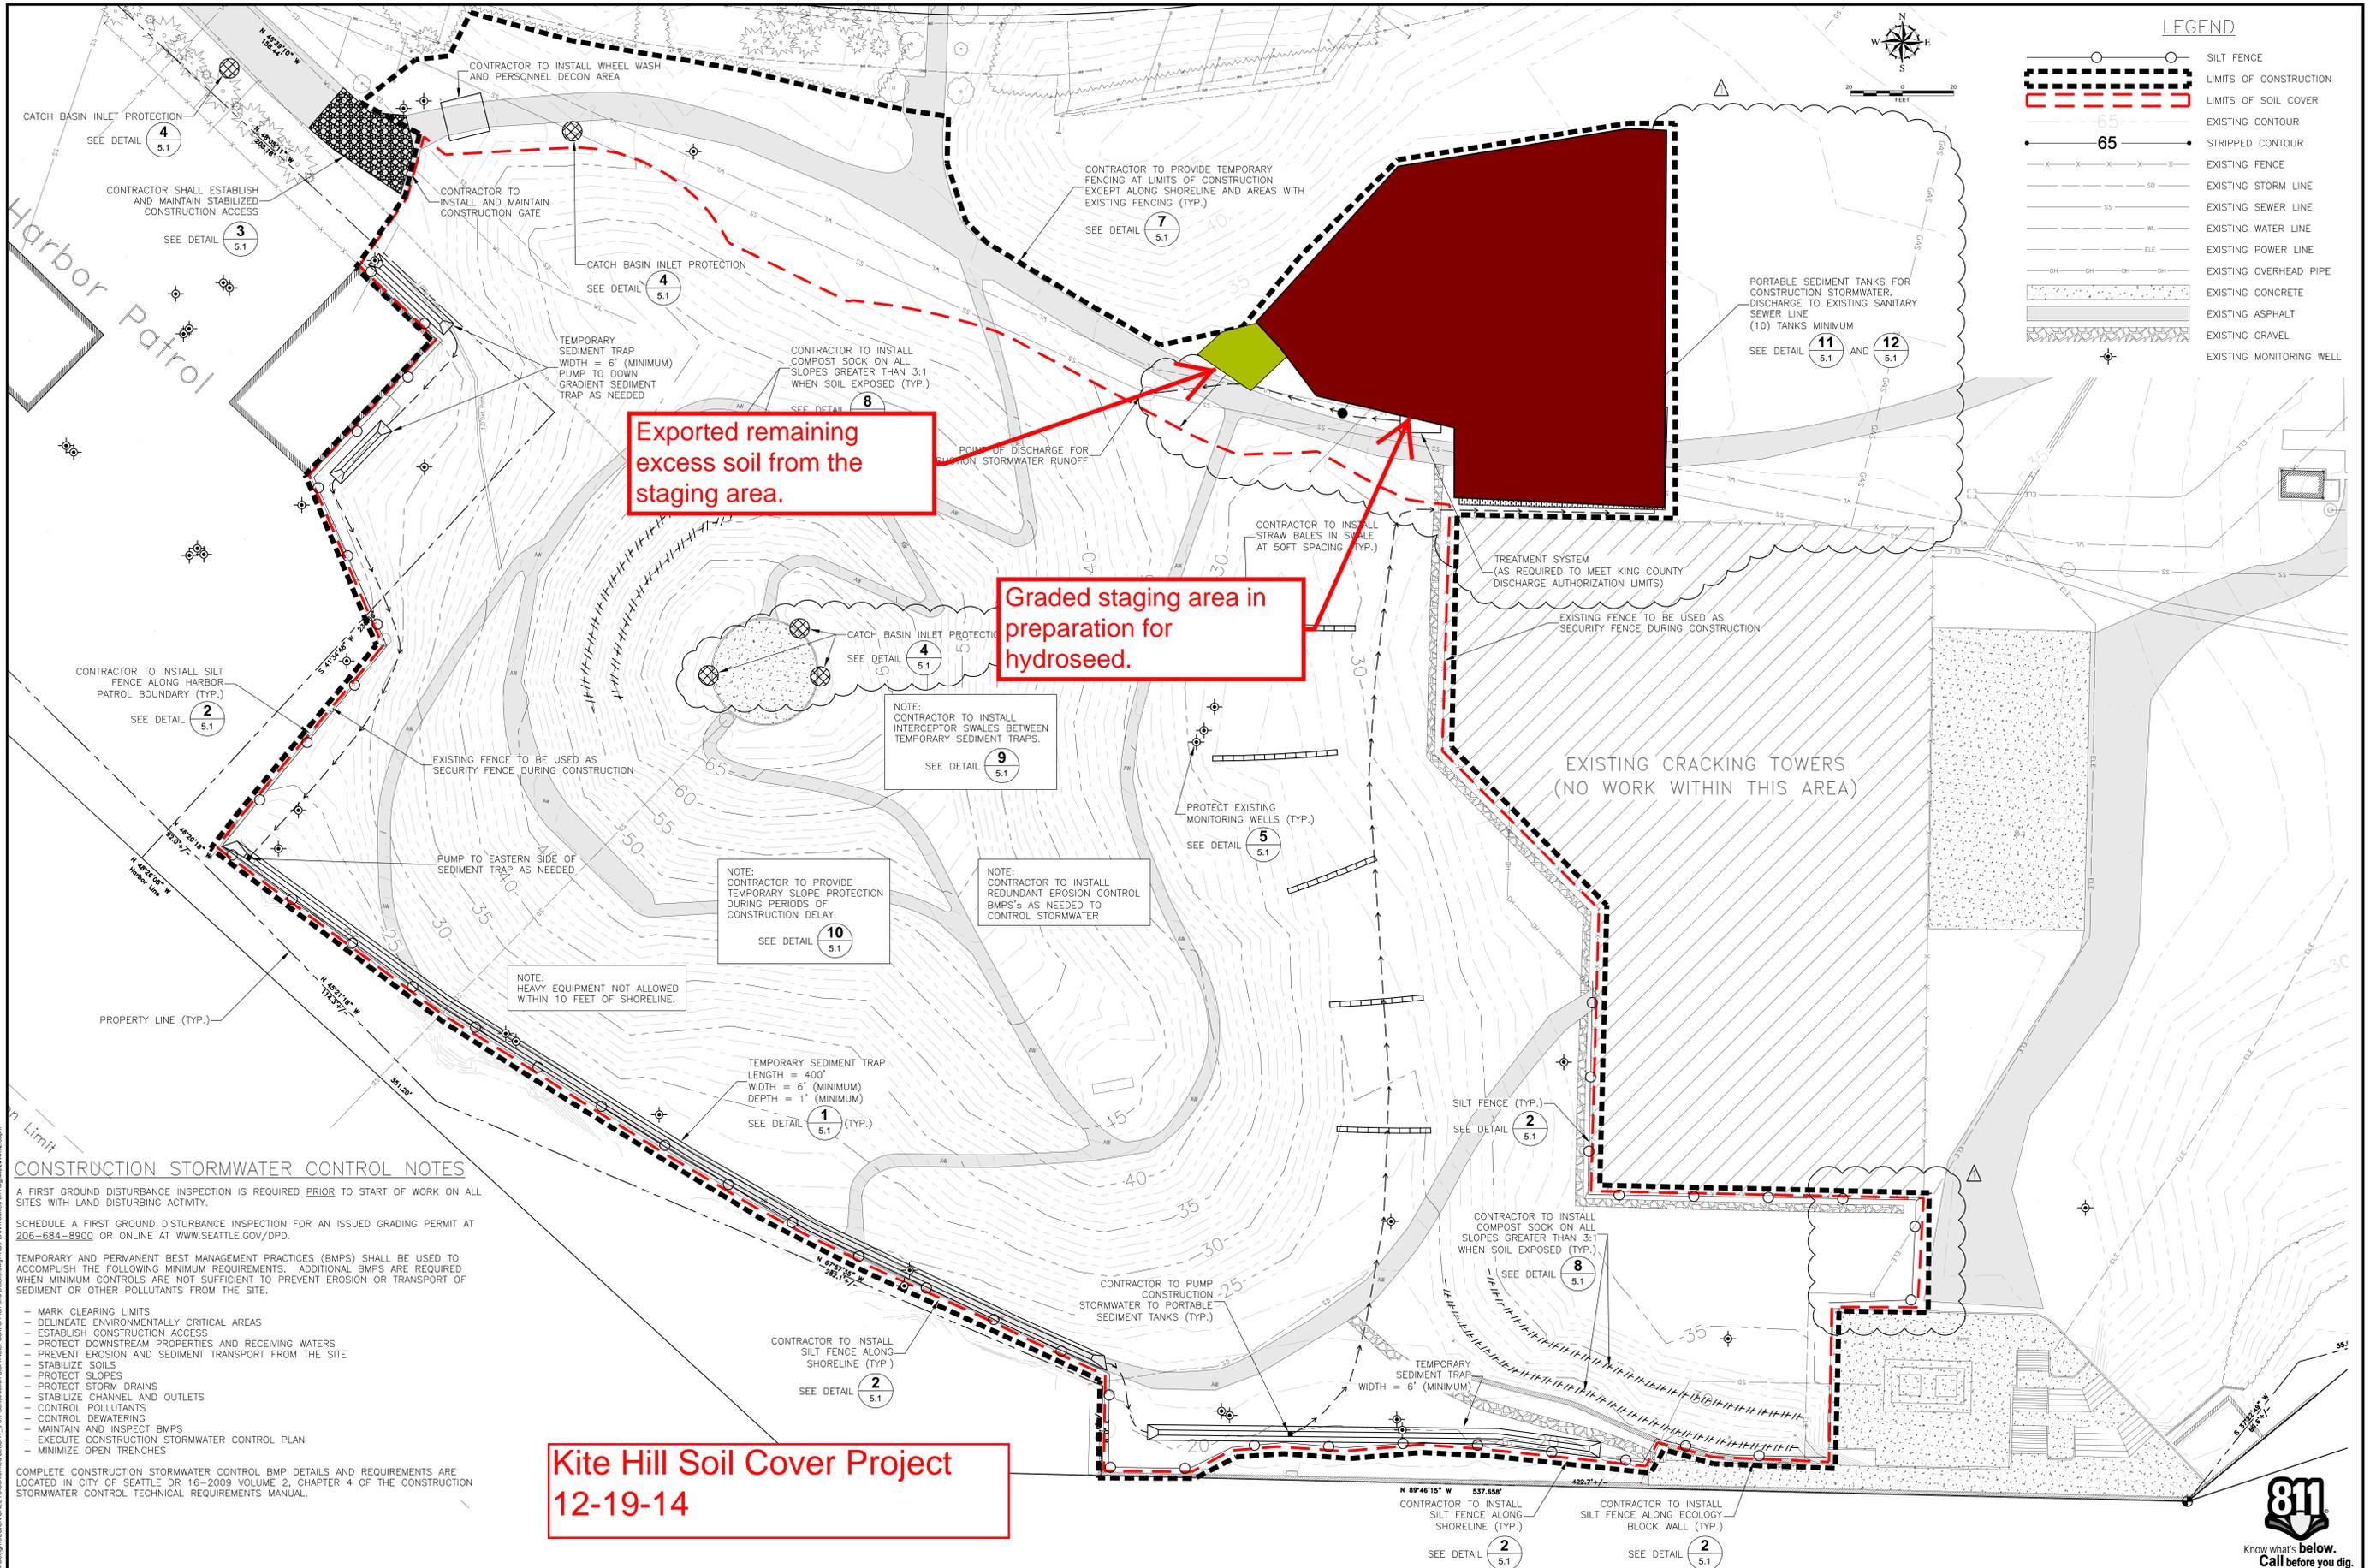
Exported remaining excess soil from the staging area.

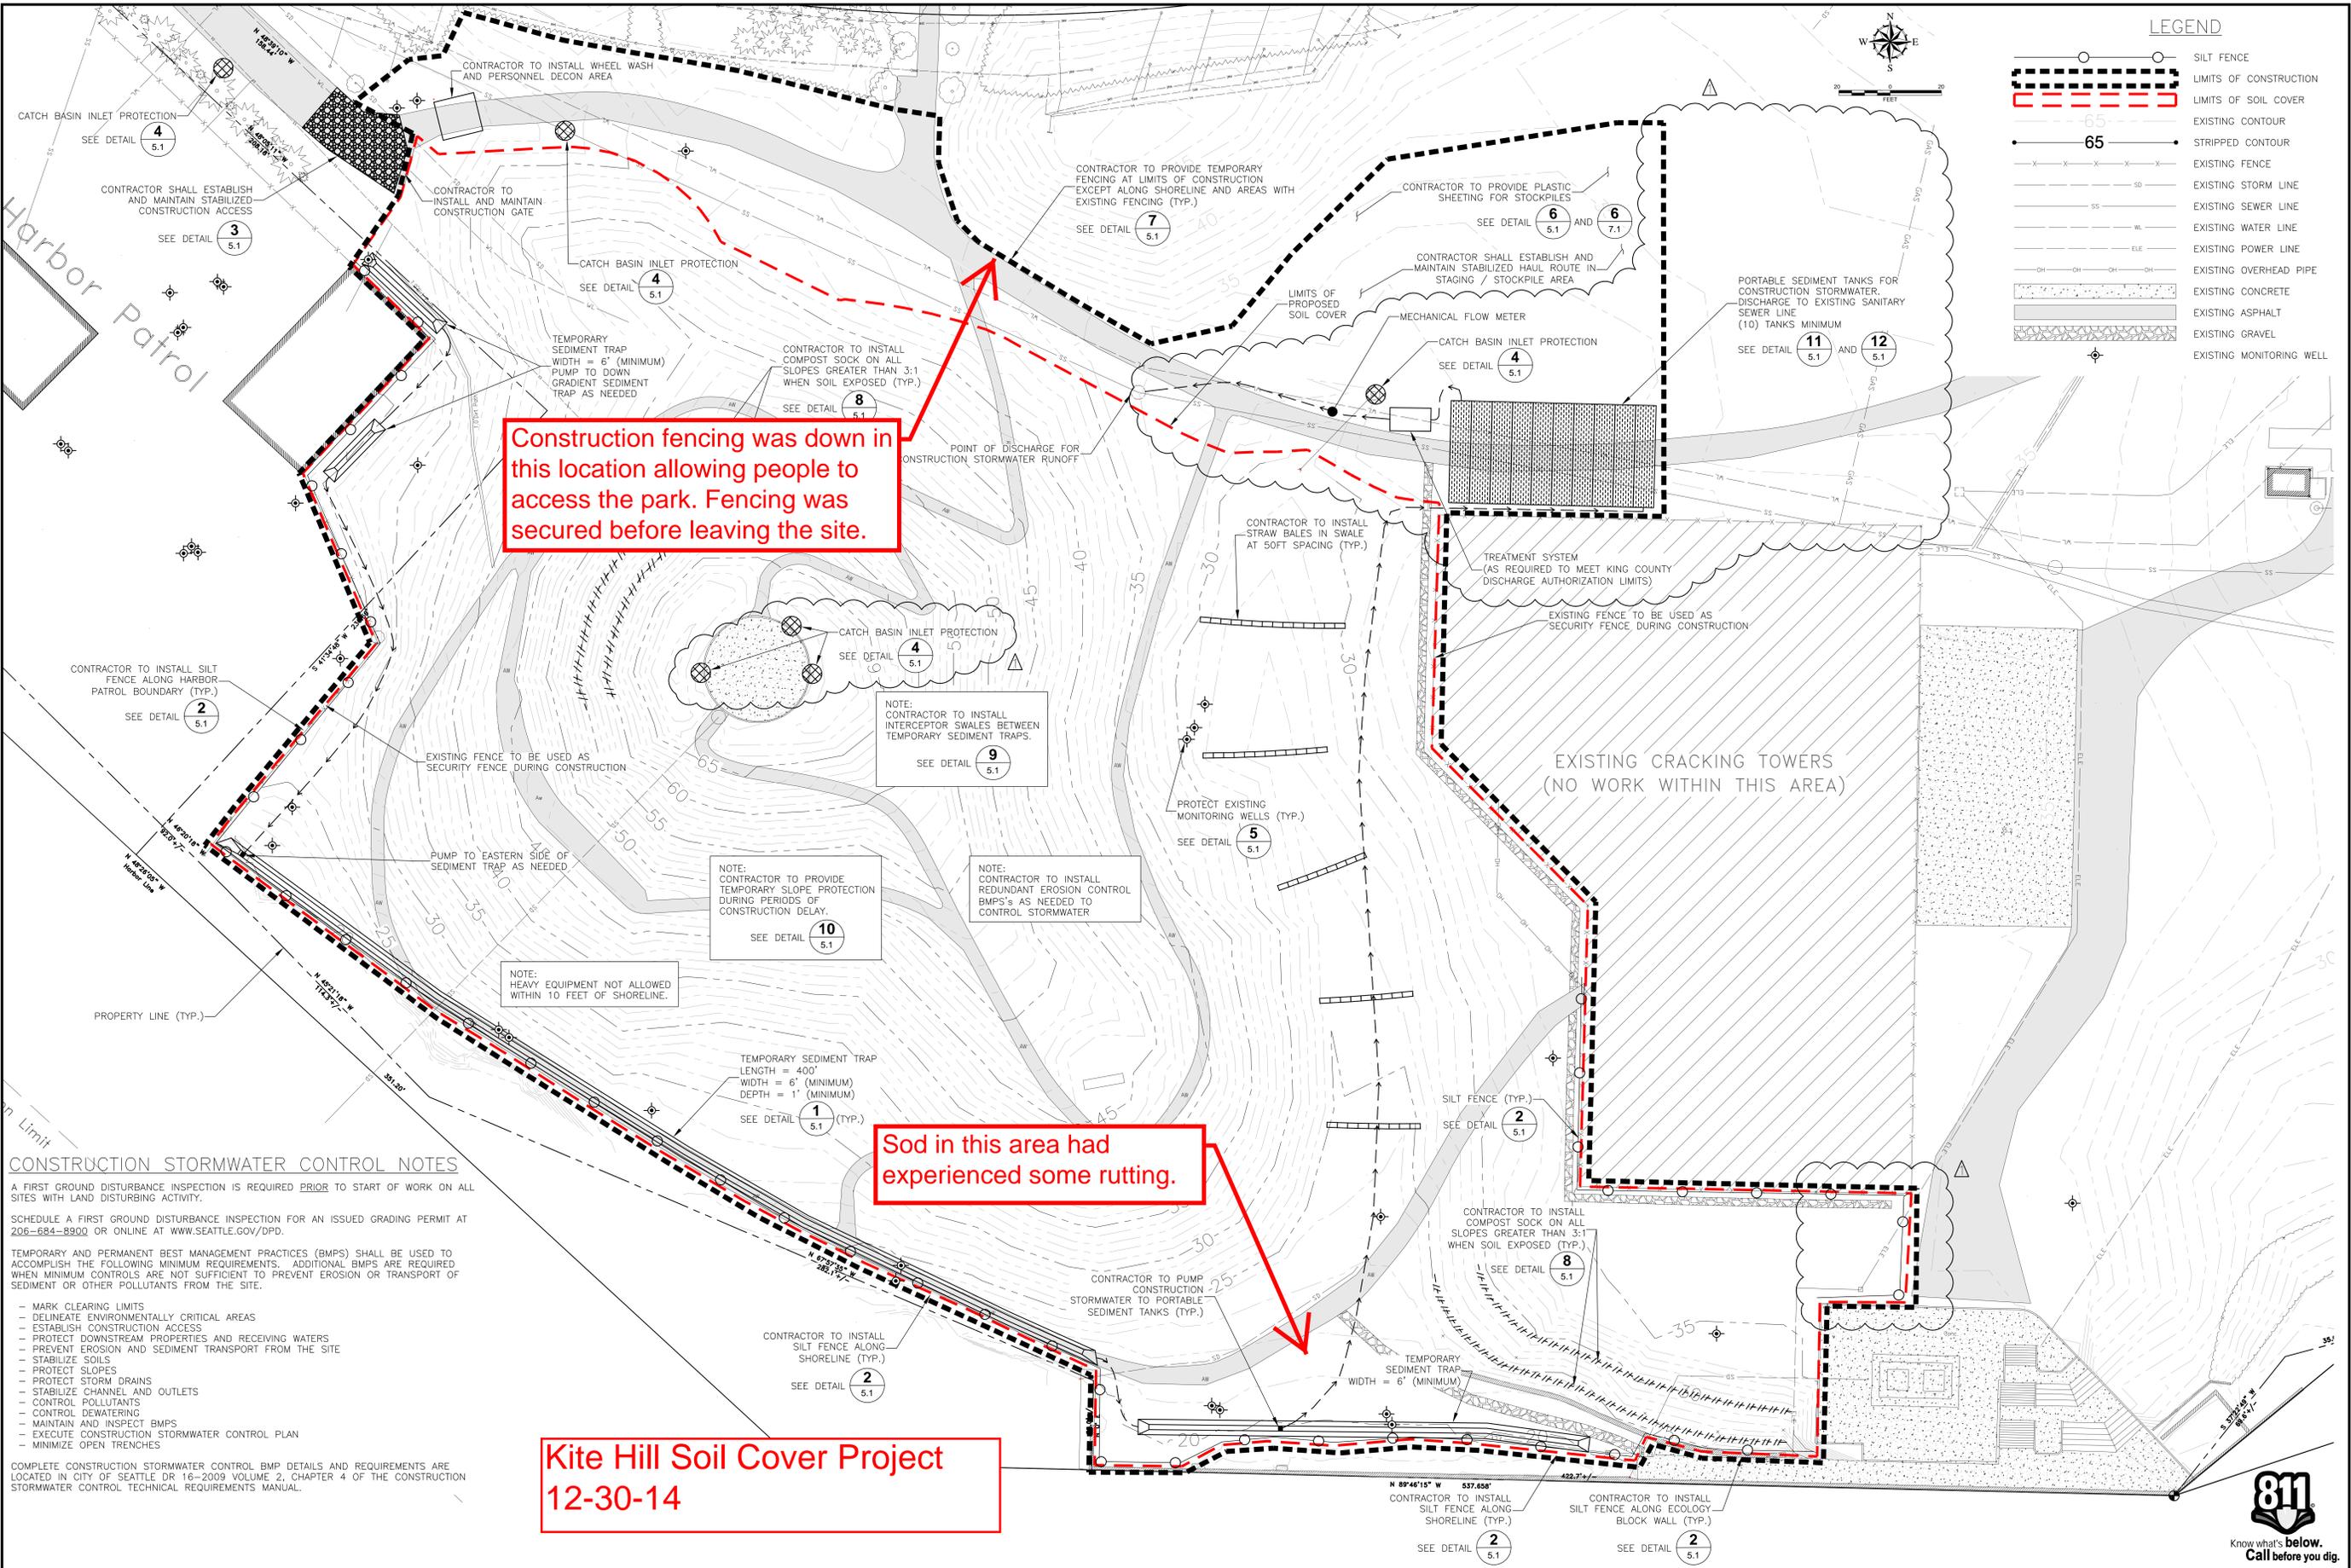
Construction fencing was down in this location allowing people to access the park. Fencing was secured before leaving the site.

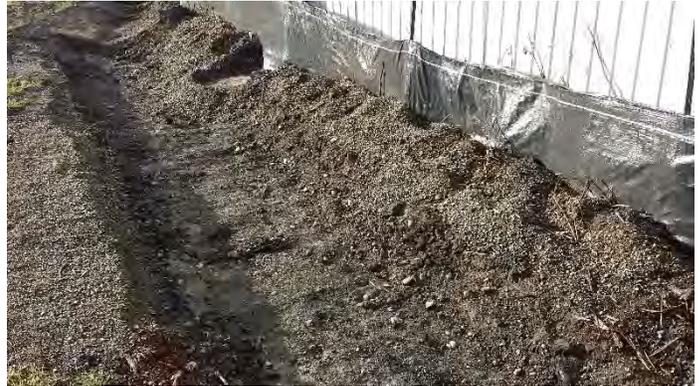
We observed the at-grade site conditions to consist mainly of sod/turf that slopes down from kite hill to the boundary of the site properties. At this time temporary erosion and sedimentation control efforts included personnel tasked with cleaning soil that migrates onto hard surfaces during excavation as well as infiltration trenches/silt fencing along the south and west perimeter of the site. The contractor also installed quarry spalls on the edge of asphalt pavement trucking route that is being used to deliver baker tanks on site. These efforts were observed to be functioning as intended so that soil was not observed to be leaving the site.

Based on our observations, it is our opinion that the temporary erosion and sedimentation control measures appear to be functioning in general accordance with the project plans and specifications.
