APPENDIX L (continued)
Field Report – Environmental

FIELD REPORT

Project:
Kite Hill Soil Cover Project

Location:
Gas Works Park, Seattle, WA

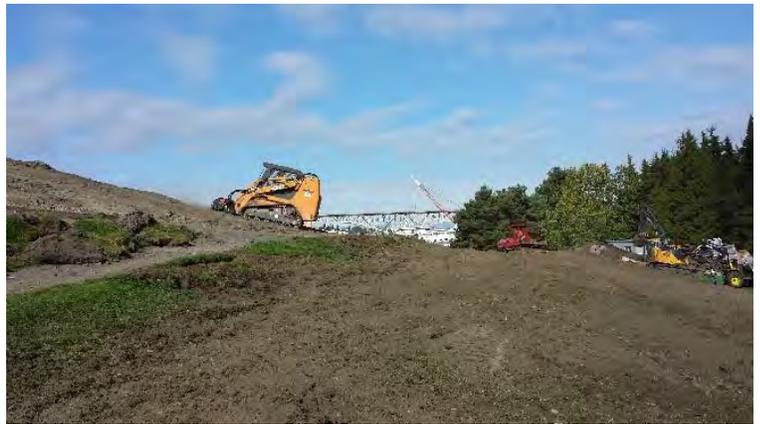
We observed the contractor continue tilling most areas of the site (see attached site plan). The contractor utilized a John Deere tractor with a rear mounted tiller and a bobcat with a front mounted tiller to break up and mix the sod and roots (see attached site plan). The till depth varied across the site between approximately 2 to 8 inches. The contractor encountered occasional concrete, brick and metal debris during tilling. Debris exceeding 4-inches in size was removed. It is our understanding that the contractor will continue tilling areas until the soil appears free of sod, roots, and organics and is inspected and deemed acceptable by the geotechnical engineer.

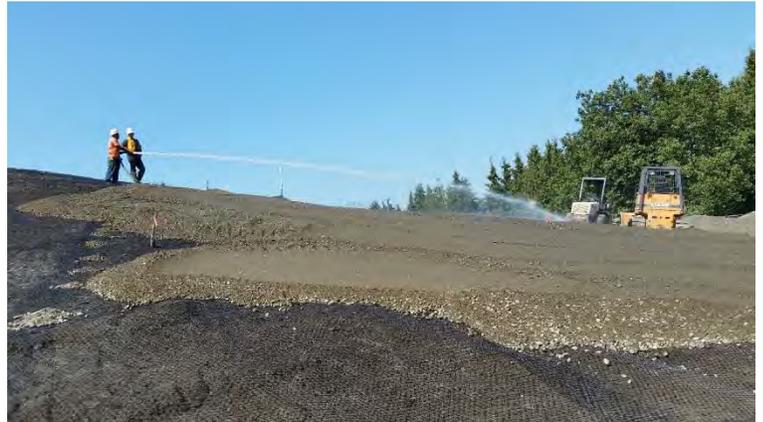
We observed the contractor lay geo-grid (Tensar TX130S) along the eastern slope of kite hill (see attached site plan). The area was evaluated before the geo-grid was placed to ensure that the area was compacted properly and was firm and unyielding. We evaluated the area using a ½-inch diameter steel probe and typical probe depths were between 2 to 3 inches.

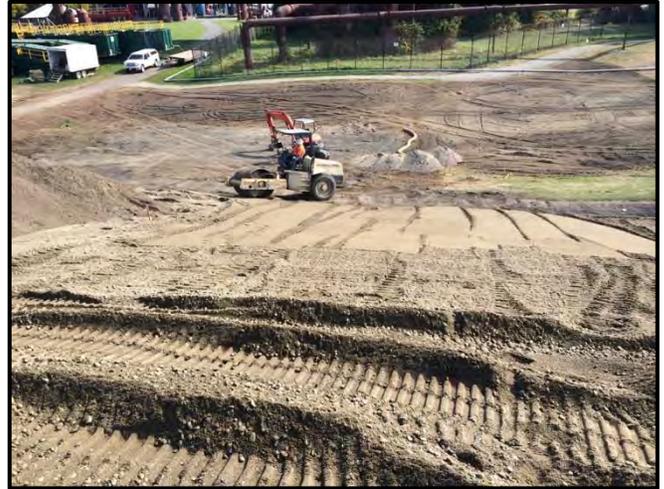
We observed the contractor place geo-grid (Tensar TX130S) on the prepared subgrade near the northeast quadrant of Kite Hill (see attached site plan). The subgrade was evaluated prior to placing the geo-grid to ensure that the subgrade was compacted properly and was free of pumping soil conditions. We evaluated the subgrade by means of probing with a ½-inch diameter steel probe rod. Probe depths were generally in the range of 2- to 3-inches.

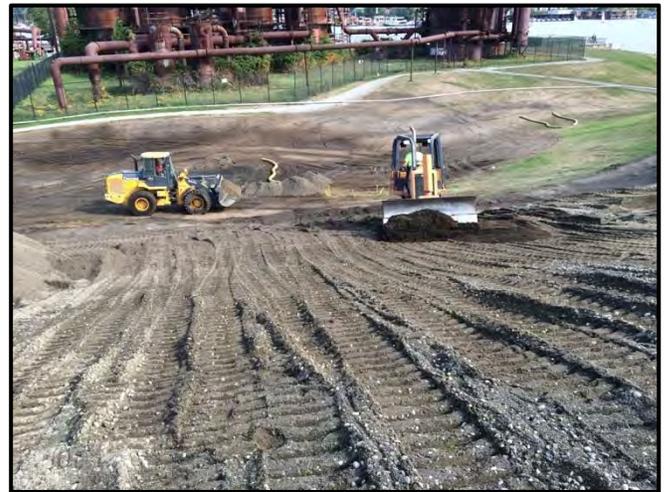
We also observed the contractor place an approximately 6-inch lift of City of Seattle Type 17 bank run gravel (City of Seattle Specification 9-03.12(2)B) over a portion of the geo-grid placed today (see attached site plan). The contractor was moisture conditioning the material utilizing a fire hose. The contractor was compacting the soil utilizing an Ingersoll Rand steel drum vibratory roller. The roller was only able to advance a short distance (~50-feet) before losing traction on the slope due to its steepness. After rolling, the material was track compacted with a minimum of 2 passes of a Case 650HLT dozer. We understand that the contractor will be having a hoepac delivered to the site tomorrow to compact the Type 17 in those areas not accessible to the roller.
