**RE: Pacific Sound Resources Superfund Site, West Seattle, WA
AOC# 10-94-0213
2023 Annual Progress Report**

Port of Seattle: Terminal 5 Cap Inspection Report

Attachment 1: RA-4 INSPECTION PHOTO LOG FOR PAVEMENT AND BALLAST COVERS, SURFACE WATER COLLECTION SYSTEMS, AND SECURITY SYSTEMS

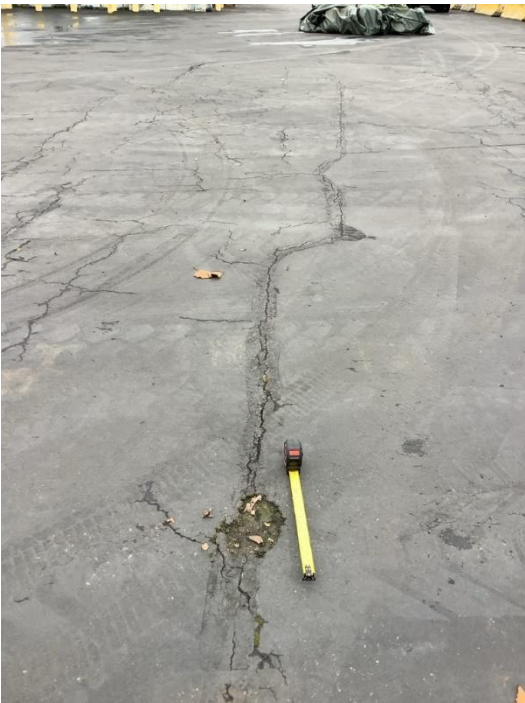
Several spidering and linear cracks >0.25" wide. Small holes present in cracks.	Clean and seal cracks, fill and seal holes.

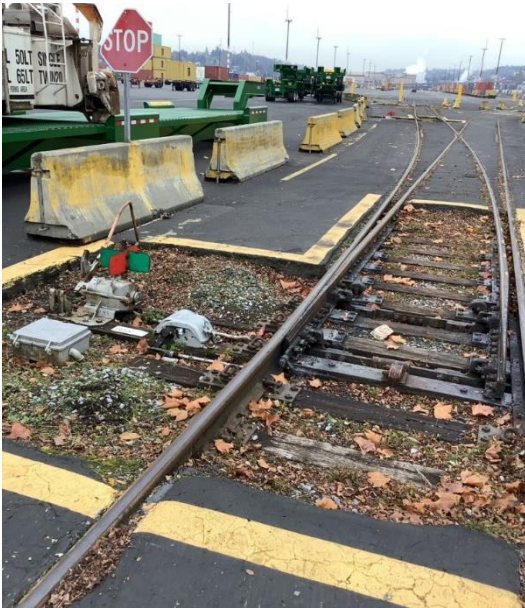
Light ballast coverage in switch pit.	Replace/restore ballast as needed.

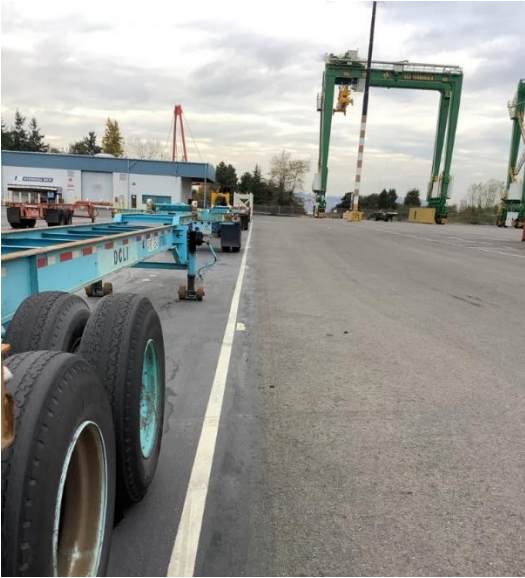
"Environmental Cap" demarcation present but mostly illegible	Replace the painted "Environmental Cap" label.

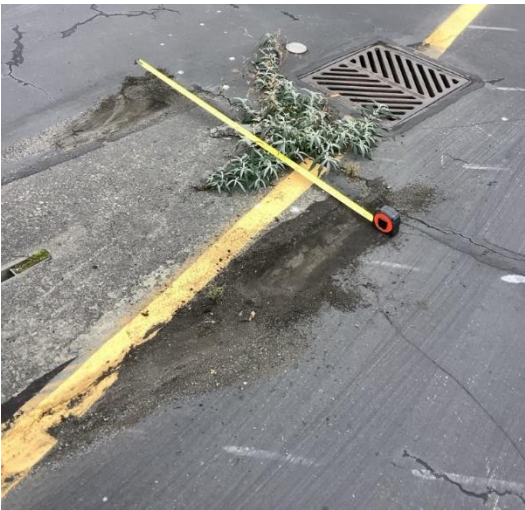
Vegetation in crack next to storm drainage. Settlement <3".	Remove vegetation, clean and seal crack. Surface patch for area of settlement.

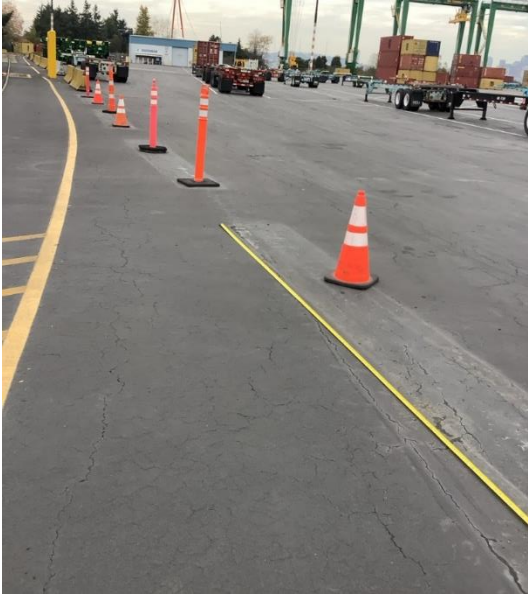
<p>Areas of unsealed pavement originally under jersey blocks.</p>	<p>Re-seal areas previously under jersey blocks.</p>

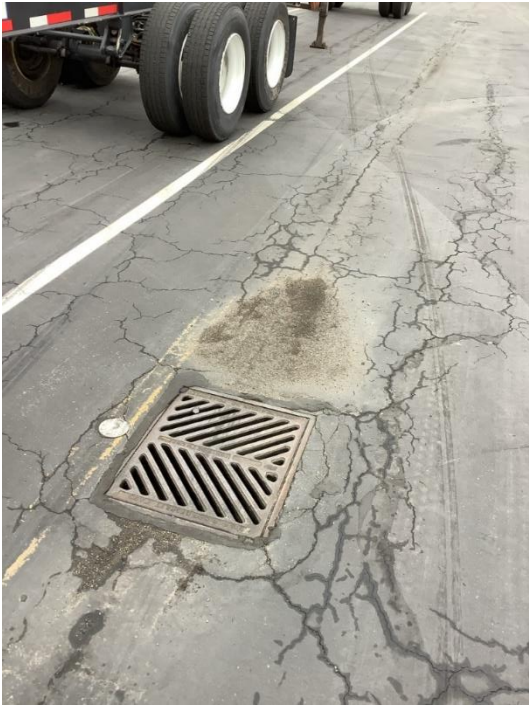
<p>Alligator cracking around catch basin and debris collecting next to storm drain.</p>	<p>Clean and seal cracks.</p>

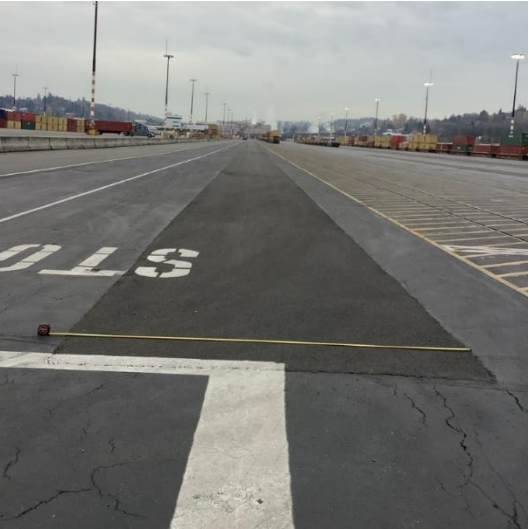
<p>Multiple patched pavement that has not been sealed that extend the length of RA (north – south).</p>	<p>Add seal coat.</p>

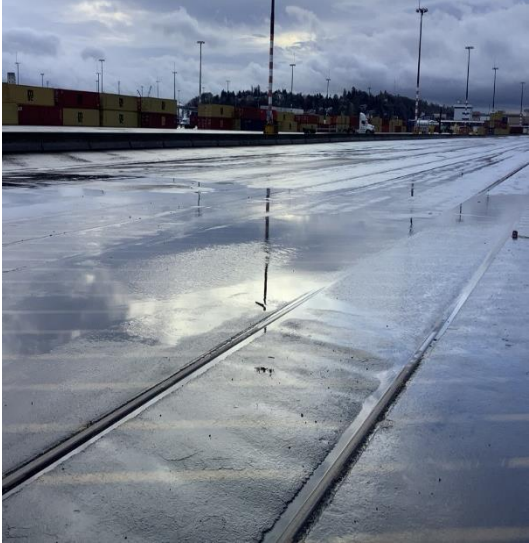
<p>Large area of standing water in tracks <3" deep.</p>	<p>Surface patch.</p>
