14 June 2022

Subject: Cap Integrity Monitoring
BNSF Railway Company, Hillyard Dross Cap
Spokane, Washington
KJ 2296114*00

Site photograph logs from the field inspection have been included as Attachment B.

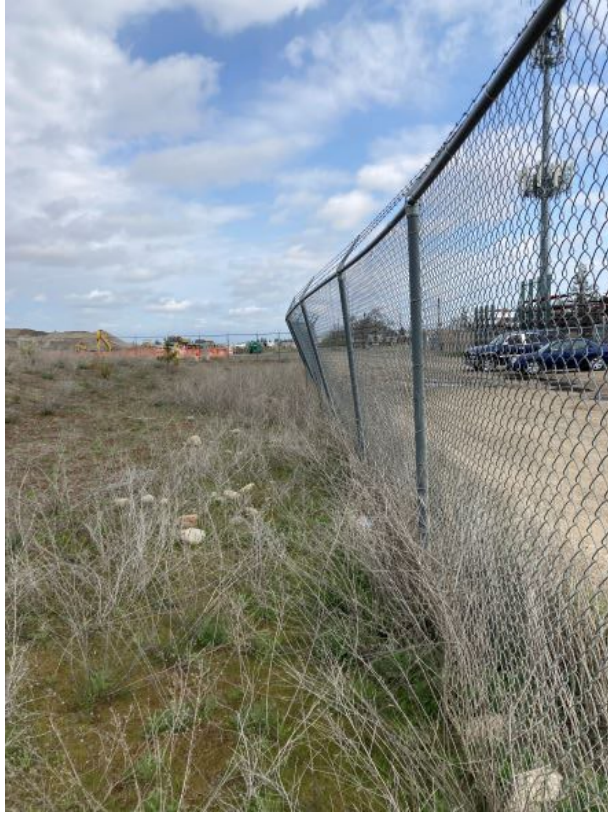
- Fence posts in the northeastern corner of the fence surrounding the dross cap were leaning, but the fence panels were stable and not in need of repair.

Photo #1: Leaning posts of fence enclosing the dross cap.

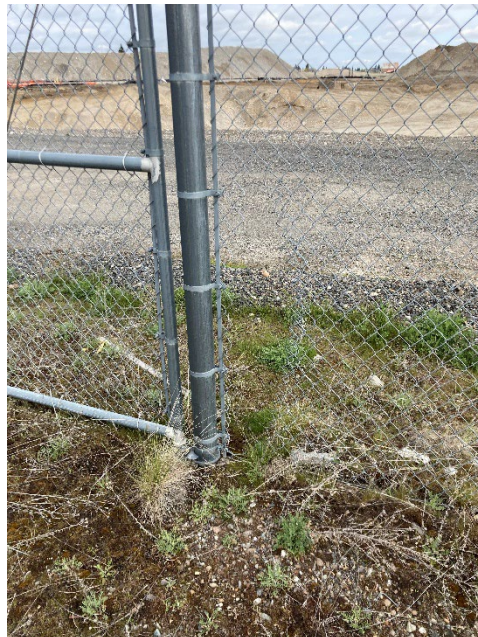
- A hole had been cut in the fence surrounding the dross cap; repairs will be performed.
- A small hole had been dug under the fence surrounding the dross cap; repairs will be performed.

Photo #2: Hole in fence enclosing the dross cap.

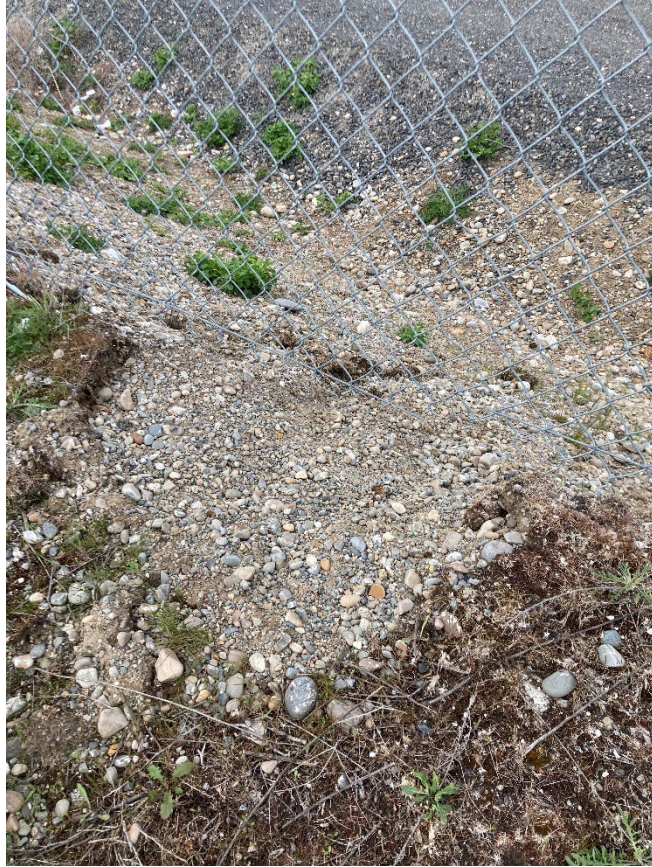
Photo #3: Hole under fence enclosing the dross cap.

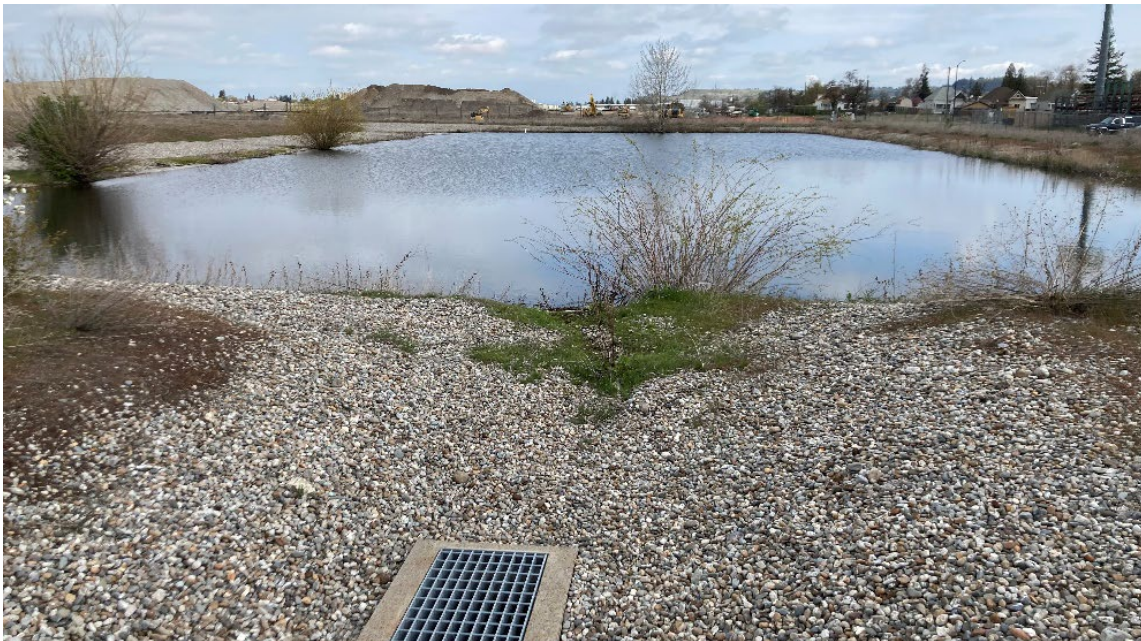
The evaporation pond that collects Site stormwater is located directly northeast of the dross encapsulation cell. Water level elevations measured in the pond are referenced to the North American Vertical Datum of 1988. Post-construction evaporation pond water level elevations are presented in Attachment A. The evaporation pond was not observed to be discharging to the overflow sump and drywell during April 2022.

Photo #4: Stormwater retention pond and overflow sump.

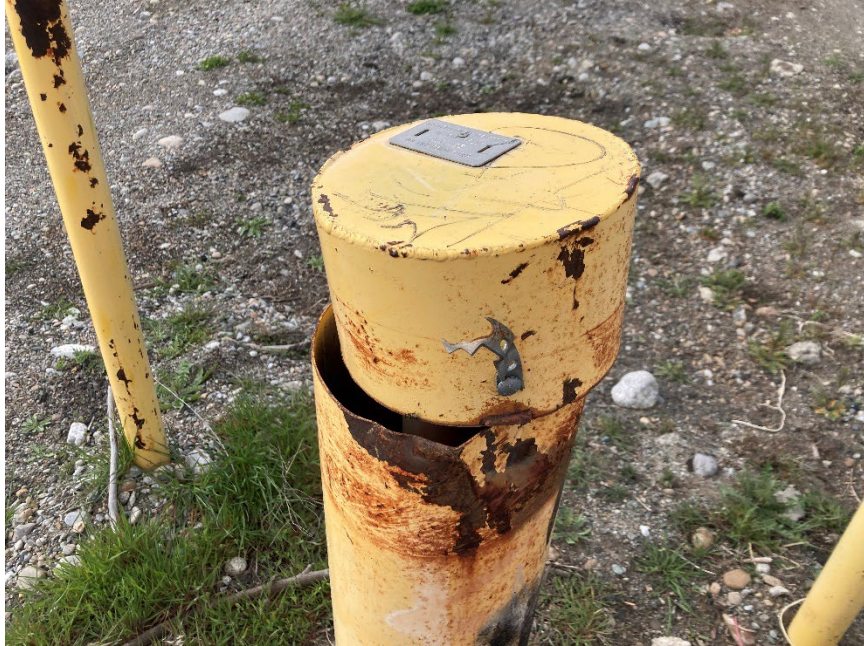
- The locking mechanism securing the monument of monitoring well MW-6 was found to be damaged during site inspections; repairs will be performed. Other monitoring wells were observed to be in good condition.

Photo #5: Damage to locking mechanism of monitoring well MW-6.

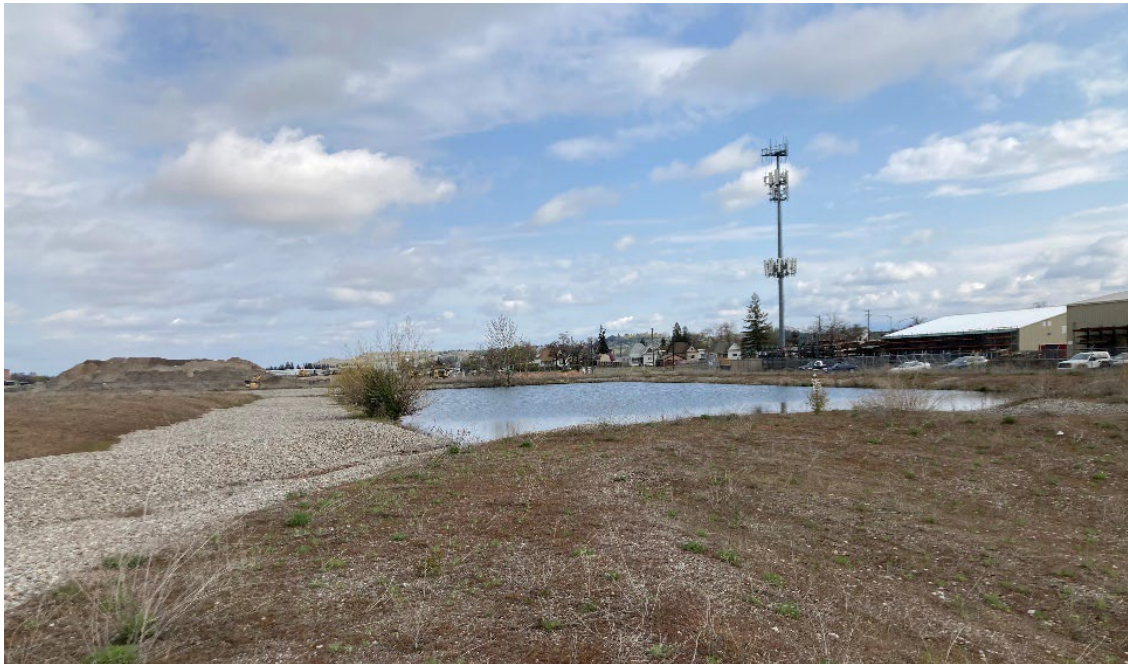
Photo #6: Stormwater retention pond and inlet channel.

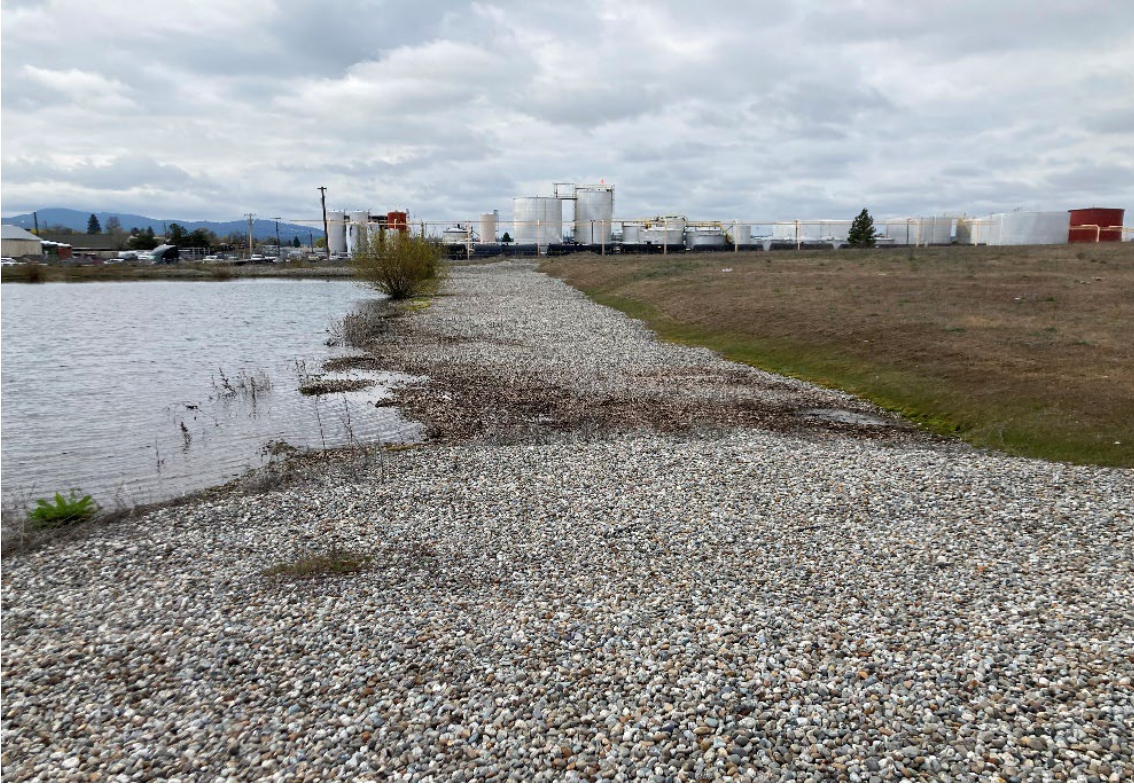
- A low area in the berm surrounding the stormwater retention pond was observed; more gravel will be added to the area.

Photo #7: Low area in berm surrounding stormwater pond.

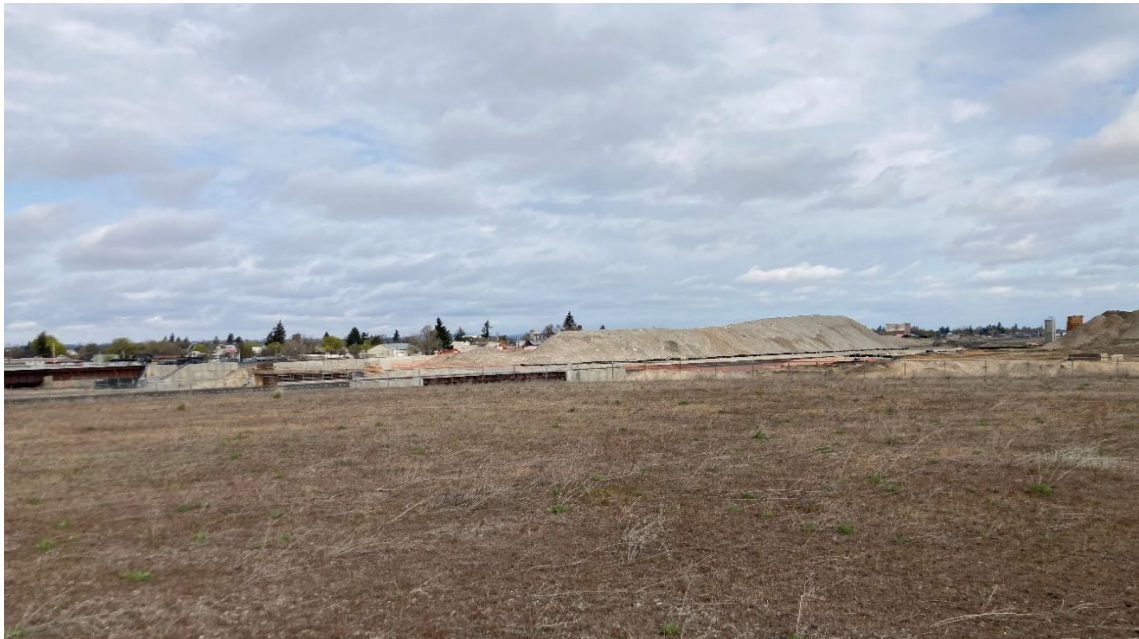
- Two monitoring wells (MW-3, MW-4) were in the work area of an ongoing Washington State Department of Transportation (WSDOT) project. The MW-4 monument was converted to a traffic-rated flush mounted monument by WSDOT, and MW-3 was decommissioned and replaced with a new monitoring well located outside of the work area.

Photo #8: Ongoing WSDOT work adjacent to the Site.

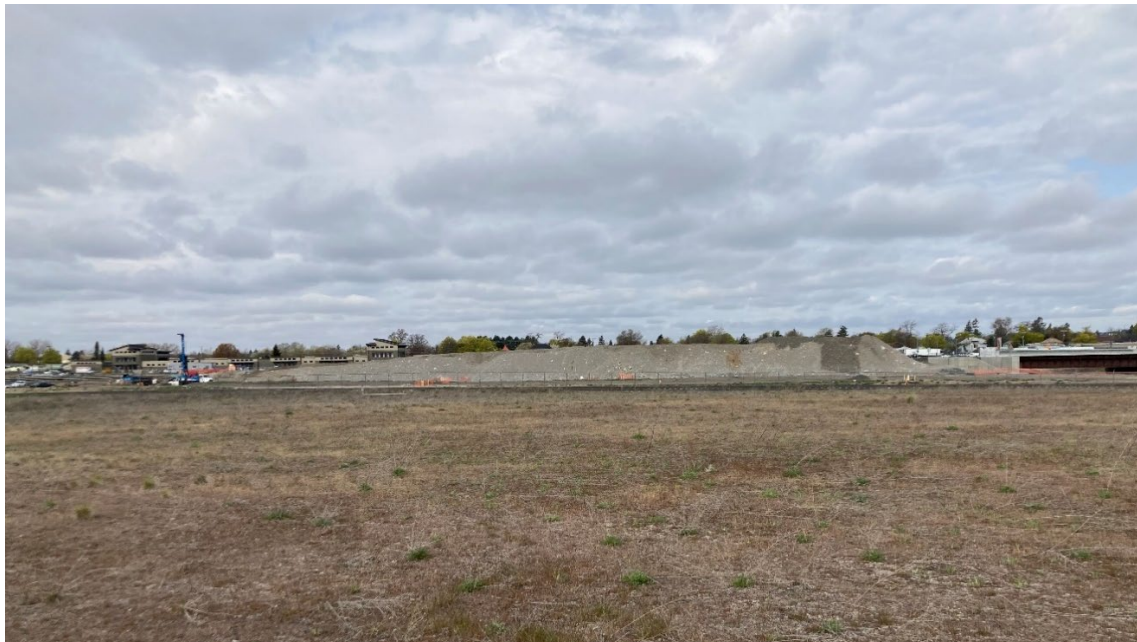
Photo #9: Ongoing WSDOT work adjacent to the Site.
