# Cleanup Action Report

*Union Pacific Railroad, Aluminum Recycling Trentwood Site*

**WSP USA Inc.**

May 3, 2024

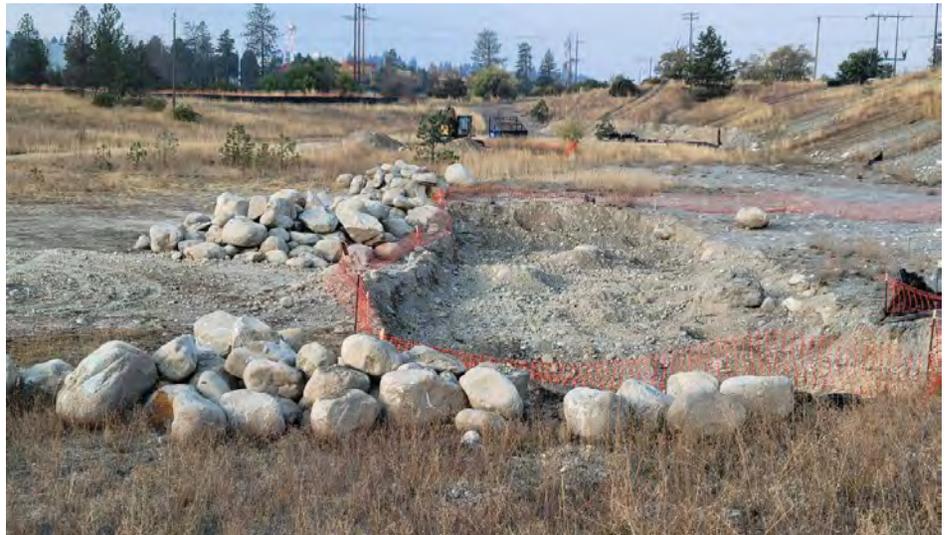
**PHOTOGRAPH 5**

During excavation, a significant number of boulders were encountered in the WSDOT property subgrade. Boulders were cleaned and stockpiled on-site prior to being put back in the excavations during backfill of the WSDOT property. See Appendix A for photographs of boulders observed in the WSDOT property subgrade.

Beginning excavation on the WSDOT property with Excavations #8 & #9. Large boulders observed. View looking west.

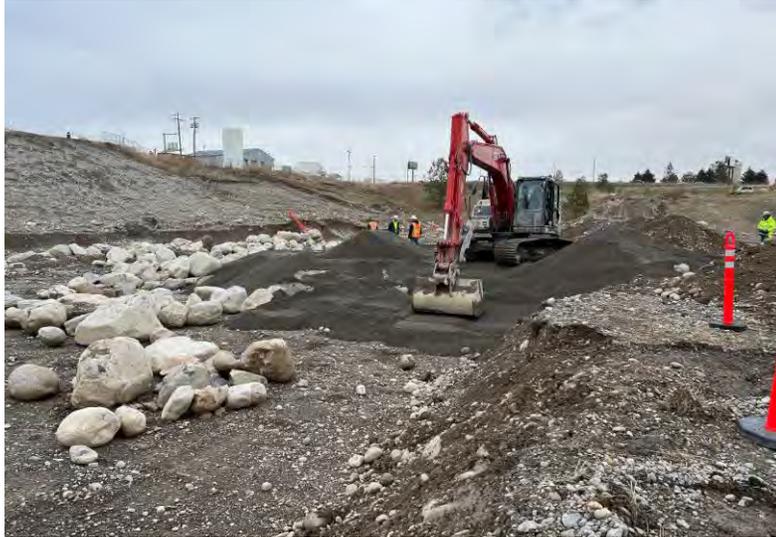
**PHOTOGRAPH 12**

Backfilling of the WSDOT excavations began on January 18, 2023. Backfill was placed in 12-inch-thick loose lifts and compacted with at least four passes of the roller. Boulders encountered during excavation were reburied in these excavations during backfilling of the WSDOT property. In areas where boulders were placed as backfill, it was unsafe or unfeasible to place backfill as specified. Consequently, in these areas, backfill material was placed in 2- to 3-foot-thick lifts or until the boulders were fully buried and then compacted with the back of an excavator bucket or at least four passes of the roller. Backfill #1 was placed around boulders using an excavator bucket and in a manner that minimized void spaces.

Backfilling of Excavation #7 in 1-foot-thick loose lifts (or as able around boulders) and compaction with back of excavator bucket. View looking east.

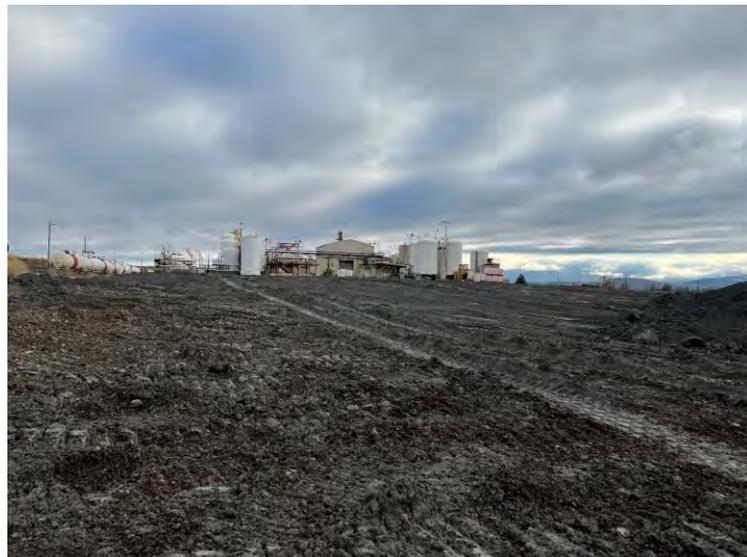
**PHOTOGRAPH 14**

On the UPRR property, the dross stockpile material and underlying soil were excavated to approximately 1 foot below the existing ground surface elevation around the periphery of the stockpile. At this elevation, a minor amount of dross material was observed comingled with native ground material. Test pits of randomly chosen areas with visible dross were excavated to determine the depth extents of the dross stockpile. The results of these test pits indicated a uniform bottom of the dross stockpile was unable to be determined. However, sampling, testing, and analysis conducted in the dross stockpile area after stockpile removal confirmed that remediation levels were achieved (see CMR in Appendix F for details).

Dross stockpile final excavation surface after confirmation sampling met remediation levels. View looking east.

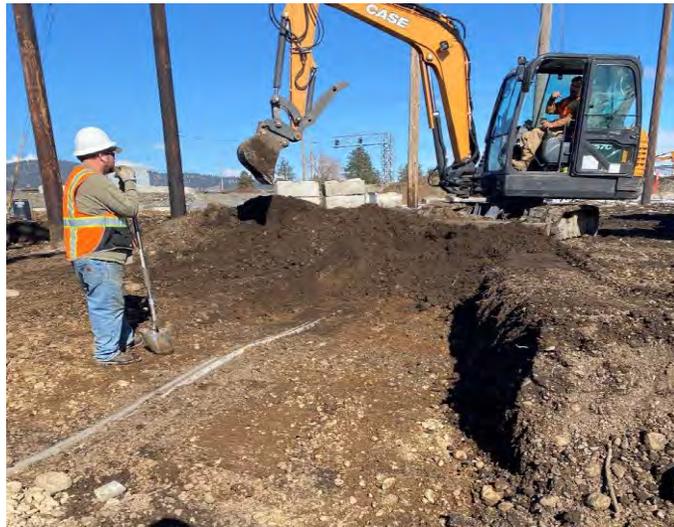
**PHOTOGRAPH 22**

Excavation around BPA infrastructure on the Pentzer property to a depth of approximately 2 feet. Hand digging around ground wire conduit. View looking east.

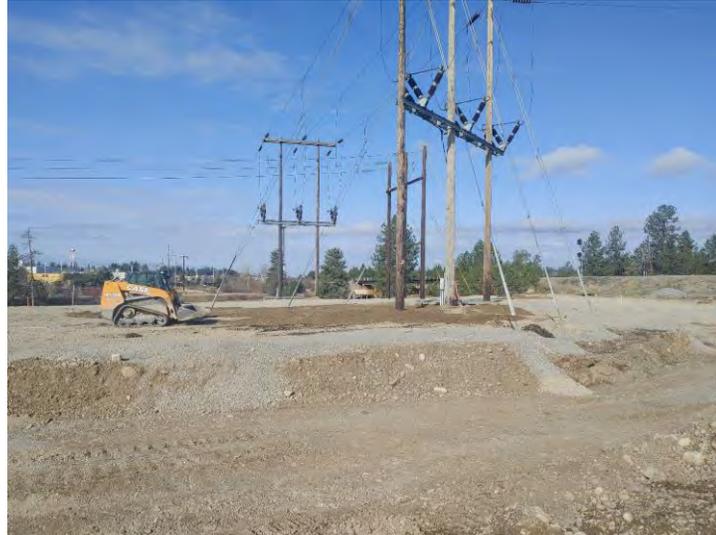
**PHOTOGRAPH 33**

Backfilling activities performed under and around utilities owned by BPA, Avista, and Inland Power and Light were communicated to and approved by the power companies. Hand shovels were used to place material immediately around the power company infrastructure, and then the material was compacted. The water truck was used in the working areas to moisture condition the soil for the compaction efforts and to suppress fugitive dust. BPA personnel at the Site approved the use of imported backfill material to be placed up to final grade around their infrastructure. See Appendix C for imported backfill extents.

Imported backfill material was placed around BPA infrastructure up to final grade using the John Deere 624 loader and the CAT TR270B skid steer with bucket attachment. Hand shovels were used to place material immediately around the infrastructure. View looking northwest.

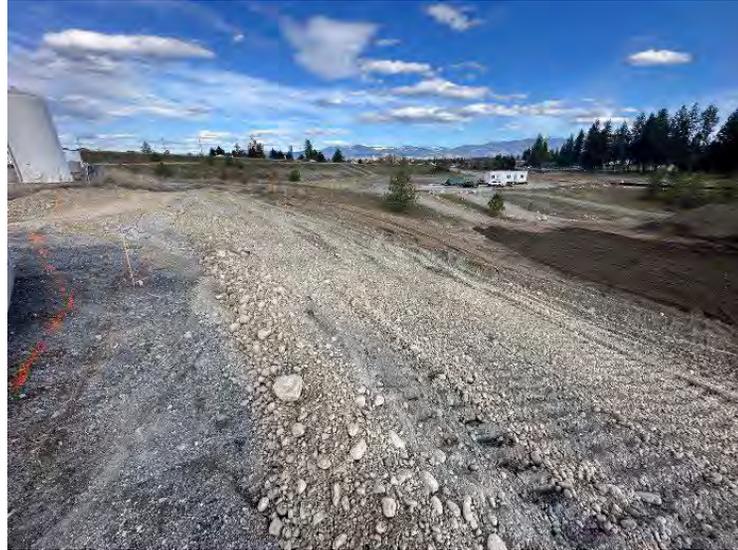
**PHOTOGRAPH 36**

A steep portion on the UPRR side slope was graded to a shallower angle. View looking east.

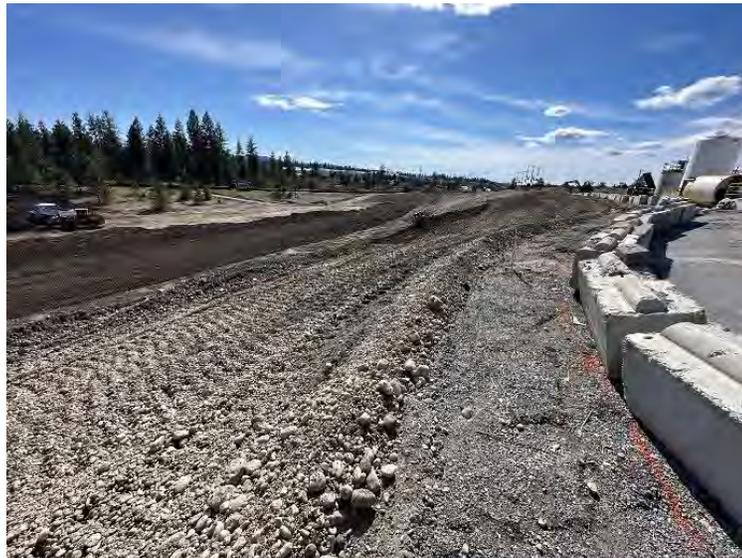
**PHOTOGRAPH 37**

A steep portion on the UPRR side slope was graded to a shallower angle. View looking west.

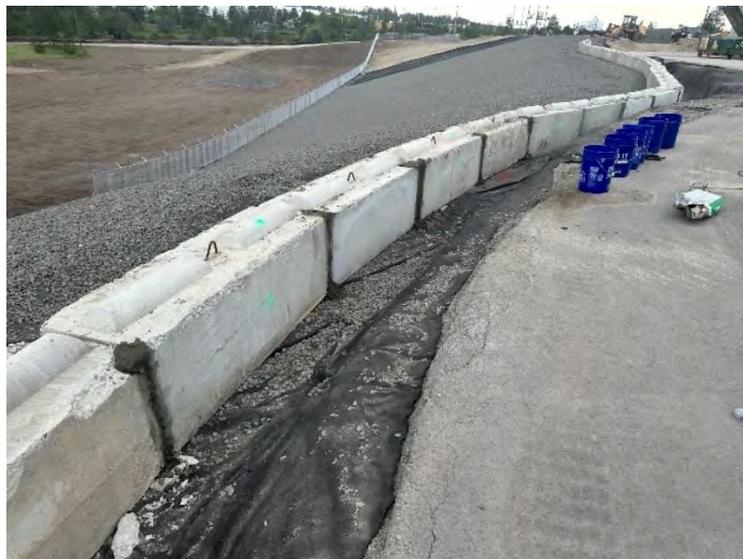
**PHOTOGRAPH 50**

Ecology block surface water feature. Gaps sealed with mortar. View looking west.

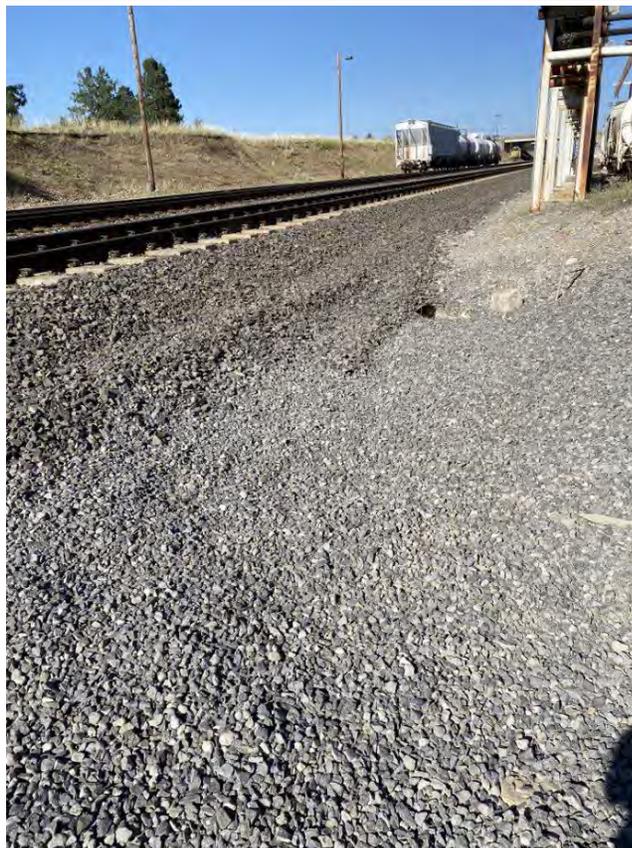
**PHOTOGRAPH 58**

During construction, a culvert outlet was observed at the eastern end of the railroad ditch which had not been observed during previous Site visits because this area was not accessible. The railroad ditch was constructed to continue to allow any water from the culvert outlet to drain into the railroad ditch.

Pre-existing culvert outlet located at the inlet of the completed railroad ditch, situated on the furthest north-east corner of the UPRR pad property. 6-inch lift of clean crushed 1- to 2-inch ballast within the railroad ditch. View looking east.
