SCOLES ASSOCIATES, INC.

October 19, 1989

This letter is a decommissioning report for the 1,000 gallon underground storage tank (UST) removed from 531 South 28th Street, Washougal, Washington on August 20, 1989. This report summarizes the UST removal process, existing soil conditions, analytical sampling, and laboratory results. Scoles Associates, Inc. (SAI) has compiled this report for the express use of the Port of Camas / Washougal and its designates.

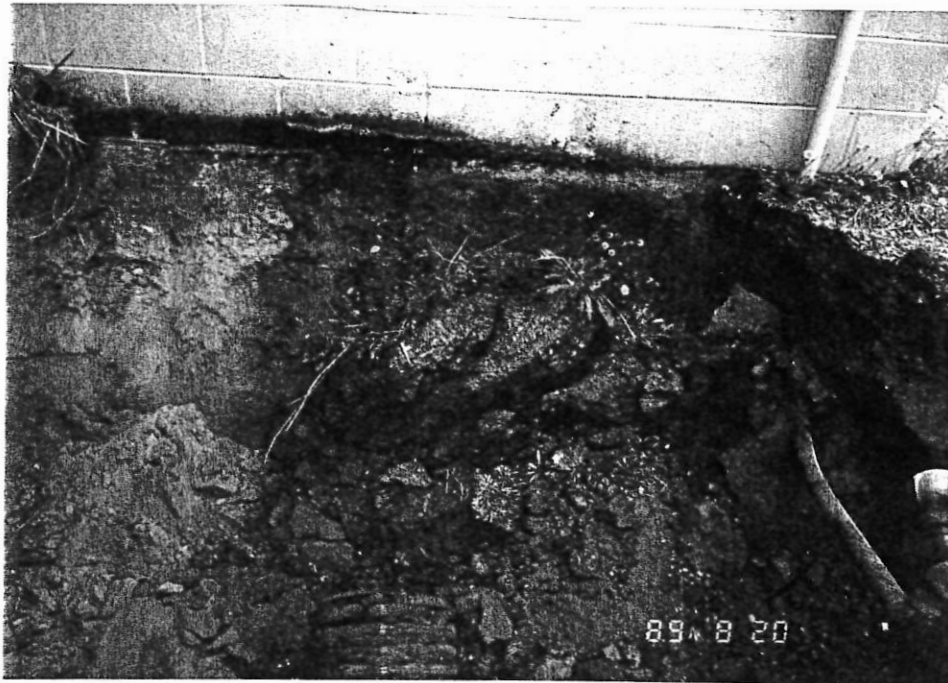
PHOTO NO. 1. View of the south side of the tank pit for UST no. 10 on the northwest side of Building 4, at 531 South 28th Street, Washougal, WA.

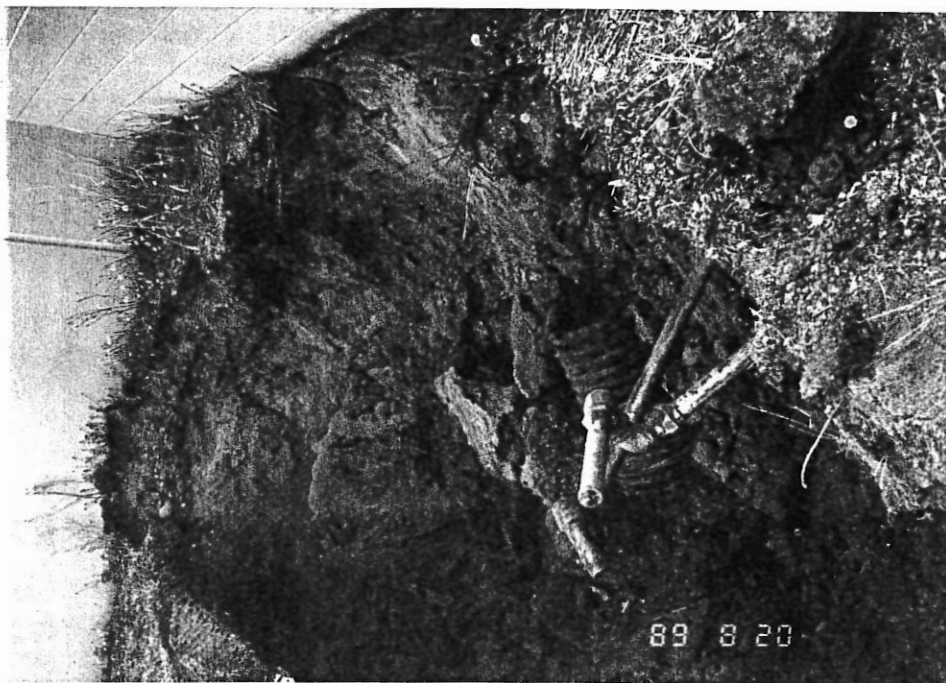
Fuel leakage was observed — by sight and smell — in the bottom of the tank pit and directly below the fuel dispenser. Above the 6-foot depth, the sandy soil was stained grayish blue and had a slight diesel odor. Below 6 feet, the clay soil was discolored dark

PHOTO NO. 2. Vertical view of the tank pit for UST no. 10. In the foreground, the venting and fuel dispensing pipes are visible. The product line is suspected of leaking.

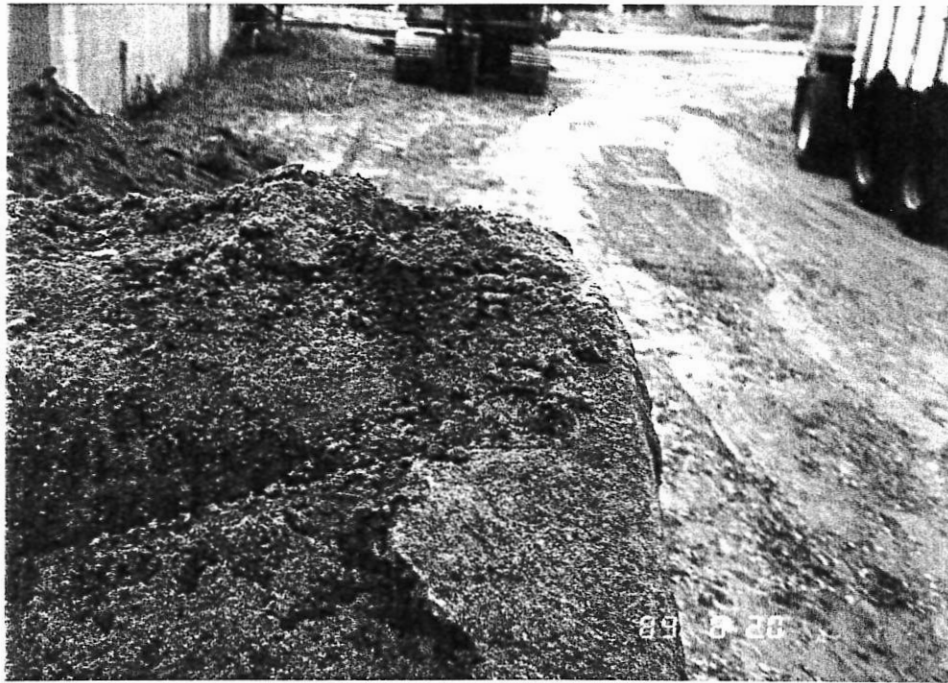
PHOTO NO. 3. Close up view of the fill spout area on UST no. 10. The top and upper half of this tank did not have any indication of fuel contamination

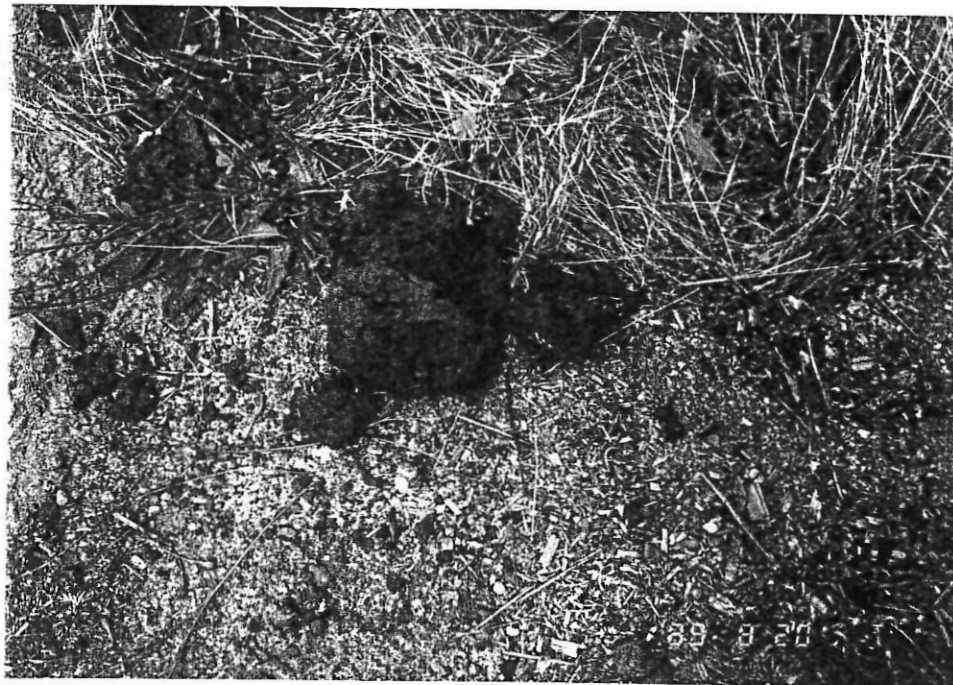
grayish blue and had a moderate diesel odor. The area having the highest apparent fuel contamination was below the fuel dispenser and pump. The UST was also inspected for fuel contamination; none was apparent on the top, but the bottom and lower side surfaces had diesel-contaminated soil attached to it. The exterior of the UST appeared in fair to good condition, so the fuel dispensing line is suspected of leaking fuel and contaminating the soil below the tank. The attached photographs show the condition of the tank and tank pit after removal and prior to sampling.

PHOTO NO. 4. Close up view of petroleum-contaminated clayey wetland soil collected from below the sandy dredge material under UST no. 10. This soil was discolored dark grayish blue and had a moderate diesel odor.

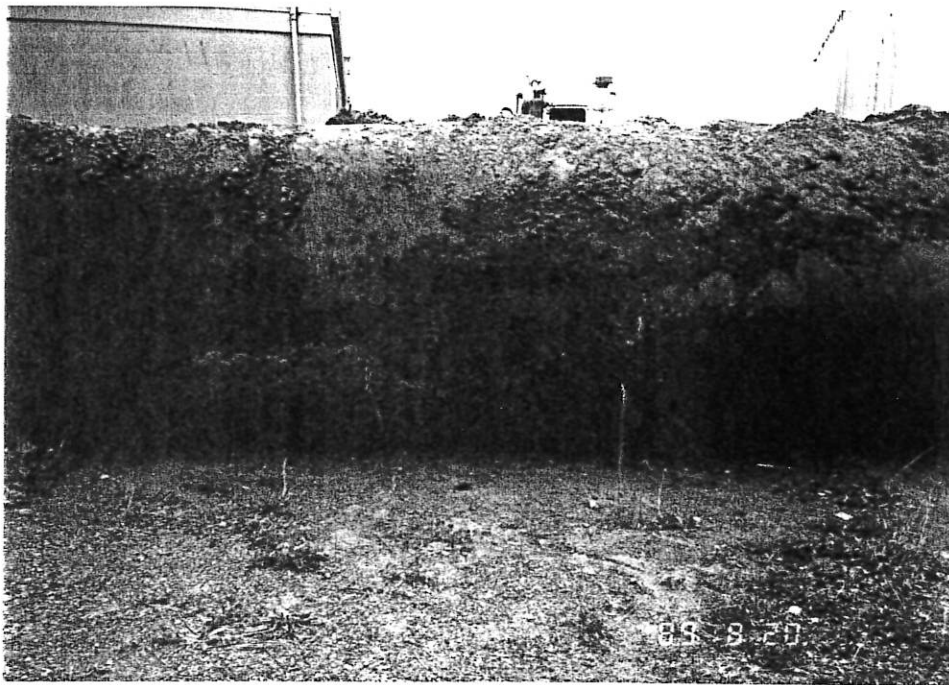
PHOTO NO. 5. Side view of UST no. 10. The exterior surface (unprotected) was in fair to good condition on all sides. The upper half had significantly more rust and scaling than the lower half.

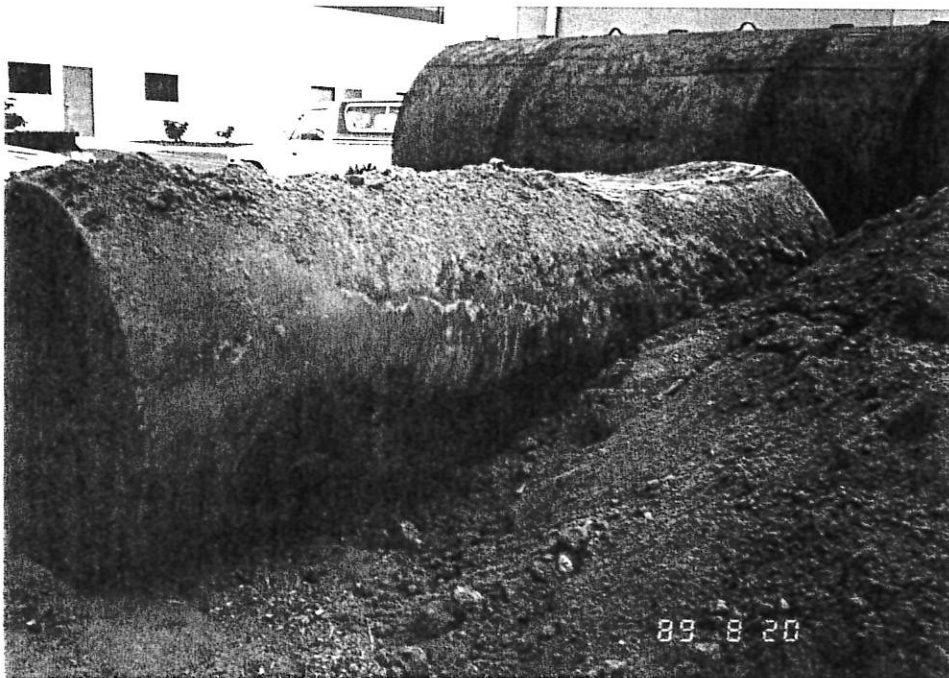
PHOTO NO. 6. Opposite side view of UST no. 10 after removal. The UST had no apparent leakage point, and the fuel dispensing line is suspected of leaking.

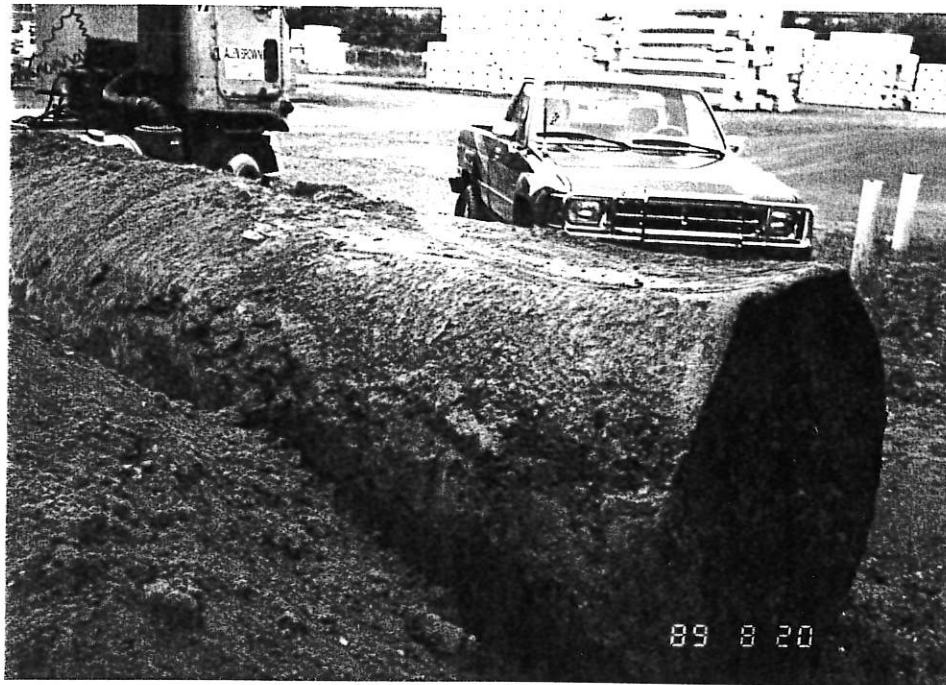
PHOTO NO. 7. End view of UST no. 9 after removal from the tank pit.

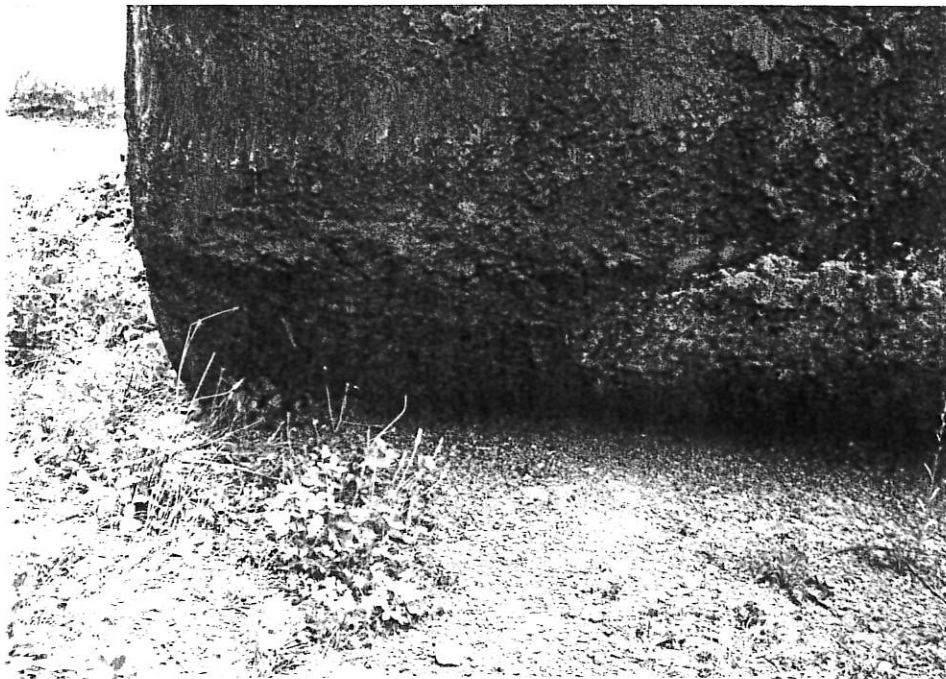
PHOTO NO. 8. Close up view of a lower corner of UST no. 10. The dark discoloring is the fuel-contaminated soil still attached to the tank exterior.
