SITE INSPECTION REPORT FOR
LYNNWOOD PLATING COMPANY, INC.
LYNNWOOD, WASHINGTON

TDD R10-8510-25B

Report Prepared By: Ecology and Environment, Inc.
Project Manager: William Carberry
Date: October 1986

SITE INSPECTION REPORT FOR
LYNNWOOD PLATING COMPANY, INC.
TDD R10-8510-25B

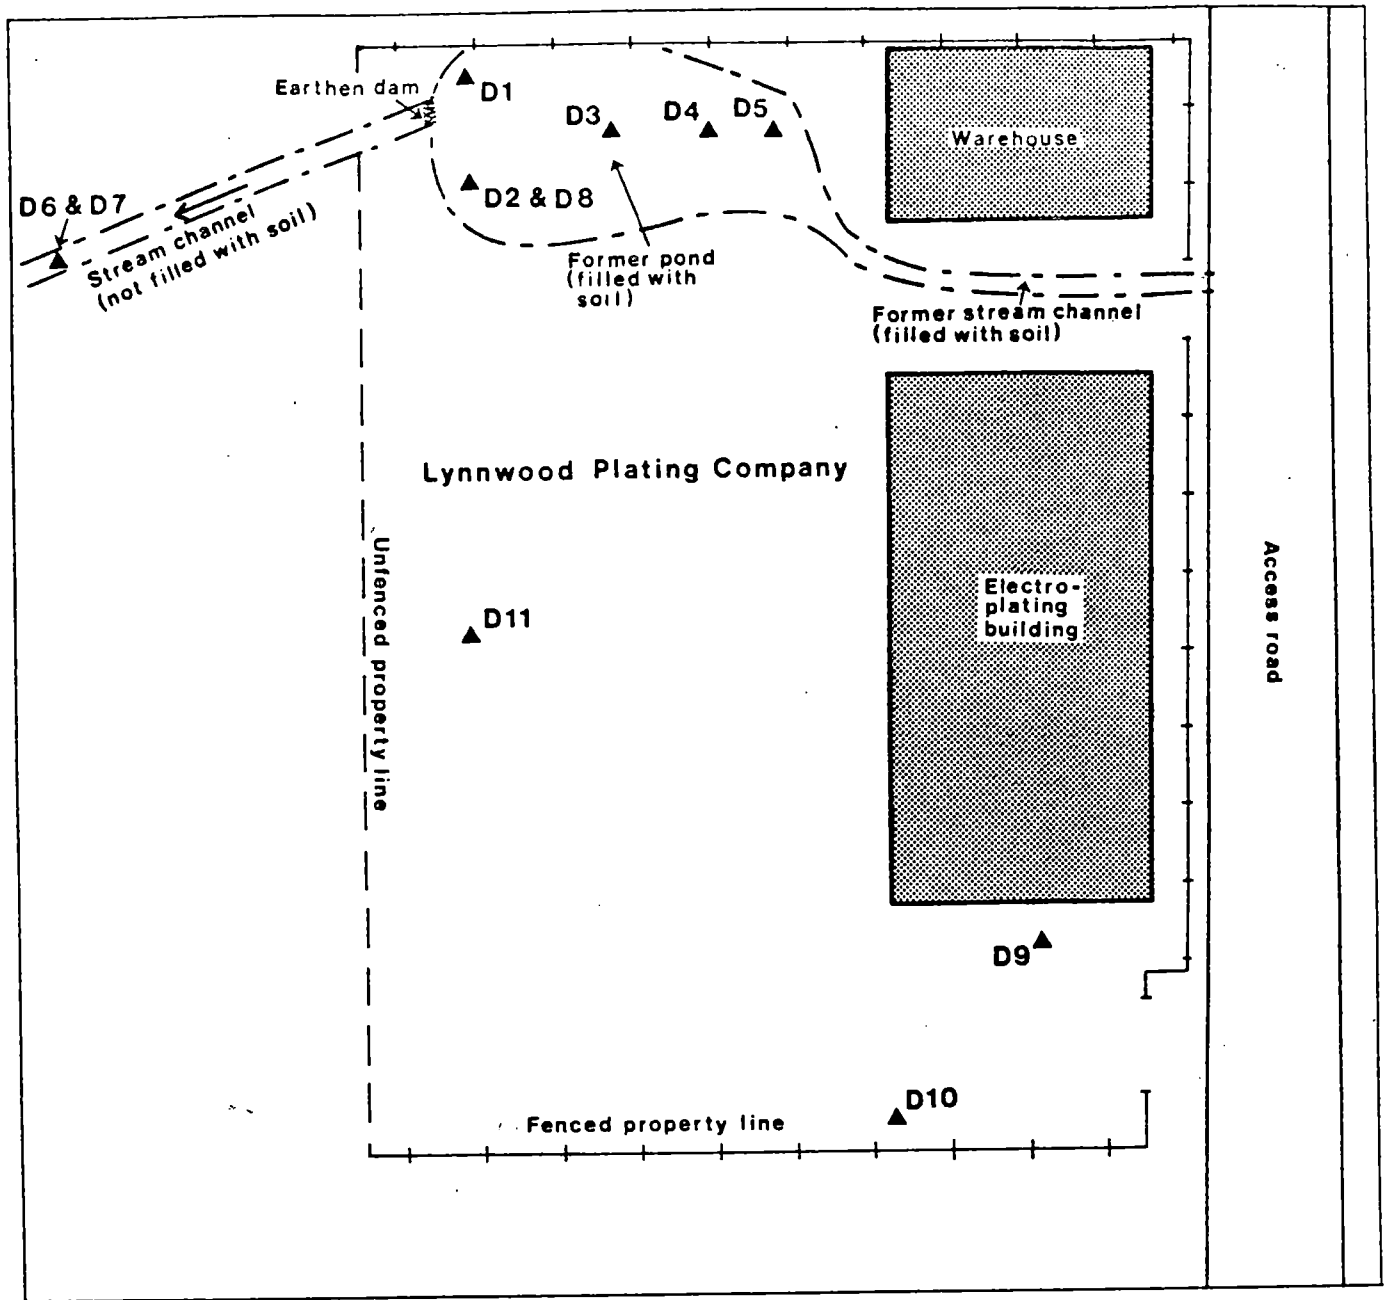
Samples D1 to D5, D7, and D8 were collected from borehole drill cuttings at depths of two to three feet below ground surface. The remaining samples (D6 and D9 to D11) were surface soil samples collected from the upper six inches of the soil column. As the entire surface of the site was covered by fill, sample D11 is considered to be a background sample only in that it was collected away from any areas of known wastewater disposal.

Two samples were collected approximately 85 feet downstream of the former on-site pond in what appeared to be the old stream channel. Surface sample (sample D6) had levels of chromium (1,490 mg/kg) and nickel (6,880 mg/kg-estimated) that were more than fifty times the background concentrations. The subsurface soil sample collected at this point (sample D7) was collected at the estimated water table level (based on standing surface water located ten feet from the sampling location, and the moisture content of the soil when sampled). Chromium (281 mg/kg) and nickel (691 mg/kg-estimated) reported from the analysis of this sample were 13 and 5 times their respective background concentrations.
