SCS ENGINEERS

July 11, 2024 File No. 04224030.19

Subject: Work Plan for Additional Landfill Liner Investigation to Address Surface Water

Management Issues, Northeast Corner of Closed Leichner Landfill, Clark County.

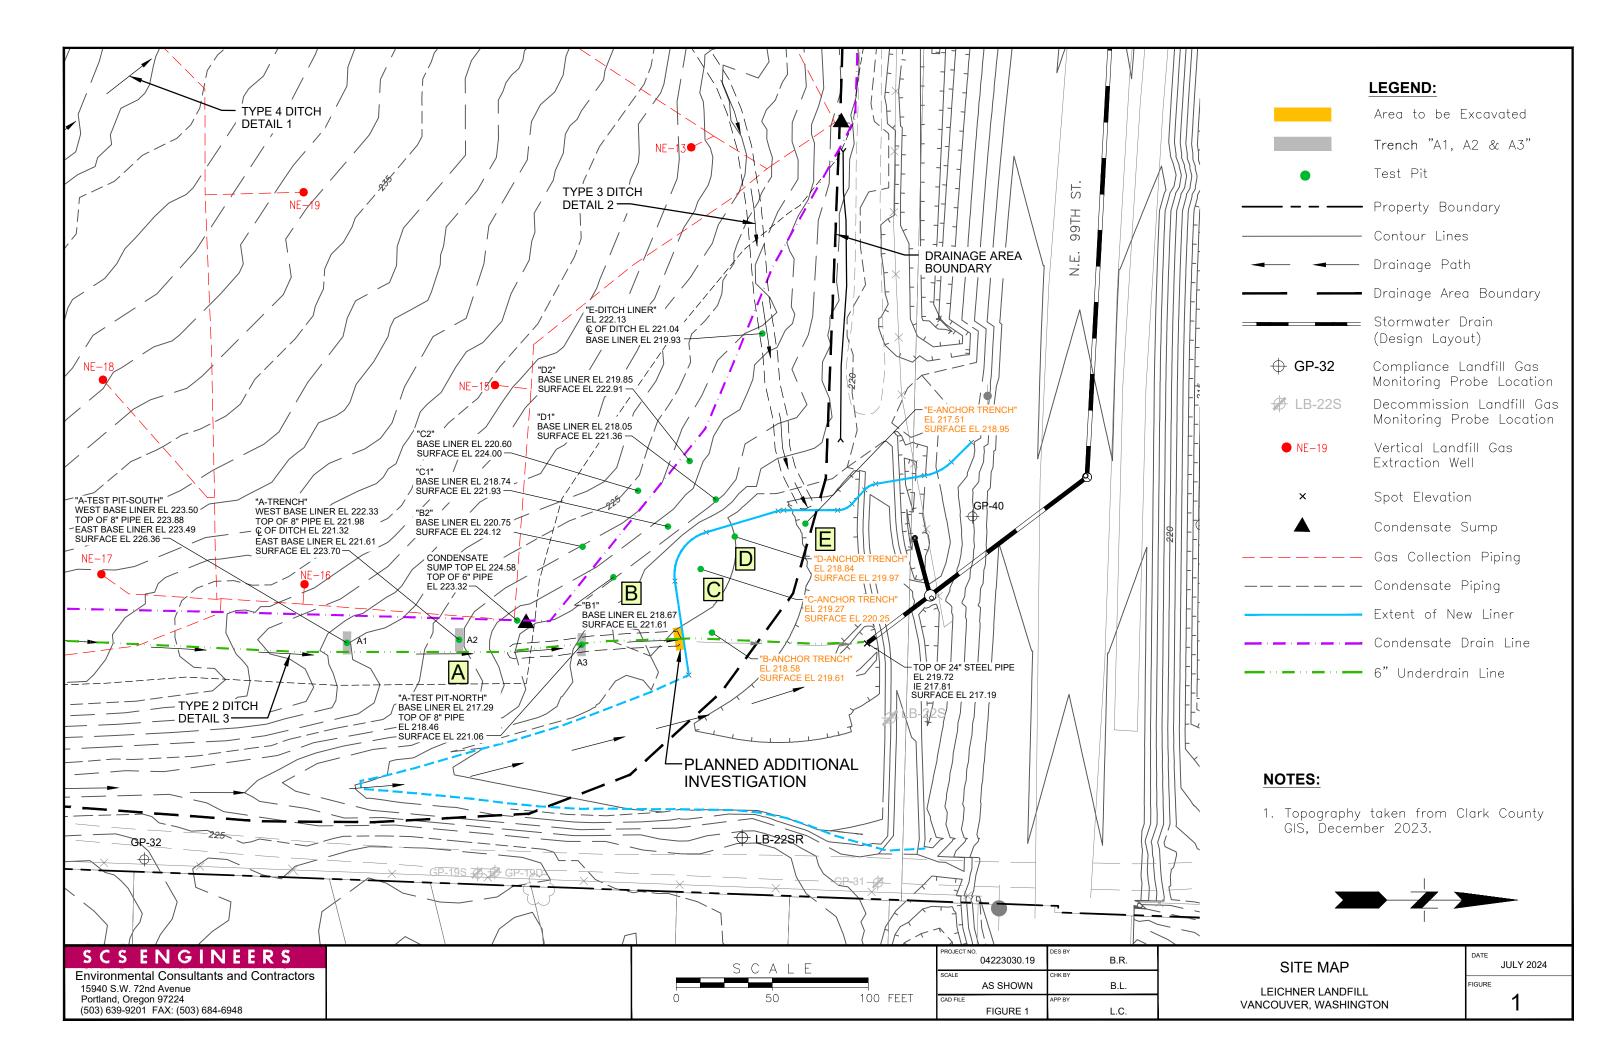
figure 1 v0.4 - 2024-07-09 (WIM 1908) Syding, 7711/2024 9,2953 AM, DWG TO PDF

The attached Figure 1 shows the location of each hand excavation and test pit. The above information will be used to create profile drawings through the investigation area that will be used to evaluate possible remedies to the drainage issues observed during the 2023-2024 winter season.

The location where the two drainage pipes were originally observed in the anchor trench will be excavated to expose the deeper drainage pipe. The approximate location of the planned excavation is shown on Figure 1. The edge of the geomembrane will be exposed within the anchor trench. Since the geomembrane for the 99th Steet extension was not welded to the original cover geomembrane, the 99th Steet extension geomembrane will be pulled back to expose the installed drainage rock. It may be necessary to cut the 99th Steet extension geomembrane to excavate the anchor trench area and expose the deeper drainage pipe.

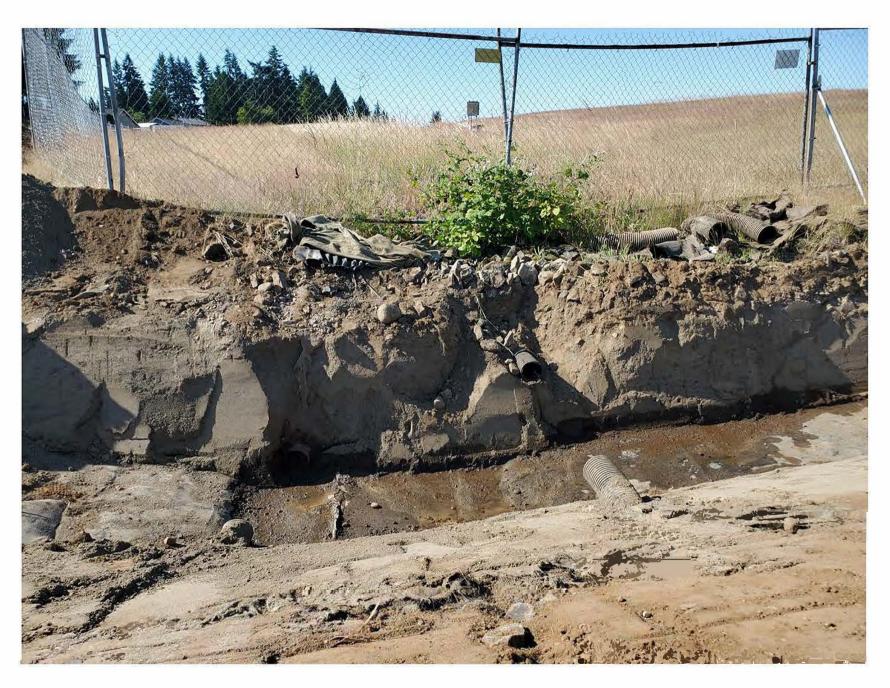
The buried 6-inch diameter drainage pipe was first observed during the installation of the geomembrane for the 99th Street extension project. While excavating the anchor trench, two 6-inch diameter drainage pipes were encountered. The deeper of the two pipes appeared partially crushed and filled with soil. Drainage rock was installed to facilitate drainage from the pipes, the geomembrane was extended over the installed rock, and the area was backfilled. The attached photographs show the two exposed pipes in the anchor trench and the installed rock drainage and geomembrane.

View looking south at the anchor trench. Note the shallow drainage pipe on both sides of the anchor trench, and the deeper drainage pipe (in the shadow) to the east.

A camera will be inserted into the deeper drainage pipe to attempt to identify the depth and location of the pipe run. It is assumed that the deeper pipe runs southerly above the Landfill cover geomembrane. Additional test pits will be excavated as appropriate to confirm the presence and depth of the deeper drainage pipe. Consistent with the approach described in the May 17th work plan, the Landfill cover geomembrane will not be cut during test pitting to expose the deeper drainage pipe.

Alternatively, if the deeper pipe cannot be accessed with the camera because it is crushed or filled with soil, the deeper pipe will likely be abandoned with bentonite and a cap fitting. The approach for managing the deeper pipe will be made based on field observations.

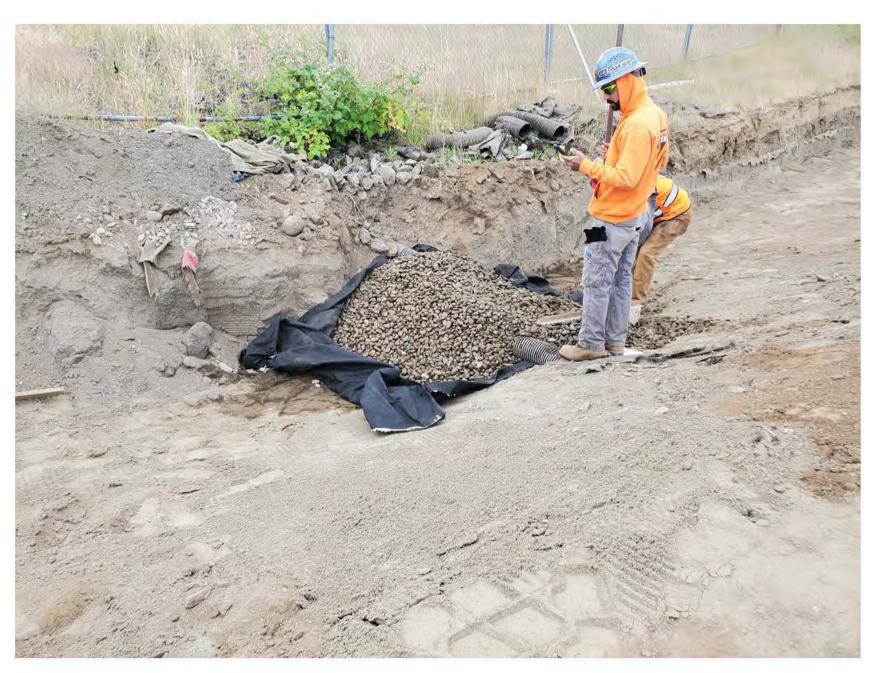
View of drain rock installed to transmit water from the shallow drainage pipe.

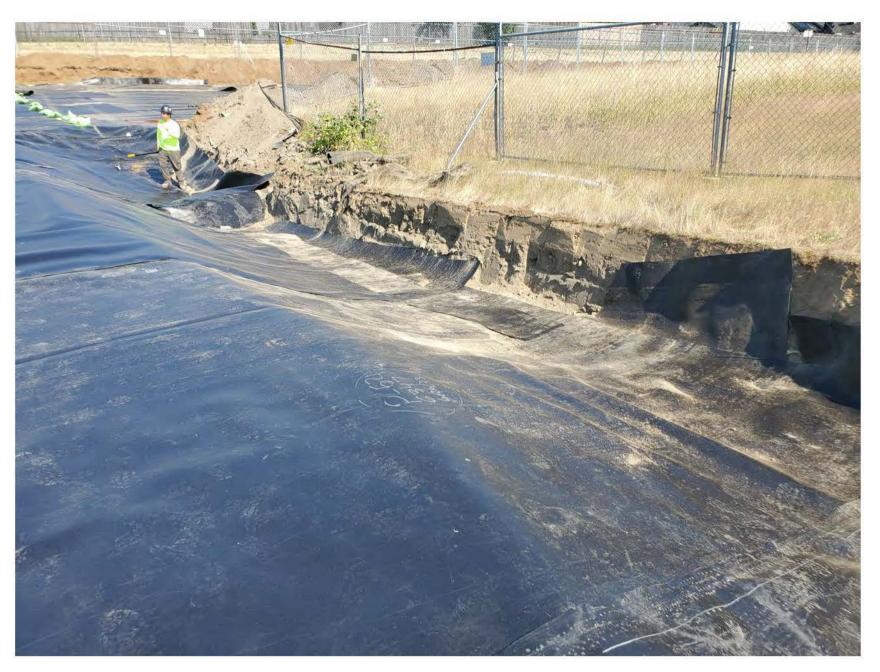
View looking east along the anchor trench. The shallow drainage pipe and drain rock are below the mound this side of the worker.
