Subject: 2024 Biennial Inspection Summary

Main Street Flats 10575 Main Street

Bellevue, Washington 98004 Ecology VCP No. NW2811

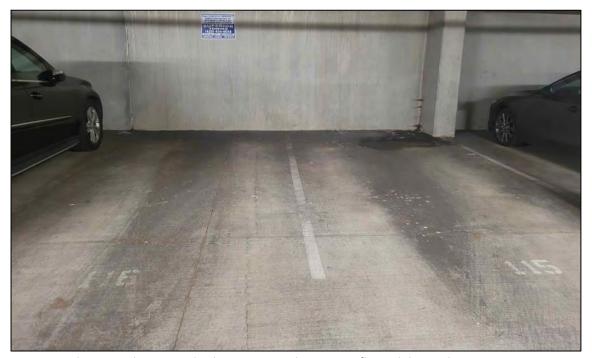
The portions of the concrete garage floor slab situated above Areas 1 and 2 were in good condition and no damage was observed (see Photos 1 through 5).

Photograph 1: View looking west at the garage floor slab overlying Area 1.

No further work is recommended at this time. The next biennial inspection will be completed in June of 2026.

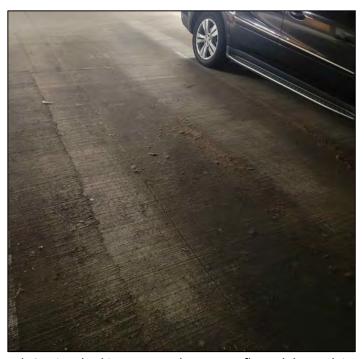
Photograph 2: View looking east at the garage floor slab overlying Area 1.

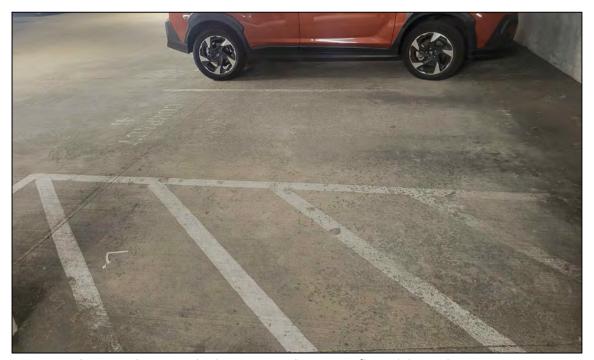
Photograph 3: View looking east at the garage floor slab overlying Area 2.

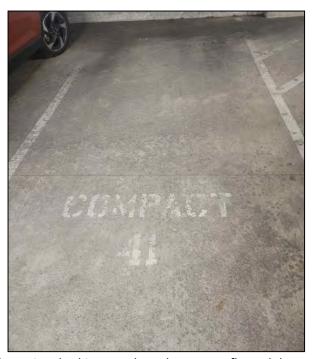
Photograph 4: View looking south at the garage floor slab overlying Area 2.

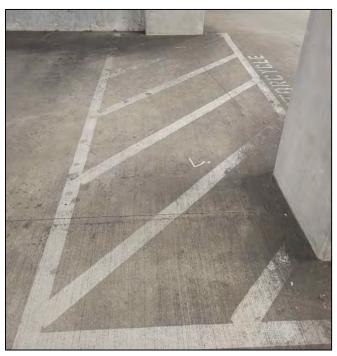
Photograph 5: View looking south at the garage floor slab overlying Area 2.
