GROUNDWATER MONITORING REPORT

1st Quarter 2024

BLT Trucking

8010 South 259th Street
Kent, Washington 98032

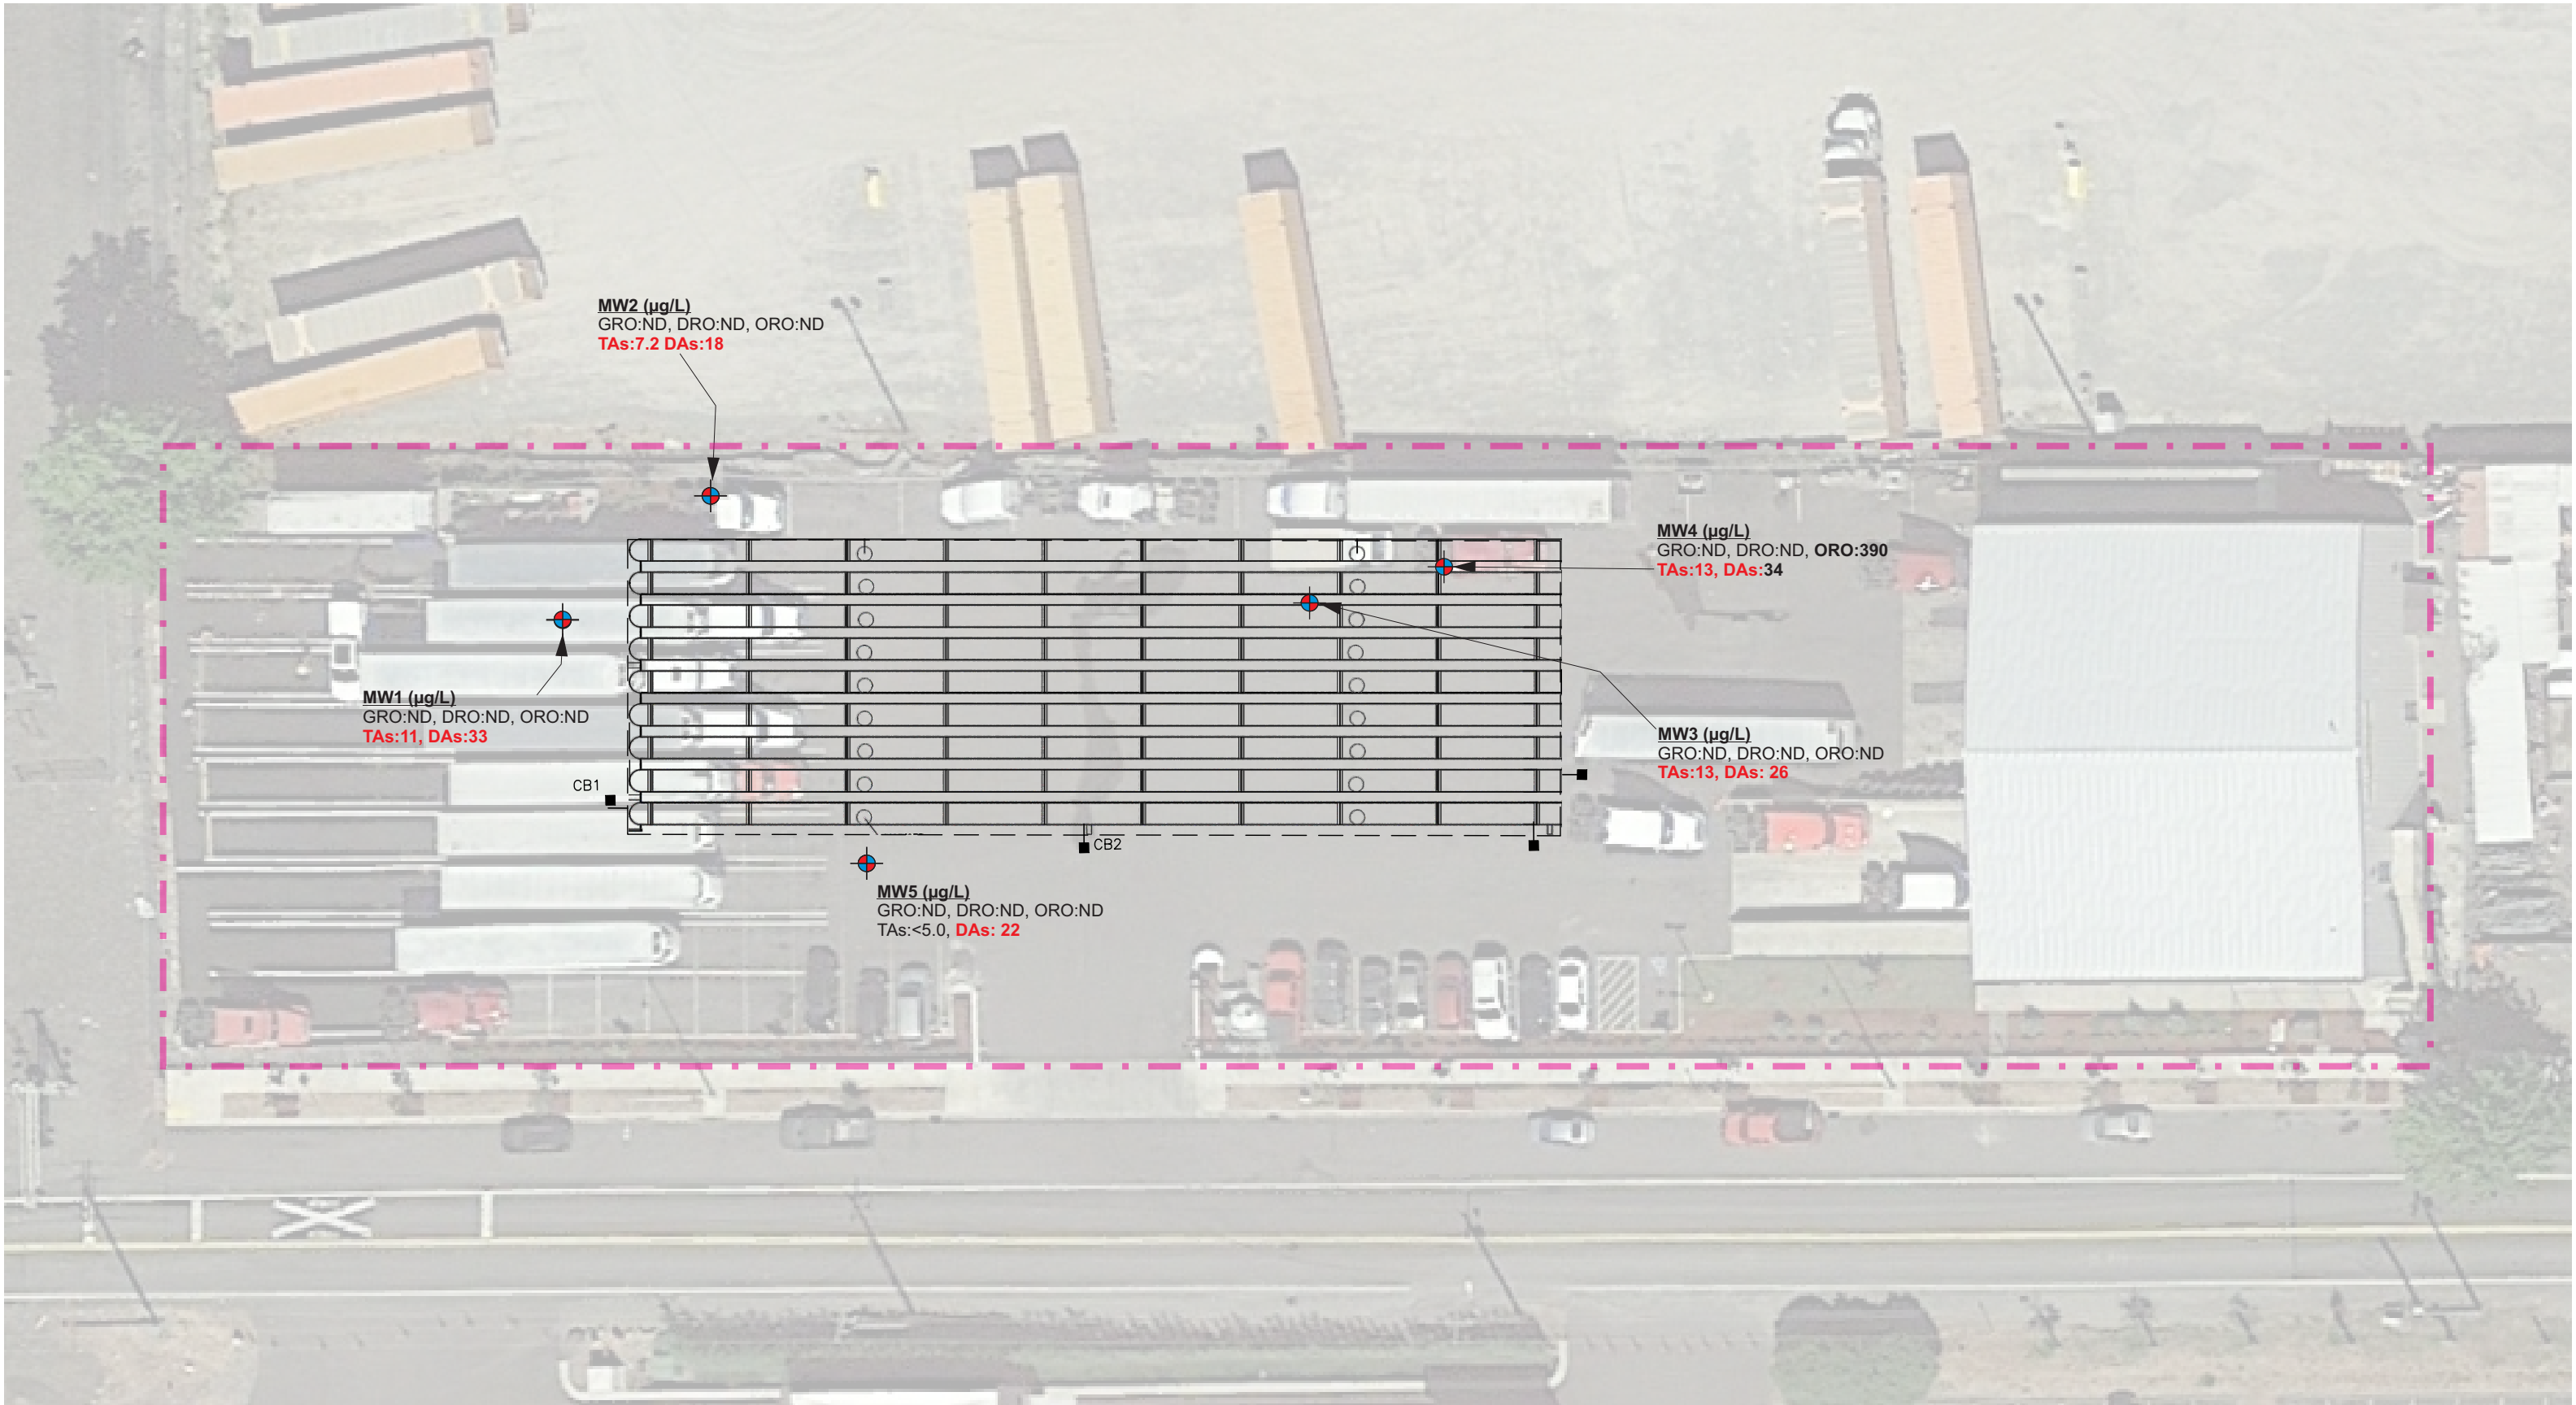
This report documents the results of groundwater samples collected from the five (5) installed groundwater monitoring wells (Figure 2, Appendix A). This report details field activities and observations, sampling activities, analytical results, and provides conclusions and recommendations.

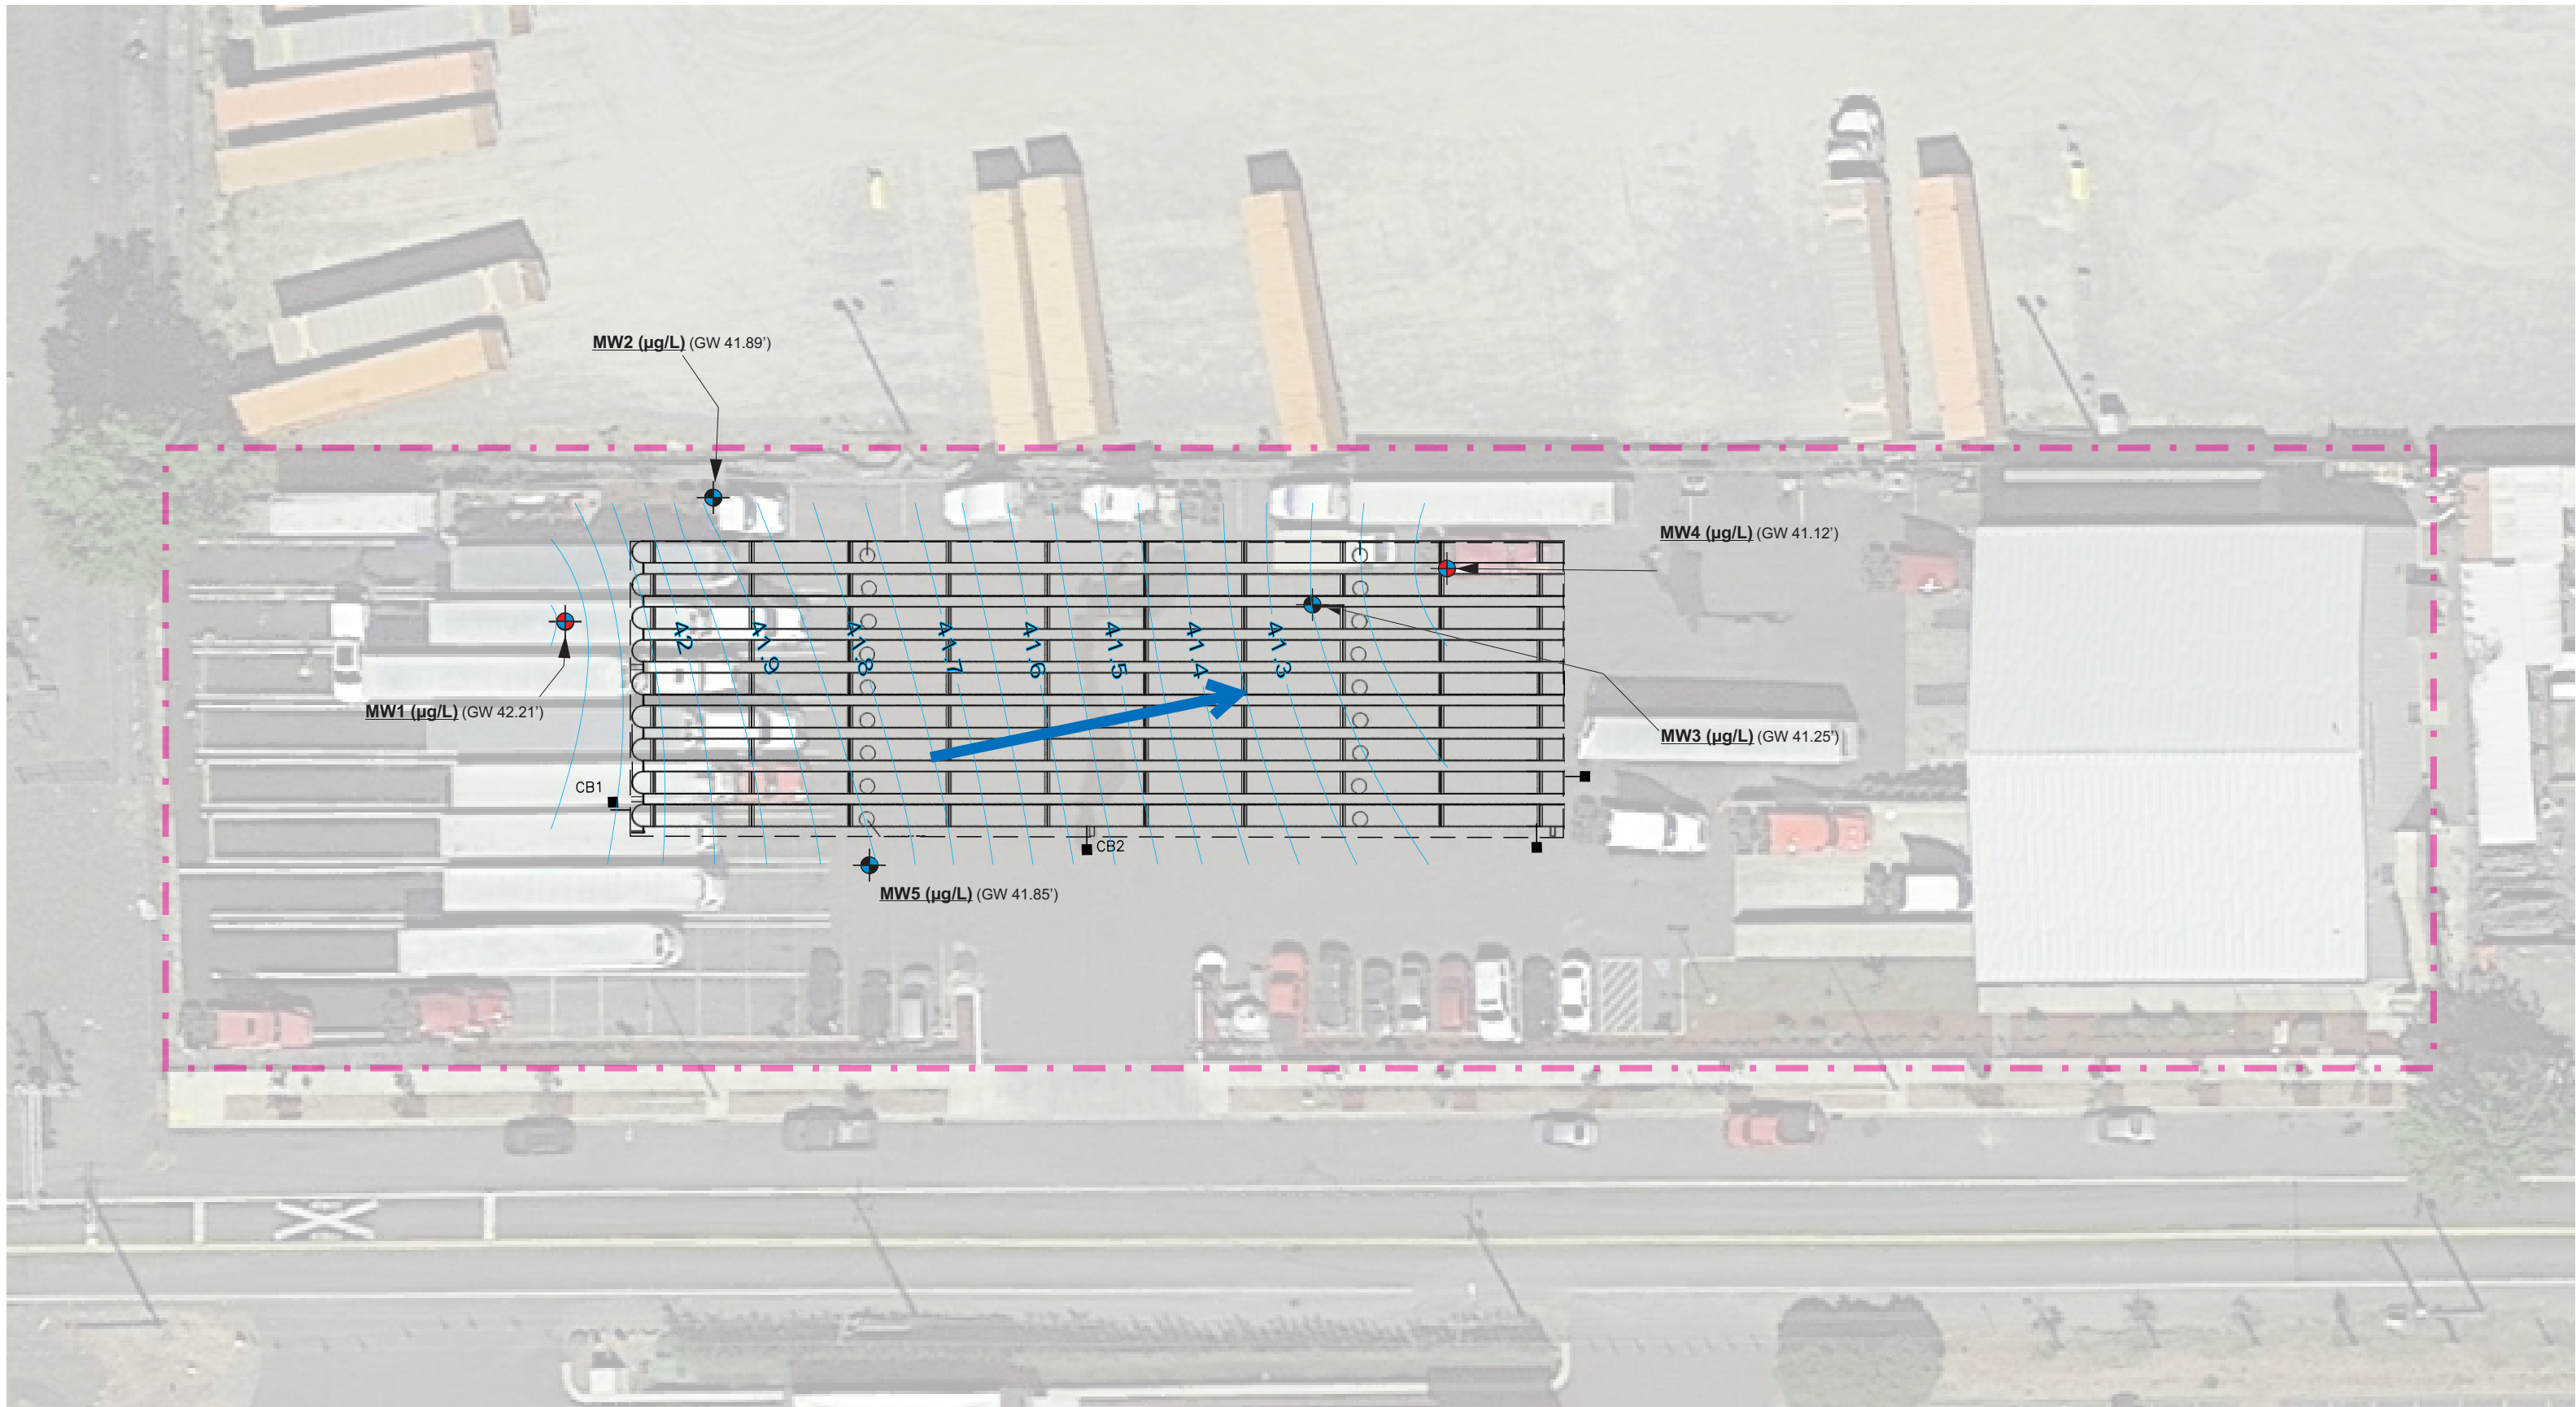
A survey of the installed monitoring wells was previously completed to locate the wells both vertically and horizontally. This data was used to prepare a groundwater contour map showing flow direction (Figure 3, Appendix A). The groundwater flow direction is gradually to the east-northeast towards MW3 and MW4. It should also be noted that the depths to groundwater are within the elevation of the infiltration pipes of the stormwater basin. It is likely that the groundwater levels and flow are affected by the stormwater basin.
