## **SunnyDell Shooting Range Data Memo**

**To:** Andy Smith, Department of Ecology  
**From:** Tom Colligan  
**cc:** Tom Kirkman  
**Date:** April 21, 2015  
**Re:** Results of Groundwater Sampling Event and Lower Pond Soil Sampling and Survey Event

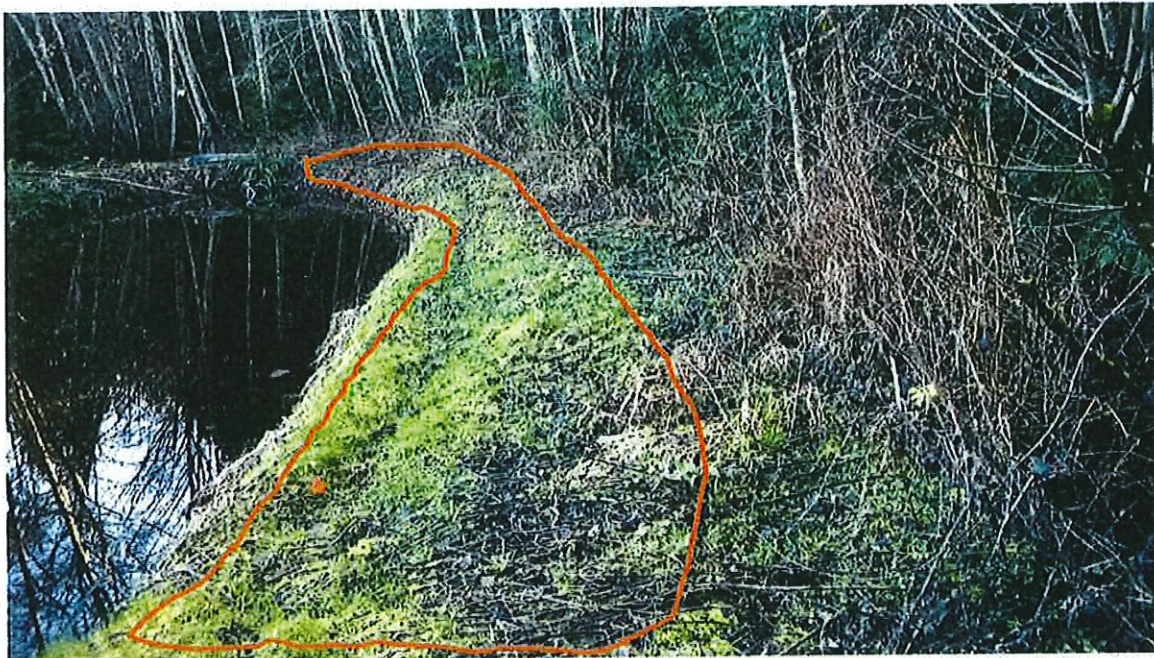
The soil sampling and elevation survey was in response to the finding that lead levels at the western edge of the pond remain above cleanup levels following two attempts at the excavation that was specified in the 2012 final cleanup action plan. The soil sampling approach was laid out to Ecology in an email transmitted to you on October 13, 2014. The goal of the recent sampling was two-fold:

Outline of Pond Berm Area that was sampled, looking south.

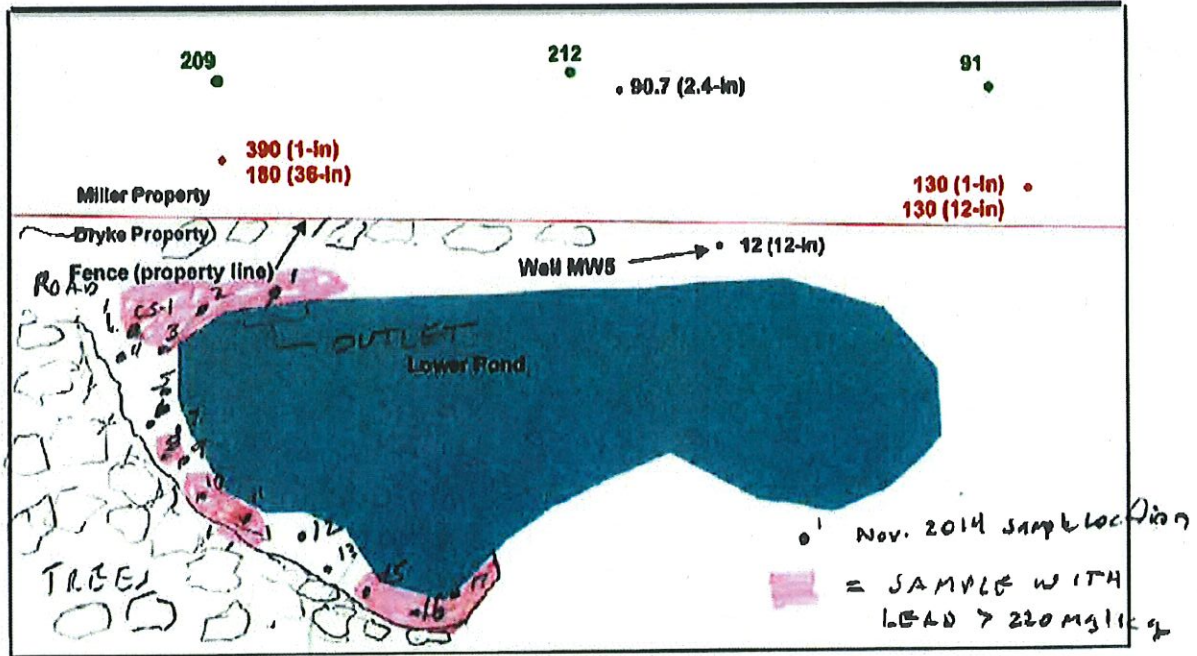
Soil Sampling Locations. North is up.

The results indicate that lead contamination occurs irregularly across three separate areas, a northern area around the outlet of the pond, a more narrow middle area and a southern area. Importantly, the depth of contamination is mostly restricted to the upper 1 foot of soil. Only two samples from the 3 foot depth interval contaminated lead above the cleanup level. Figure 2 shows these areas in highlight.

Further excavation of contaminated soil in the area of the pond outlet would exacerbate the current situation of pond overflow, as it would lower the berm by a minimum of one foot. It would also damage existing vegetation and would be considered work in a wetlands so difficult to permit under the Clean Water Act. Given that this area is of limited use and the soil well covered by vegetation, there is no immediate human health risk. The best solution may be to place a thin (6") cover of soil over the surface soils, rather than further excavation. This would be protective of the environment and also help alleviate the frequency of pond overflow by raising the ground surface elevation in this area.

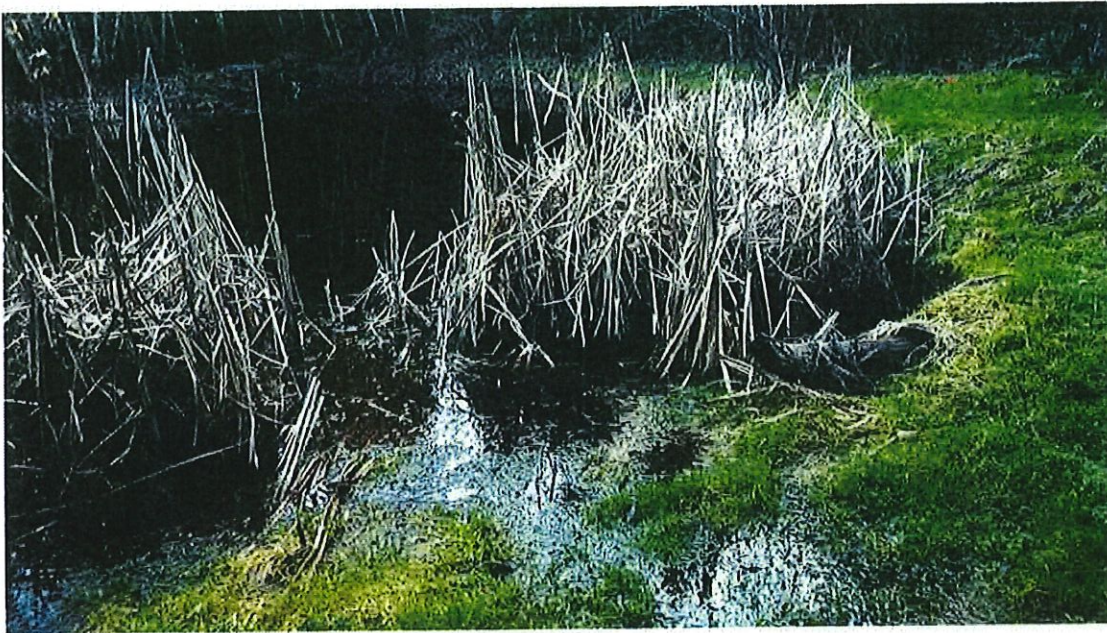
An elevation survey was conducted using transit and rod to determine land survey elevations in areas that were sampled. The survey results were relative to the ground surface at nearby well MW-5 at elevation 220 feet MSL. Results supported the rather obvious visual impression that the lowest area (i.e., the pond outlet) is located at the northwest end of the pond close to sample 1-1. The elevation of the "spillway" was measured at 218.25 ft MSL. The land surface then rises along the berm to the south. Direct evidence of this area being the low point is demonstrated by the photograph below which shows actual pond overflow to the adjacent property during the past winter.

Pond Overflow from Outlet During Recent Flooding Event
