MEMORANDUM FOR THE RECORD

From: Leah Rohan, Environmental Engineer, City of Walla Walla
Date: August 20, 2024
Subject: Dye Testing of Janitorial Sink in 106 N. 2nd Avenue Building

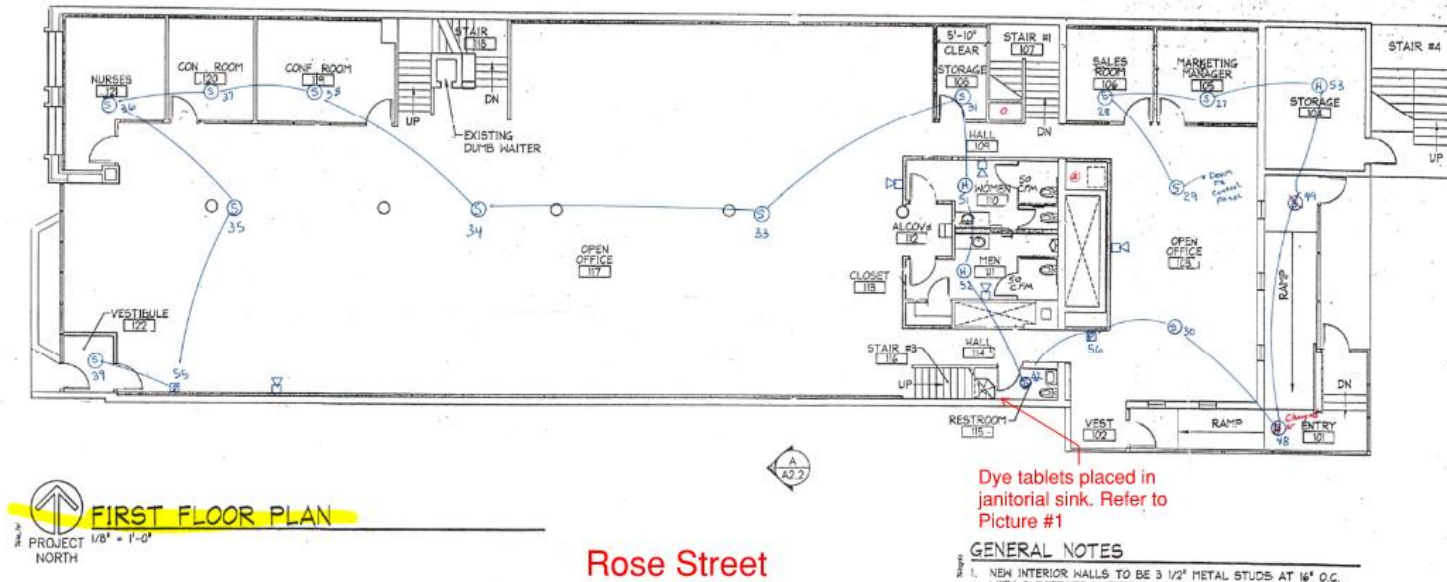
Figure 3: 1998 floor plan for the first floor of the 106 N. 2nd Avenue building and the location of the janitorial sink and where dye tablets were placed (Source: 5/12/1998 Integrus Architecture Mechanical-HVAC Plans)

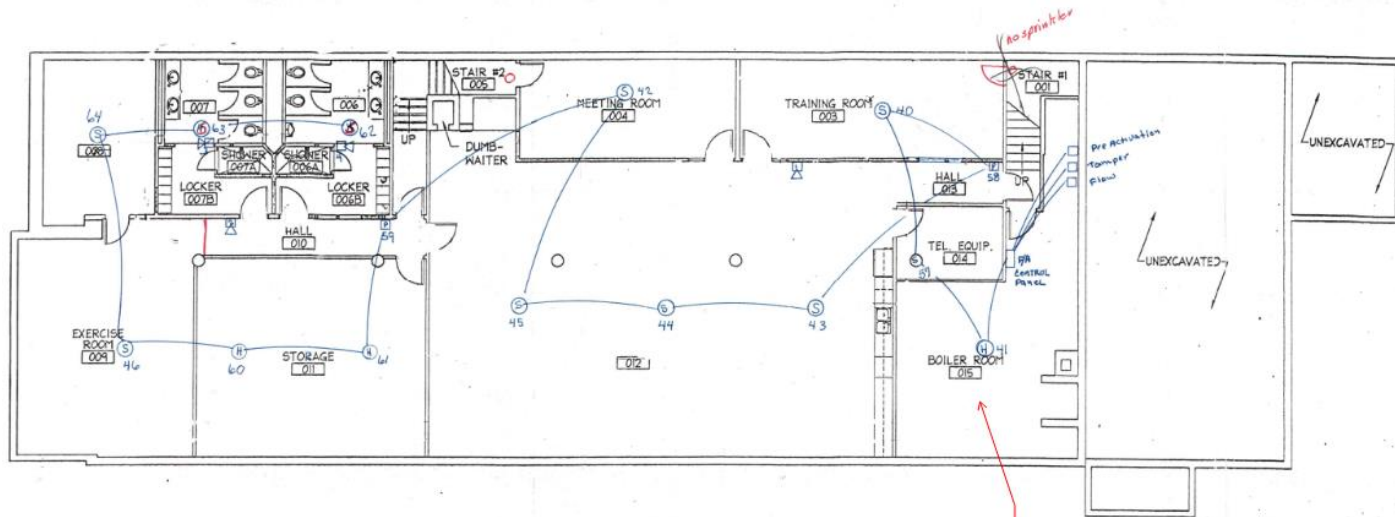
Location of sewage sump. Green dye visible. Refer to Pictures #3 and 4

Figure 4: 1998 floor plan for the basement floor of the 106 N. 2nd Avenue building and the location of the sewage sump and where dyed water from the janitorial sink was first located (Source: 5/12/1998 Integrus Architecture Mechanical-HVAC Plans)

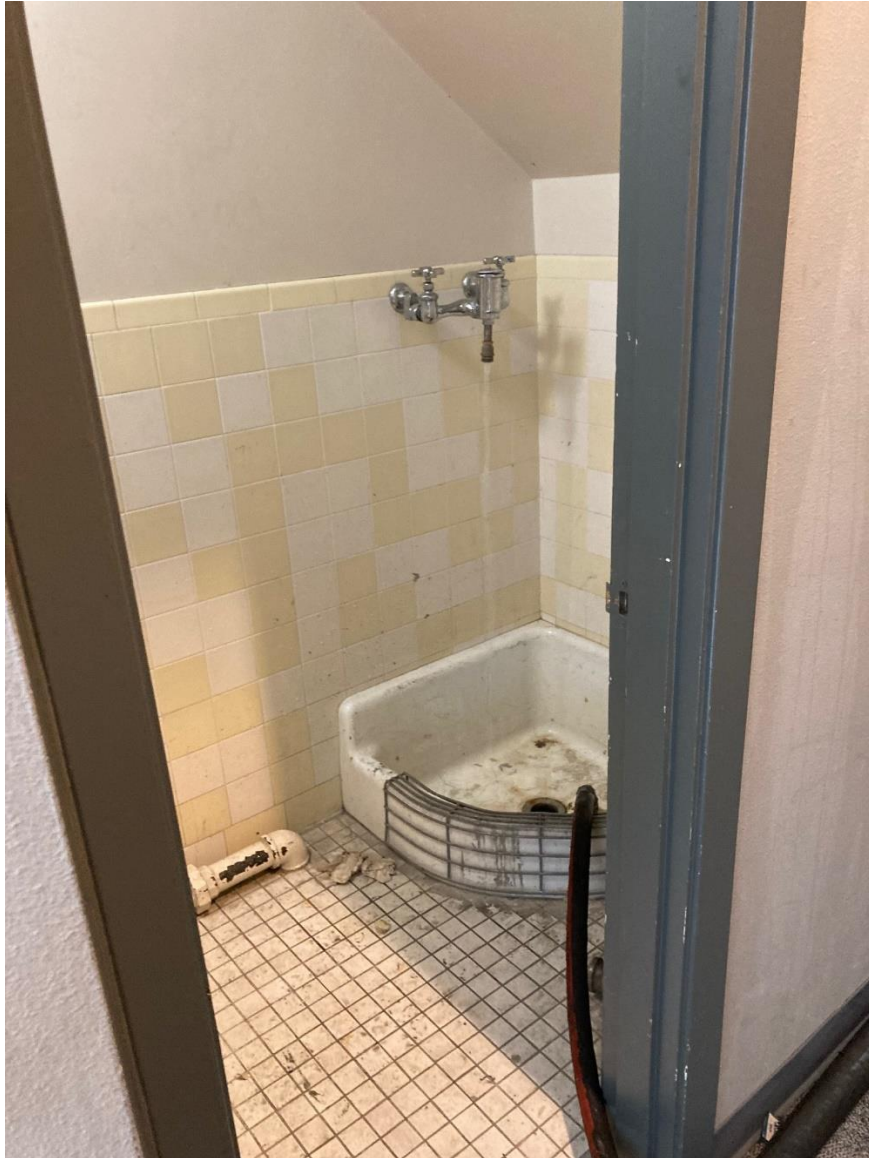
- The camera was first placed in the cleanout in the sidewalk on 2nd Avenue (refer to picture #2). Dye tablets were then placed in the janitorial sink (refer to picture # 1) located on the first floor of the building, and the water to the sink was slightly opened. No dyed water was visible in the cleanout on 2nd Avenue.

Picture 1: Janitorial sink where Clean Harbors treatment system discharges into. Location of where dye tablets were added

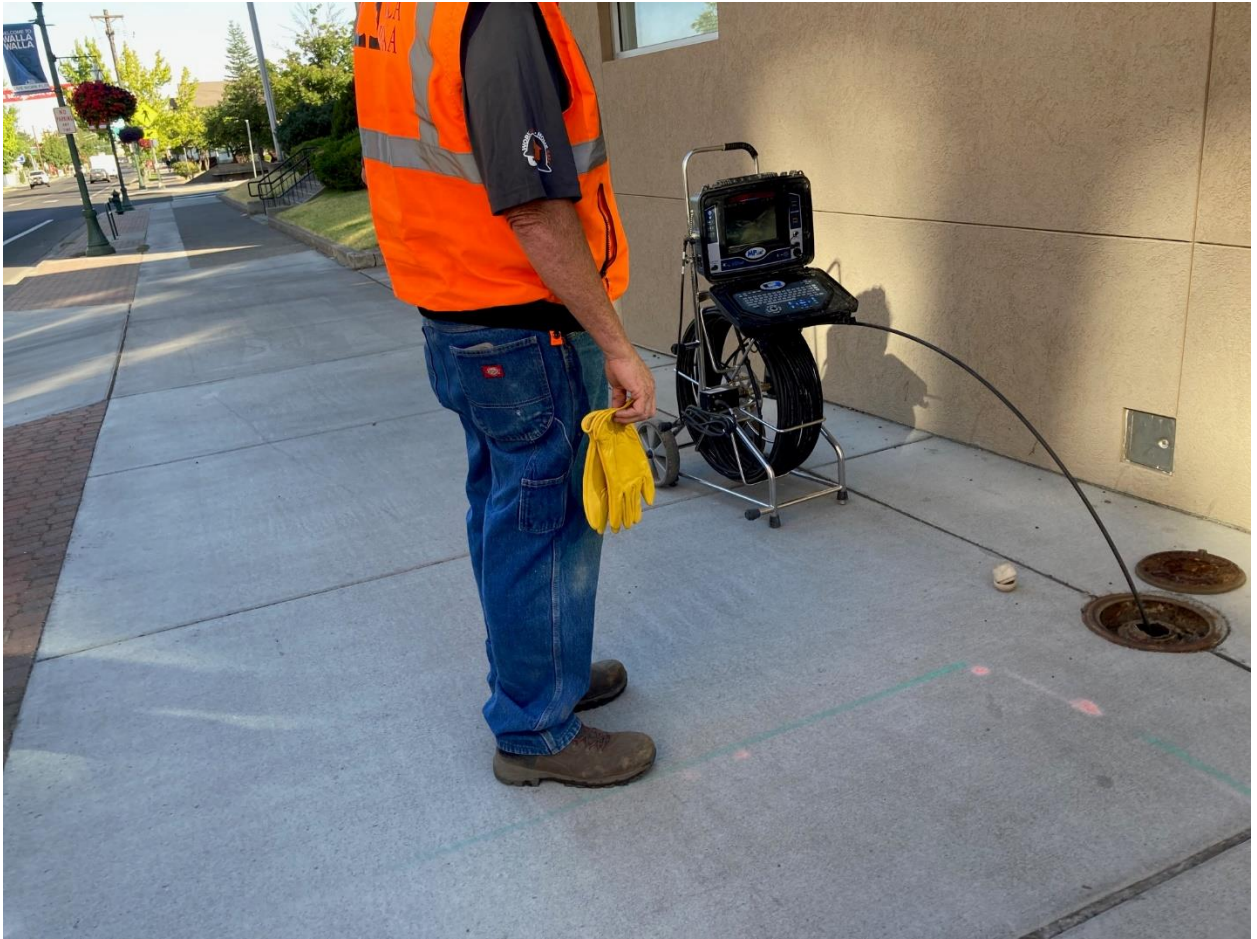
Picture 2: Video inspection of cleanout located in sidewalk on 2nd Avenue

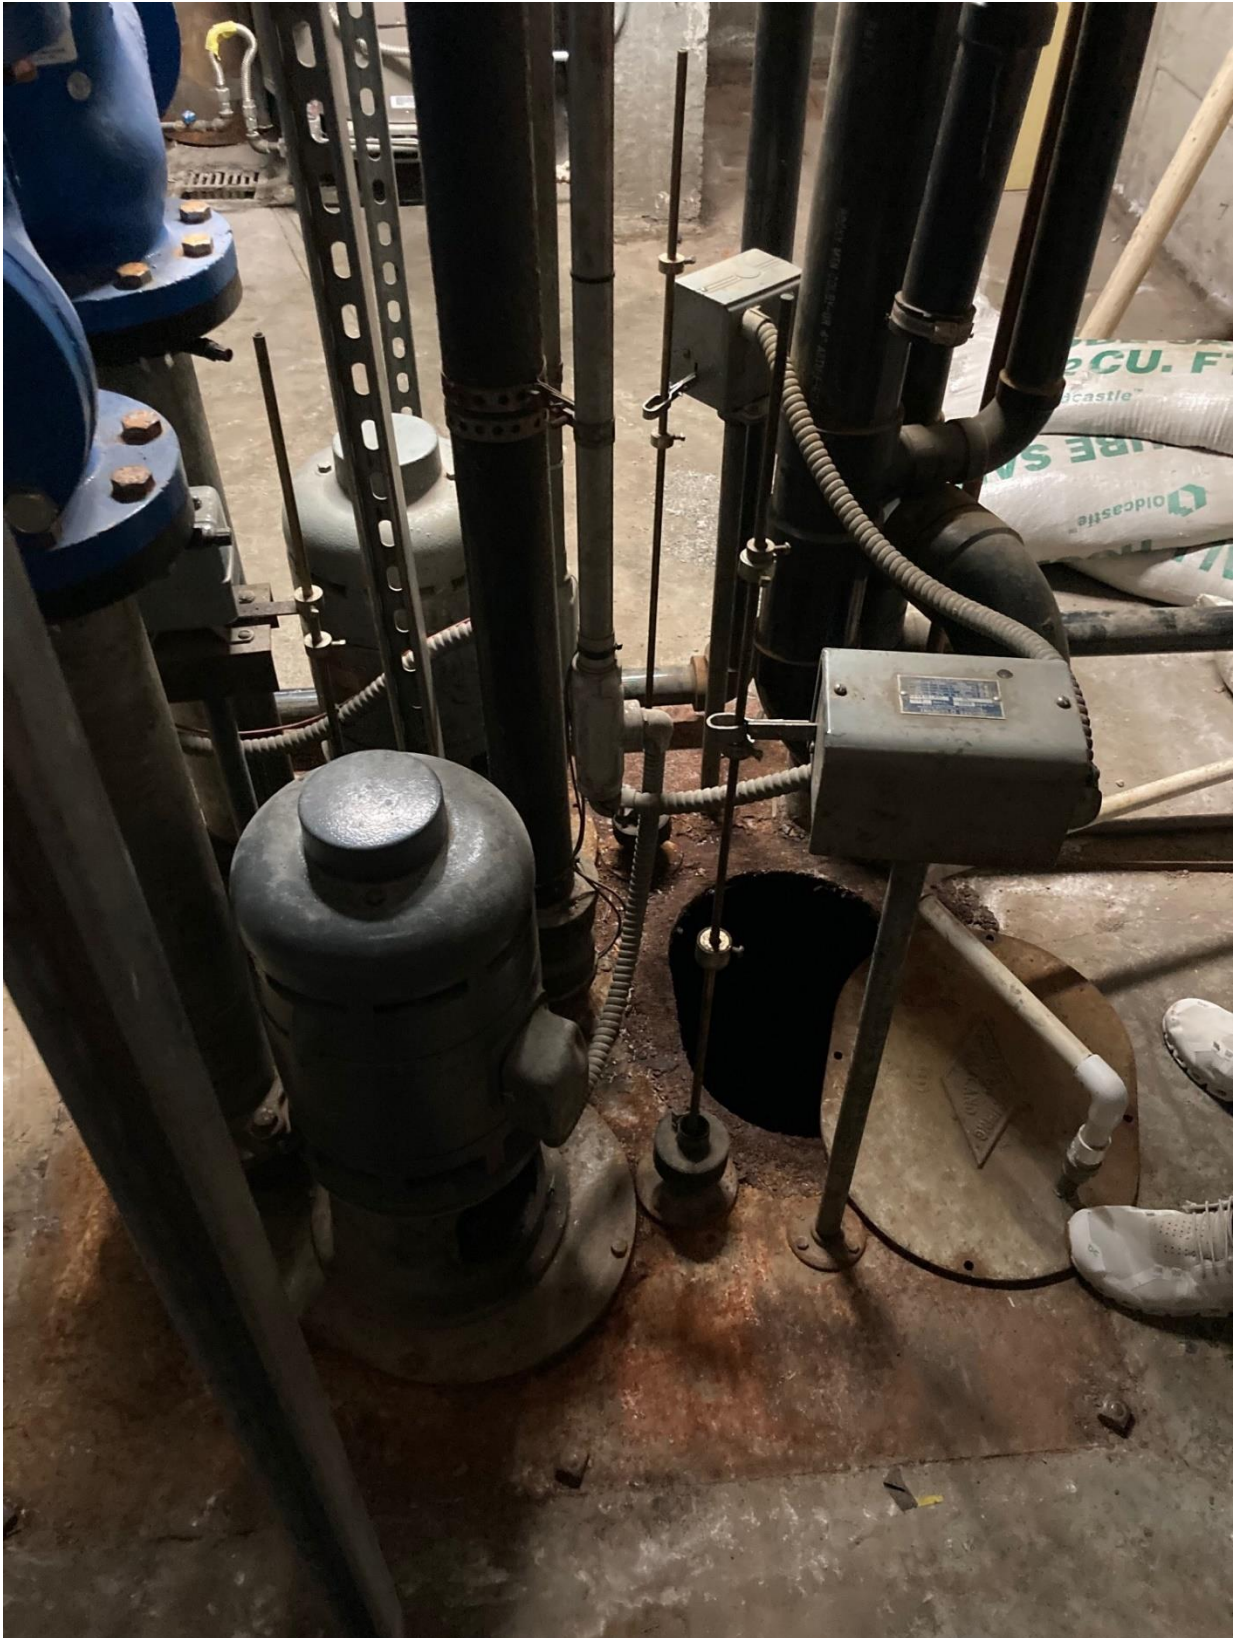
- The sewage sump for the building was inspected and green dyed water was visible in the sump (refer to pictures #3 and 4). The sump pump was manually activated to empty the sump. The water to the janitorial sink was then increased to full flow. The City streets crew performing the video inspection on 2nd Avenue was consulted and no dyed water was visible in the cleanout.

Picture 3: Sewage sump. Located in the basement, below the janitorial sink

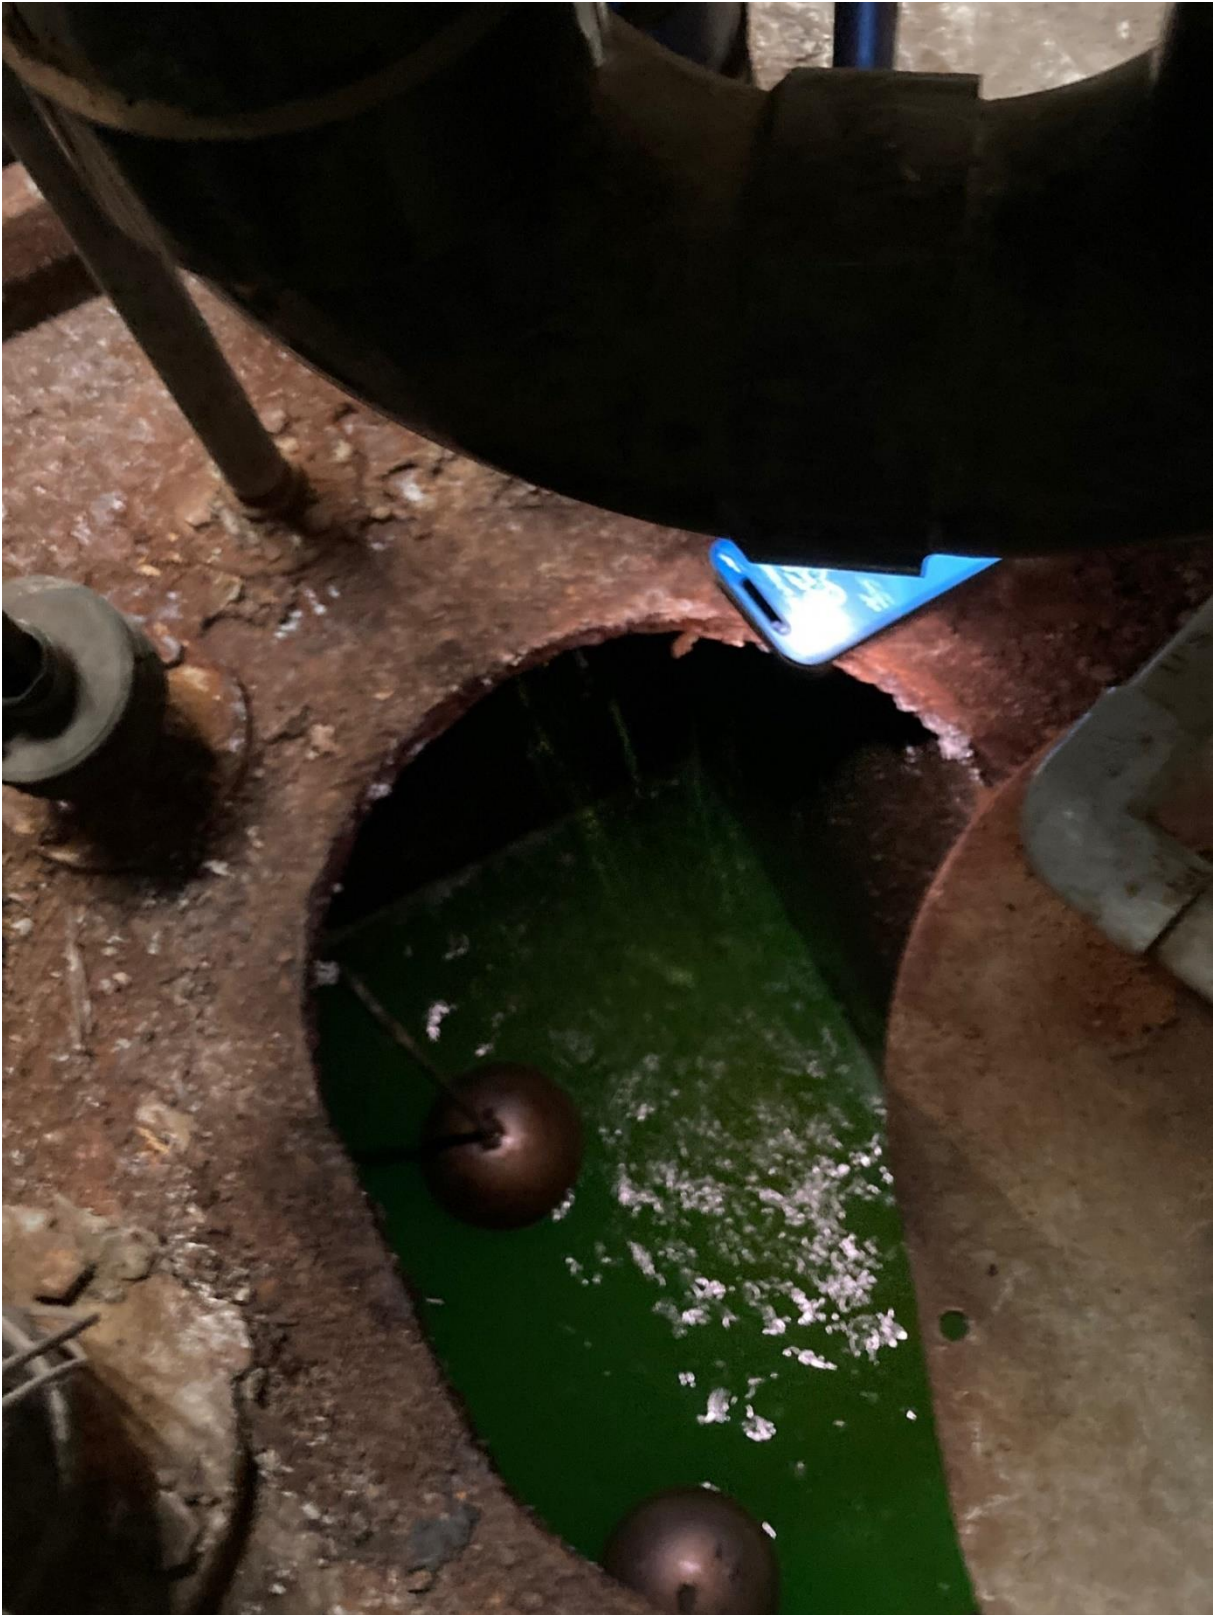
Picture 4: dyed water (green) visible in sewage sump

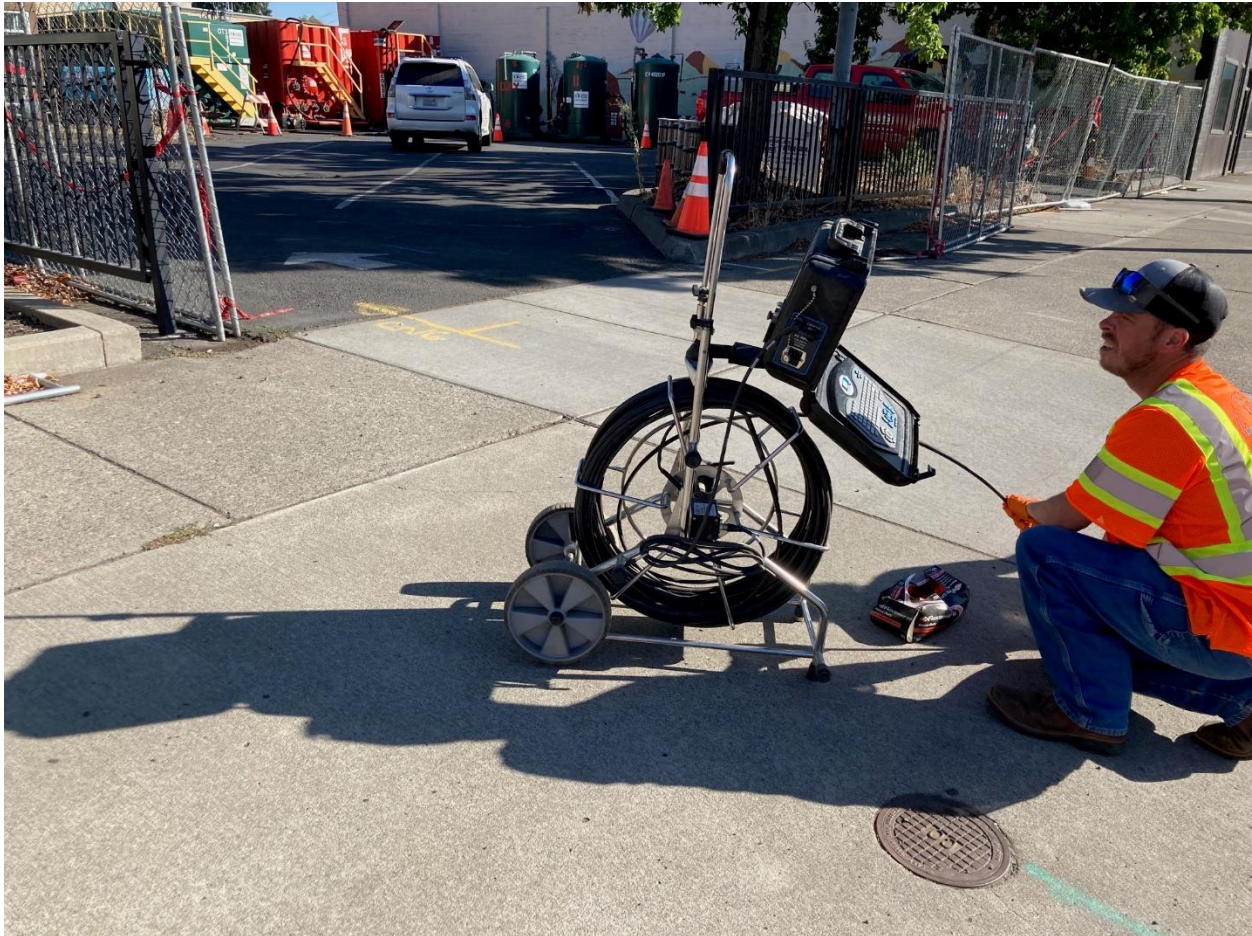
- The City streets crew relocated the camera to the cleanout located in the sidewalk on Rose Street (refer to picture #5). Water that appeared to be slightly green from the dye tablets was visible on first inspection. More dye tablets were added to the janitorial sink and water that was very obviously green from the dye tablets was visible in the cleanout on Rose Street (refer to pictures #6 and 7). This dye testing confirmed that the water from the janitorial sink does discharge to the City sewer system on Rose Street.

Picture 5: Video inspection of cleanout in sidewalk on Rose Street. Dyed water (green) visible in cleanout

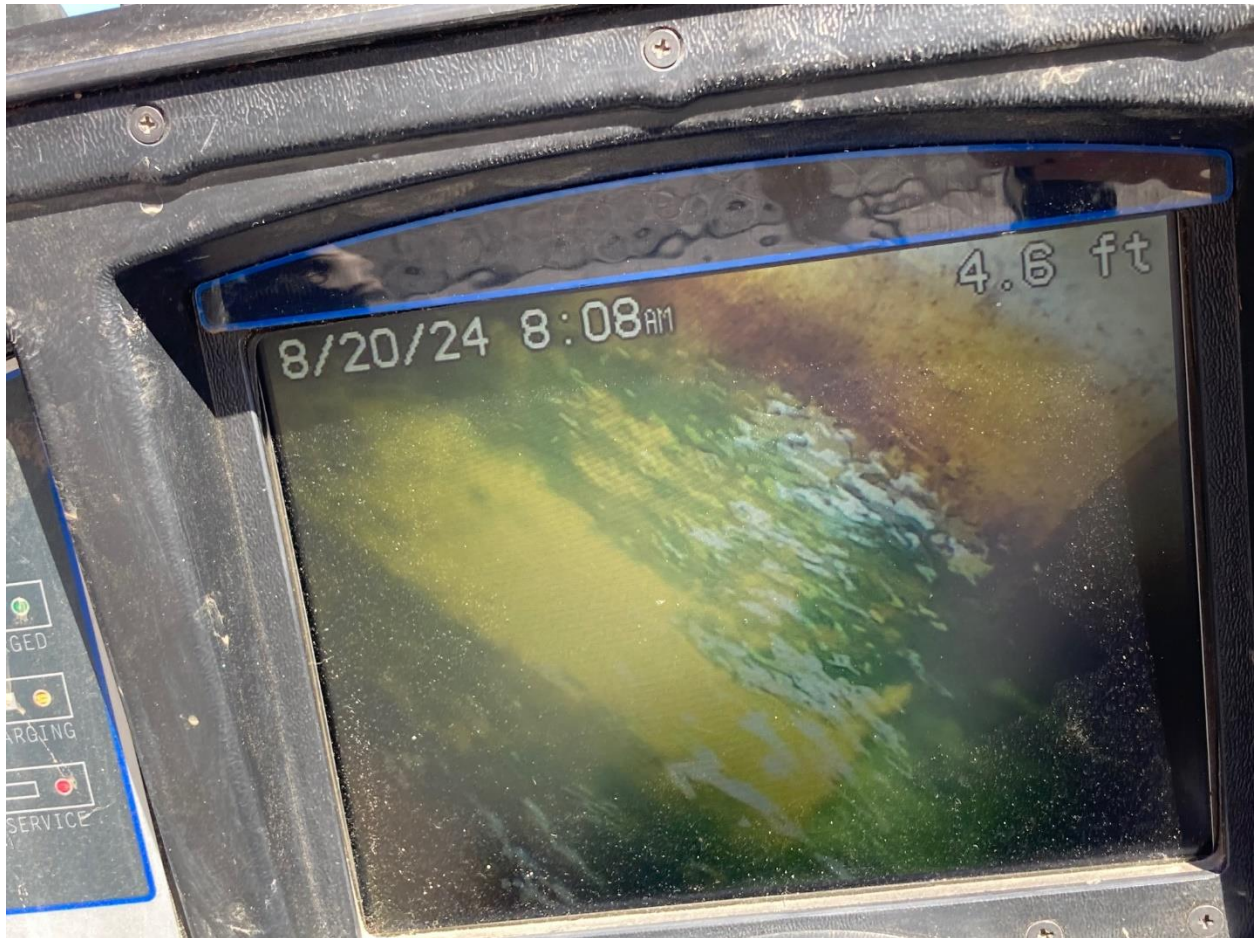
Picture 6: Screen of video inspection of cleanout in sidewalk on Rose Street. Dyed water (green) visible

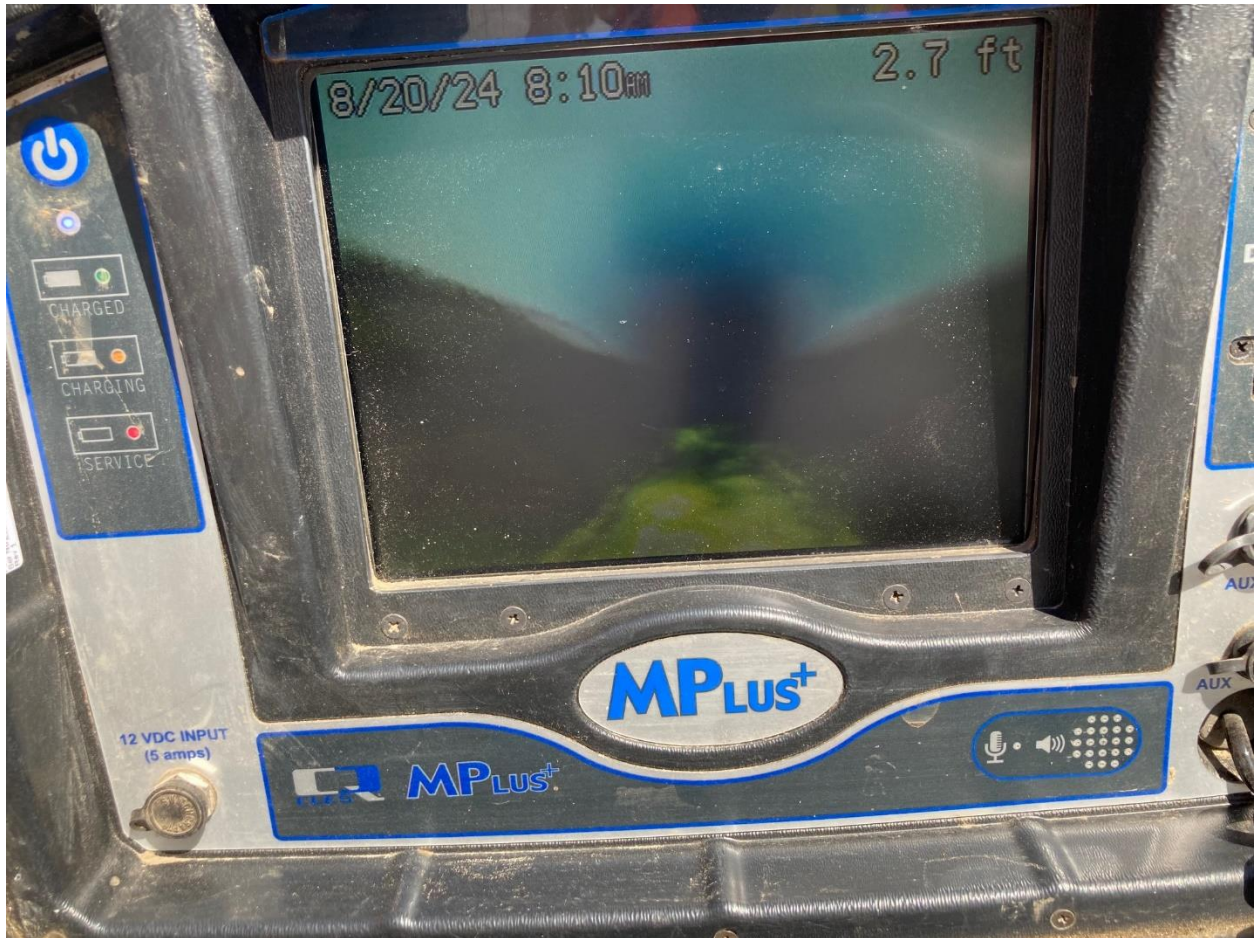
Picture 7: Screen of video inspection of cleanout in sidewalk on Rose Street. Dyed water (green) visible
