DRAFT
FOCUSED REMEDIAL INVESTIGATION SUMMARY
HEXCEL PLANT 1
KENT, WASHINGTON

August 31, 2018

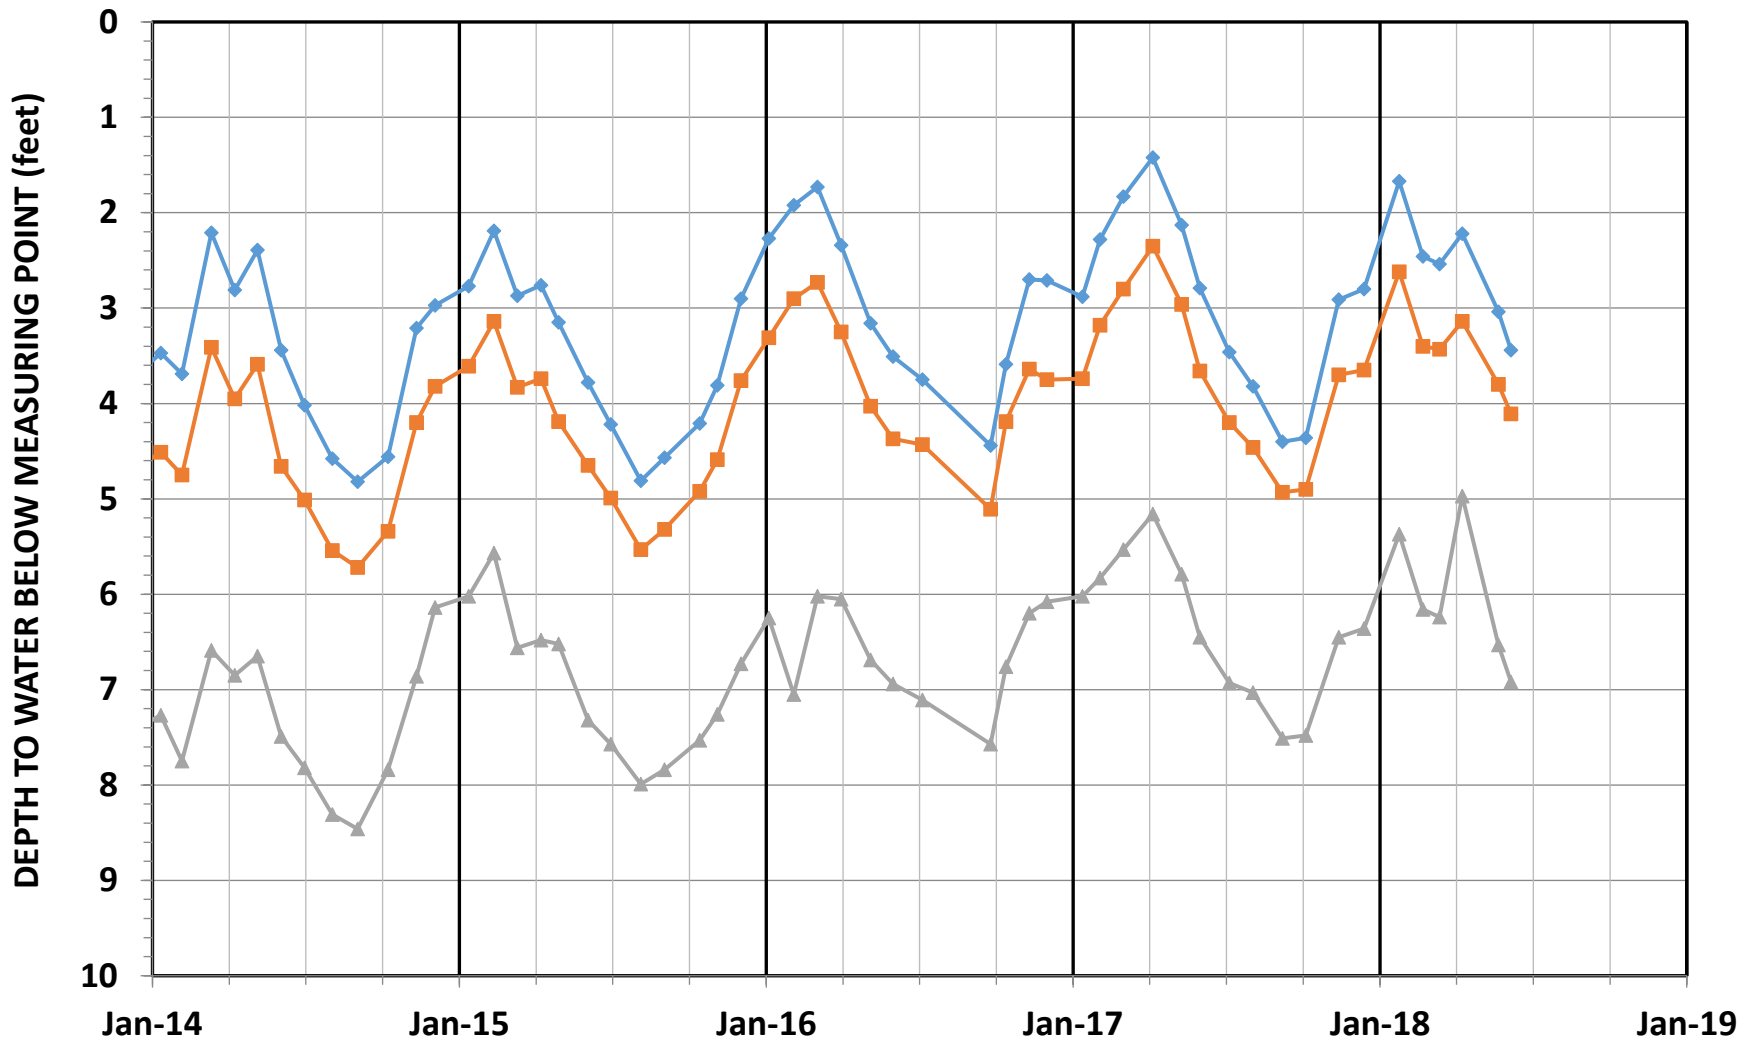
FIGURE 9
Depths to Groundwater

elevations in the deep aquifer wells at Plant 1 are consistent with the north to northeast dipping hydraulic gradient that has been observed over time. The hydraulic gradient between the shallow and deep aquifers remains upward at well HEX-10, as shown by Figure 9.

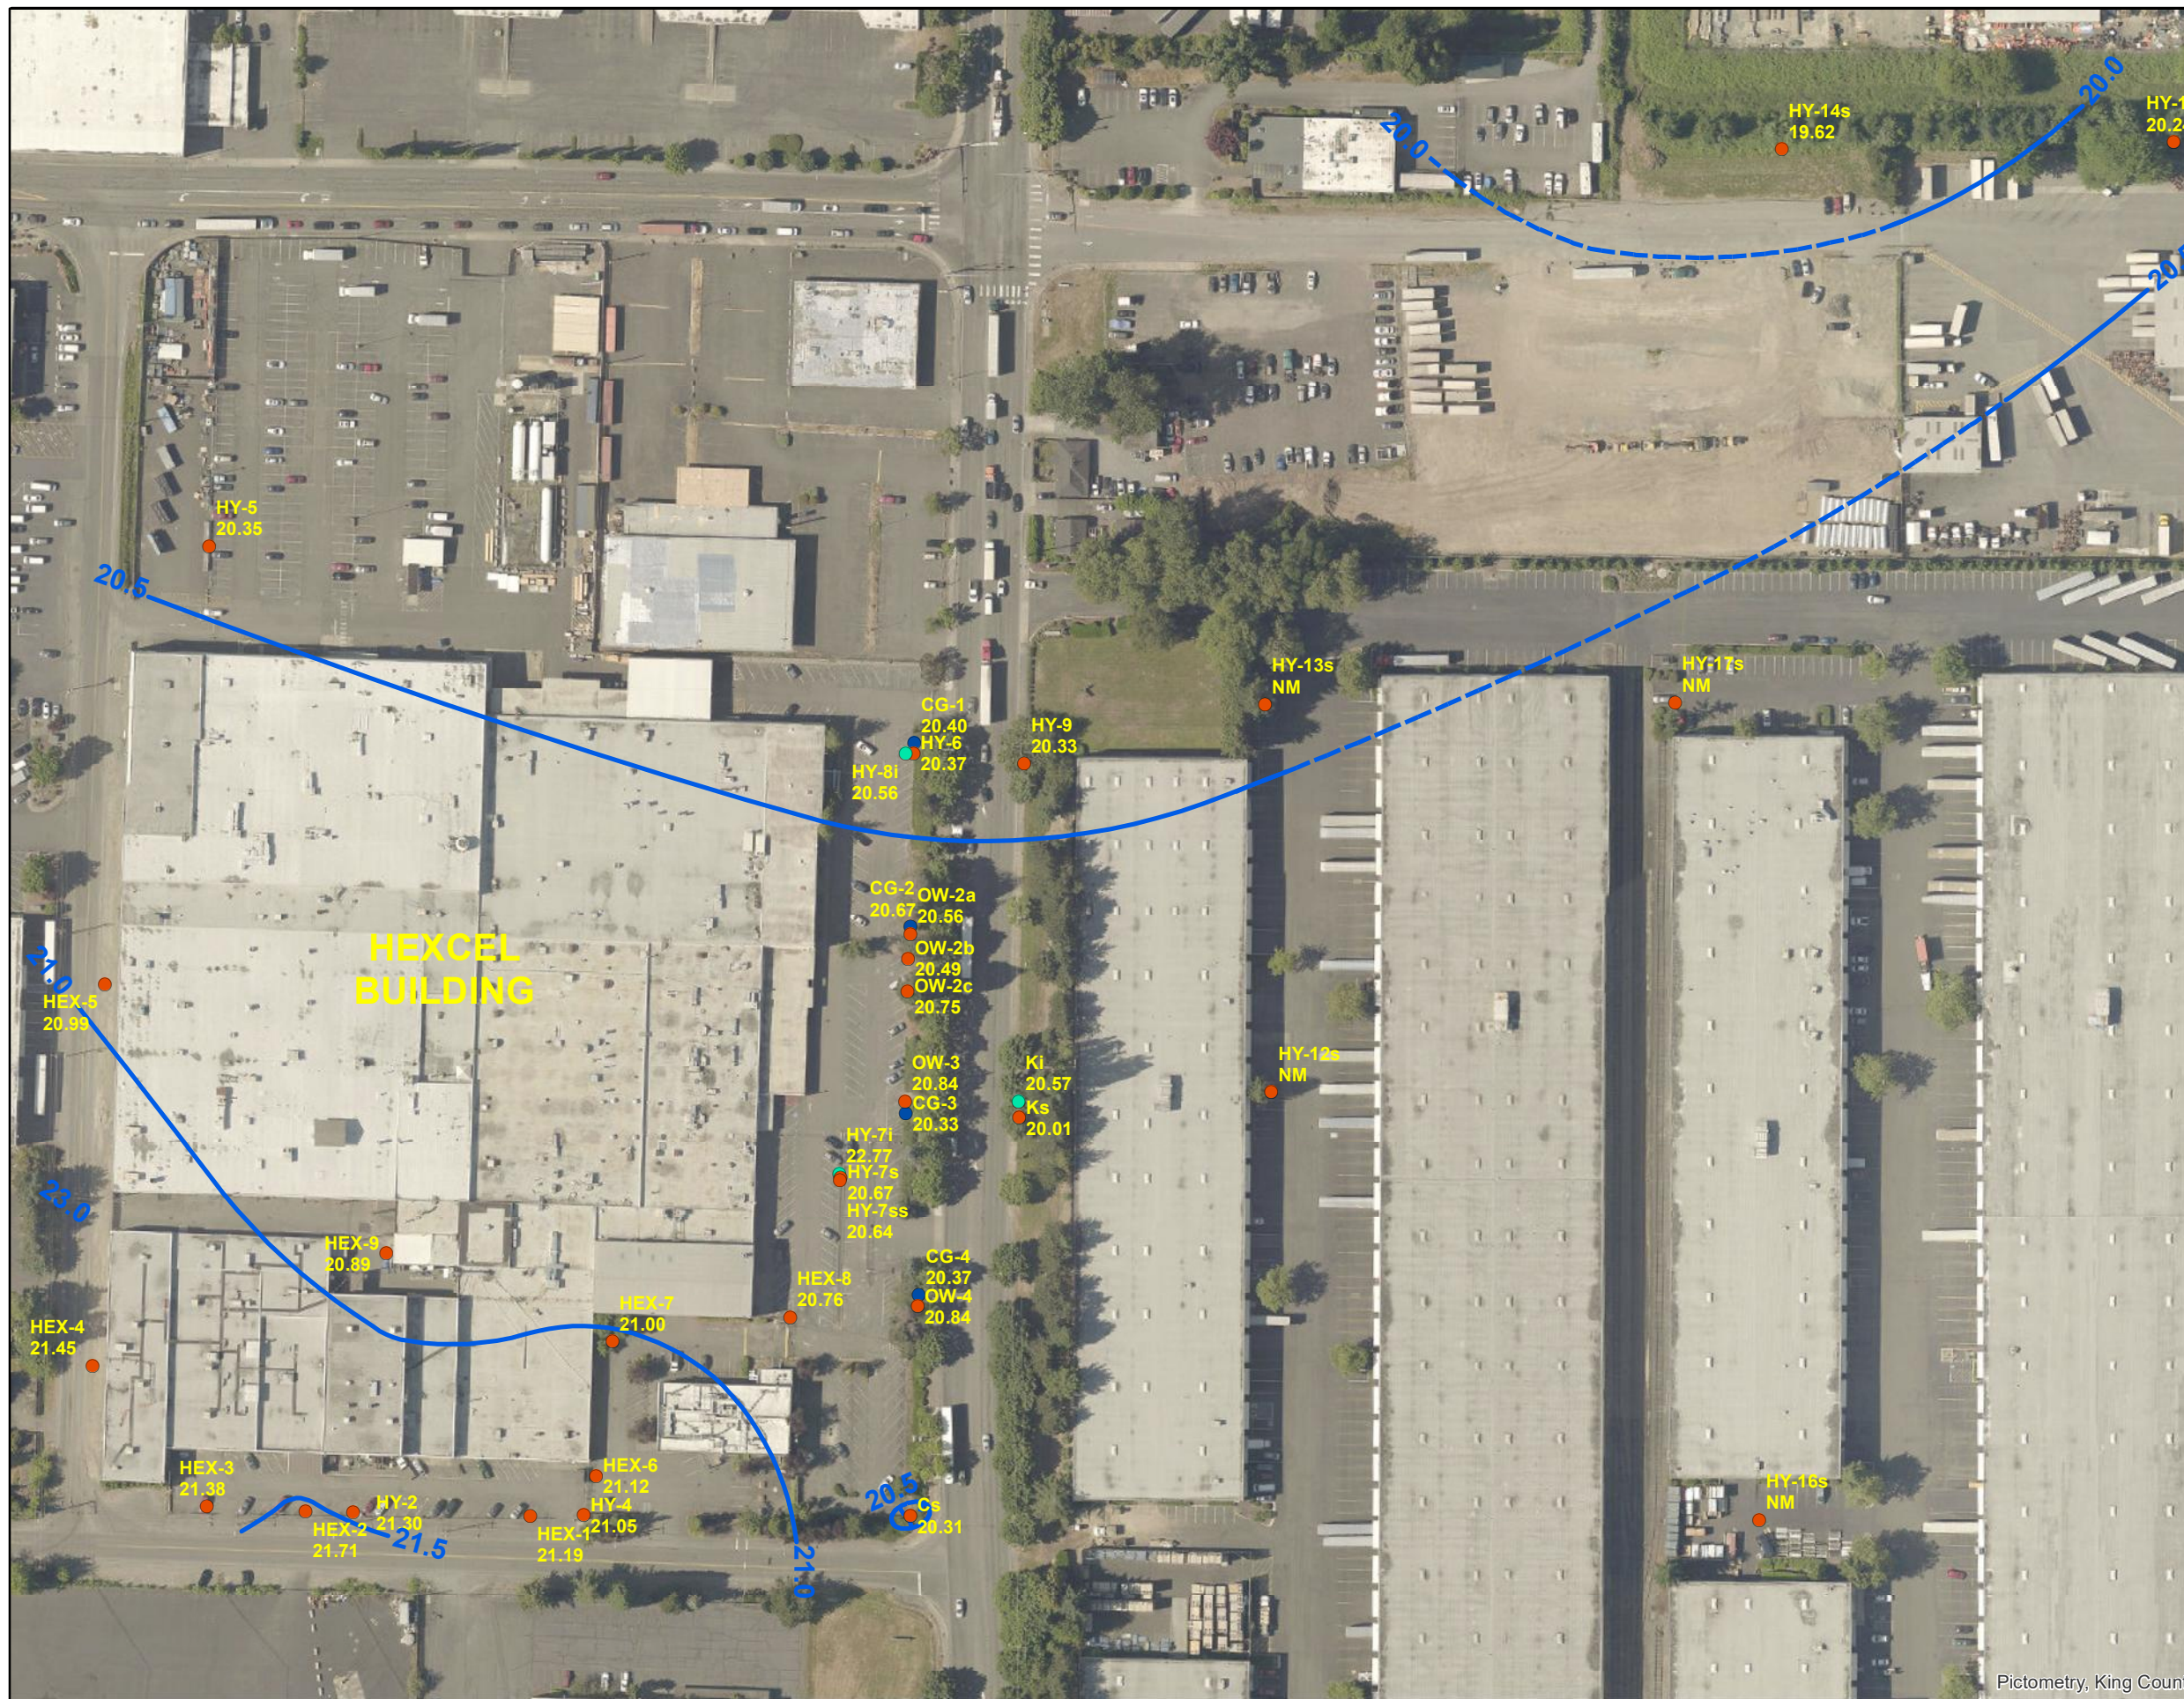
FIGURE 11
 Contour Map of Shallow Groundwater Elevations
 July 7, 2017

Figures 11 and 12 are groundwater elevation contour maps for the shallow aquifer in July 2017 and January 2018, to illustrate current conditions during which there is no groundwater pumping. These maps show conditions during the dry and wet times of the year, respectively. Groundwater flow beneath Plant 1 is generally northeasterly to northerly, and can vary slightly through the year in response to seasonal precipitation.

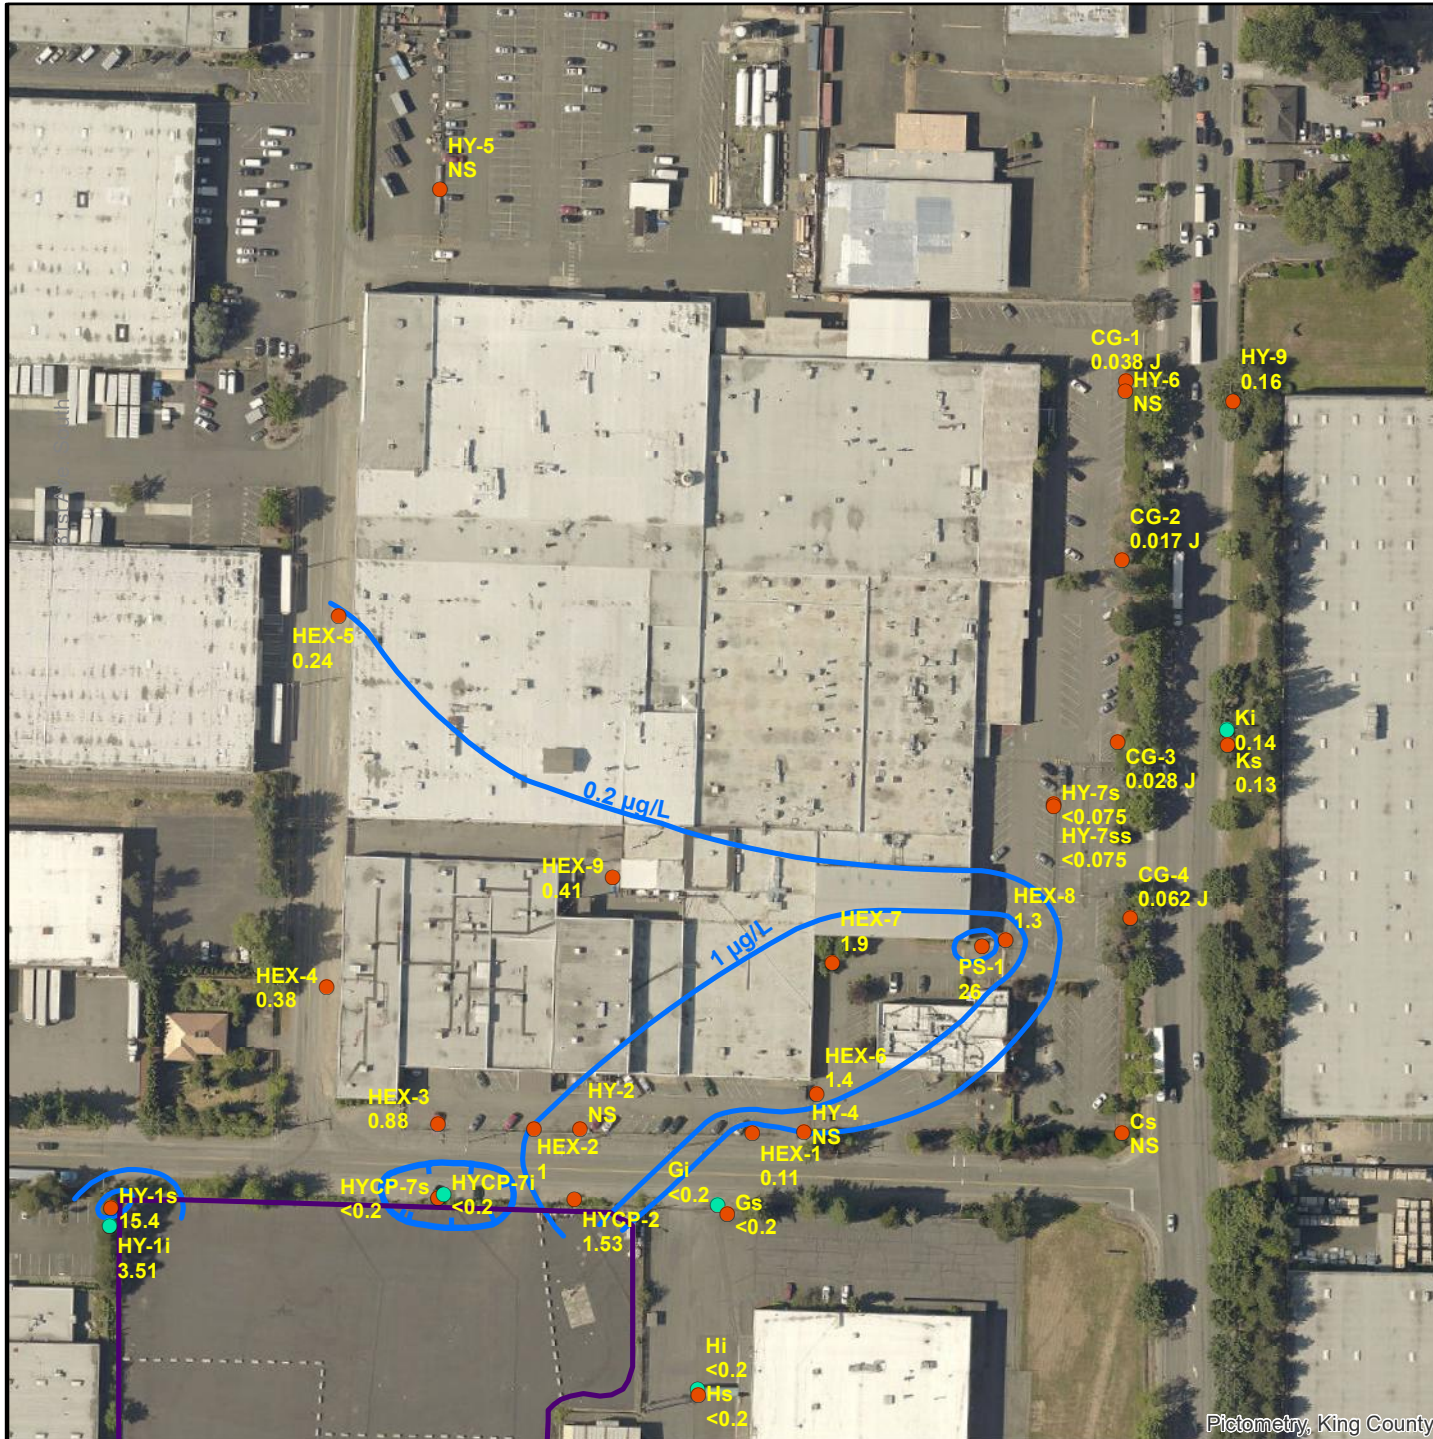
FIGURE 17A
Vinyl Chloride (µg/L)
in Shallow Aquifer
September 2017

Comparison of the historical distributions of VC, cDCE, and TCE (Figures 13, 14, and 15) and the current conditions (Figures 17, 22, and 26) indicates that there was a substantial reduction in the size of the groundwater plumes for these VOCs over time. The shrinkage of the plumes was due to groundwater remedial actions between 1992 and present which removed contaminant mass and isolated the source at Parcel G.

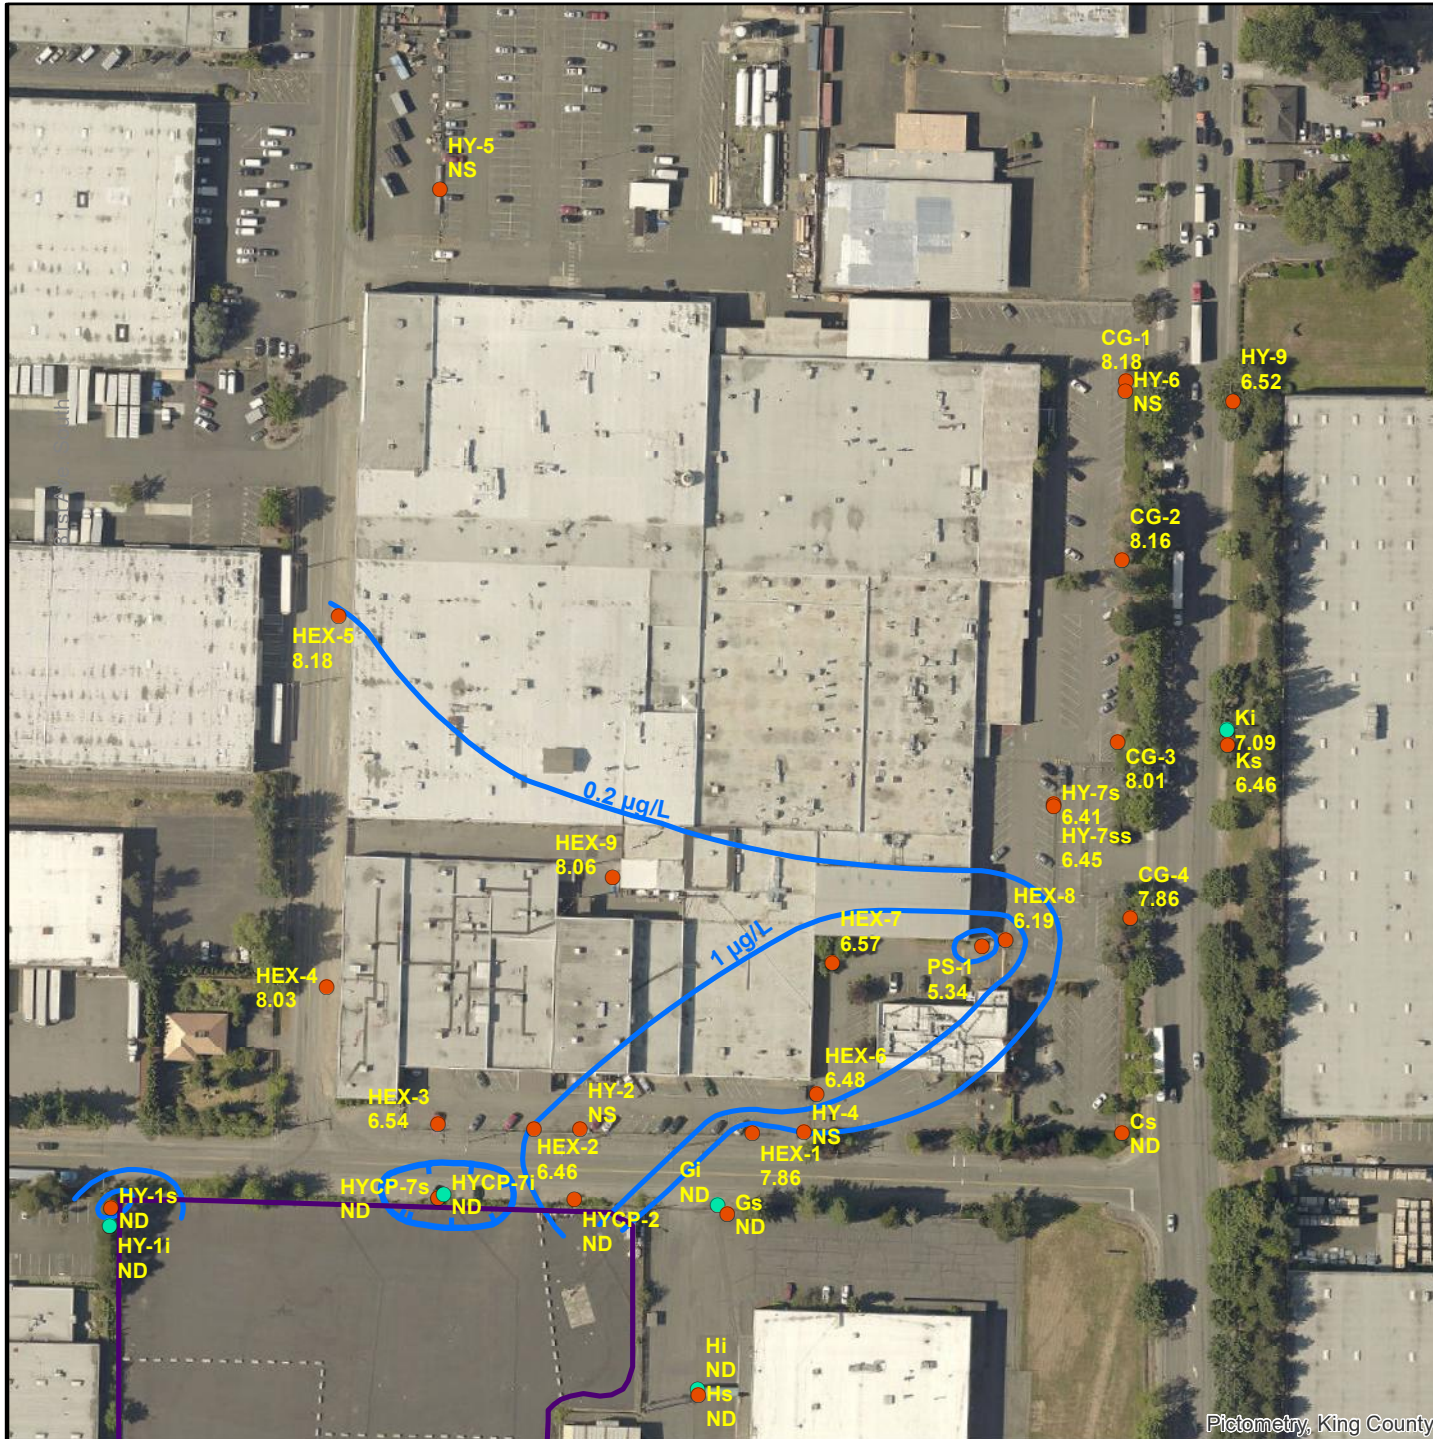
FIGURE 27
pH (standard units)
in Shallow Aquifer
September 2017

Figures 27 and 28 show pH and oxidation-reduction (redox) potential measurements for the shallow aquifer in September 2017. The pH and redox measurements are shown against the contours of VC concentration taken from Figure 17. The pH measurements range from 6.15 to 8.18, or from slightly acidic to slightly alkaline. The redox potential measurements range from -189 to -15.7 millivolts; indicating that reducing conditions predominate in the shallow aquifer. The data show that groundwater in the VC plume is circumneutral and reduced, which are chemically favorable for the reductive dechlorination of VC (Wiedemeier et. al., 1996).

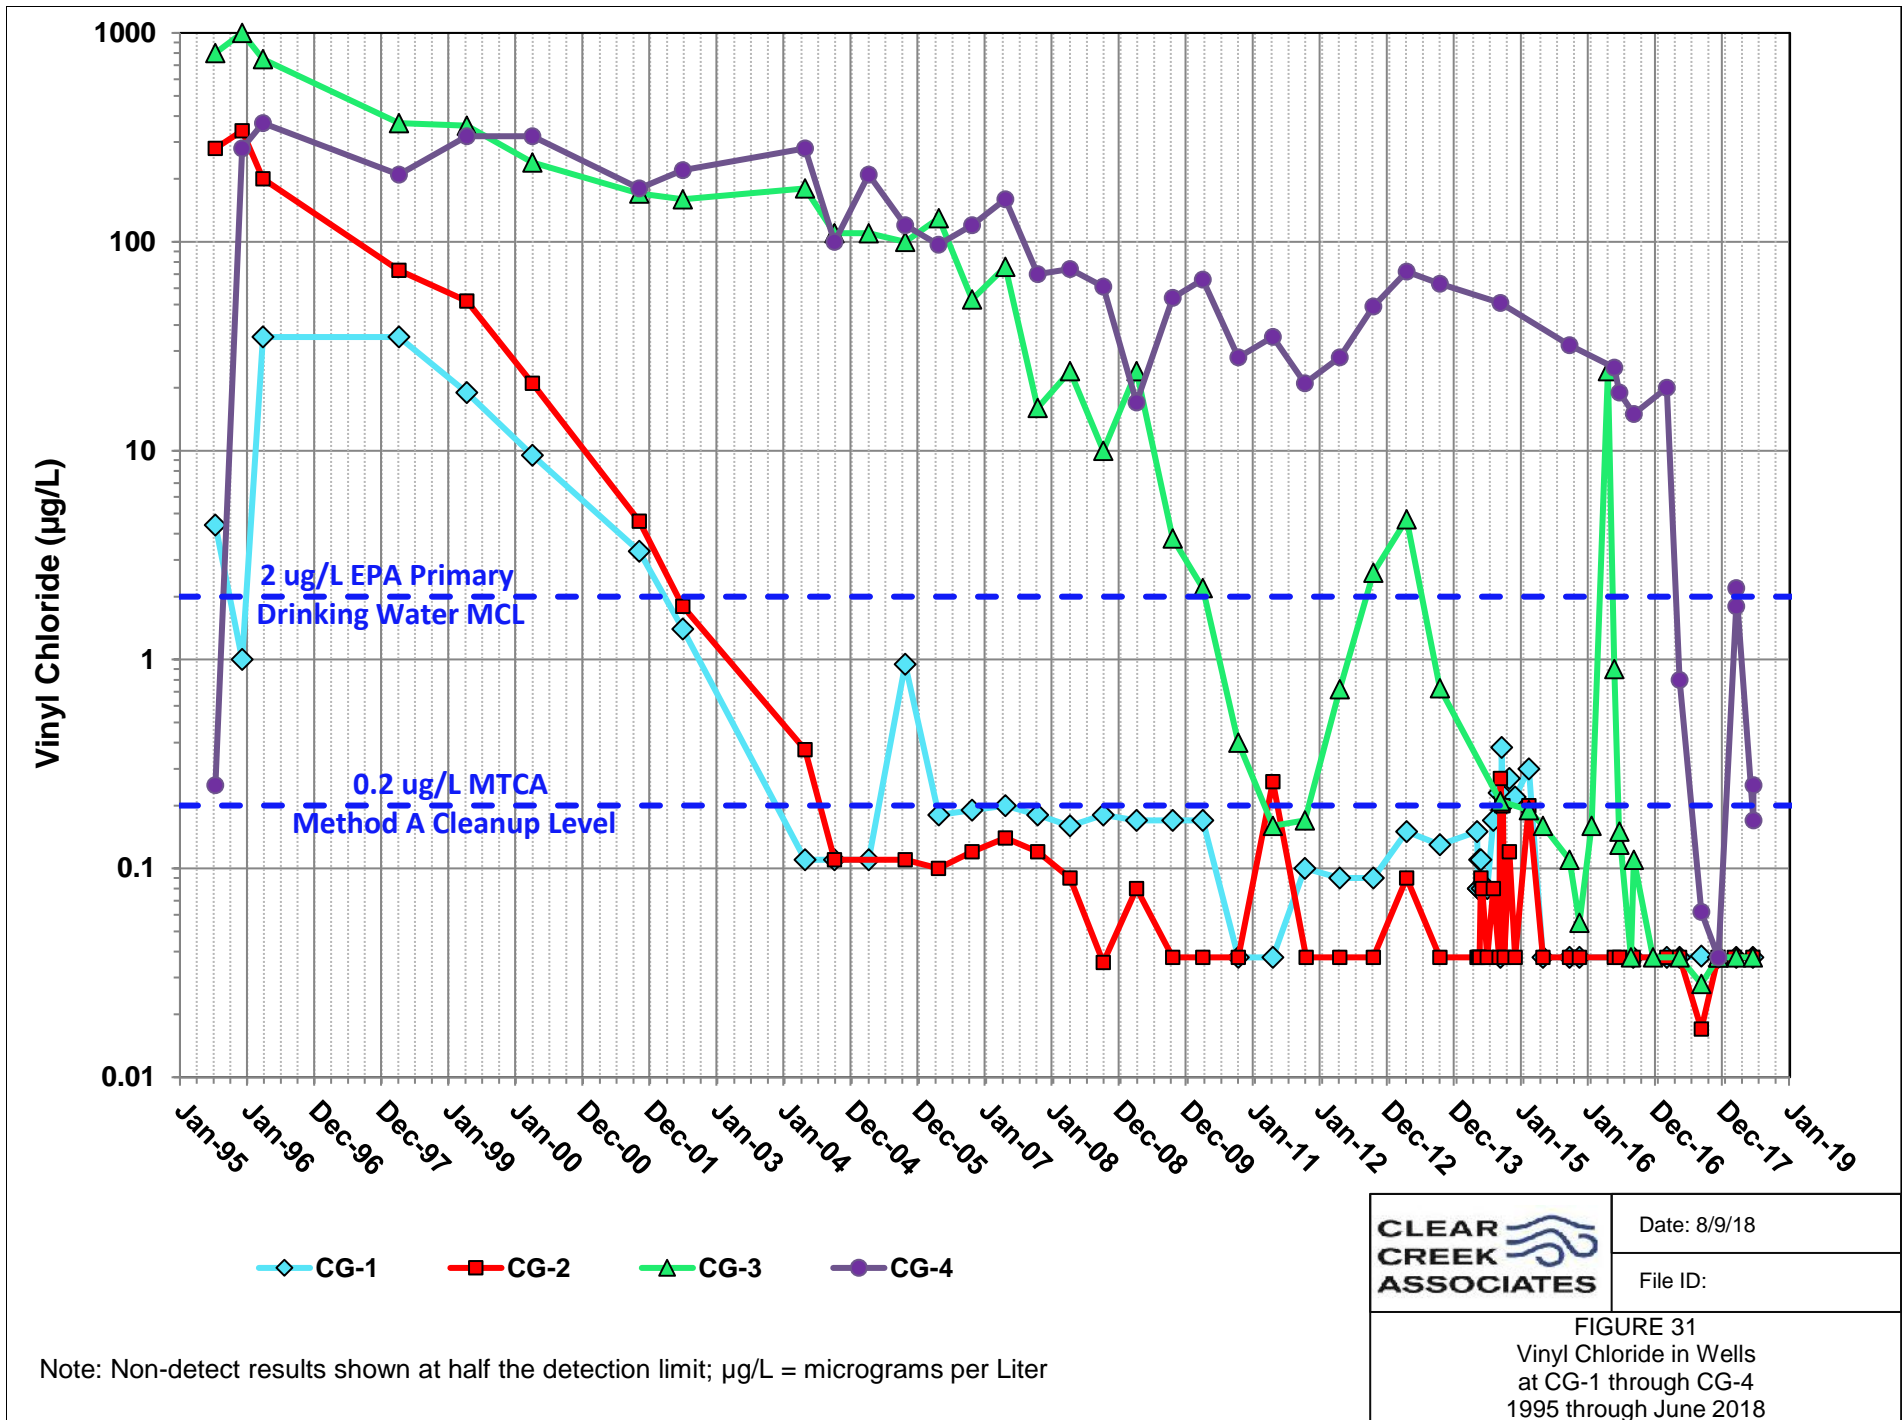
Date: 8/9/18
	File ID:
FIGURE 31 Vinyl Chloride in Wells at CG-1 through CG-4 1995 through June 2018

The monitored natural attenuation approach is feasible at this time because the Parcel G remedy has contained the source of VC, cDCE, and TCE; naturally occurring biodegradation of VC is occurring; and *in situ* biodegradation of VC can be stimulated to enhance its effectiveness, if needed. The pH and redox conditions of the shallow aquifer are in ranges considered appropriate for reductive dechlorination (Wiedemeier et. al, 1996). Dehalococcoides is present and has been dechlorinating TCE for decades, as evidenced by the presence of cDCE and VC in shallow groundwater samples collected since the 1980s. As indicated by Figures 13, 14, 15, 17, 22, and 26 the groundwater plumes of VC, cDCE, and TCE have been shrinking over time. In September 2017, there were no detections of cDCE above MTCA Method A cleanup levels for groundwater, making VC the sole constituent of concern (Section 4.2.2). Natural attenuation, due in part to the intrinsic biodegradation of VC, in the shallow aquifer at Plant 1 has reduced concentrations in the CG wells on the east side of Plant 1. For example, the VC concentrations in wells CG-1, CG-2, and CG-3 declined from a range of 35 to 1,000 ug/L in 1995 and 1996 to less than the MTCA Method A cleanup level of 0.2 ug/L in 2016 (Figure 31).

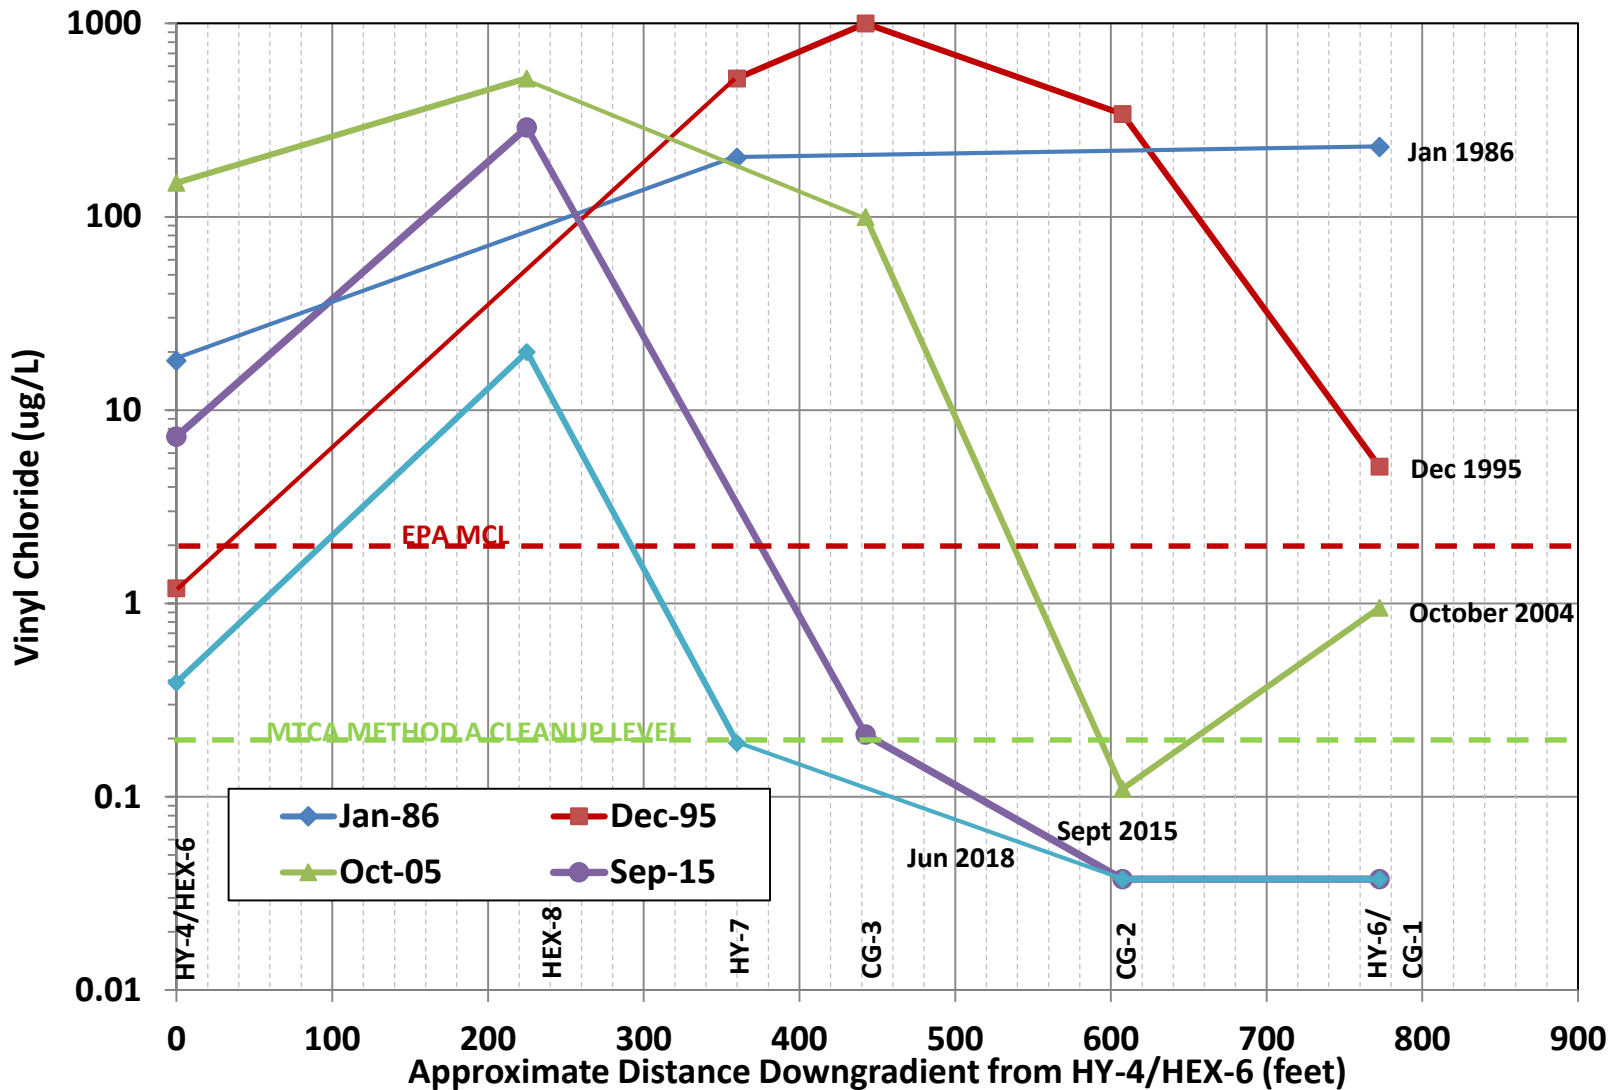
Date: 8/16/18
	File No.: AI273-002
FIGURE 32 Concentration versus Downgradient Distance

Figure 32 shows information documenting the reduction in plume extent over time. The fact that the concentrations of VC at downgradient wells CG-2, CG-3, CG-4, HY-7s, and HY-7ss, HY-9, Ki, and Ks remain less than the MTCA Method groundwater cleanup level after the termination of groundwater extraction is another indication that the plume is not migrating and that biodegradation is occurring at a rate needed to control the plume by the property boundary.
