SUBJECT: COST-BENEFIT ANALYSIS REPORT
North Substation Property
7500 8th Avenue Northeast, Seattle, Washington
Project Number: 1267-004-03

TREE AND LANDSCAPE APPRAISAL REPORT

Seattle City Light North Substation

Tree and Landscape Appraisal

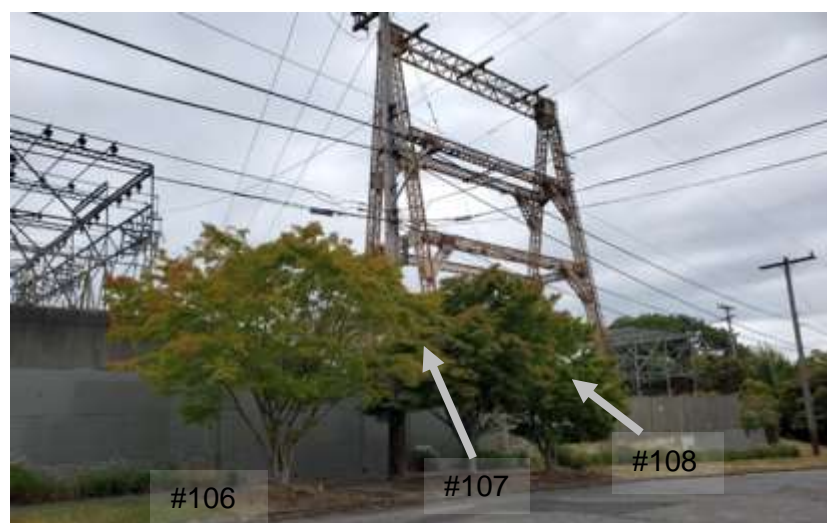
The west side of the substation (Areas 1-4) consists of eight street trees in dispersed groups in the right of way. These maple trees are in fair health and are an appropriate species for under power lines. These trees provide relatively few benefits and can be effectively replaced with new trees planted in well prepared soil. Lifted pavement and curbs near many of the trees is indicative of shallow roots and conditions that will eventually require root pruning to decrease infrastructure impacts. Area 11, a 2-foot planter strip between the sidewalk and the substation wall is filled with pollinator habitat flowers. This is a great landscape that can be easily replaced or improved with soil removal.

Photo 1. Trees 106-108 in Area 3 within the ROW. This ROW planting is similar to others in Area 1-4 along the west side of the substation.

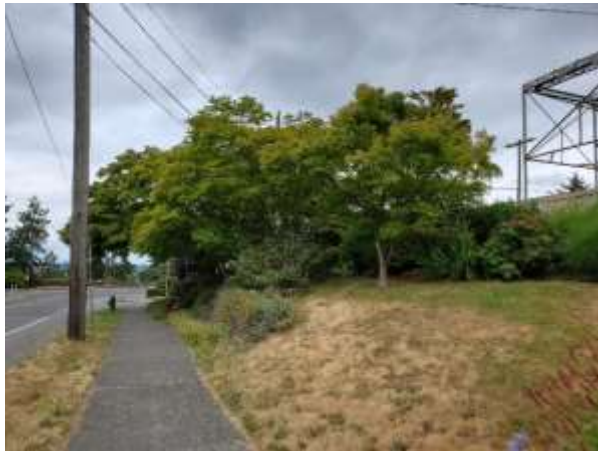
The south west side of the substation (Areas 6 and 7) contain 11 trees in a well-maintained lawn and garden landscape. This area has a large diversity of flowering shrubs and ground covers. Trees in this area buffer the view of the substation wires and building and provides a public garden space and path. Many trees in this area are smaller and grouped close together. Some of the larger trees have higher value and are well placed for retention.

Photo 2. Trees #109-117 in Area 7 are grouped to form a grove over a garden path.

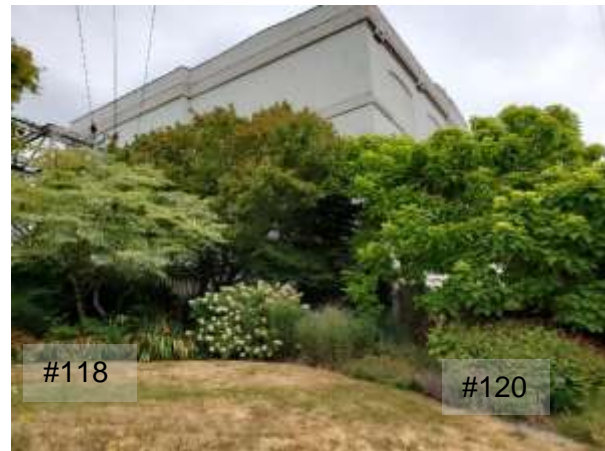
Photo 3. Trees #118-120 in Area 7 soften the view of the building and substation.

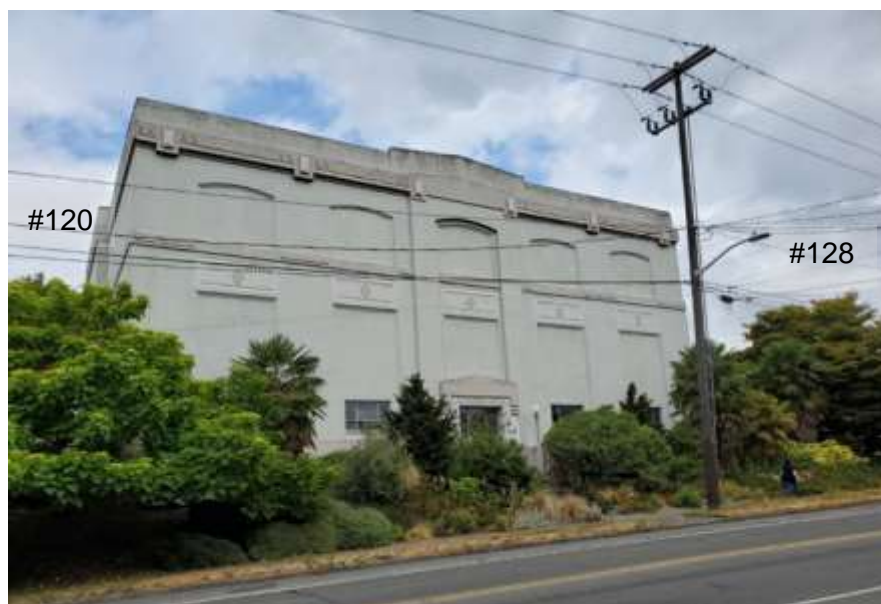
South of the substation (Area 8) is a mature landscape full of unusual tropical plants. Mexican fan palms, pomegranate, and banana trees create a unique visual buffer between neighboring homes, the road and the large building. Only eight plants met the diameter to be counted as trees for appraisal in this area. The remaining were considered shrubs. The south aspect and the radiant heat from the building make this a great location for this unique landscape.

Photo 4. Trees #120-128 and plants in Area 8.

Area 08 – This area has many landscape plants that can be transplanted bare root during the dormant season to soil removal. The palm and banana trees have small root balls and can be transplanted with little soil disturbance or offsite soil movement. Japanese maple (#128) has a high value and is recommended for retention.

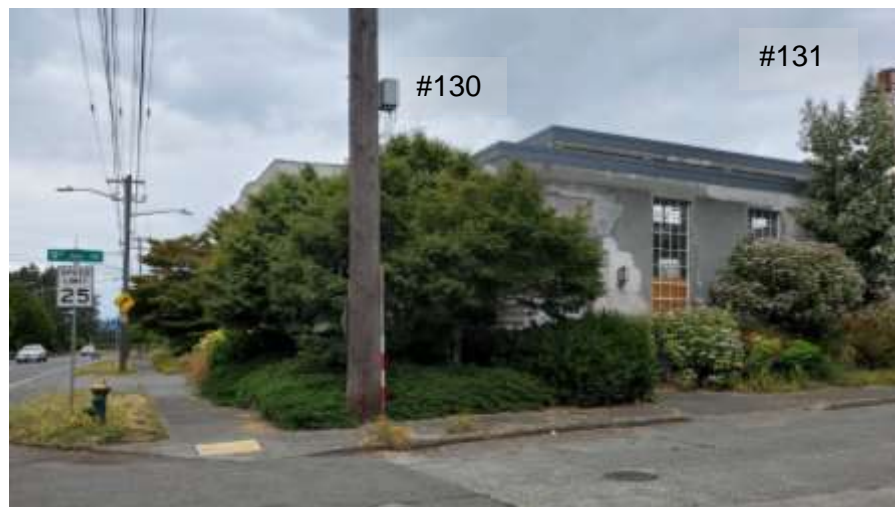
The south east and east side of the property contain large multi stem Japanese maples, camelias and very large hydrangeas and one unusual tree anemone (#131) with flowers similar to a Stewartia. The largest of these trees provide excellent visual buffering value for neighbors and will take many decades to replace if removed.

Photo 5. Trees #129-131 in Area 9. The shrubs in this area are very mature.
