SUBJECT: Annual Inspection of Protective Cap at 255 South King Street

King Street Property
255 South King Street
Seattle, Washington

Project No.: 2000-027-02_11404
Date: August 27, 2024
Drawn By: DIL
Chk By: FNL

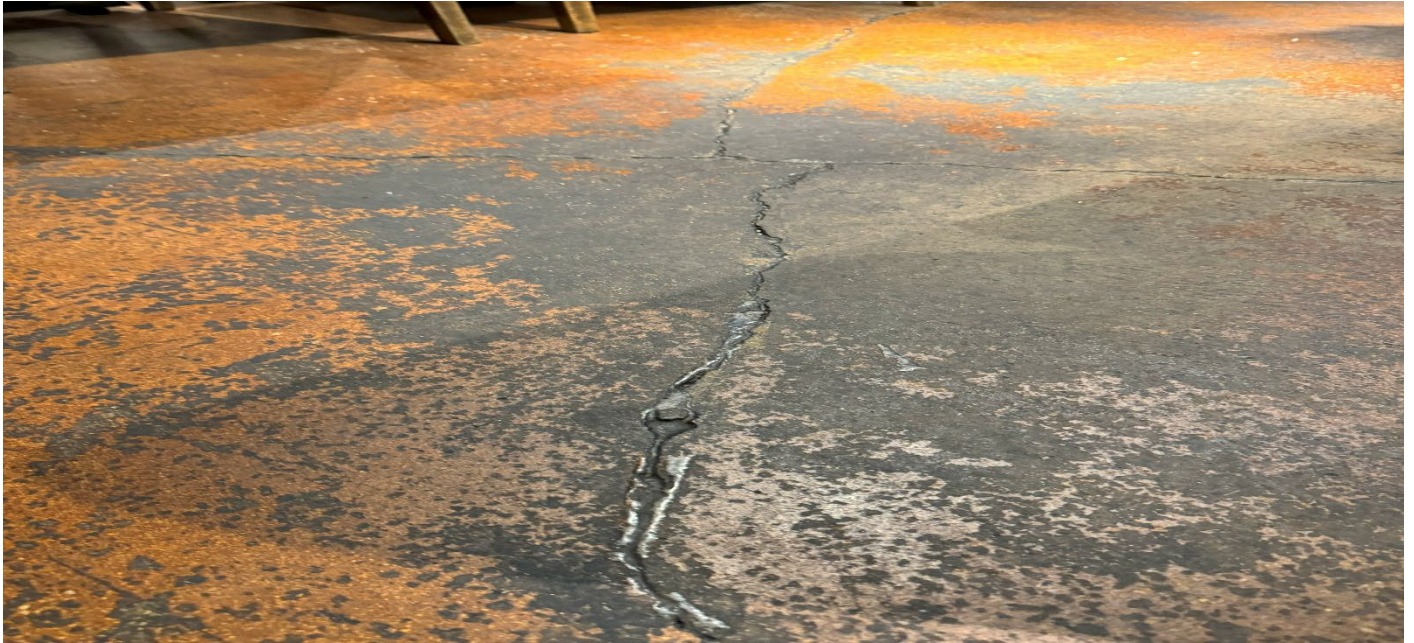
Photograph 1. The previously identified crack sealed with compatible epoxy/ caulking in good shape at the 13 Coins Restaurant on the King Street property.

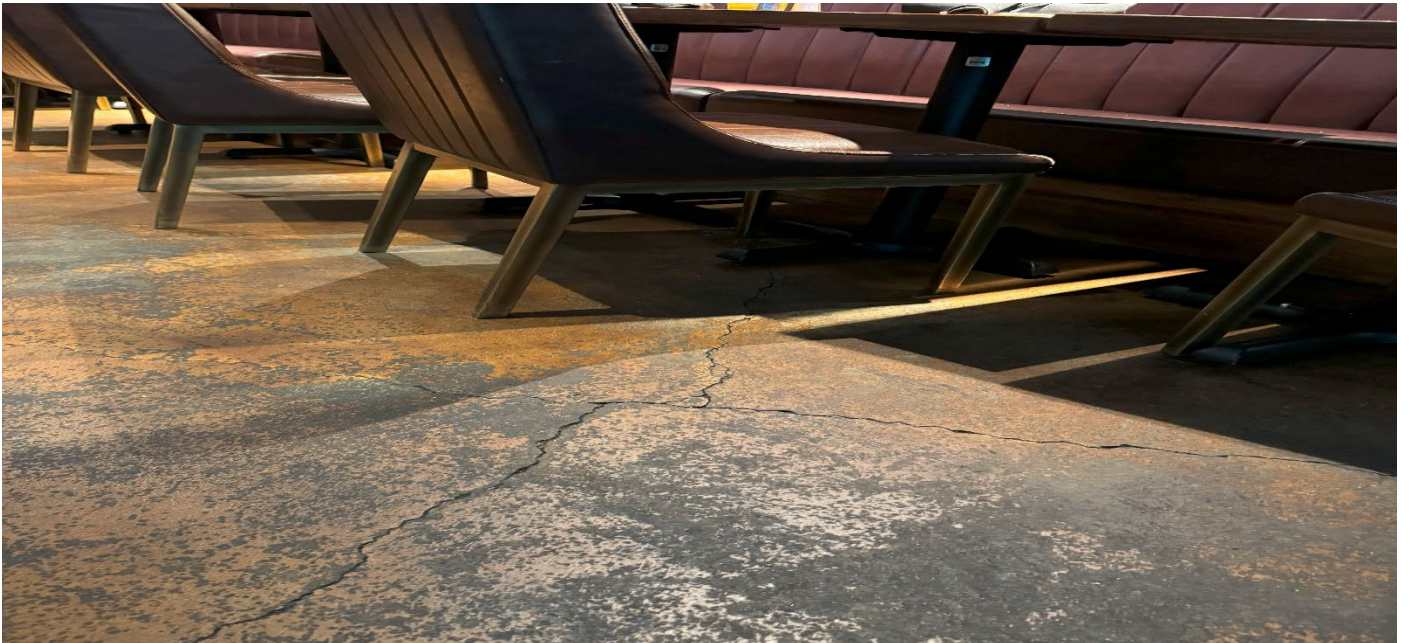
Photograph 2. Cracking in the northwestern portion of the 13 Coins Restaurant on the King Street property. Crack size is comparable to 2022 and 2023 inspections, but quantity of cracks has increased.

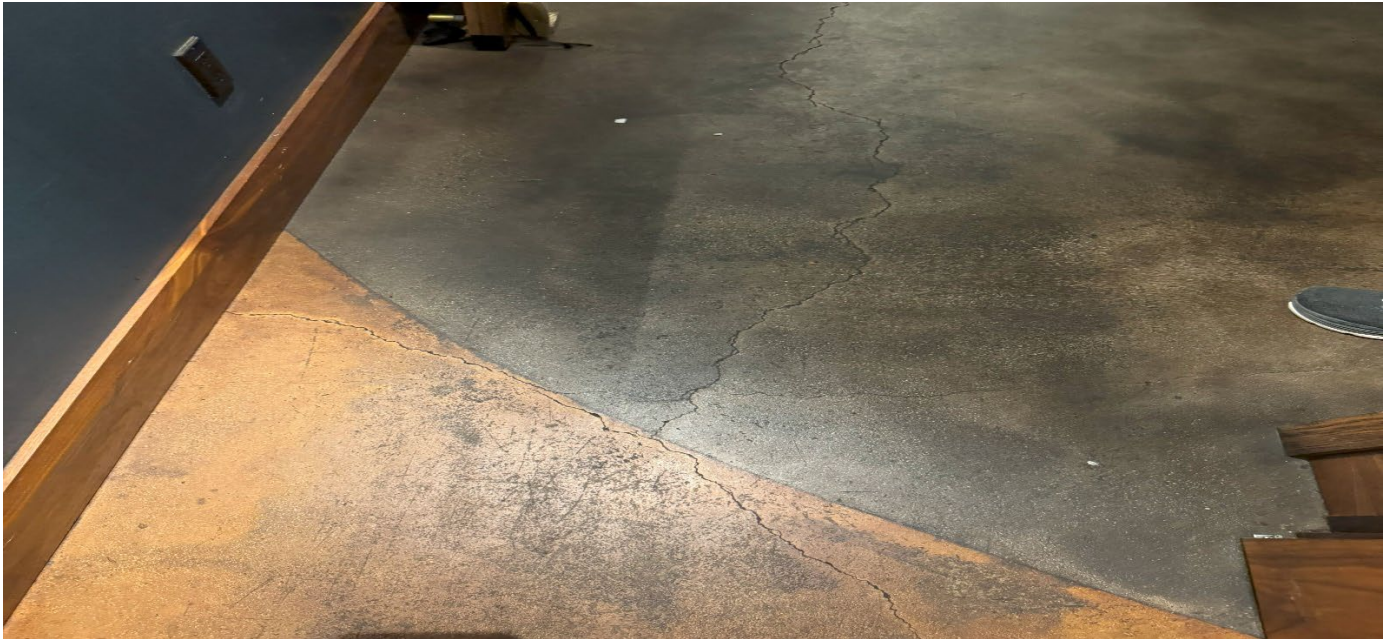
Photograph 3. Sizable cracking in the bathroom hallway of the 13 Coins Restaurant on the King Street property. Crack size is comparable to 2022 and 2023 inspections, but quantity of cracks has increased.

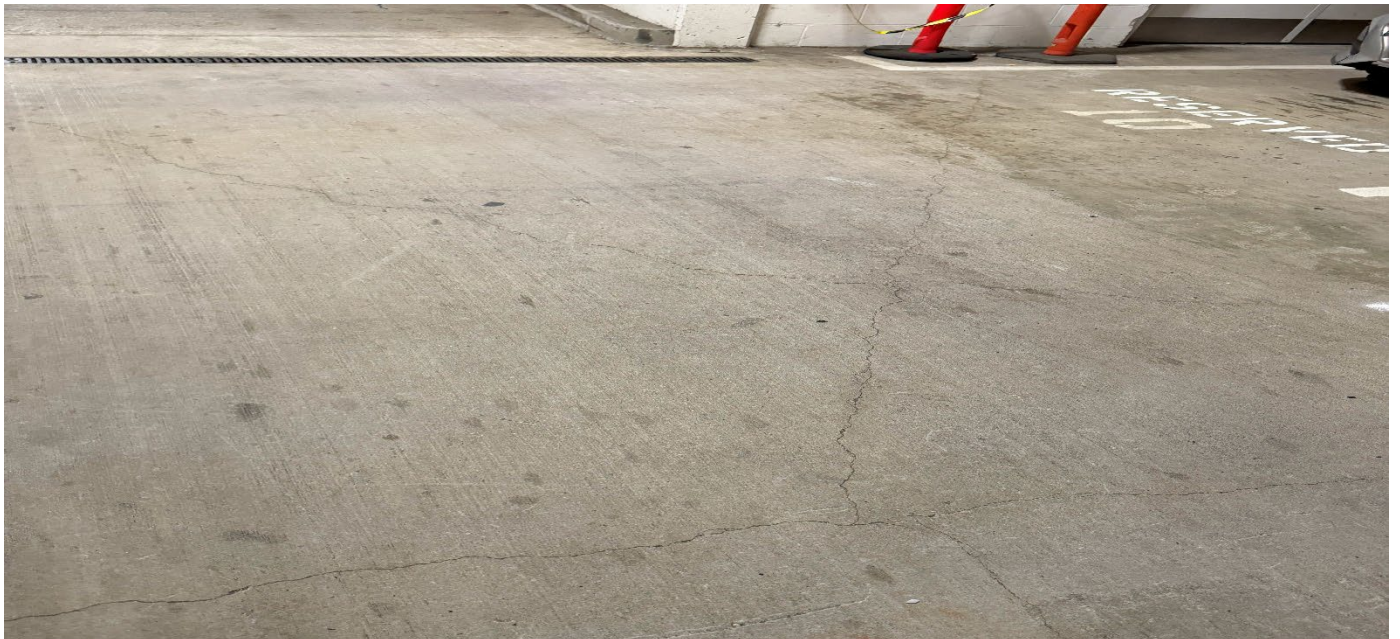
Photograph 4. Nonstructural hairline cracking in the underground parking garage. The overall amount of cracking does appear to have increased since the 2022 and 2023 inspections. This area is to be monitored in the next annual inspection; repairs are not needed at this time.

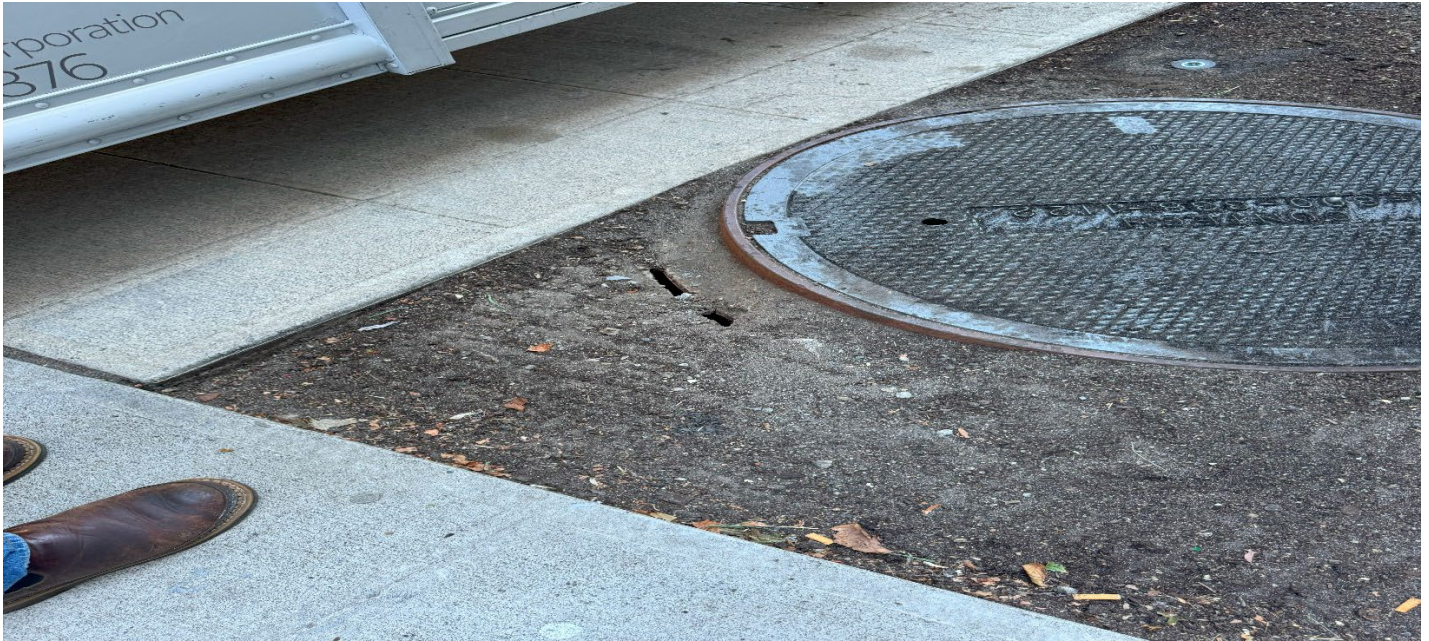
Photograph 5. Sizeable cracking noted near the manhole on the landscaped area immediately east of the building. Repairs are recommended at this time; This area is to be monitored in the next annual inspection.

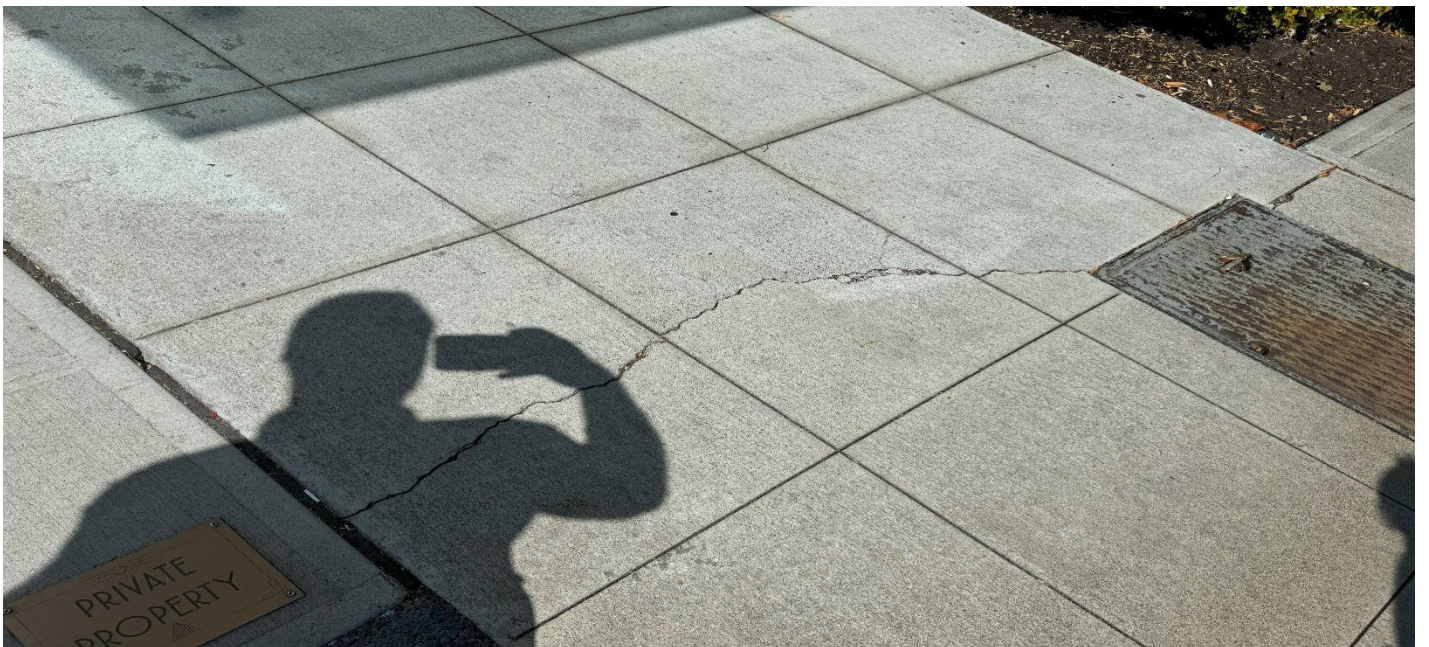
Photograph 6. Cracking on the southern exterior walkway of the building; immediately adjacent to the southeast corner of the building. Repairs are recommended at this time; This area is to be monitored in the next annual inspection.
