DATE: September 25, 2024  
TO: Mark Jusayan, Seattle Public Utilities  
Ashley Piatek, CenterPoint Properties  
FROM: Laura Lee, Amber Bailey, and Tiffany Neier, PE  
SUBJECT: South Park Landfill 2024 Annual Landfill Cap Inspection  
CC: Ryan Gardiner, Washington State Department of Ecology  
PROJECT NUMBER: 553-1550-067  
PROJECT NAME: South Park Landfill Site Coordinator

The purpose of this Technical Memorandum is to summarize the findings of the March 2024 annual landfill cap inspection at the South Park Landfill.

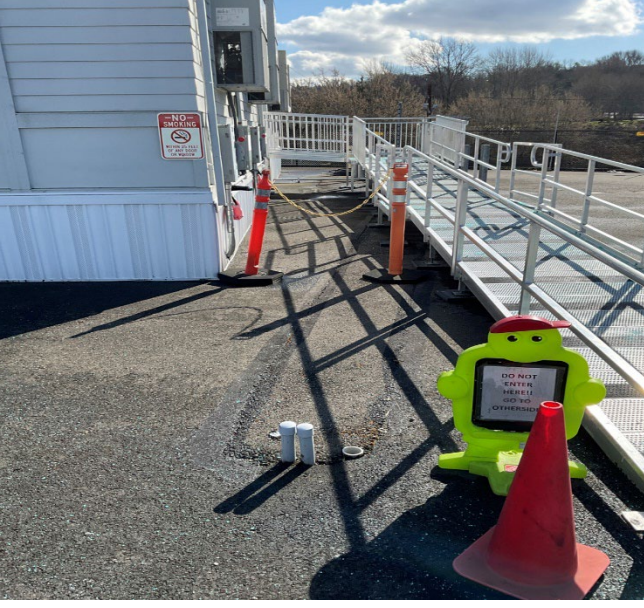
| CPSP Location | Description | October 2023 Inspection | | Condition Status | March 2024 Inspection | | | Photographs |
|---|---|--|---|---|---|---|---|---|
| AC-3 | Uncapped pipe | Uncapped pipe protruding from the asphalt needs to be capped or filled and sealed.. | Pipe is still not capped. | No significant changes observed | Pipe has not been capped.<br>Previous recommended actions remain. | 60 days | CenterPoint | |

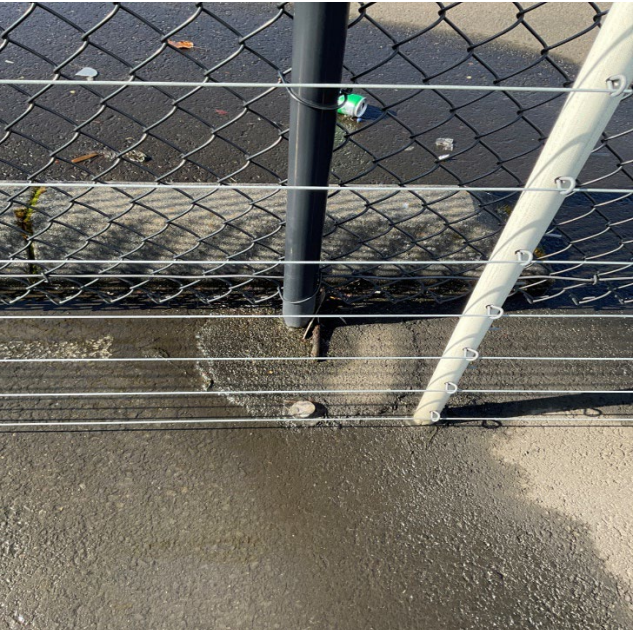
| CPSP Location | Description | October 2023 Inspection | | Condition Status | March 2024 Inspection | | | Photographs |
|---|---|--|---|---|---|---|---|---|
| AC-6 | Gaps and holes in electric fence post holes | Seal the remaining gaps in the interface between the posts of the new electric fence and the asphalt<br><br>There are still some electric fence posts that have not been completely sealed, especially around the back of the pipe where it would be hard to reach. There are also some holes that were drilled next to the installed post. All posts and holes need to have complete seals. | Action Not Yet Completed | No visible improvement | Evidence of continued ponding. Unclear if changes were made. | No later than end of calendar year | CenterPoint | |

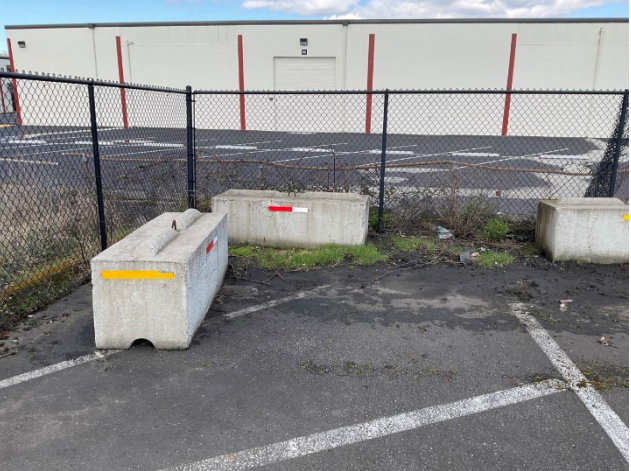
| CPSP Location | Description | October 2023 Inspection | | Condition Status | March 2024 Inspection | | | Photographs |
|---|---|--|--|---|---|---|---|--|
| AC-13 | Blackberry shrubs growth and stagnated water behind the concrete blocks | Blackberries continue to grow. Sediment blocking flow from the swale causing up to 4" of ponding water.<br><br>Remove blackberry shrubs and clear pathways to allow proper water flow into the storm drains. | Plants were cut back. No maintenance form was submitted. | Improved | There is still some sediment buildup. This is an area that will likely need continuous maintenance. Most of the blackberries were removed but there are still some small plants that will likely grow.<br><br>Additional sediment removal needed. | No later than end of calendar year | CenterPoint | |

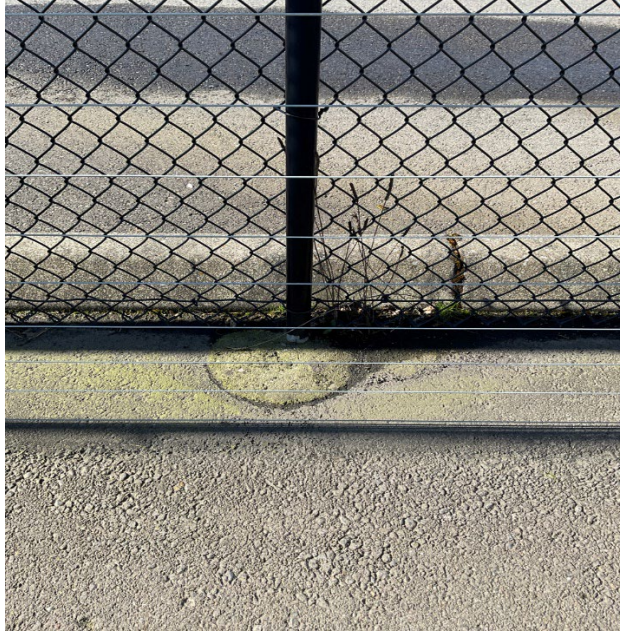
| CPSP Location | Description | October 2023 Inspection | | Condition Status | March 2024 Inspection | | | Photographs |
|---|---|--|--|---|---|---|---|--|
| AC-19 | Pavement cracks near to fences | Remove plants and seal cap penetrations. | No actions taken | No significant changes observed | Plants are still there, and the crack is not sealed.<br><br>Previous recommended repairs remain. | No later than end of calendar year | CenterPoint | |

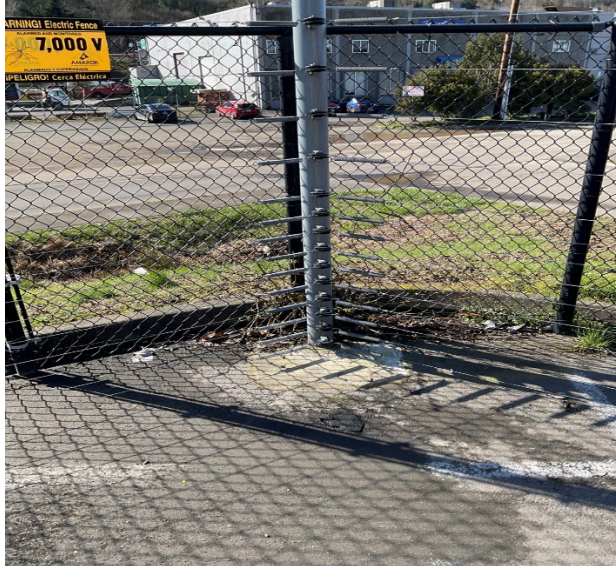
| CPSP Location | Description | October 2023 Inspection | | Condition Status | March 2024 Inspection | | | Photographs |
|---|--|---|---|---|---|---|---|--|
| AC-21 | Holes near fence allowing growth of invasive plants & ponding presence | Invasive plants continue to grow in hole near fence with ponding<br><br>Previous recommendations remain | Plant was cut back.<br>No maintenance form was submitted. | Improved | Plant has been mostly removed. Seal pavement where the plant was growing. | 60 days | CenterPoint | |

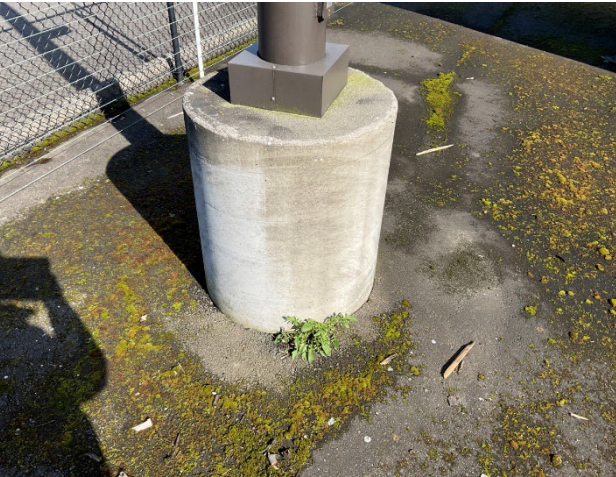
| CPSP Location | Description | October 2023 Inspection | | Condition Status | March 2024 Inspection | | | Photographs |
|---|--|---|---|---|---|---|---|--|
| AC-22 | Unsealed pavement after plant removal | Part of the plant has been removed but the pavement has not been sealed | No actions taken | Worse | Plant has regrown. Remove plant and seal pavement. | 60 days | CenterPoint | |

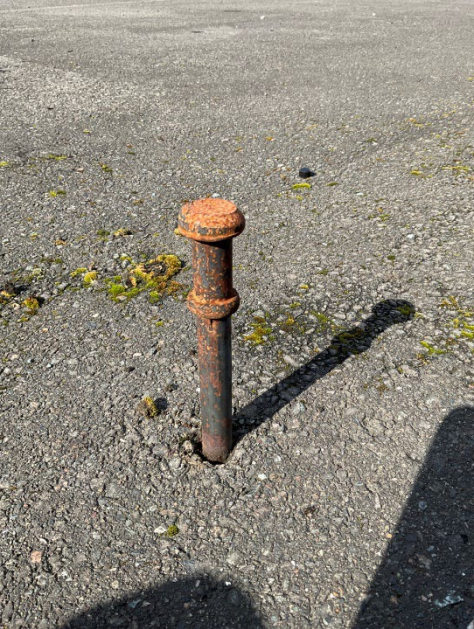
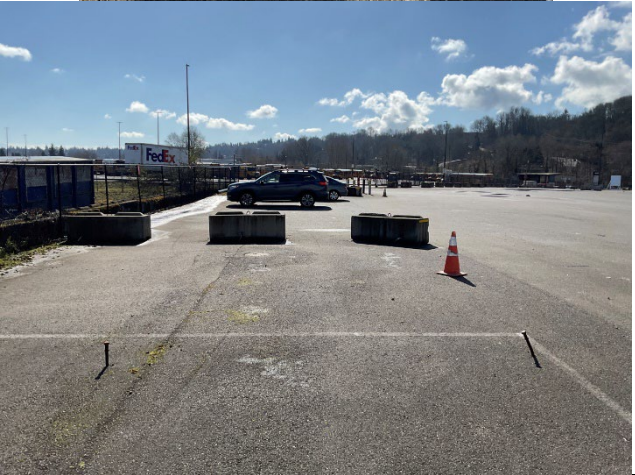
| CPSP Location | Description | October 2023 Inspection | | Condition Status | March 2024 Inspection | | | Photographs |
|---|---|--|---|---|---|---|---|--|
| AC-29 | Metal stakes penetrating the cap | | | New Point | Four (4) Metal stakes penetrating the cap. Cap needs to either be sealed around the stakes or the stakes removed and the pavement repaired. | 60 days | CenterPoint | |

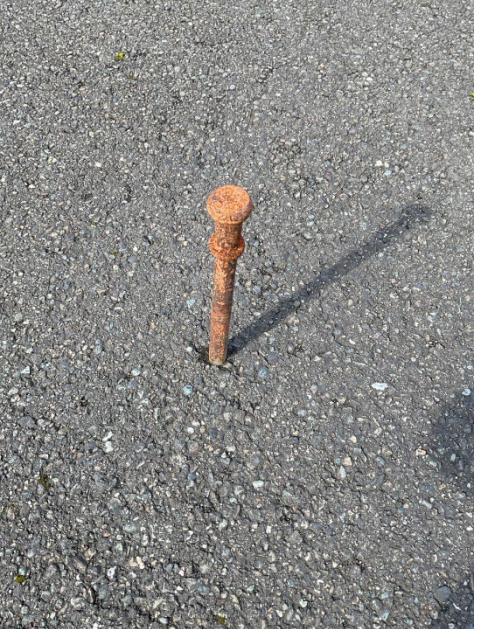
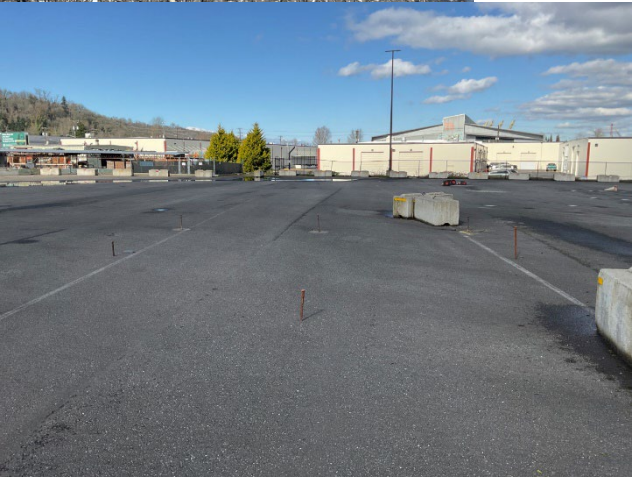
| CPSP Location | Description | October 2023 Inspection | | Condition Status | Conditions Observed and Recommended Action | March 2024 Inspection | | Photographs |
|---|---|--|---|---|--|---|---|--|
| AC-31 | Metal stakes penetrating the cap | | | New Point | Six (6) metal stakes penetrating the cap. Cap needs to either be sealed around the stakes or the stakes removed and the pavement repaired. | 60 days | CenterPoint | |

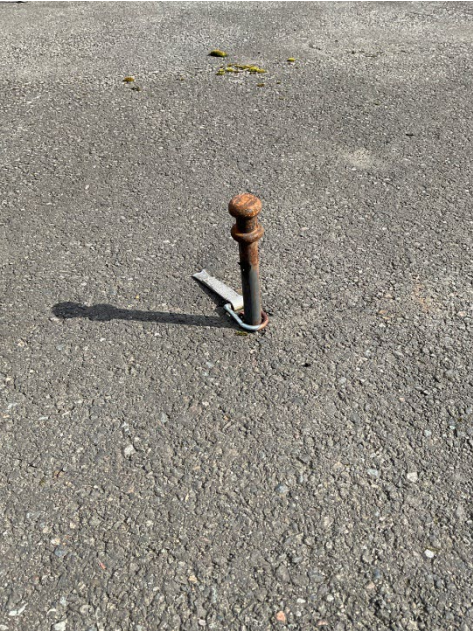
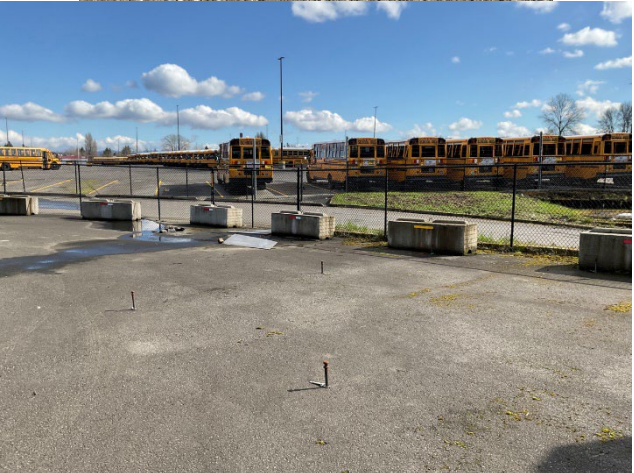
| CPSP Location | Description | October 2023 Inspection | | Condition Status | March 2024 Inspection | | | Photographs |
|---|---|--|---|---|---|---|---|--|
| AC-32 | Metal stake penetrating the cap | | | New Point | Four (4) metal stakes penetrating the cap. Cap needs to either be sealed around the stakes or the stakes removed and the pavement repaired. | 60 days | CenterPoint | |

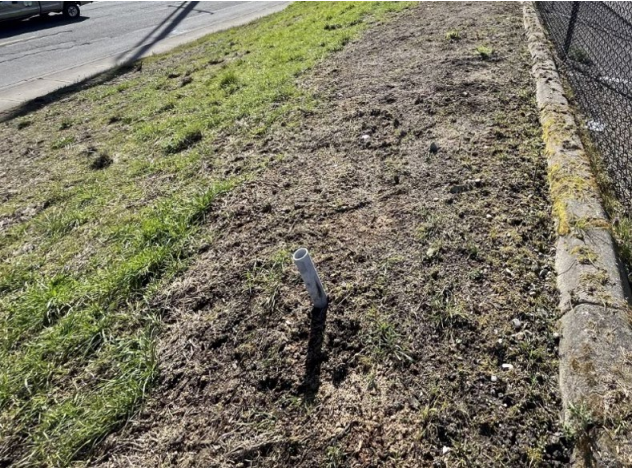
| CPSP Location | Description | October 2023 Inspection | | March 2024 Inspection | | | | Photographs |
|---|---|---|---|---|--|---|---|---|
| G-1 | An open pipe present | Need investigation of this open pipe and action should be taken to cap it, if it does not have any purpose. | Action Not Yet Completed | No significant changes observed | Previous recommendations remain | 60 days | CenterPoint | |

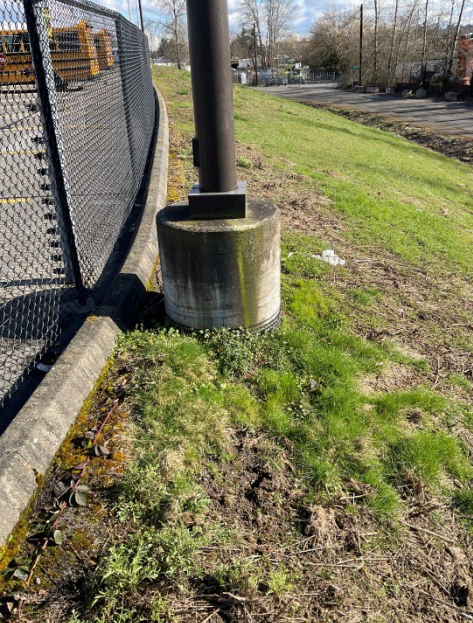
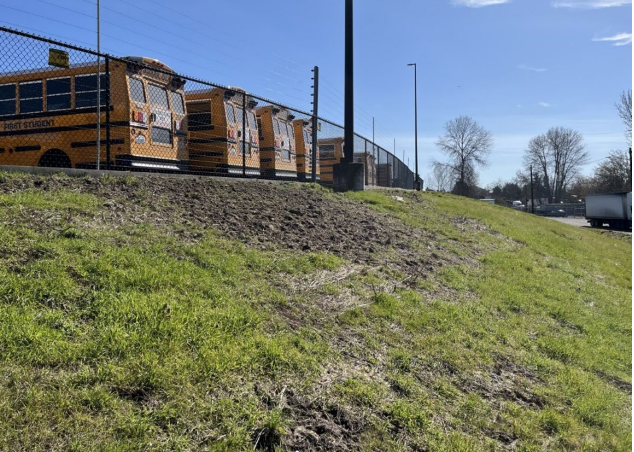
| CPSP Location | Description | October 2023 Inspection | | Condition Status | March 2024 Inspection | | | Photographs |
|---|---|--|---|---|--|---|---|--|
| G-4 | Blackberry shrubs growth in the area and poor vegetation. | Improved growth of grass and growth of blackberry shrubs around the region.<br><br>Remove the blackberry shrubs before the roots spread and re-seed the grass. | Blackberries removed and evidence of seeding. No maintenance form was submitted for this point. | Improved | Blackberries have mostly been removed, no new grass is growing, but there is evidence of an attempt to reseed (small holes in the ground).<br><br>Re-establish appropriate vegetation.<br><br>Submit maintenance form. | No later than end of calendar year | CenterPoint | |

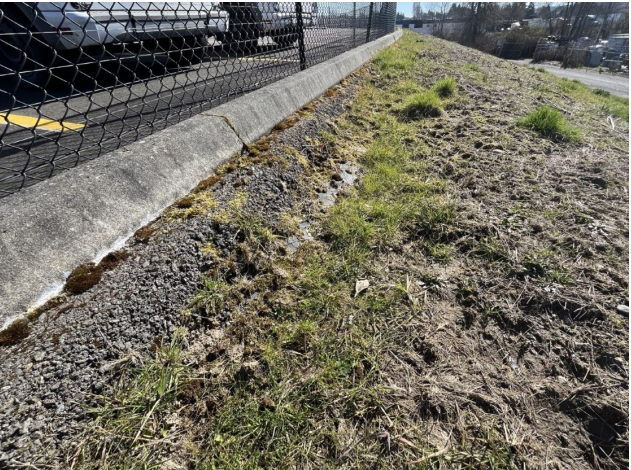
| CPSP Location | Description | October 2023 Inspection | | Condition Status | March 2024 Inspection | | | Photographs |
|---|---|--|---|---|--|---|---|--|
| G-6 | Geomembrane exposed in this area | <p>Geomembrane still exposed.</p> <p>Locations with exposed geomembrane are of the highest concern due to the potential compromise of the landfill cap. The configuration of the geomembrane and cover at the interface of the parking area does not appear to be in accordance with Figure 5 of the Interim Action Work Plan (IAWP). The geomembrane appears to be directly below the asphalt with no drainage layer or surfacing layer in between. Along with Site Coordinator, prepare a plan to reestablish cover over the geomembrane. Most likely, the area should be exposed, and the geomembrane tested for damage before repairs are made. The crest of slope should then be provided cover to the maximum extent possible considering the existing asphalt and curb configuration.</p> | Action Not Yet Completed | No significant changes observed | Geomembrane still exposed. Previous recommendations remain. | 60 days | CenterPoint will work in coordination with Site Coordinator to establish a solution | |

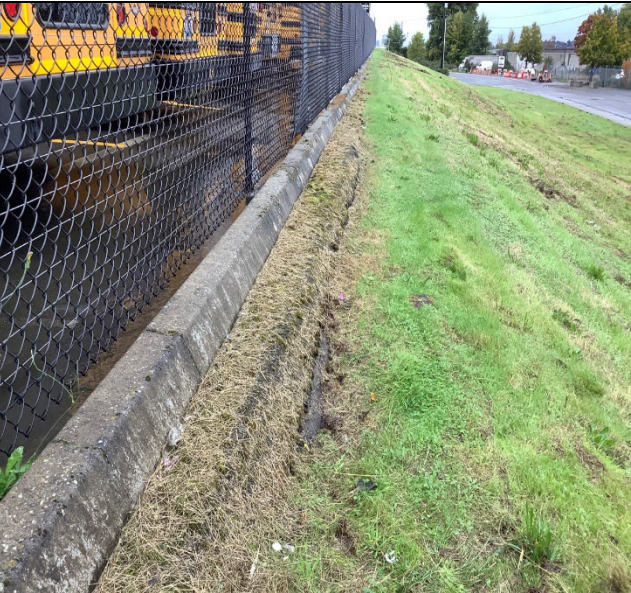
| CPSP Location | Description | October 2023 Inspection | | Condition Status | March 2024 Inspection | | | Photographs |
|---|---|--|---|---|--|---|---|--|
| G-7 | Exposed and damaged geomembrane at the parking area interface | <p>Geomembrane still exposed.</p> <p>See G-6 for recommended action.</p> | Action Not Yet Completed | No significant changes observed. | Maintenance forms were received, however geomembrane still exposed. Previous recommendations remain. | 60 days | CenterPoint will work in coordination with Site Coordinator to establish a solution | |

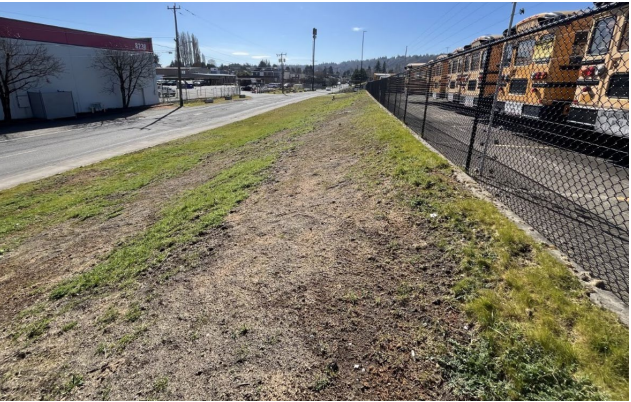
| CPSP Location | Description | October 2023 Inspection | | March 2024 Inspection | | | | Photographs |
|---|--|---|---|---|---|---|---|---|
| G-12 | Poor vegetative cover | Dirt appears to be tilled and the area may have been seeded. No maintenance report received. Submit maintenance report if the tilling was intentional otherwise repair vegetation. | No documentation of actions taken. | Worse | No vegetation established. | No later than end of calendar year | CenterPoint | |

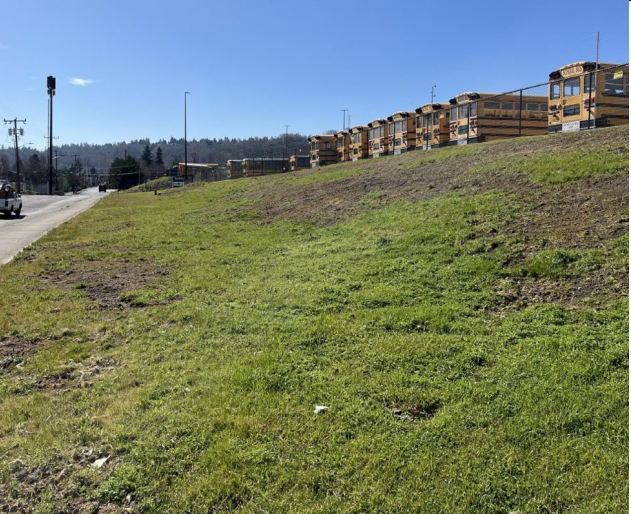
| CPSP Location | Description | October 2023 Inspection | | March 2024 Inspection | | | | Photographs |
|---|--|---|---|---|---|---|---|---|
| G-14 | Invasive Plants | Invasive large plant growth. Remove the large plant due to risk of roots compromising the cover system. | Plants removed. No maintenance form was submitted for this point. | Improved | Large plants were removed. Stump was not found to determine if the roots had damaged the cap.<br><br>Recommend inspecting the cap to determine if it was damaged.<br><br>Submit maintenance form. | No later than end of calendar year | CenterPoint | |

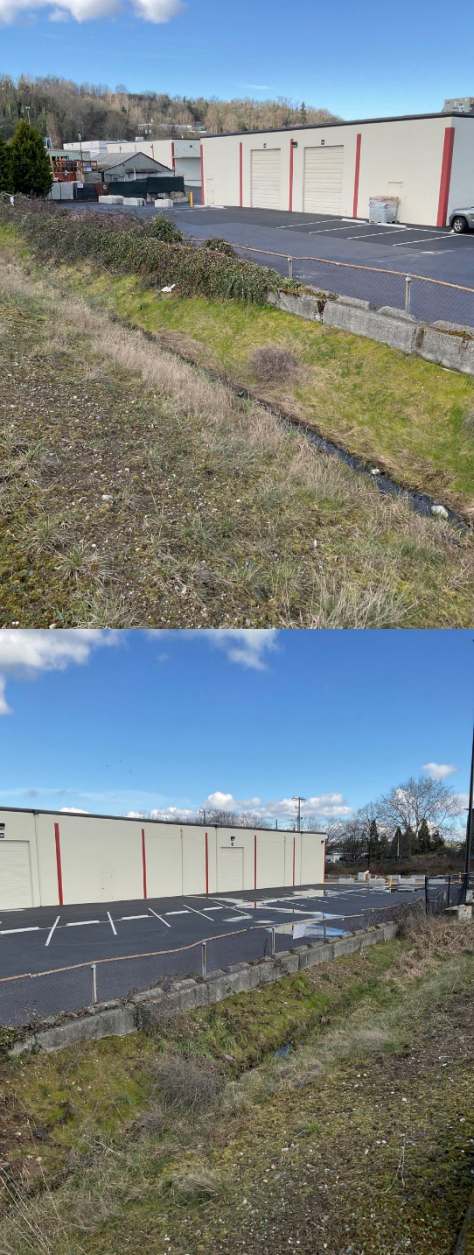
| CPSP Location | Description | October 2023 Inspection | | March 2024 Inspection | | | | Photographs |
|---|---|--|---|---|---|---|---|--|
| SW-1 | Standing water | <p>Improved plant growth but there are still patches of bare soil. Water presence in the swale due to improper sloping.</p> <p>The swale does not meet City of Seattle Stormwater Manual requirement for a biofiltration swale to have a minimum slope of 1.5%. Bottom channel should be regraded to the intended 1.5% slope. Along with Site Coordinator, prepare a plan to address this situation.</p> | Action Not Yet Completed. | Improved | <p>Improved plant growth but there are still patches of bare soil. Water presence in the swale due to improper sloping.</p> <p>Previous recommended actions from 2023 remain.</p> | No later than end of calendar year | CenterPoint will work in coordination with Site Coordinator to establish a solution | |

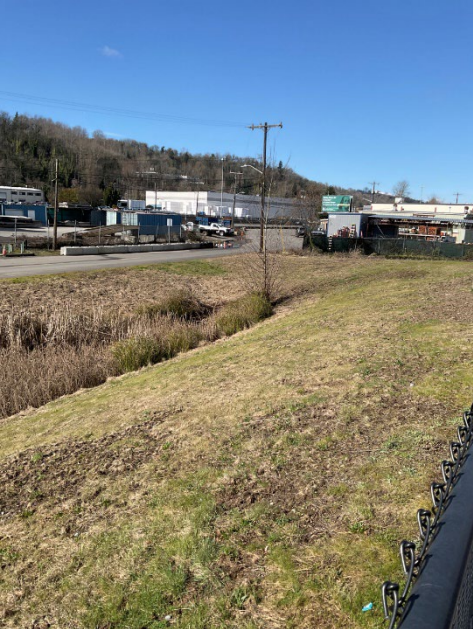
| CPSP Location | Description | October 2023 Inspection | | Condition Status | March 2024 Inspection | | | Photographs |
|---|---|---|---|---|--|---|---|--|
| SW-2 | Invasive/Deep Rooted Plants – Appear to be off of the liner. No longer a concern. | Trees have grown larger. Remove the tree coordinating with CenterPoint<br><br>Previous recommendations from 2023 remain | | Remove | Decided that these plants will likely not harm the geomembrane | | | |

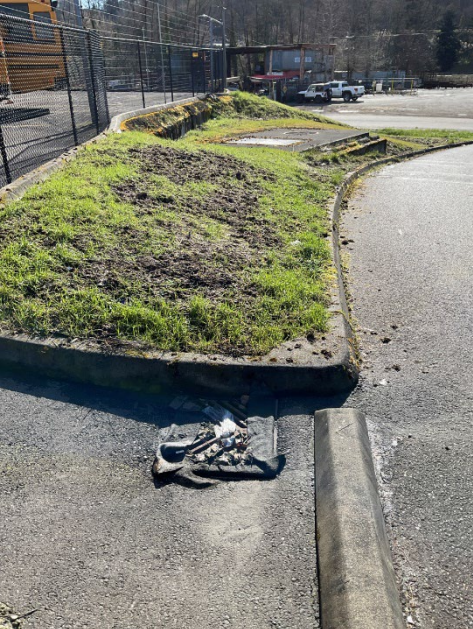
| CPSP Location | Description | October 2023 Inspection | | Condition Status | March 2024 Inspection | | | Photographs |
|---|---|---|---|---|--|---|---|--|
| SW-3 | Catch basin clogged | Catch basin inlet obstructed. Remove the obstruction. | Some debris were removed.<br>No maintenance form was submitted. | Improved | Catch basin inlet partially obstructed. Remove the obstruction. This will likely be an area of continuous maintenance. | No later than end of calendar year | CenterPoint | |

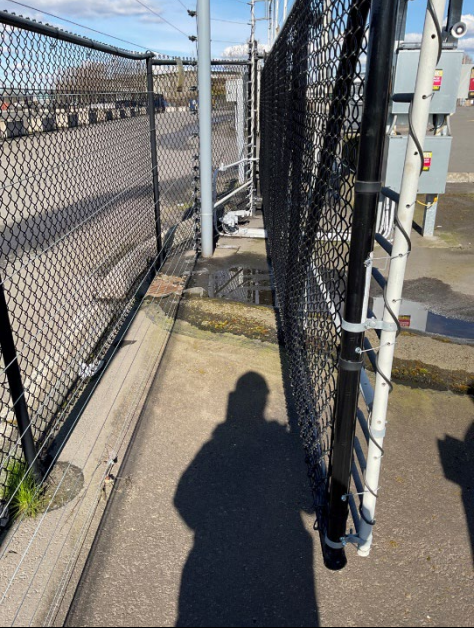
| CPSP Location | Description | October 2023 Inspection | | Condition Status | March 2024 Inspection | | | Photographs |
|---|---|---|---|---|---|---|---|---|
| SW-4 | Catch basin clogged | Catch basin inlet obstructed with sediment buildup and plant growth. Remove the obstruction and vegetation. | | No significant changes observed | Catch basin inlet obstructed with sediment buildup and plant growth. Remove the obstruction and vegetation. | No later than end of calendar year | CenterPoint | |

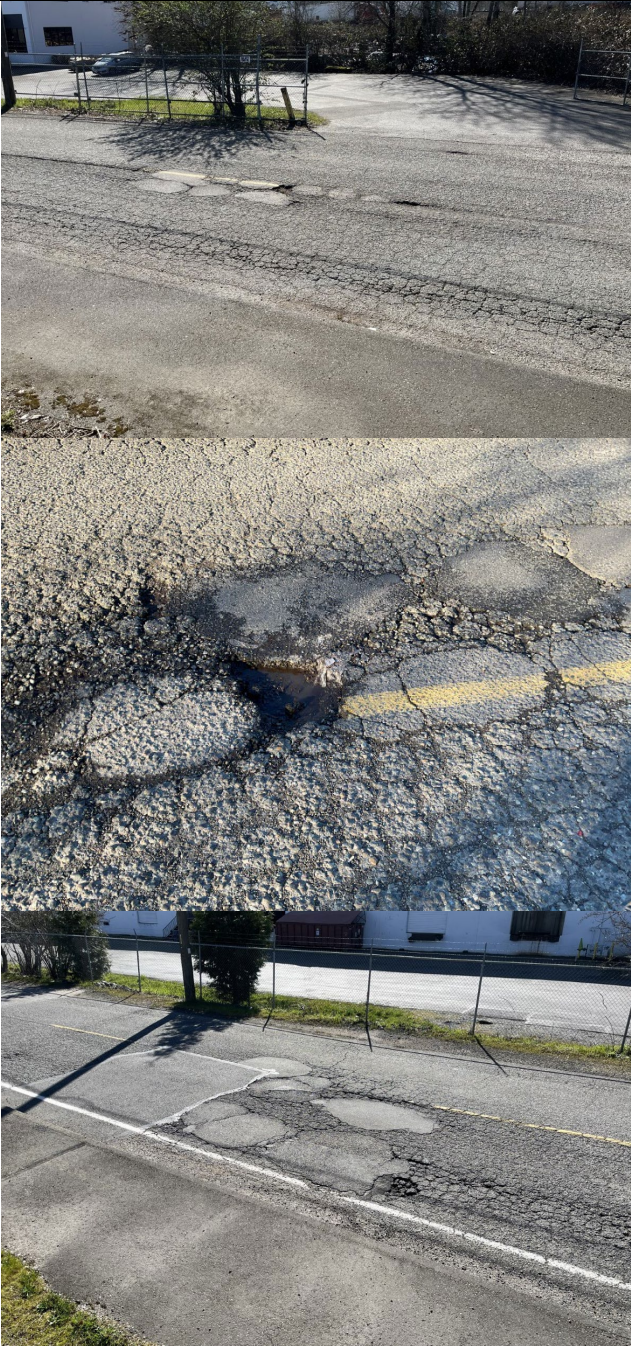
| ROW Location | Description | October 2023 Inspection | | March 2024 Inspection | | | | Photographs |
|---|---|--|---|--|--|---|---|--|
| AC-1 | Cracks and pavement repair | Cracks got worse with ponding. Repair/repatching should be coordinated with SDOT | Asphalt Patching | Improved. Maintenance form not received. | Part of the pothole was repaired but there is still a significant size hole in the asphalt and cracking. | No later than end of calendar year | SPU to coordinate with SDOT | |

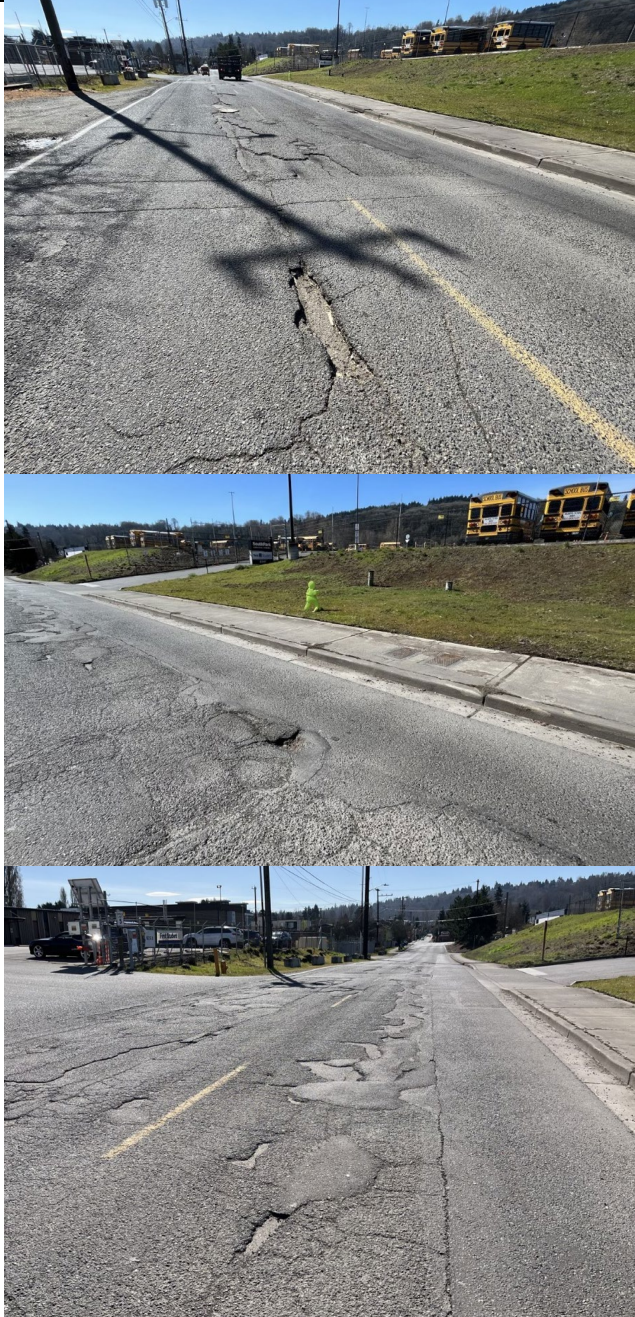
| ROW Location | Description | October 2023 Inspection | | March 2024 Inspection | | | Photographs | |
|---|---|--|---|---|--|---|---|--|
| AC-2 | Asphalt open cracking | Cracks got extended.<br><br>Repatching should be coordinated with SDOT | No action taken | Worse | Cracks got extended and holes are deeper. Some of the holes are close to penetrating the cap.<br><br>Previous recommendation remains | No later than end of calendar year | SPU to coordinate with SDOT | |

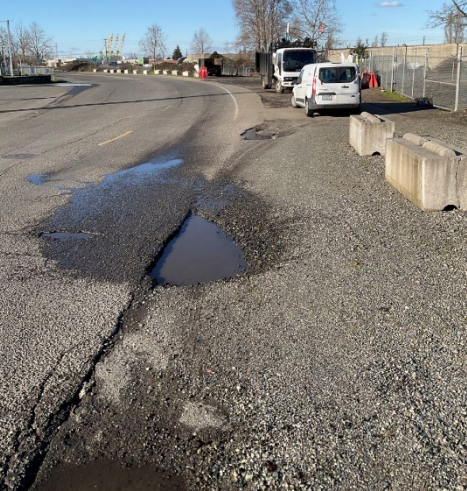
| ROW Location | Description | October 2023 Inspection | | March 2024 Inspection | | | | Photographs |
|---|--|--|---|---|--|---|---|--|
| AC-3 | Potholes alongside of street in the gravel | Pothole appears to be getting worse and should be patched to prevent further erosion. | No action taken | Worse | Previous recommendations remain. | 60 days | SPU to coordinate with SDOT | |

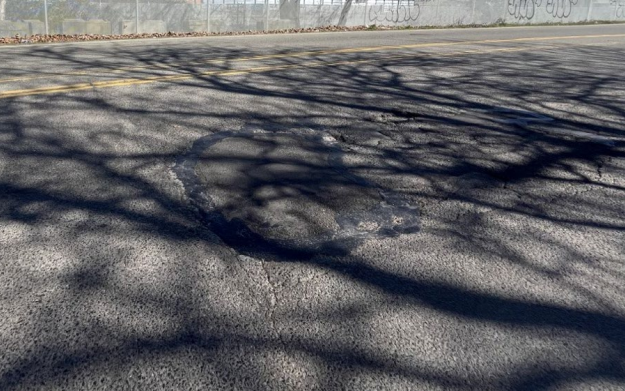
| ROW Location | Description | October 2023 Inspection | | March 2024 Inspection | | | | Photographs |
|---|--|--|---|---|--|---|---|--|
| AC-4 | Potholes in the middle of roadway | The pothole got bigger and ponding inside.<br><br>Repatching should be done coordinating with SDOT | Repaired | Resolved | Previous pothole had been patched | Resolved | SPU to coordinate with SDOT | |

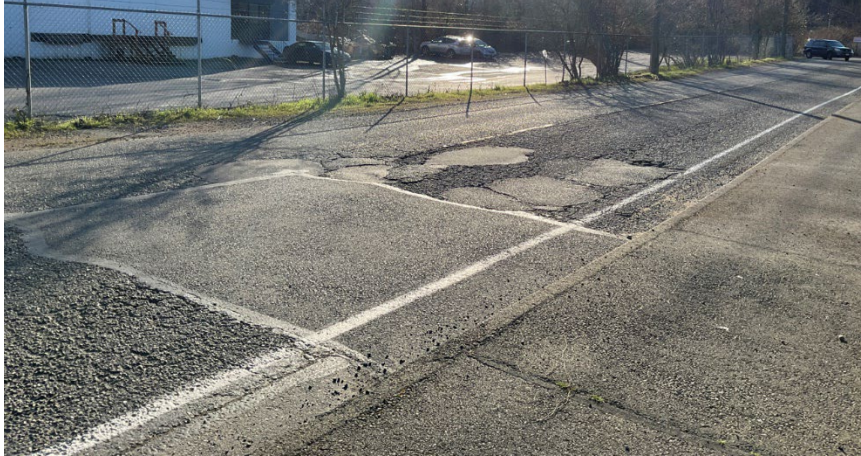
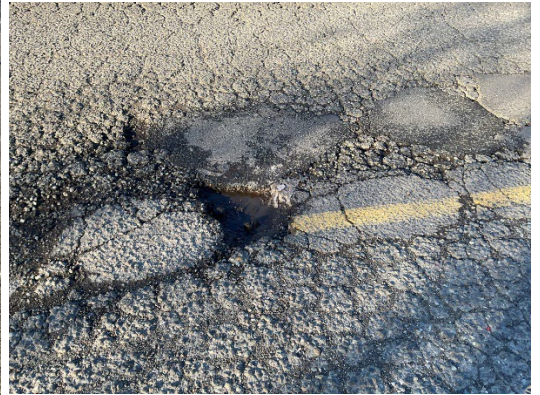
ROW AC-1. Partially complete. A large portion of this area of concern was patched; several of the potholes were filled, but there is an area that still needs repair.

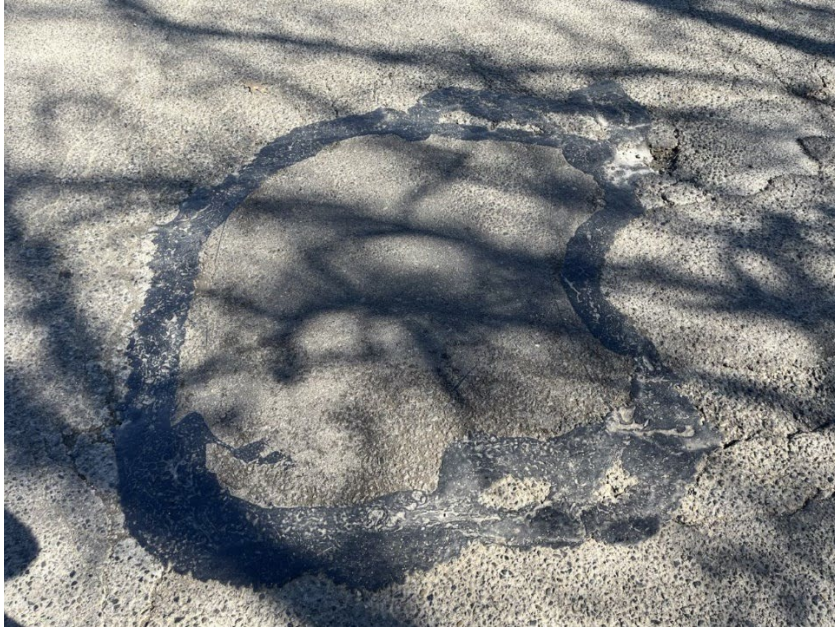
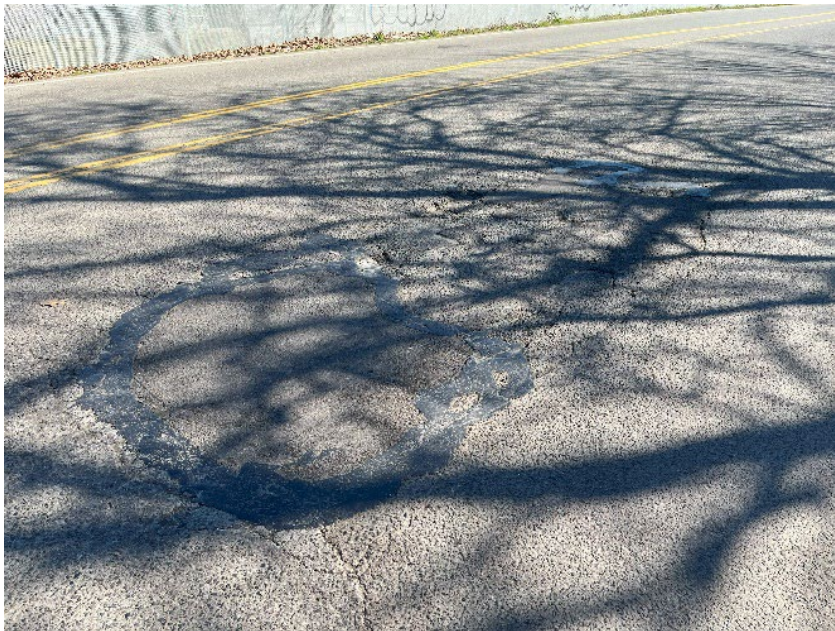
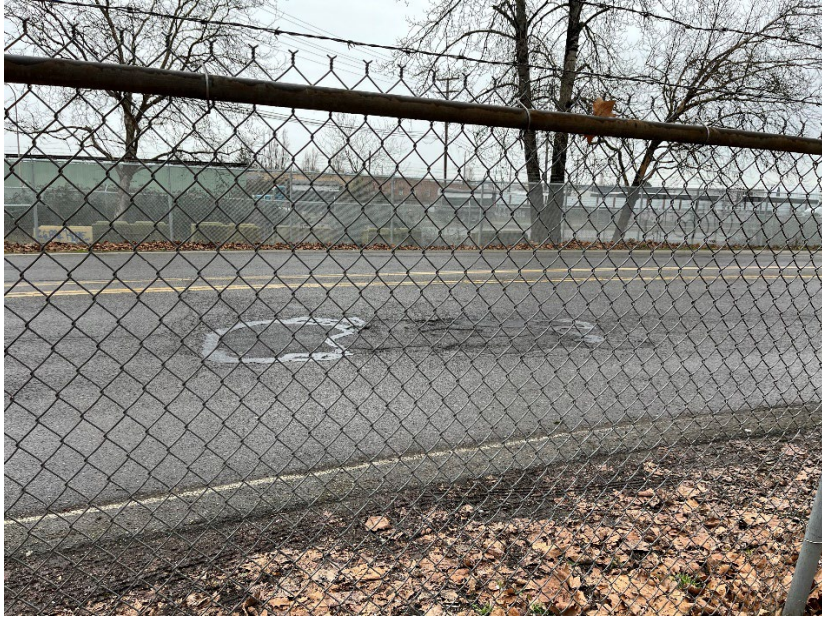
ROW AC-4. Complete. Large and smaller potholes patched with asphalt.
