Site: Union Pacific Railroad – Aluminum Recycling Trentwood Site

Date/Time of Inspection: 6/06/2024 11:30 am

Ecological Cap Inspection

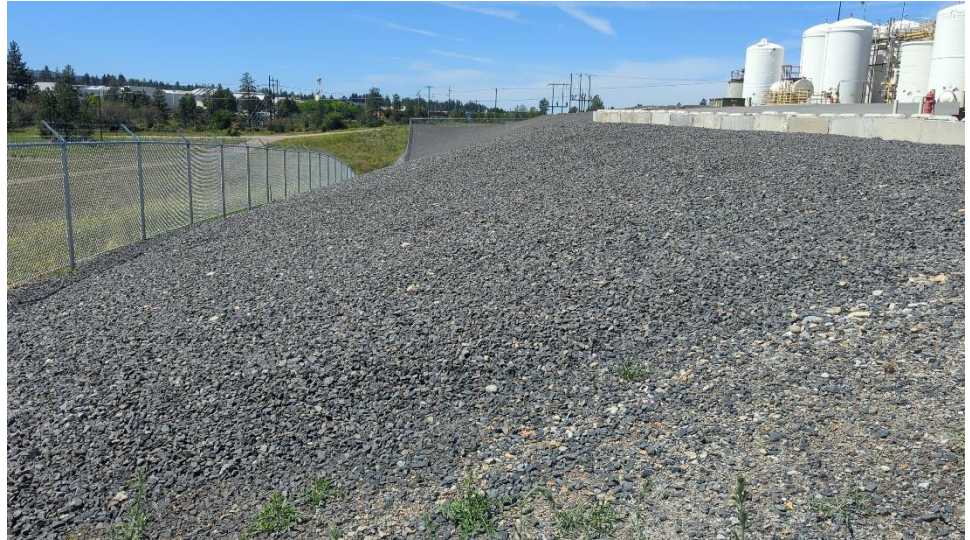
PHOTOGRAPH 1

Ecological cap south slope overview. View looking west-southwest.

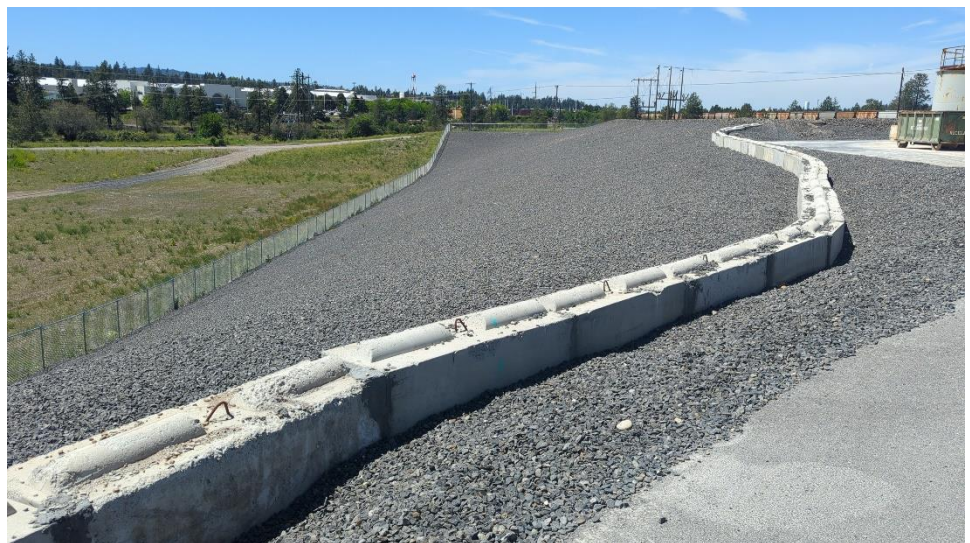
PHOTOGRAPH 2

Ecological cap south side slope from Kemira Facility. View looking west-southwest.

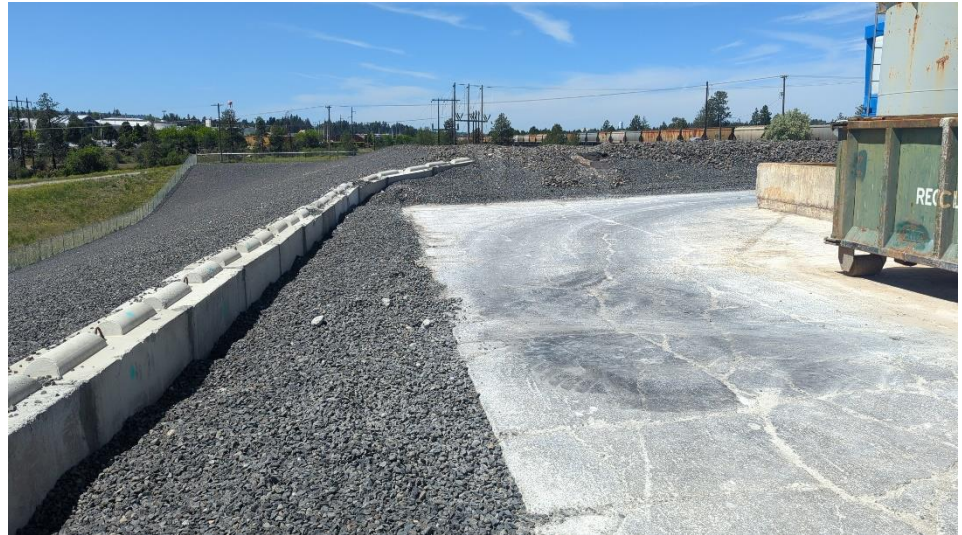
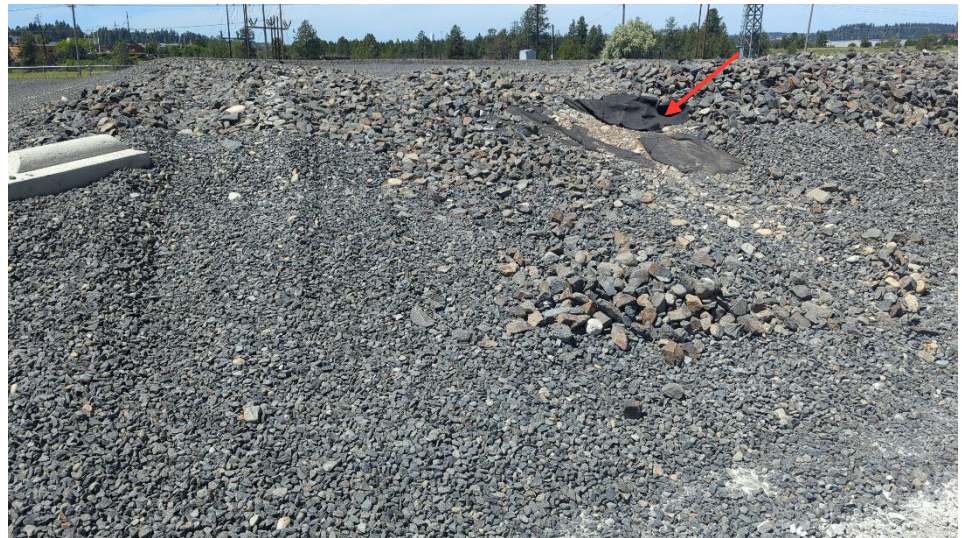
**PHOTOGRAPH 3A AND
PHOTOGRAPH 3B**

Evidence of vehicle use (tire tracks) was present at the Kemira Water Solutions, Inc. (Kemira) Facility access point to the inside of the bermed portion of the cap. An area approximately 5-foot by 6-foot of geotextile was damaged and underlying material were exposed in this area, see photographs 3a and 3b. The damaged geotextile requires maintenance, and the overlying gravel needs to be replaced. A barricade should be placed across the access point to limit vehicular traffic.

Kemira facility ecological cap
overview (3a) and closeup of
compromised cap area (3b).
Views looking west.

(a) List Other 1 - "Access Point" at Kemira Facility; South end of East Berm, eastern side Evidence of vehicle use (two tracks) that probably caused breach/damage of ecological cap

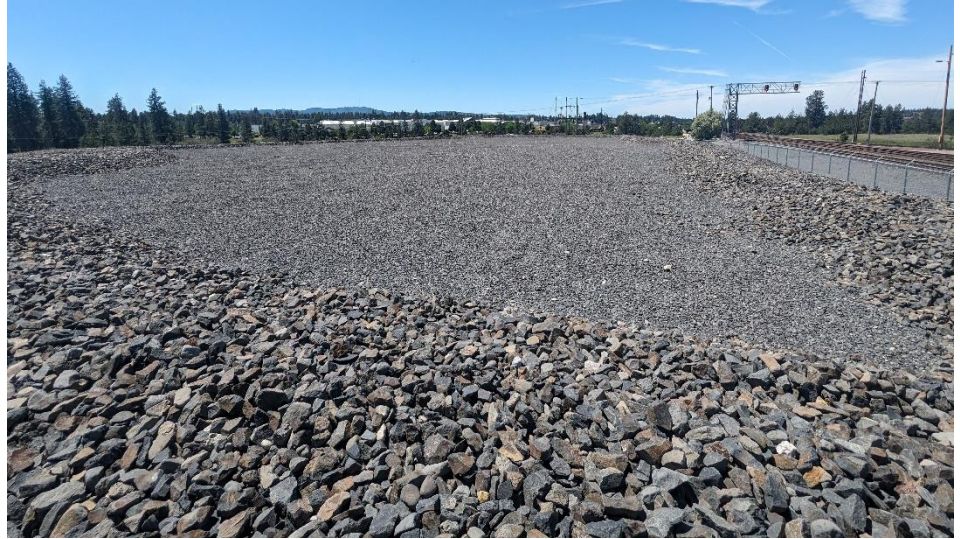
PHOTOGRAPH 4

Ecological cap and berm overview. View looking west.

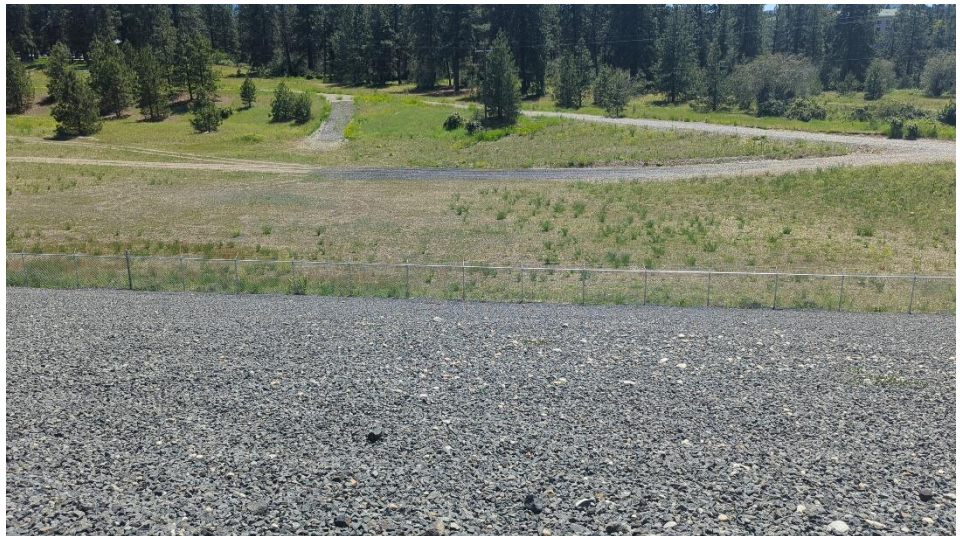
PHOTOGRAPH 5

Ecological cap south slope and WSDOT property below. View looking south.

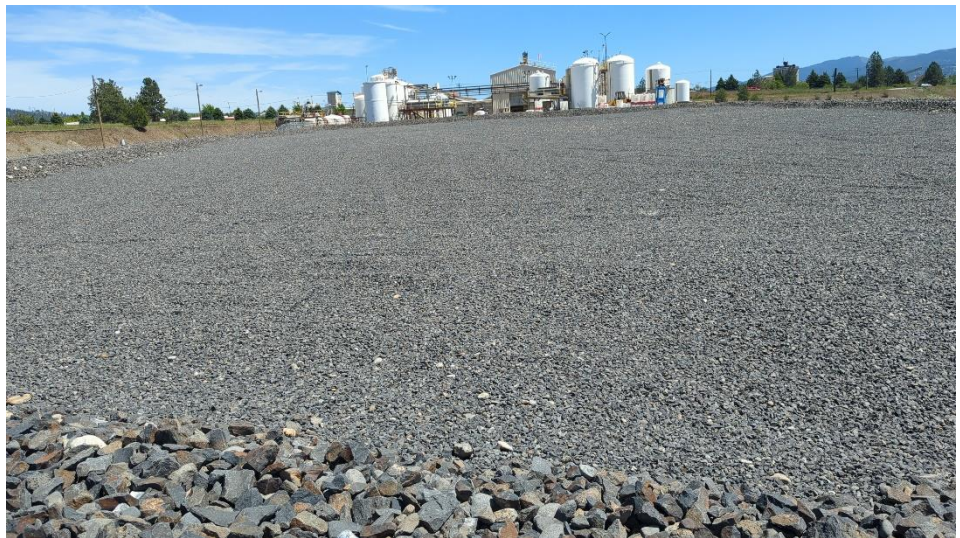
PHOTOGRAPH 6

Ecological cap overview. Looking east toward Kemira facility.

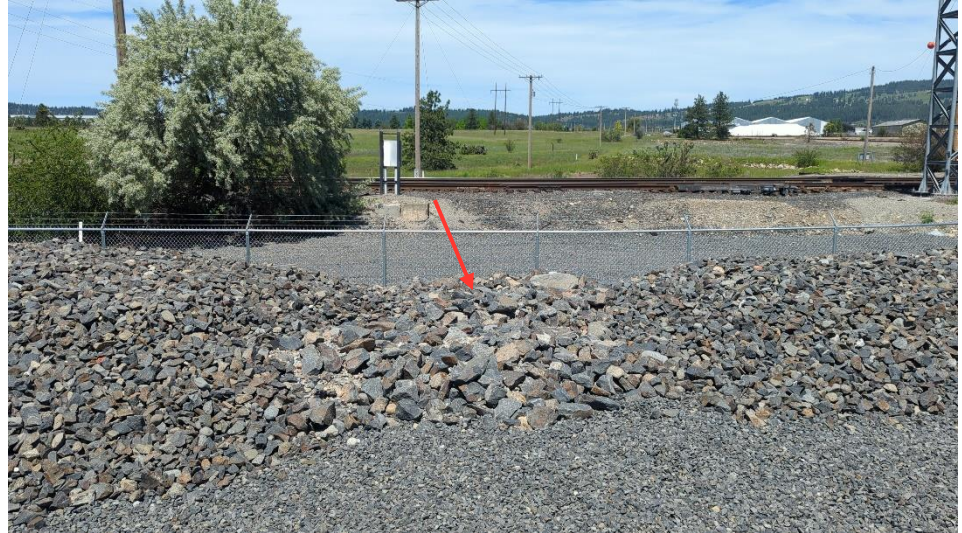
PHOTOGRAPH 7

Top of Overflow Channel.
View looking north.

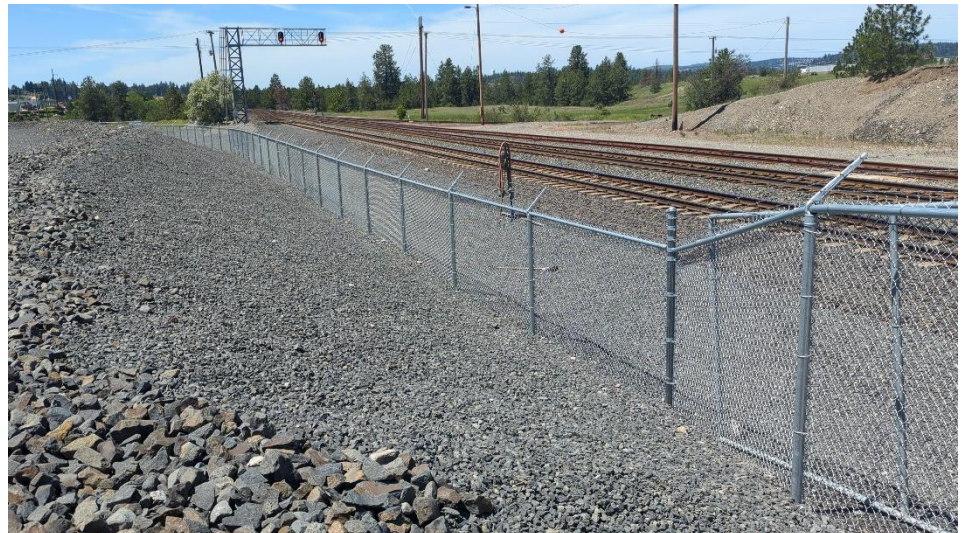
PHOTOGRAPH 8

North berm overview and
railroad ditch north side of
UPRR property. View looking
west.

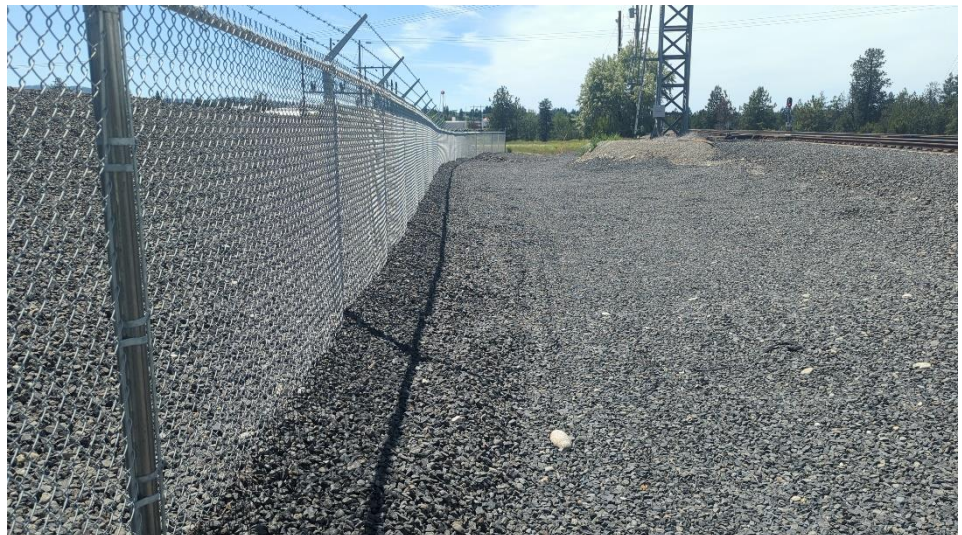
PHOTOGRAPH 9

Railroad ditch overview. View
looking west.

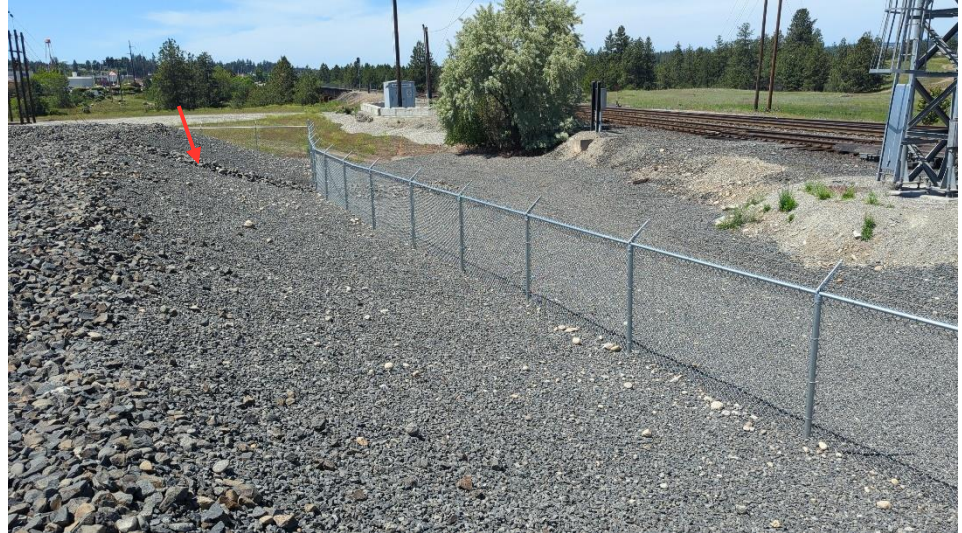
PHOTOGRAPH 10

Overflow channel area leading into railroad ditch. View looking west-southwest.

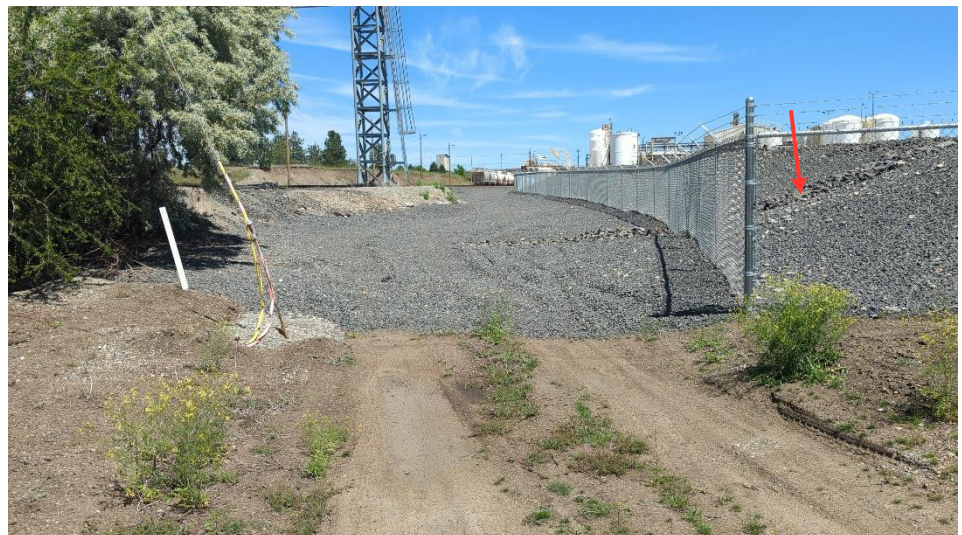
PHOTOGRAPH 11

Railroad ditch and overflow channel. View looking east-northeast.

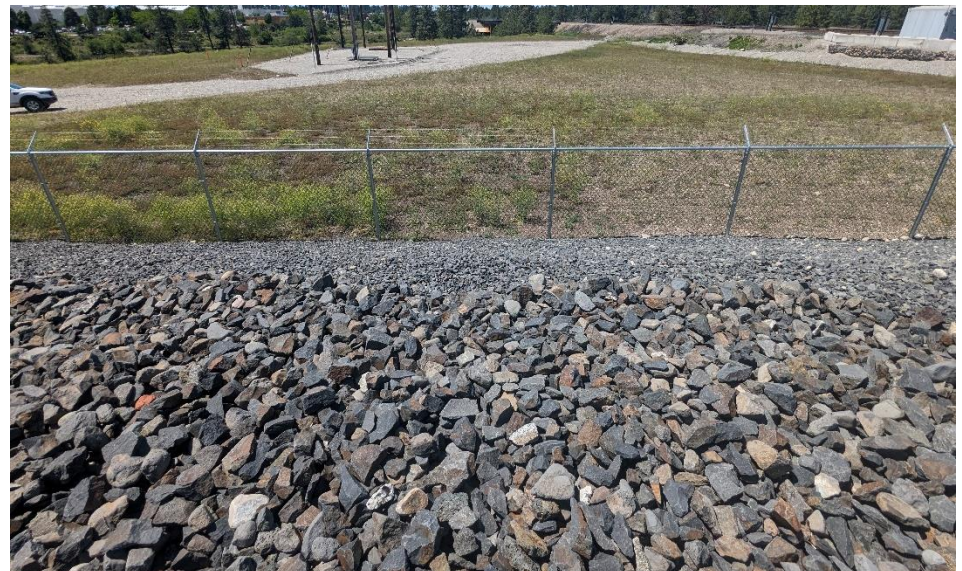
PHOTOGRAPH 12

West Berm and Pentzer Property. View looking west.

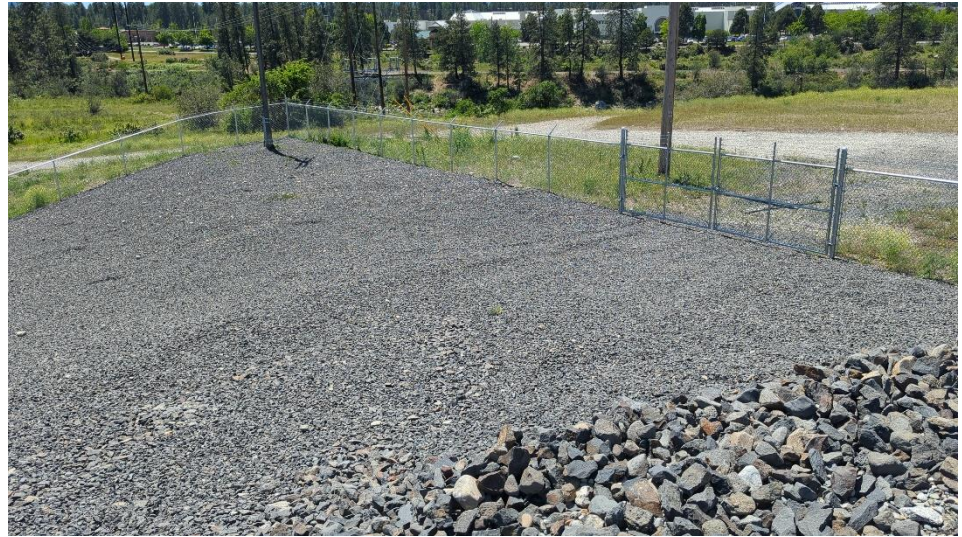
PHOTOGRAPH 13

Southwest corner of Ecological Cap and access gate. View looking south-southwest.

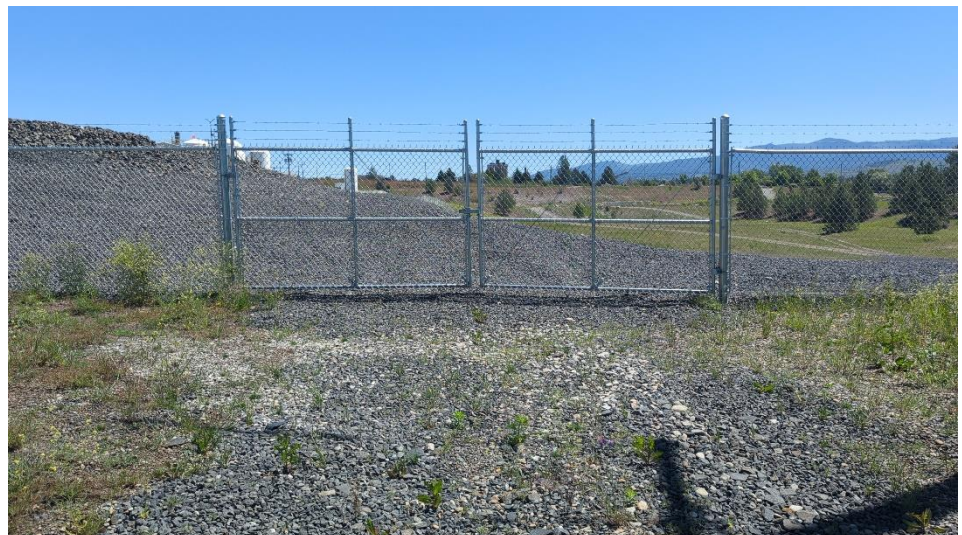
PHOTOGRAPH 14

UPRR property access gate. View looking east.

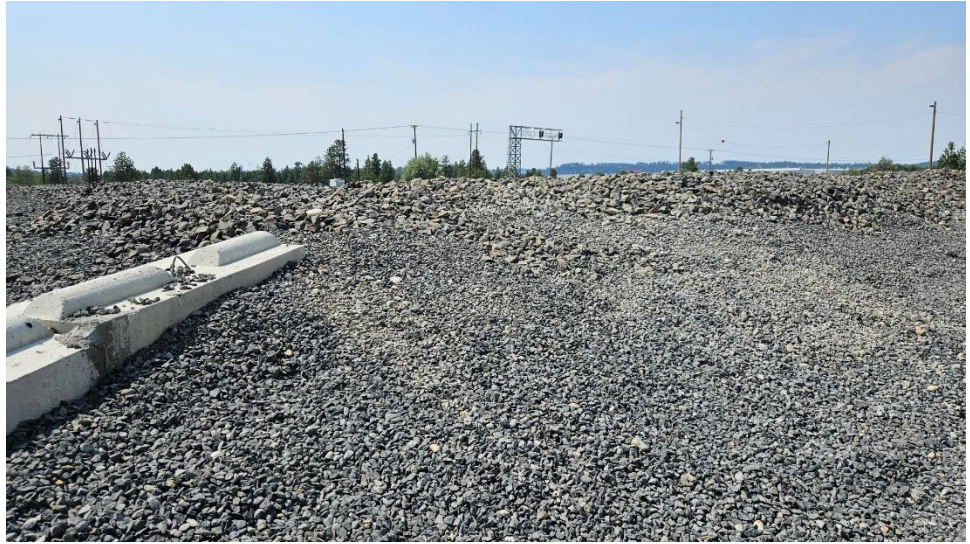
**ADDENDUM
PHOTOGRAPH 1**

Ecological cap damage repair
facing west, August 2, 2024

Kemira repaired the damaged to cap during the week of July 29th. Repairs were performed by the original remediation contractor GrayMar Environmental. Photographs of the repaired cap area are provided in the attached Photolog.

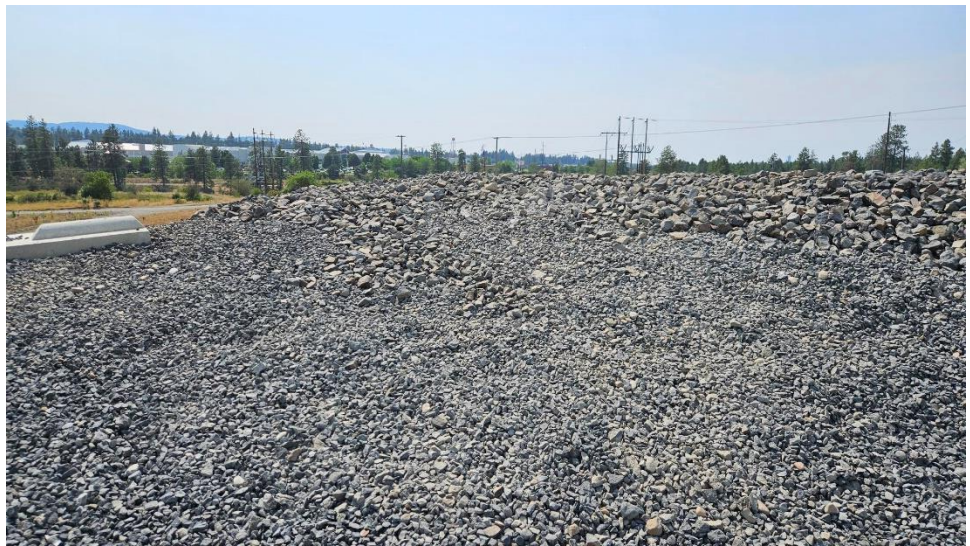
**ADDENDUM
PHOTOGRAPH 2**

Ecological cap repair area
facing southwest, August 2,
2024
