# Site Reconnaissance and Data Review Report

Raplee Property  
Cleanup Site ID #5275

October 1, 2024

Project No. M1030.08.003

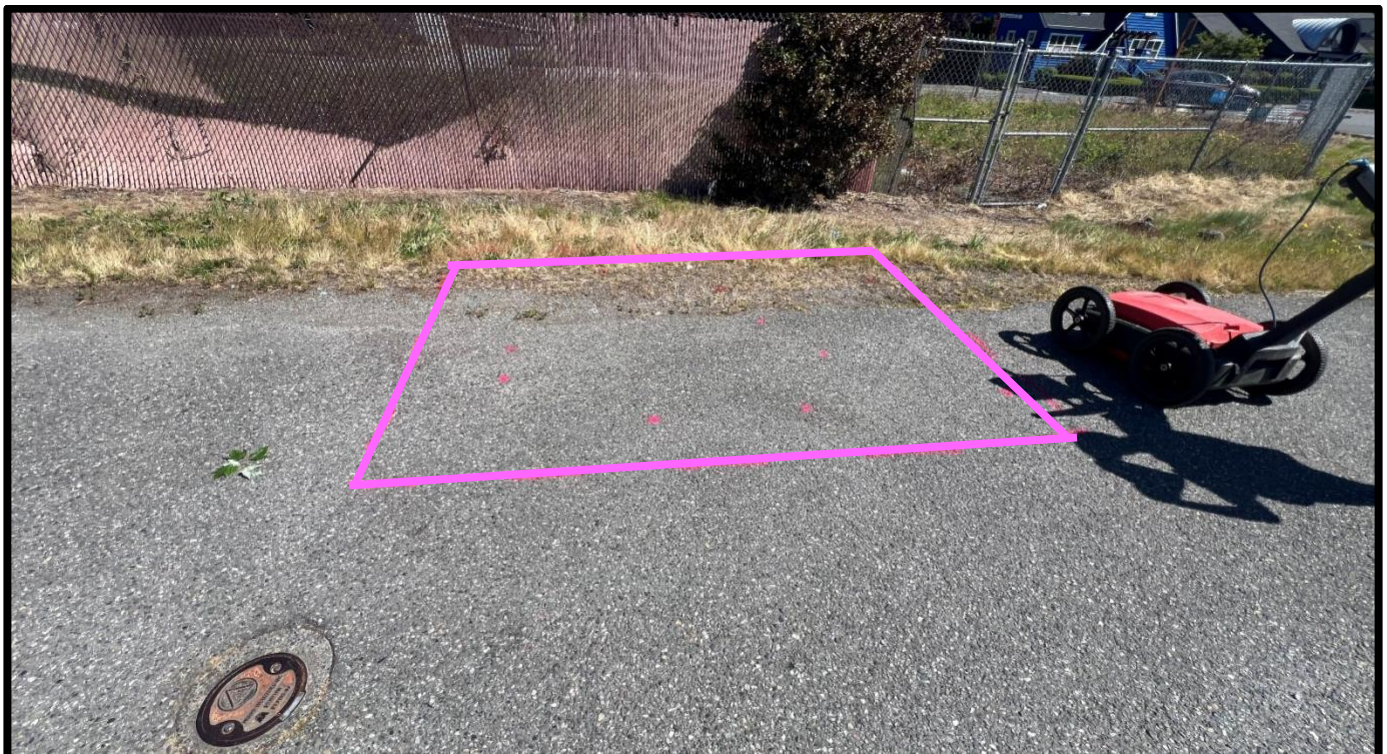
Indications of potential USTs were observed at a depth of approximately 3 feet bgs within a single 7-foot by 11-foot rectangular area near the southeast corner of the fence line. This area is located approximately 2 feet to the northeast of monitoring well MW-02. This area corresponds with the location of the USTs identified in the 2006 site investigation (SAIC 2006).

**Image 2:** Portion of the area scanned on this date, with pink lines indicating the approximate boundary of potential UST indications.

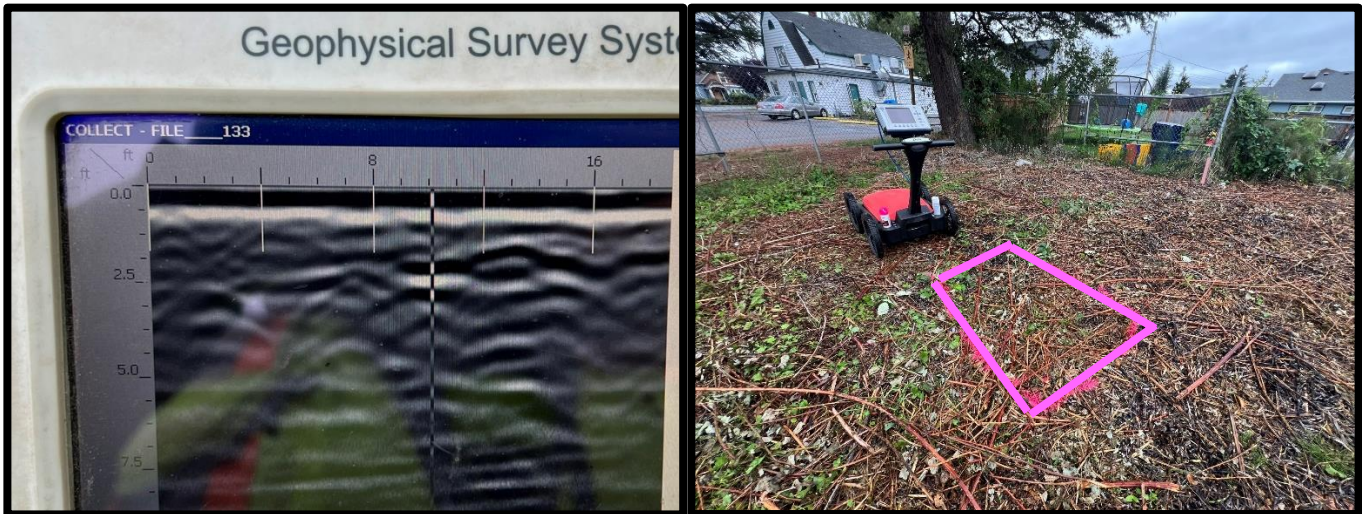
**Image 2:** GPR cross-section with vertical reference line centered on Anomaly 1 (left). Its observed extent is outlined in pink (right).

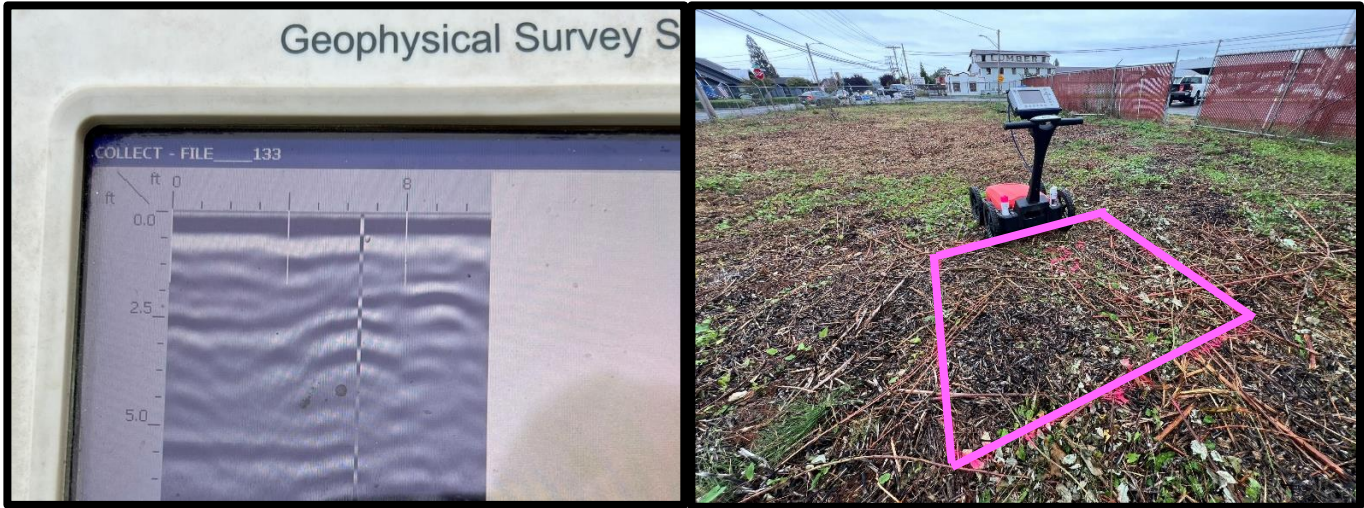
**Image 3:** GPR cross-section with vertical reference line centered on Anomaly 2 (left). Its observed extent is outlined in pink (right).

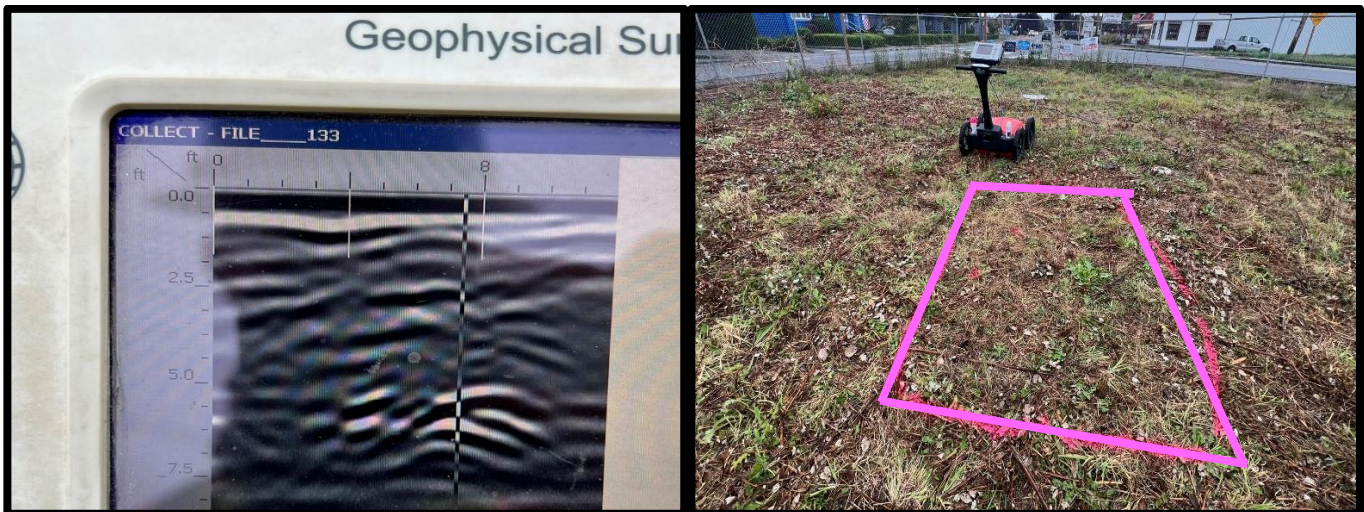
**Image 4:** GPR cross-section with vertical reference line centered on Anomaly 3 (left). Its observed extent is outlined in pink (right).

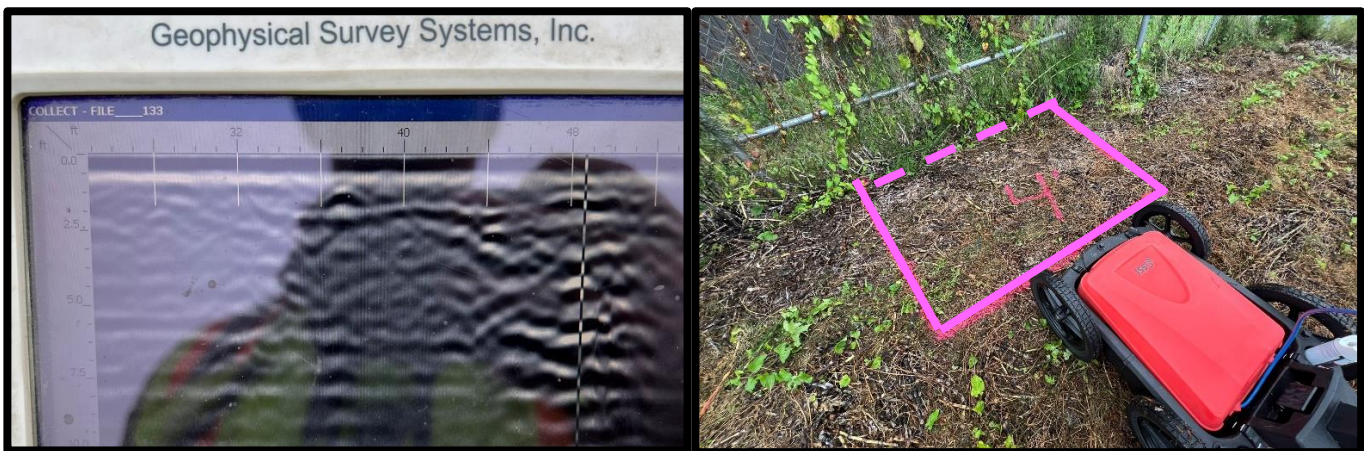
**Image 5:** GPR cross-section with vertical reference line centered on Anomaly 4 (left). Its observed extent is outlined in pink (right).

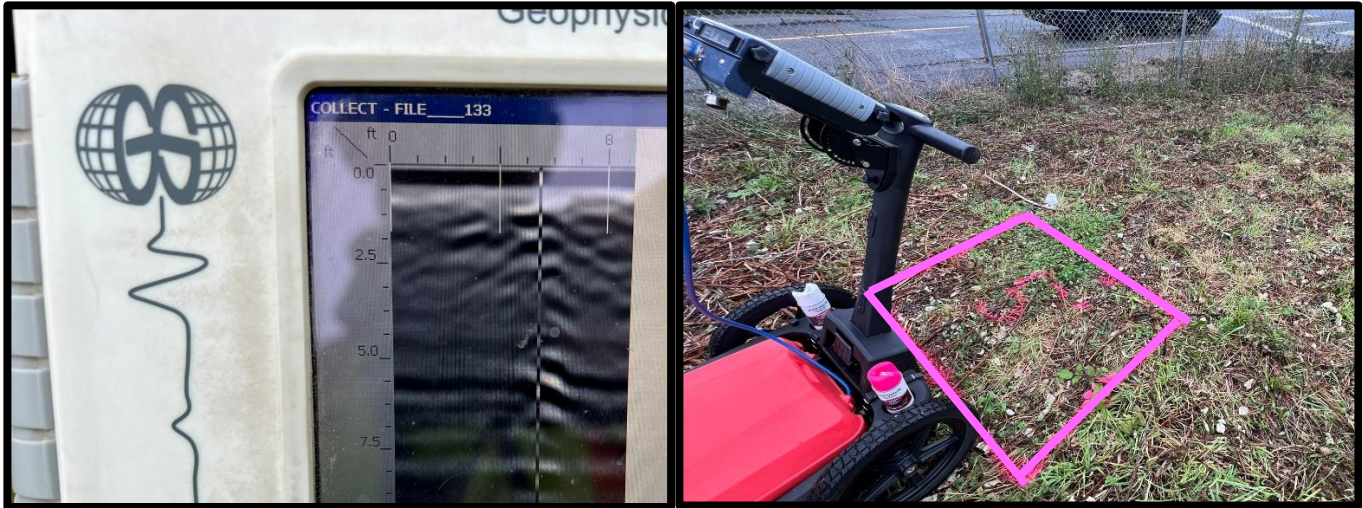
**Image 6:** GPR cross-section with vertical reference line centered on Anomaly 5 (left). Its observed extent is outlined in pink (right).

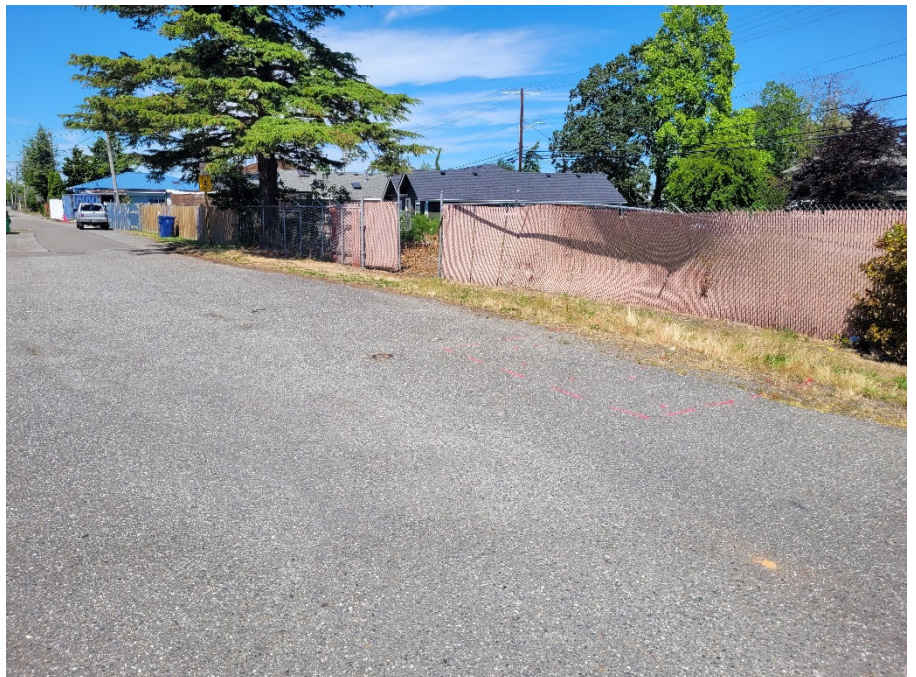
## Photo No. 4.

Photo from the neighboring property to the south, looking northwest. Monitoring well MW-02 is in the center with the adjacent ground-penetrating radar (GPR) anomaly marked in pink paint.

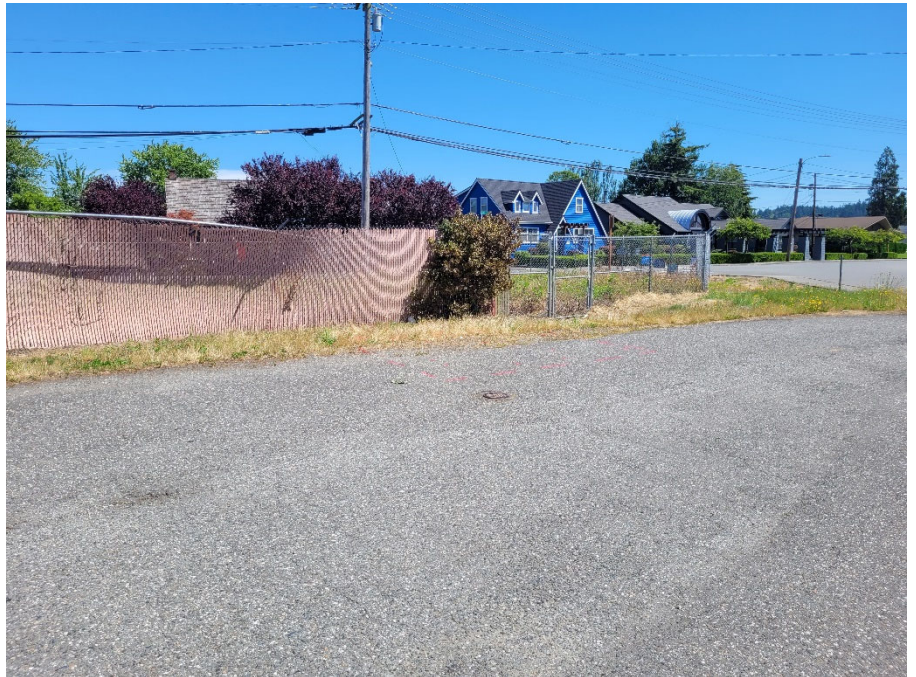
Photo from the neighboring property to the south, looking northeast towards MW-02 and the GPR anomaly.

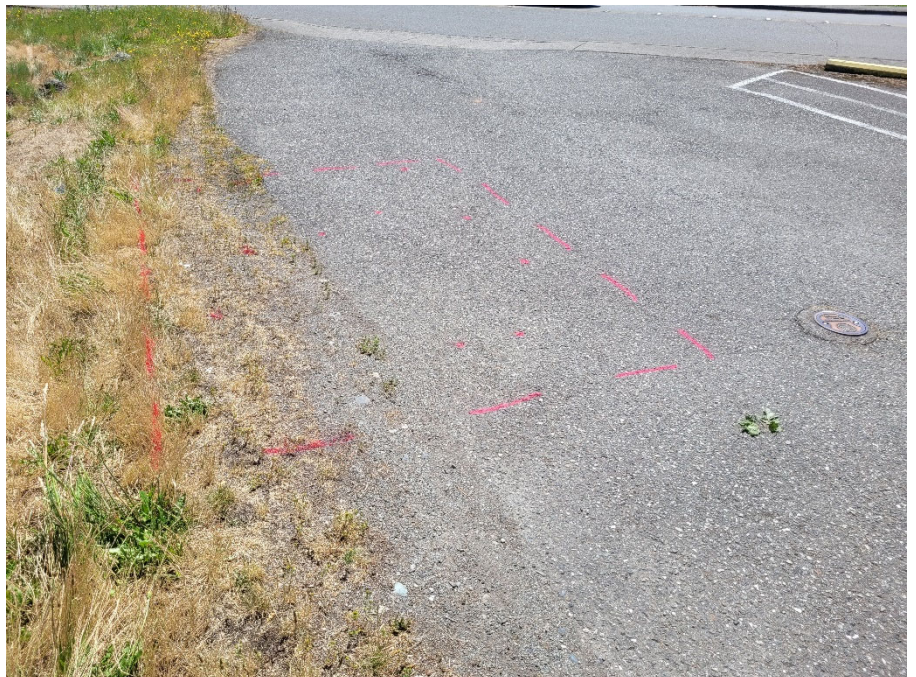
## Photo No. 6.

Photo looking east toward the GPR anomaly marked in pink paint, with MW-02 to the right.

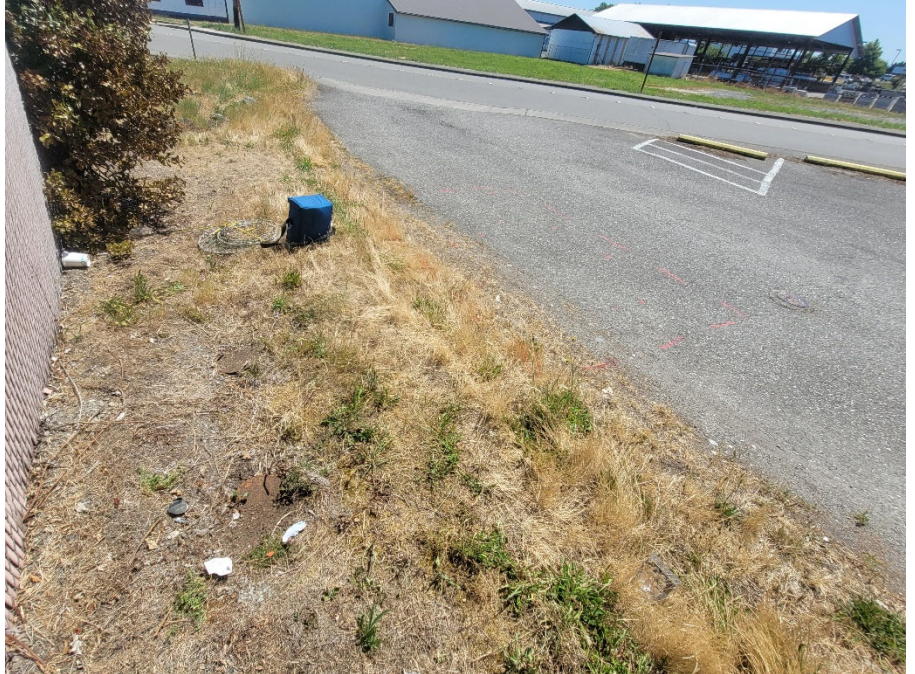
As stated in the table above, two potential fill ports were observed in the grassy area between the south fence of the Property and the paved alley. The ports had iron caps situated in iron flush-mount vaults spaced approximately three feet apart. The caps were rusted in place and unable to be opened. The ports are located 5 feet immediately north of the area identified in the GPR survey and approximately 15 feet north of monitoring well MW-02. These are likely the two fill ports identified in the same area during the 2006 site investigation (SAIC 2006).

Photo on the south side of the Property looking east toward the two presumed fill ports (center left and bottom left), the GPR anomaly marked in pink paint (center) and monitoring well MW-02 (right).

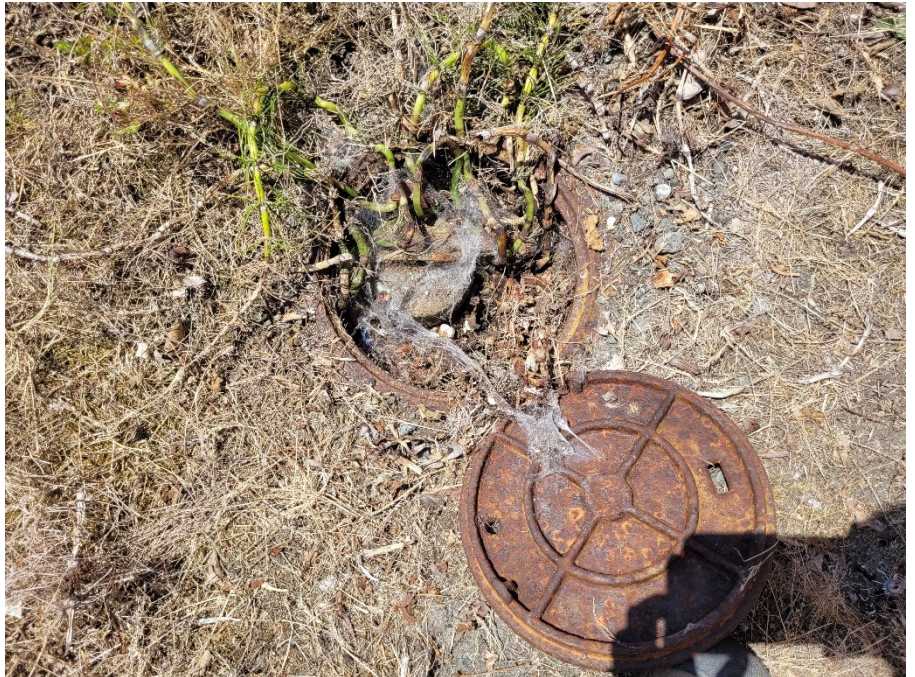
## Photo No. 8.

Photo of the interior of the east presumed fill port showing the metal pipe and pipe cap within.

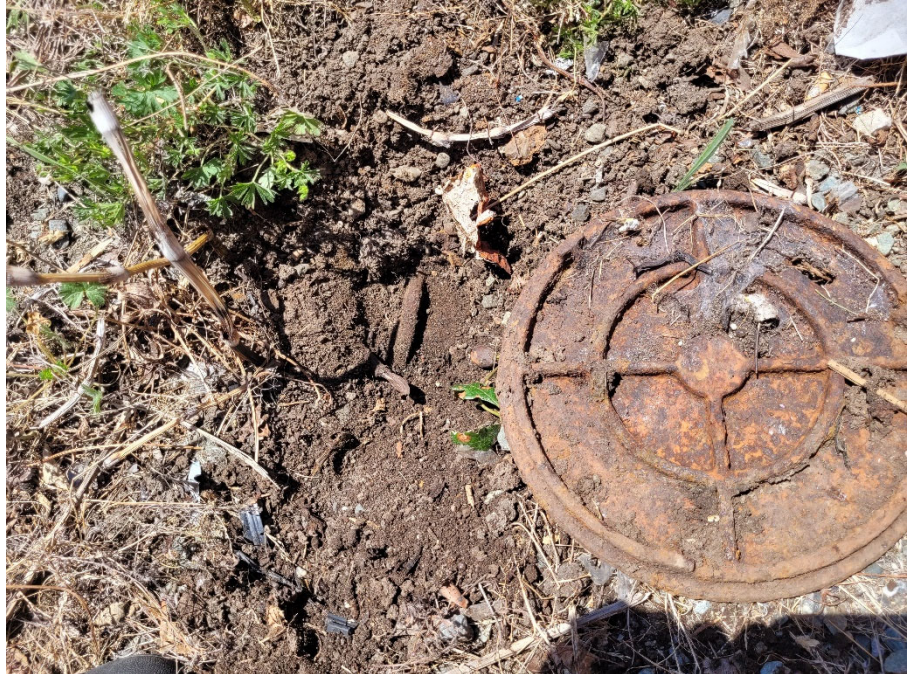
Photo of the interior of the west presumed fill port showing the metal pipe and pipe cap buried with soil inside.

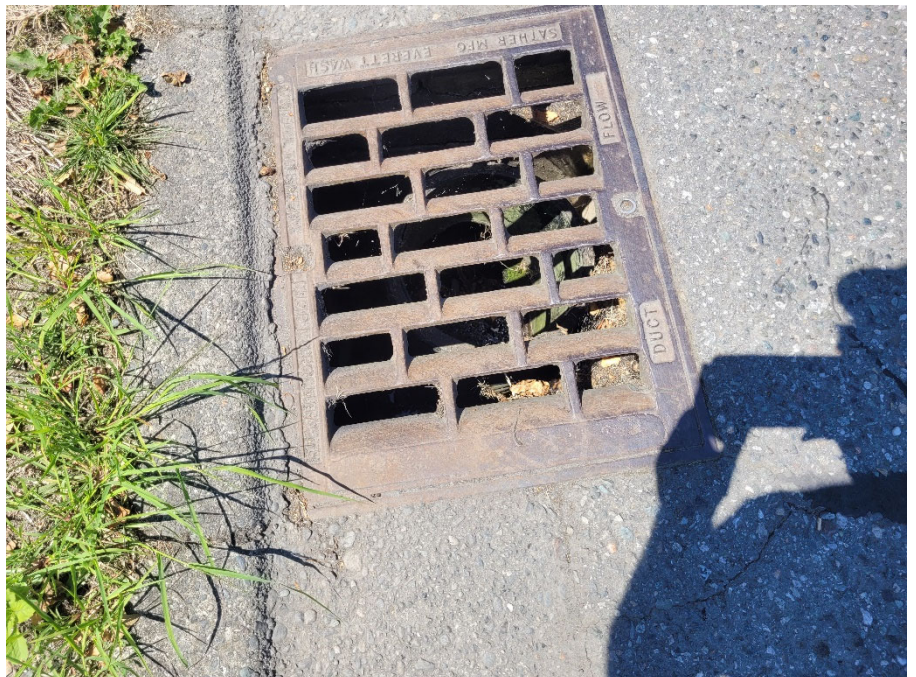
## Photo No. 16.

Photo of the interior of the catch basin in 271st Street NW near the northwest corner of the Property. No sheen, odor, or staining was observed through the grate.

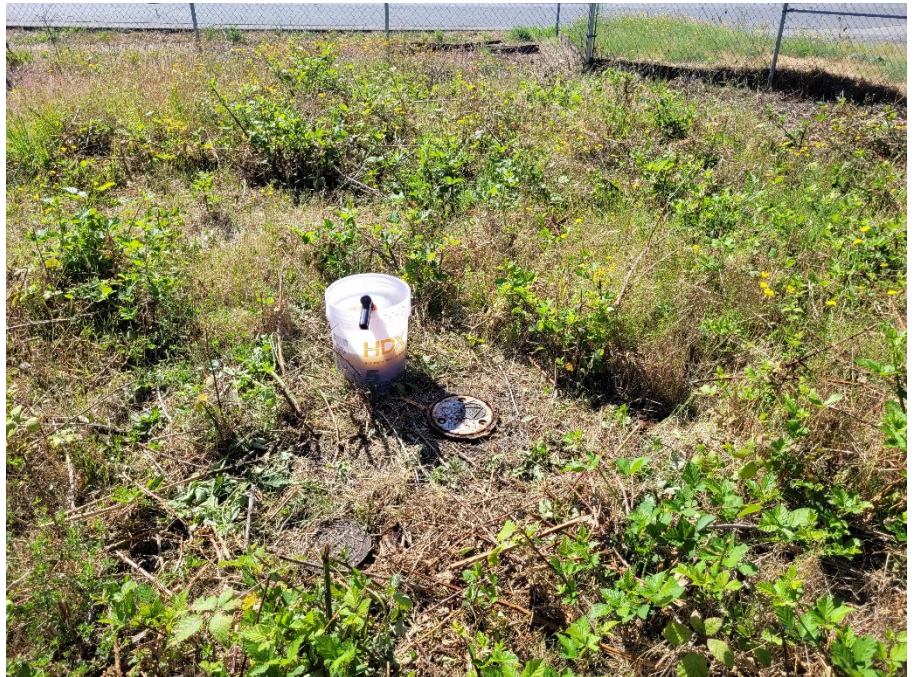
Photo looking southeast toward monitoring well MW-03. Down and to the left of MW-03 in the photo is an old iron monitoring well cover. The bucket contains surface water removed from the monitoring well monuments on the day of the site visit.
