Mitigation Opportunities Inventory Report

Waterfront Marina, Albert Jensen and Sons Boatyard and Marina, and Jackson Beach Recreation Area

Port of Friday Harbor

April 2020

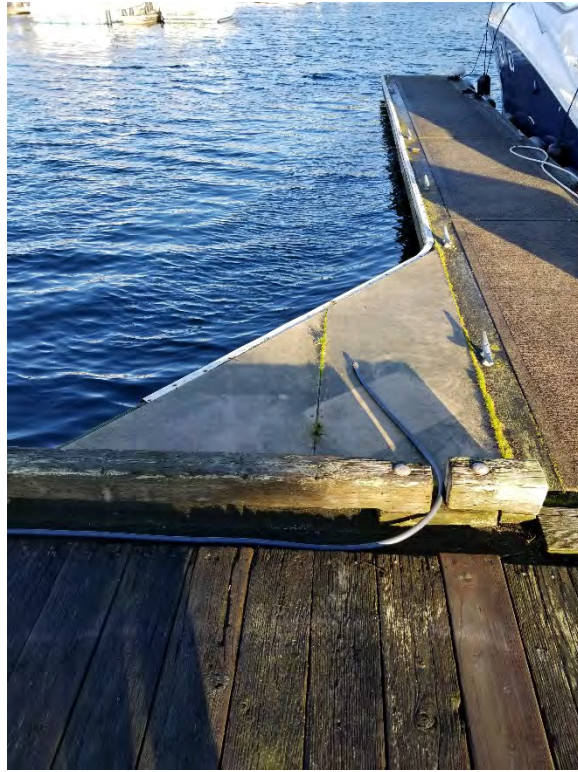
Photograph 1. Solid plywood fillet, wood and concrete floats with solid surfacing.

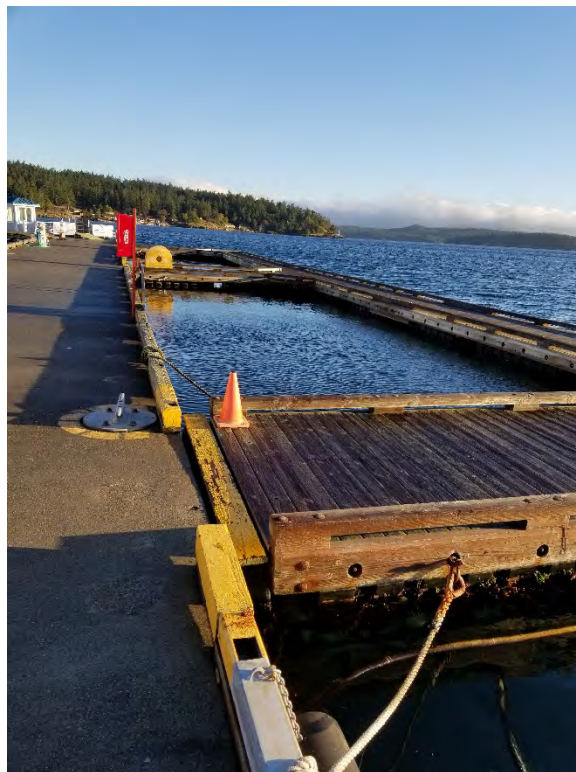
Photograph 2. Seaplane float and Breakwater C with solid surfacing.

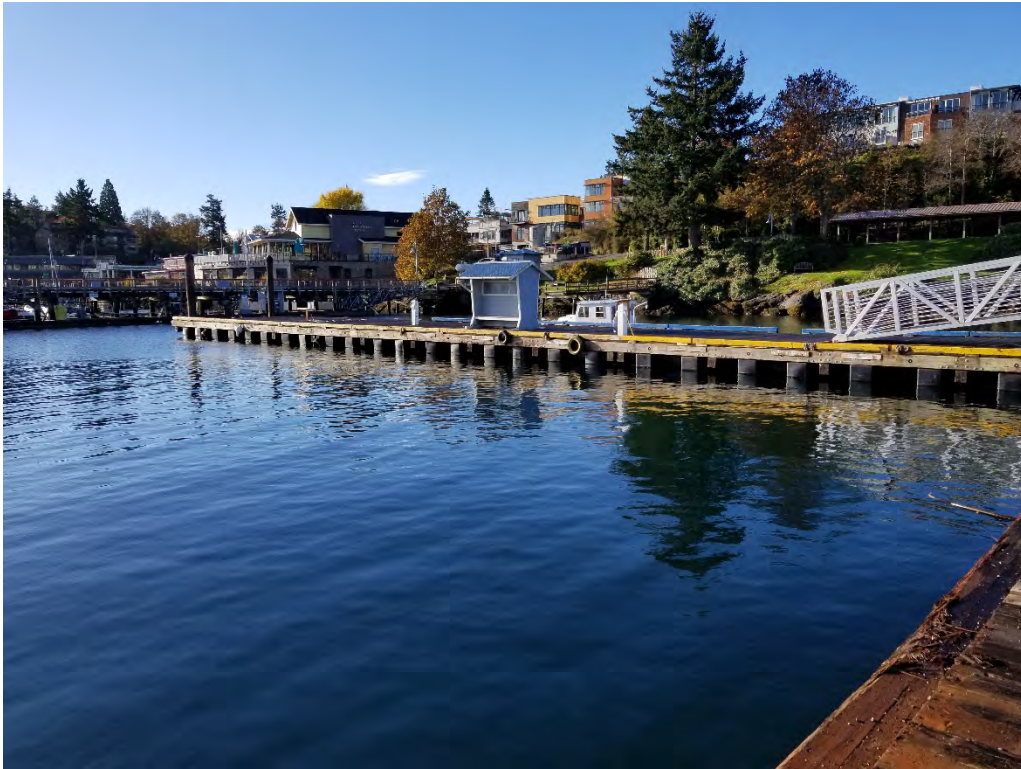
Photograph 3. Load dock with solid timber surfacing, tire bumpers, and creosote-treated pilings at the end of the dock.

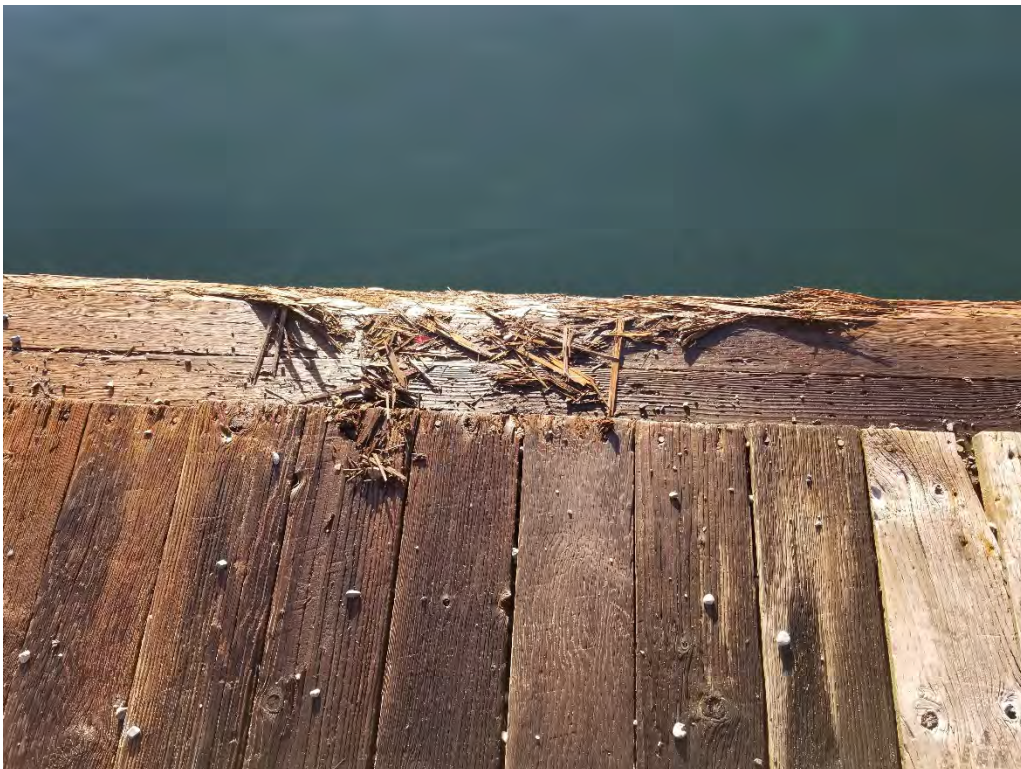
Photograph 4. Close up of worn treated wood rubstrip.

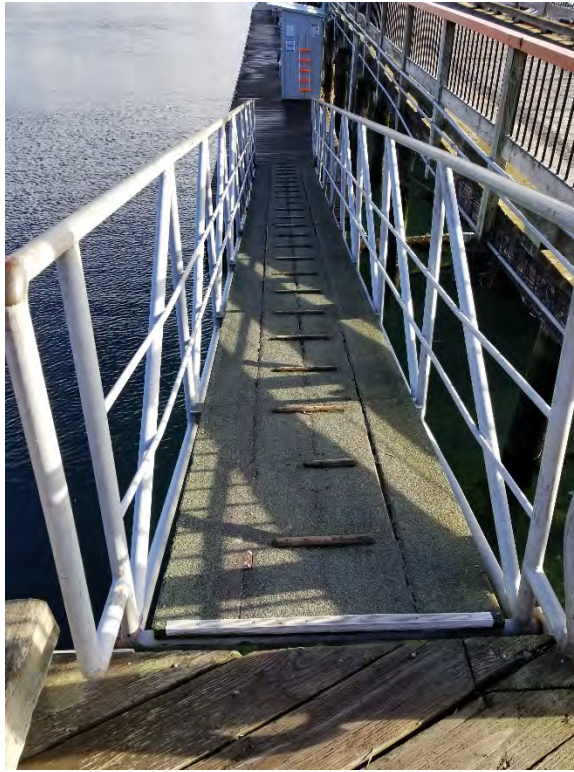
Photograph 5. Solid surfaced wood ramp between a solid surfaced pier and float at the Fuel dock.

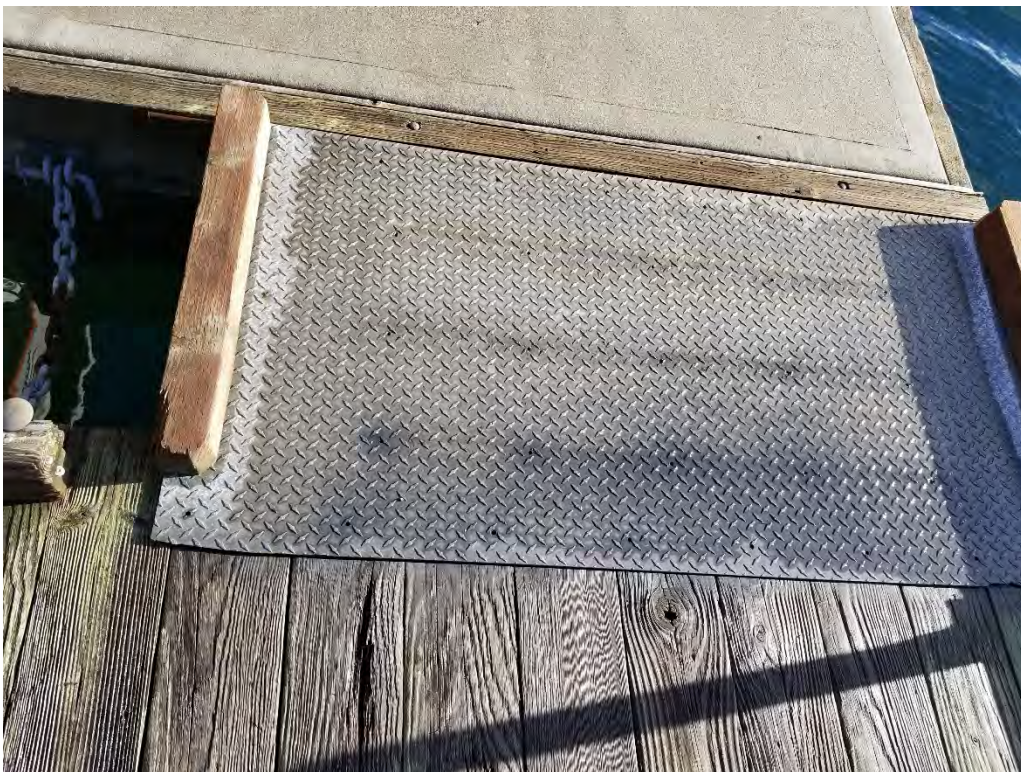
Photograph 6. Metal plate between solid surfaced floats.

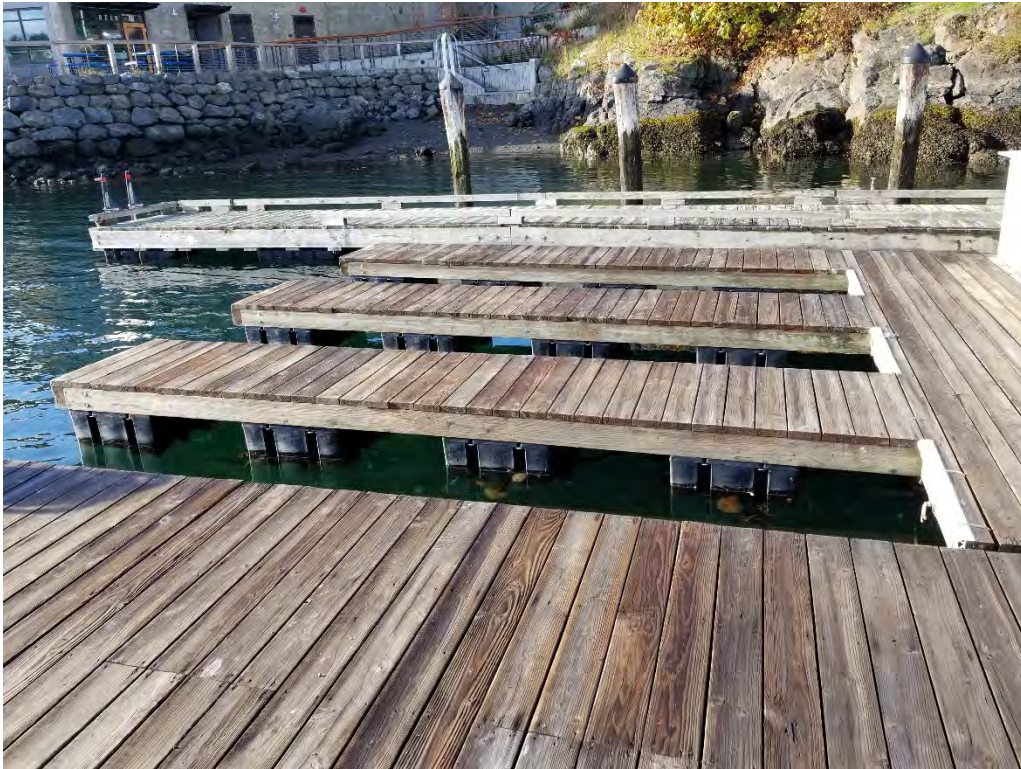
Photograph 7. Solid surfaced treated wood floats off of the Fuel Pier, creosote-treated piles, rock debris from retaining wall spilled on the pocket beach.

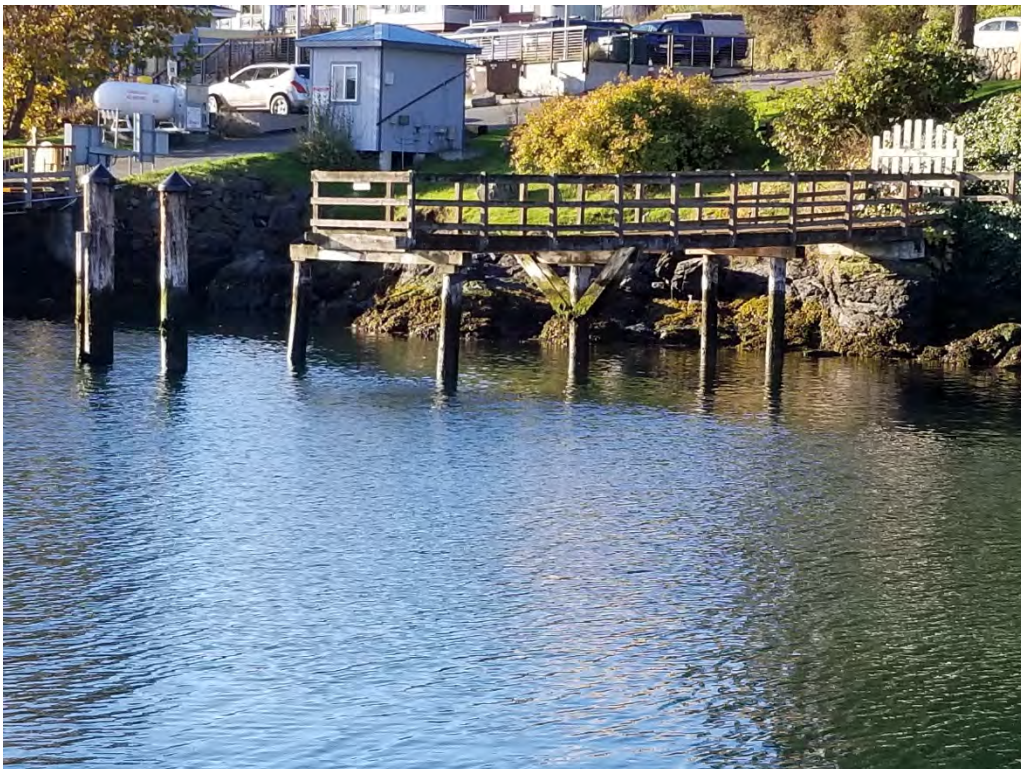
Photograph 8. Closed pier with degraded solid wood surfacing supported by creosote-treated pilings, invasive plants in upland (e.g., English ivy, blackberry).

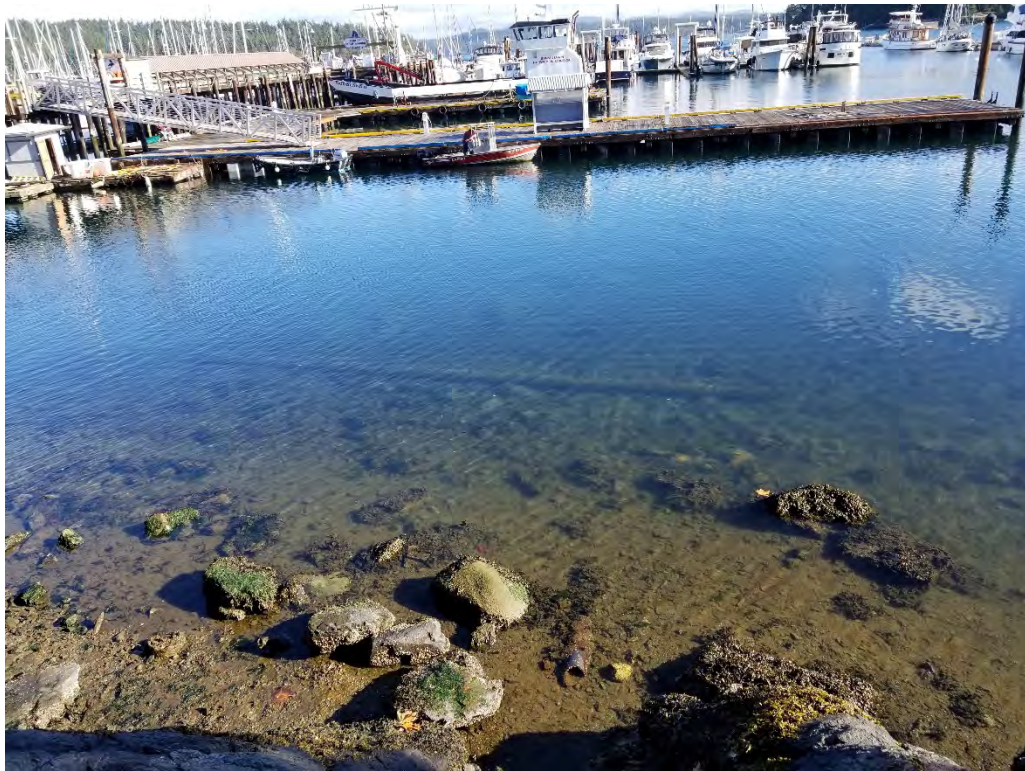
Miscellaneous debris, including concrete blocks and a pipe, and rock debris from a retaining wall were observed in the intertidal zone. Table 2 lists items that could be removed from below the mean higher high water (MHHW) mark to increase aquatic area and improve general habitat conditions and water quality.

Photograph 9. Intertidal debris (e.g., pipes, concrete blocks).

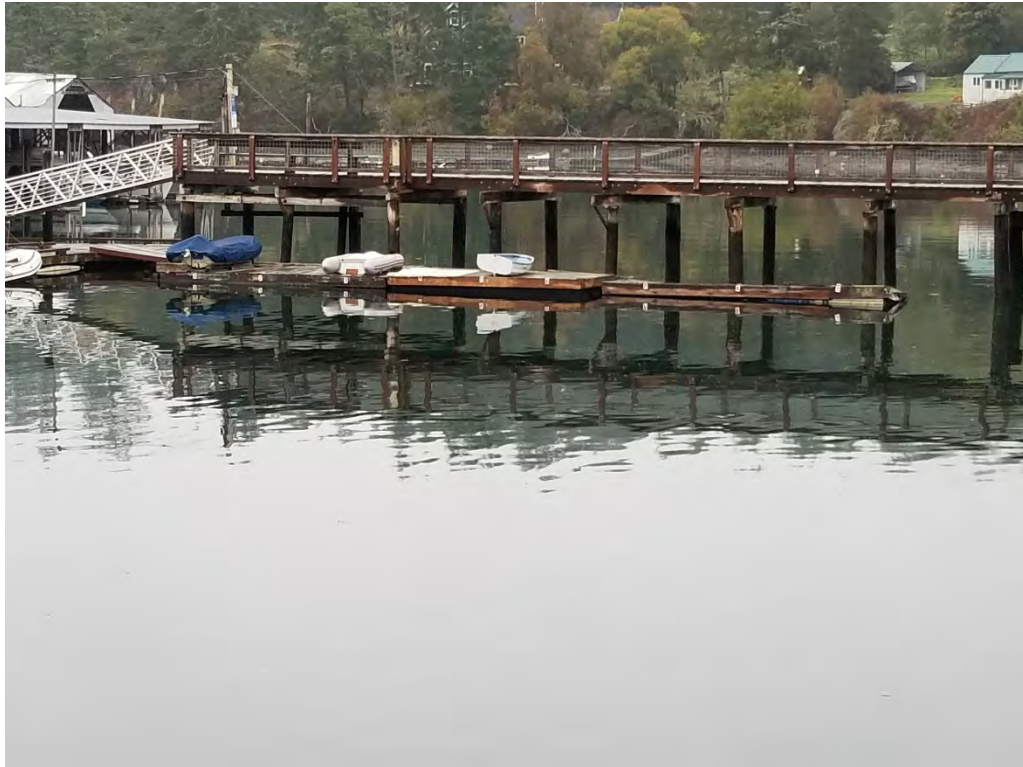
Photograph 1. Marina pier supported by creosote-treated pilings. The pier has wood surfacing with a central grating strip. Float surfacing is solid.

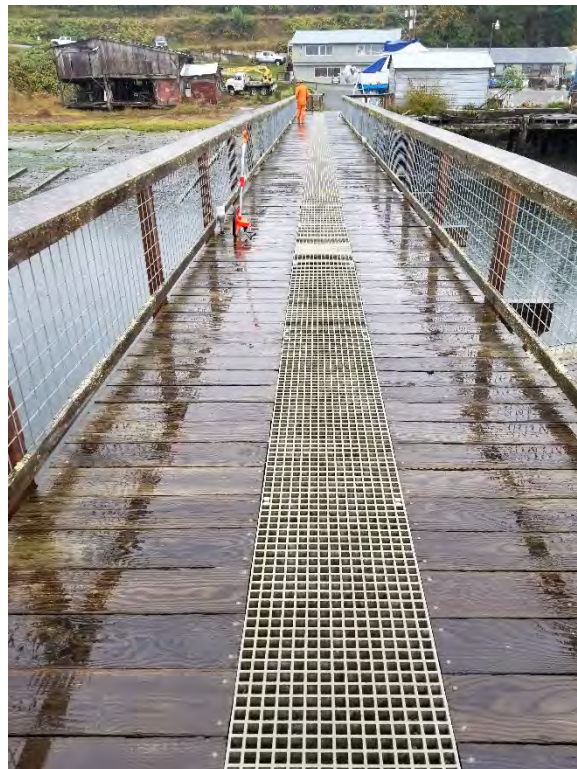
Photograph 2. Close-up of marina pier surfacing.

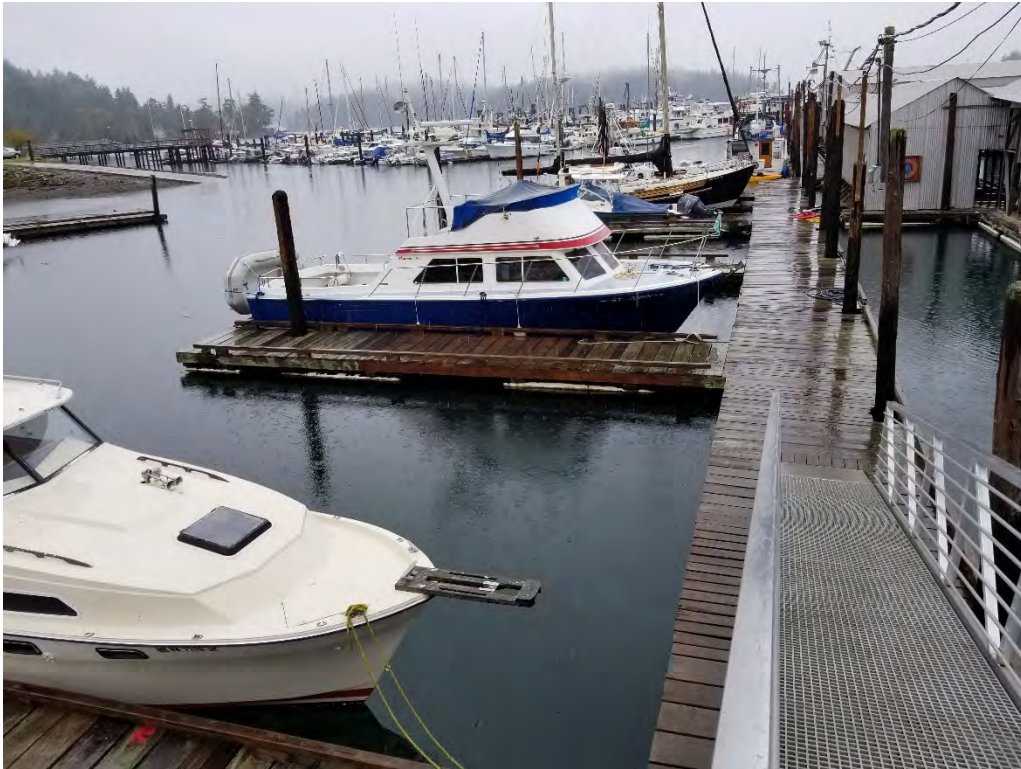
Photograph 3. The floating section of the marina pier and attached finger floats with solid wood surfacing, creosote-treated pilings, and treated wood rub strips.

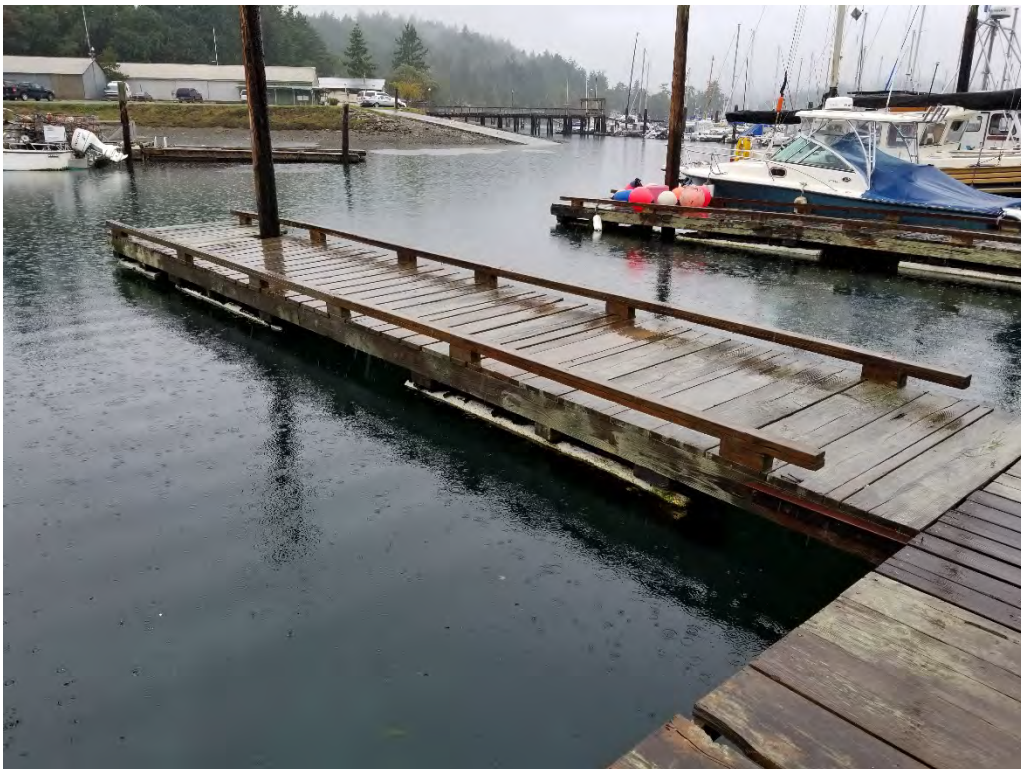
Photograph 4. Close up of finger floats attached to floating section of the marina pier. Exposed, degrading Styrofoam floats under the solid-surface finger pier with treated wood rub strips.

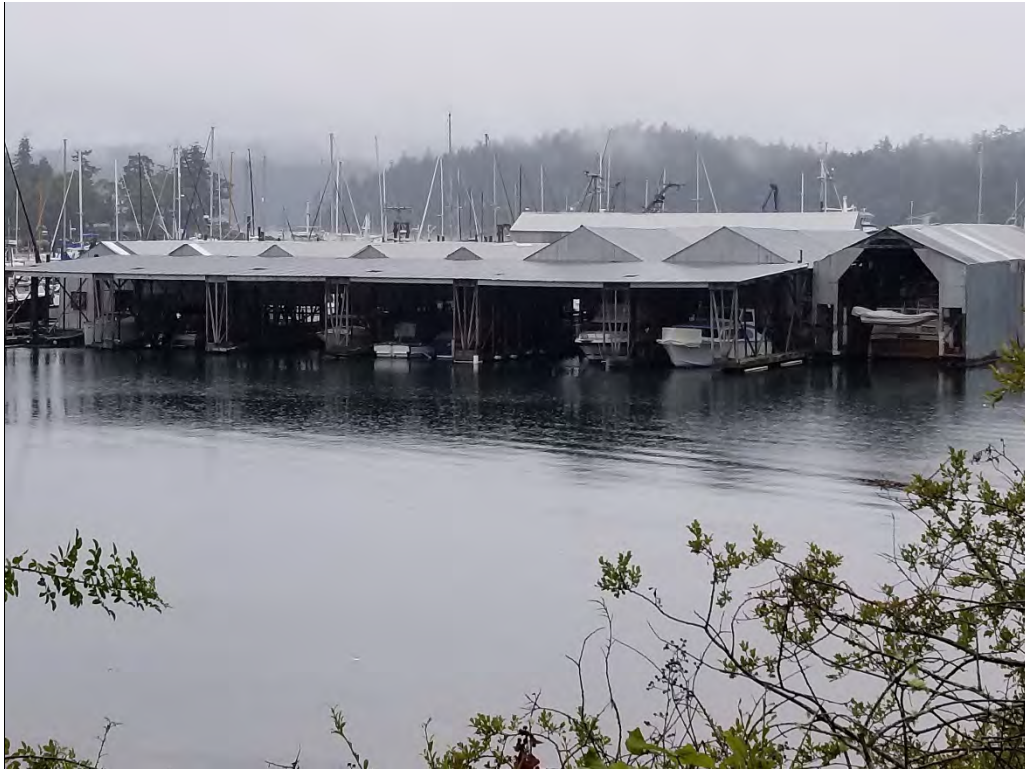
Photograph 5. Covered boat houses with solid roofing.

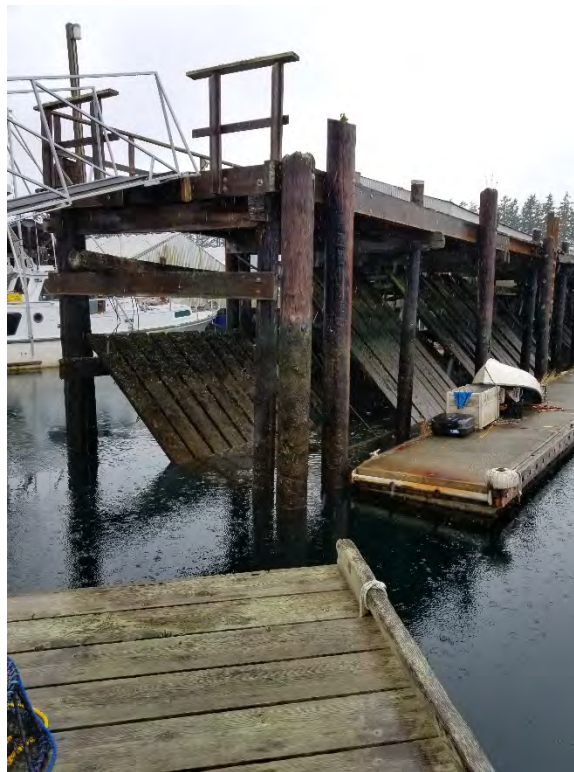
Photograph 6. Creosote-treated wood wave wall beneath the northern solid surfaced pier supported by creosote-treated piles.

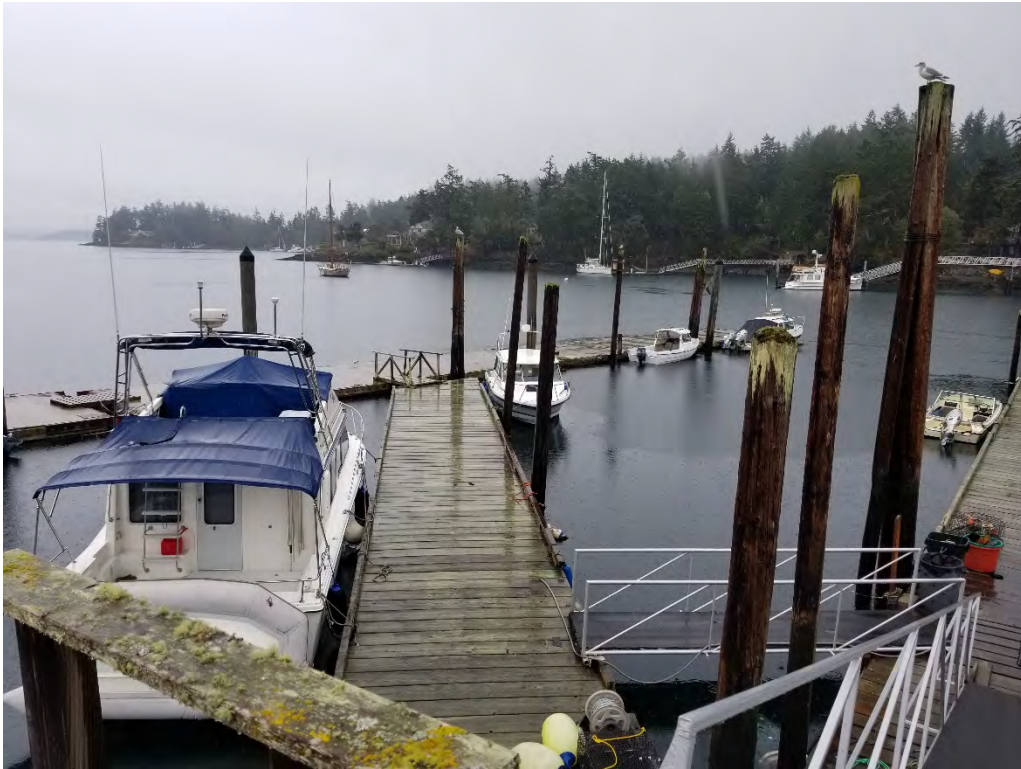
Photograph 7. Solid surfaced floats, solid surfaced gangways, creosote piles waterward of the covered boat houses.

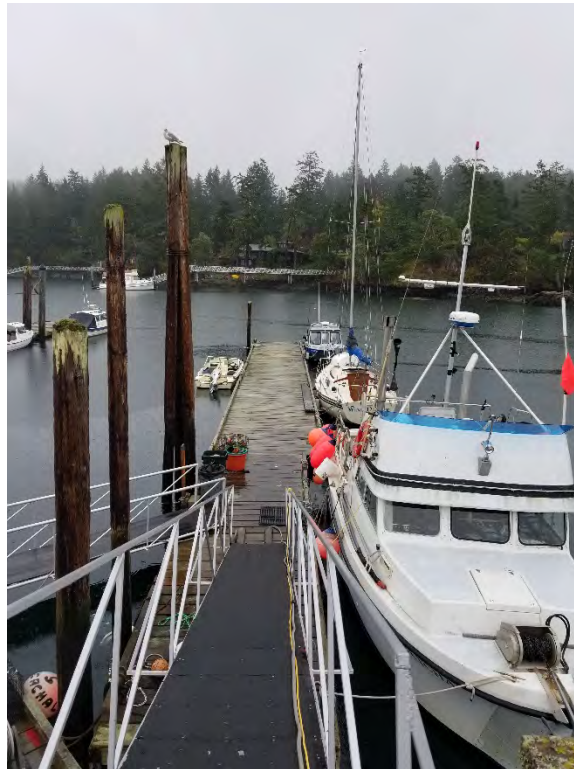
Photograph 8. Close up of solid surfaced gangways.

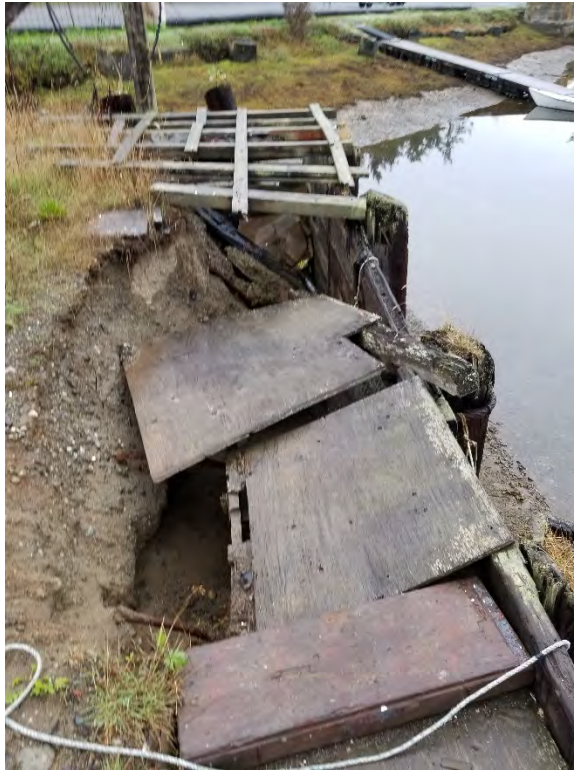
Photograph 9. Fill material sloughing into intertidal area beneath failing treated wood bulkhead adjacent to boatyard.

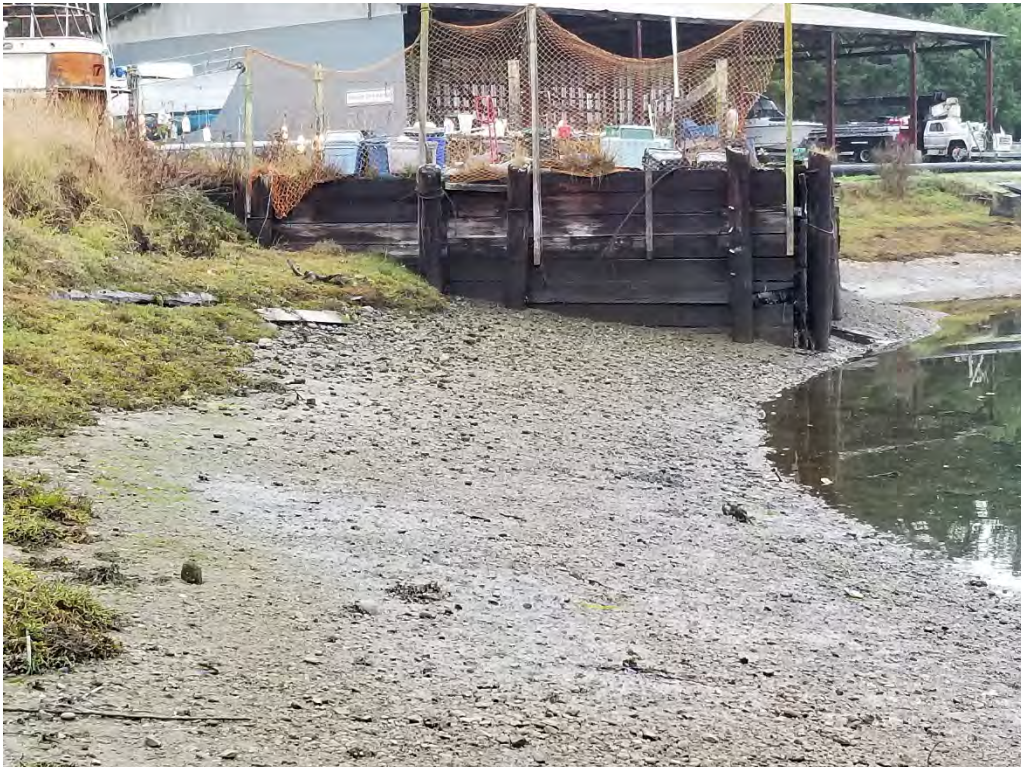
Photograph 10. Treated wood bulkhead and fill area at boat haul-out. The berm between the boat haul-out and the bulkhead appears to be composed of rubble and debris.

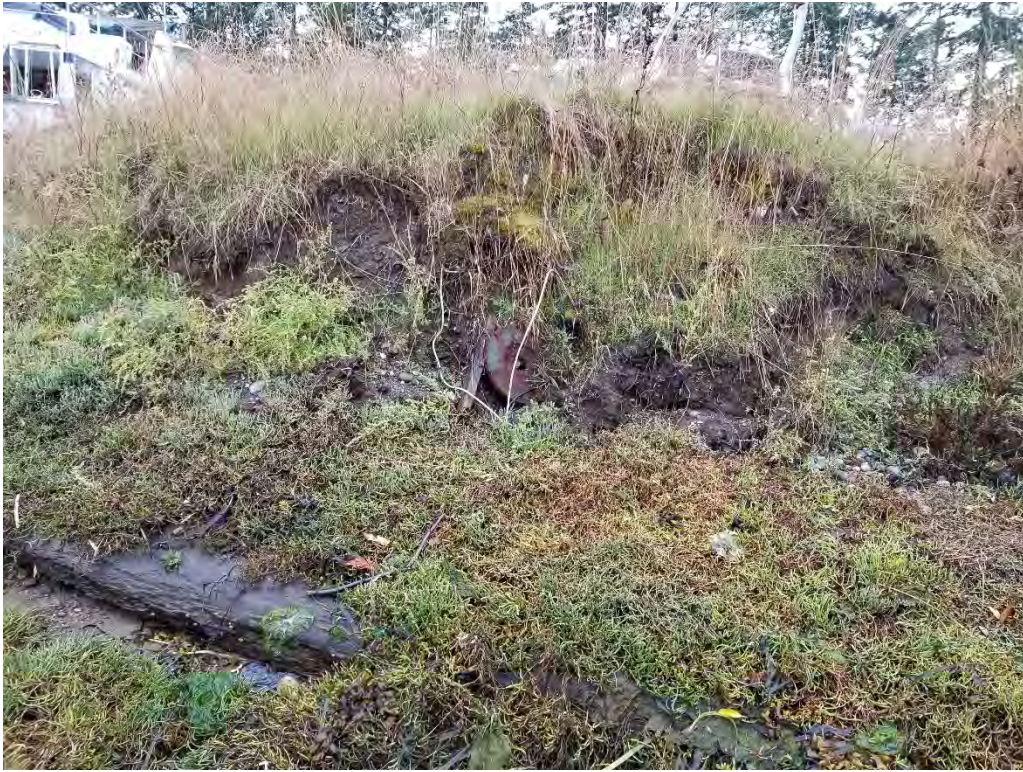
Photograph 11. Close-up of berm between the bulkhead/fill area and the boat haul-out.

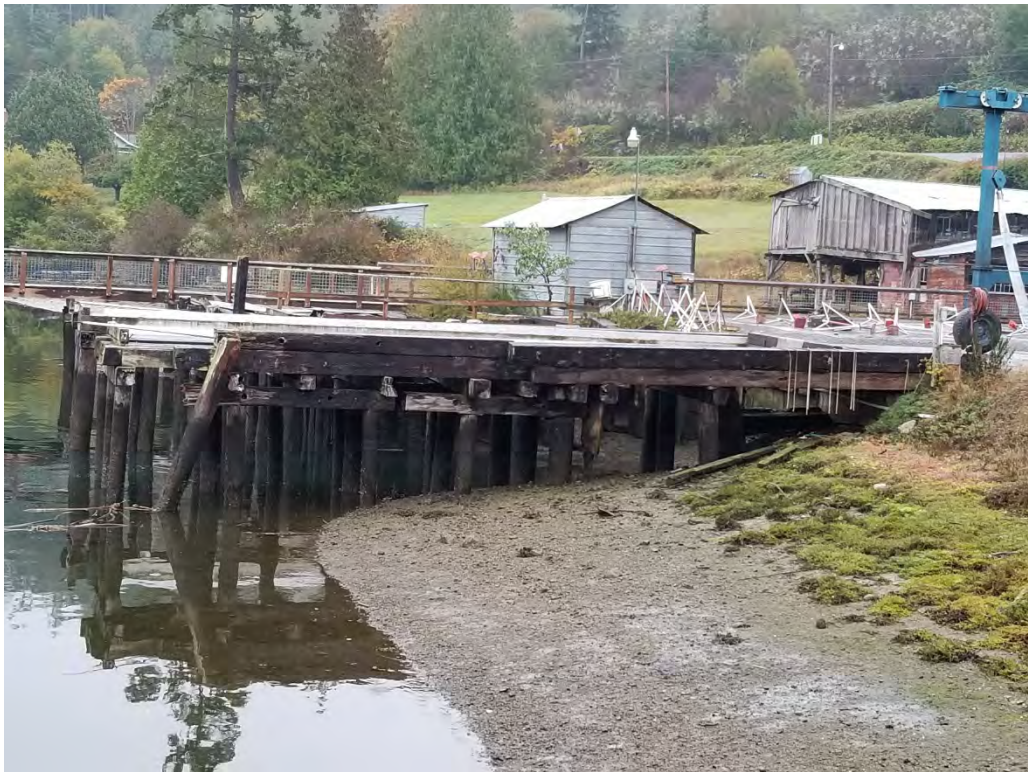
Photograph 12. The solid-surface boat haul-out structure, supported by creosote-treated pilings.

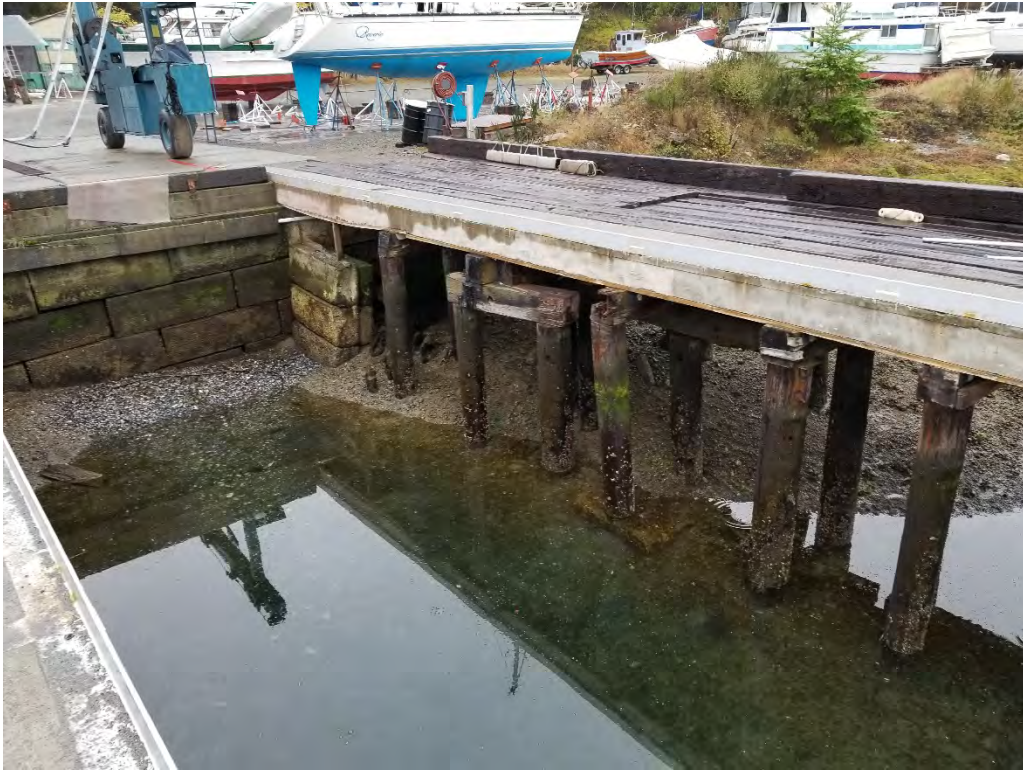
Photograph 13. Concrete ecology block bulkhead inside of the boat haul-out.

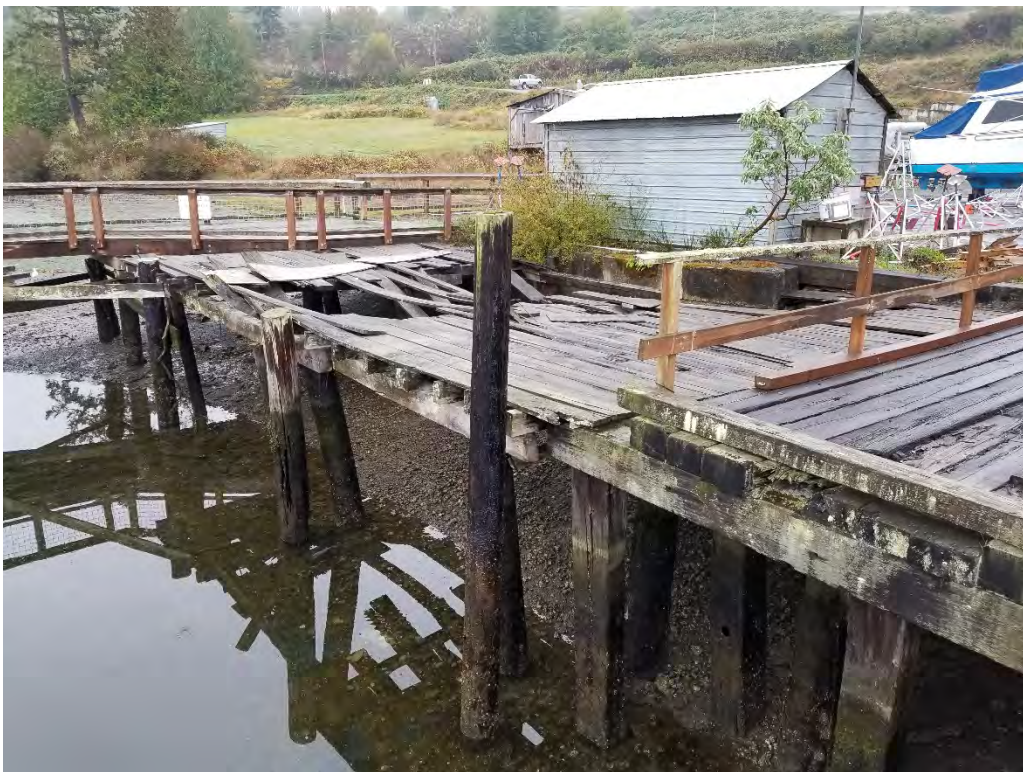
Photograph 14. Failing overwater structure with treated wood surfacing and creosote-treated pilings.

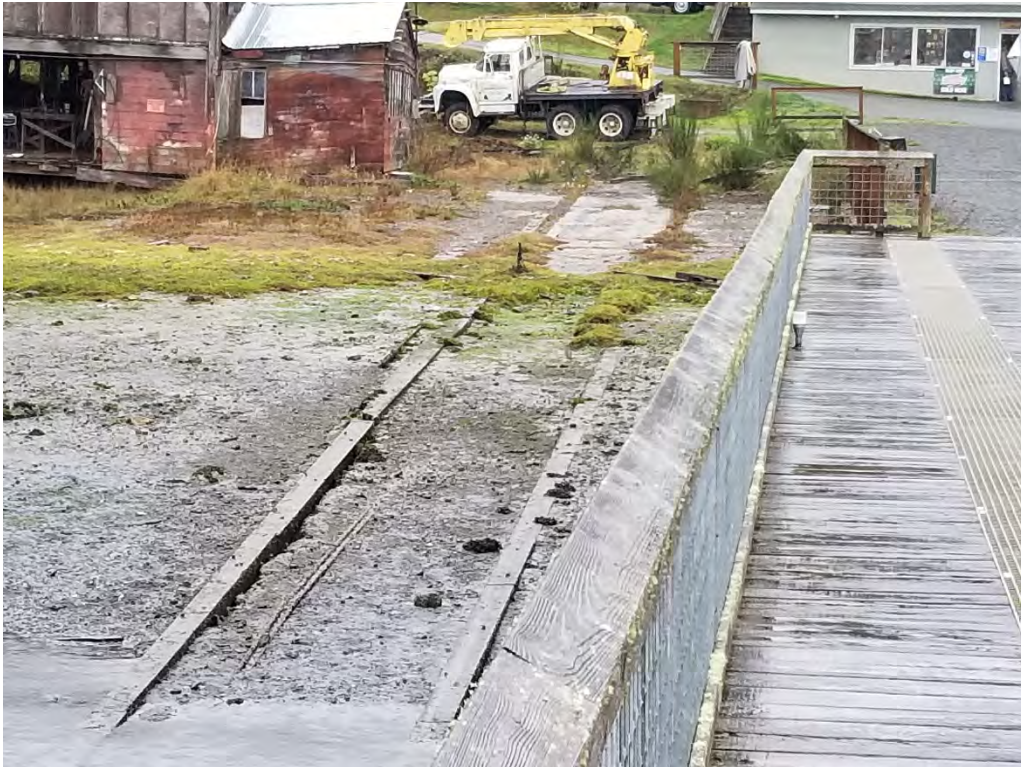
Photograph 15. Shoreline and intertidal areas east of the marina pier include concrete pads, treated wood rails, and miscellaneous debris.

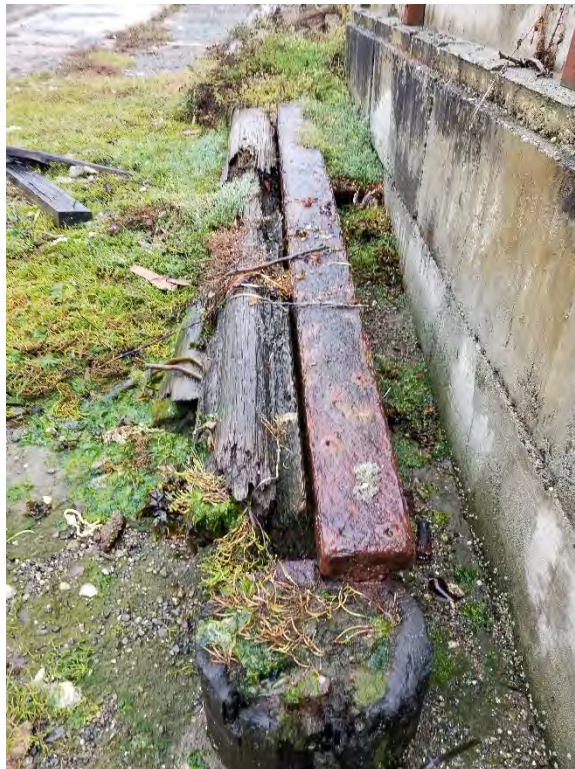
Photograph 16. Pile of treated wood in the intertidal area east of the marina pier.

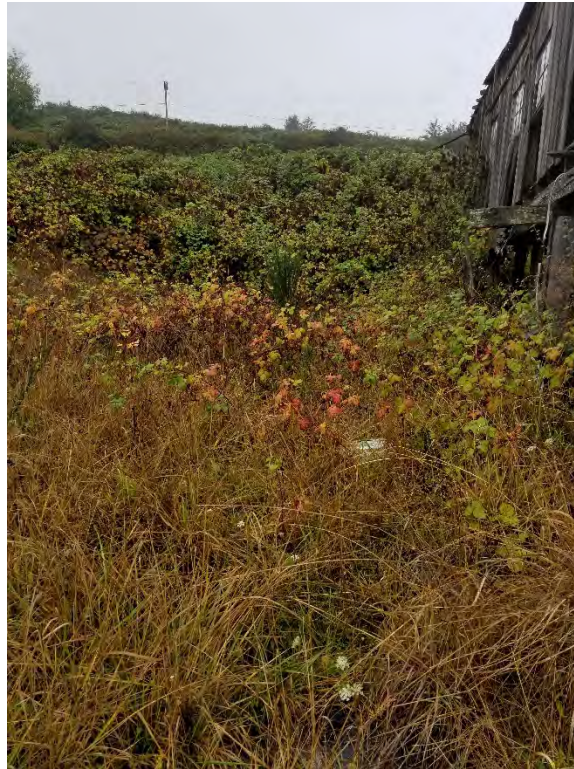
Photograph 17. Upland invasive plant species east of the marina pier.

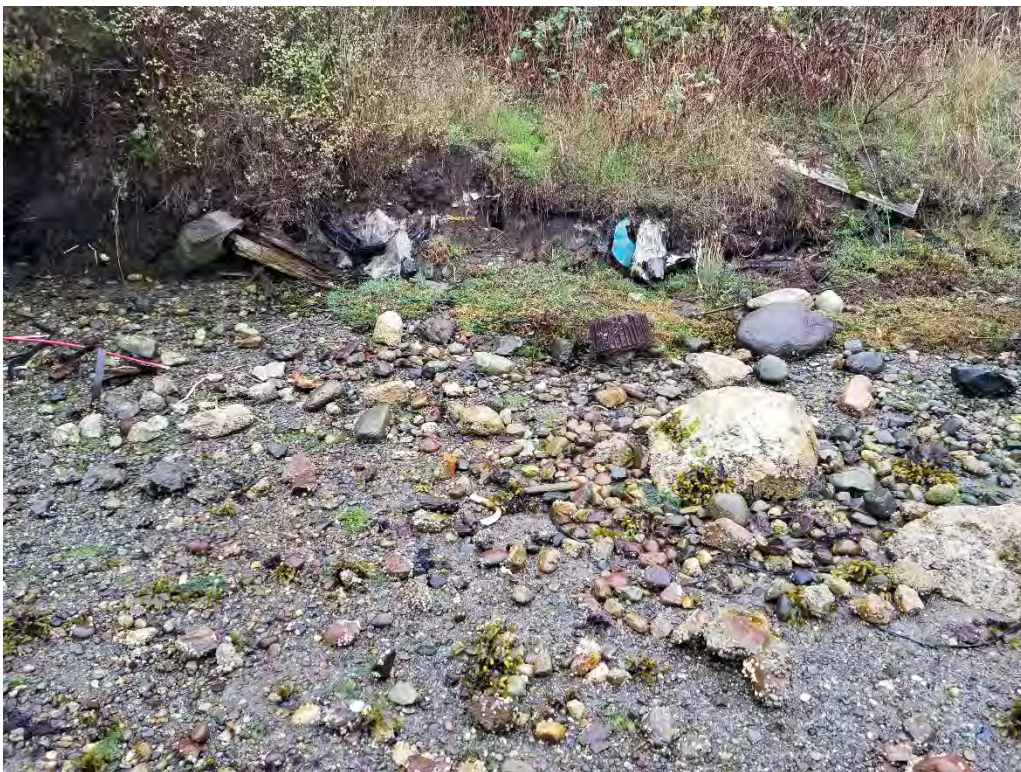
Photograph 18. Intertidal debris east of the marina pier.

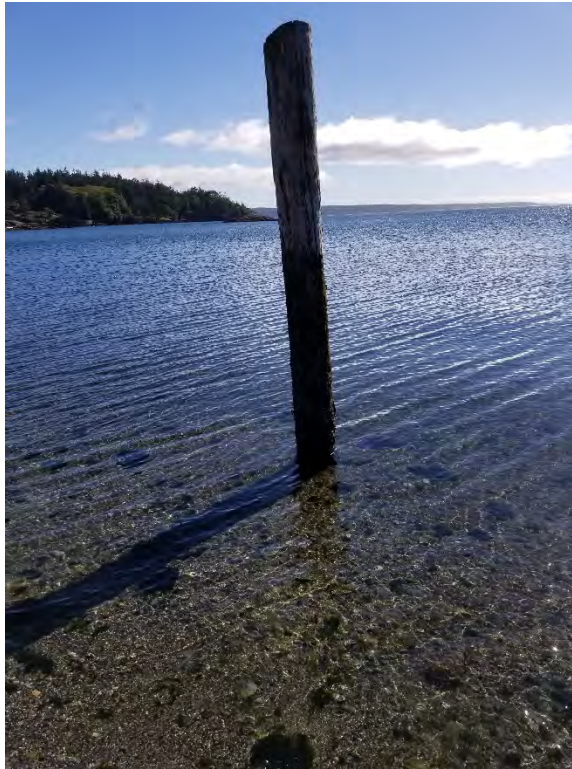
Photograph 1. Creosote-treated pile in the intertidal.

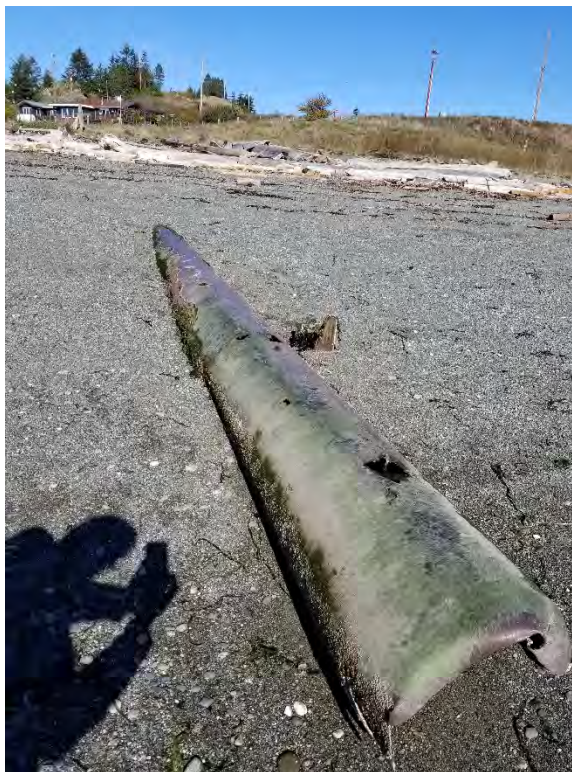
Photograph 2. Metal outfall and a creosote-treated pile stub.

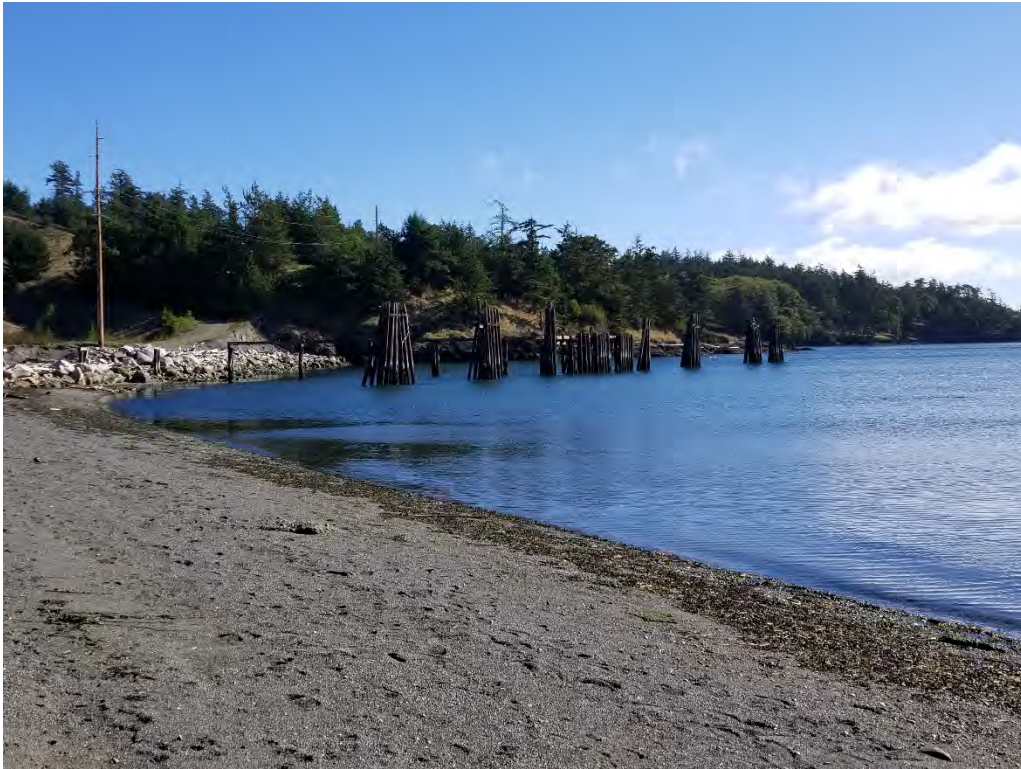
East of the Port-owned property a defunct barge landing (approx. 1,500 sf) with 9 creosote piles, a remnant of the former cannery operations at the site, and concrete and plastic debris as well as creosote-treated wood was observed scattered below and above MHHW (see Attachment B). This might be another opportunity for the Port to partner with the private property owner to develop additional mitigation credits.

Photograph 3. Defunct barge landing with creosote piles, concrete debris.

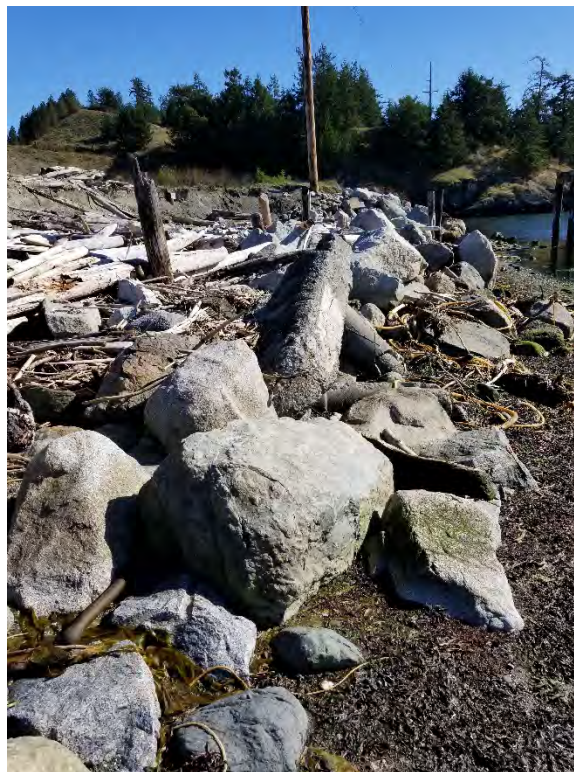
Photograph 4. Close up of concrete debris and creosote-treated piles among driftwood.

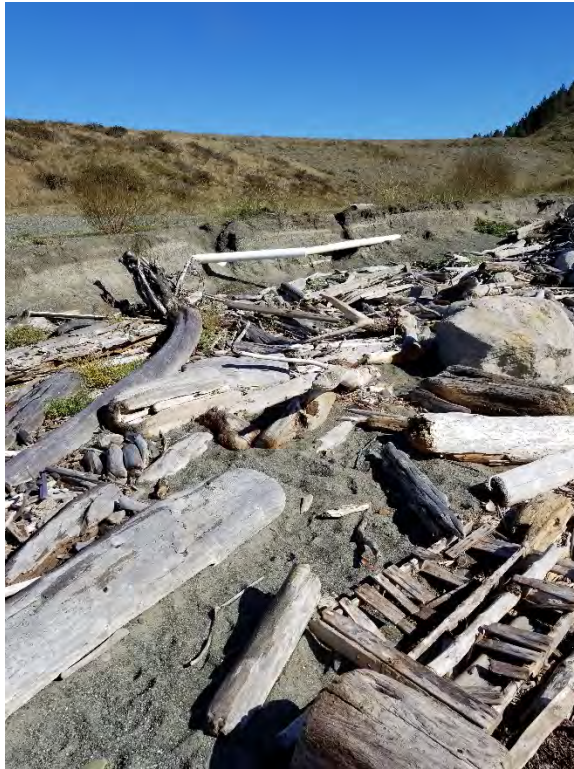
Photograph 5. Plastic debris in scarp, wood debris among driftwood.

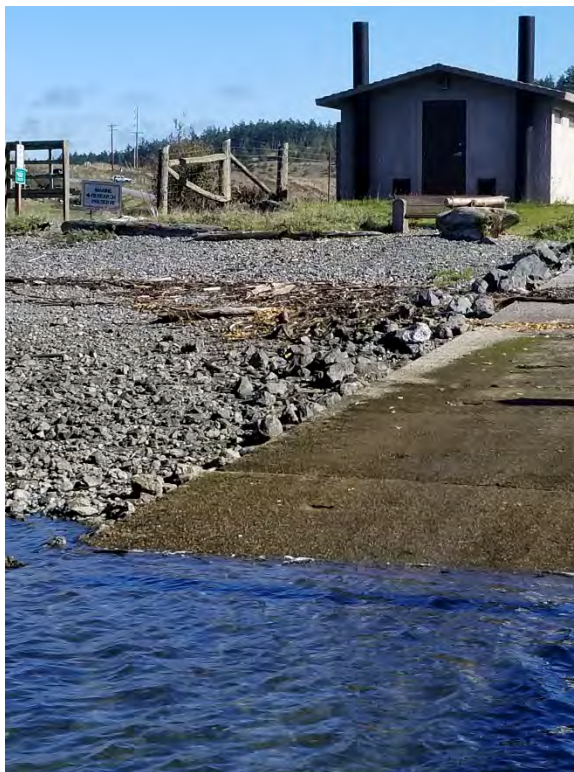
Photograph 6. Concrete boat ramp and adjacent angular rock.
