Subject: 2024 Cap Inspection and Repair
Hillyard Lead Soils Site, Spokane, Washington
FSID No: 960924; CSID No. 1371

Fence Repair
Hillyard Lead CAP
Spokane, Washington

SES Project No.:
1480-011

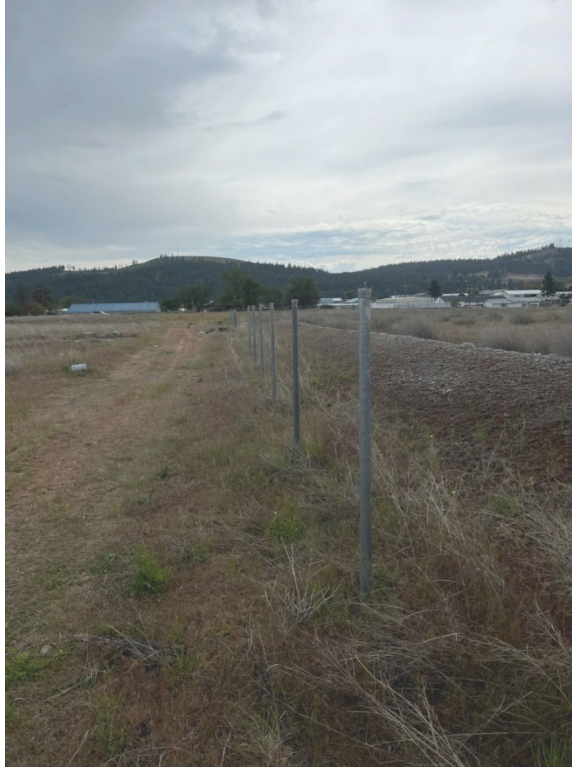
Photo No.
1

Northern boundary of the fence line prior to work completed seen from the west.

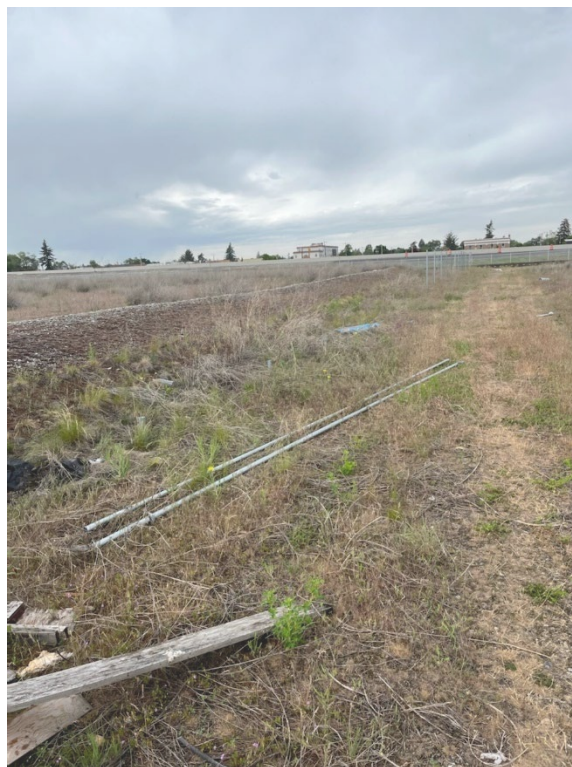
Photo No.
2

Northern boundary of the fence line prior to work completed seen from the east.

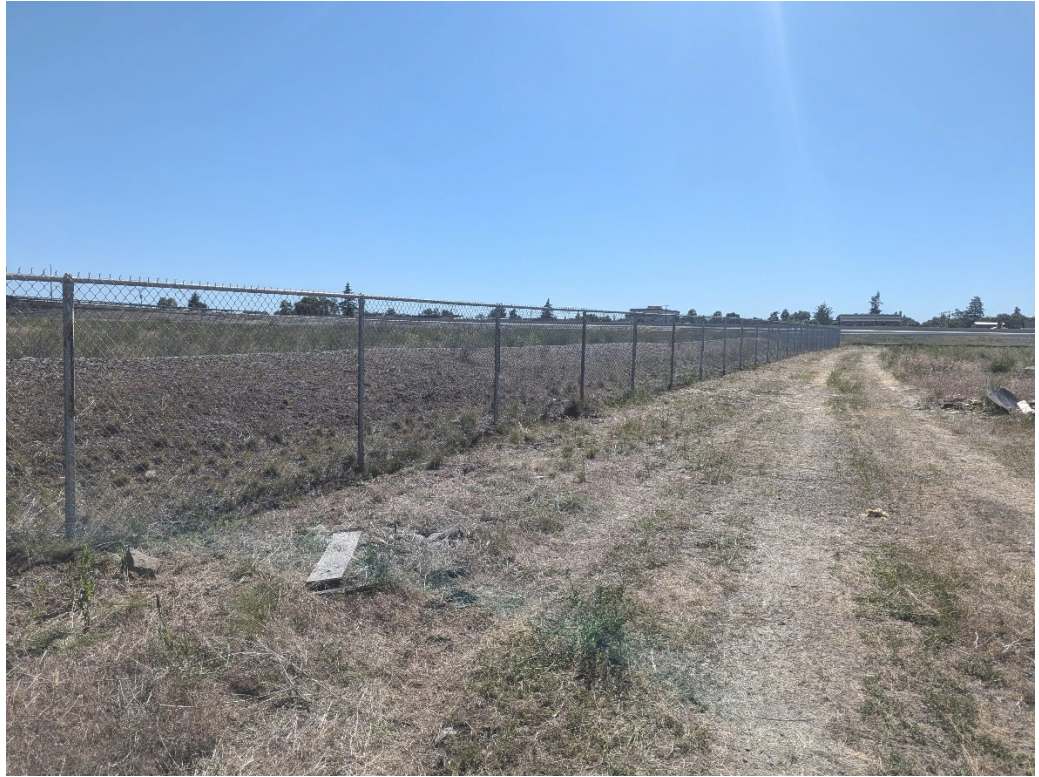
Photo No.
3

Repaired and reinforced section of fence along north side of lead CAP.

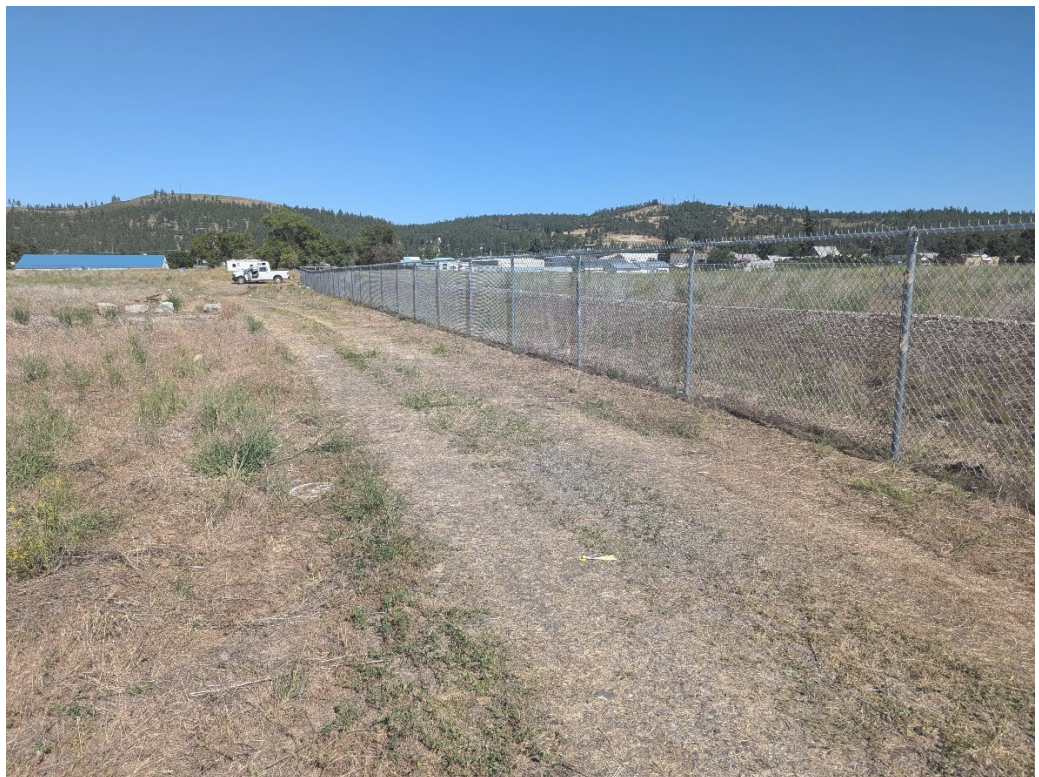
Photo No.
4

Repaired and reinforced section of fence along north side of lead CAP.

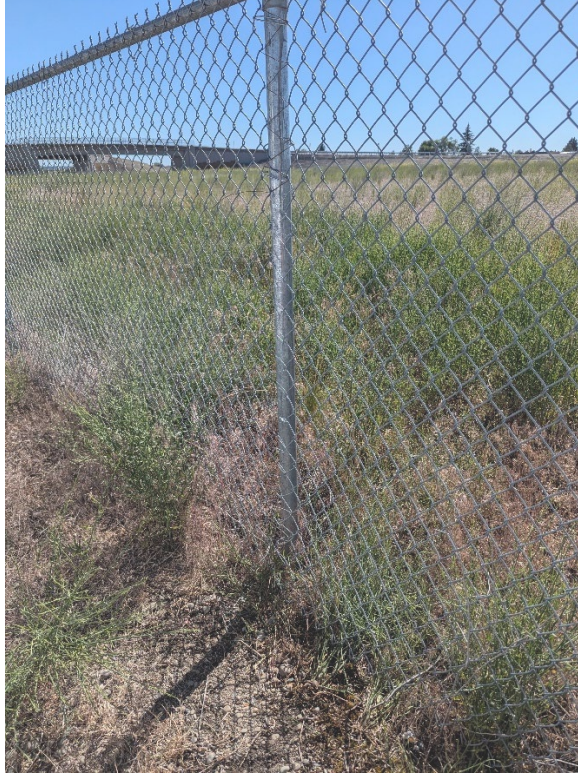
Photo No.
5

Hole cut into a section of the east side of the fence repaired with wire.

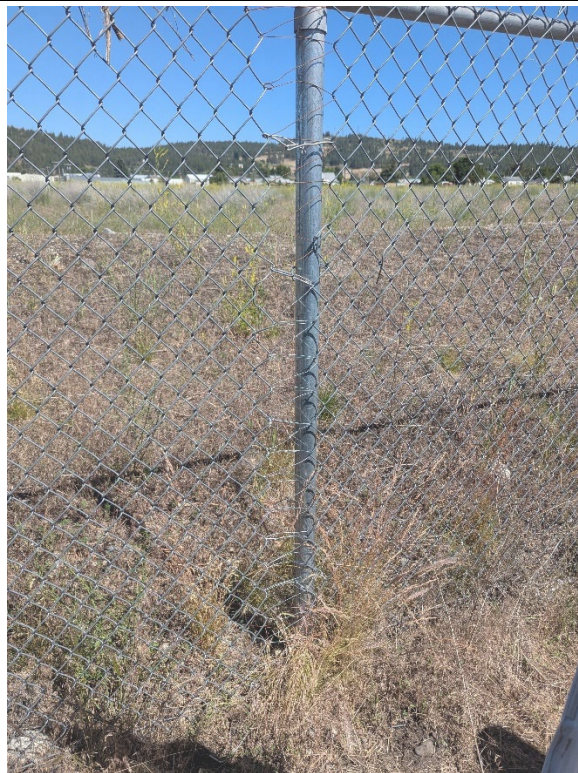
Photo No.
6

Hole cut into a section of the west side of the fence repaired with wire.
