***Storage Tank Investigation
4321 University Way N.E.
(Tower Records)
Seattle, Washington***

June 1997

RE: STORAGE TANK INVESTIGATION, 4321 UNIVERSITY WAY N.E. (TOWER RECORDS), SEATTLE, WASHINGTON

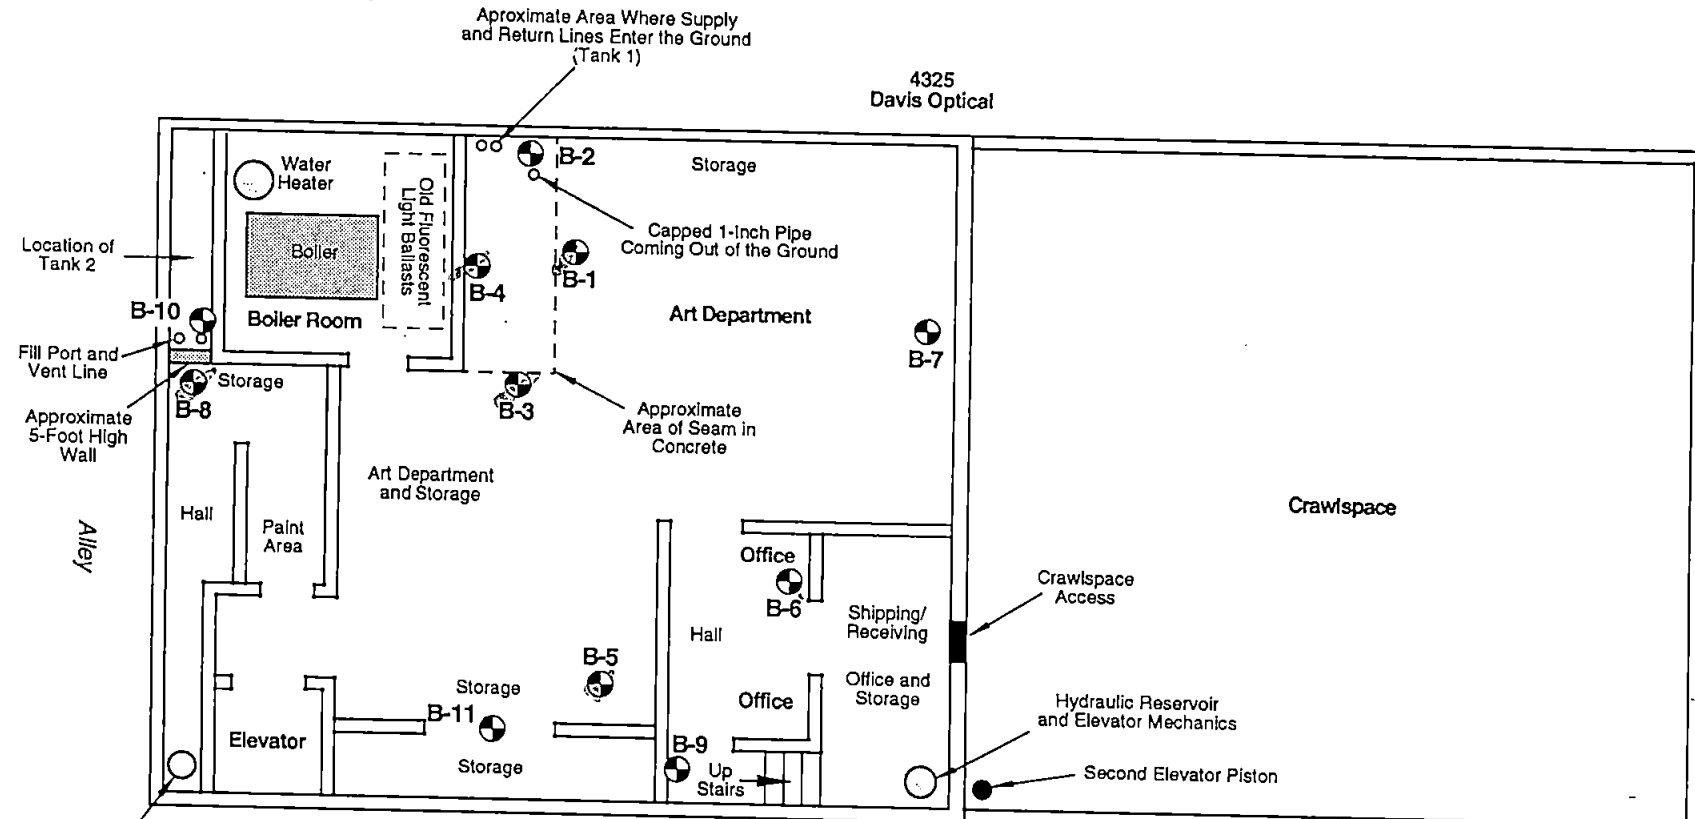
4321 University Way N.E. Storage Tank Investigation Seattle, Washington	
BASEMENT FLOOR PLAN AND EXPLORATION PLAN	
May 1997	T-1720-03
SHANNON & WILSON, INC. Geotechnical and Environmental Consultants	FIG. 2

On October 31, 1996, a Shannon & Wilson representative installed four soil borings at the site, one on each side of Tank 1, as shown on Figure 2. ~~No sample was collected at boring location B-2.~~ During the first attempt at this location, a terra cotta drain tile was encountered at 6 inches below the surface. The second attempt was terminated at 2 feet when the top of the tank was reached. Soil samples were collected from the remaining three boring locations (B-1, B-3, and B-4). ~~Water seepage was noted in B-4 at a depth of approximately 4 feet below the concrete floor.~~ The soil samples were analyzed by method Washington Total Petroleum Hydrocarbons as Diesel extended (WTPH-D-Extended) to include oil-range hydrocarbons. ~~Diesel-range and oil-range hydrocarbons were detected in the samples at concentrations of 360 to 10,000 milligrams per kilogram (mg/kg), and 140 to 550 mg/kg, respectively.~~ Table 1 presents a summary of the analytical results, and the complete laboratory reports are provided in Appendix B.

Two storage tanks have been confirmed to be located in the basement of the building located on site. One of the tanks (Tank 1) is located beneath the concrete floor of the basement, and the other tank (Tank 2) is located behind a 5-foot concrete wall on the west side of the boiler room. It is believed that Tank 2 is resting on a concrete floor, which could act as a secondary containment, minimizing the potential impact to the underlying soils and/or groundwater; however, the extent of the concrete floor could not be determined.

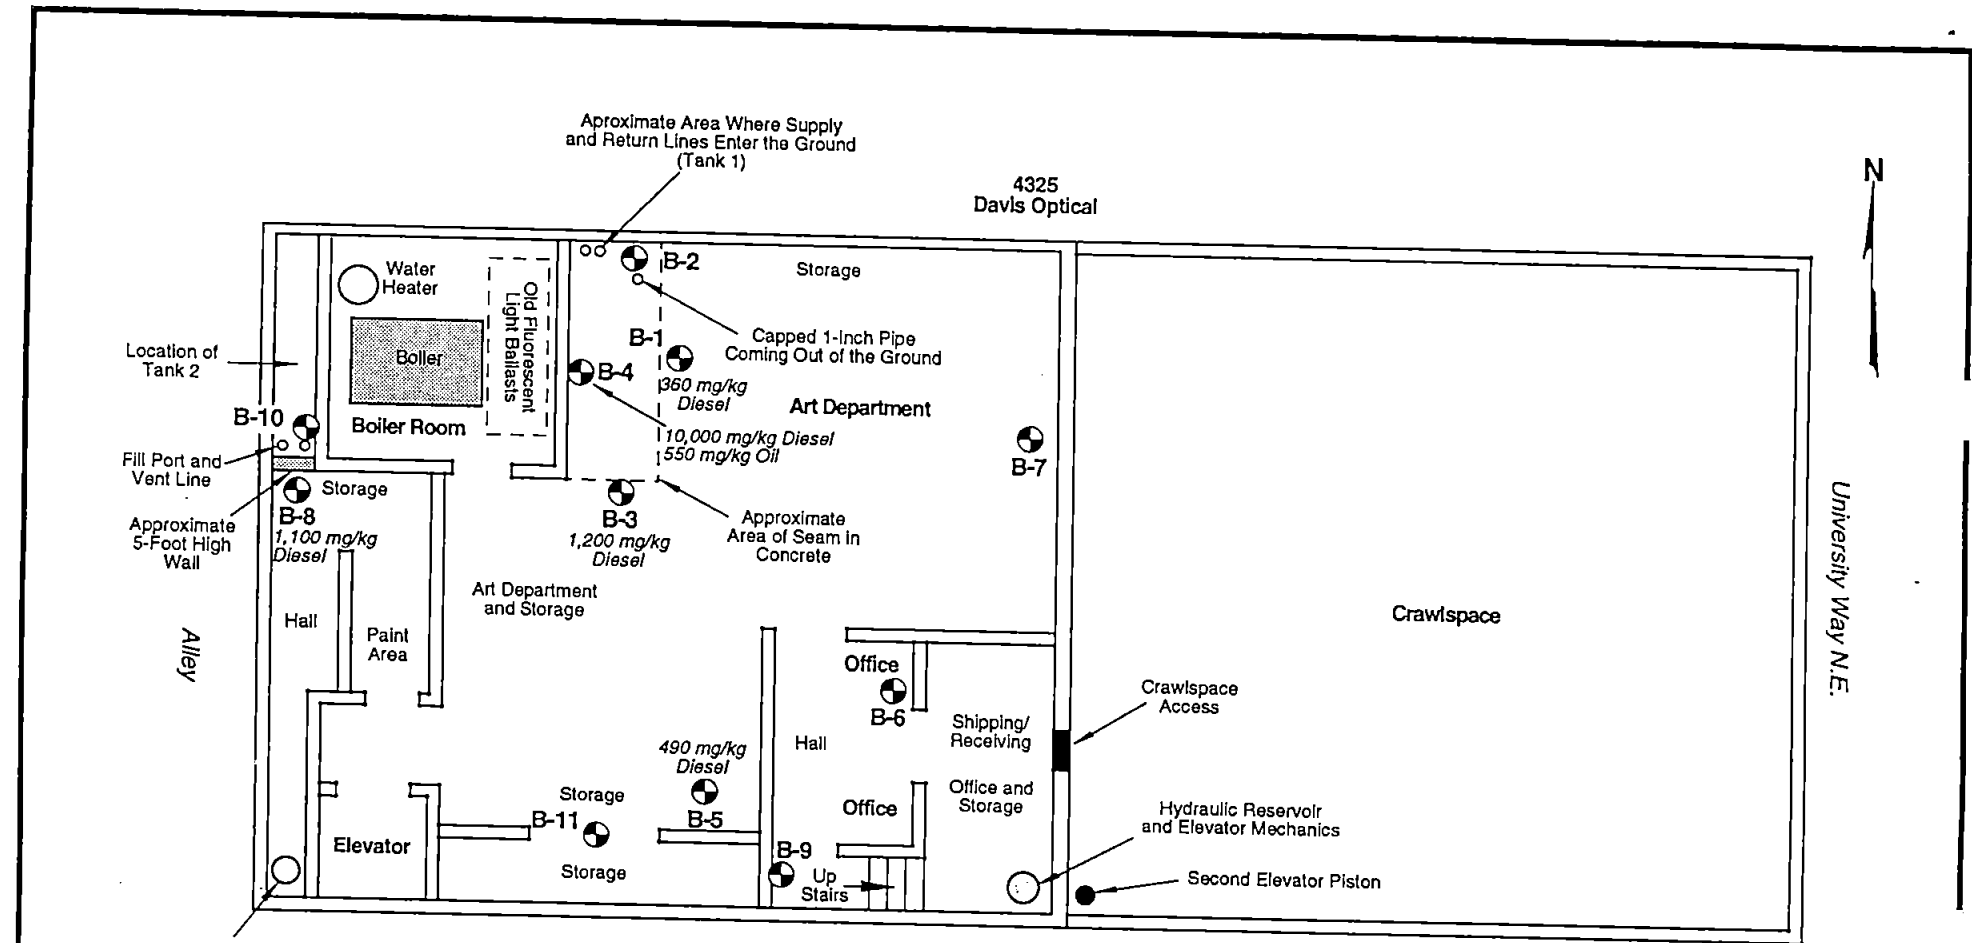
4321 University Way N.E. Storage Tank Investigation Seattle, Washington	
LOCATIONS OF DIESEL AND OIL ABOVE POTENTIAL REGULATORY CRITERIA	
May 1997	T-1720-03
SHANNON & WILSON, INC. Geotechnical and Environmental Consultants	FIG. 3

Both tanks contained fuel product. **Diesel- and oil-range petroleum hydrocarbon soil contamination exceeding Model Toxics Control Act (MTCA) Method A cleanup levels exists beneath the basement floor of the building.**

→ The comparison was inconclusive; we were unable to determine if either tank is contributing to the soil contamination detected. The extent of the contamination is unknown. However, it appears to exist beneath the western portion of the basement at depths greater than 3 feet below the basement floor. It was not possible to determine the bottom depth of the contamination because of difficult sampling conditions.

Water was encountered at an approximate depth of 4 feet below the basement floor. This water may be facilitating horizontal migration of the petroleum contamination. The water is believed to be a perched groundwater layer resulting from local surface water drainage. The water's direction of flow is unknown but may be to the south-southeast, corresponding with local surface topography.

Owners are required by law to report any release of any hazardous substance, including petroleum products, to Ecology within 90 days of discovery. This includes any discovery during excavation, or geotechnical or environmental investigations. In our opinion, the analytical results from this investigation qualify as reportable concentrations. We are available to assist with Ecology reporting.

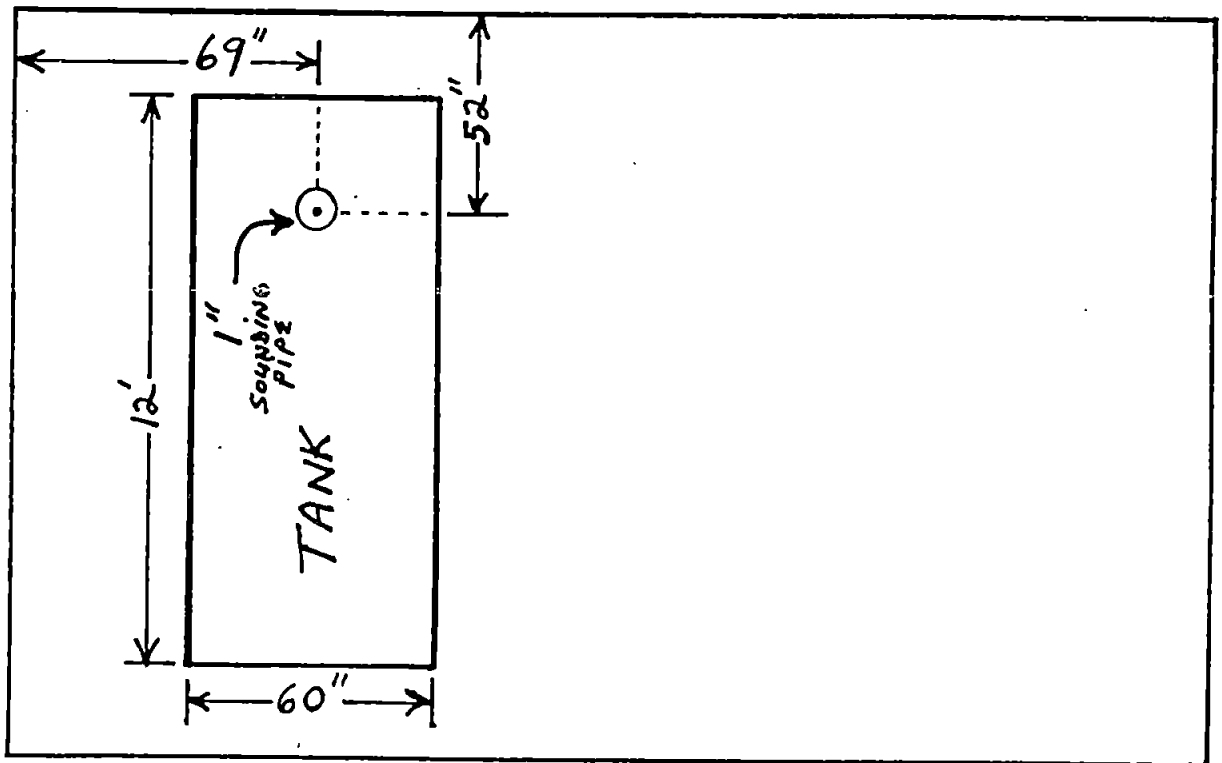
Tank Size (60"X12') 1760 Gal. Lay of Tank North to South

Comments: Tank lays beneath cement basement floor. 1 inch sounding tube over north
end of tank. Difficult access to tank from alley. Fill pipe and vent pipe not located.
Center line of tank marked with silver paint.

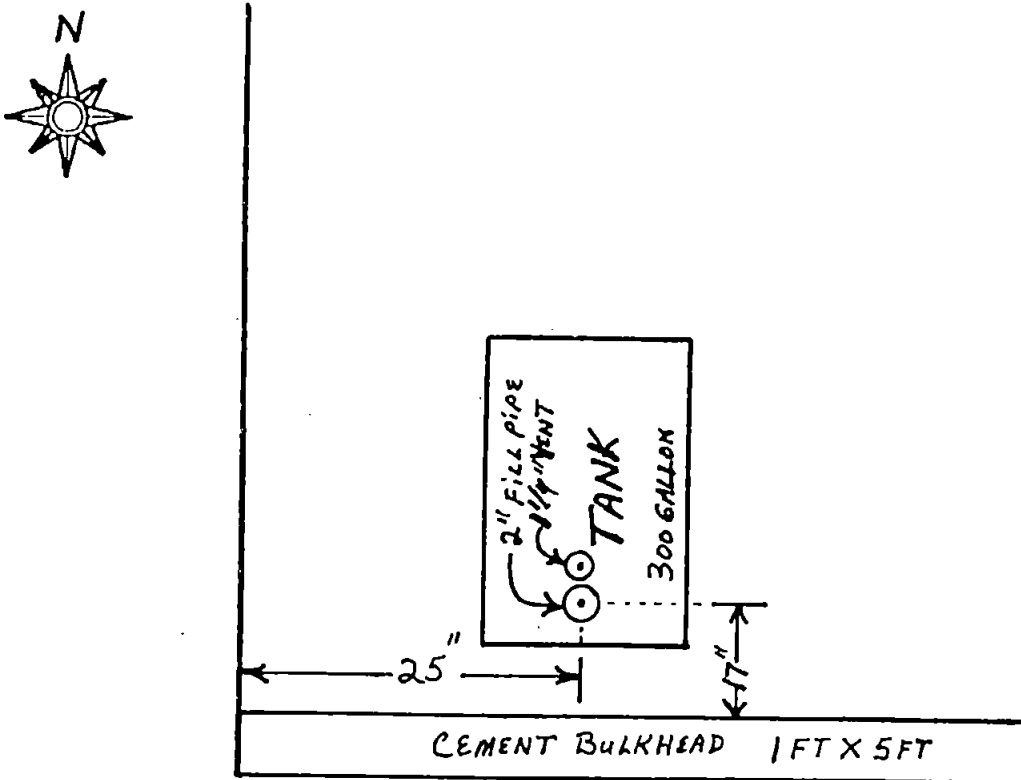
Tank Size Estimate 38"X61" = 300 Gal. Lay of Tank North to South
Depth Below Surface 24 inches Type of Ground Cover Earth
Tank Diameter 38 Inches Amount of Liquid 4 Inches Gal.
Amount of Fuel 4 Inches Gal. Amount of Water 0 Inches Gal.
Date of Location 10/25/96 By: Ken Stoffel

Comments: Tank lays in cement crib, in basement, west side of building. 2 inch direct fill pipe over south end of tank. 1 1/4 inch vent pipe also over south end of tank.
Low overhead over tank, apx 2 1/2 - 3 feet.
