LEAK TESTING CHECKLIST FOR UNDERGROUND STORAGE TANKS (USTs)

UST ID #: 10841
County: Walla Walla

I. UST FACILITY		II. CERTIFIED SERVICE PROVIDER	
Facility Compliance Tag #: A <u>4239</u>		Service Provider Name: <u>Casey Eldridge</u>	
UST ID #: <u>10841</u>		Company Name: <u>Mascott Equipment Co.</u>	
Site Name: <u>Boise Trucking</u>		Address: <u>200 S 20th Ave.</u>	
Site Address: <u>31572 Hwy 12</u>		City: <u>Pasco</u> State: <u>Wa</u> Zip: <u>99301</u>	
City: <u>Walulla</u>		Phone: (503) 282-2547 Email: <u>celdridge@mascottec.com</u>	
County: <u>Walla Walla</u>		ICC Certification Type: <u>U1,U3</u>	
Site Phone:		ICC Cert. #: <u>9317992</u> Exp. Date: <u>11/25</u>	
III. UST OWNER/OPERATOR			
Name:		Phone:	Email:
IV. UST SYSTEM INFORMATION			
Observations on test day.

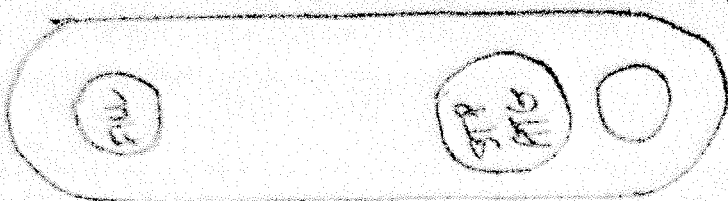
VIII. UST SITE AND SYSTEM DIAGRAM

Master Disp 1/2 liquid sensor did not function when tested. Notified site rep a new one would be ordered, installed, and tested.
