# Environmental Cap and Drainage System Inspection Report

Former Wasser Winters Log Sort Yard  
(Ecology Facility ID #1218)

October 31, 2024

Project No. M0615.23.002

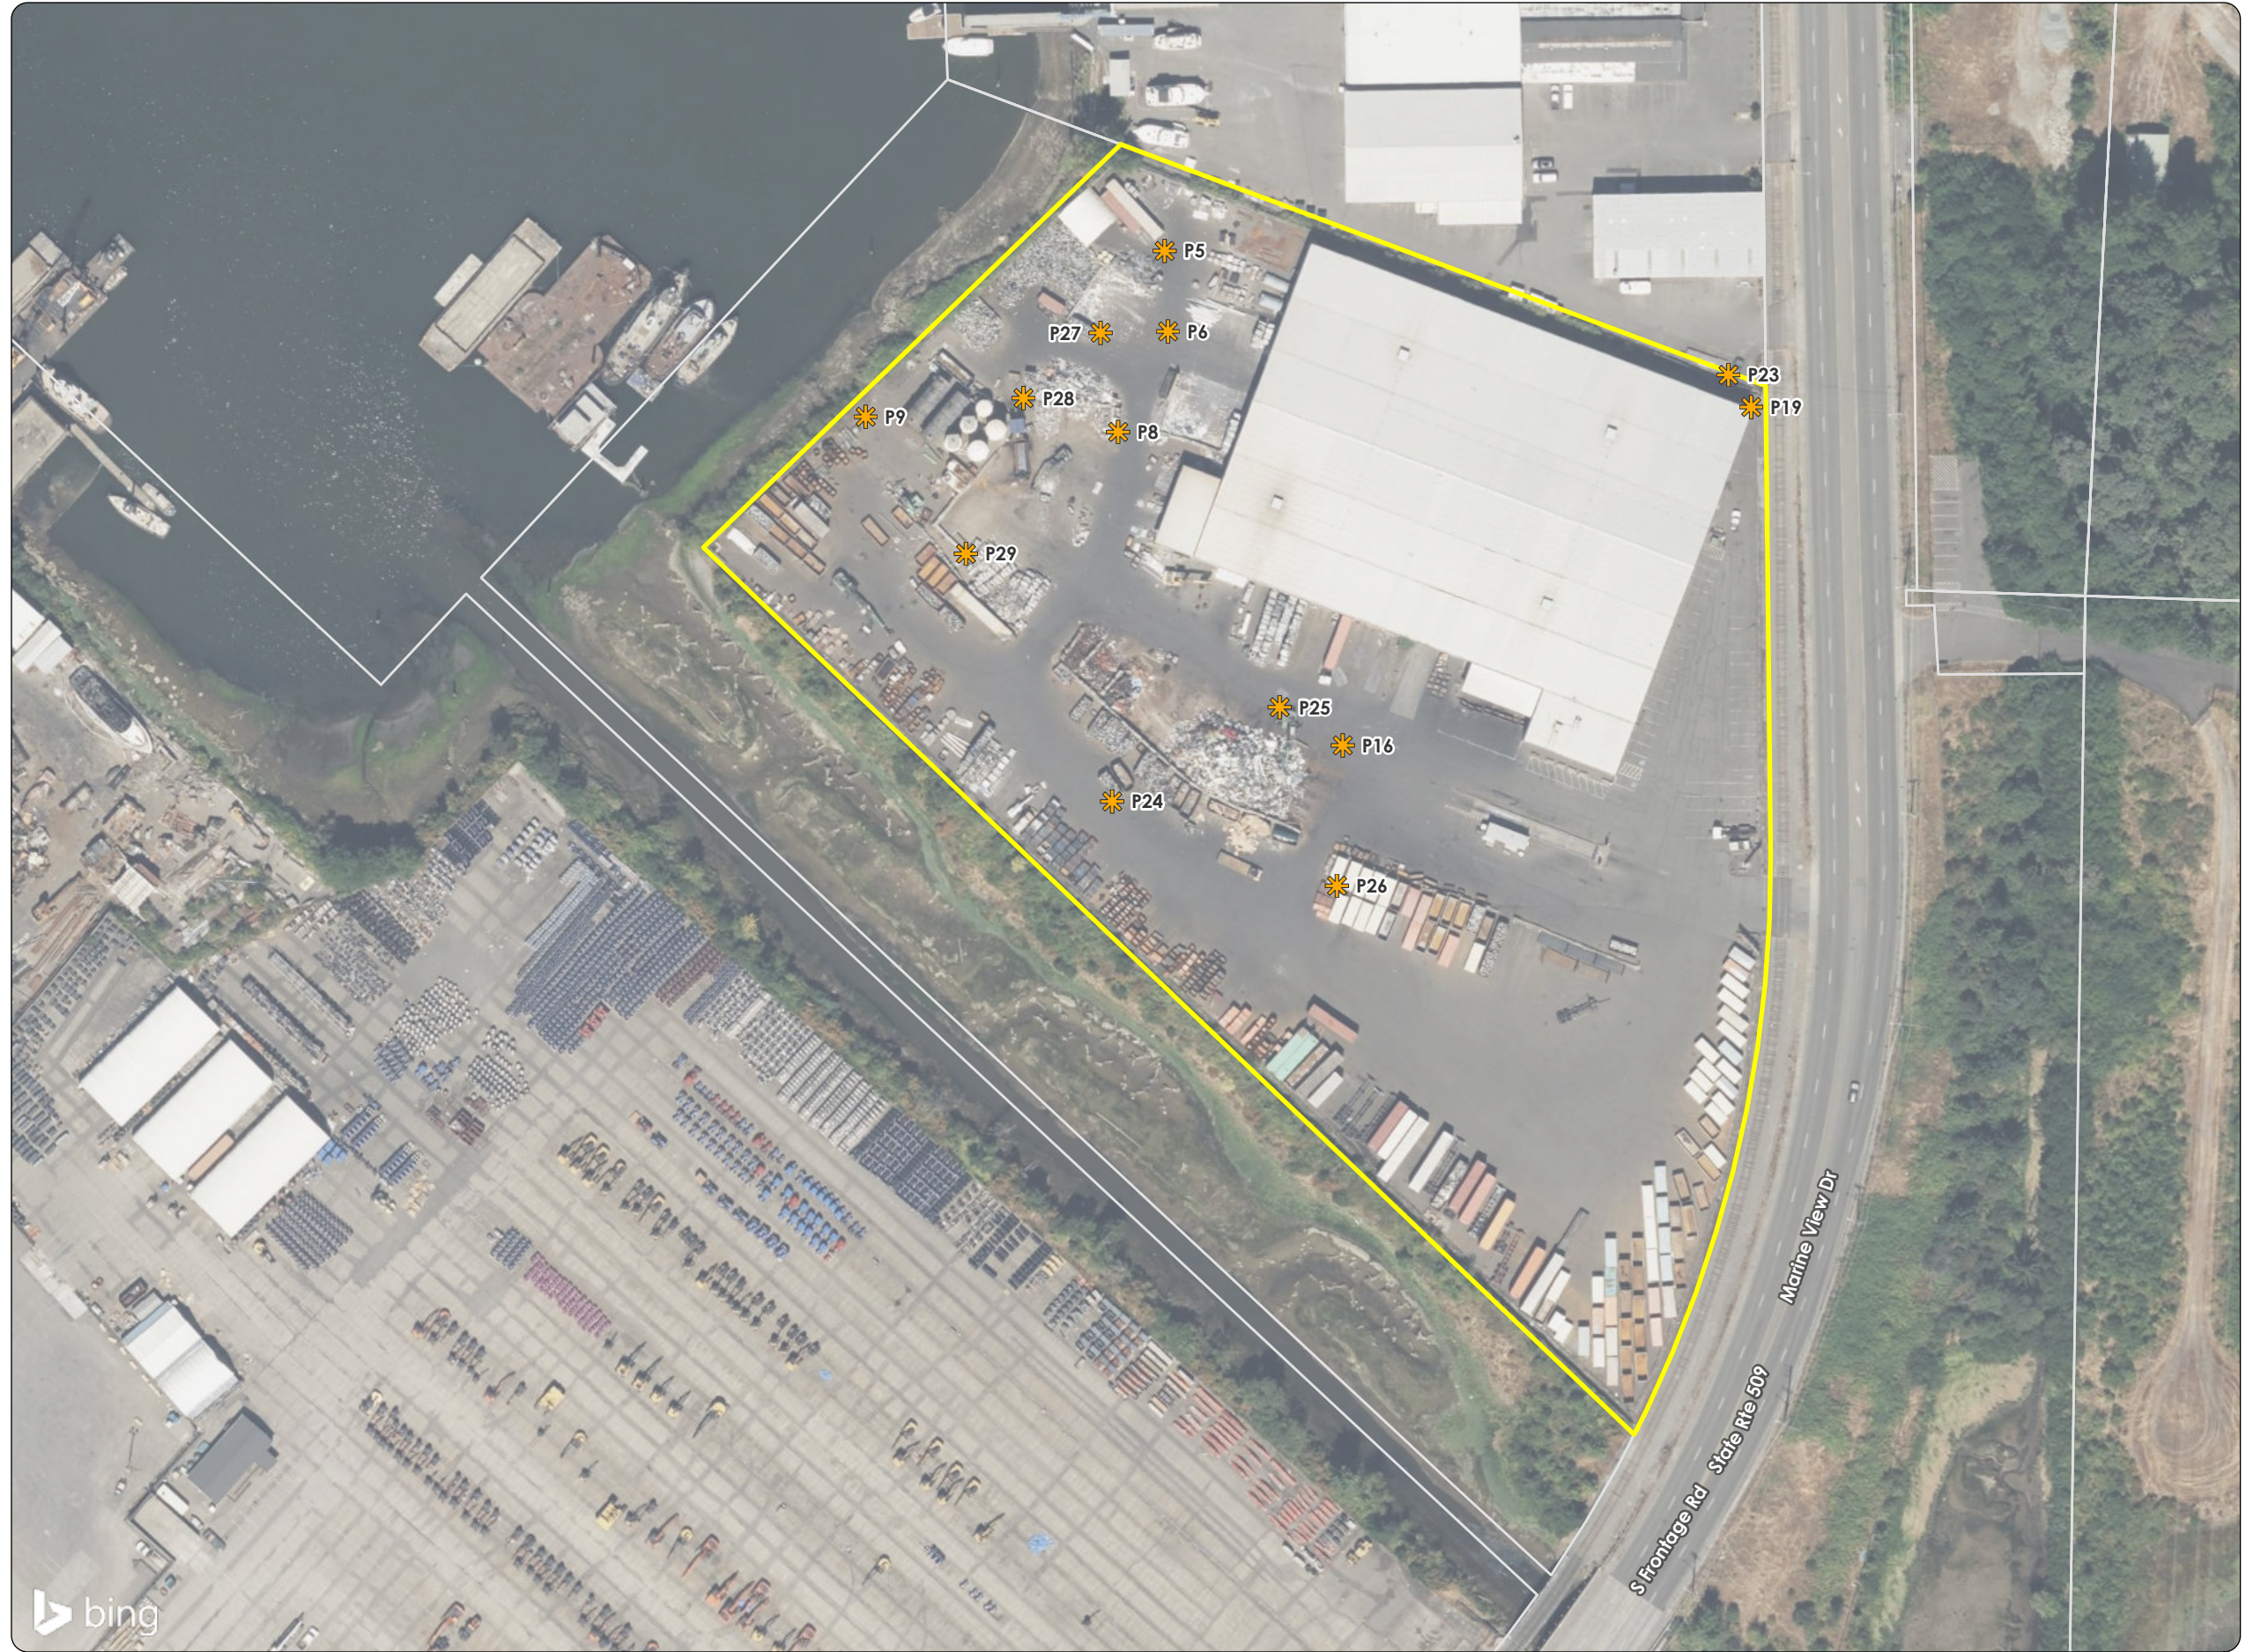
## Figure 2-1 Environmental Cap Issues Observations

The table below provides a summary of the cap conditions observed during the 2024 inspection; observations, photographs, and recommended actions keyed to specific locations are presented in Table 2-1 following this report.

| Required Inspection Element | Observed Condition | Recommended Action |
|---|---|---|
| Presence of cracks wider than 1/8 inch | Cracks wider than 1/8 inch were observed across the site | Repair pavement as shown in Figure 2-1 and described in Table 2-1 |

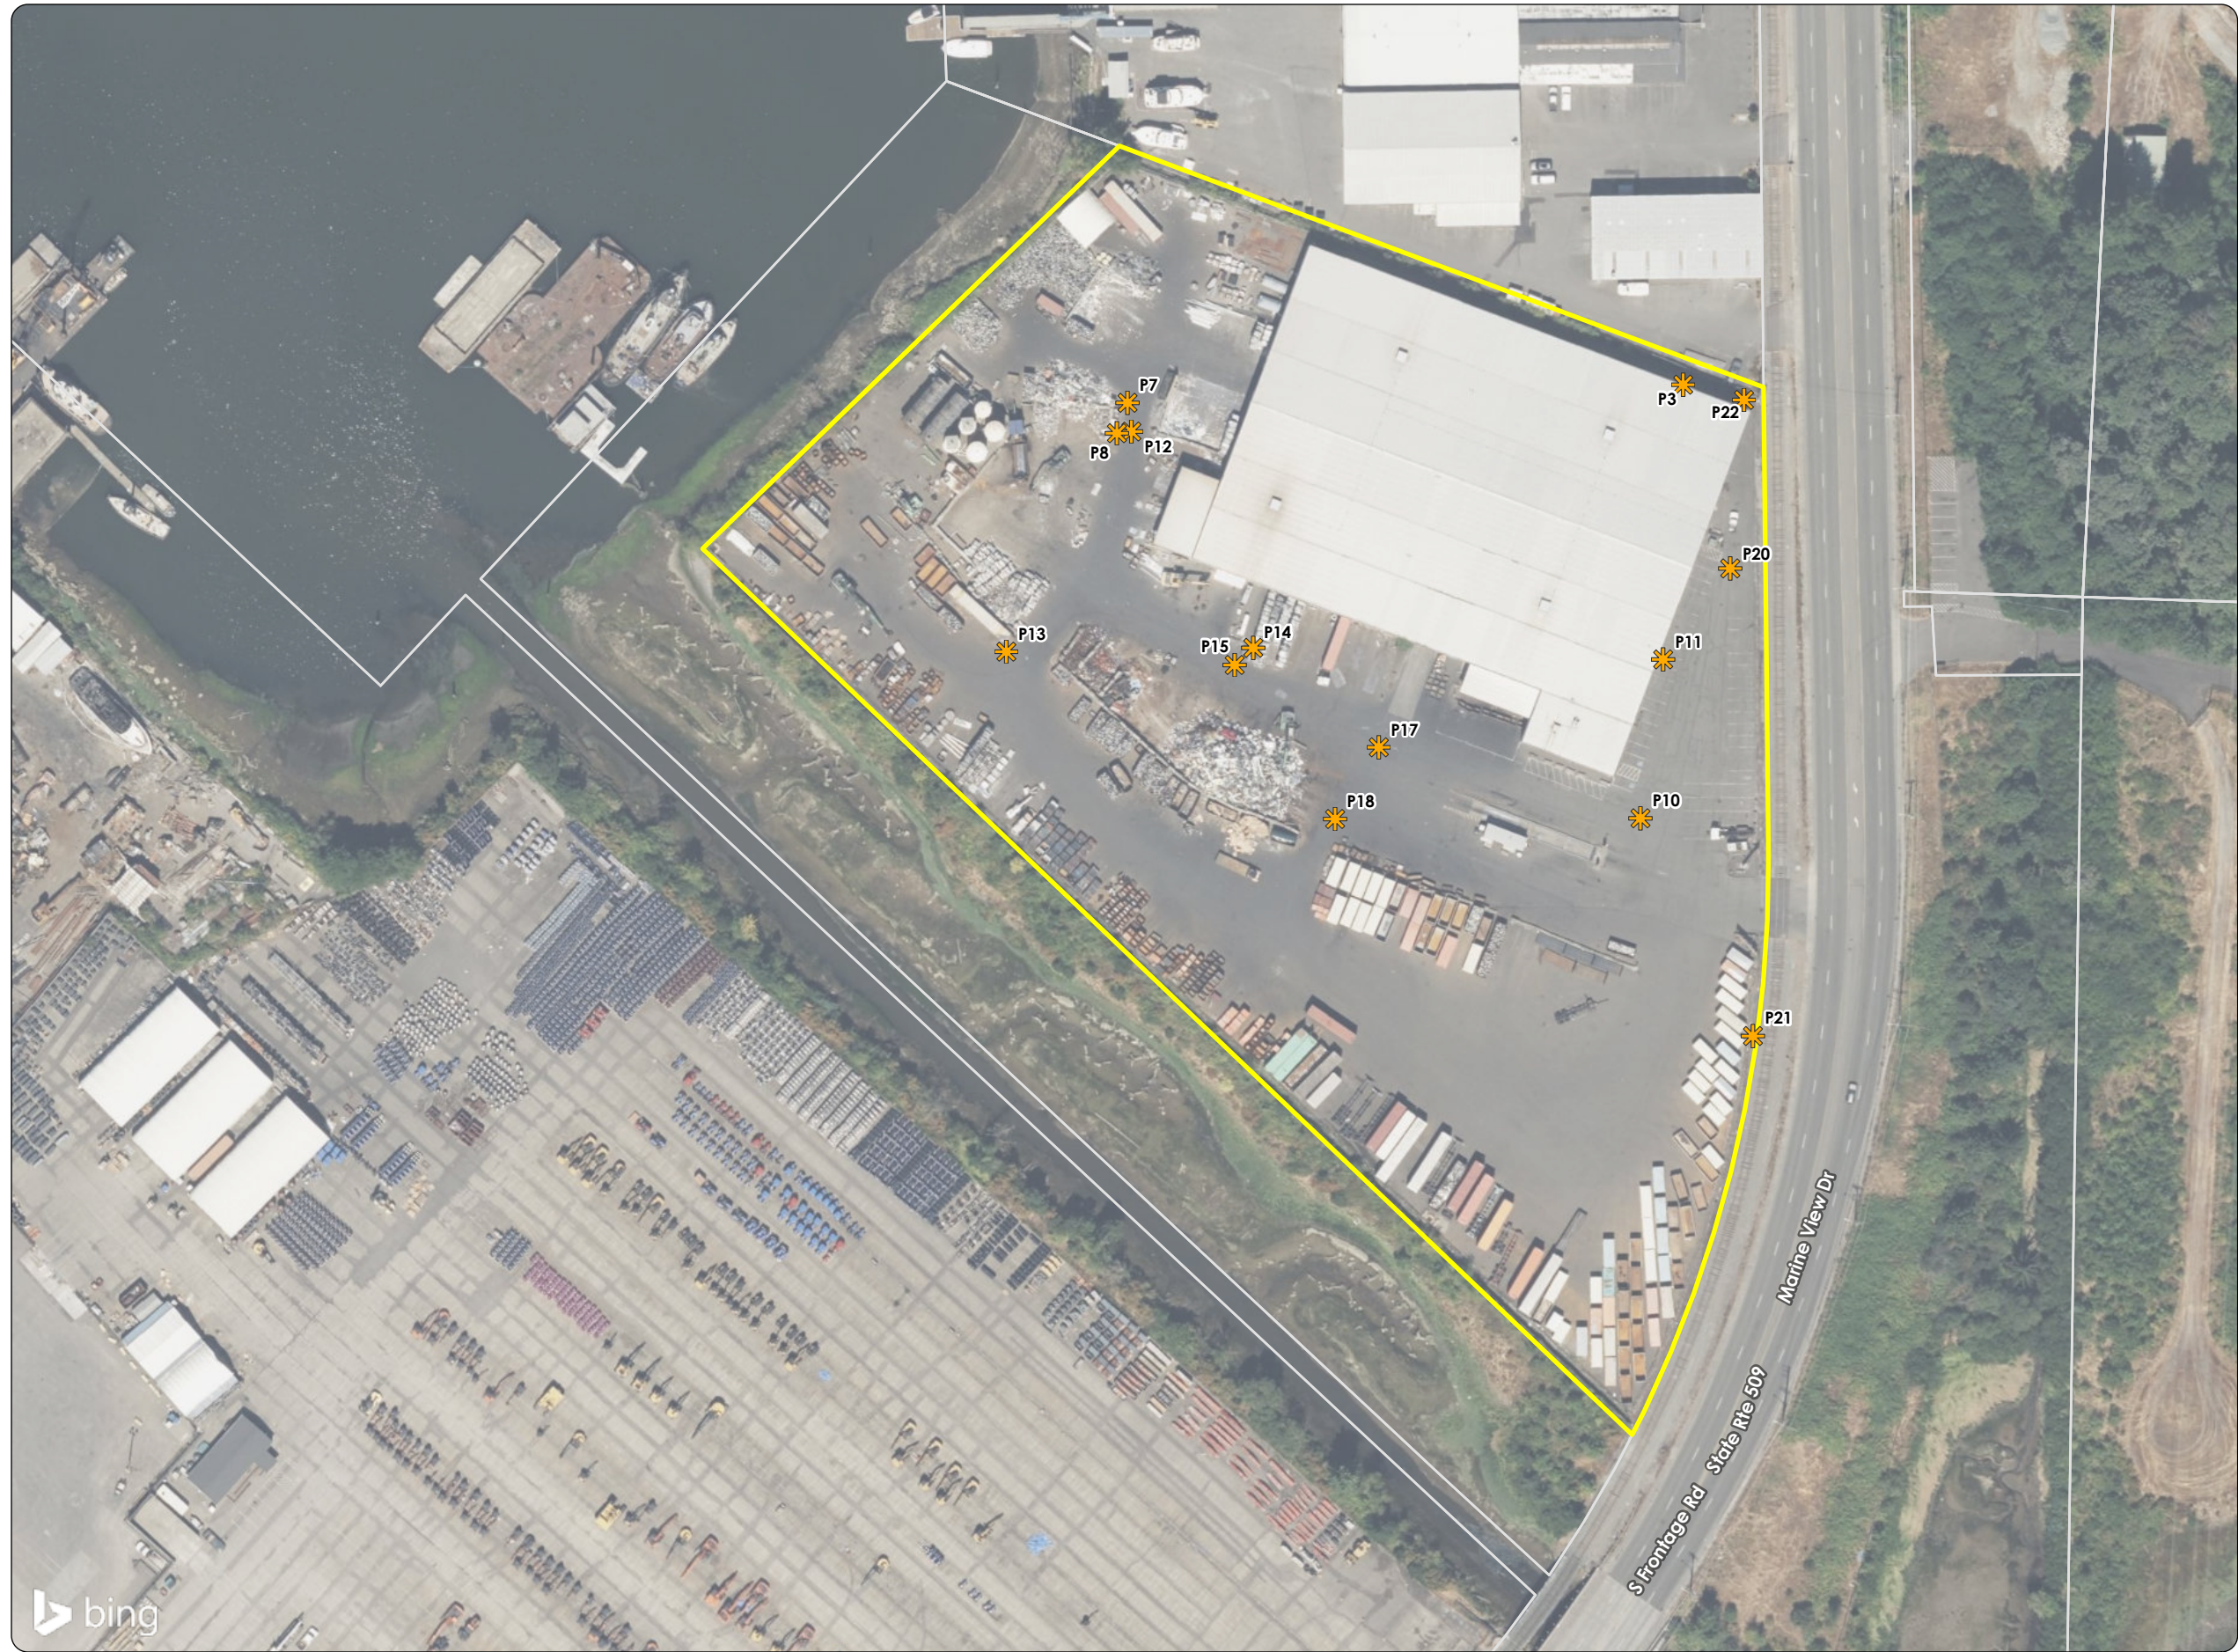
## Figure 2-2 Environmental Cap Repairs Observations

Pavement repairs observed during the 2024 inspection are presented in Figure 2-2 and described in Table 2-2.

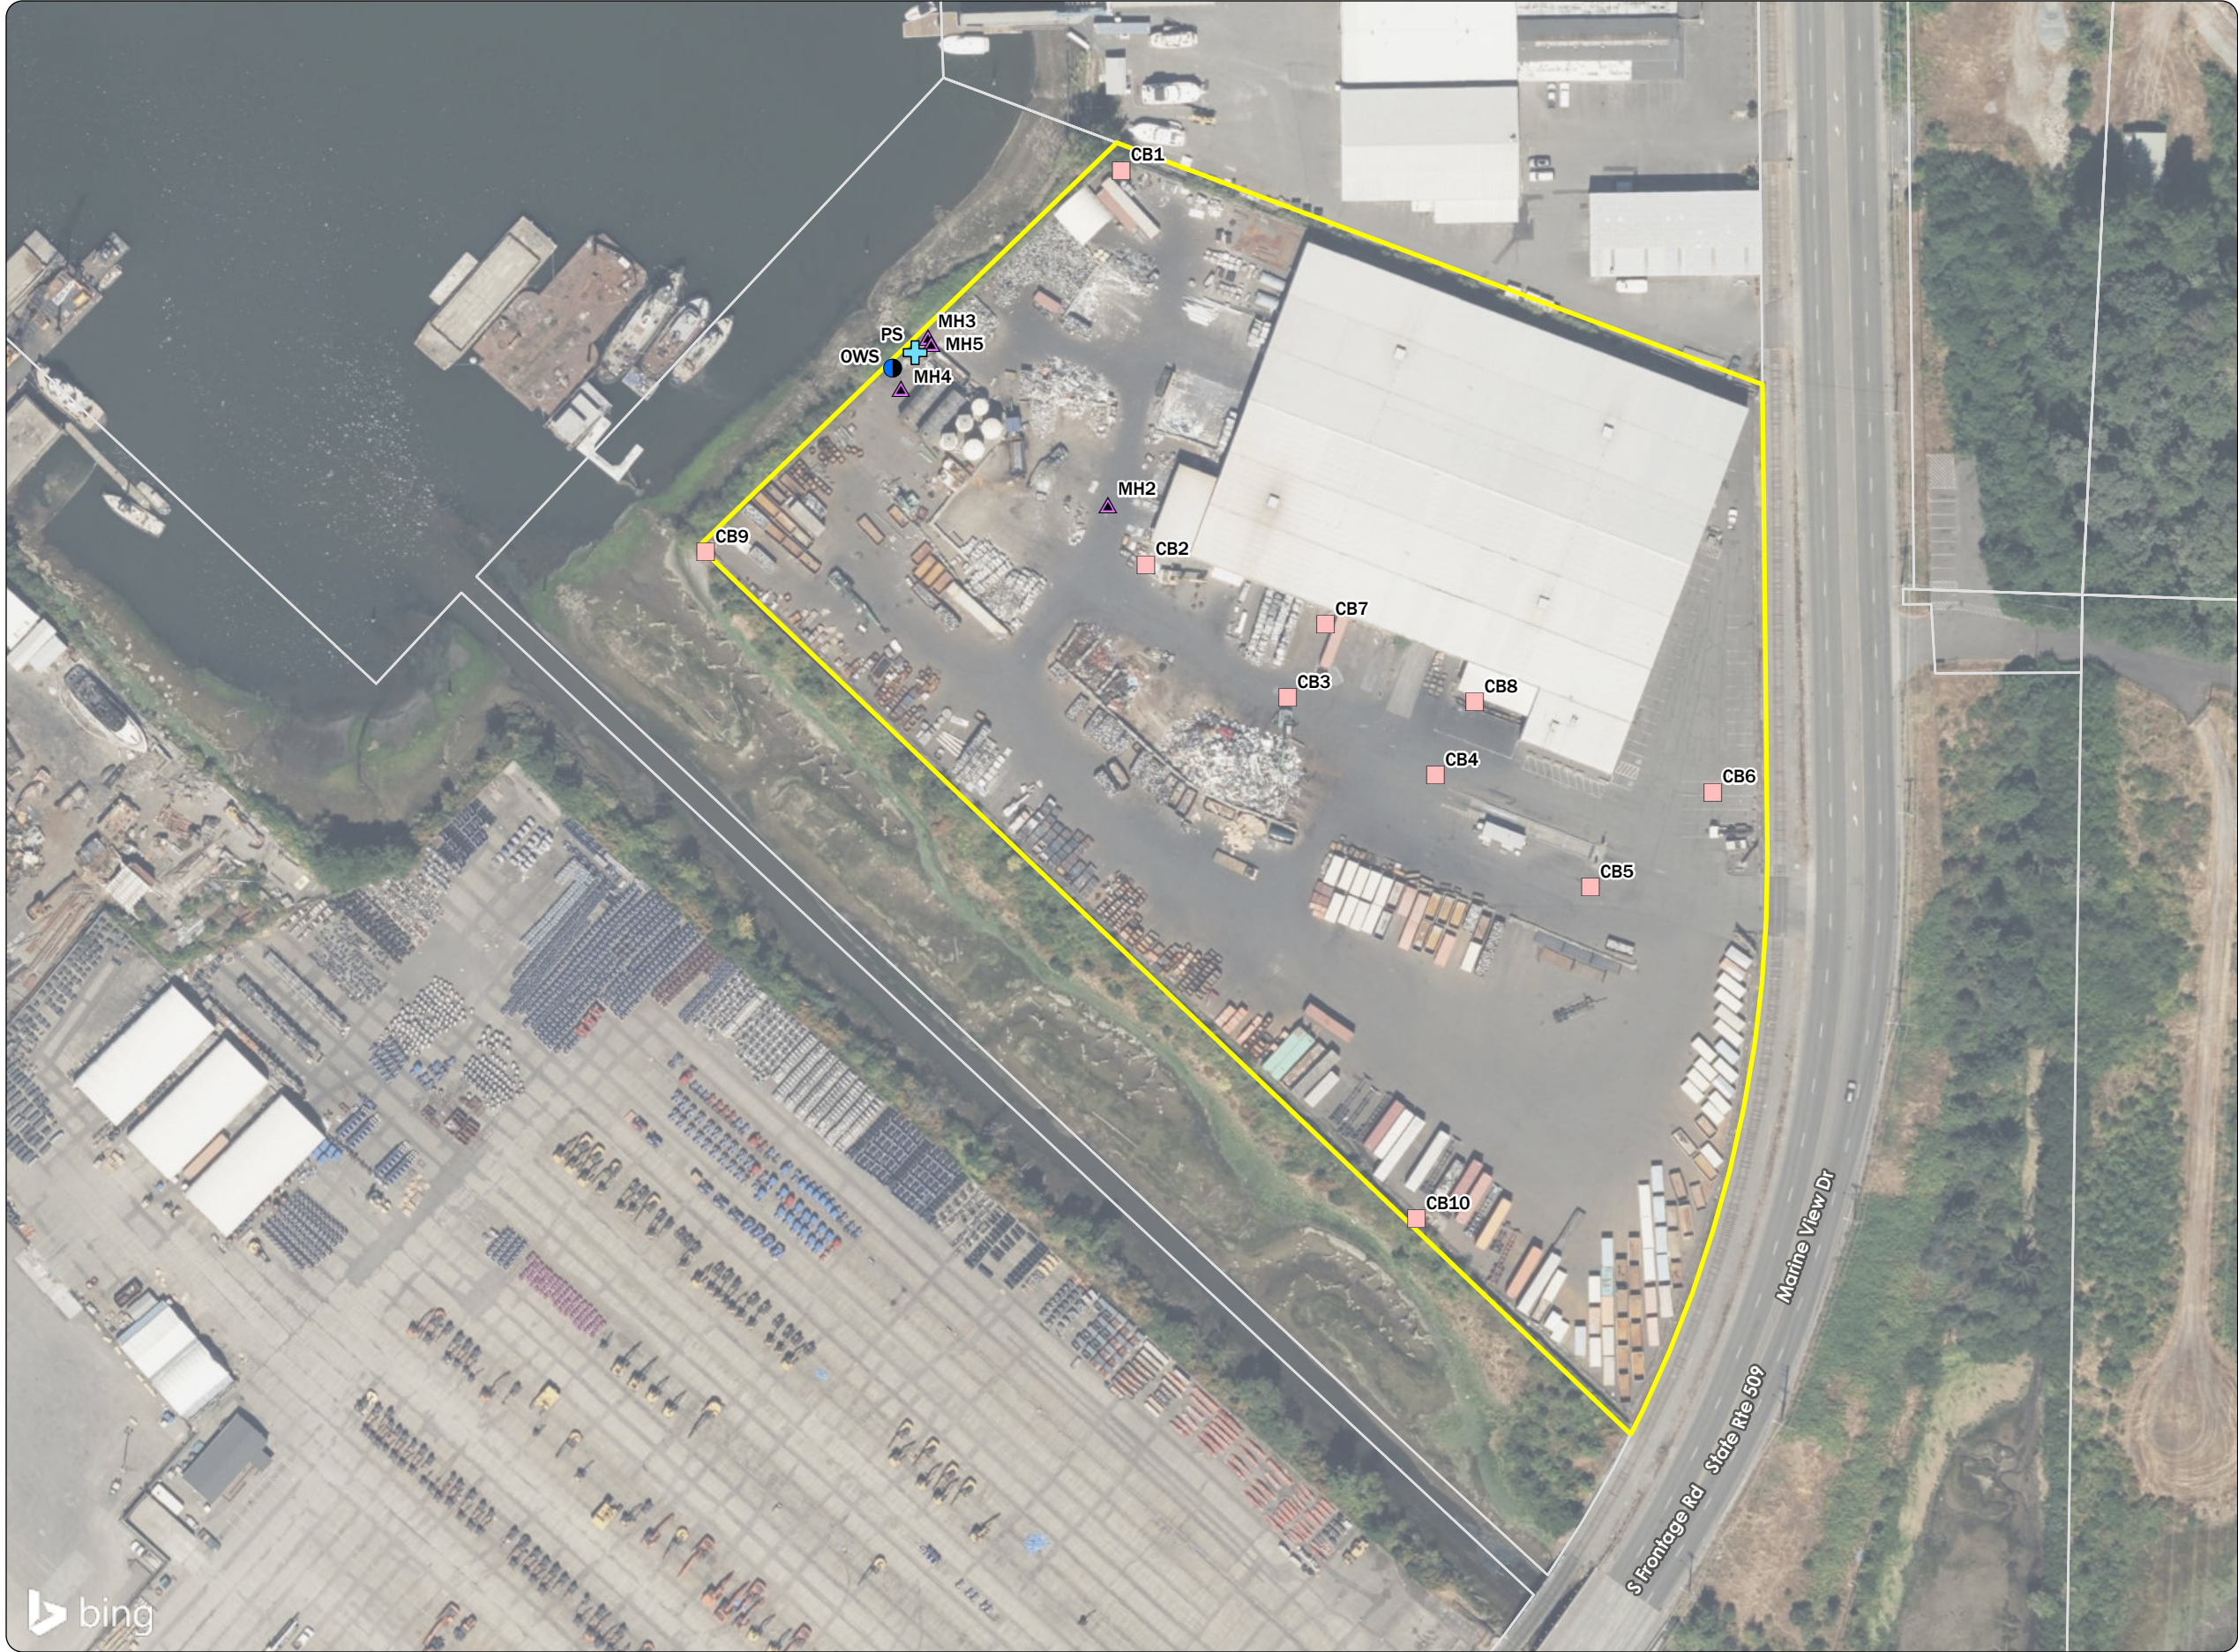
## Figure 2-3 Stormwater Drainage System Observations

The Site's stormwater drainage system consists of 10 catch basins, five maintenance holes, one pump station, and one oil/water separator (formerly a spill containment vessel). In 2024, each drainage system component was inspected for general appearance, sediment and debris accumulation, and structural and functional condition. Catch basins CB1, CB3, CB4, CB7, CB8, CB9, and CB10, were only partially inspected because they were not accessible due to ponded water from the active rain event or the grate was unable to be removed due to a damaged insert or tight fit of the grate. Catch basin CB2 was not inspected because it has been permanently sealed with a steel plate. Maintenance hole MH1 was unable to be located (consistent with the last several inspections). The stormwater features were observed to be functioning normally. Table 2-3 summarizes the observations made at each drainage structure.

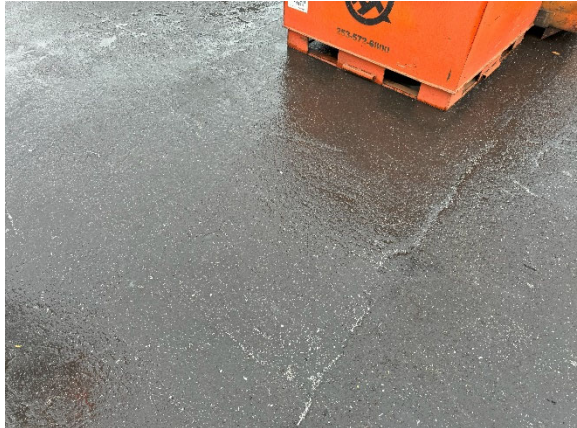
| ID <sup>1</sup> | Type of Structure | Observation | Recommended Actions | Photographs |
|---|---|---|---|---|
| P5 | Pavement | Surface gouging, typical; less than 1 inch deep | Monitor and reevaluate repair during next inspection cycle | |

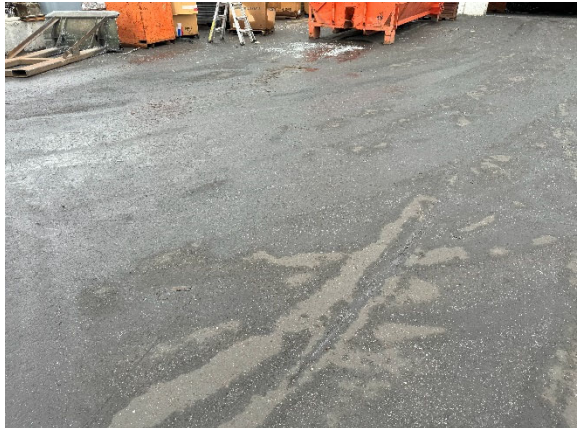
| ID <sup>1</sup> | Type of Structure | Observation | Recommended Actions | Photographs |
|---|---|---|---|---|
| P6 | Pavement | Surface gouging; typical; less than 1 inch deep | Monitor and reevaluate repair during next inspection cycle | |

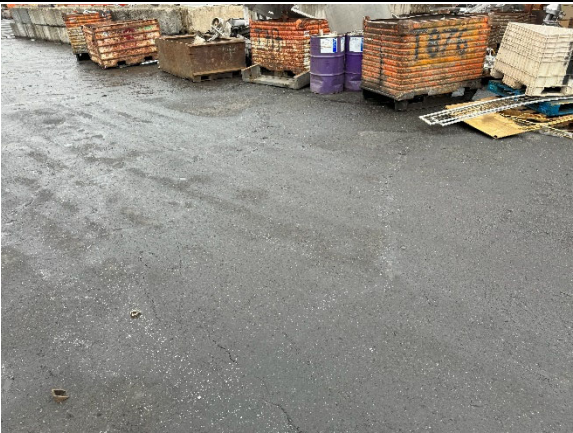
| ID <sup>1</sup> | Type of Structure | Observation | Recommended Actions | Photographs |
|---|---|---|---|---|
| P8 | Pavement | Repaired/sealed cracks incompletely sealed | Reseal | |

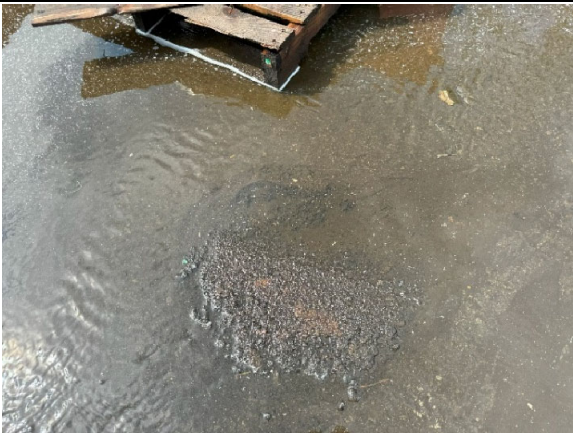
| ID <sup>1</sup> | Type of Structure | Observation | Recommended Actions | Photographs |
|---|---|---|---|---|
| P9 | Pavement | Gouge in asphalt; approximately 1 foot by 4 inches | Monitor and reevaluate during next inspection cycle | |

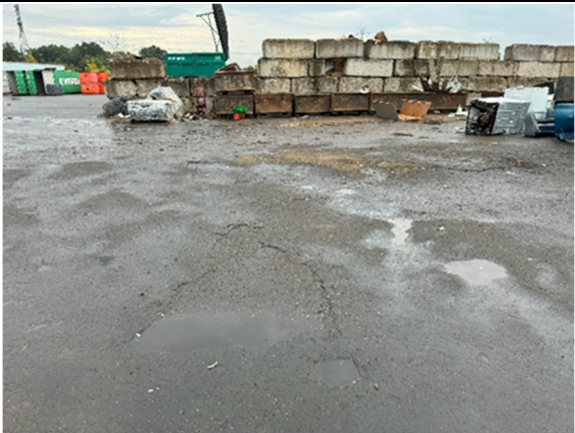
| ID <sup>1</sup> | Type of Structure | Observation | Recommended Actions | Photographs |
|---|---|---|---|---|
| P16 | Pavement | Gouges, scratches, and depressions; typical; less than 1 inch deep | Monitor for cracking and repair if observed; reevaluate during next inspection cycle | |

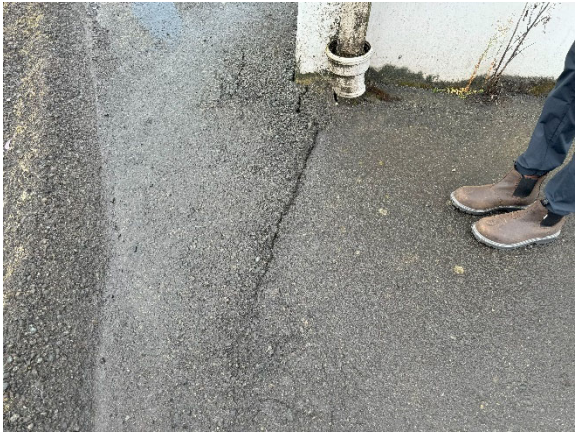
| ID <sup>1</sup> | Type of Structure | Observation | Recommended Actions | Photographs |
|---|---|---|---|---|
| P19 | Pavement | Crack wider than 1/8 inch; extends approximately 2 feet from building corner in the vicinity of the roof drain. | Seal crack | |

- Seal cracks at P19 and P26
- Remove vegetation at P23
- Monitor asphalt gouges and pavement deteriorations and reevaluate during the next inspection cycle (P5, P6, P8, P9, P12, P13, P14, P15, P16, P18, 921, P24, P25, P27, P28, and P29).

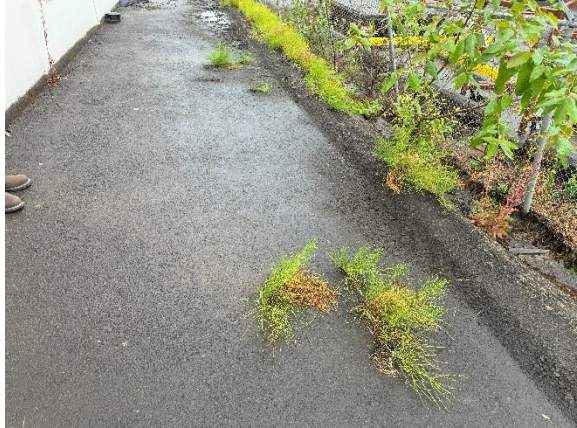
several areas of surface depressions in the asphalt believed to be caused by activity on the site. Some vegetation growing from the asphalt was observed around the northeast corner of the building (See P23 on Table 2-1).

| ID <sup>1</sup> | Type of Structure | Observation | Recommended Actions | Photographs |
|---|---|---|---|---|
| P23 | Pavement | Vegetation growth from cracks less than 1/8 inch wide | Remove vegetation; monitor and reevaluate during next inspection cycle | |

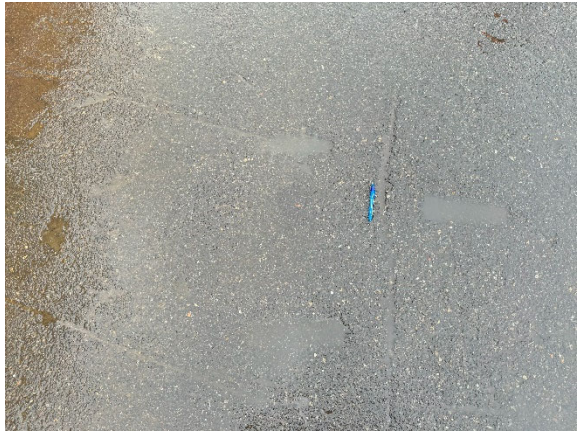
| ID <sup>1</sup> | Type of Structure | Observation | Recommended Actions | Photographs |
|---|---|---|---|---|
| P24 | Pavement | Multiple gouges in asphalt less than 1 inch deep, various lengths | Monitor and reevaluate during next inspection cycle | |

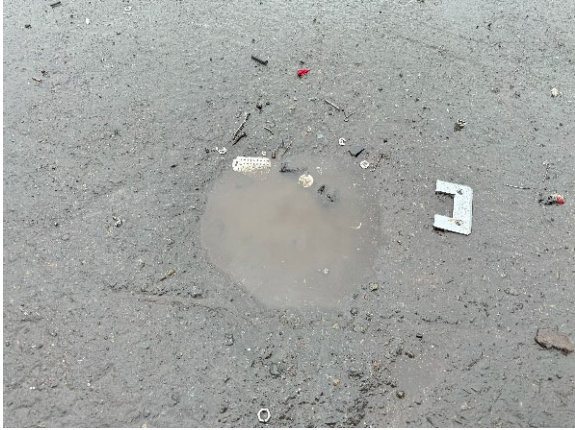
| ID <sup>1</sup> | Type of Structure | Observation | Recommended Actions | Photographs |
|---|---|---|---|---|
| P25 | Pavement | Asphalt depression approximately 1 foot wide and 1 inch deep | Monitor for cracking and repair if observed; reevaluate during next inspection cycle | |

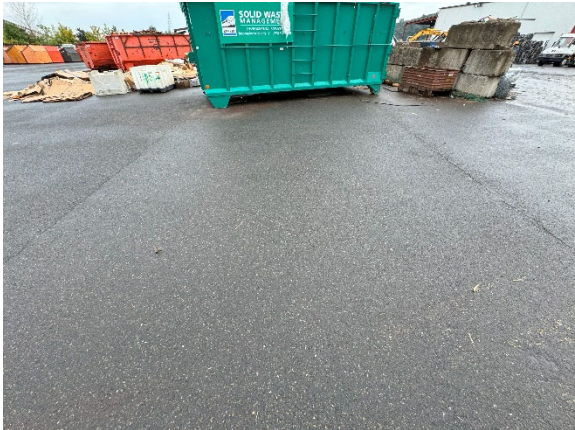
| ID <sup>1</sup> | Type of Structure | Observation | Recommended Actions | Photographs |
|---|---|---|---|---|
| P26 | Pavement | Two parallel cracks wider than 1/8 inch wide, approximately 30 feet long | Seal cracks | |

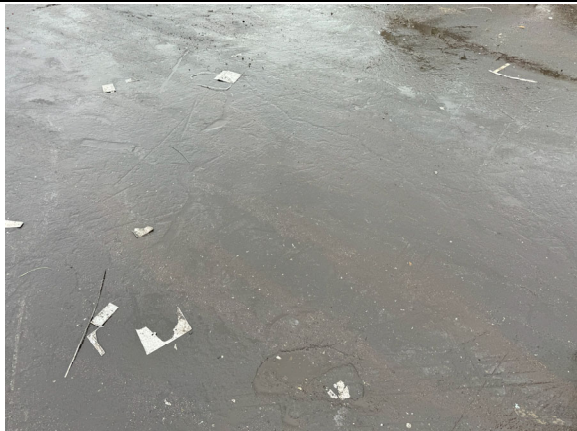
| ID <sup>1</sup> | Type of Structure | Observation | Recommended Actions | Photographs |
|---|---|---|---|---|
| P27 | Pavement | Surface depressions and gouges | Monitor and reevaluate during next inspection cycle | |

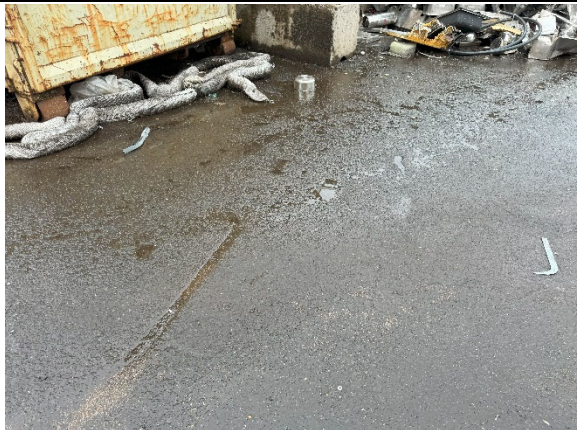
| ID <sup>1</sup> | Type of Structure | Observation | Recommended Actions | Photographs |
|---|---|---|---|---|
| P28 | Pavement | Surface depressions and gouges | Monitor and reevaluate during next inspection cycle | |

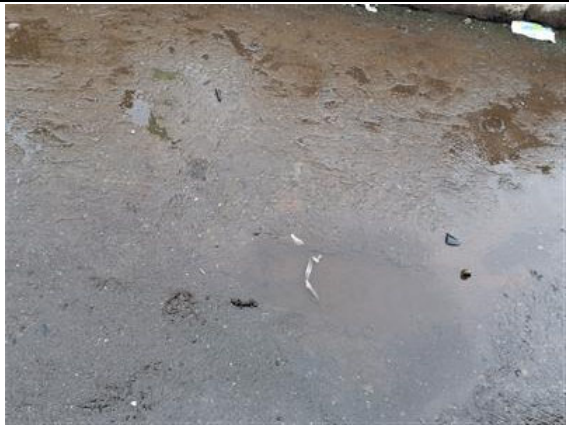
| ID <sup>1</sup> | Type of Structure | Observation | Recommended Actions | Photographs |
|---|---|---|---|---|
| P29 | Pavement | 1.5 inch deep depression; about 2 feet by 1 foot | Monitor for cracking and repair if observed; reevaluate during next inspection cycle | |

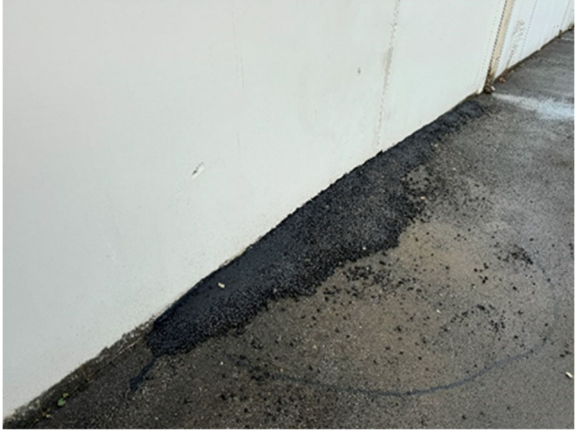
| ID <sup>1</sup> | Type of Structure | Observation | Recommended Actions | Photographs |
|---|---|---|---|---|
| P3 | Pavement | Madrone stump removed and gap patched with asphalt | None | |

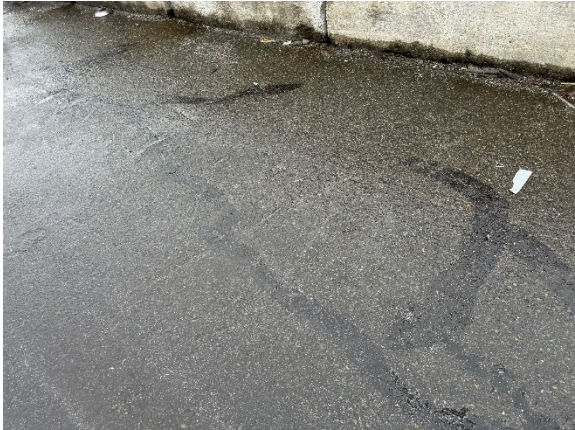
| ID <sup>1</sup> | Type of Structure | Observation | Recommended Actions | Photographs |
|---|---|---|---|---|
| P7 | Pavement | Sealed cracks; sealant in good condition | None | |

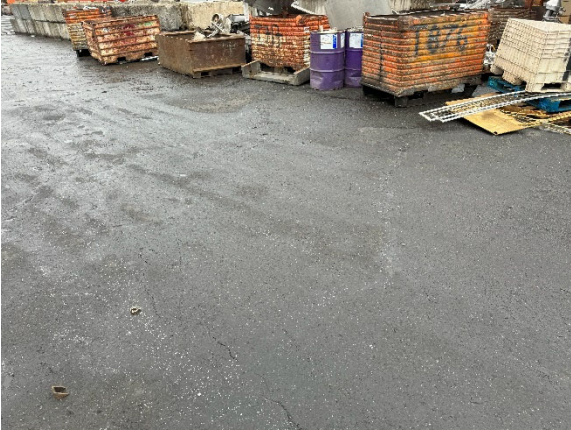
| ID <sup>1</sup> | Type of Structure | Observation | Recommended Actions | Photographs |
|---|---|---|---|---|
| P8 | Pavement | Sealed cracks; asphalt cracked in places | Reseal | |

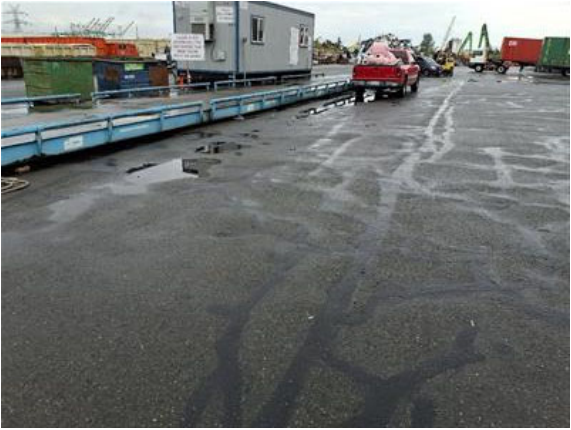
| ID <sup>1</sup> | Type of Structure | Observation | Recommended Actions | Photographs |
|---|---|---|---|---|
| P10 | Pavement | Sealed cracks; sealant in good condition | None | |

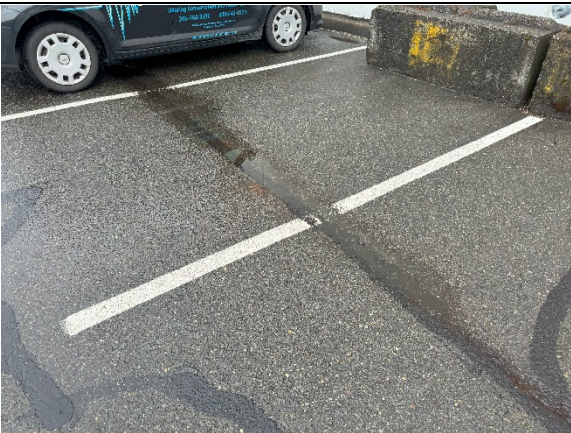
| ID <sup>1</sup> | Type of Structure | Observation | Recommended Actions | Photographs |
|---|---|---|---|---|
| P11 | Pavement | Sealed crack running parallel to building; sealant in good condition; approximately 12 lf | None | |

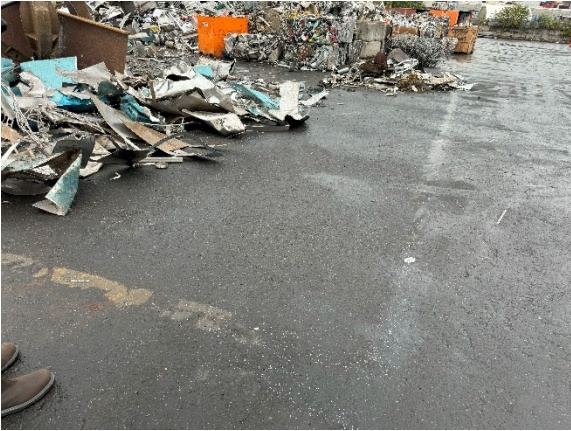
| ID <sup>1</sup> | Type of Structure | Observation | Recommended Actions | Photographs |
|---|---|---|---|---|
| P12 | Pavement | Previous asphalt repair in good condition | None | |

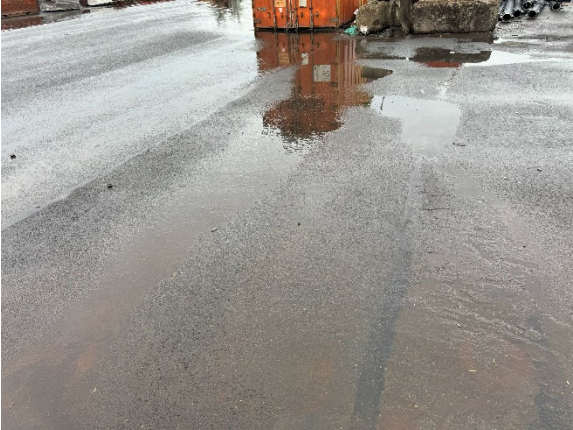
| ID <sup>1</sup> | Type of Structure | Observation | Recommended Actions | Photographs |
|---|---|---|---|---|
| P13 | Pavement | Sealed cracks; sealant in good condition | None | |

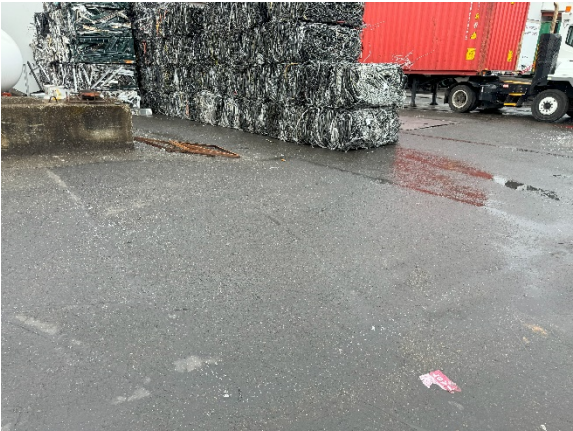
| ID <sup>1</sup> | Type of Structure | Observation | Recommended Actions | Photographs |
|---|---|---|---|---|
| P14 | Pavement | Previous asphalt repair, good condition | None | |

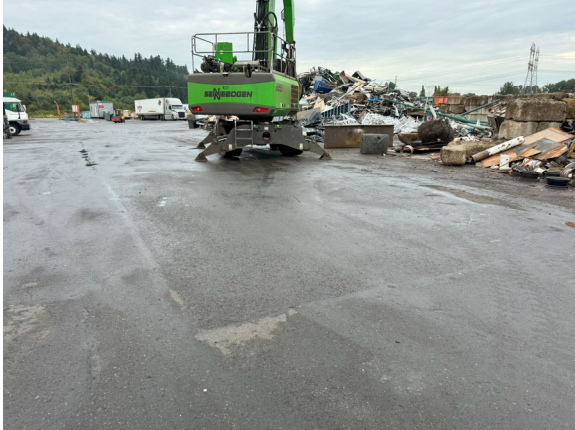
| ID <sup>1</sup> | Type of Structure | Observation | Recommended Actions | Photographs |
|---|---|---|---|---|
| P15 | Pavement | Repaired asphalt; approximately 12 lf by 15 lf | None | |

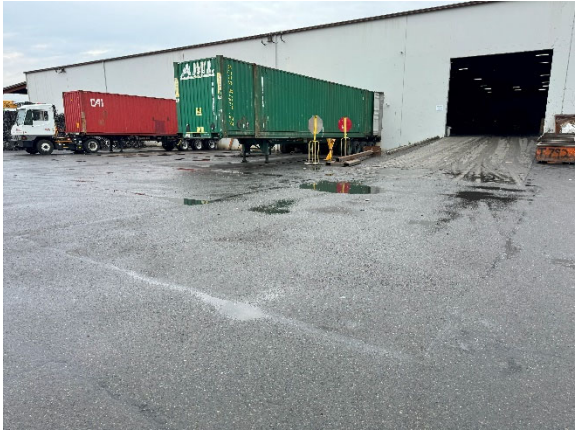
| ID <sup>1</sup> | Type of Structure | Observation | Recommended Actions | Photographs |
|---|---|---|---|---|
| P17 | Pavement | Previous asphalt repair; good condition | None | |

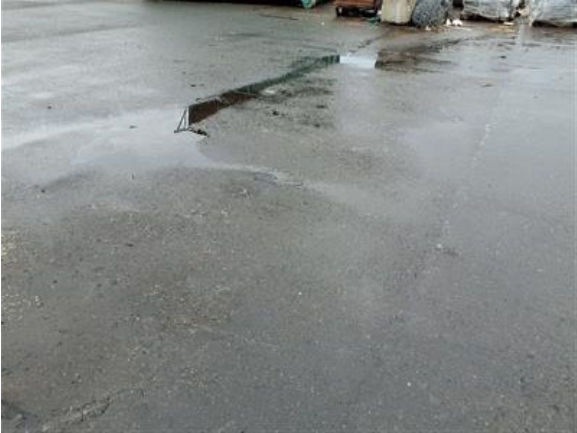
| ID <sup>1</sup> | Type of Structure | Observation | Recommended Actions | Photographs |
|---|---|---|---|---|
| P18 | Pavement | Previous asphalt repair; good condition | None | |

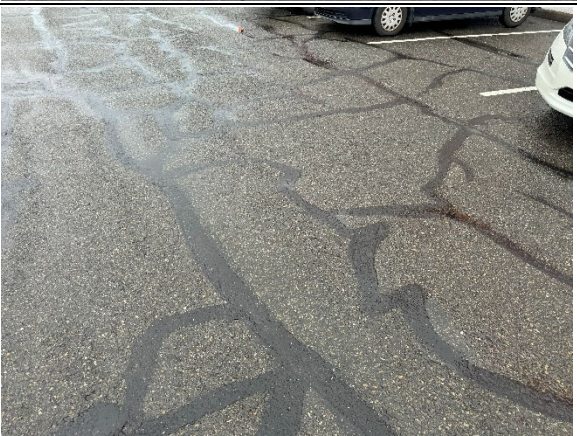
| ID <sup>1</sup> | Type of Structure | Observation | Recommended Actions | Photographs |
|---|---|---|---|---|
| P20 | Pavement | Sealed cracks; sealant in good condition | None | |

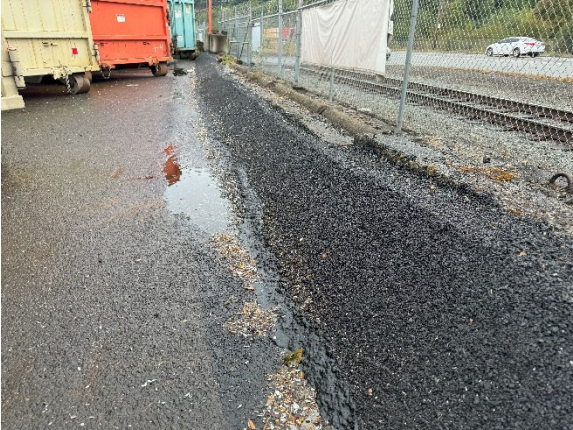
| ID <sup>1</sup> | Type of Structure | Observation | Recommended Actions | Photographs |
|---|---|---|---|---|
| P21 | Cap edge | Repaired asphalt edge, 30 lf of the southeast portion | None | |

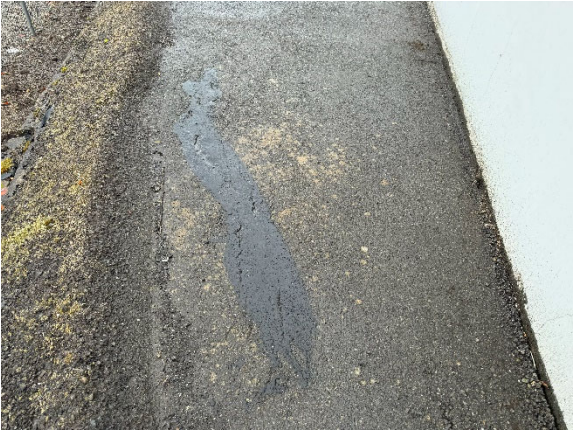
| ID <sup>1</sup> | Type of Structure | Observation | Recommended Actions | Photographs |
|---|---|---|---|---|
| P22 | Pavement | Sealed crack; approximately 4 lf; sealant in good condition | None | |

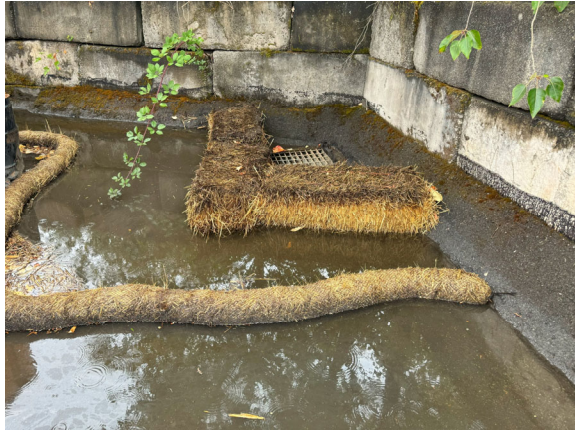
| ID | Type of Structure | Observed Condition | Sediment Accumulation | Additional Observations | Recommended Actions | Photographs |
|---|---|---|---|---|---|---|
| CB1 | Catch basin | Unable to inspect | nm | Unable to access due to rain event and ponded water | Monitor and reevaluate during next inspection | A photograph showing a catch basin (CB1) that is completely submerged in murky, brown water. The basin is surrounded by concrete walls, and some green vegetation is visible on the right side. The water level is high, preventing any inspection of the basin's interior. |

- Remove debris and sediment accumulation from around catch basins CB1, CB7, CB8, CB9, and CB10
- Determine status and condition of maintenance hole MH1

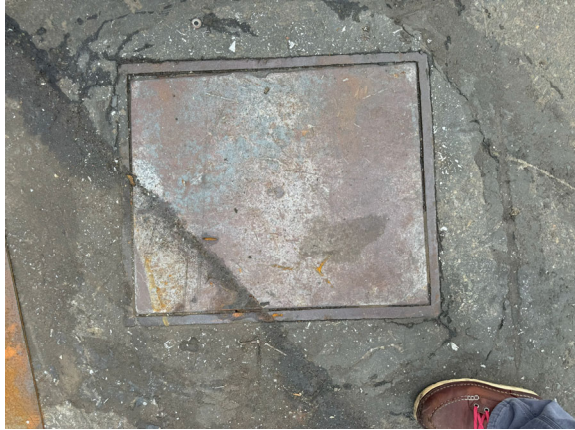
| ID | Type of Structure | Observed Condition | Sediment Accumulation | Additional Observations | Recommended Actions | Photographs |
|---|---|---|---|---|---|---|
| CB2 | Catch basin | Unable to inspect | nm | Catch basin sealed closed with metal plate/does not receive stormwater | None | A photograph of a catch basin (CB2) that is sealed closed with a large, square, rusted metal plate. The plate is set into a concrete surface. The surrounding area is dark and appears to be a paved or concrete surface. A person's foot is visible in the bottom right corner, providing a sense of scale. |

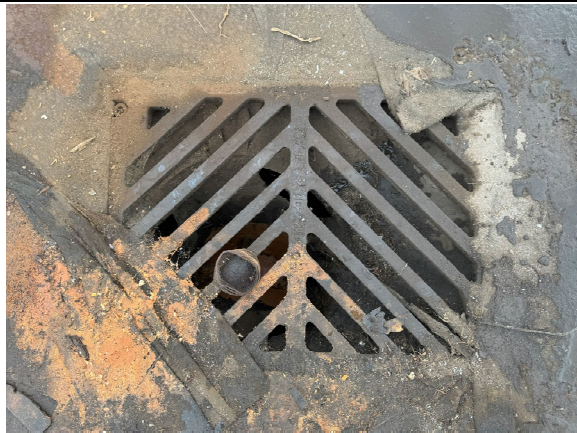
| ID | Type of Structure | Observed Condition | Sediment Accumulation | Additional Observations | Recommended Actions | Photographs |
|---|---|---|---|---|---|---|
| CB3 | Catch basin | Unable to inspect interior of structure due to tight fit of grate | Sediment and debris accumulation visible in insert | Damaged insert. Prior to inspection, structure was covered by steel plate to protect structure from heavy equipment used in the vicinity | Replace insert; clean structure in accordance with stormwater maintenance requirements. Consider permanently sealing structure, similar to CB2 | |

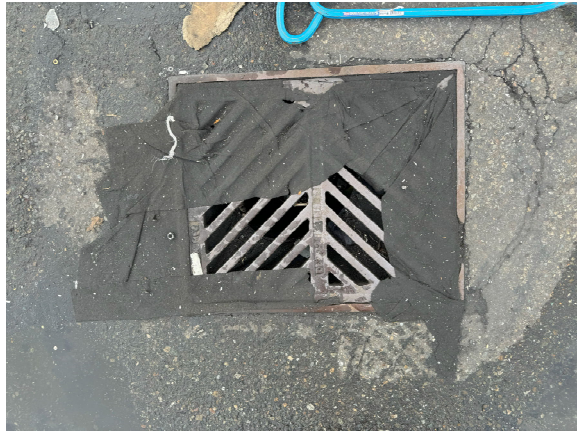
| ID | Type of Structure | Observed Condition | Sediment Accumulation | Additional Observations | Recommended Actions | Photographs |
|---|---|---|---|---|---|---|
| CB4 | Catch basin | Unable to inspect due to integrity of insert | Sediment and debris accumulation visible in insert | Damaged insert | Replace insert; clean structure in accordance with stormwater maintenance requirements | |

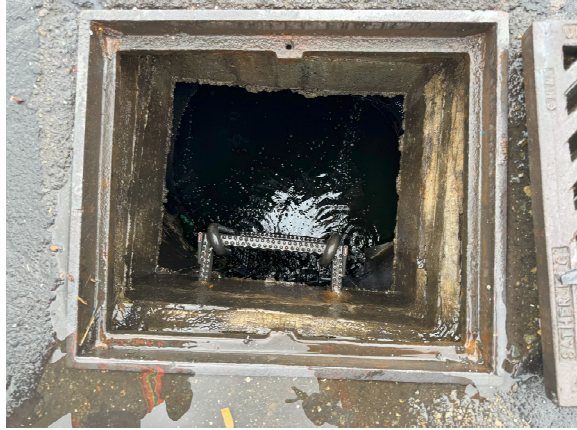
| ID | Type of Structure | Observed Condition | Sediment Accumulation | Additional Observations | Recommended Actions | Photographs |
|---|---|---|---|---|---|---|
| CB5 | Catch basin | Structurally sound, functioning normally. | Water in structure and too deep to measure | No insert, trace floatables on surface | Replace insert; remove floatables in accordance with stormwater maintenance requirements | |

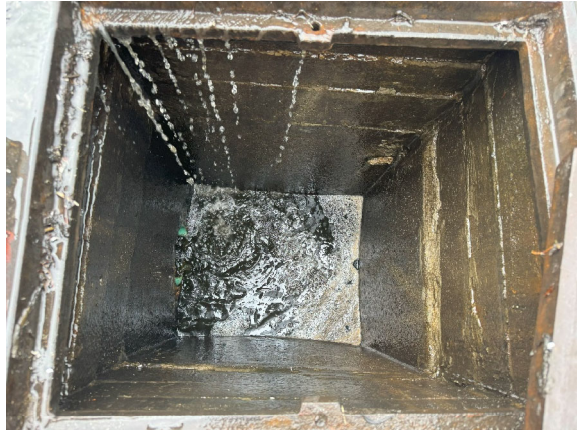
| ID | Type of Structure | Observed Condition | Sediment Accumulation | Additional Observations | Recommended Actions | Photographs |
|---|---|---|---|---|---|---|
| CB6 | Catch basin | Structurally sound, functioning normally. | Water in structure and too deep to measure | No insert; floatables and sheen on surface | Replace insert; remove floatables in accordance with stormwater maintenance requirements | |

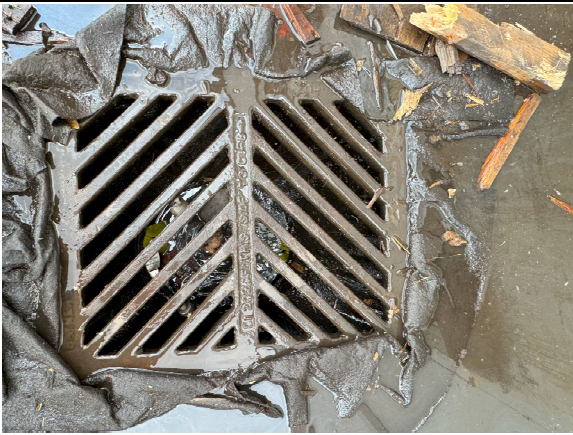
| ID | Type of Structure | Observed Condition | Sediment Accumulation | Additional Observations | Recommended Actions | Photographs |
|---|---|---|---|---|---|---|
| CB7 | Catch basin | Unable to inspect | Sediment and debris accumulation around structure | Damaged insert; | Clean structure in accordance with stormwater maintenance requirements; replace insert | |
