# Environmental Cap and Drainage System Inspection Report

Former Wasser Winters Log Sort Yard  
(Ecology Facility ID #1218)

October 31, 2024

Project No. M0615.23.002

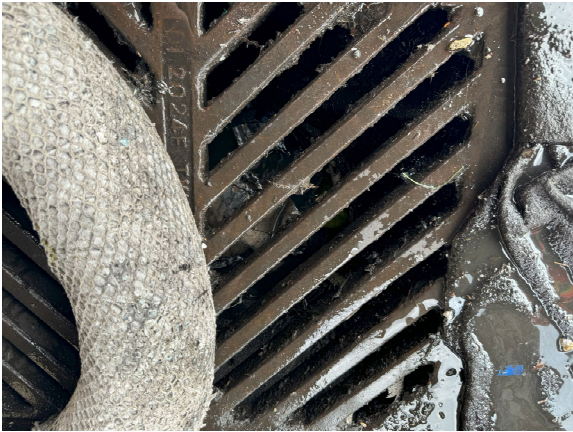
| ID | Type of Structure | Observed Condition | Sediment Accumulation | Additional Observations | Recommended Actions | Photographs |
|---|---|---|---|---|---|---|
| CB8 | Catch basin | Unable to inspect | Sediment accumulation around structure | Damaged insert; trash and debris around structure | Clean structure in accordance with stormwater maintenance requirements; replace insert | |

- Remove debris and sediment accumulation from around catch basins CB1, CB7, CB8, CB9, and CB10
- Determine status and condition of maintenance hole MH1

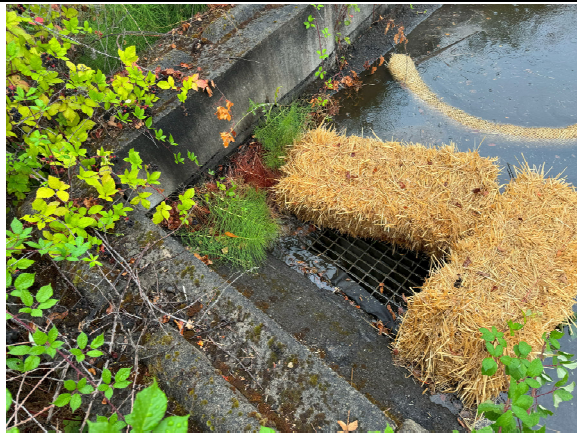
| ID | Type of Structure | Observed Condition | Sediment Accumulation | Additional Observations | Recommended Actions | Photographs |
|---|---|---|---|---|---|---|
| CB9 | Catch basin | Unable to inspect | nm | Straw barrels and waddles surround structure | Monitor and reevaluate during next inspection cycle | |

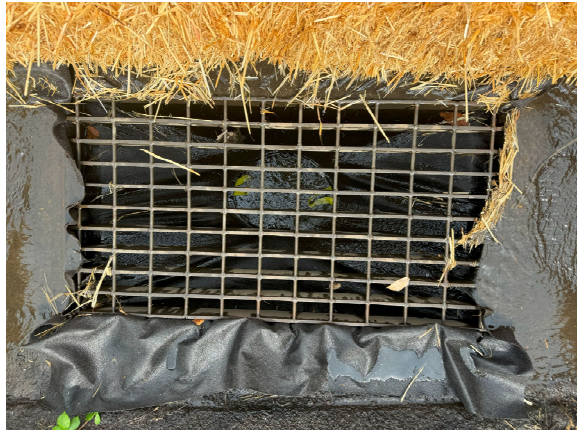
| ID | Type of Structure | Observed Condition | Sediment Accumulation | Additional Observations | Recommended Actions | Photographs |
|---|---|---|---|---|---|---|
| CB10 | Catch basin | Unable to inspect | nm | Debris and sediment accumulation around structure | Monitor and reevaluate during next inspection cycle | |

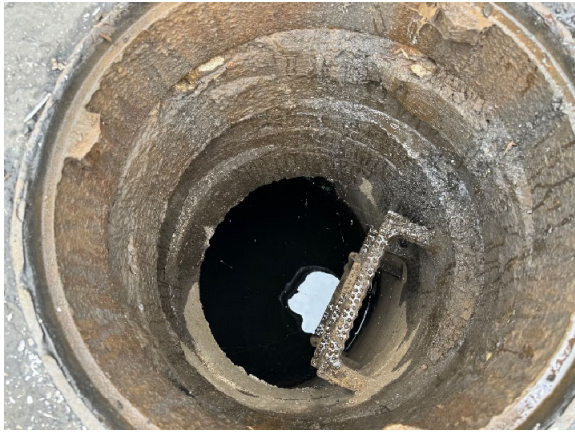
| ID | Type of Structure | Observed Condition | Sediment Accumulation | Additional Observations | Recommended Actions | Photographs |
|---|---|---|---|---|---|---|
| MH2 | Maintenance hole | Structurally sound; functioning normally | Water in structure and too deep to measure | None | None | |

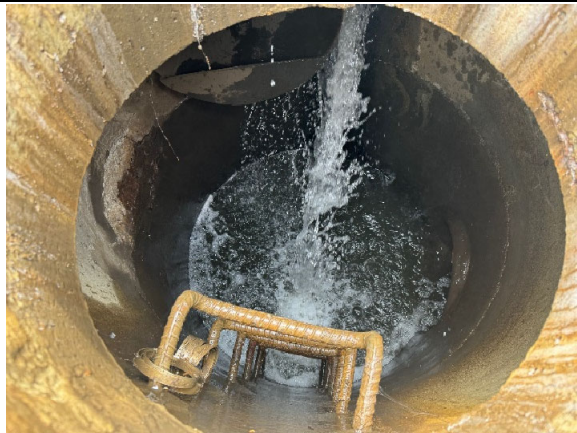
| ID | Type of Structure | Observed Condition | Sediment Accumulation | Additional Observations | Recommended Actions | Photographs |
|---|---|---|---|---|---|---|
| MH3 | Maintenance hole | Structurally sound; functioning normally | Water in structure and too deep to measure | None | None | |

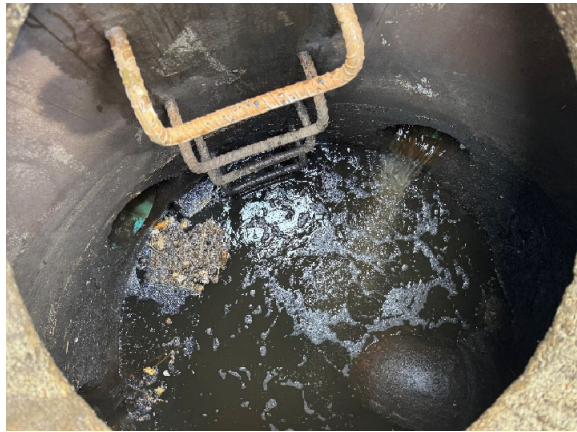
| ID | Type of Structure | Observed Condition | Sediment Accumulation | Additional Observations | Recommended Actions | Photographs |
|---|---|---|---|---|---|---|
| MH4 | Maintenance hole | Structurally sound; functioning normally | Water in structure and too deep to measure | Floatables on surface | Remove floatables in accordance with stormwater maintenance requirements | |

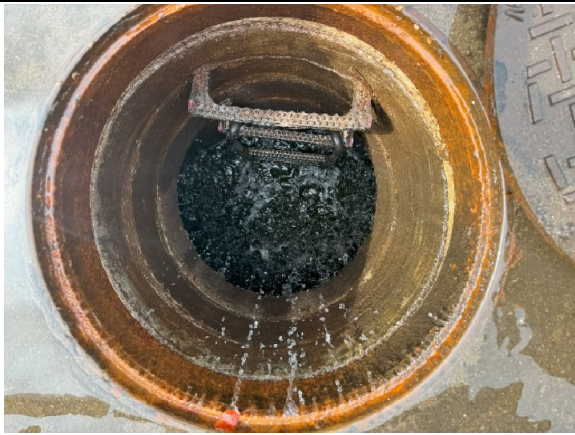
| ID | Type of Structure | Observed Condition | Sediment Accumulation | Additional Observations | Recommended Actions | Photographs |
|---|---|---|---|---|---|---|
| MH5 | Maintenance hole | Structurally sound; functioning normally | Water in structure and too deep to measure | None | None | |

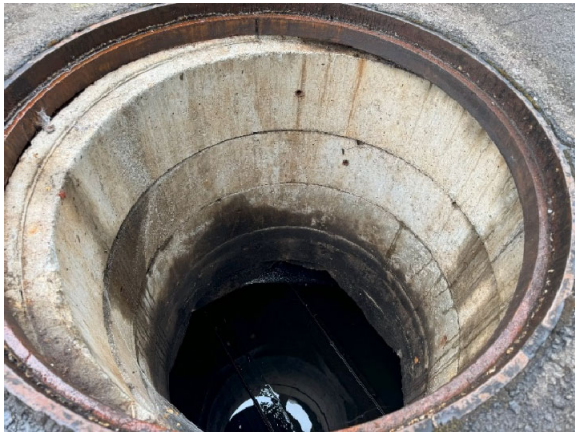
| ID | Type of Structure | Observed Condition | Sediment Accumulation | Additional Observations | Recommended Actions | Photographs |
|---|---|---|---|---|---|---|
| OW1 | Oil/water separator | Structurally sound; functioning normally | Water in structure and too deep to measure | None | None | |

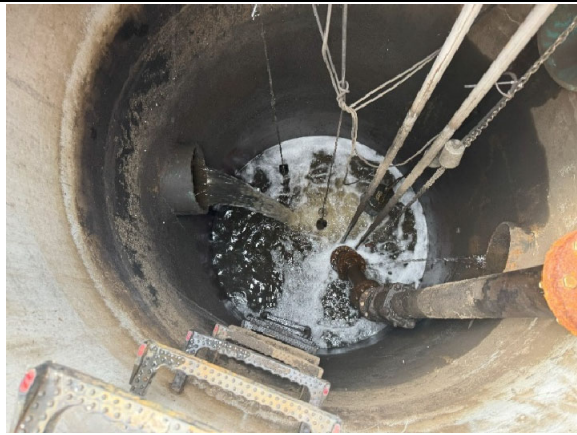
| ID | Type of Structure | Observed Condition | Sediment Accumulation | Additional Observations | Recommended Actions | Photographs |
|---|---|---|---|---|---|---|
| PS | Pump station | Structurally sound;<br>functioning normally | Water in structure and too deep to measure | None | None | |
