STATE OF WASHINGTON
DEPARTMENT OF ECOLOGY

Re: Stormwater Management at the City of Walla Walla Post Office and 106 N 2nd Ave Buildings:

- **Site Name:** Chevron Stillwater Holdings
- **Site Address:** 7 East Rose Street, WA 99362
- **Cleanup Site ID:** 16913
- **Facility/Site ID:** 70525886

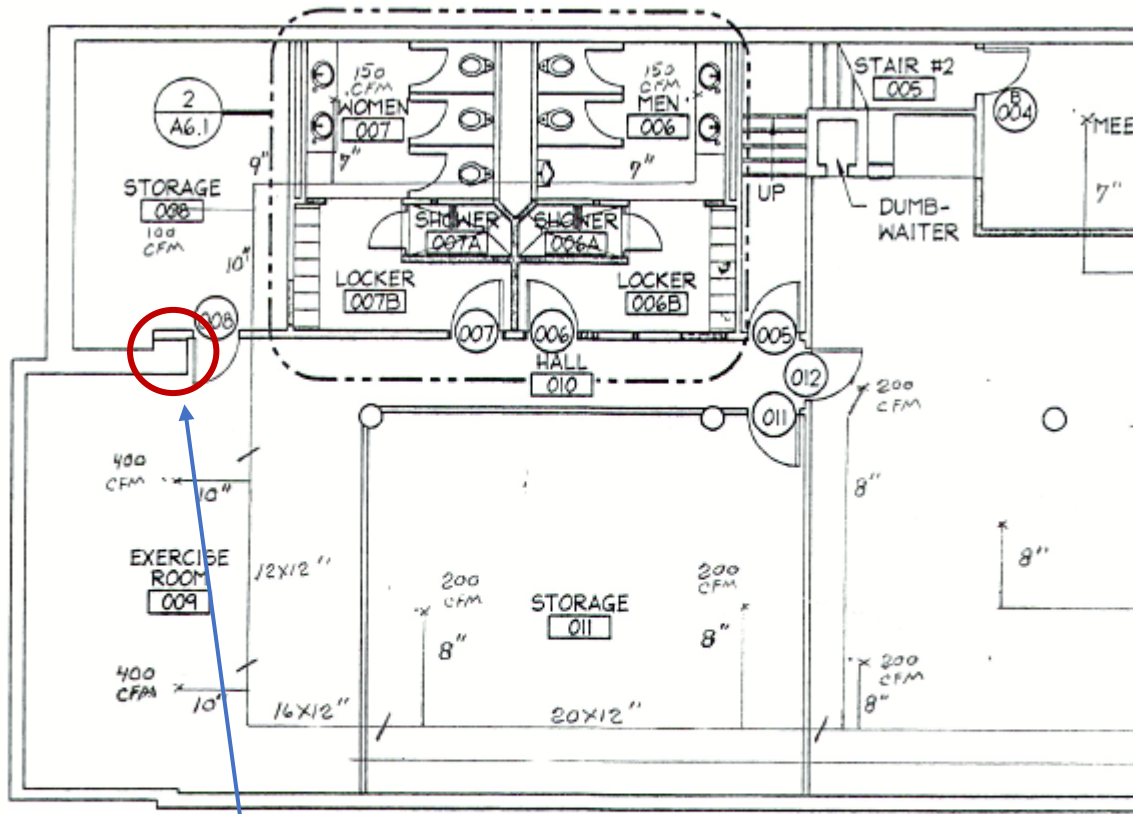
Pipe Duct from 1998 Renovation Drawings, Basement

Pipe duct that in 1965 carried sewer and roof stormwater. Whether it is a single or dual sanitary/stormwater sewer system is unknown

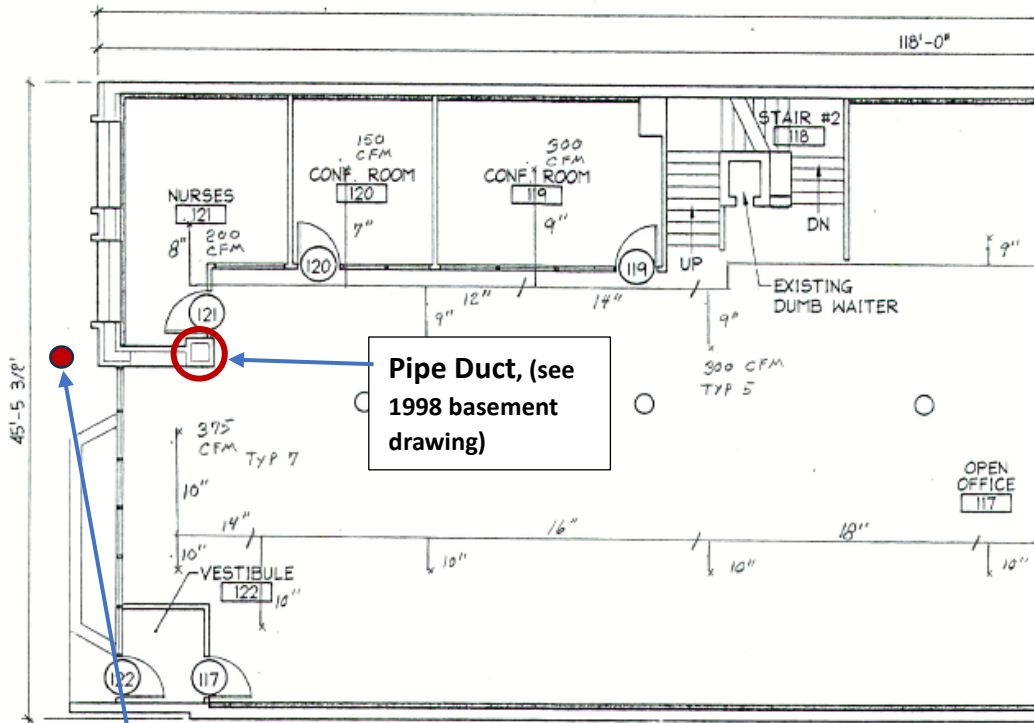
Pipe Duct from 1998 Renovation Drawings

Sewer line cleanout in sidewalk from which the City conducted the video camera survey

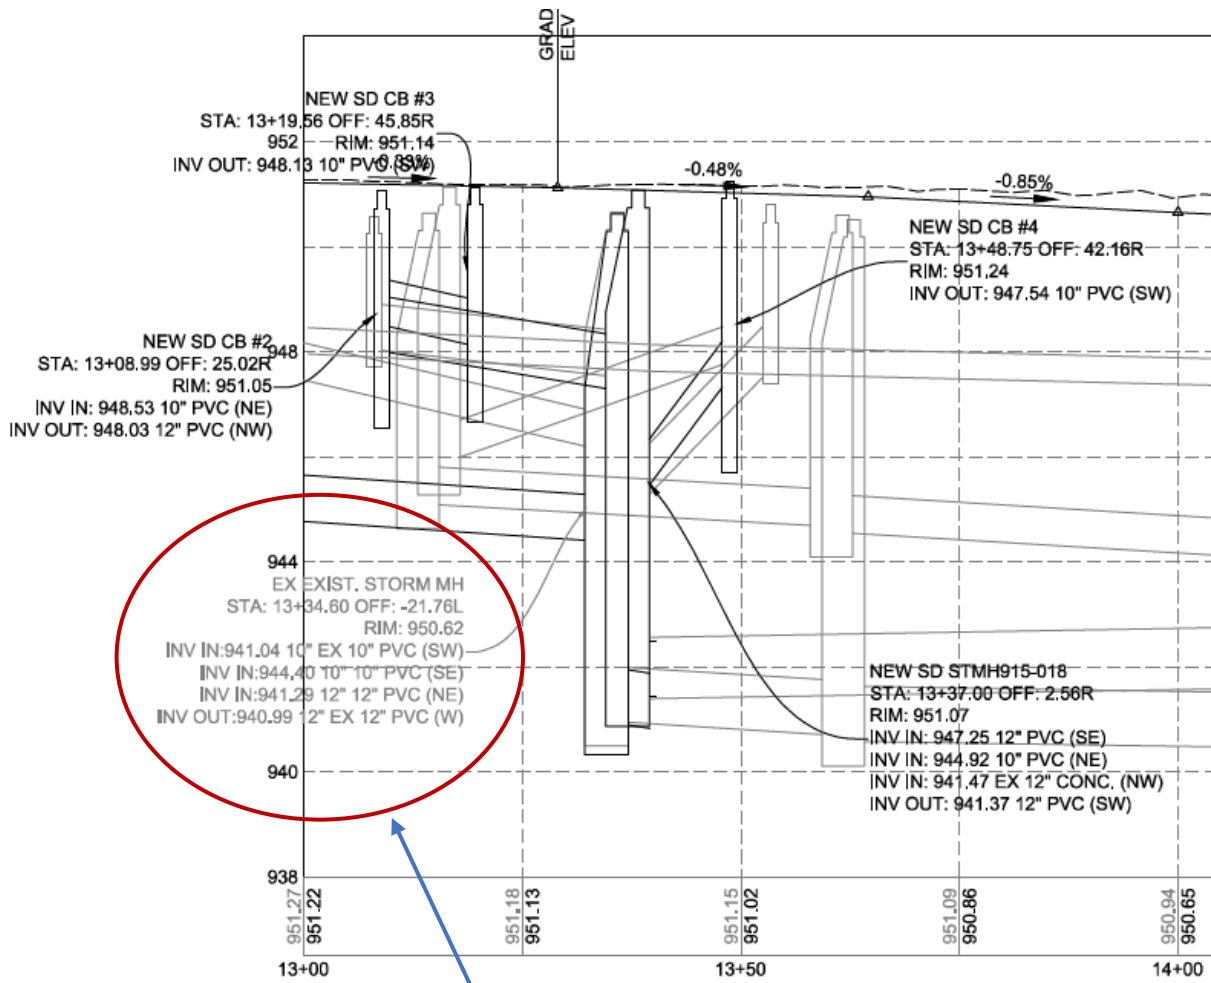
Cross Section Manholes 2019 work on 2ns Ave-Sumach Str Intersection

What happened to the pipes leading into this stormwater manhole?
