APRIL 2024

2023 Land Use Controls Inspection Report

Naval Air Station Whidbey Island, Oak Harbor, Washington

**Department of the Navy
Naval Facilities Engineering Systems Command Northwest**

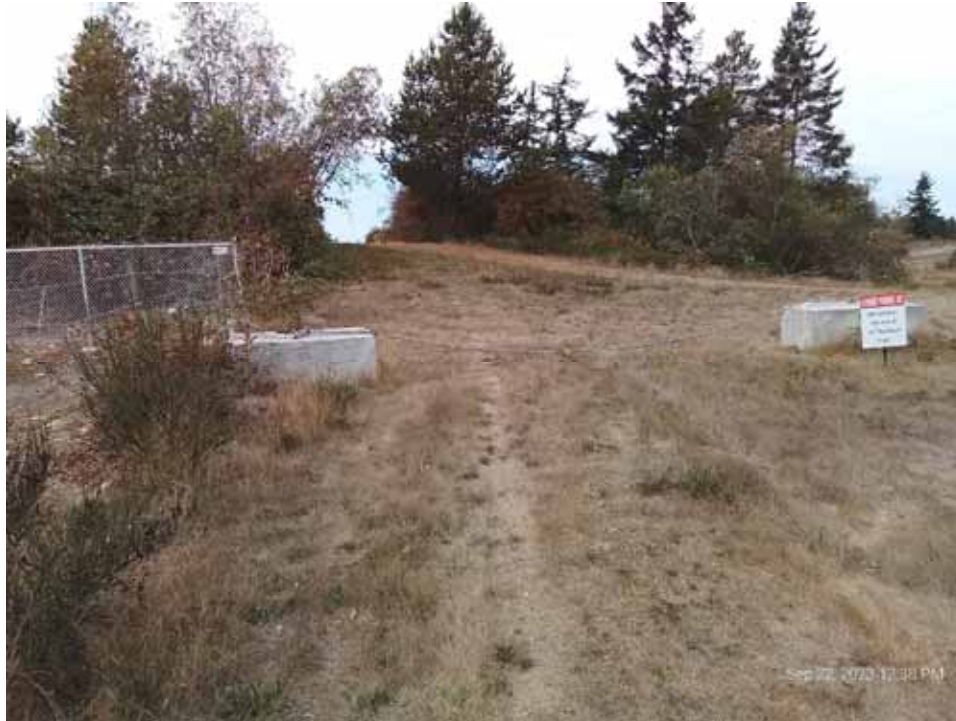
B10: Site overview
southeast corner of site,
adjacent to MW-3B,
and repaired gate

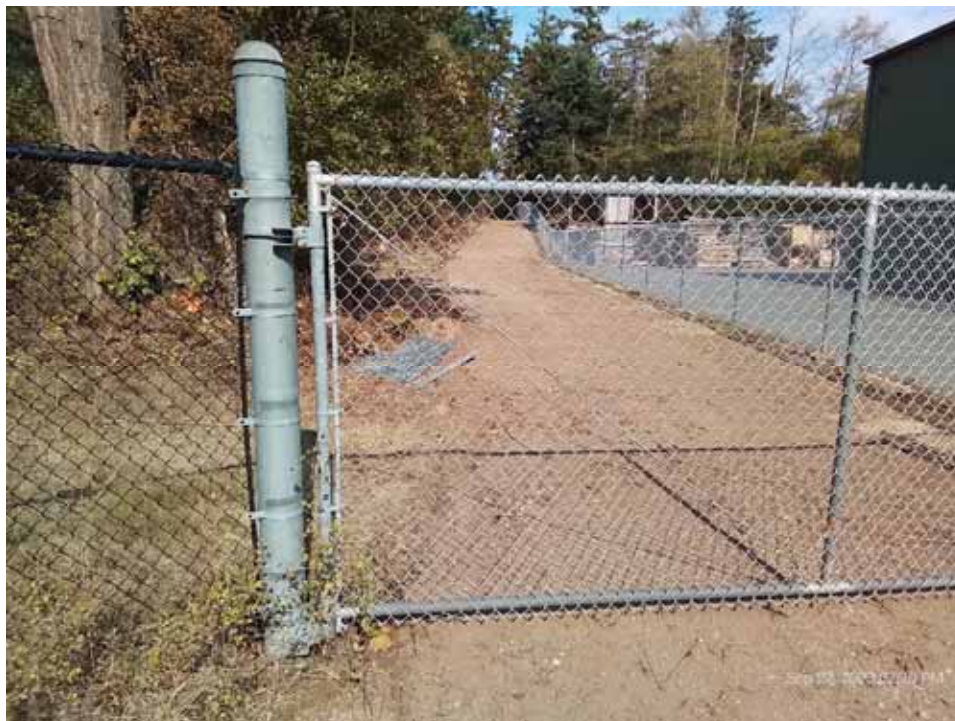
B89: Damaged section of fencing

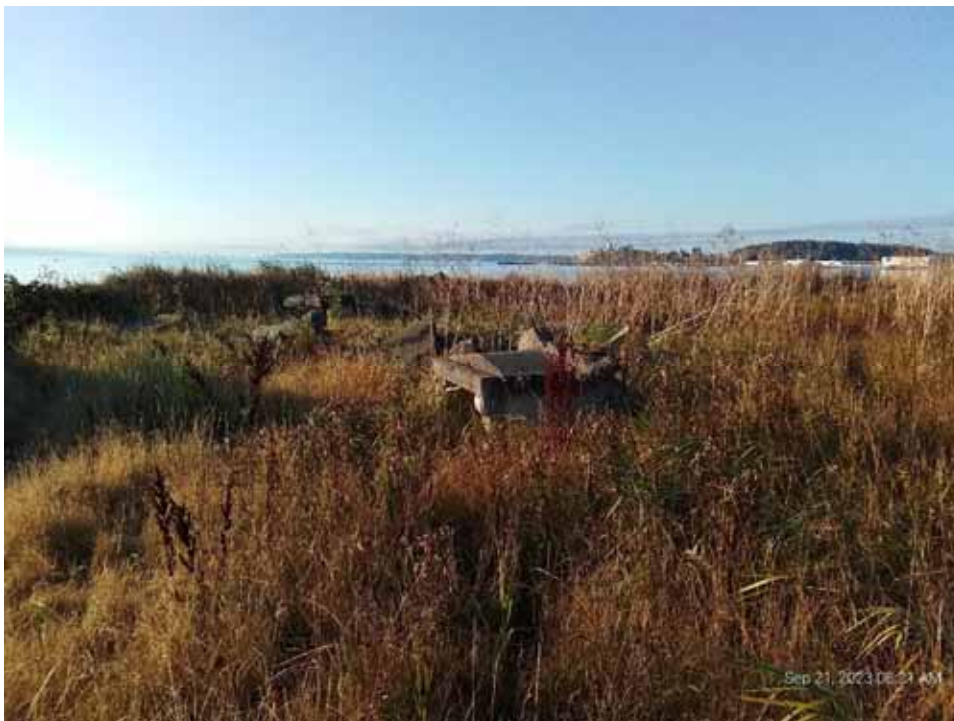
H19: Degraded foam
encased in metal

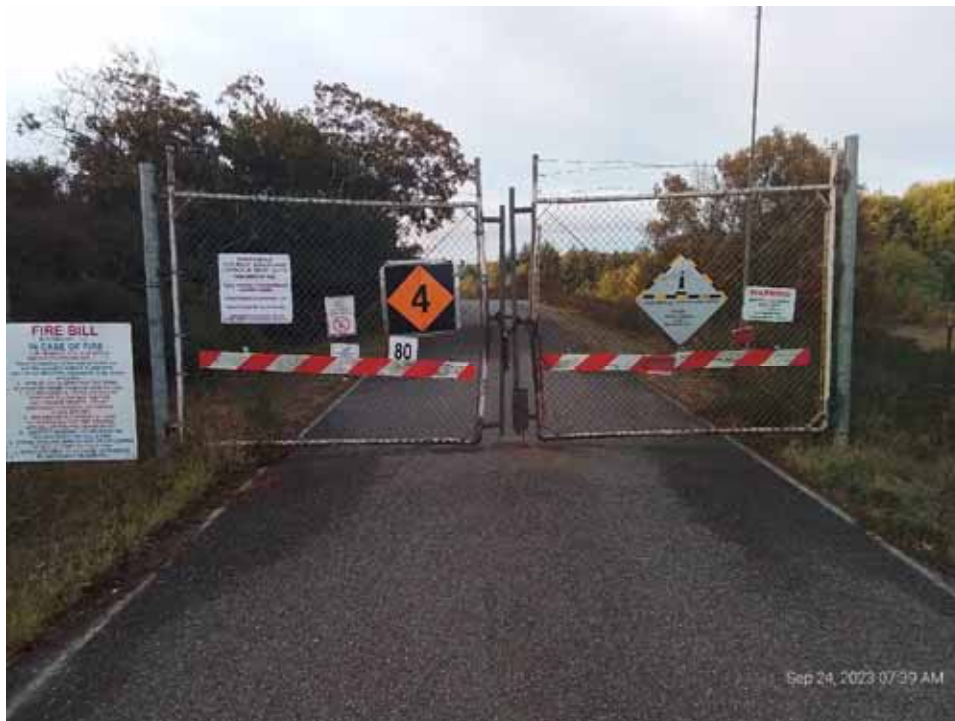
M17: Damaged
signage, west side of
site

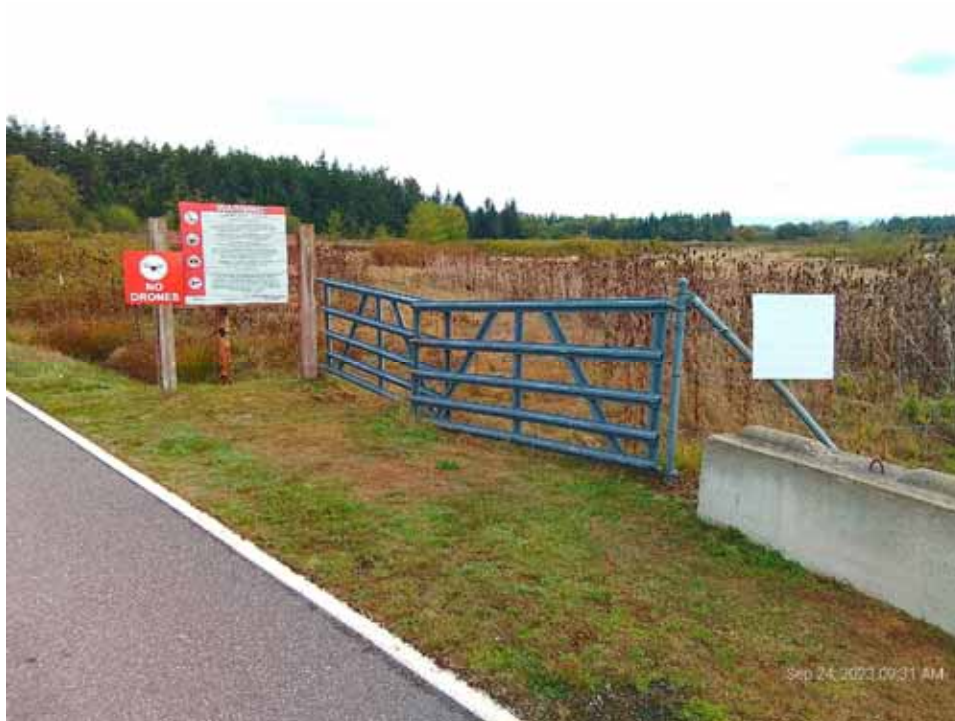
N10: Damaged
signage, southeast
corner of site

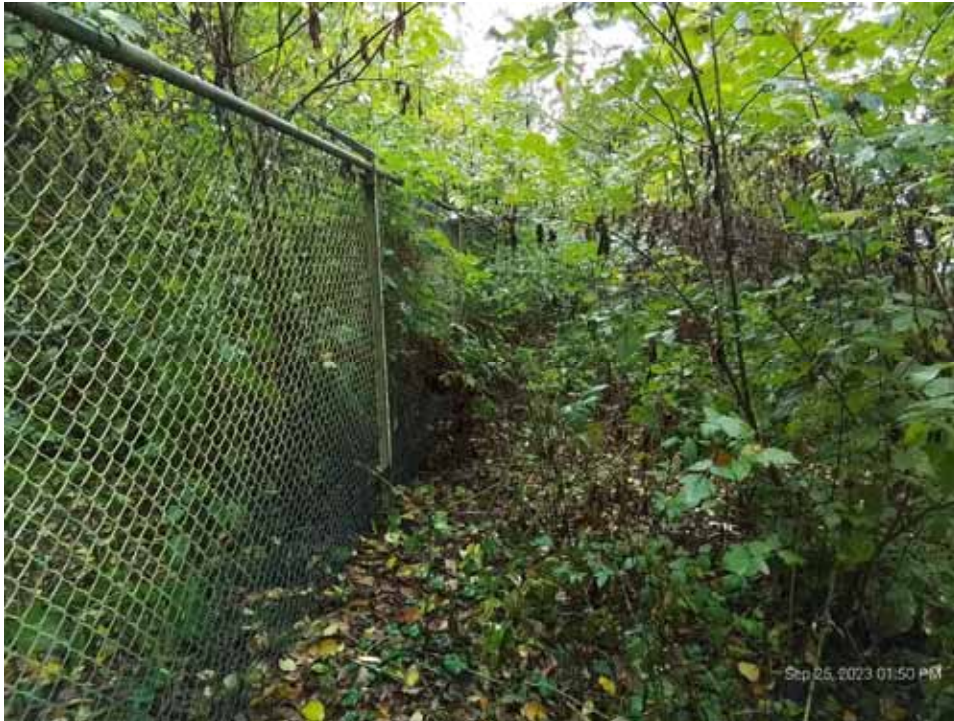
N16: Damaged fence
on northern portion of
site facing east

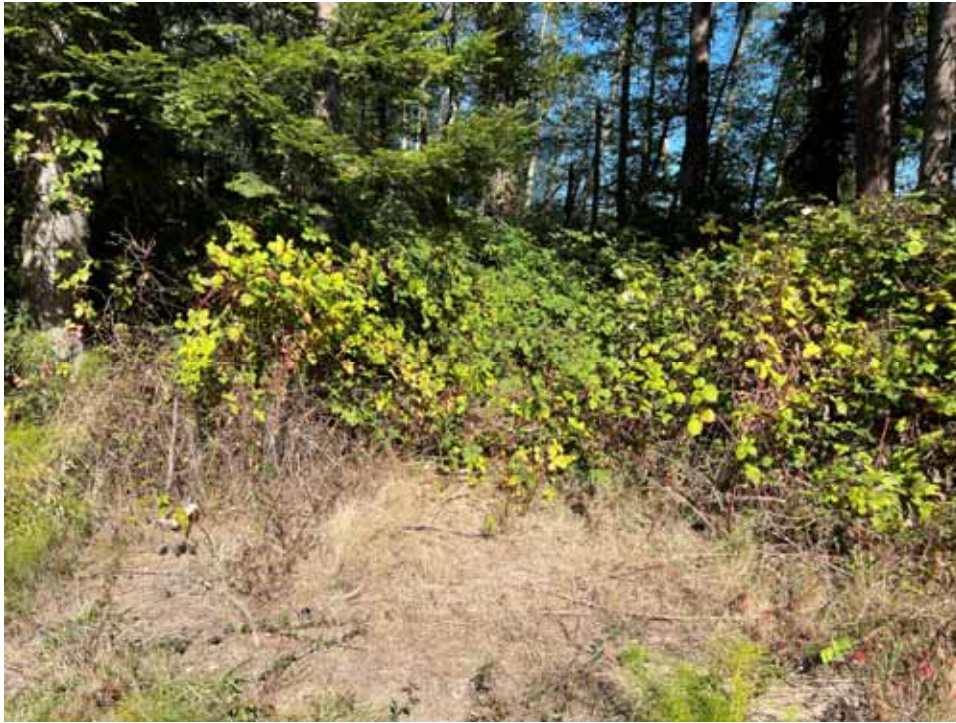
O2: Northwestern site
overview and missing
signage, facing north

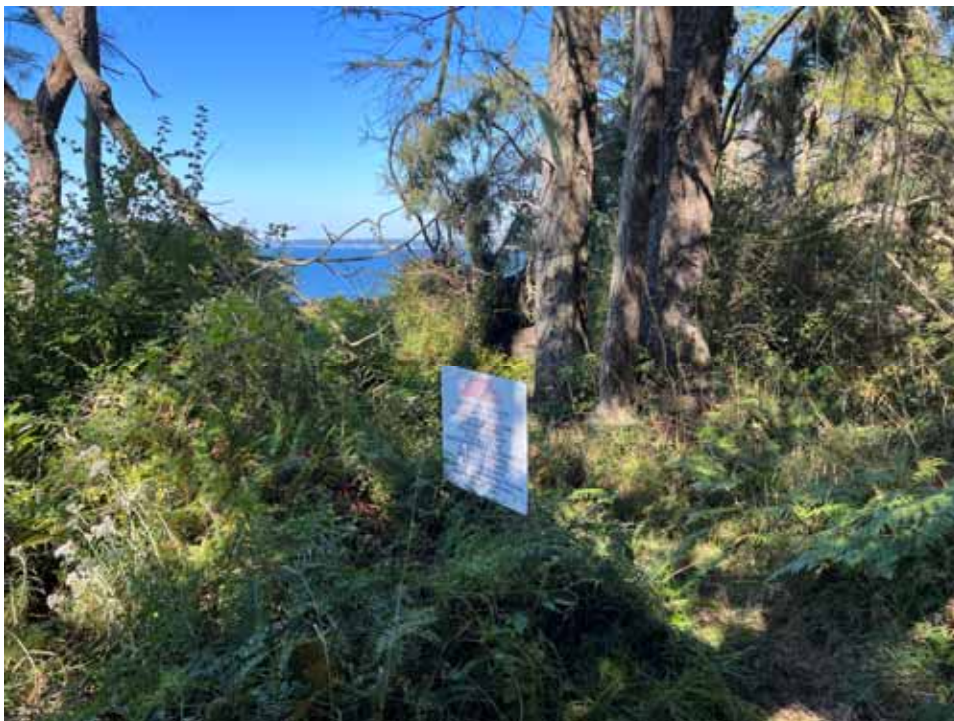
O29: Damaged signage
on central beachfront,
facing southeast

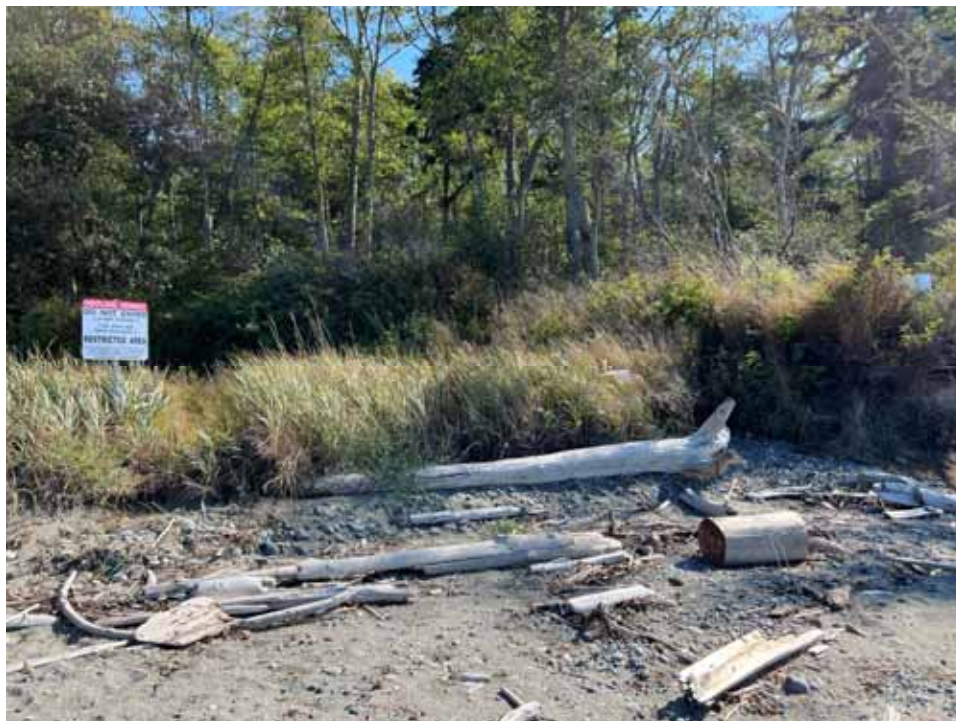
O31: Repaired fence
signage and downed
tree in southwest corner
facing northwest

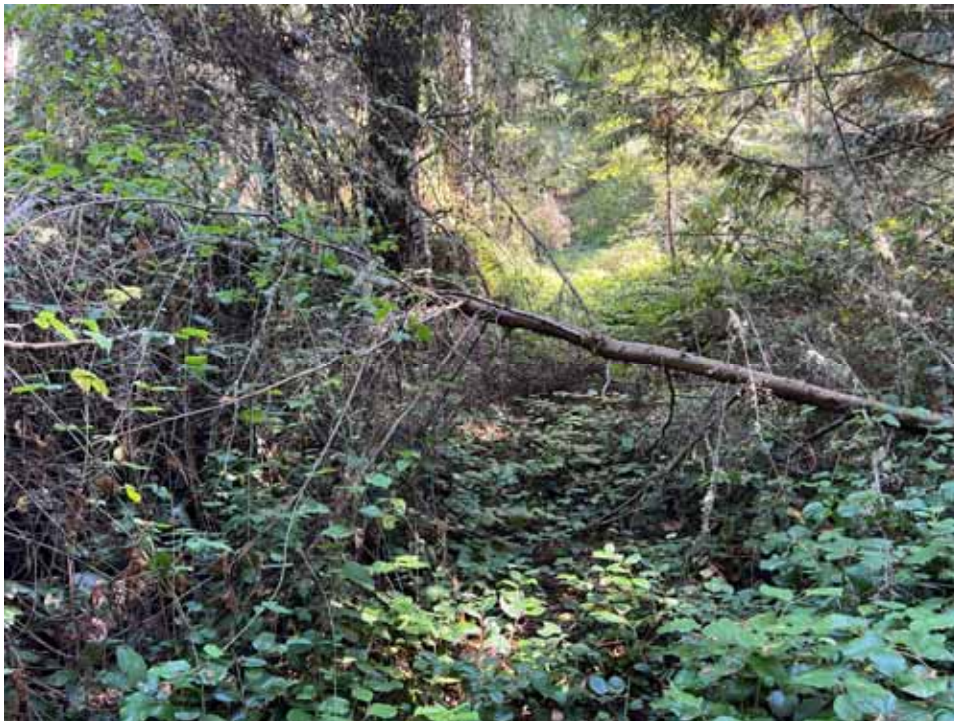
O45: Downed tree and
damaged fencing on
northeast portion of site

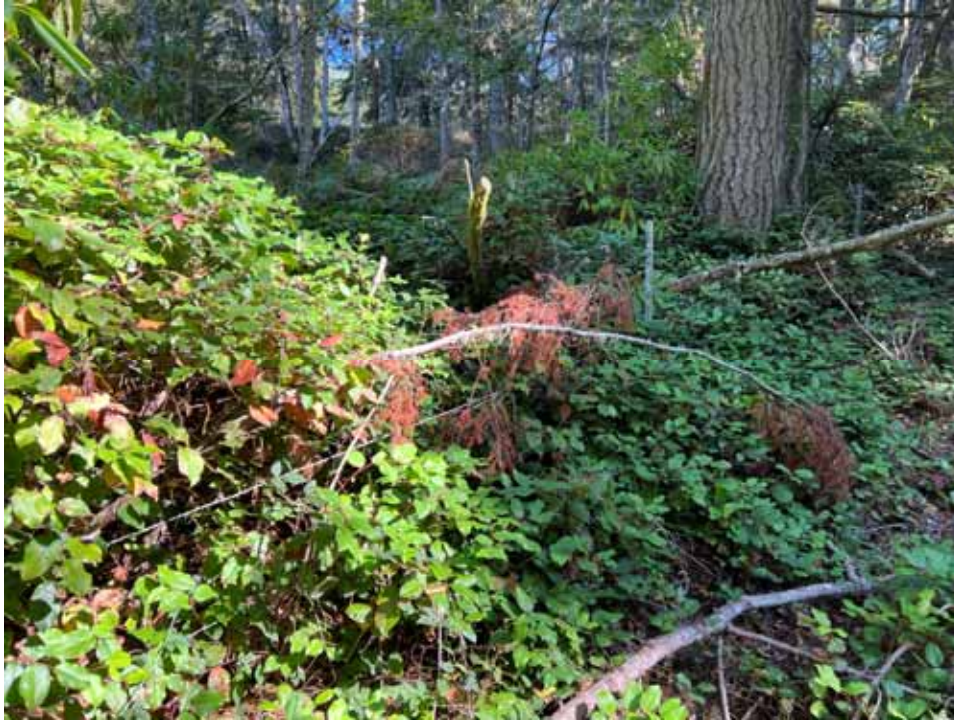
O46: Small tree fall on
fence along northern
boundary facing east

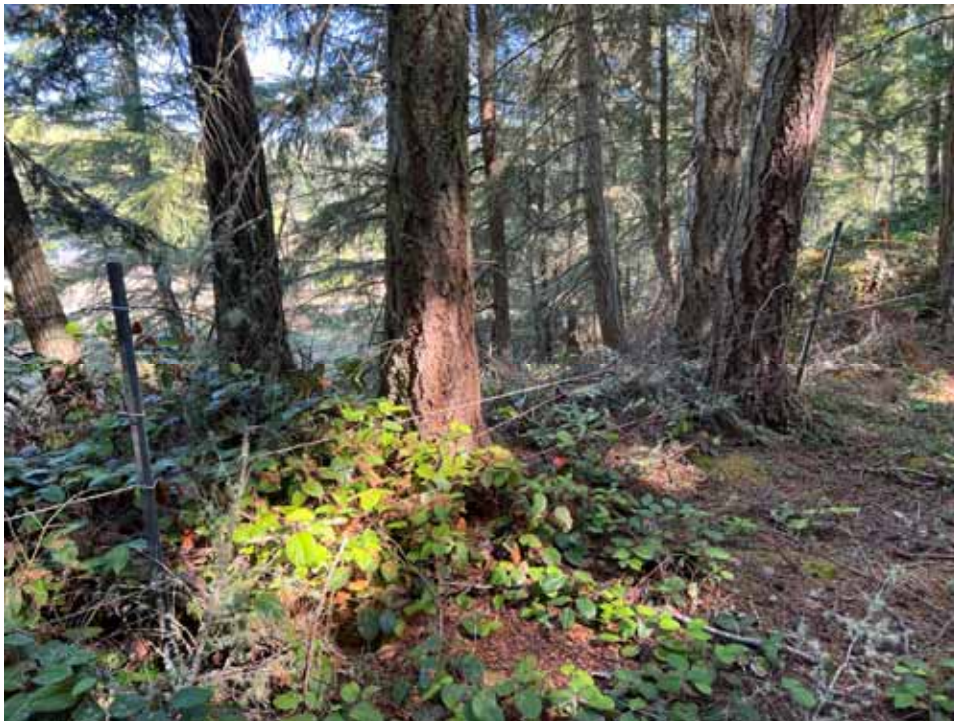
O47: Damaged fencing
along northern
boundary facing
northeast

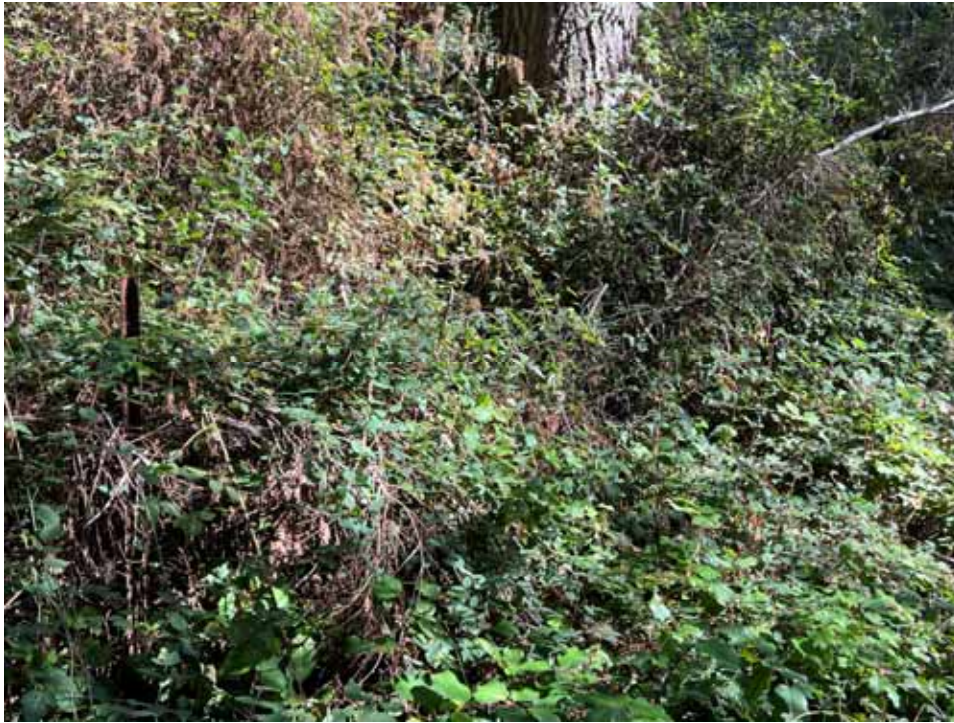
O48: Damaged fence
along northern
boundary facing
northeast

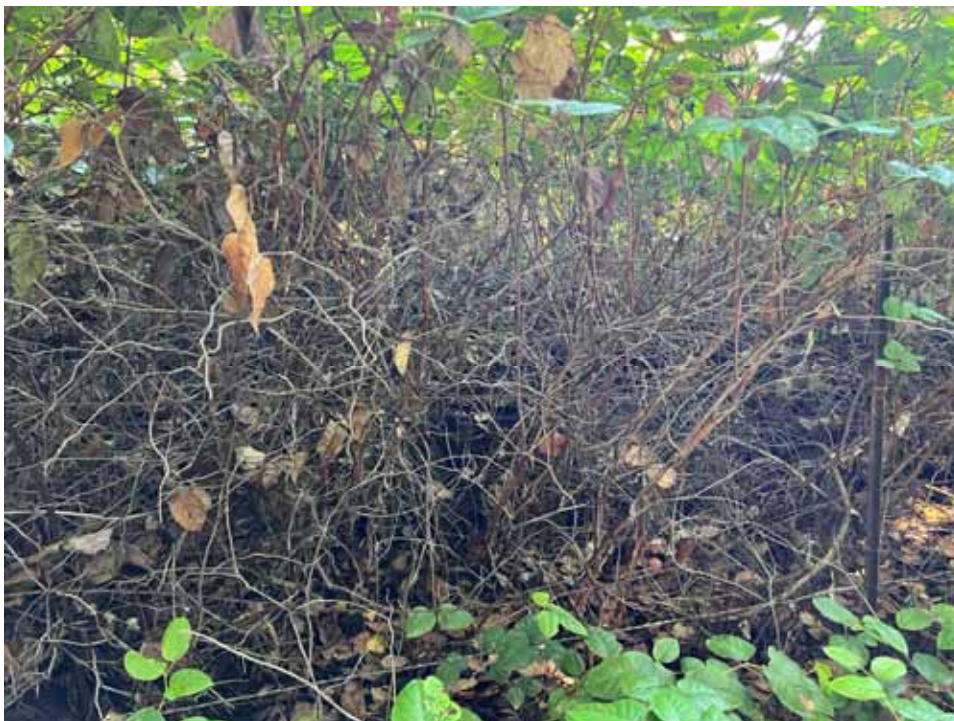
O49: Damaged fence
northeast side of site
facing northeast

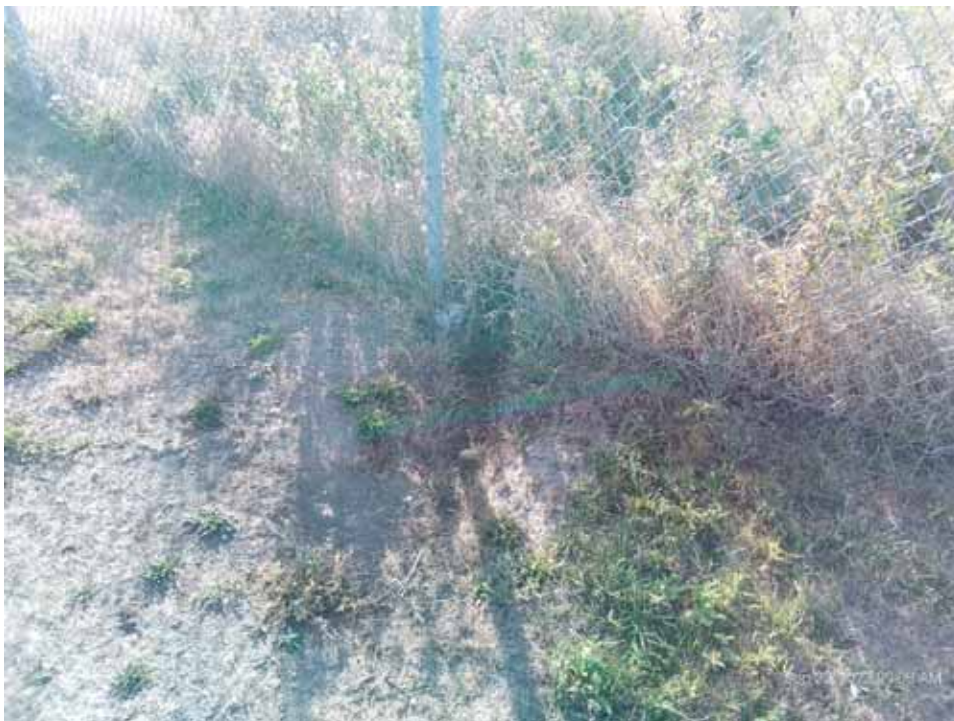
P55: Surface fissure facing east
