STATE OF WASHINGTON
DEPARTMENT OF ECOLOGY

Re: Sediments Data Gap at the Albert-Jensen site:

Site Name: Albert Jensen & Sons
Site Address: 1293 Turn Point Road, Friday Harbor, 98250, San Juan County
Cleanup Site ID: 14759
Facility Site ID: 42226979
Agreed Order No. DE 18071

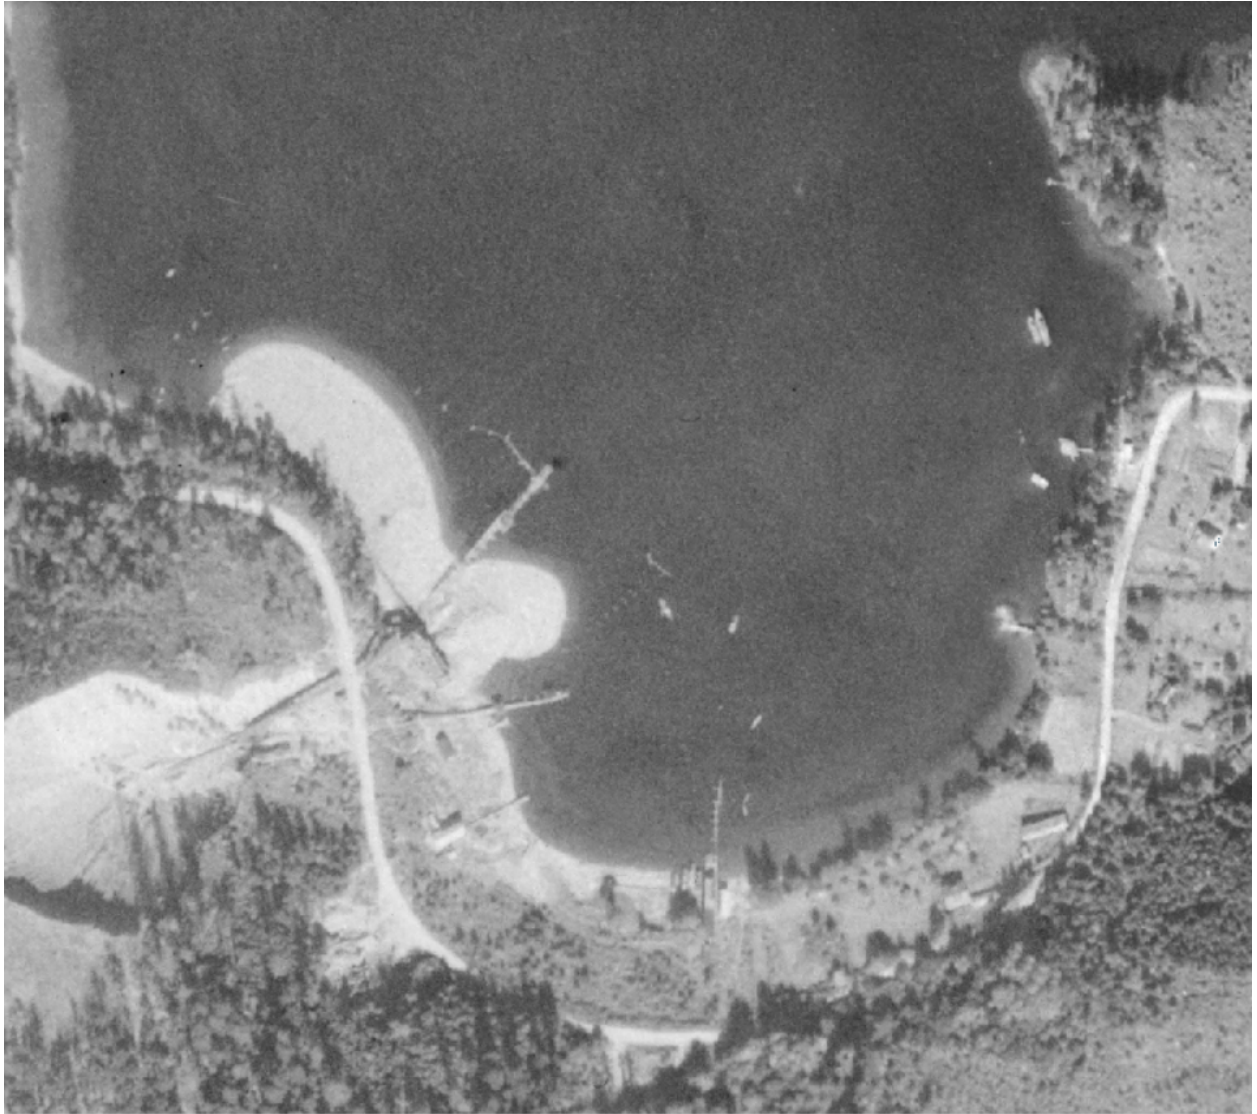
Figure 1. 1932 Aerial photo of the Albert-Jensen site

For the SRWA, a few lines of evidence call for the need to better characterize potential sediment contamination. First, the period that boat building and maintenance operations at that portion of the property are quite long, which as noted on page 3-1 of the Remedial Investigation Work Plan (RIWP) dated 7/2022 have been ongoing since at least 1910. Photographic evidence from 1932 (Figure 1, attached) shows a dock and boat-works at the same location. An aerial photograph dated 1977 (Figure 2) shows a much more extensive building footprint taking up all the SRWA area. Historical photos also show a third lift rail was utilized at the site.

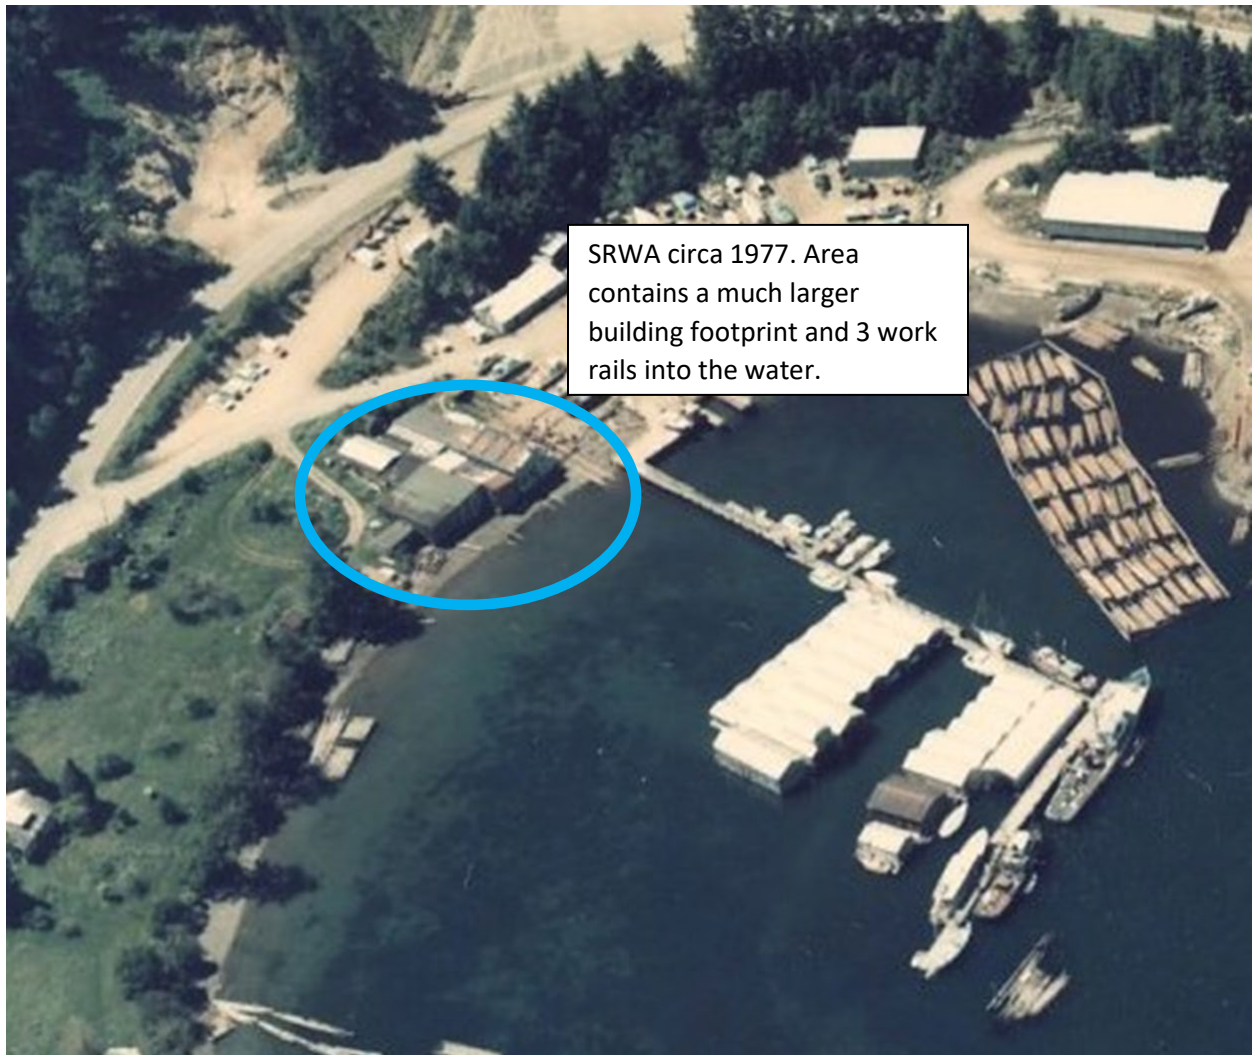
Figure 2.

SRWA circa 1977. Area contains a much larger building footprint and 3 work rails into the water.

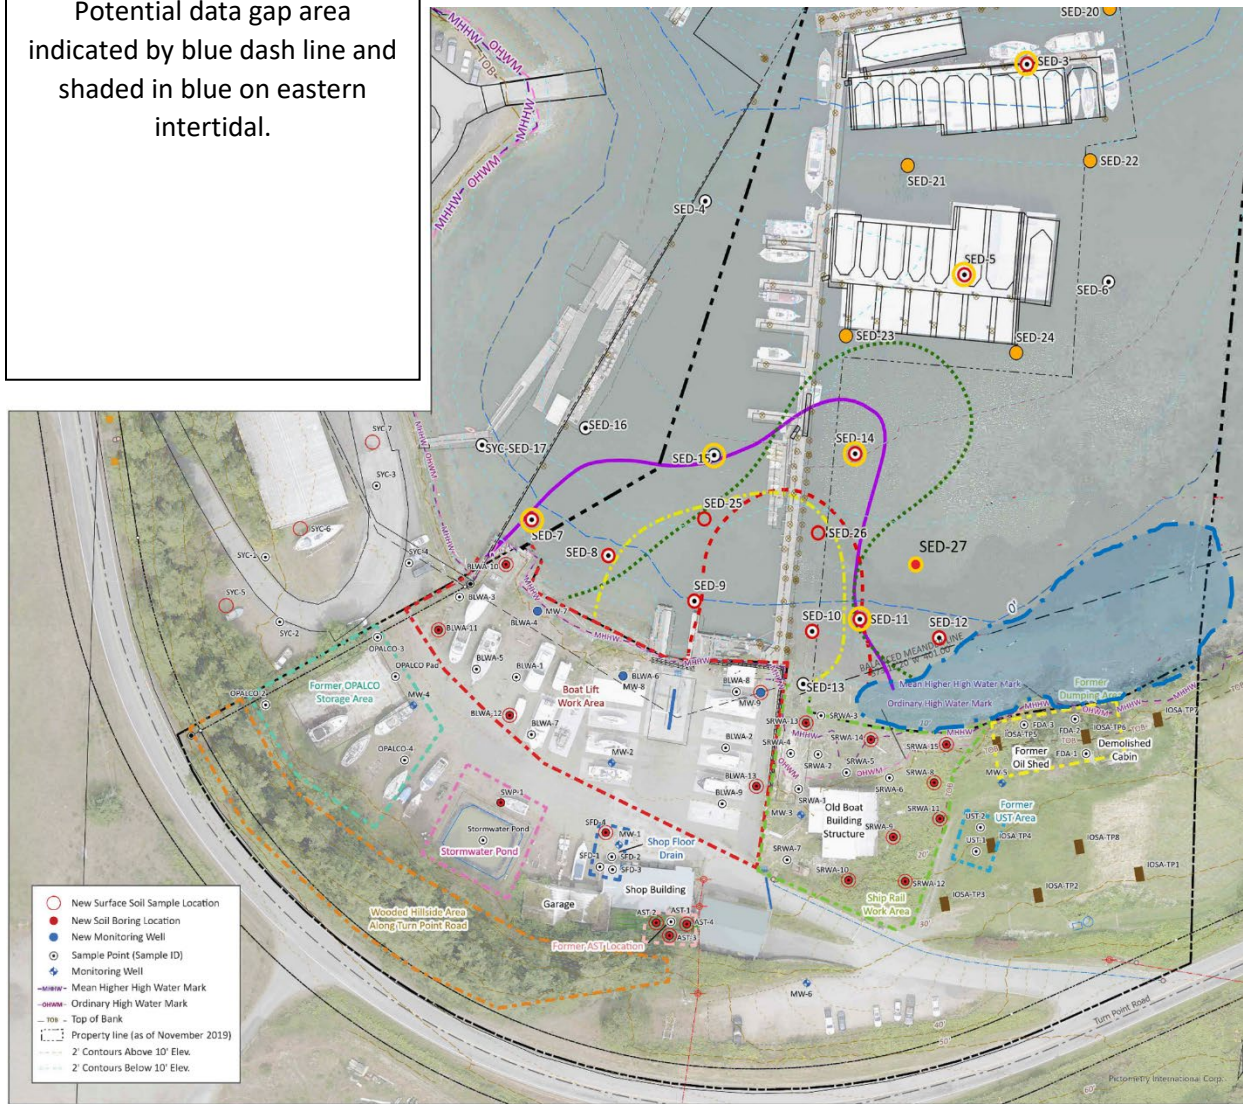
Based on these lines of evidence, Ecology believes that there is a high potential for contaminants of concern to be present in these near shore sediments in the area shown in Figure 3. Please note that Ecology’s conclusions regarding the sufficiency of characterization is based on the information provided to date and our conclusions be affected by new information as it becomes available.

Potential data gap area indicated by blue dash line and shaded in blue on eastern intertidal.

Ecology recommends that this data gap be investigated concurrently with feasibility study activities at the Site. Ecology has concluded that existing data appear to be sufficient to determine potential remedial options for both upland and marine areas, and this data gap would appear to affect the scale of implementation of appropriate remedial action(s) more than their selection.

A map showing proposed sampling locations and a table listing proposed locations, depths and analytes to address this data gap can be submitted to Ecology following submittal of the RI reports. We will plan on following up with you on this subject following receipt of the draft RI reports. This letter is being provided at this time to give you a heads up on this data gap concern.
