# 2017 ANNUAL CAP INSPECTION AND GROUNDWATER MONITORING REPORT

## EAST SURFACE IMPOUNDMENT GOLDENDALE, WASHINGTON

November 2018

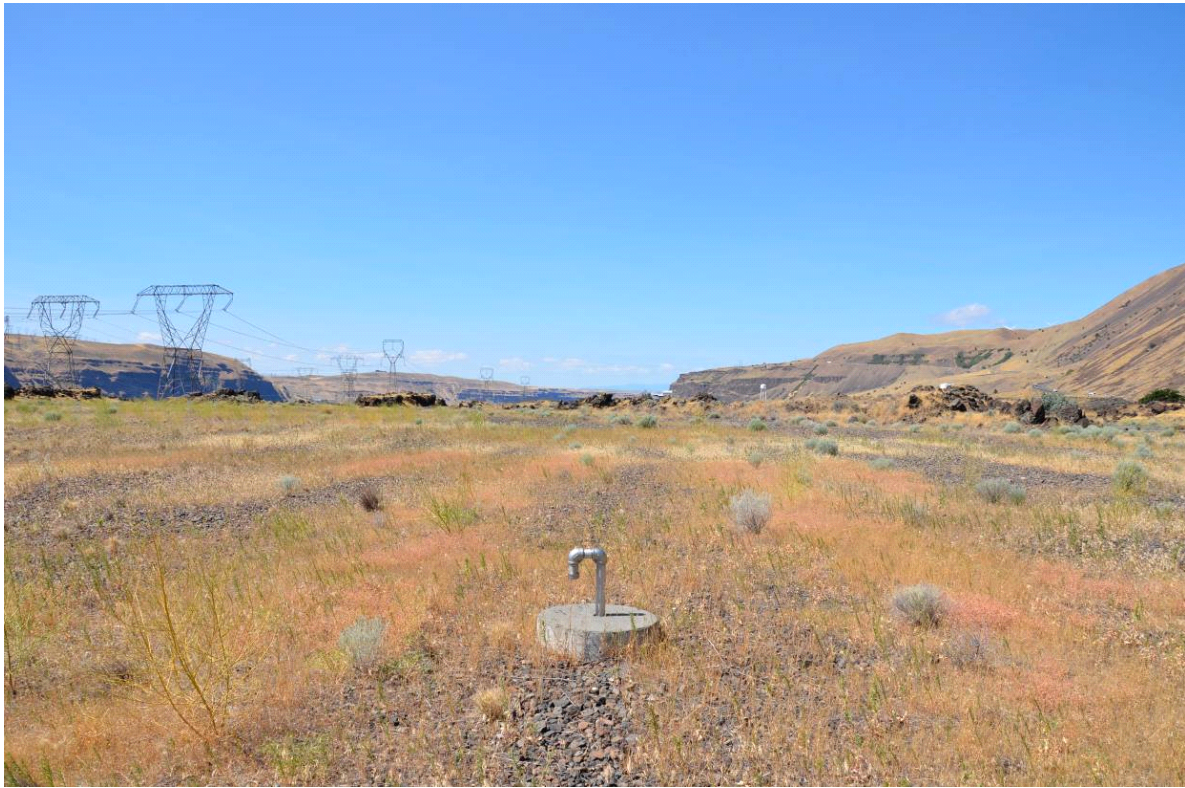
Photograph No. 1: View of capped Vent #1 (typical of Vents #1 and Vents #3 through #9).

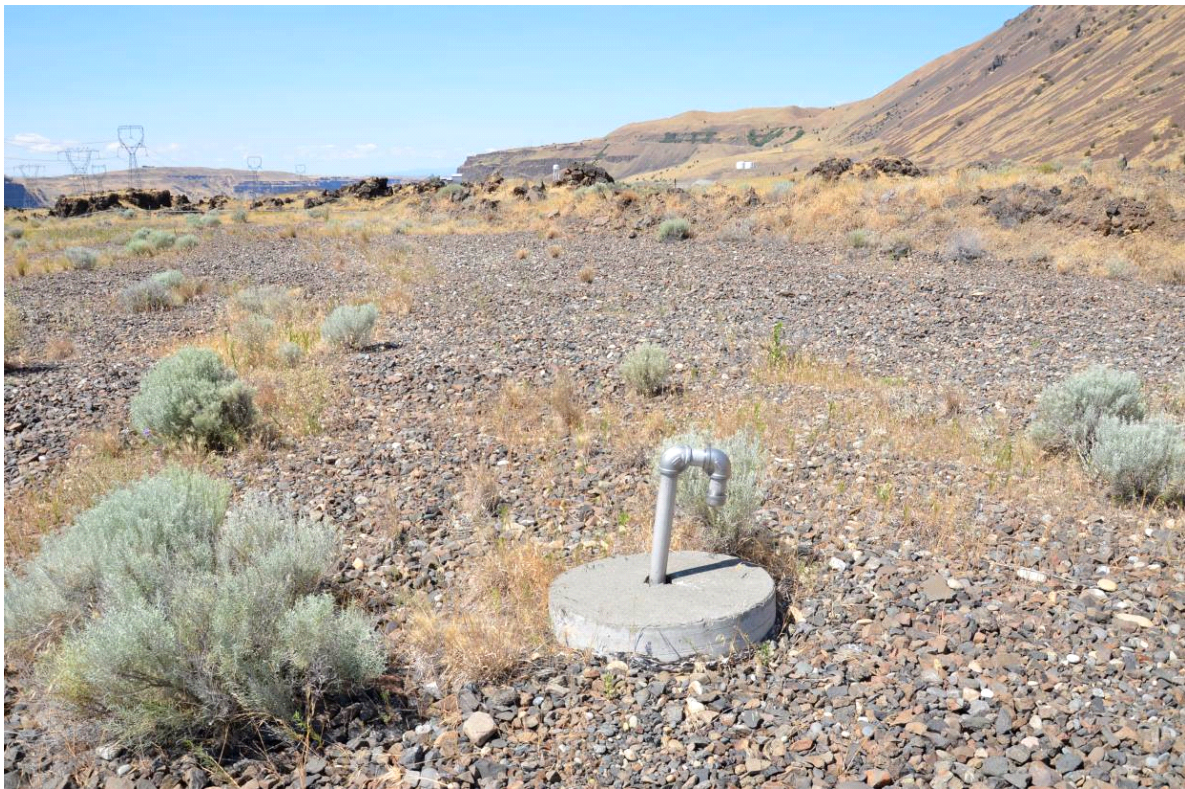
As previously reported in earlier cap inspection reports (Tetra Tech 2015c, Tetra Tech 2016), the westernmost vent-riser pipe (ESI-V2) appears to have settled or has been previously backed into by a vehicle based on its tilted orientation (refer to Appendix B photograph). However, the concrete pad associated with this riser was in good condition and the riser pipe was not damaged. Therefore, this pipe structure has been determined to be functioning as designed.

Photograph No. 2: View of capped Vent #2 with bent riser.

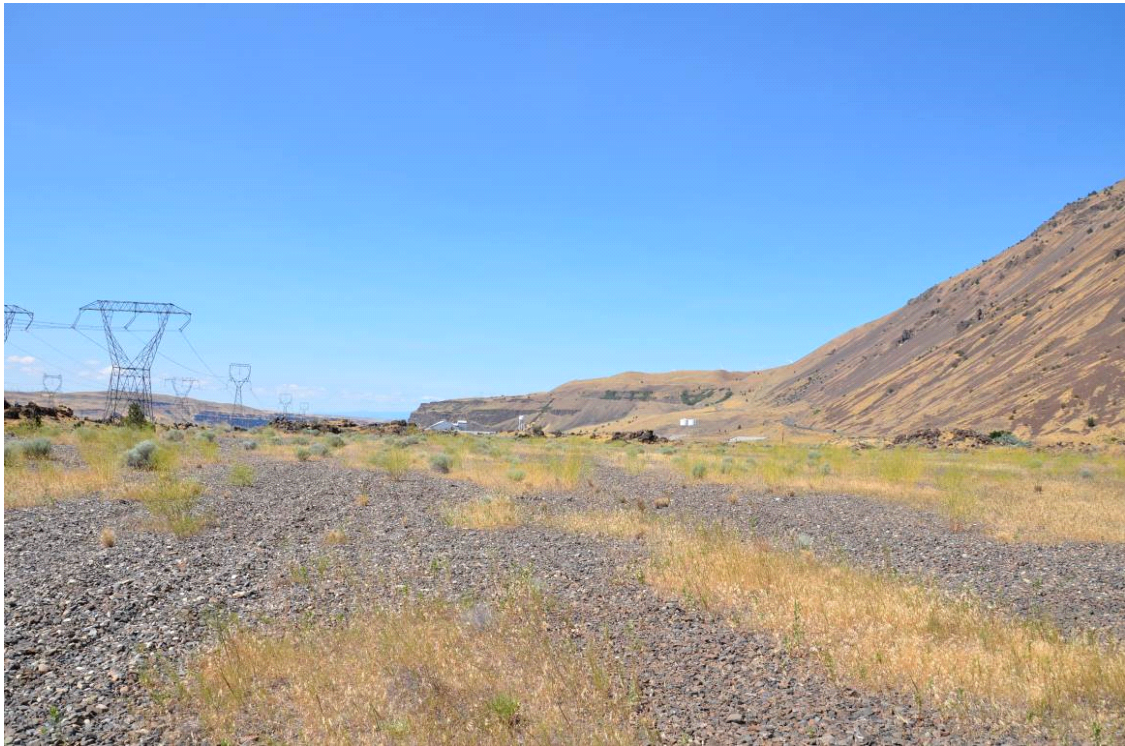
Photograph No. 3: View southwest across ESI cap.

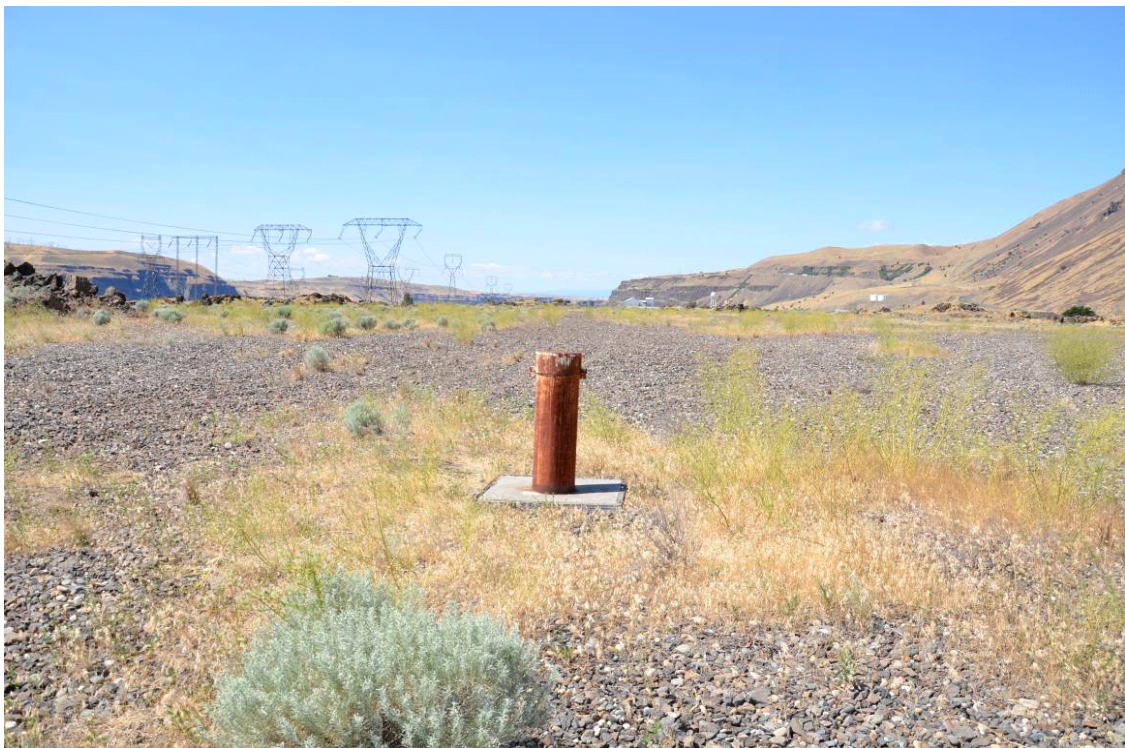
Photograph No. 4: View southwest of monitoring well ESI-1.

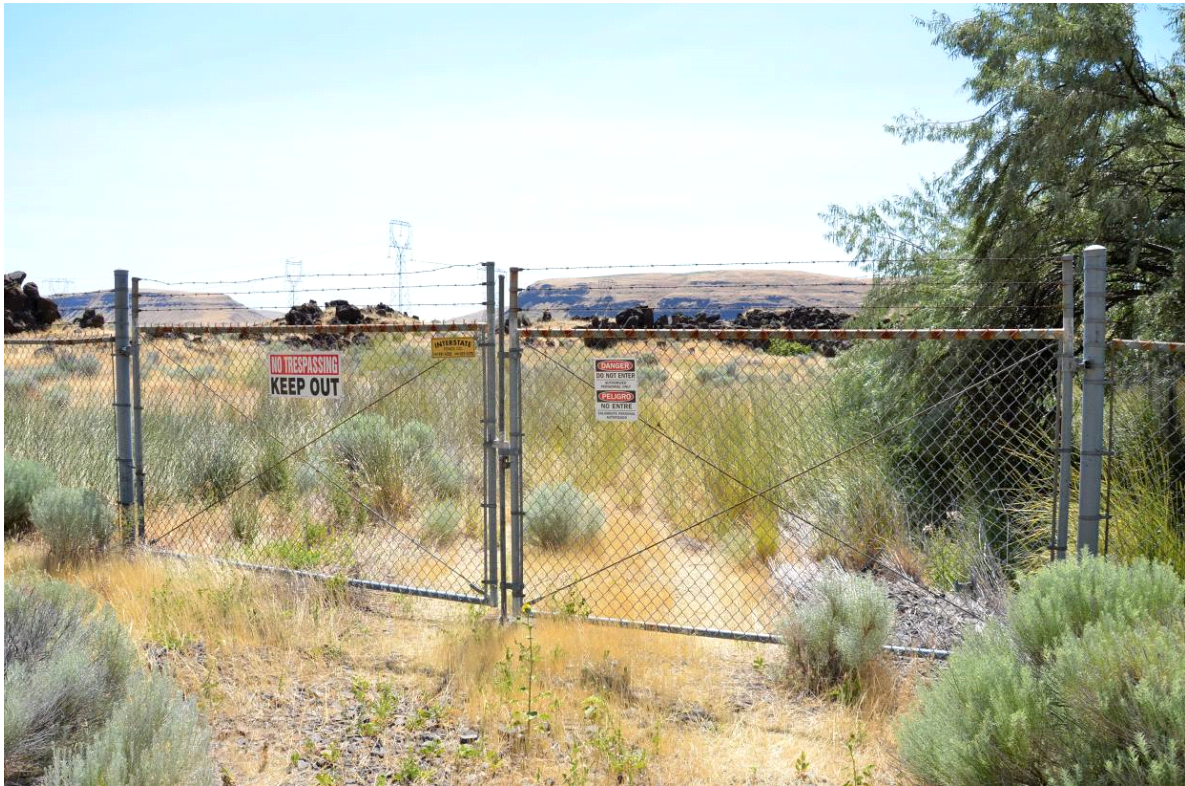
Photograph No. 5: View southeast of the main entrance gate to the ESI cap.

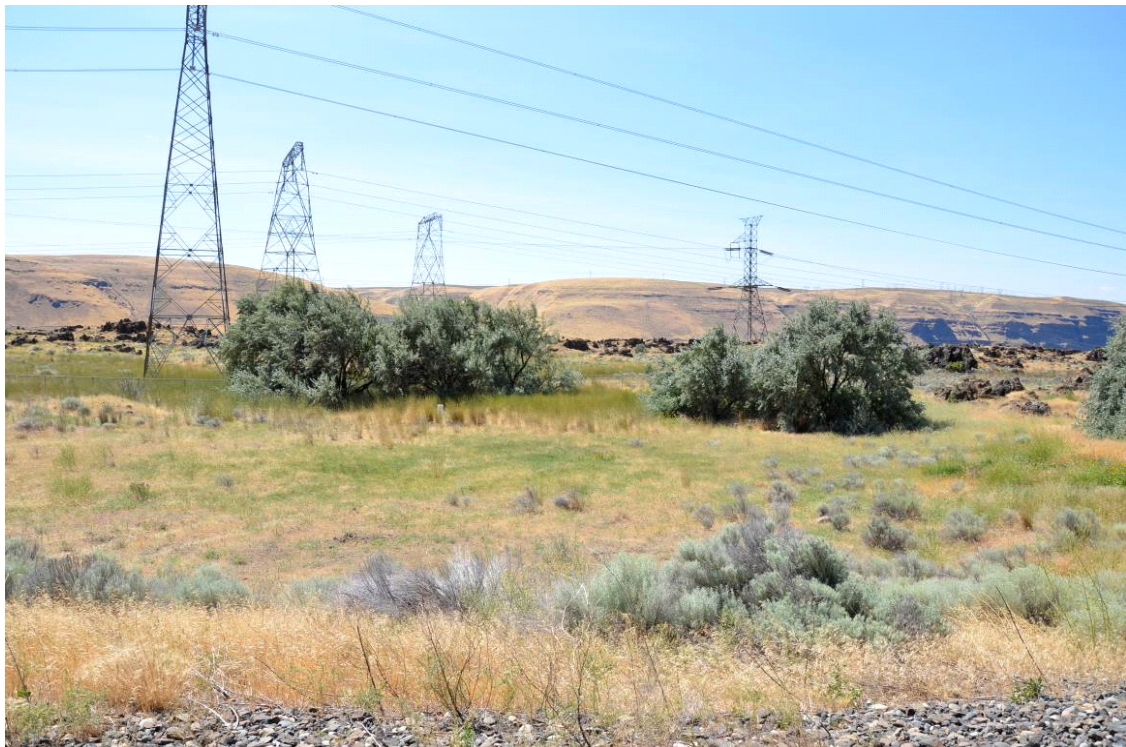
Photograph No. 6: View southeast of the open area on the southeast side of the ESI cap.

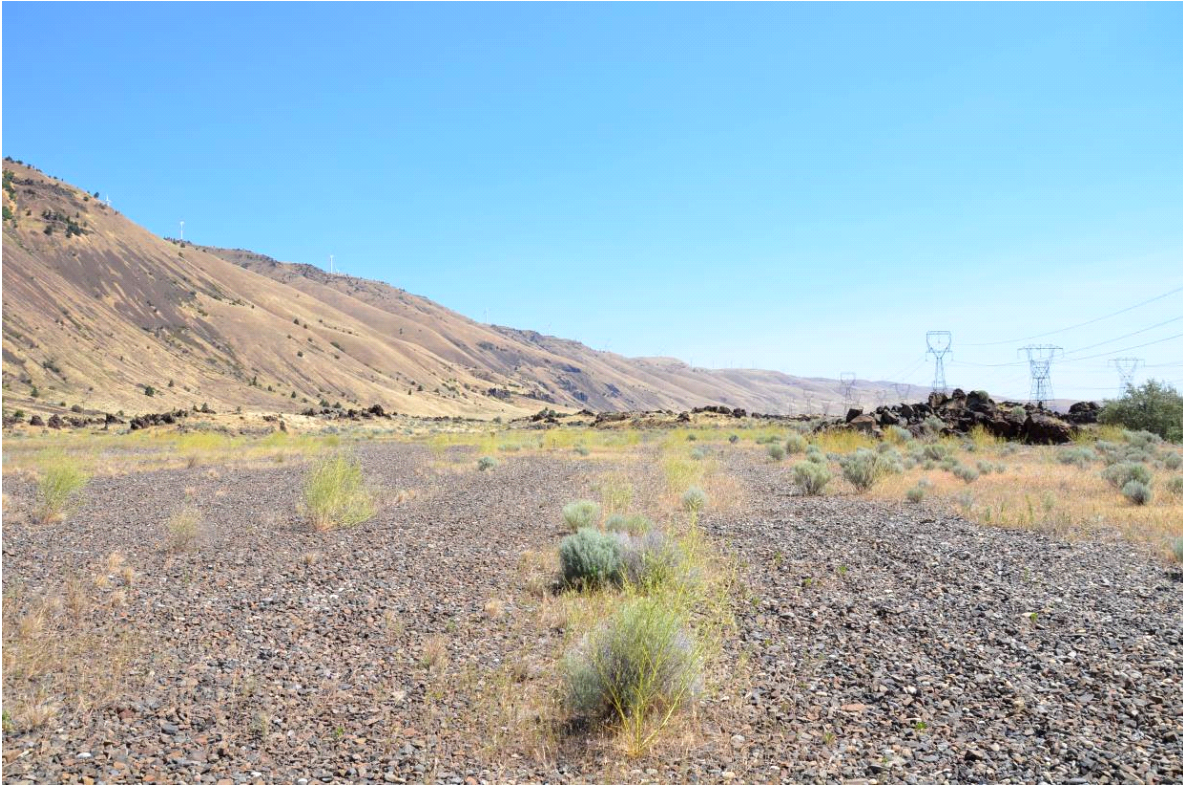
Photograph No. 7: View northeast across ESI cap.

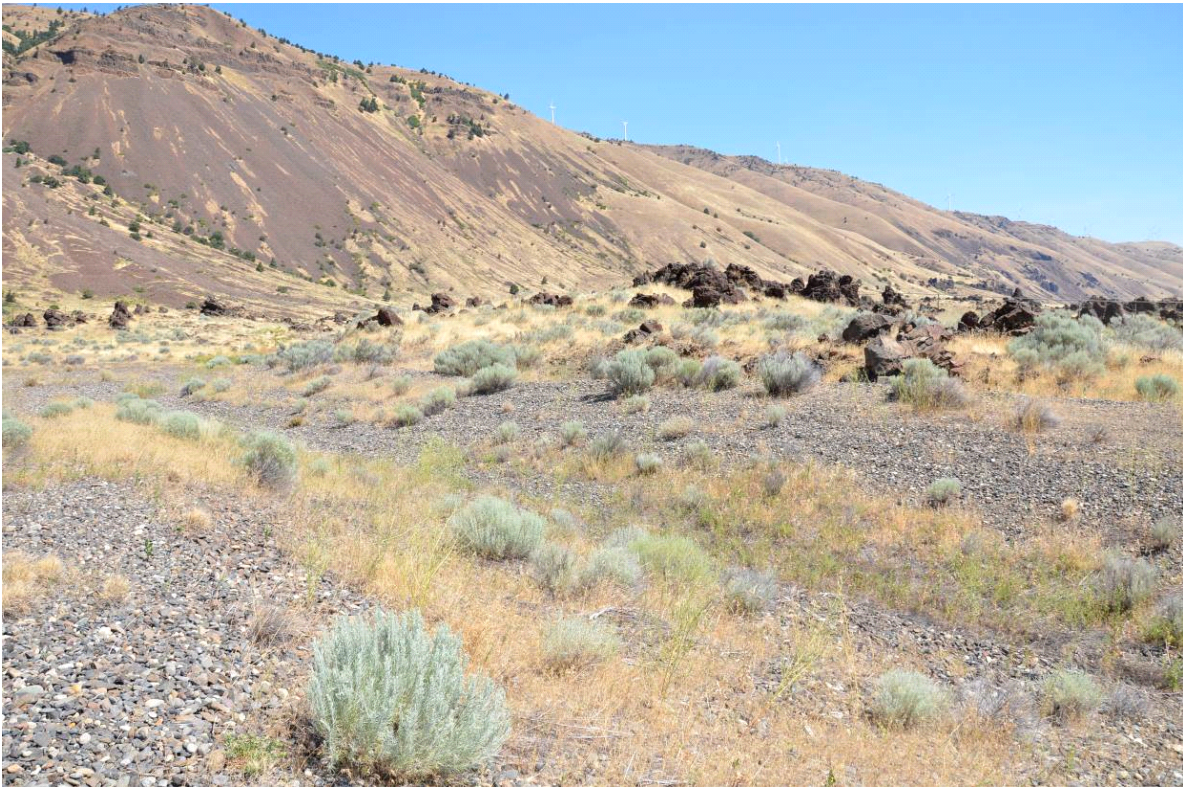
Photograph No. 8: View of vegetation in drainage channel at southeast corner of ESI.

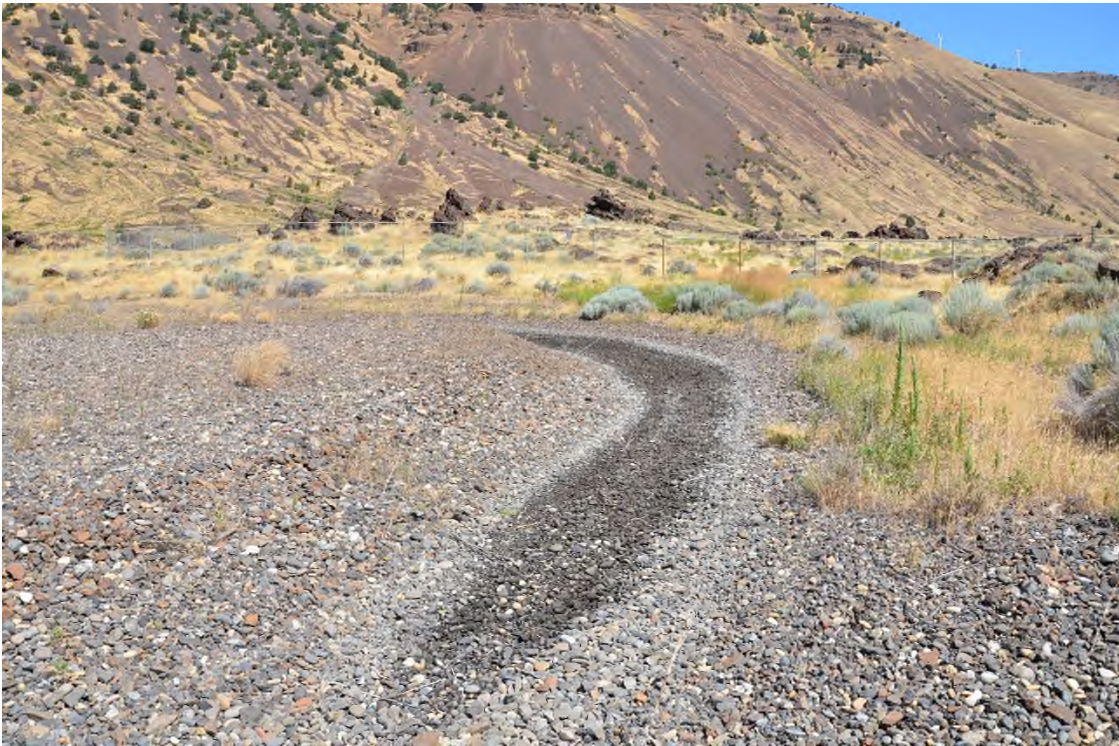
Photograph No. 9: View to north along drainage channel at southeast corner of ESI.

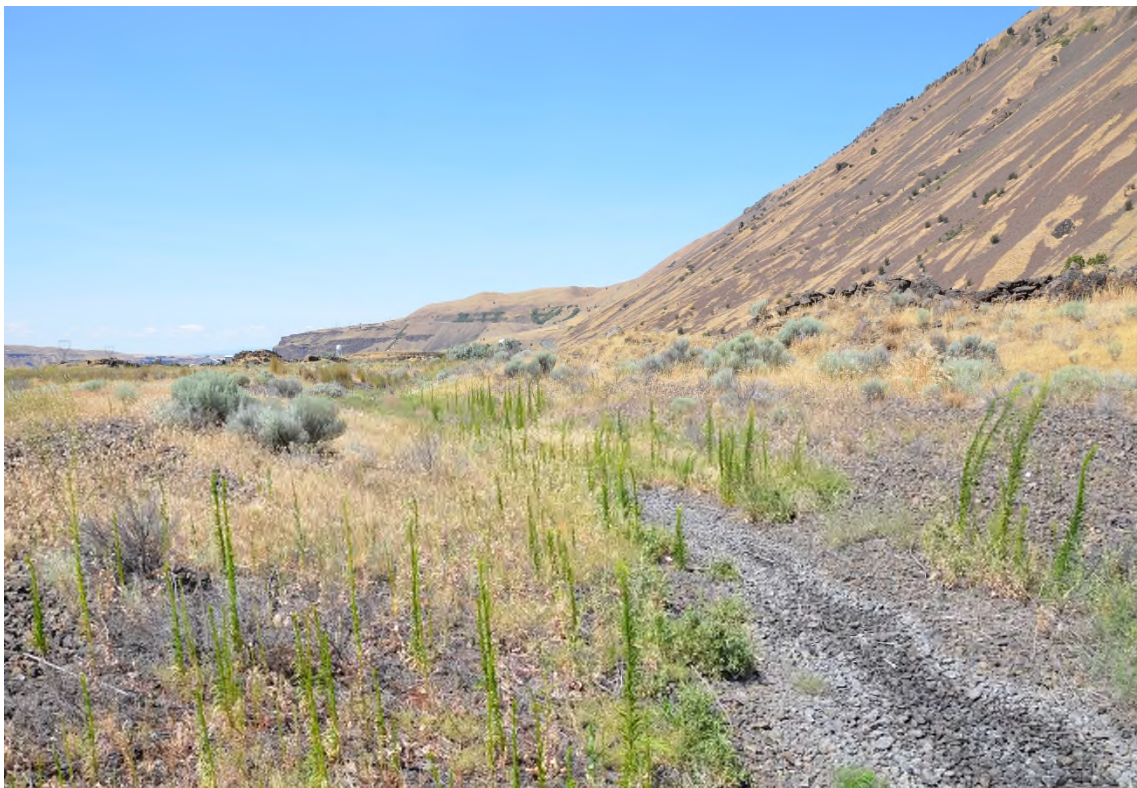
Photograph No. 10: View to west along drainage channel along northern boundary of ESI.

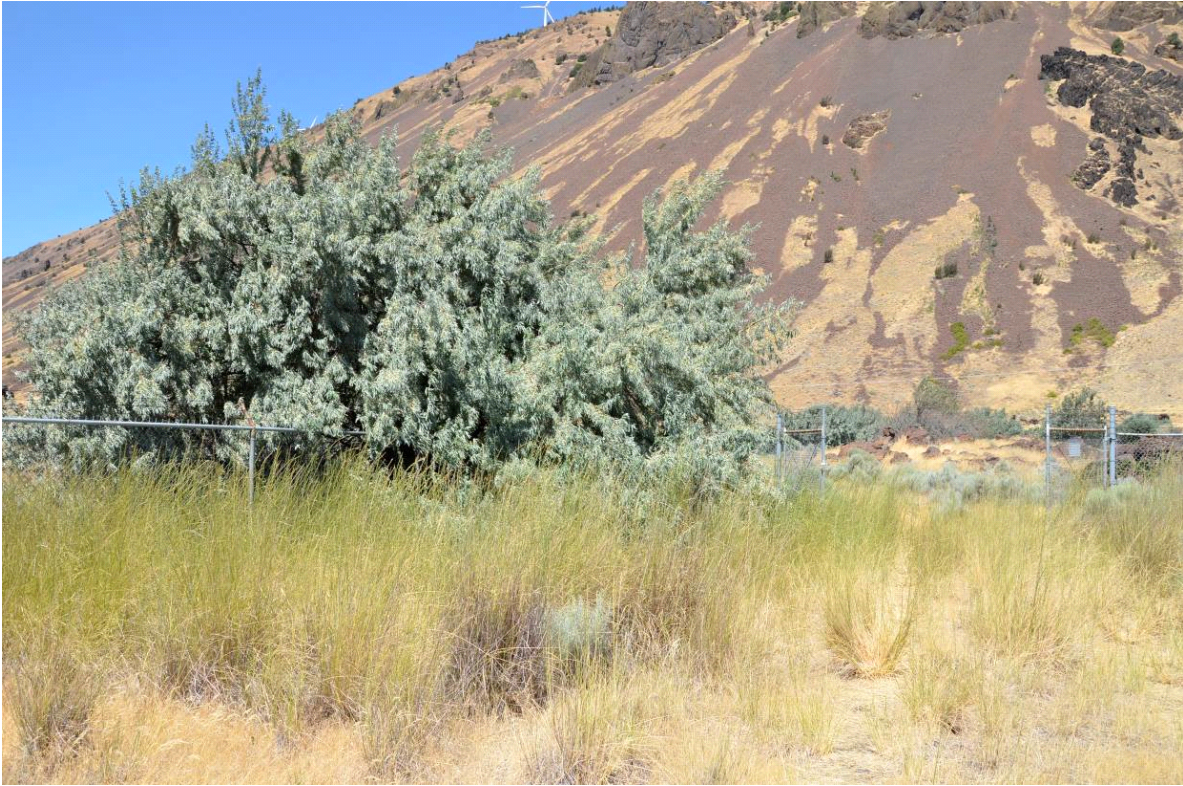
Photograph No. 11: View of vegetation at northwest corner of ESI at the main entrance.

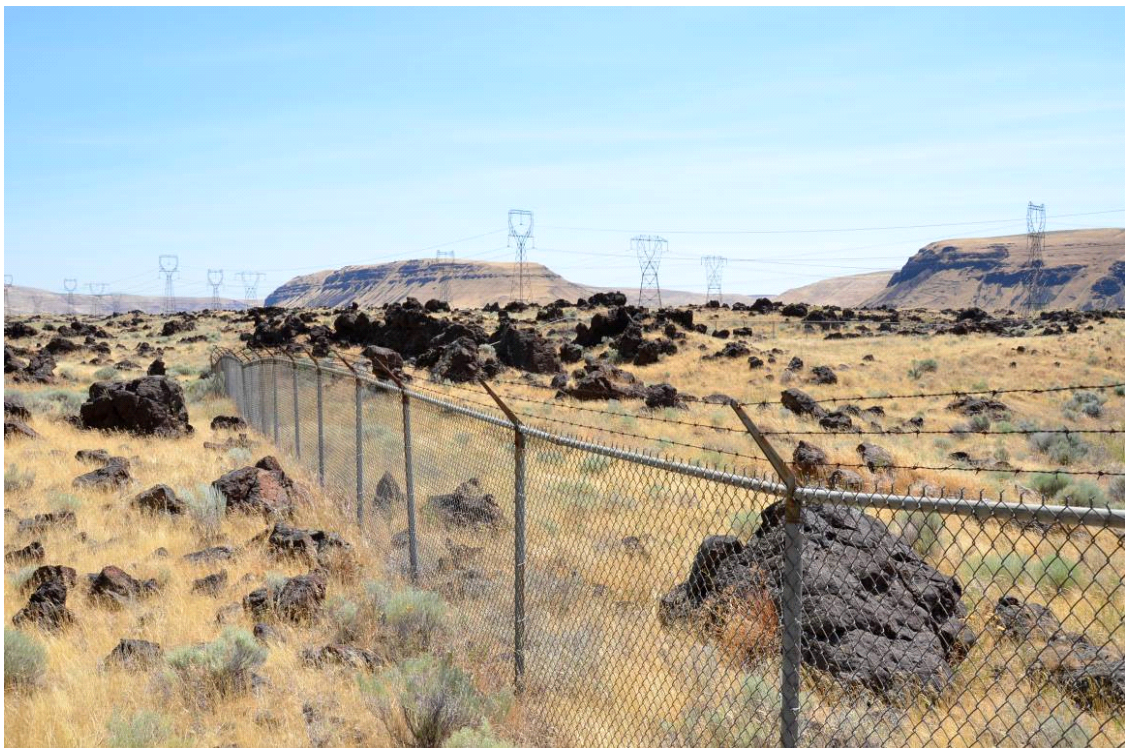
Photograph No. 12: View to the east along northern boundary fence of ESI (typical of entire exterior fence perimeter).

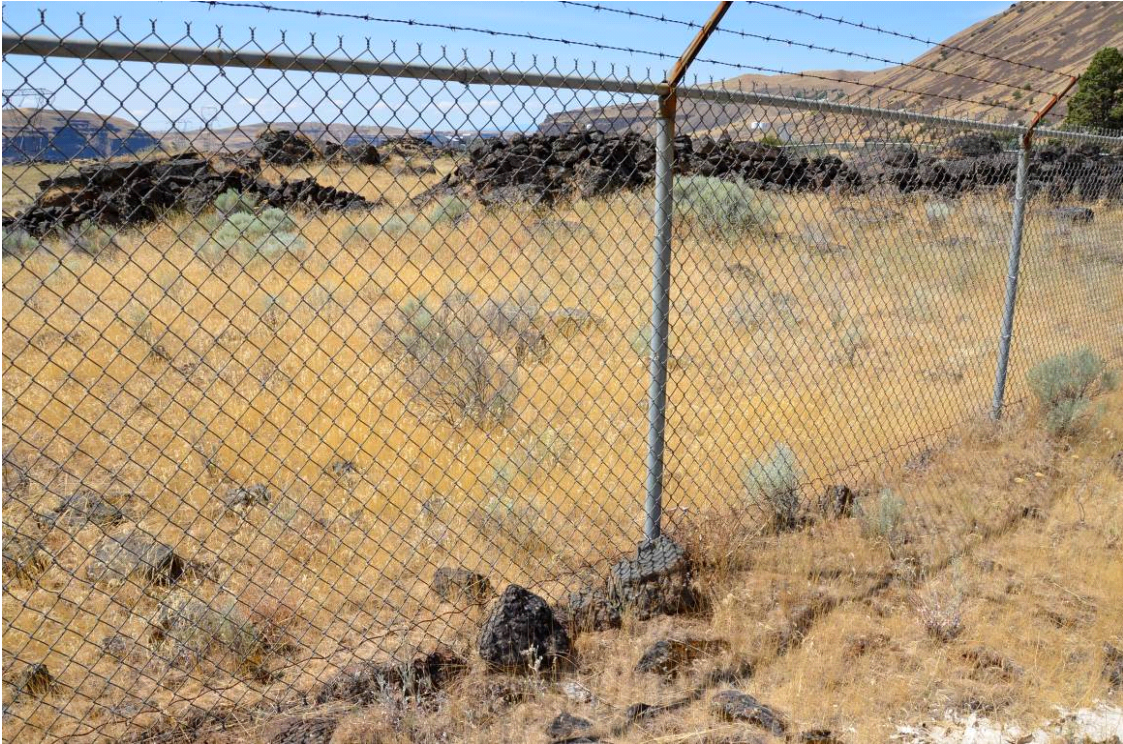
- **Fencing:** The fencing and gates were generally found in good condition with gates locked and operational. Evidence of animal burrowing under the fence was observed in approximately 3 locations. Basalt cobbles found immediately adjacent to the burrows were piled and used to block all new burrows that were found. The extensive small-animal burrowing repairs that were performed in 2016 (Tetra Tech 2016) were inspected and found to be in good condition with no need for further repair.
- **Signs:** The fence signs were observed to be properly spaced and in good condition. A total of 17 signs were observed at the time of the inspection.

Photograph No. 13: View of gap under fence blocked by basalt cobbles near northeast corner.

The primary maintenance activity consisted of filling burrows located under the fence line and addressing areas of stained soils identified during the 2016 annual inspection. During the exterior inspection of the chain-link fence perimeter, field personnel addressed all locations where evidence of animal burrows under the fence was observed. At three new locations, basalt cobbles found in the vicinity of the burrow were gathered and stacked along the outside of the fence to block new gaps between the bottom of the fence and the ground surface.

During the inspection completed on 20 July 2017, all of the basalt cobble repairs completed in 2016 were observed intact and required only minor repair. Some areas where cobbles were already stacked were reinforced with more basalt cobbles (refer to Appendix B photographs).

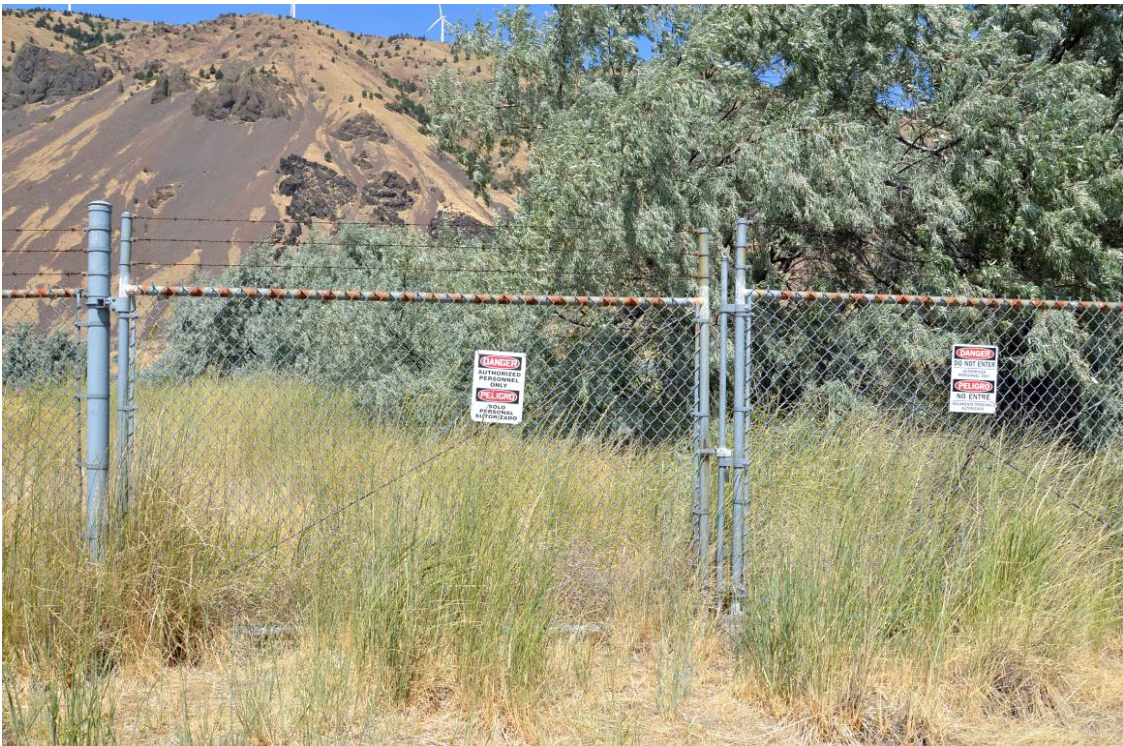
Photograph No. 14: View to northwest at locked gate along southeastern side of fence.

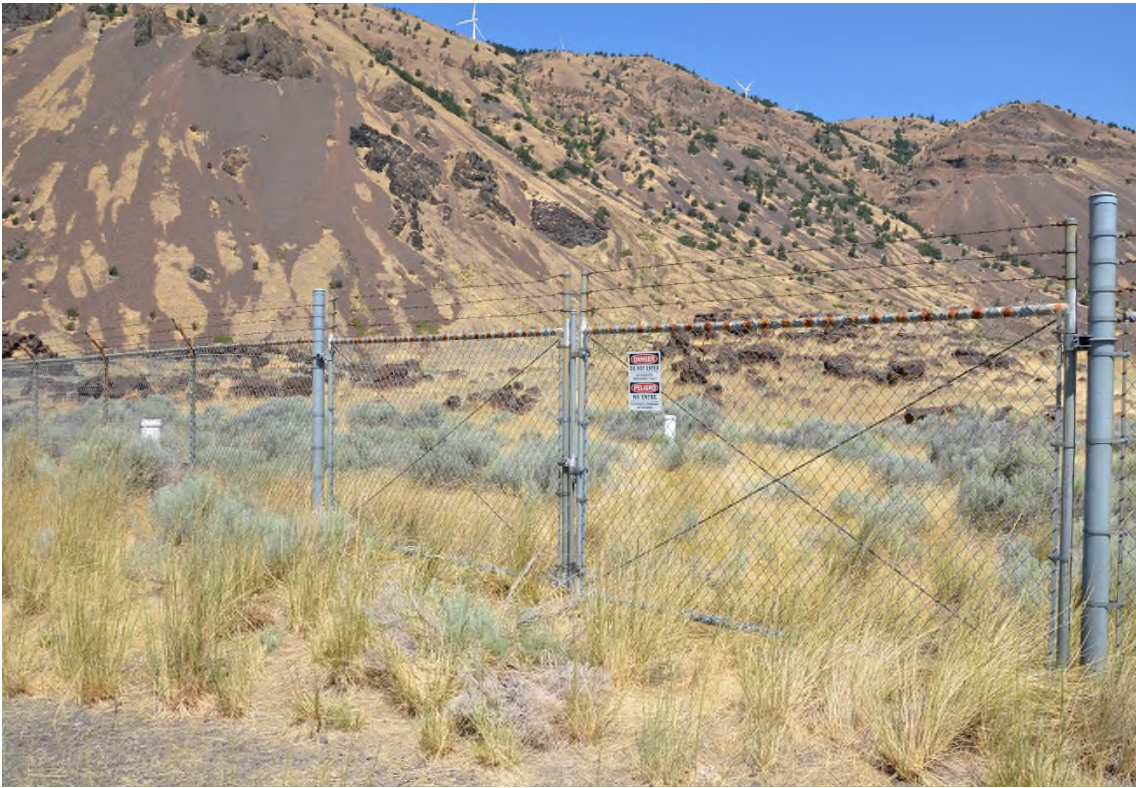
Photograph No. 15: View to north at locked gate at southwestern corner of fence by MW-9 and IB-12A.

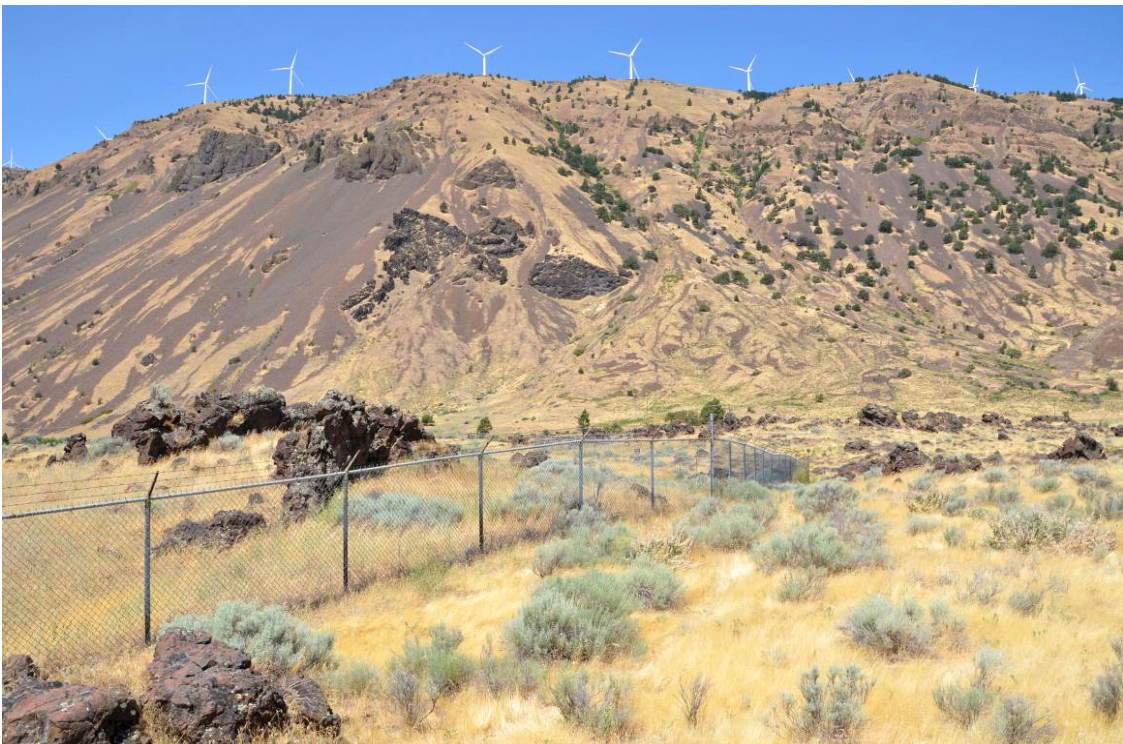
Photograph No. 16: View to north along eastern edge of ESI fence.

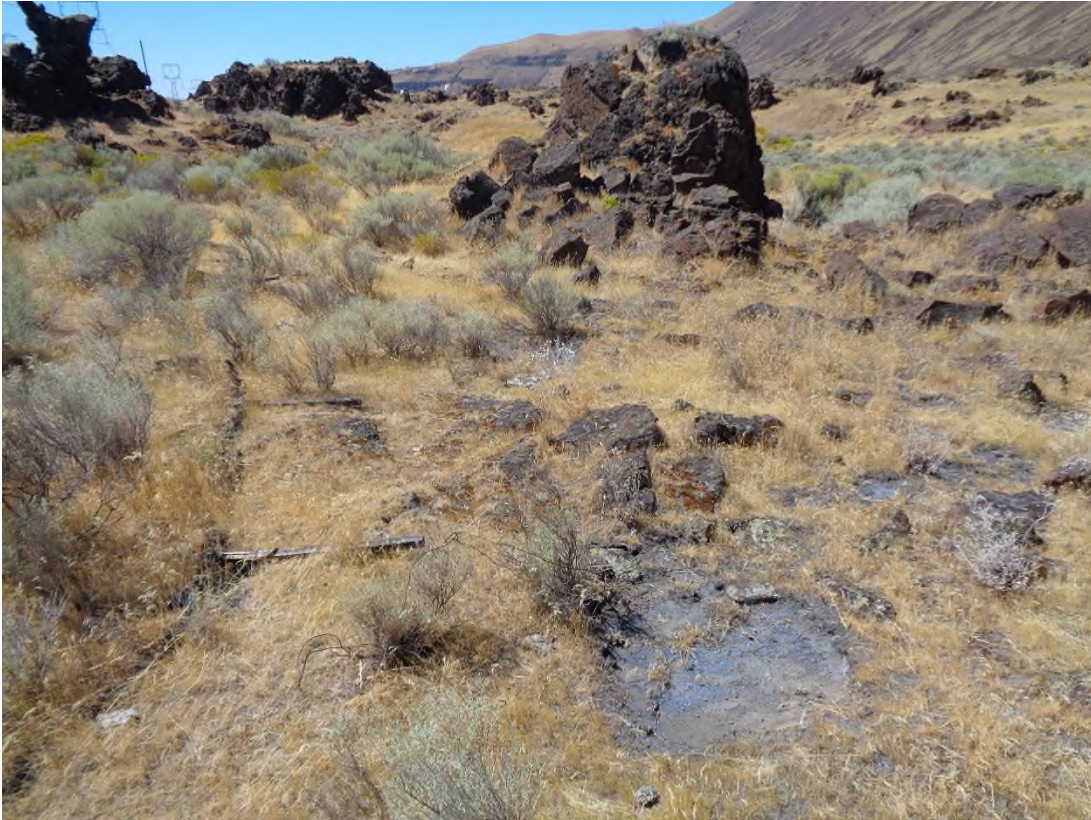
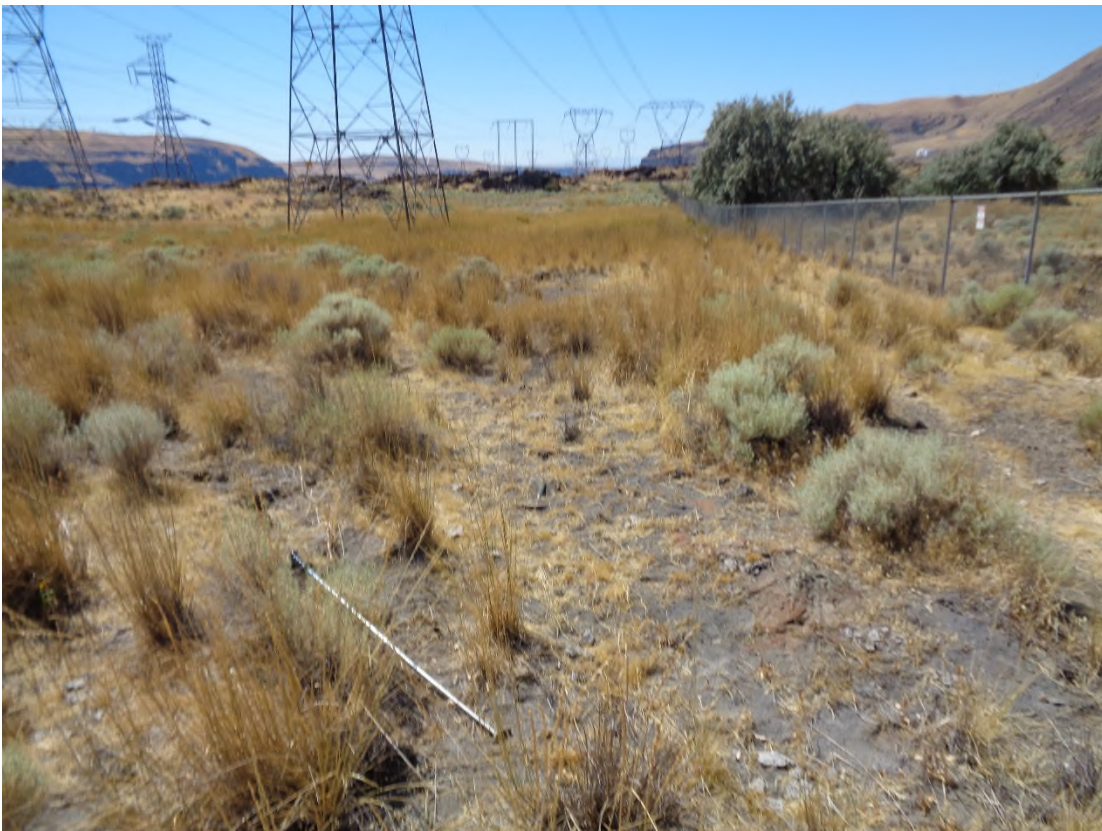
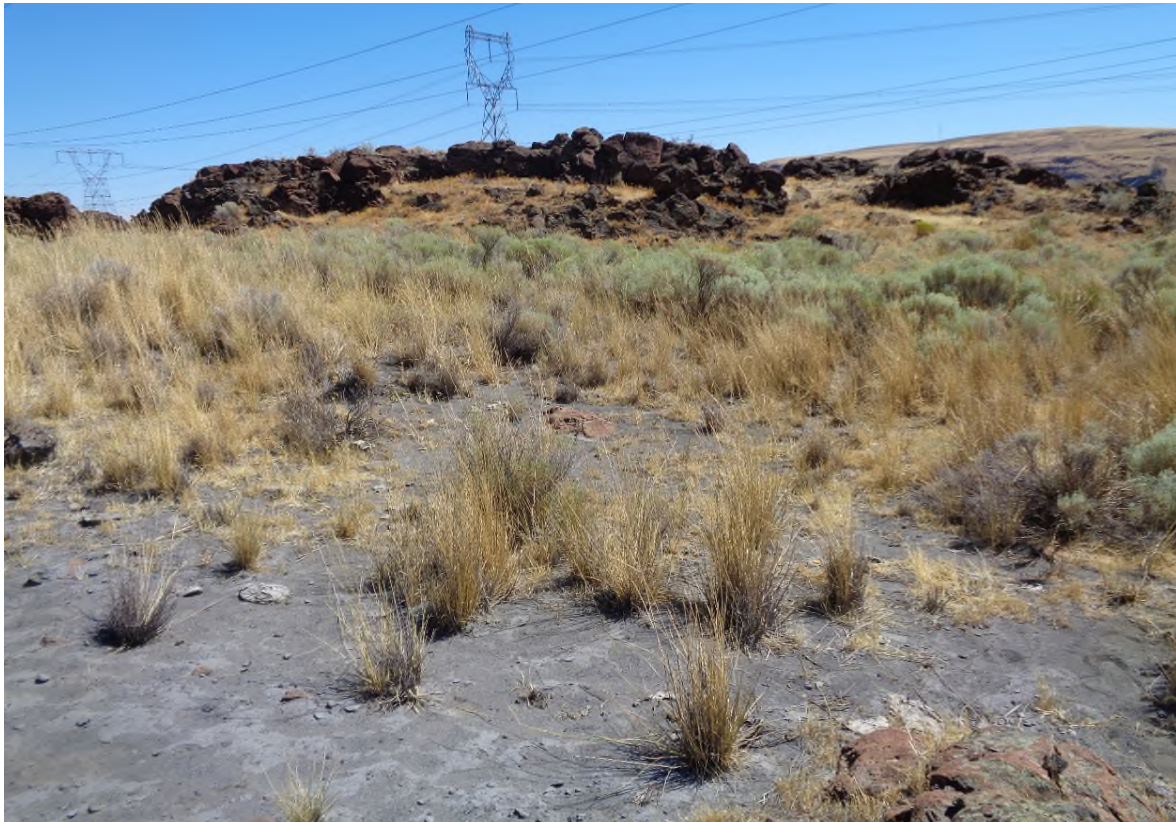
- **Area of Discolored Soil.** An area of discolored surface soil was found outside and inside the southeastern corner of the ESI fence line during 2016 (Tetra Tech 2016). This area was visited by Ecology representative Guy Barrett during a site visit on October 28, 2016. These soils were addressed as a maintenance activity in October 2018, as discussed in Section 3, Maintenance Activities Summary.

Photograph No. 17: View of discolored soils inside southeast corner of fence line, facing west.

Photograph No. 18: View of discolored soils, outside of southeastern fence line, facing west.

Photograph No. 19: View of discolored soil outside of southeastern fence line, facing south-southeast.

As part of ongoing maintenance activities, the area(s) of discolored soil observed outside and inside the southeastern corner of the ESI fence line during the 2016 ESI inspection (refer to Appendix B photographs) were excavated in October 2018. The discolored surface soils were confirmed to be limited in both lateral and vertical extent and were transported to an offsite disposal facility.

The soil excavation was generally shallow (less than 1 foot). Approximately 435 tons of discolored surface soils were excavated and disposed at Columbia Ridge Landfill between 5-22 October 2018. Manifest/disposal receipts are included in Appendix F.
