## **First Periodic Review 318 State Ave NE Olympia**

**318 State Ave NE, Olympia, Thurston County  
Facility Site ID: 3024394, Cleanup Site ID: 2010**

**Toxics Cleanup Program, Southwest Region**

November 2024

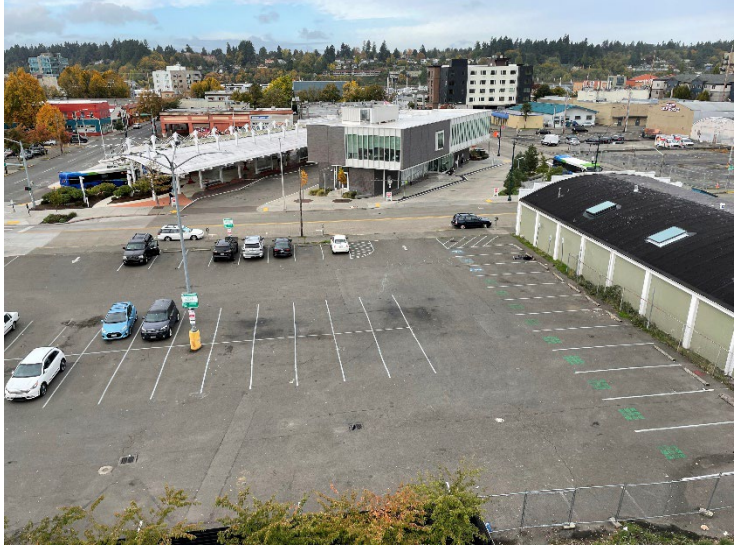
An aerial photograph showing a large, mostly empty asphalt parking lot. In the background, there are several buildings, including a modern multi-story building with a glass facade. The sky is overcast. The parking lot has white and green painted lines for parking spaces.	<p>Looking west at parking lot that is part of the 318 State Ave NE Olympia cleanup site. Olympia Transit Center is beyond. View is from atop Billy Frank Jr. Place building.</p>

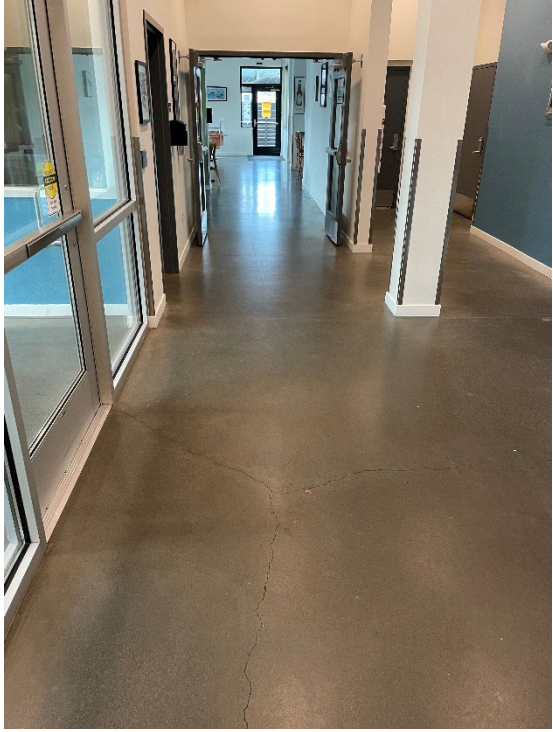
A photograph of an interior hallway. The floor is a smooth, light-colored concrete. On the left, there are large glass windows or doors. On the right, there are white structural columns and blue-painted walls. The hallway leads to a bright area at the end.	<p>Typical concrete floor on first level of Billy Frank Jr. Place. There are reportedly no subsurface floors.</p>

Ecology recommends sealing the minor cracks observed in the concrete of the first floor, as seen in the lobby of the Billy Frank Jr. place building, during the site visit on October 23, 2023. This is a proactive measure, and not considered a violation of the environmental covenant.

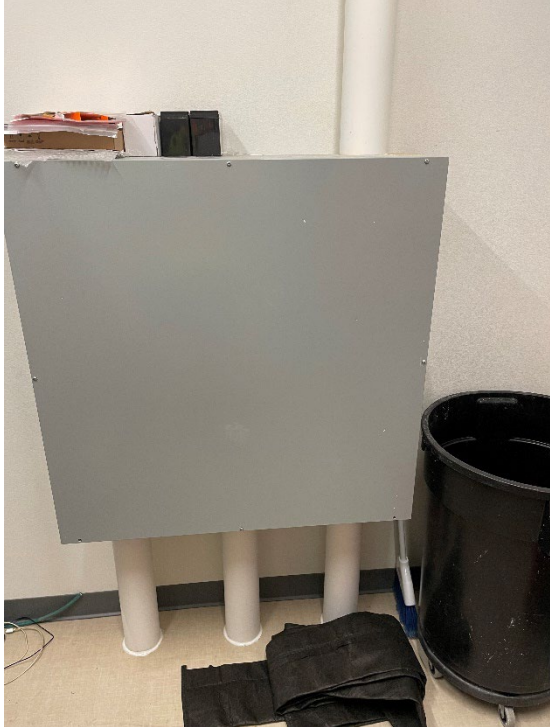
A photograph showing the exterior of a grey metal cover box for a sub-slab depressurization system. The box is mounted on a wall and has three white PVC pipes extending downwards from its base. To the right of the box is a black trash can. On the floor in front of the box, there is a pair of black work boots and some papers.	<p>Sub-slab depressurization vapor mitigation system cover box in telecom closet on second floor.</p>

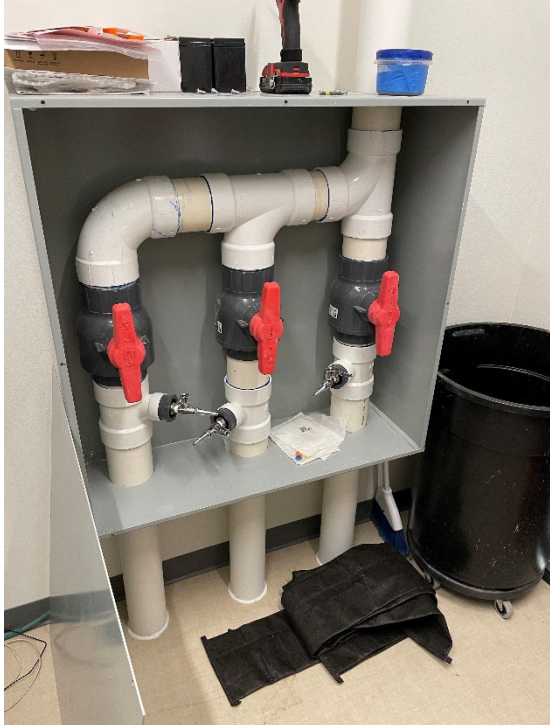
Vapor intrusion is mitigated by the ongoing sub-slab depressurization passive system in place for the building. The system appeared to be in good condition and operating as expected during the Site visit on October 23, 2023.

A photograph showing the interior of the grey metal control box. It features a complex network of white PVC pipes with three black valves, each with a red handle, positioned vertically. The valves are currently in the open position. The box is mounted on a wall, and the same black trash can and boots from the previous photo are visible in the background.	<p>Sub-slab depressurization vapor mitigation system, inside control box. Valves are in "open" position.</p>
