STATE OF WASHINGTON  
**DEPARTMENT OF ECOLOGY**

**Re: Further Action opinion for the following contaminated Site:**

**Site name:** Winlock School Bus Garage  
**Site address:** King Rd & Byham Rd Winlock, 98596-9417 Lewis  
**Facility/Site ID:** 23232326  
**Cleanup Site ID:** 8363

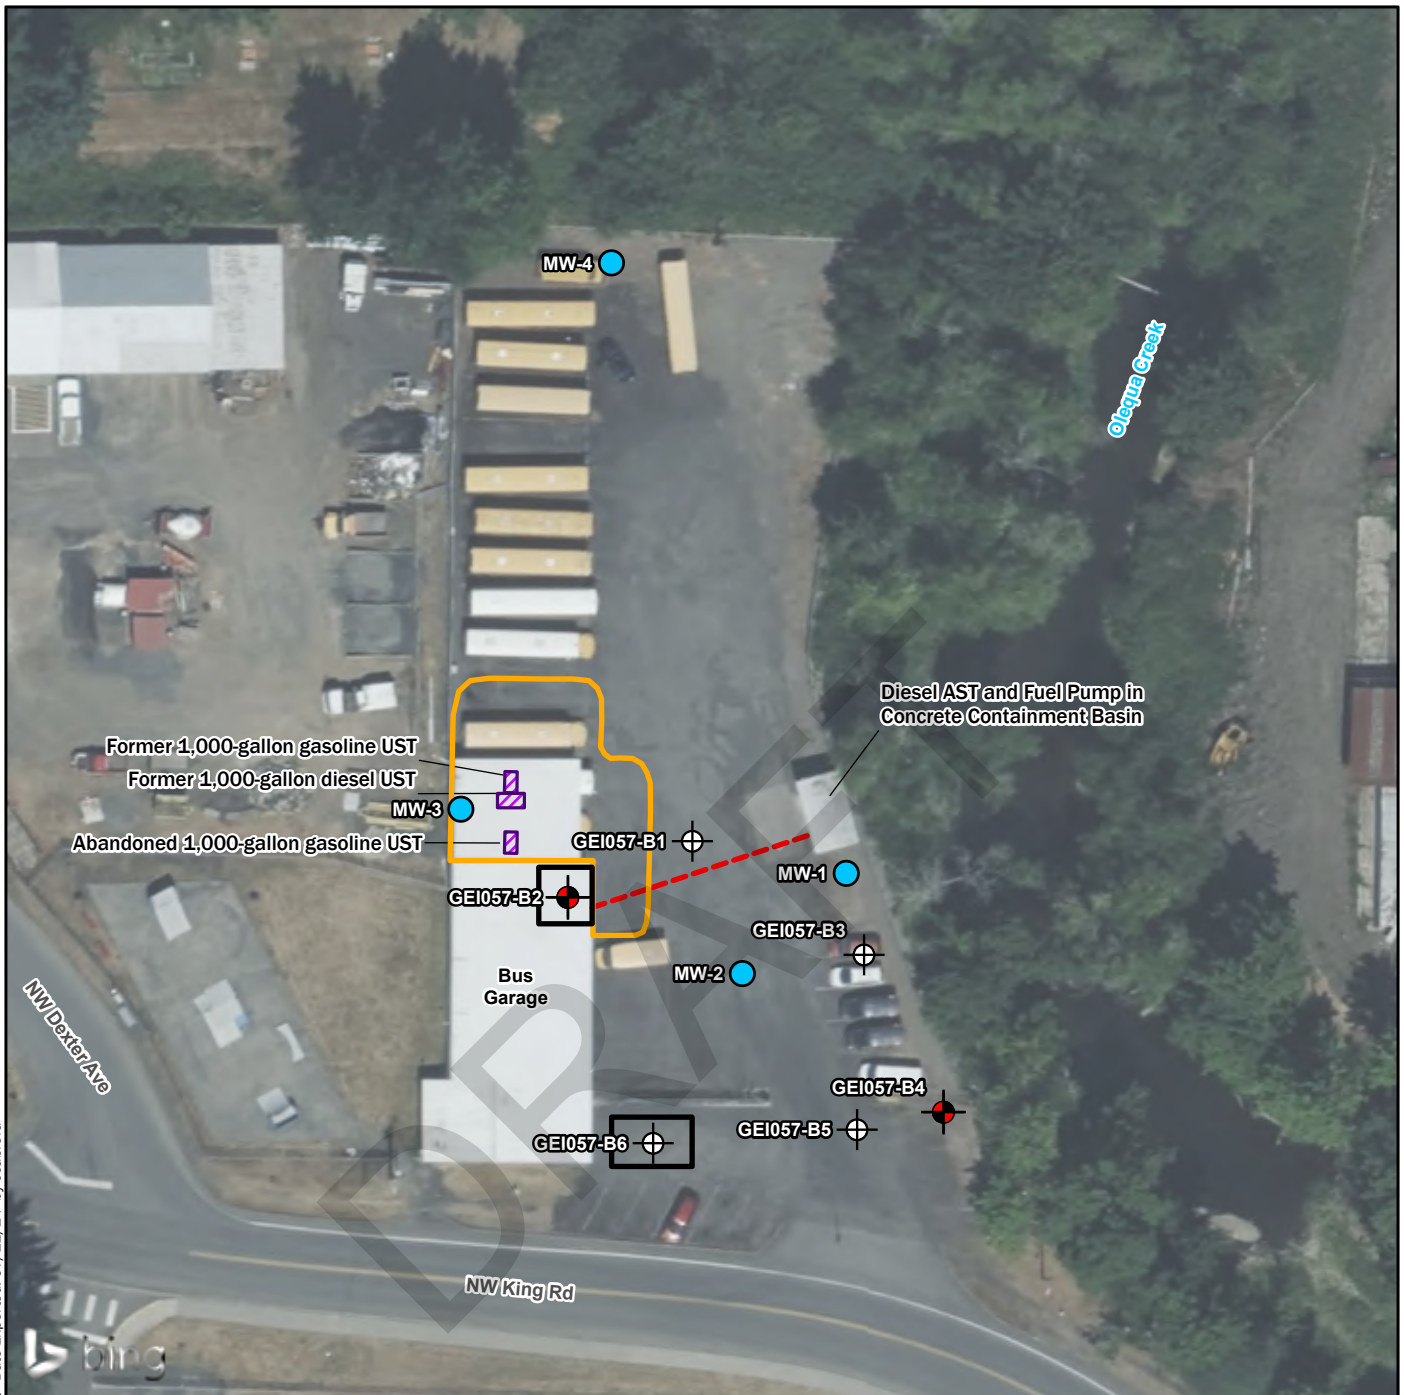
Figure 2

The 2024 limited assessment indicates soil contamination remains on Site beneath the northeast corner of the bus garage structure (B2) and the southeast corner of the property (B4) adjacent to Olequa Creek (Figure 2). Additional sampling between the 2024 detection depths and the direct contact point of compliance (15 ft bgs) is needed to vertically define the site. Additional sampling and analysis is also needed to laterally define the detections exceeding the MTCA-A CULs. Once the soil contamination is vertically and horizontally characterized, the soil should be remediated to the maximum extent possible.

The soil samples collected during the 2024 characterization event bore detections of TPH-G above MTCA Method A CULs in B2 (1,000 mg/kg) at 6-7 ft bgs and in B4 (980 mg/kg) at 7-8 ft bgs. B2 is located under the northeast portion of the garage onsite (Figure 2). B4 is located on the southeast portion of the parcel, adjacent to Olequa Creek (Figure 2). Soil samples collected at borings B2 through B6 all bore detections of TPH-G. Additionally, B2 bore detectable concentrations of ethylbenzene, total xylenes, EDC, and MTBE below the MTCA Method A CULs. Soil boring B4 exhibited detections of ethylbenzene and total xylenes below Method A CULs. No soil samples were collected to the compliance depth of 15 ft bgs, to the south of B4, or to the north or west of B4 (Figure2).

Additional soil sampling near boring B2 and B4 is needed. Contaminated soil above MTCA-A CULs remains on the Site, and the extent of contamination has not been fully delineated as required by WAC 173-340-350.

Ecology recommends further cleanup to address remaining petroleum-contaminated soil (PCS) to the maximum extent practicable. In particular, near 2024 boring B4 on the southeastern portion of the property where contaminated soil was observed (6-7 feet bgs) at less than the direct contact point of compliance. Further excavation and disposal of PCS in this area would afford the Site to utilize Ecology's Model Remedies.
