## MEMORANDUM

**Subject:** 2024 Annual Inspection Summary  
Former Harbour Pointe Cleaners Lynnwood (Facility Site ID 41352598)

**Project No.:** C3163

**Former Harbour Pointe Cleaners Lynnwood  
13619 Mukilteo Speedway, Lynnwood, WA 98037  
Photographs from 2024 Annual Inspection**

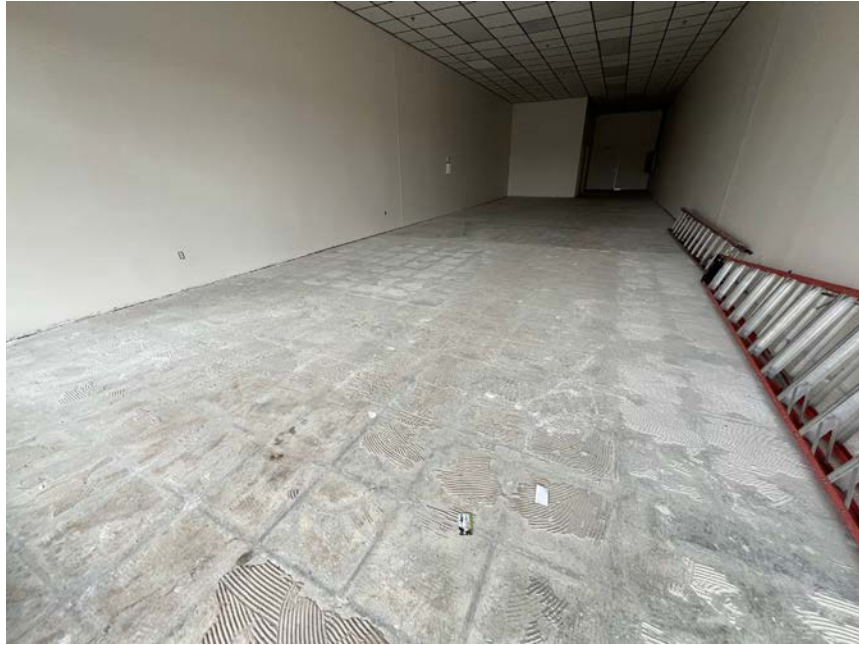
Photograph 1. Floor Slab in Former Harbour Pointe Cleaners (Suite B6)  
(November 14, 2024)

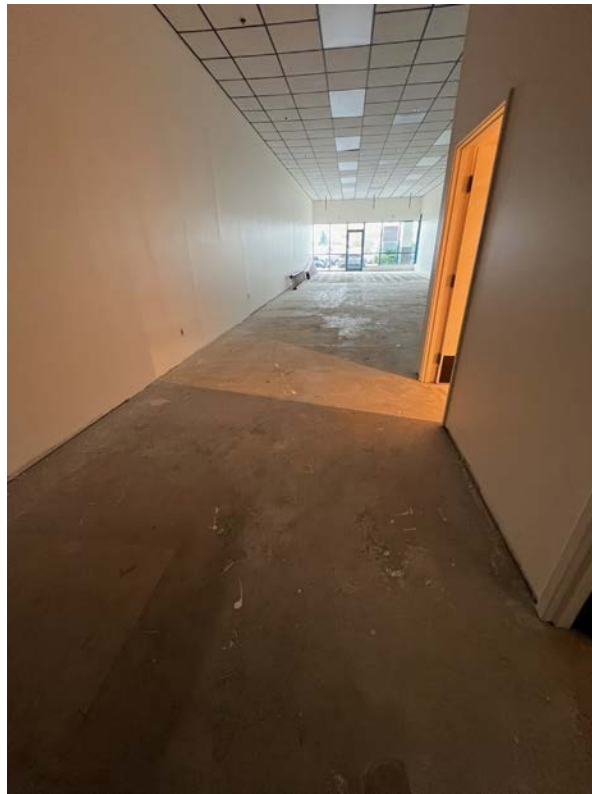
Photograph 2. Floor Slab in Rear of Former Harbour Pointe Cleaners (Suite B6)  
(November 14, 2024)

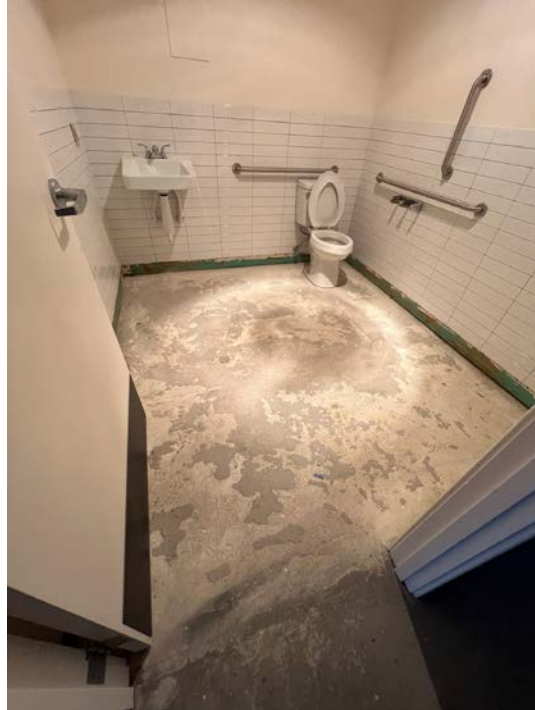
Photograph 3. Floor Slab in Bathroom of Former Harbour Pointe Cleaners (Suite B6) (November 14, 2024)

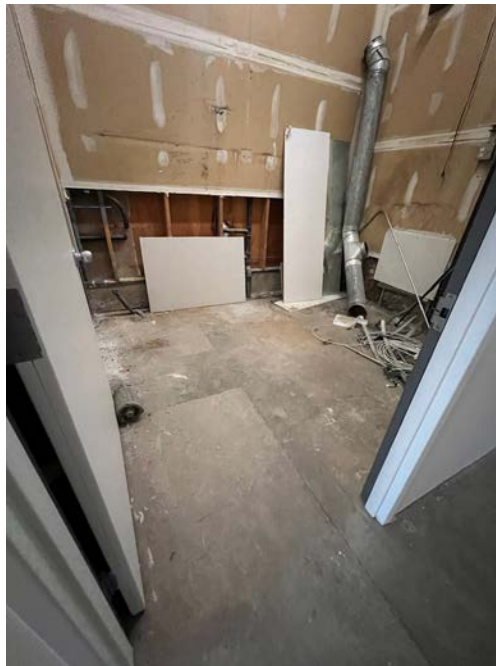
Photograph 4. Floor Slab in Rear Utility Room of Former Harbour Pointe Cleaners (Suite B6) (November 14, 2024)

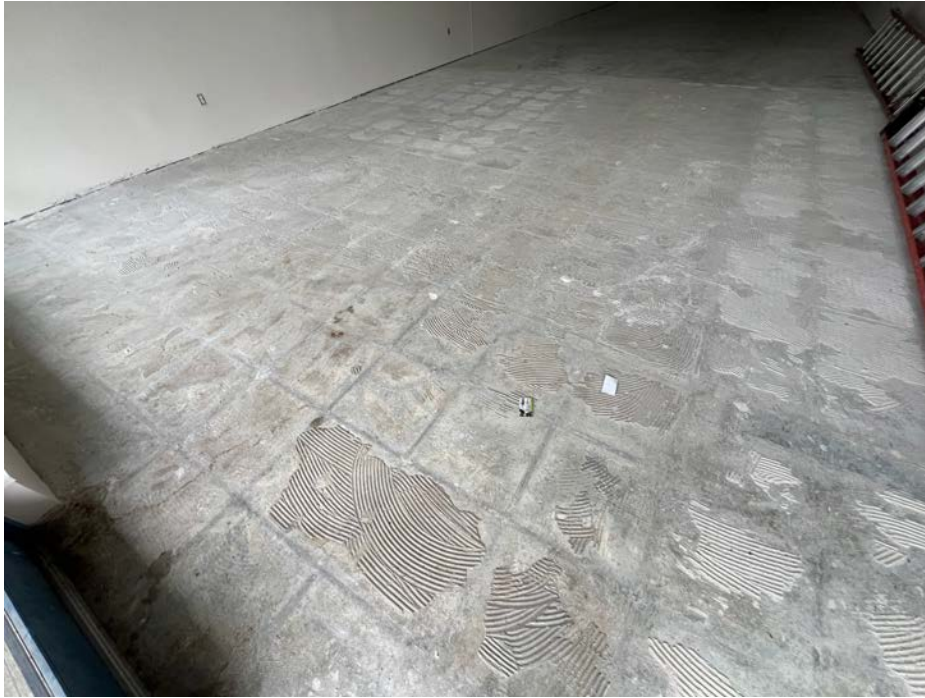
Photograph 5. Floor Slab in Front of Former Harbour Pointe Cleaners, Facing Northwest (Suite B6) (November 14, 2024)

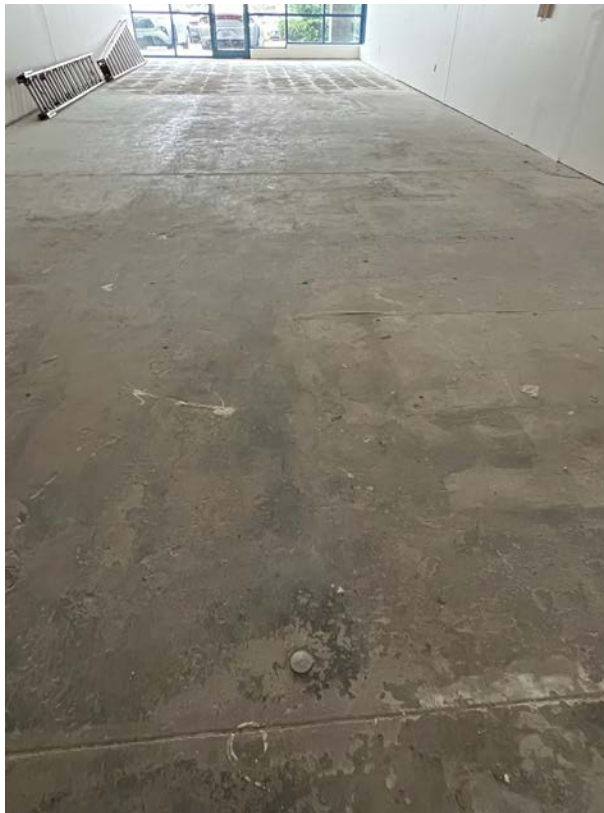
Photograph 6. Floor Slab in Middle of Former Harbour Pointe Cleaners, Facing South (Suite B6) (November 14, 2024)

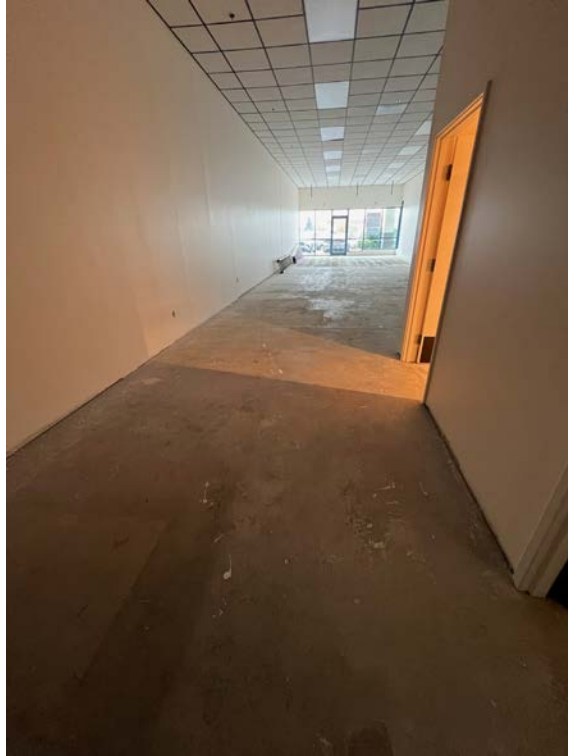
Photograph 7. Ceiling of Former Harbour Pointe Cleaners (Suite B6)  
(November 14, 2024)

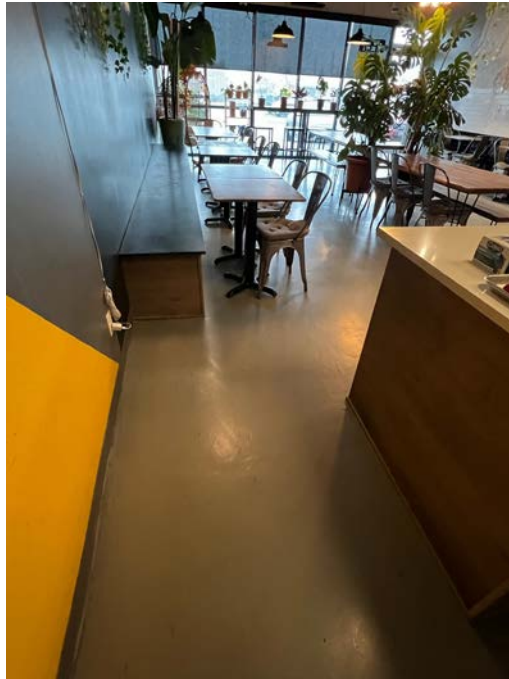
Photograph 8. Floor Slab in Adjacent-West Tenant Space (Suite B5)  
(November 14, 2024)

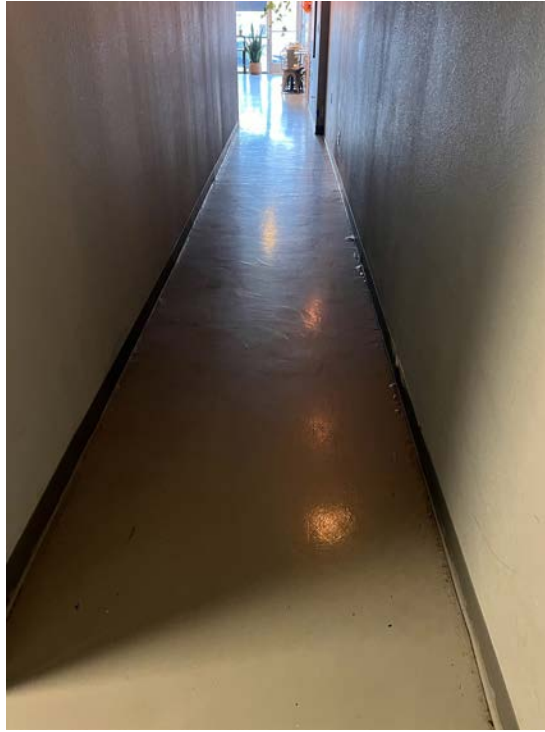
Photograph 9. Floor Slab in Hallway of Adjacent-West Tenant Space (Suite B5)  
(November 14, 2024)

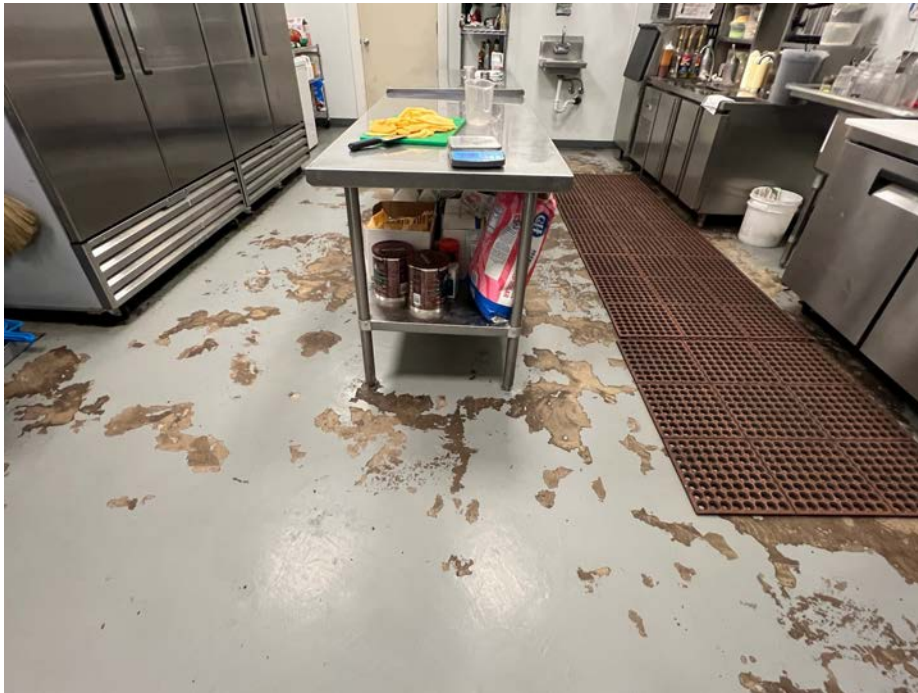
Photograph 10. Floor Slab in Kitchen of Adjacent-West Tenant Space (Suite B5)  
(November 14, 2024)

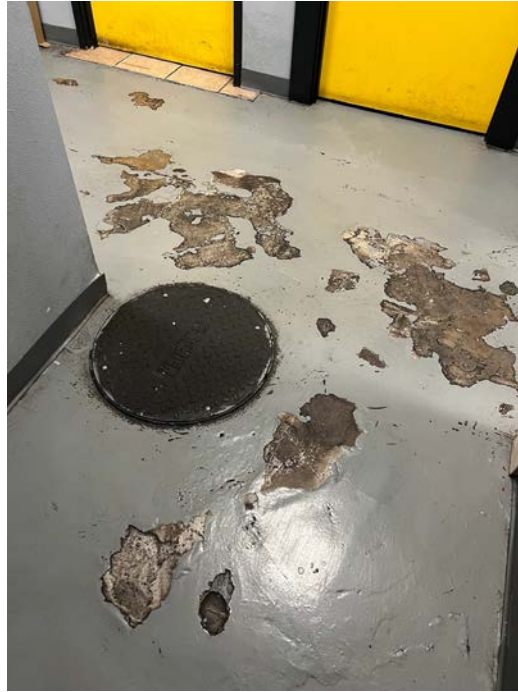
Photograph 11. Floor Slab in Rear Hallway of Adjacent-West Tenant Space (Suite B5) (November 14, 2024)

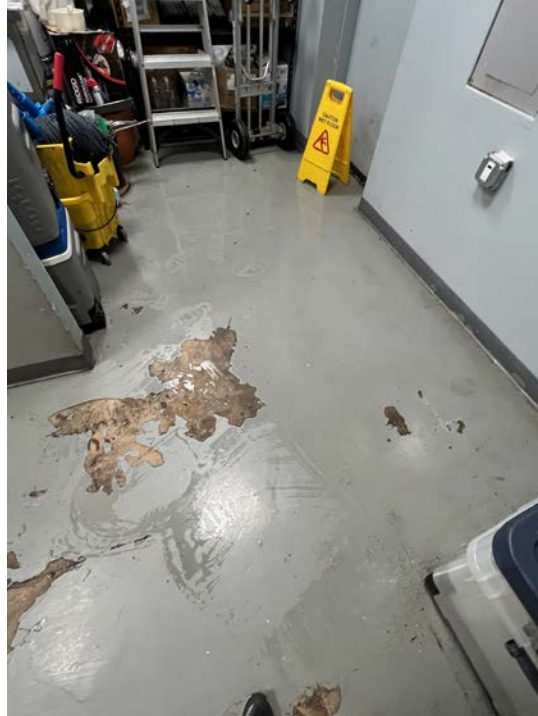
Photograph 12. Floor Slab in Rear Hallway of Adjacent-West Tenant Space (Suite B5) (November 14, 2024)

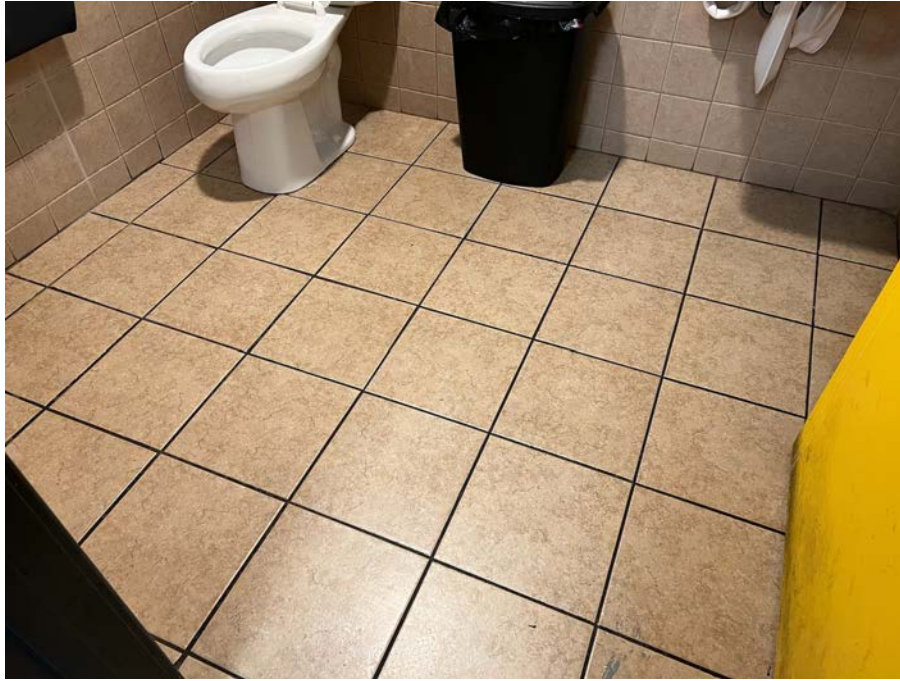
Photograph 13. Floor Slab in Bathroom 1 of Adjacent-West Tenant Space (Suite B5) (November 14, 2024)

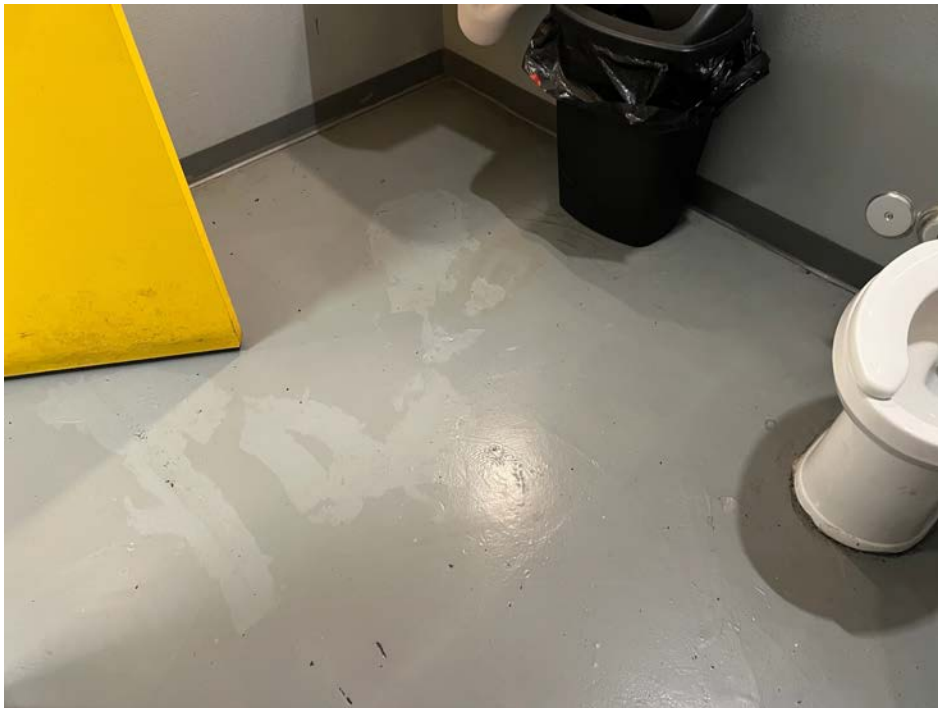
Photograph 14. Floor Slab in Bathroom 2 of Adjacent-West Tenant Space (Suite B5) (November 14, 2024)

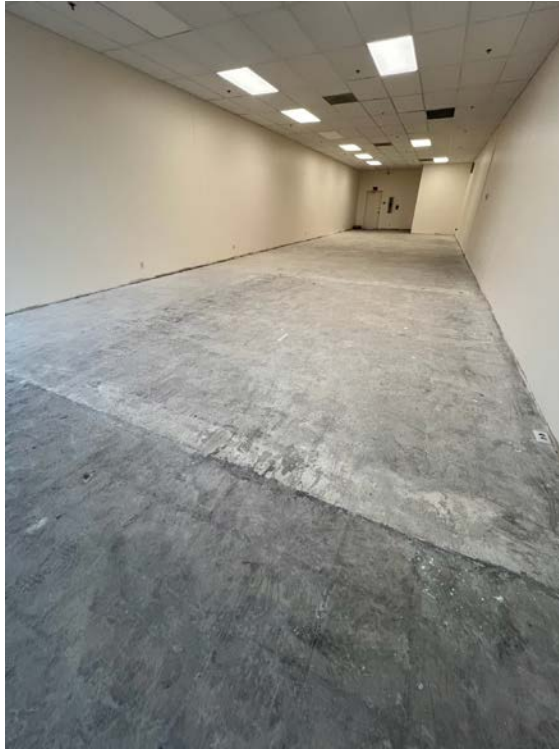
Photograph 15. Floor Slab and Ceiling in Suite B7 (November 14, 2024)

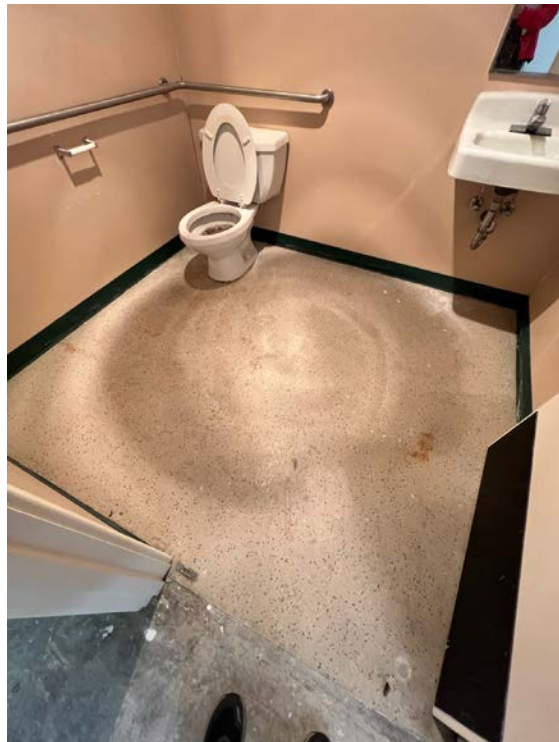
Photograph 16. Bathroom Floor in Suite B7 (November 14, 2024)
