# POST REMEDY INSPECTION REPORT

BNSF Northport Site

December 13, 2024

## ANNUAL POST REMEDY INSPECTION REPORT

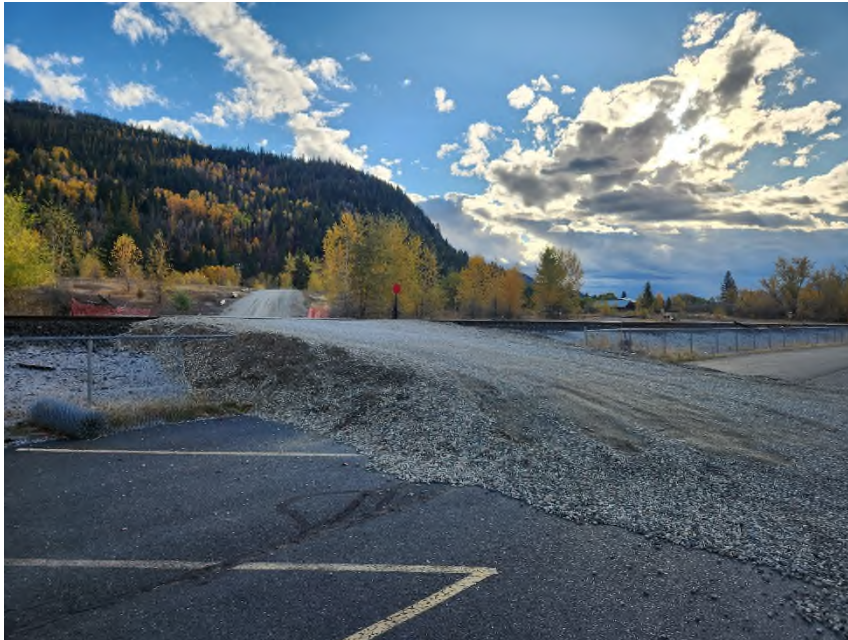
**Inspection Point:** 001

- Disturbance along the tracks over the capped area from a road installed by Ecology and removal of fence posts (Inspection Points: 001, 002, and 003 in Appendix A).
- Possible animal burrows observed north of BNSF tracks within the remediated area in the city park (Inspection Point: 007 in Appendix A).
- A portion of the asphalt parking lot could not be inspected due to the presence of the gravel road installed by Ecology (Inspection Point: 001 in Appendix A).

- Fence disassembly along the tracks from a road installed by Ecology (Inspection Points: 001, 003, and 008 in Appendix A).

Disturbance along track within capped area from road built by Ecology. View looking SW.

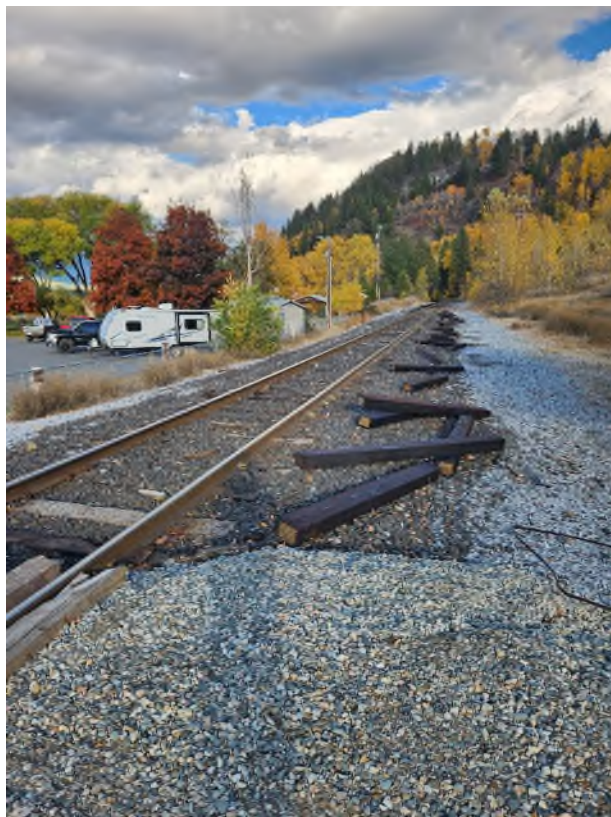
**Inspection Point:** 002

Disturbance along track over capped area from road built by Ecology. Looking NE.

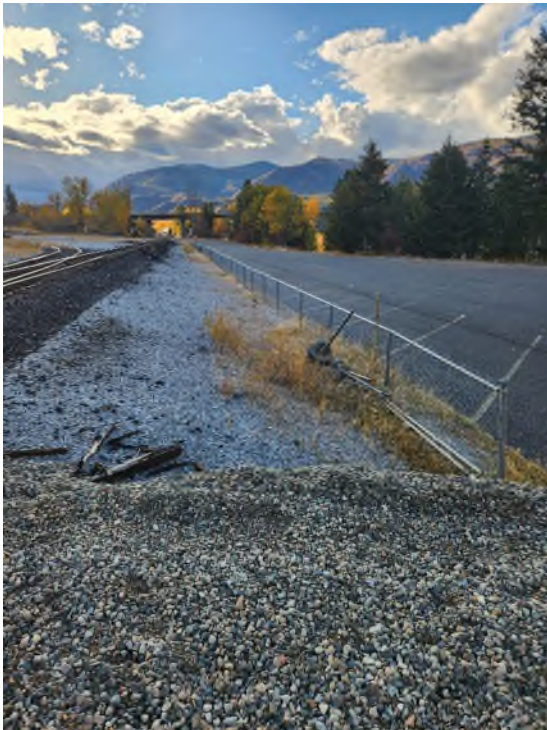
**Inspection Point:** 003

Disturbance to track prism and removal of fence posts and pilings within capped area.

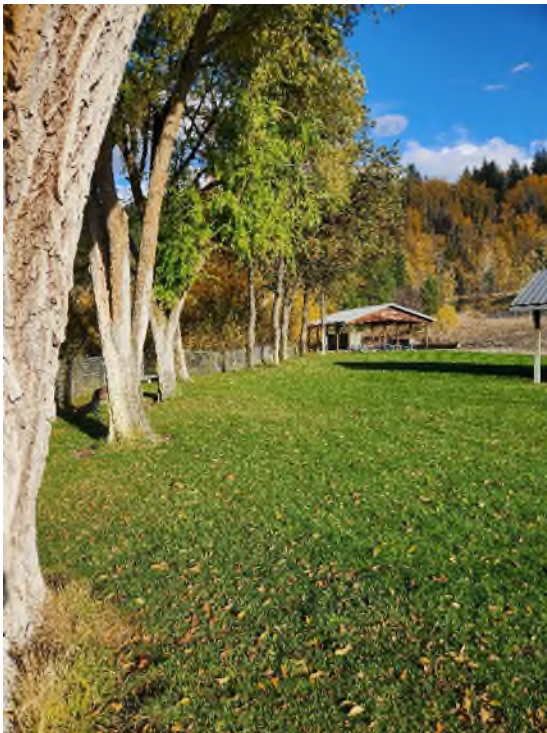
**Inspection Point:** 004

Trees located in areas that were not remediated appeared in good health and overlying sod and soil in those areas were also observed to be in good condition (Inspection Point: 004 in Appendix A)

Sod over remedied area. Trees in good health and do not appear stressed.

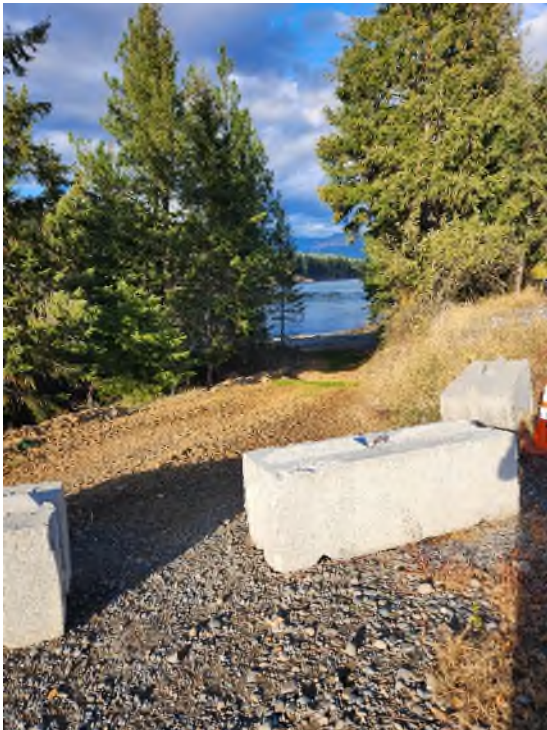
**Inspection Point:** 005

Ecology blocks in place blocking access to disturbed area leading to river shoreline.

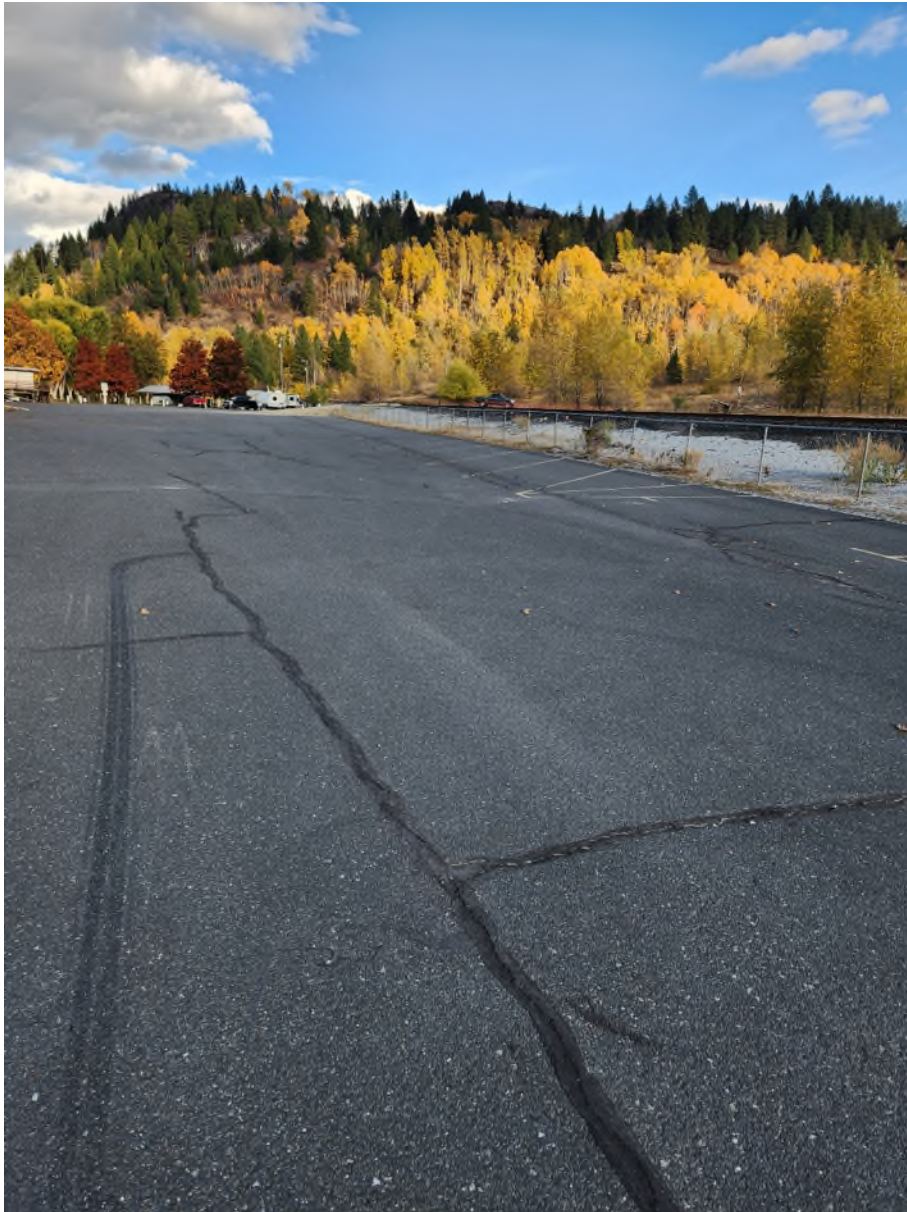
**Inspection Point:** 006

**Description:**  
Asphalt over  
remediated area in  
good condition.

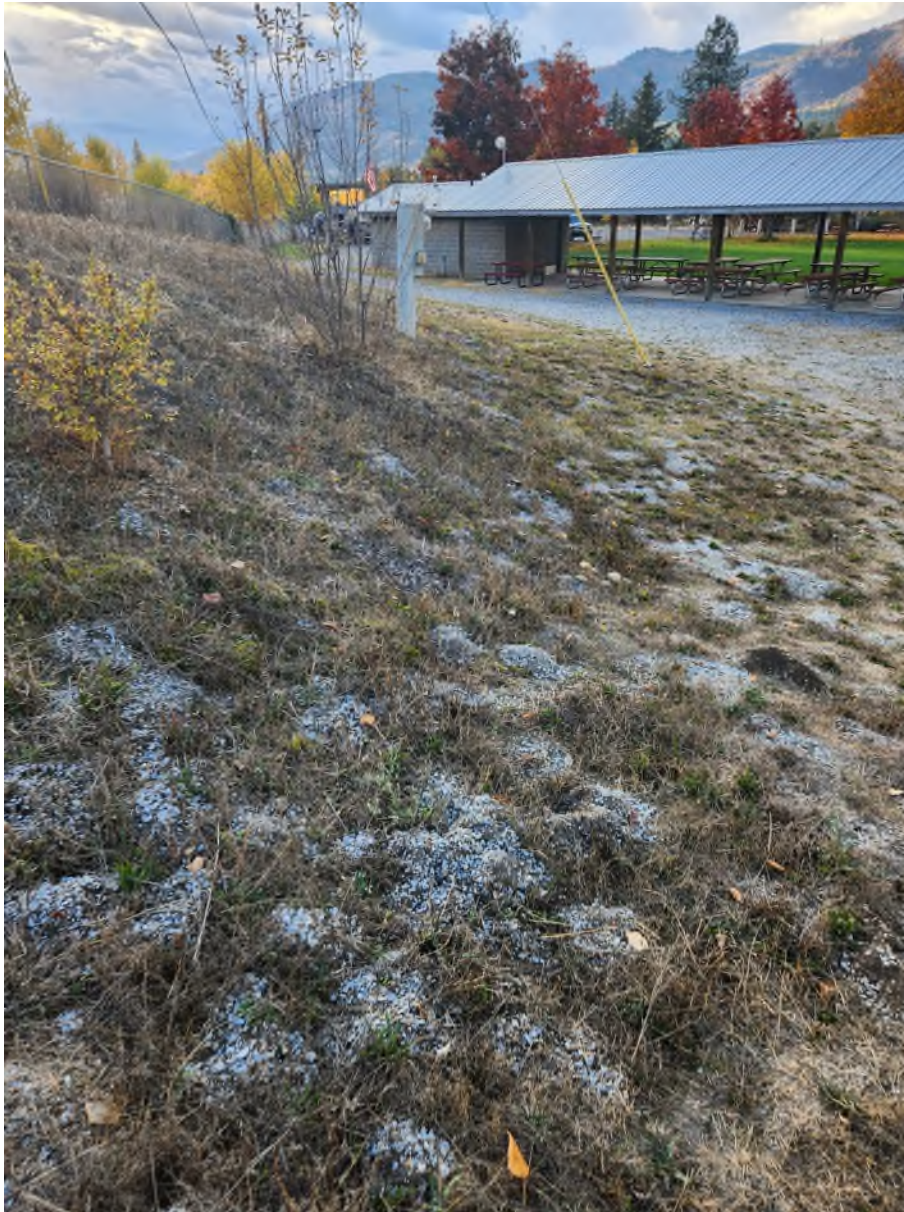
**Inspection Point:** 007

Erosional features could develop from the multiple burrows observed on the south end of the city park adjacent to the track and fence. The next post remedy inspection will occur in the second half of 2025.

Possible animal burrows present on north side of track in park area within remediated area. Fence condition on south end of the city park.

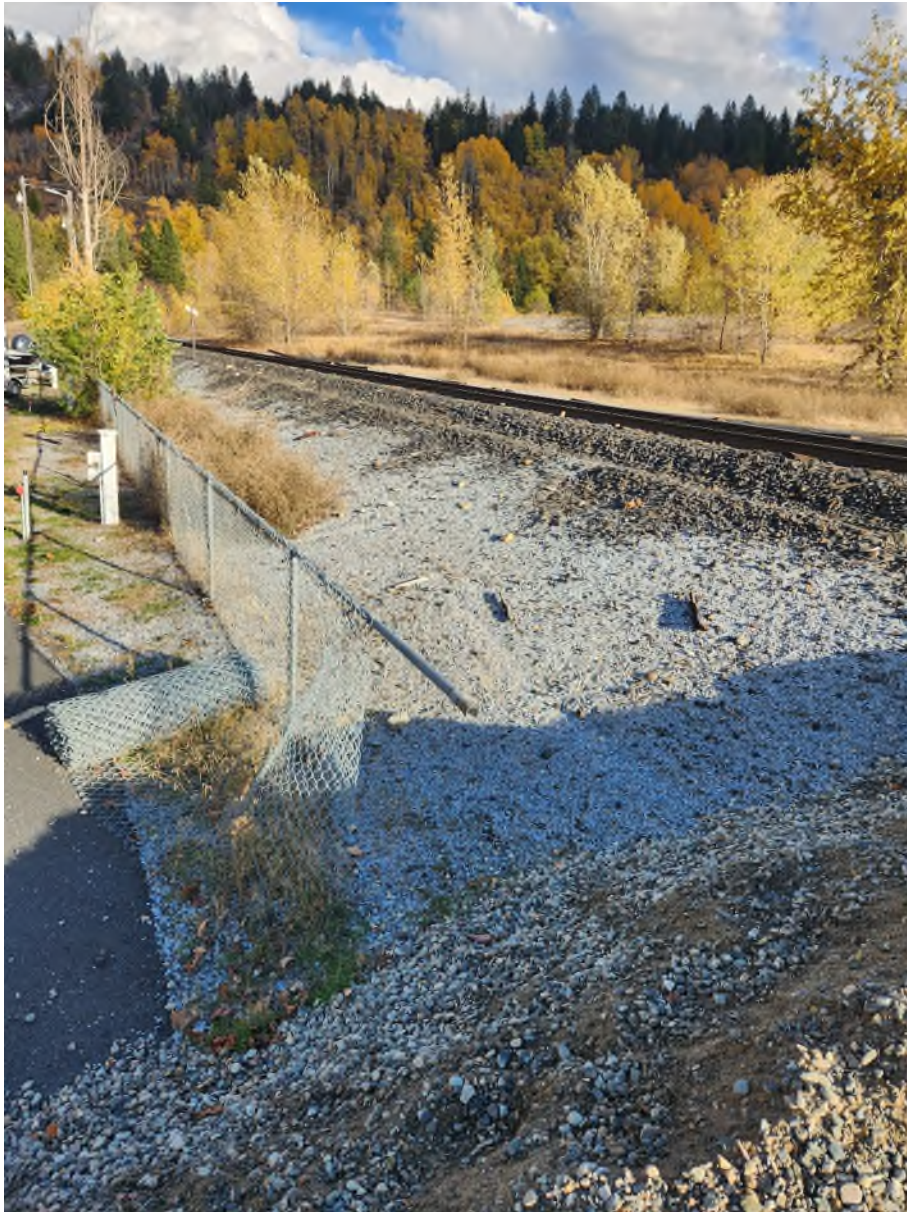
**Inspection Point:** 008

**Description:**  
Fence disassembly on  
the south edge of city  
park parking lot
