# Environmental Cap and Drainage System Inspection Report

Former Cascade Timber No. 3 Log Sort Yard  
(Ecology Facility ID #1206)

December 19, 2024

Project No. M0615.17.004

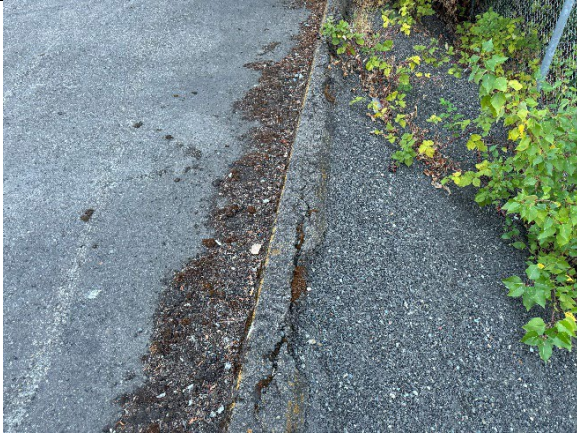
| ID <sup>1</sup> | Type of Structure | Observation | Recommended Actions | Photograph |
|---|---|--|--|--|
| C9 | Curb | Curb degradation extending approximately 20 lf; damage limited to backside of curb | Monitor repair and reevaluate during next inspection cycle | |

- Continue to monitor curb and slope deterioration at C9, C13, P5, and P6
- Reseal asphalt patch edges with missing sealant (P1, P7, P9, P12, and P58)

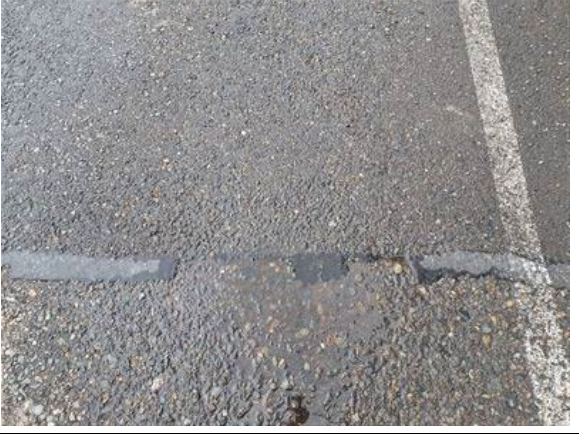
| ID <sup>1</sup> | Type of Structure | Observation | Recommended Actions | Photograph |
|---|---|--|---|--|
| P1 | Pavement | Repaired asphalt patch;<br>approximately 5 feet by 30 feet;<br>adjacent to catch basin CB2;<br>missing sealant around patch edge | Reseal edges | |

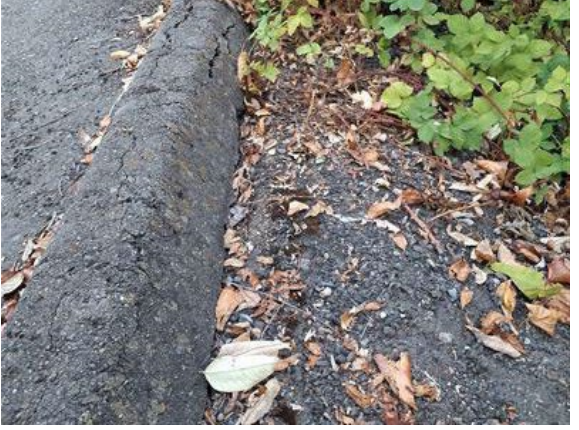
| ID <sup>1</sup> | Type of Structure | Observation | Recommended Actions | Photograph |
|---|---|--|---|--|
| P5 | Pavement | Recycled asphalt repair of pavement<br>edge deterioration; small gap<br>approximately 40 feet long | Monitor gravel and pavement edge and<br>reevaluate during next inspection cycle | |

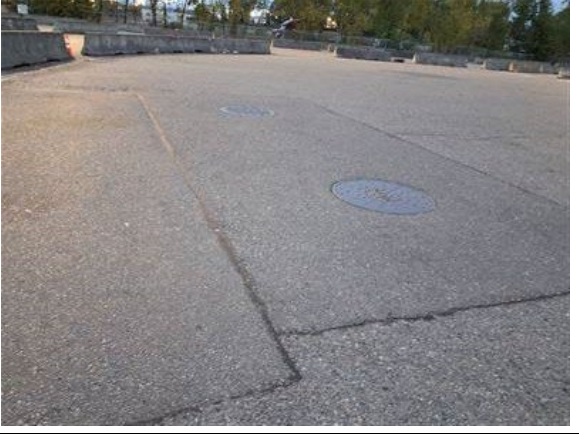
| ID <sup>1</sup> | Type of Structure | Observation | Recommended Actions | Photograph |
|---|---|--|---|--|
| P7 | Pavement | Repaired asphalt in good condition; joints previously sealed but missing sealant in places | Reseal edges | |

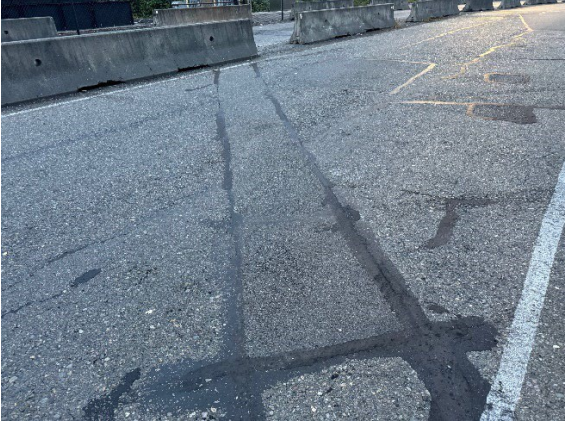
| ID <sup>1</sup> | Type of Structure | Observation | Recommended Actions | Photograph |
|---|---|--|---|--|
| P9 | Pavement | Repaired asphalt in good condition; joints previously sealed but missing sealant in places | Reseal joint | |

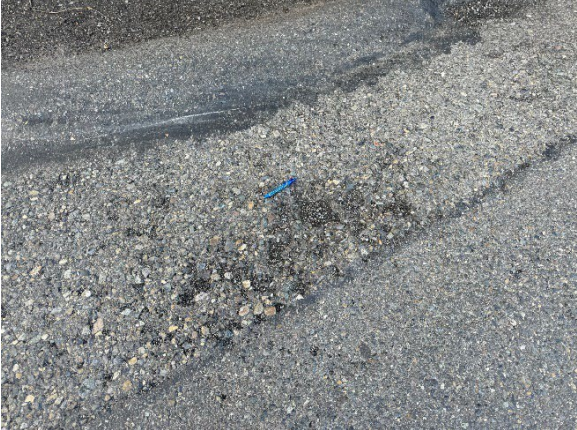
| ID <sup>1</sup> | Type of Structure | Observation | Recommended Actions | Photograph |
|---|---|--|---|--|
| P37 | Pavement | Repaired asphalt, degraded in places | Monitor and reevaluate during next inspection cycle | |

- Seal cracks at P16, P19, P28, P29, P38, P65, P67, P68, P70, P73, P74, P89, and P90
- Repair asphalt depressions/divots at P19, P84, P86, and P87
- Monitor gouges, cracks, and depressions in asphalt at P37, P46, P69, P71, and P75.

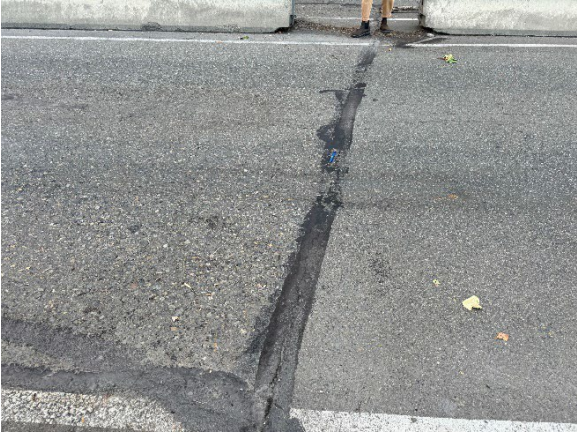
| ID <sup>1</sup> | Type of Structure | Observation | Recommended Actions | Photograph |
|---|---|--|--|--|
| P38 | Pavement | Previously sealed crack with sealant missing in places; approximately 30 lf | Reseal crack | |

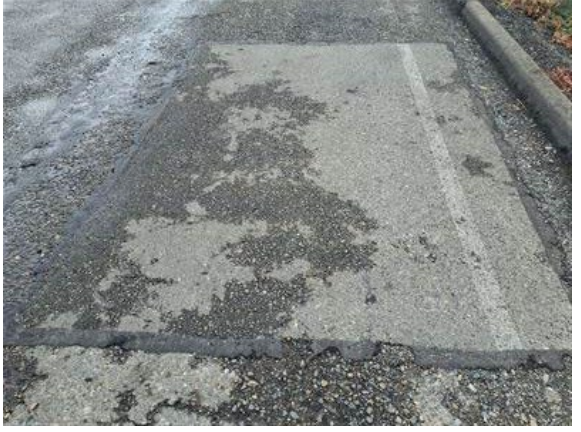
| ID <sup>1</sup> | Type of Structure | Observation | Recommended Actions | Photograph |
|---|---|--|---|--|
| P58 | Pavement | Previously repaired asphalt; approximately 5-foot-by-8-foot area; sealant missing on edges | Reseal edges | |

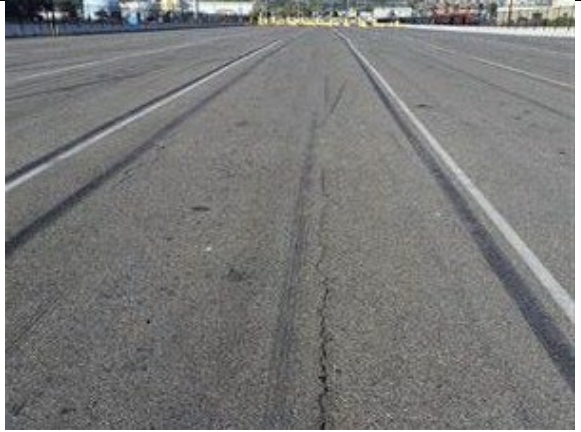
| ID <sup>1</sup> | Type of Structure | Observation | Recommended Actions | Photograph |
|---|---|--|---|--|
| P65 | Pavement | Linear crack approximately 75 lf wider than 1/8 inch; runs along driveway lane | Seal crack | |

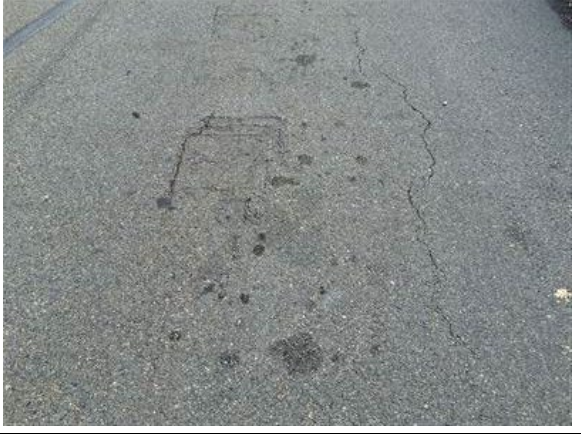
| ID <sup>1</sup> | Type of Structure | Observation | Recommended Actions | Photograph |
|---|---|--|---|--|
| P67 | Pavement | Cracks and depression in asphalt near northeast extent of cap; runs along width of cap | Seal cracks | |

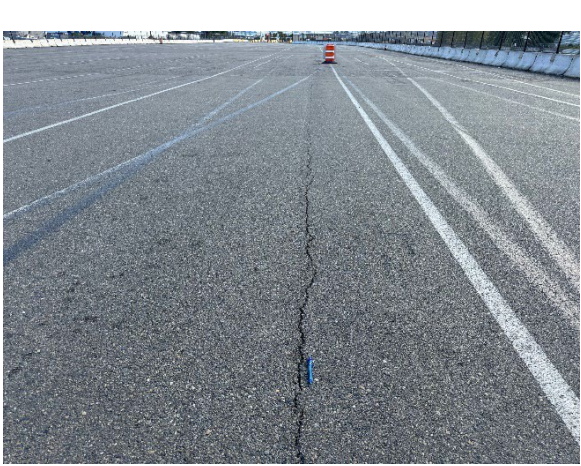
| ID <sup>1</sup> | Type of Structure | Observation | Recommended Actions | Photograph |
|---|---|--|---|--|
| P68 | Pavement | Linear crack approximately 75 lf; wider than 1/8 inch; runs along driveway lane | Seal crack | |

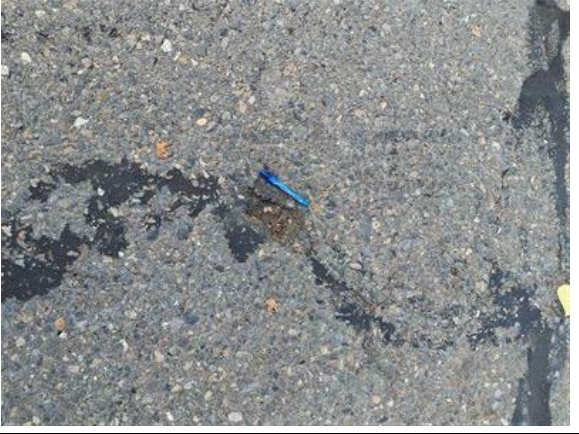
| ID <sup>1</sup> | Type of Structure | Observation | Recommended Actions | Photograph |
|---|---|---|---|--|
| P71 | Pavement | Minor gouge in asphalt; approximately 4 inches long and 1/2 inch deep | Monitor and reevaluate during next inspection cycle | |

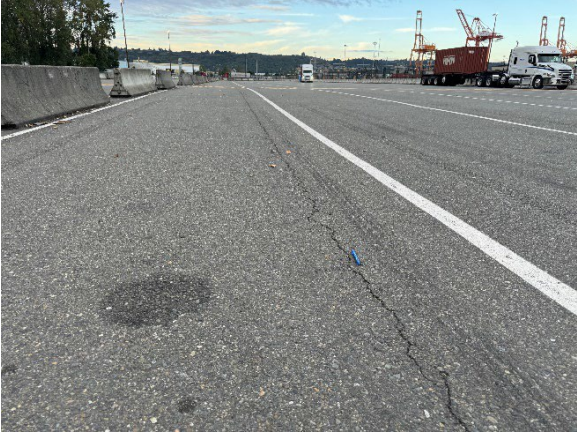
| ID <sup>1</sup> | Type of Structure | Observation | Recommended Actions | Photograph |
|---|---|--|---|--|
| P74 | Pavement | Linear crack approximately 100 lf; wider than 1/8 inch; runs along driveway lane | Seal crack | |

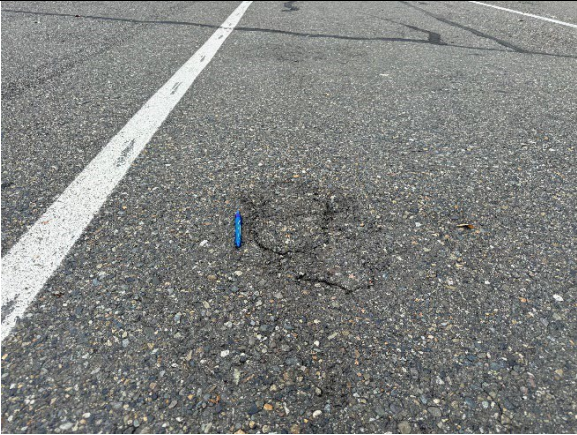
| ID <sup>1</sup> | Type of Structure | Observation | Recommended Actions | Photograph |
|---|---|--|---|--|
| P75 | Pavement | Minor depression in asphalt; approximately 1-foot-by-1-foot | Monitor and reevaluate during next inspection cycle | |

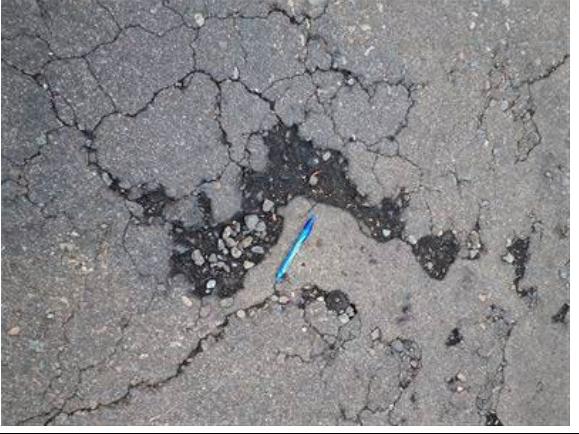
| ID <sup>1</sup> | Type of Structure | Observation | Recommended Actions | Photograph |
|---|---|--|---|--|
| P84 | Pavement | Alligator cracking and divot in asphalt; approximately 4-foot-by-4-foot area | Repair asphalt alligator cracking and reseal smaller cracks | |

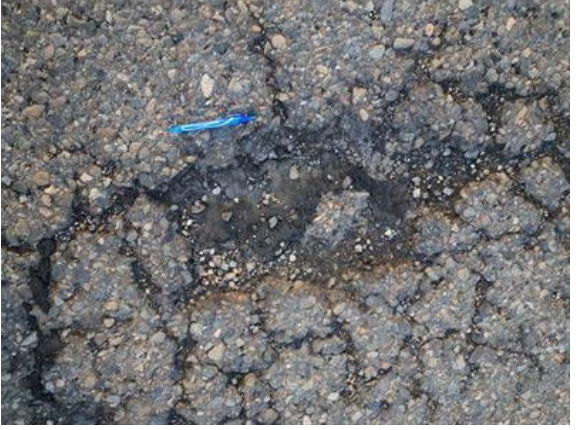
| ID <sup>1</sup> | Type of Structure | Observation | Recommended Actions | Photograph |
|---|---|--|---|--|
| P86 | Pavement | Previously sealed divot in asphalt with sealant missing in places; approximately 2-foot-by-1-foot area and 1/2 inch deep | Reseal cracks and divot | |

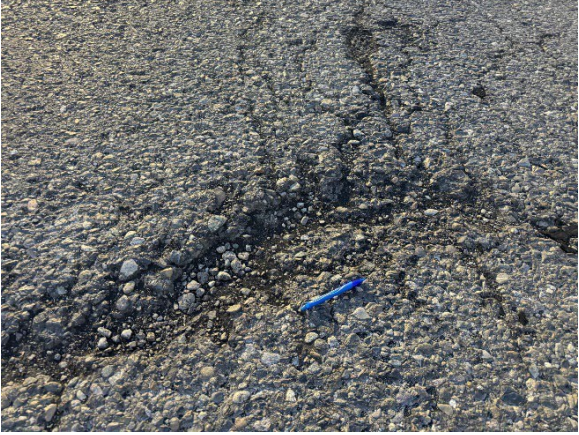
| ID <sup>1</sup> | Type of Structure | Observation | Recommended Actions | Photograph |
|---|---|--|---|--|
| P87 | Pavement | Gouge in asphalt; approximately 3-foot-by-1-foot area and 1/2 inch deep | Repair asphalt gouge | |

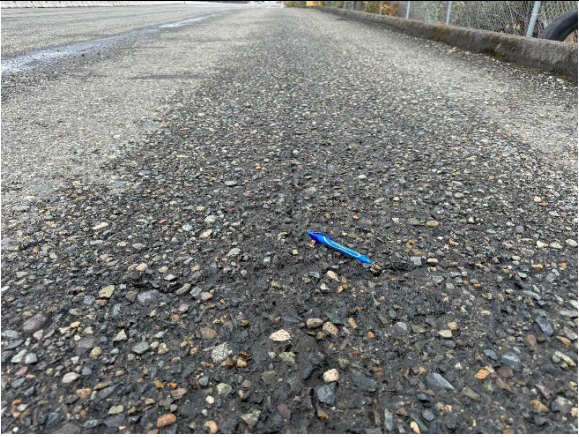
| ID <sup>1</sup> | Type of Structure | Observation | Recommended Actions | Photograph |
|---|---|--|---|--|
| P89 | Pavement | Linear crack approximately 15 lf 1/4-inch wide; extends from P52 and P53 | Seal crack | |

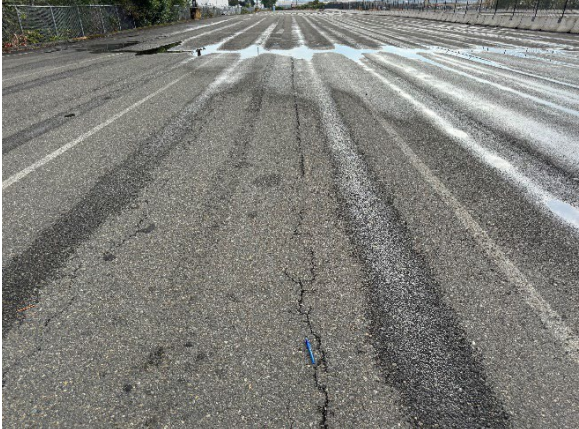
| ID <sup>1</sup> | Type of Structure | Observation | Recommended Actions | Photograph |
|---|---|---|---|---|
| P90 | Pavement | Multiple linear cracks within tire ruts; wider than 1/8 inch; extending to end of cap | Repair larger rut cracks; seal smaller cracks | |

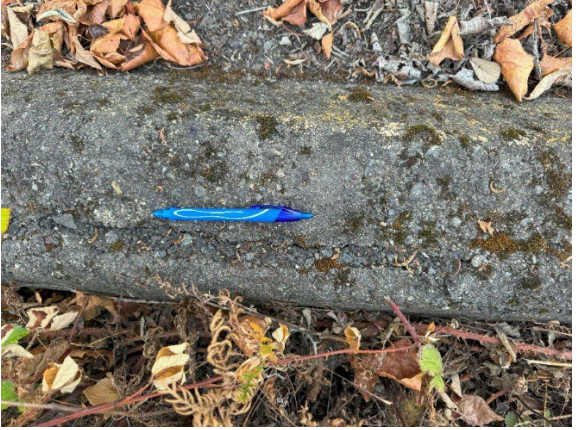
| ID <sup>1</sup> | Type of Structure | Observation | Recommended Actions | Photograph |
|---|---|--|--|--|
| C12 | Curb | Sealed crack in top of curb as wide as 2 inches; approximately 15 lf | None | |

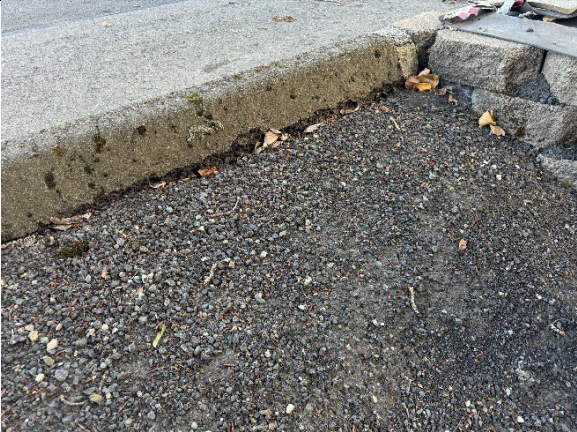
| ID <sup>1</sup> | Type of Structure | Observation | Recommended Actions | Photograph |
|---|---|--|---|--|
| P4 | Pavement | Slope stabilized with gravel at pavement edge; approximately 20 lf | None | |

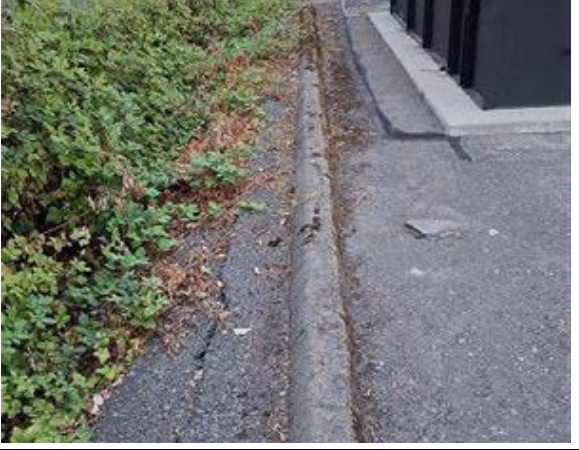
| ID <sup>1</sup> | Type of Structure | Observation | Recommended Actions | Photograph |
|---|---|--|--|--|
| P6 | Pavement | Gravel added to stabilize pavement edge; approximately 45 lf; cracks forming again | Monitor repair and reevaluate during next inspection cycle | |

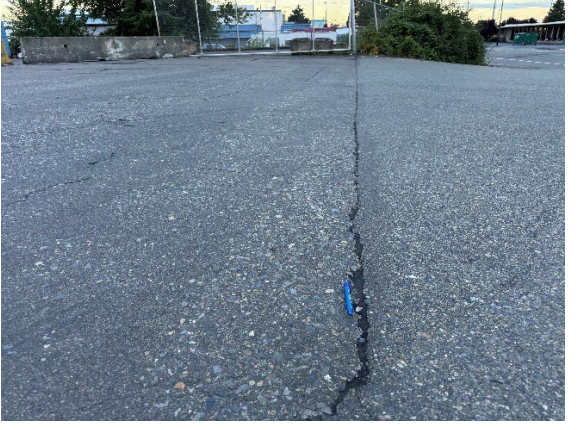
| ID <sup>1</sup> | Type of Structure | Observation | Recommended Actions | Photograph |
|---|---|--|--|--|
| P10 | Pavement | Sealed crack extending across site entrance; approximately 50 lf | None | |

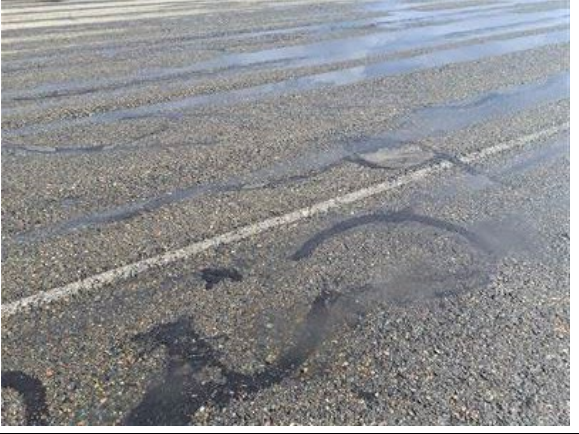
| ID <sup>1</sup> | Type of Structure | Observation | Recommended Actions | Photograph |
|---|---|---|---|--|
| P11 | Pavement | Sealed cracks | None | |

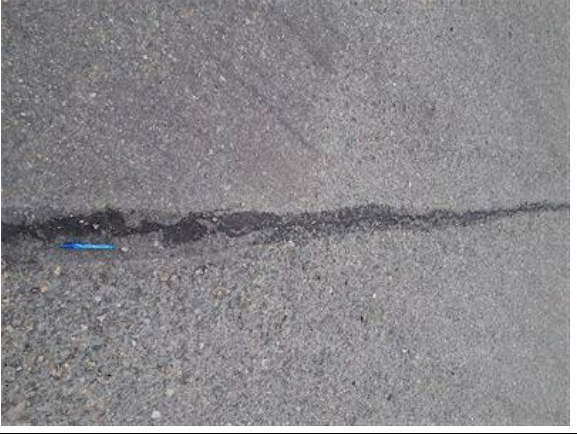
| ID <sup>1</sup> | Type of Structure | Observation | Recommended Actions | Photograph |
|---|---|---|---|--|
| P15 | Pavement | Sealed crack runs northeast along length of cap | None | |

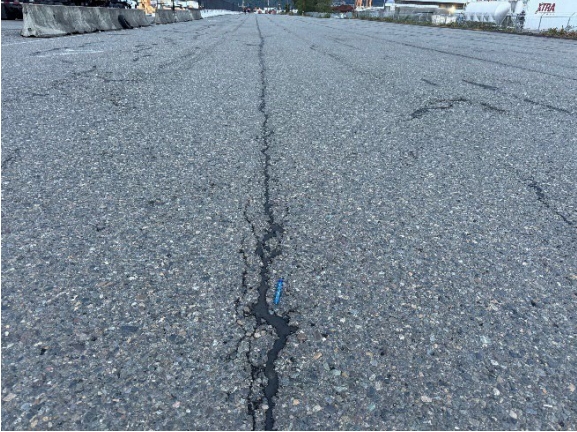
| ID <sup>1</sup> | Type of Structure | Observation | Recommended Actions | Photograph |
|---|---|---|---|--|
| P17 | Pavement | Sealed crack | None | |

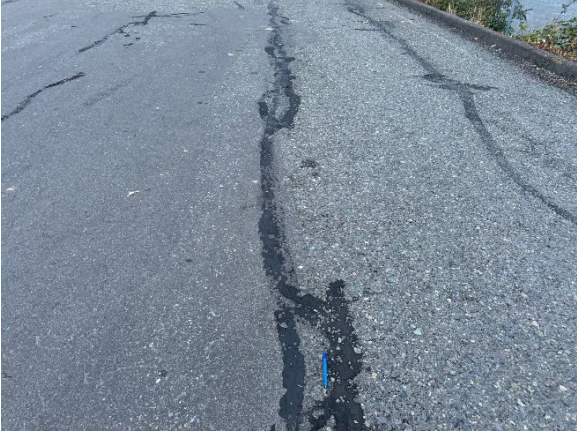
| ID <sup>1</sup> | Type of Structure | Observation | Recommended Actions | Photograph |
|---|---|---|---|--|
| P20 | Pavement | Sealed cracks run northeast along the length of cap | None | |

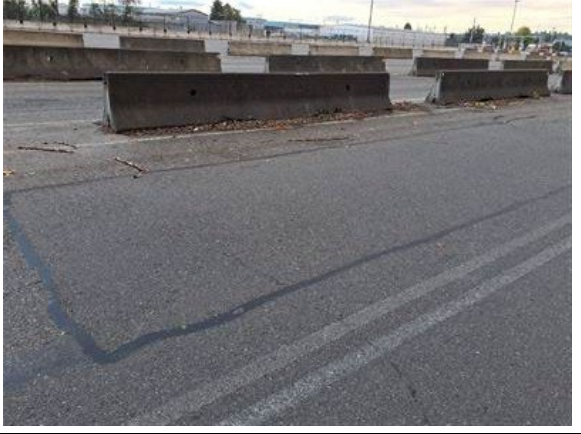
| ID <sup>1</sup> | Type of Structure | Observation | Recommended Actions | Photograph |
|---|---|--|---|--|
| P23 | Pavement | Sealed edges of previous asphalt repair; approximately 10-foot-by-20-foot area | None | |

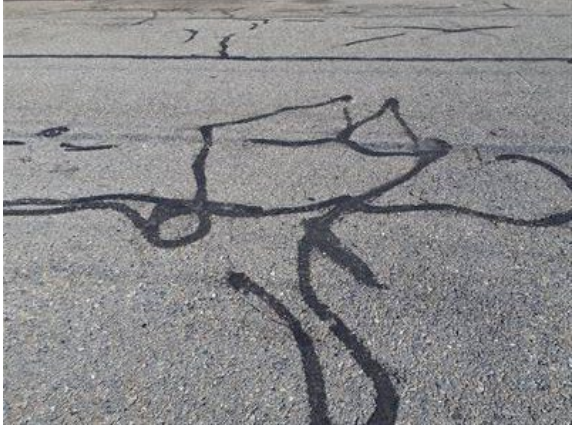
| ID <sup>1</sup> | Type of Structure | Observation | Recommended Actions | Photograph |
|---|---|--|---|--|
| P26 | Pavement | Sealed cracks | None | |

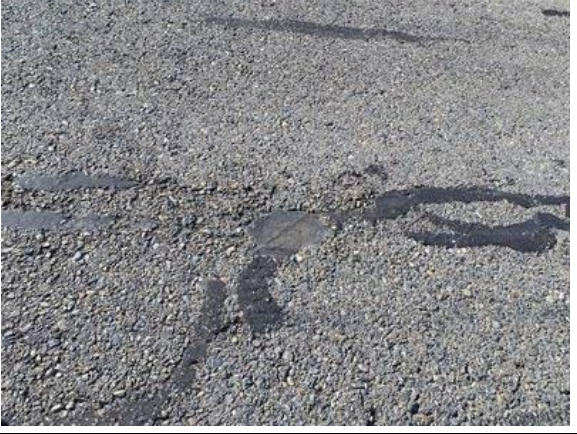
| ID <sup>1</sup> | Type of Structure | Observation | Recommended Actions | Photograph |
|---|---|---|---|--|
| P27 | Pavement | Sealed cracks and asphalt depression | None | |

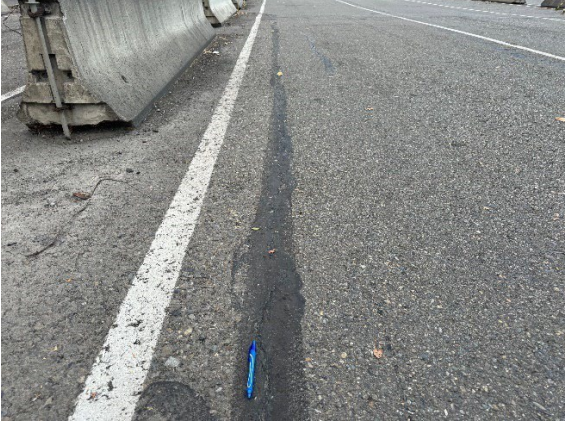
| ID <sup>1</sup> | Type of Structure | Observation | Recommended Actions | Photograph |
|---|---|---|---|--|
| P30 | Pavement | Sealed crack | None | |

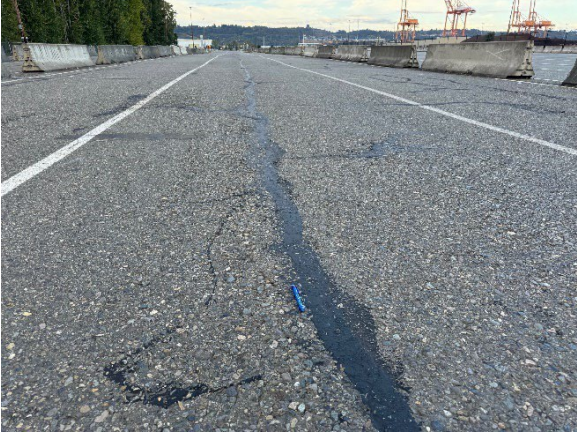
| ID <sup>1</sup> | Type of Structure | Observation | Recommended Actions | Photograph |
|---|---|---|---|--|
| P31 | Pavement | Sealed cracks | None | |

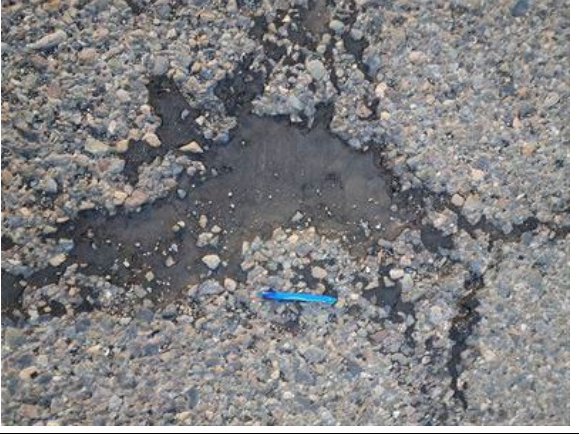
| ID <sup>1</sup> | Type of Structure | Observation | Recommended Actions | Photograph |
|---|---|---|---|--|
| P35 | Pavement | Repaired asphalt | None | |

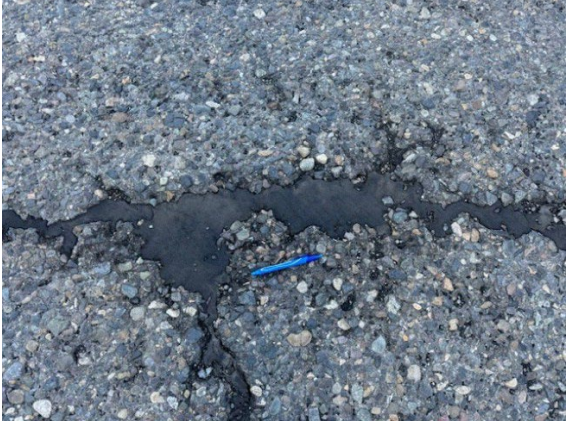
| ID <sup>1</sup> | Type of Structure | Observation | Recommended Actions | Photograph |
|---|---|---|---|--|
| P36 | Pavement | Sealed crack/divot | None | |

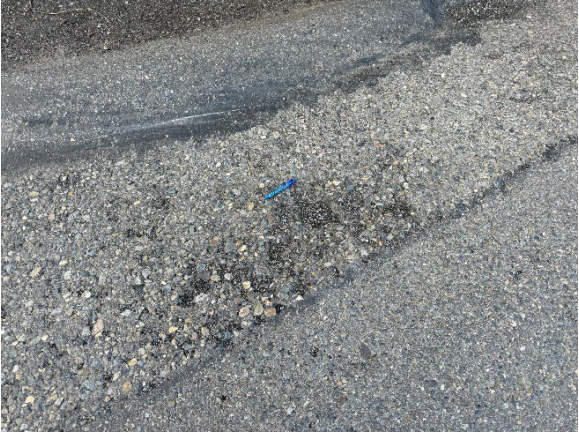
| ID <sup>1</sup> | Type of Structure | Observation | Recommended Actions | Photograph |
|---|---|---|---|--|
| P37 | Pavement | Repaired asphalt, degraded in places | Monitor and reevaluate during next inspection cycle | |

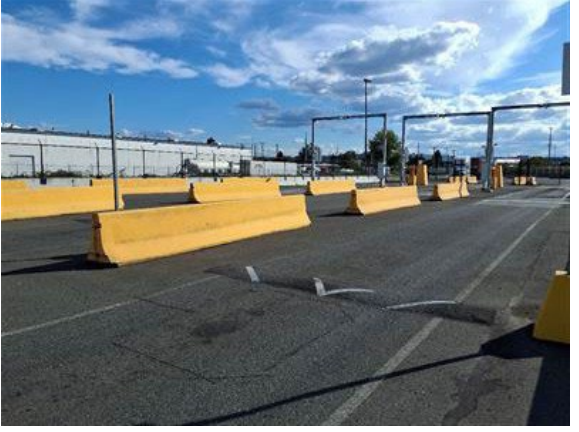
| ID <sup>1</sup> | Type of Structure | Observation | Recommended Actions | Photograph |
|---|---|--|--|--|
| P46 | Pavement | Asphalt repair near truck scale area; approximately 250-foot-by-150-foot area; wheel ruts present, but no visible cracking | Monitor and reevaluate wheel ruts during next inspection cycle | |

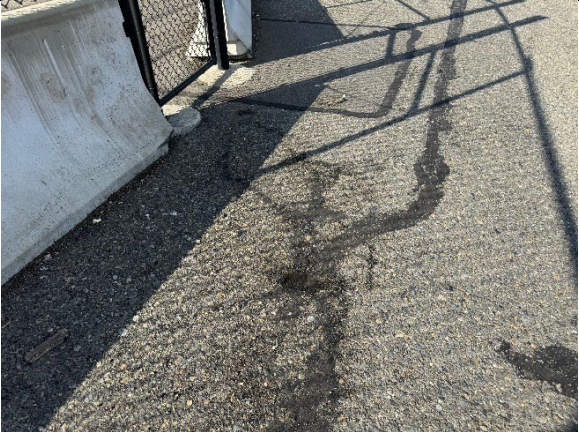
| ID <sup>1</sup> | Type of Structure | Observation | Recommended Actions | Photograph |
|---|---|--|--|--|
| P47 | Pavement | Sealed cracks | None | |

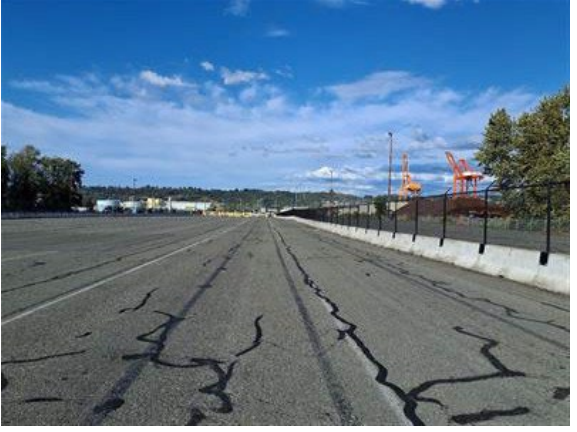
| ID <sup>1</sup> | Type of Structure | Observation | Recommended Actions | Photograph |
|---|---|---|---|--|
| P50 | Pavement | Sealed cracks; several hundred lf | None | |

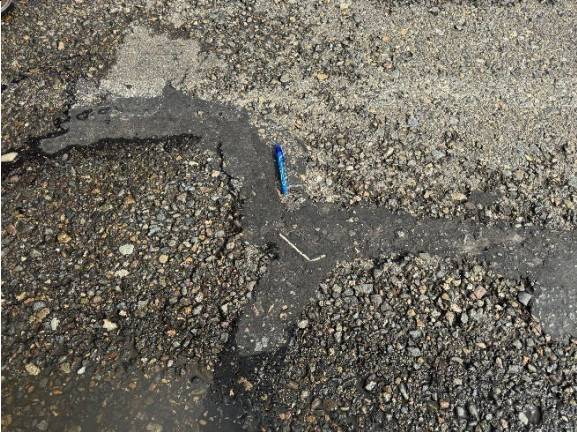
| ID <sup>1</sup> | Type of Structure | Observation | Recommended Actions | Photograph |
|---|---|---|---|--|
| P59 | Pavement | Sealed crack | None | |

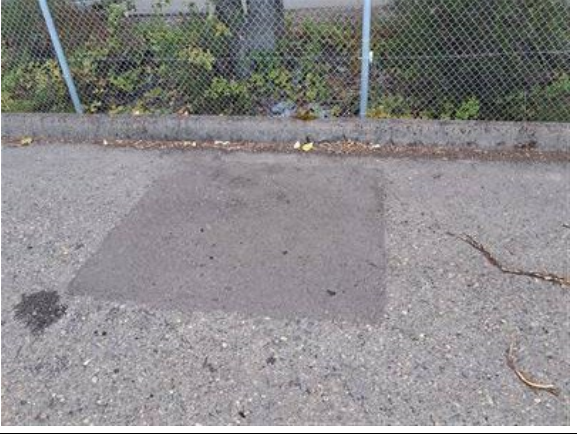
| ID <sup>1</sup> | Type of Structure | Observation | Recommended Actions | Photograph |
|---|---|---|---|--|
| P60 | Pavement | Asphalt repair; approximately 3-foot-by-3-foot area | None | |

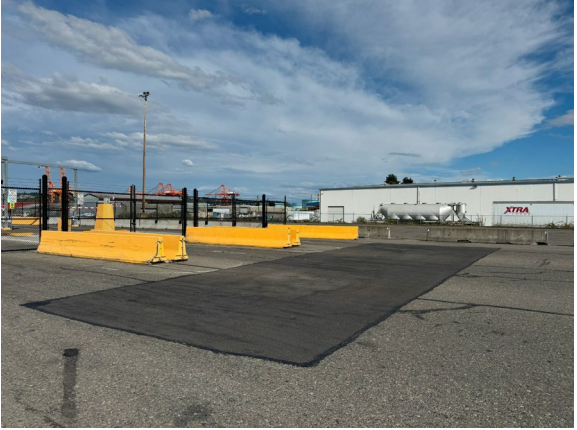
| ID <sup>1</sup> | Type of Structure | Observation | Recommended Actions | Photograph |
|---|---|---|---|--|
| P61 | Pavement | Repaired asphalt; approximately 30-foot-by-15-foot area | None | |

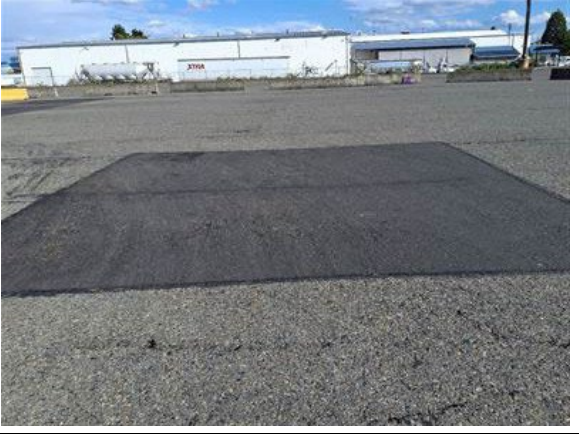
| ID <sup>1</sup> | Type of Structure | Observation | Recommended Actions | Photograph |
|---|---|---|---|--|
| P62 | Pavement | Repaired asphalt; approximately 20-foot-by-20-foot area; location of previous cap observation P34 | None | |

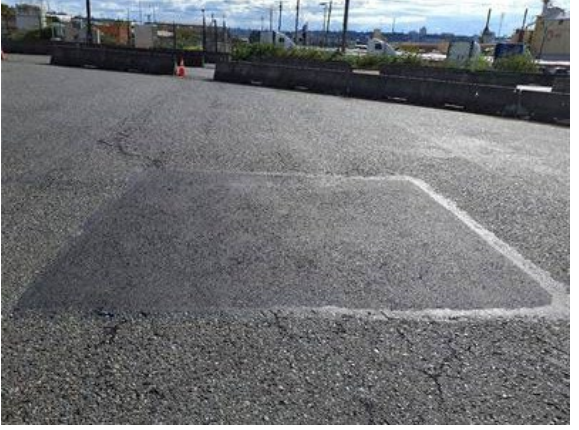
| ID <sup>1</sup> | Type of Structure | Observation | Recommended Actions | Photograph |
|---|---|---|---|--|
| P63 | Pavement | Repaired asphalt; approximately 10-foot-by-12-foot area; location of previous cap observation P33 | None | |

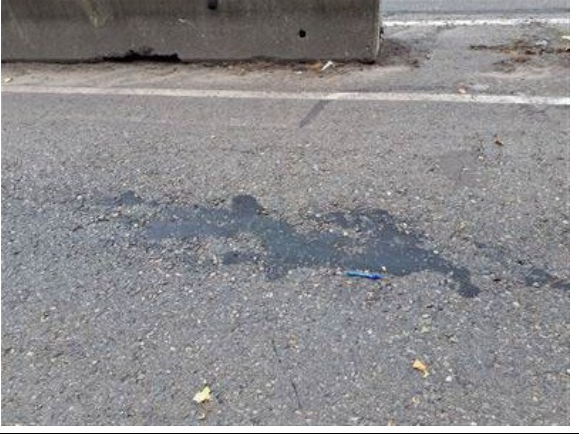
| ID <sup>1</sup> | Type of Structure | Observation | Recommended Actions | Photograph |
|---|---|---|---|--|
| P72 | Pavement | Repaired asphalt; approximately 4-foot-by-1-foot area | None | |

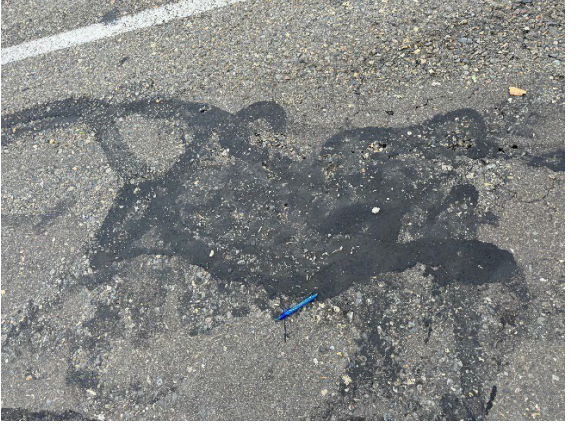
| ID <sup>1</sup> | Type of Structure | Observation | Recommended Actions | Photograph |
|---|---|---|---|--|
| P76 | Pavement | Sealed cracks | None | |

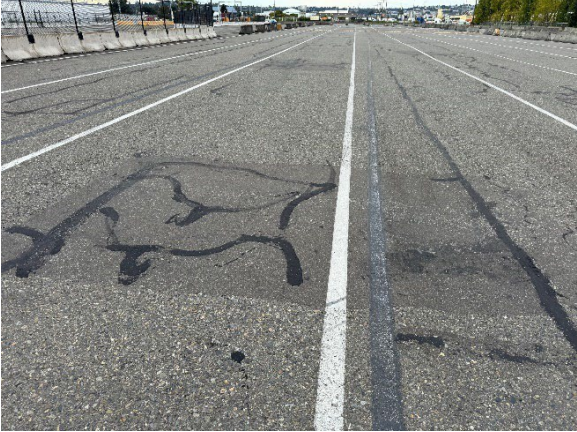
| ID <sup>1</sup> | Type of Structure | Observation | Recommended Actions | Photograph |
|---|---|--|---|--|
| P78 | Pavement | Sealed cracks and repaired asphalt; approximately 6-foot-by-12-foot area | None | |

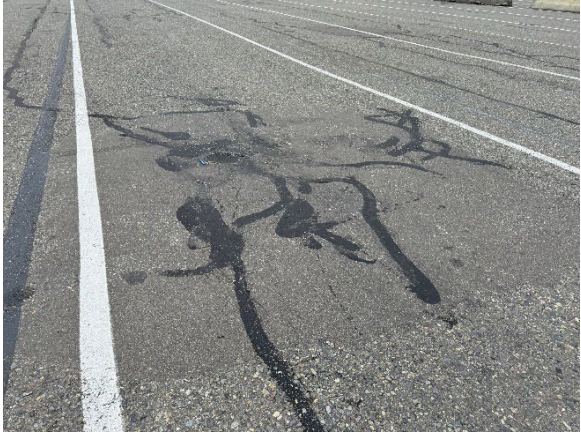
| ID <sup>1</sup> | Type of Structure | Observation | Recommended Actions | Photograph |
|---|---|--|---|--|
| P79 | Pavement | Sealed cracks and repaired asphalt; approximately 8-foot-by-8-foot area; divot filled with sealant | None | |

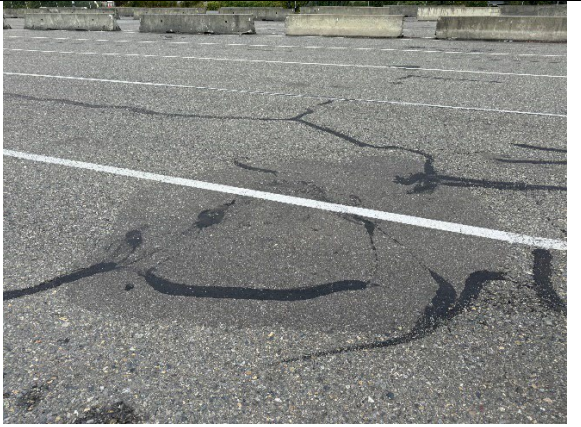
| ID <sup>1</sup> | Type of Structure | Observation | Recommended Actions | Photograph |
|---|---|--|---|--|
| P80 | Pavement | Sealed cracks and circular asphalt patch; approximately 6-foot diameter | None | |

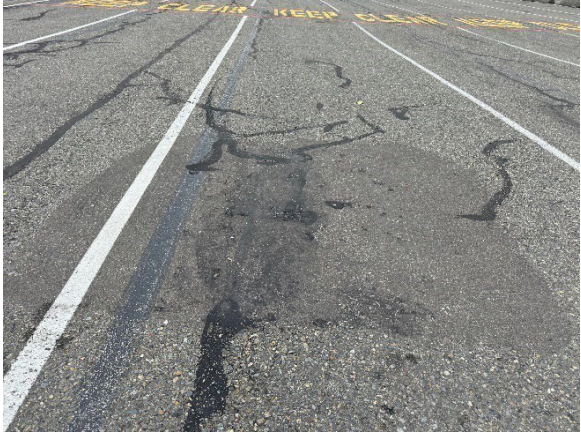
| ID <sup>1</sup> | Type of Structure | Observation | Recommended Actions | Photograph |
|---|---|---|---|--|
| P81 | Pavement | Sealed cracks and repaired asphalt; approximately 5-foot-by-6-foot area | None | |

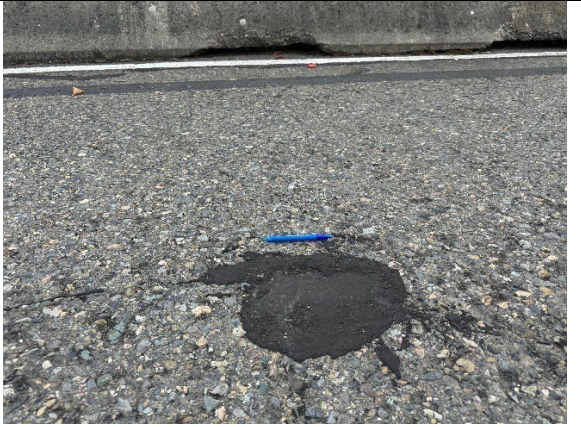
| ID <sup>1</sup> | Type of Structure | Observation | Recommended Actions | Photograph |
|---|---|---|---|--|
| P82 | Pavement | Repaired sealant; approximately 6-inch-by-3-inch area | None | |

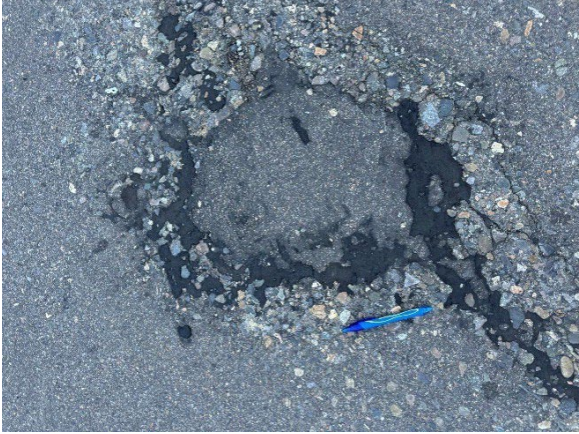
| ID <sup>1</sup> | Type of Structure | Observation | Recommended Actions | Photograph |
|---|---|--|---|--|
| P83 | Pavement | Sealed divot near site entrance; approximately 1-foot-by-1-foot area | None | |

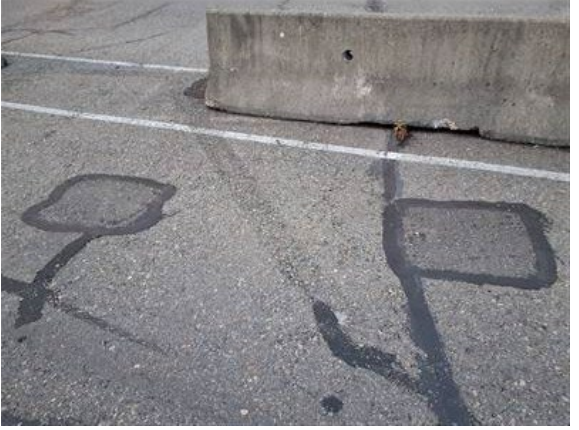
| ID <sup>1</sup> | Type of Structure | Observation | Recommended Actions | Photograph |
|---|---|--|---|--|
| P85 | Pavement | Two adjacent asphalt repairs; approximately 2-foot-by-2-foot areas | None | |

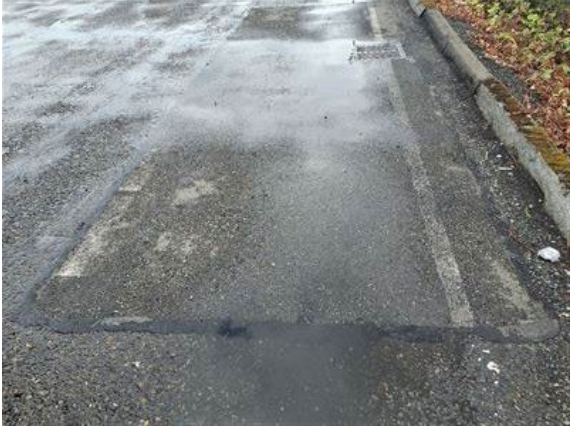
| ID <sup>1</sup> | Type of Structure | Observation | Recommended Actions | Photograph |
|---|---|--|---|---|
| P88 | Pavement | Sealant around previous asphalt repair; approximately 5-foot-by-15-foot area | None | |

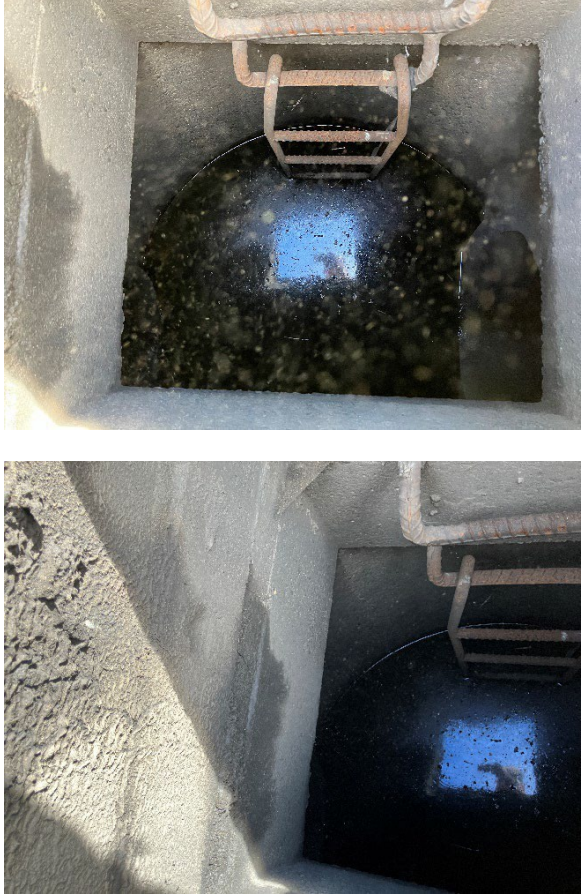
| ID | Type of Structure | Observed Condition | Sediment Accumulation | Additional observations | Recommended Actions | Photographs |
|---|---|--|---|---|--|--|
| CB2 | Catch basin | Structurally sound, functioning normally | Water in structure, too deep to measure | Trace floatables on surface | Replace insert; remove floatables in accordance with stormwater maintenance requirements | |

Floatables were observed in several catch basins and maintenance hole structures. Structures should be cleaned in accordance with stormwater maintenance requirements. Stormwater structures were generally in good condition and recommendations are limited to regular cleaning and maintenance, as required by the facility's stormwater permit. Required and recommended actions are further described in Table 2-3.

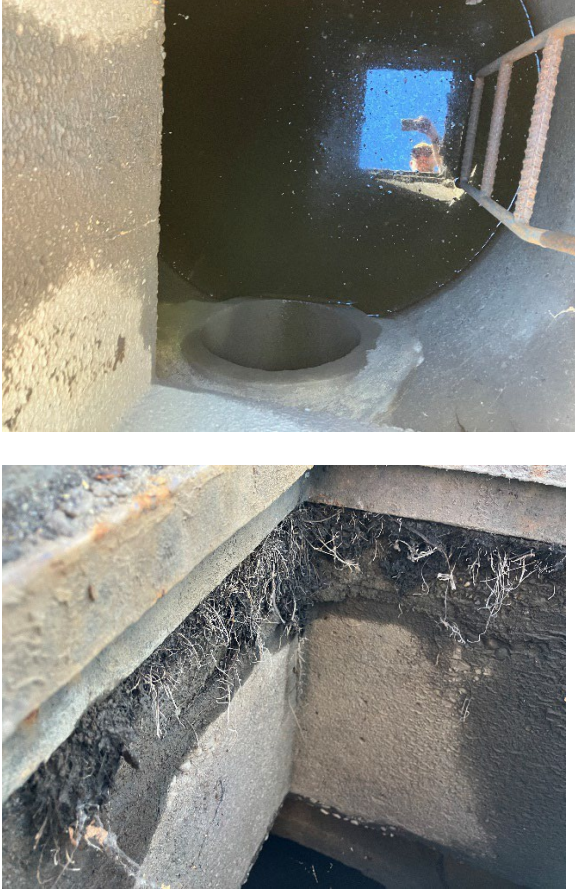
| ID | Type of Structure | Observed Condition | Sediment Accumulation | Additional observations | Recommended Actions | Photographs |
|---|---|--|--|---|---|--|
| CB3 | Catch basin | Structurally sound; functioning normally | Water in structure and too deep to measure | Trace floatables on surface | Clear debris around catch basin; replace insert; remove floatables in accordance with stormwater maintenance requirements | |

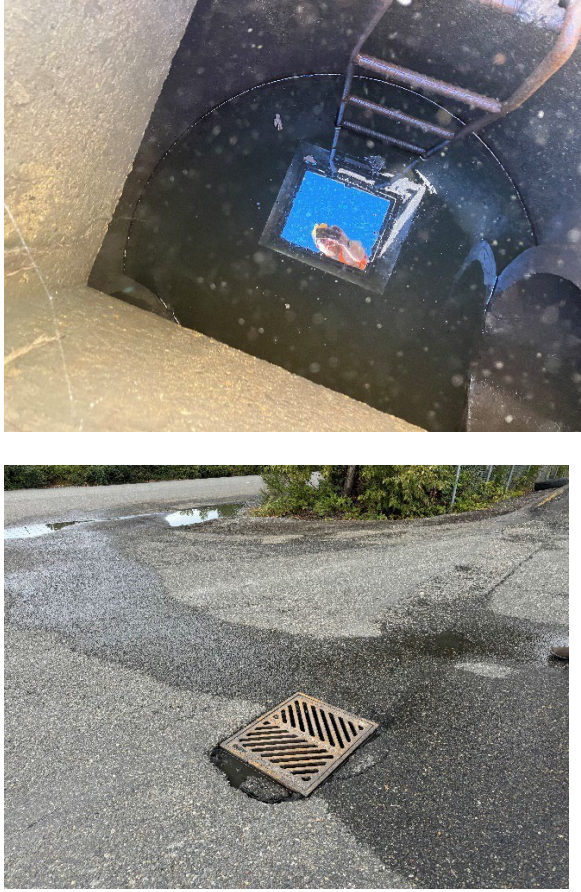
| ID | Type of Structure | Observed Condition | Sediment Accumulation | Additional observations | Recommended Actions | Photographs |
|---|---|--|--|---|--|--|
| CB5 | Catch basin | Structurally sound; functioning normally | Water in structure and too deep to measure | Damaged insert; trace floatables on surface; some sheet flow from site appears to bypass catch basin and run off site to Maxwell Way before ponding | Reseal area around grate; evaluate means for directing stormwater to structure; replace insert; remove floatables in accordance with stormwater maintenance requirements | |

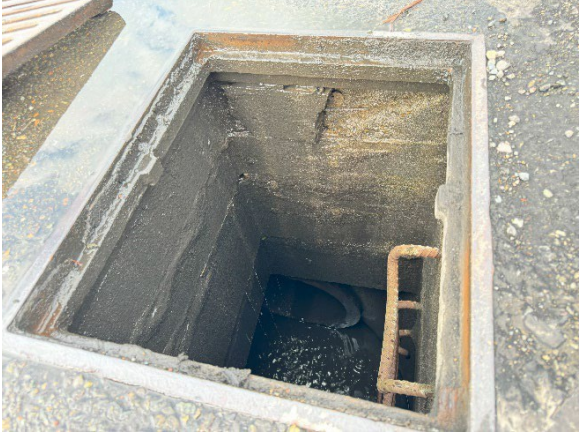
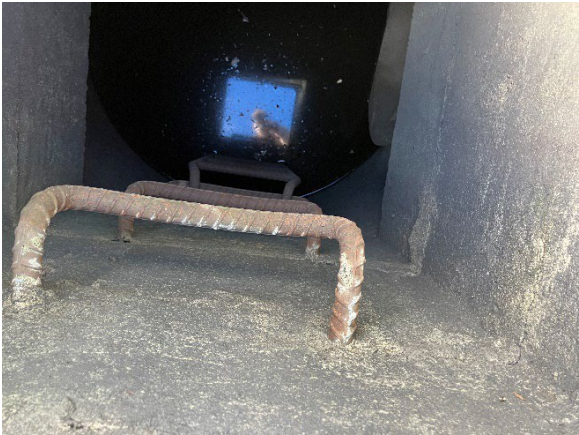
| ID | Type of Structure | Observed Condition | Sediment Accumulation | Additional observations | Recommended Actions | Photographs |
|---|---|--|--|---|--|---|
| CB6 | Catch basin | Exposed rebar in structure; functioning normally | Water in structure and too deep to measure | Trace floatables on surface | Replace insert; remove floatables in accordance with stormwater maintenance requirements | <br> |

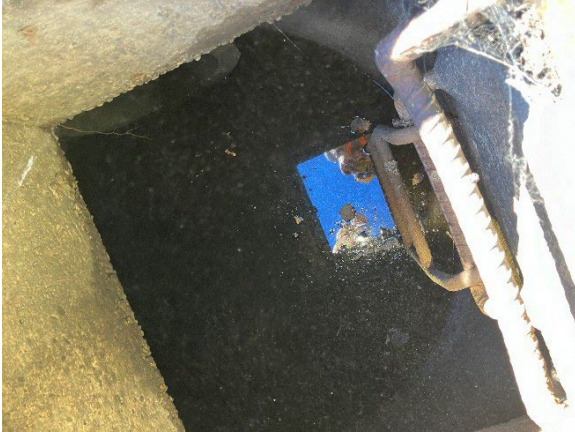
| ID | Type of Structure | Observed Condition | Sediment Accumulation | Additional observations | Recommended Actions | Photographs |
|---|---|--|---|---|---|--|
| CB7 | Catch basin | Structurally sound; functioning normally | water in structure and too deep to measure; visible accumulation in insert and around structure | Damaged insert; trace floatables on surface | Clear debris around catch basin; replace insert; remove floatables in accordance with stormwater maintenance requirements | |

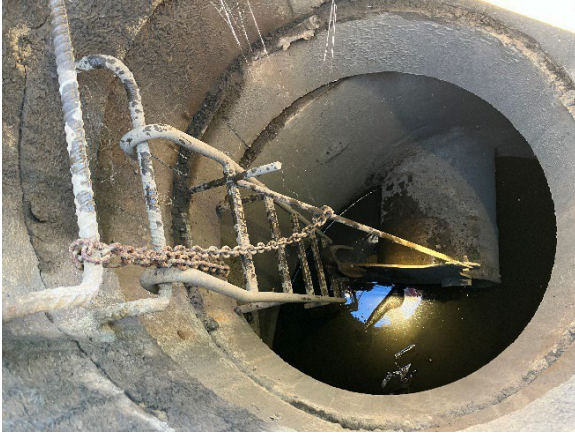
| ID | Type of Structure | Observed Condition | Sediment Accumulation | Additional observations | Recommended Actions | Photographs |
|---|---|--|---|---|---|--|
| OW1 | Oil/water separator | Structurally sound; functioning normally | Water in structure and too deep to measure | None | Coordinate with Port to open for future inspections | |
