Tidewater Fuel Line Leak, CSID No. 2331
2024 Periodic Review Report

Periodic Review Tidewater Fuel Line Leak

**2900 Sacajawea Park Rd., Pasco, Franklin County
Facility Site ID: 2331, Cleanup Site ID: 39378684**

December 2024

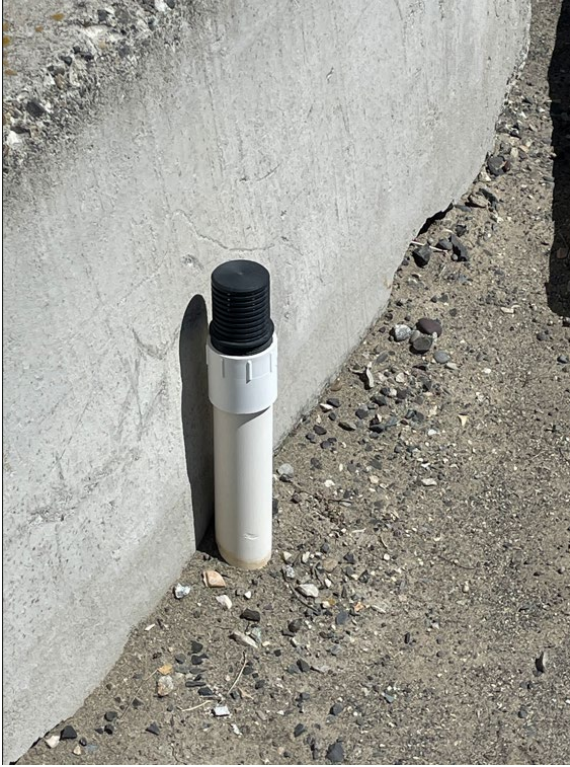
AR-01 Biovent. No protection around the PVC pipe.

Well ID	Well Head Type	Well Head Condition	Recommended Action	Comments
AR-01	Flush with ground	No bolts	Add bolts or replace with new cover	
AR-01	Biovent	No protection	Add vented protective cover	Paint yellow
AR-02	N/A	Well missing		Abandon* well if found
AR-03	PVC stickup	No protection	Add protective cover	Add bollards‡, paint yellow
AR-04	Steel monument cover	Good		Add bollards‡, paint yellow
AR-05	Biovent	No protection	Add vented protective cover	Add bollards‡, paint yellow
AR-06	PVC stickup	No protection	Add protective cover	Add bollards‡, paint yellow
AR-07	PVC stickup	No protection	Add protective cover	Add bollards‡, paint yellow
AR-08	Flush with ground	OK		Keep an eye on bolt conditions
AR-09	Biovent, flush with ground	No bioventing action, sealed cover	Replace with vented protective cover	Add bollards‡, paint yellow if above ground
AR-10	Flush with ground	No gasket	Add new gasket	
AR-11	Flush with ground	No bolts	add bolts or replace with new cover

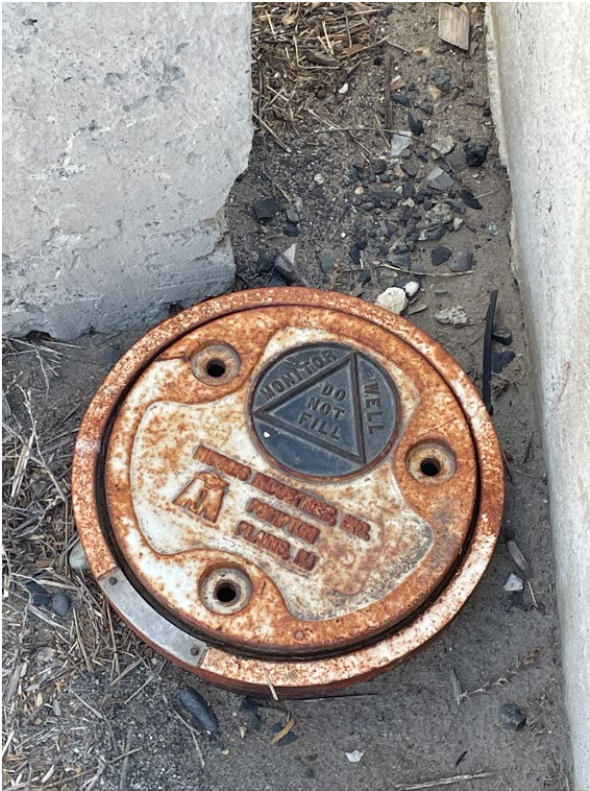
AR-01 Well cover. Missing bolts in well cover

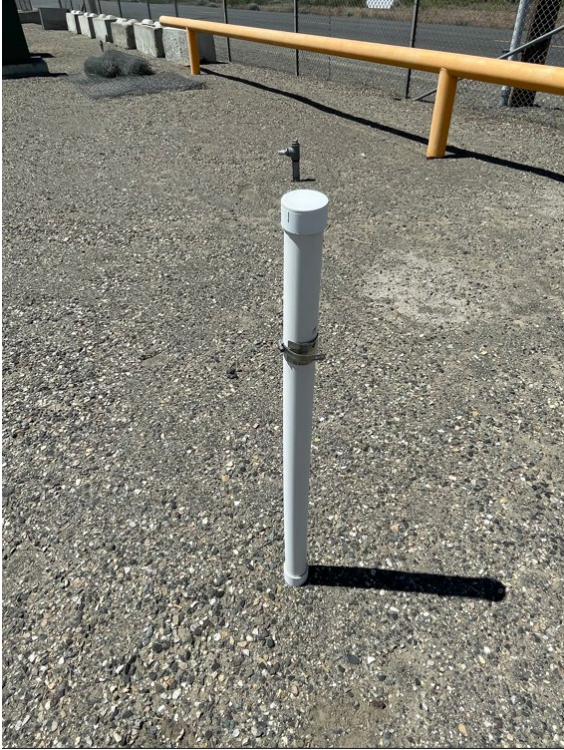
Well AR-03. No protective cover or bollards.

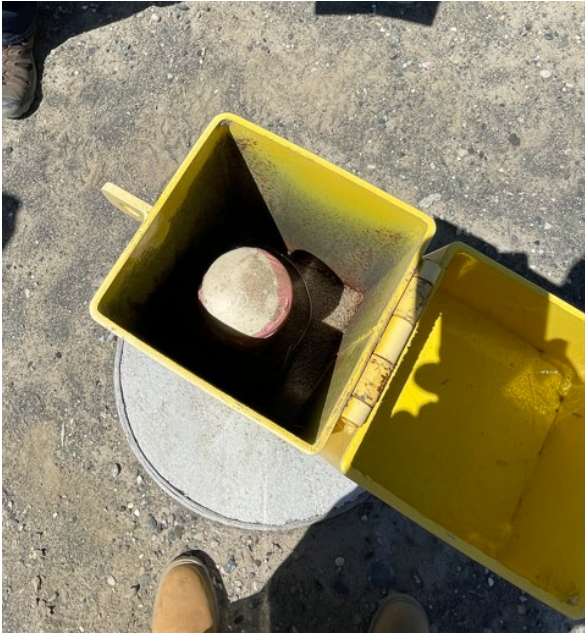
Well AR-04

The sampling pump lost in the base of AR-4 during the 2020 monitoring event could not be retrieved by Environmental West. At Tidewater's request, Ecology approved the use of AR-1 for compliance monitoring in place of the damaged AR-4. Steel monuments were installed over wells AR-4 and AR-8 during the July 2021 monitoring event; remaining protective well covers at the Site were considered to still be sufficiently protective of remaining wells at this time (GeoEngineers, 2021).

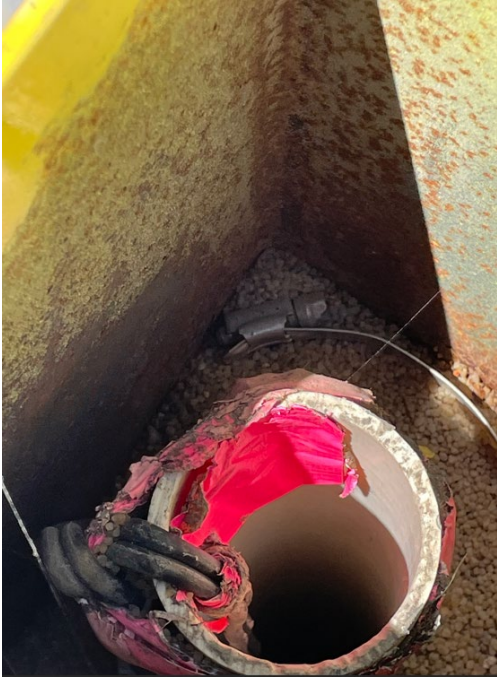
Well AR-04, with stuck pump

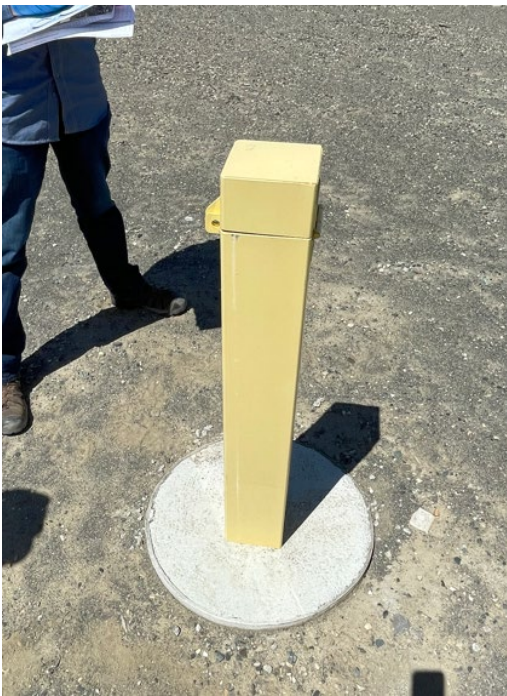
Well AR-04, well cover, no bollards

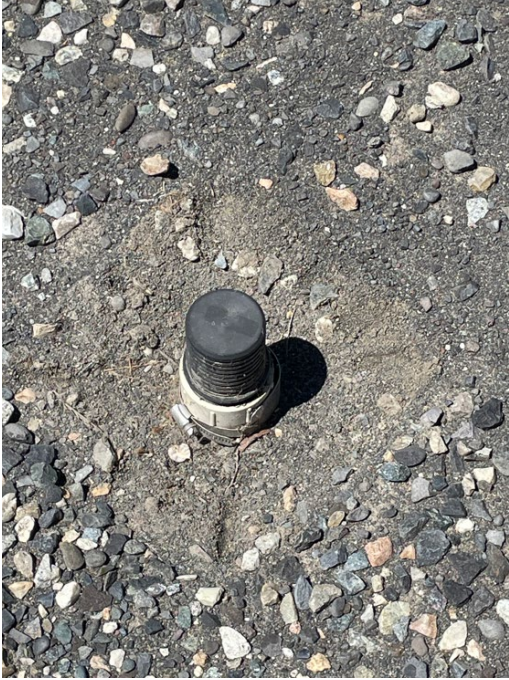
Biovent well AR-05. No protective cover or bollards.

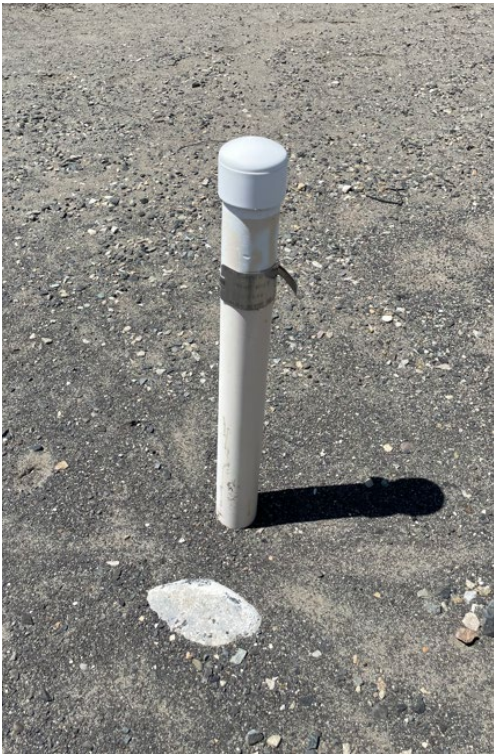
Well AR-06. No protection

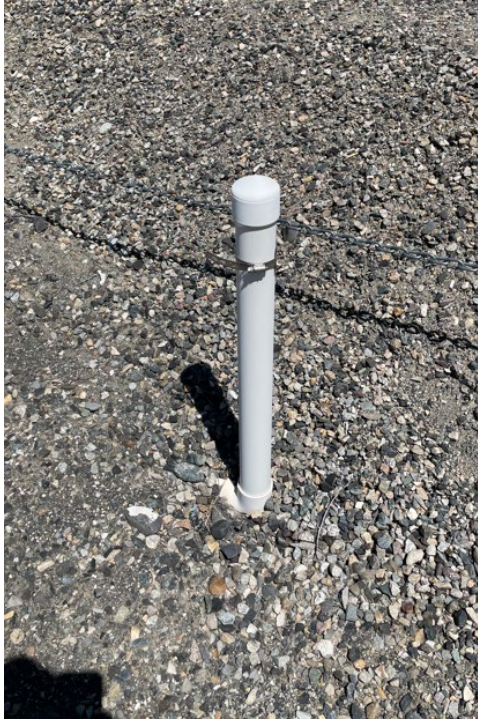
Well AR-07. No protection

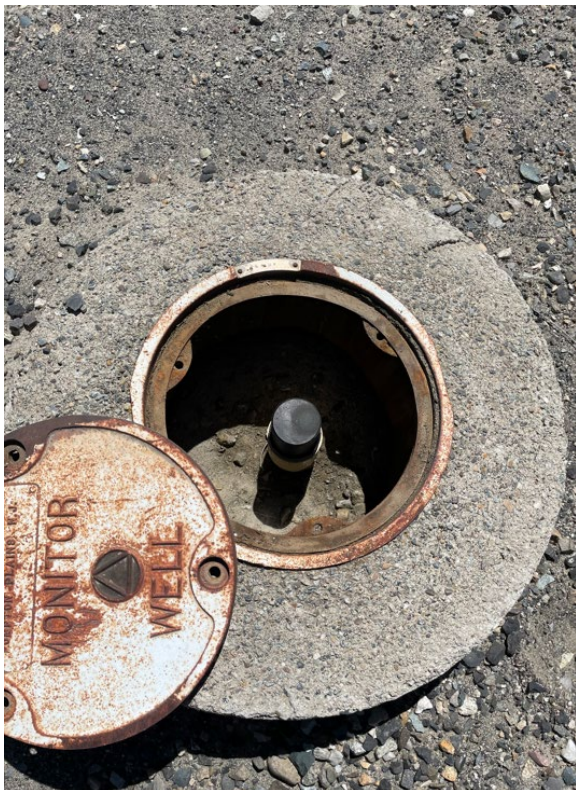
AR-09 Bioventing well, old gasket

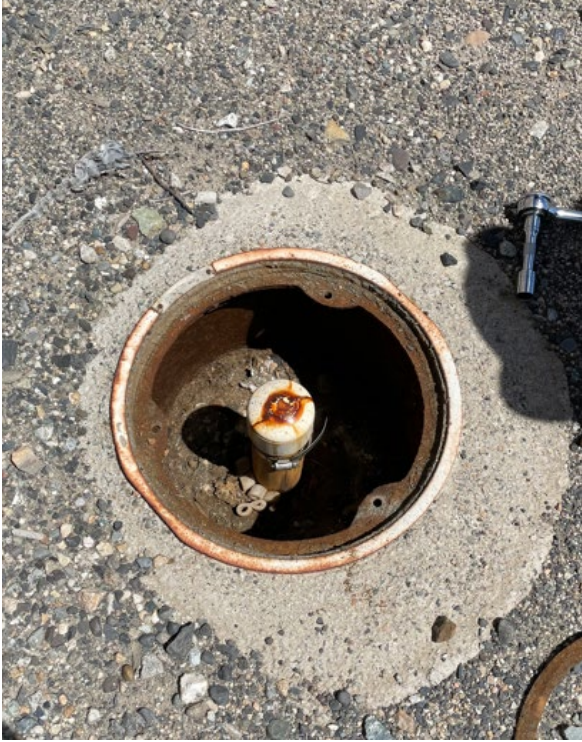
Well AR-10. No gasket

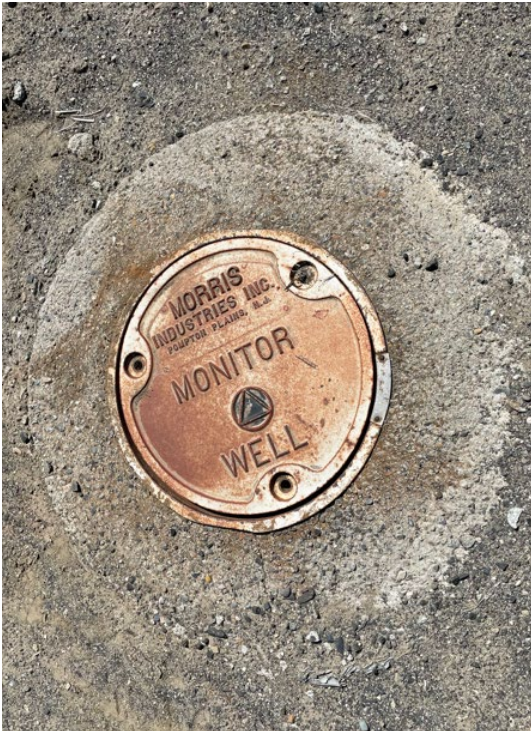
Well AR-11. No bolts

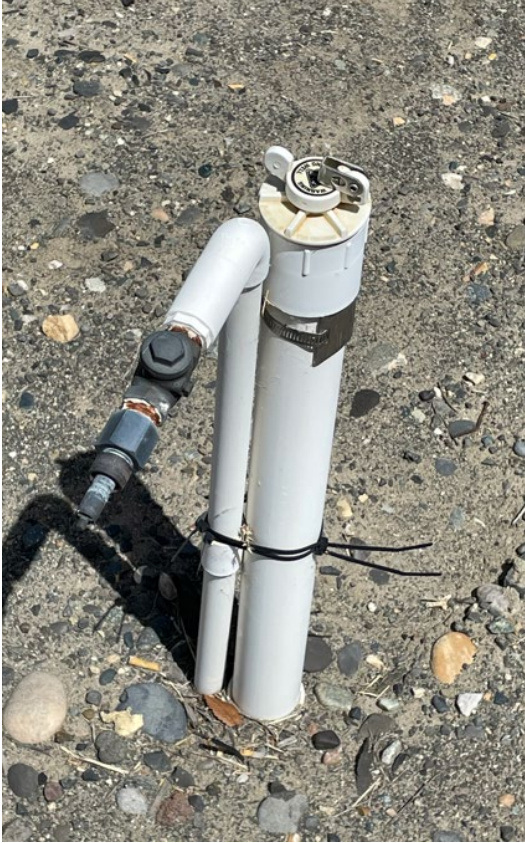
Dry well AR-12. No protection

AR-12	PVC stickup	No protection, well is dry	Convert into biovent well or abandon* well	Paint any aboveground cover yellow
MW-01	N/A	Well missing	Locate well	Abandon* well if damaged beyond repair
MW-02	Flush with ground	No gasket	Add new gasket	
MW-03	Flush with ground	Water in wellhead, no gasket	Clean out well, add new gasket	
MW-04	Flush with ground	Old worn gasket	Replace gasket	
MW-05	Steel stickup 2" steel pipe inside 4" steel pipe	Open top, hornet nest inside pipe	Cover top to keep out critters and debris	Add bollards‡, paint yellow
MW-06	Flush with ground	No gasket	Add new gasket	
MW-07	Steel stickup 2" steel pipe inside 4" steel pipe	Open top	Cover top to keep out critters and debris	Add bollards‡, paint yellow
MW-08	Steel stickup 2" steel pipe inside 4" steel pipe	Open top	Cover top to keep out critters and debris	Add bollards‡, paint yellow

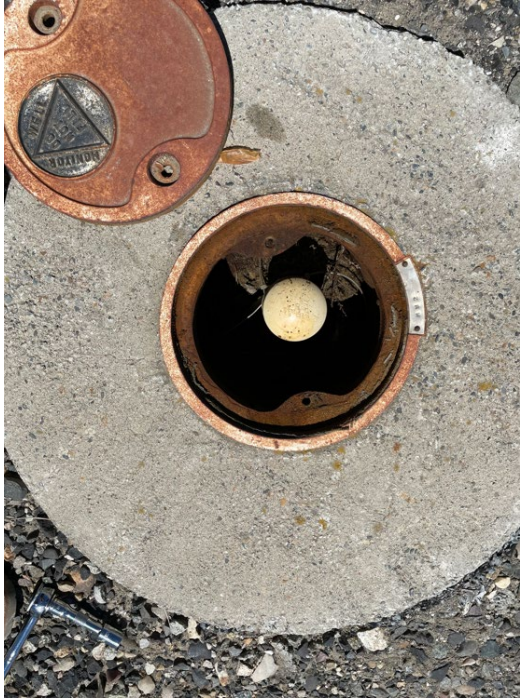
Well MW-02, No gasket

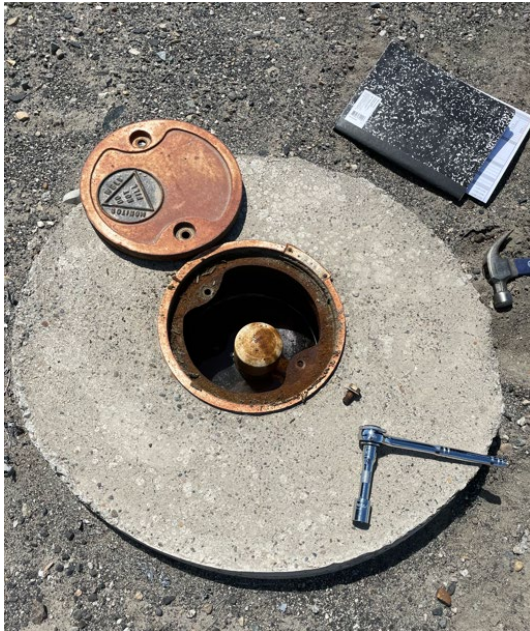
Well MW-03. No gasket

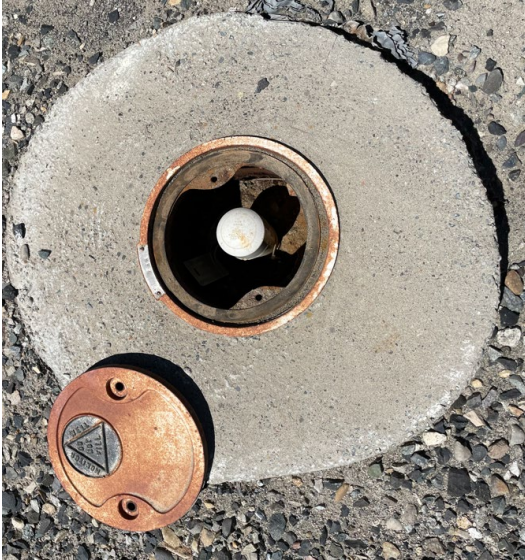
Well MW-04. Old gasket

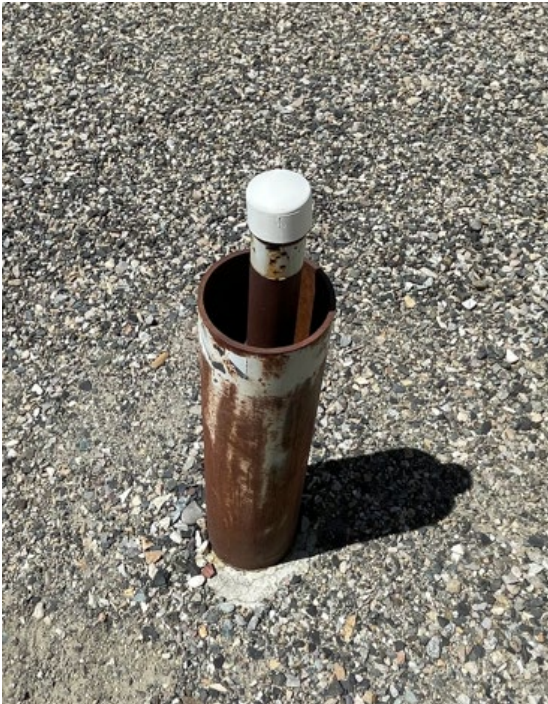
Well MW-5, No bollards, low visibility, open top

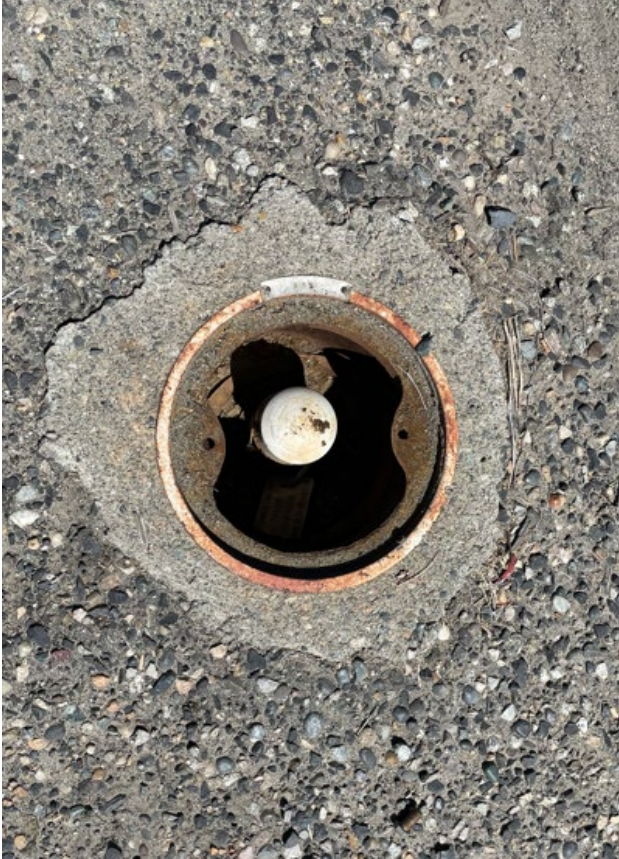
Well MW-06. No gasket

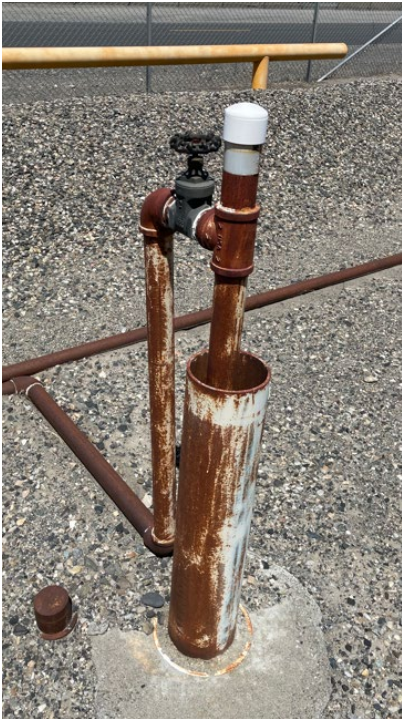
Well MW-07. Open top, no bollards, low visibility

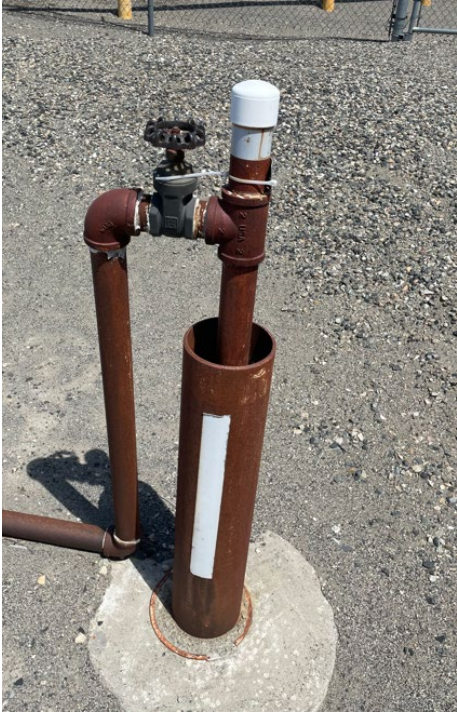
Well MW-08, open top, low visibility
