# First Five - Year Review Report Gas Works Park Site Seattle, Washington

Washington State Department of Ecology Northwest Regional Office Bellevue, Washington

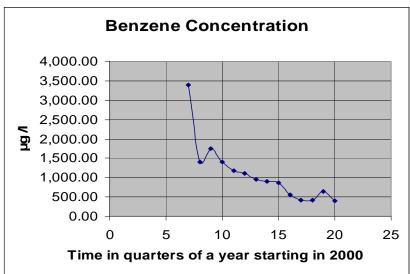
Figure 3.

Benzene concentration in the compliance well OBS-1 remains below the action level but above the method B groundwater cleanup level. The remedy, therefore, remains effective. See figure 3 below.
