Port of Anacortes
Engineering and Institutional Controls Report
Year 10 -- 2024

Cap Sante Marine Site
Anacortes, WA
Ecology Consent Decree No. 9917

for
Washington State Department of Ecology
January 22nd, 2025

Subject: Engineering and Institutional Controls Monitoring Report – Year 10 – 2024
Cap Sante Marine Site
Anacortes, Washington
Ecology Consent Decree No. 9917

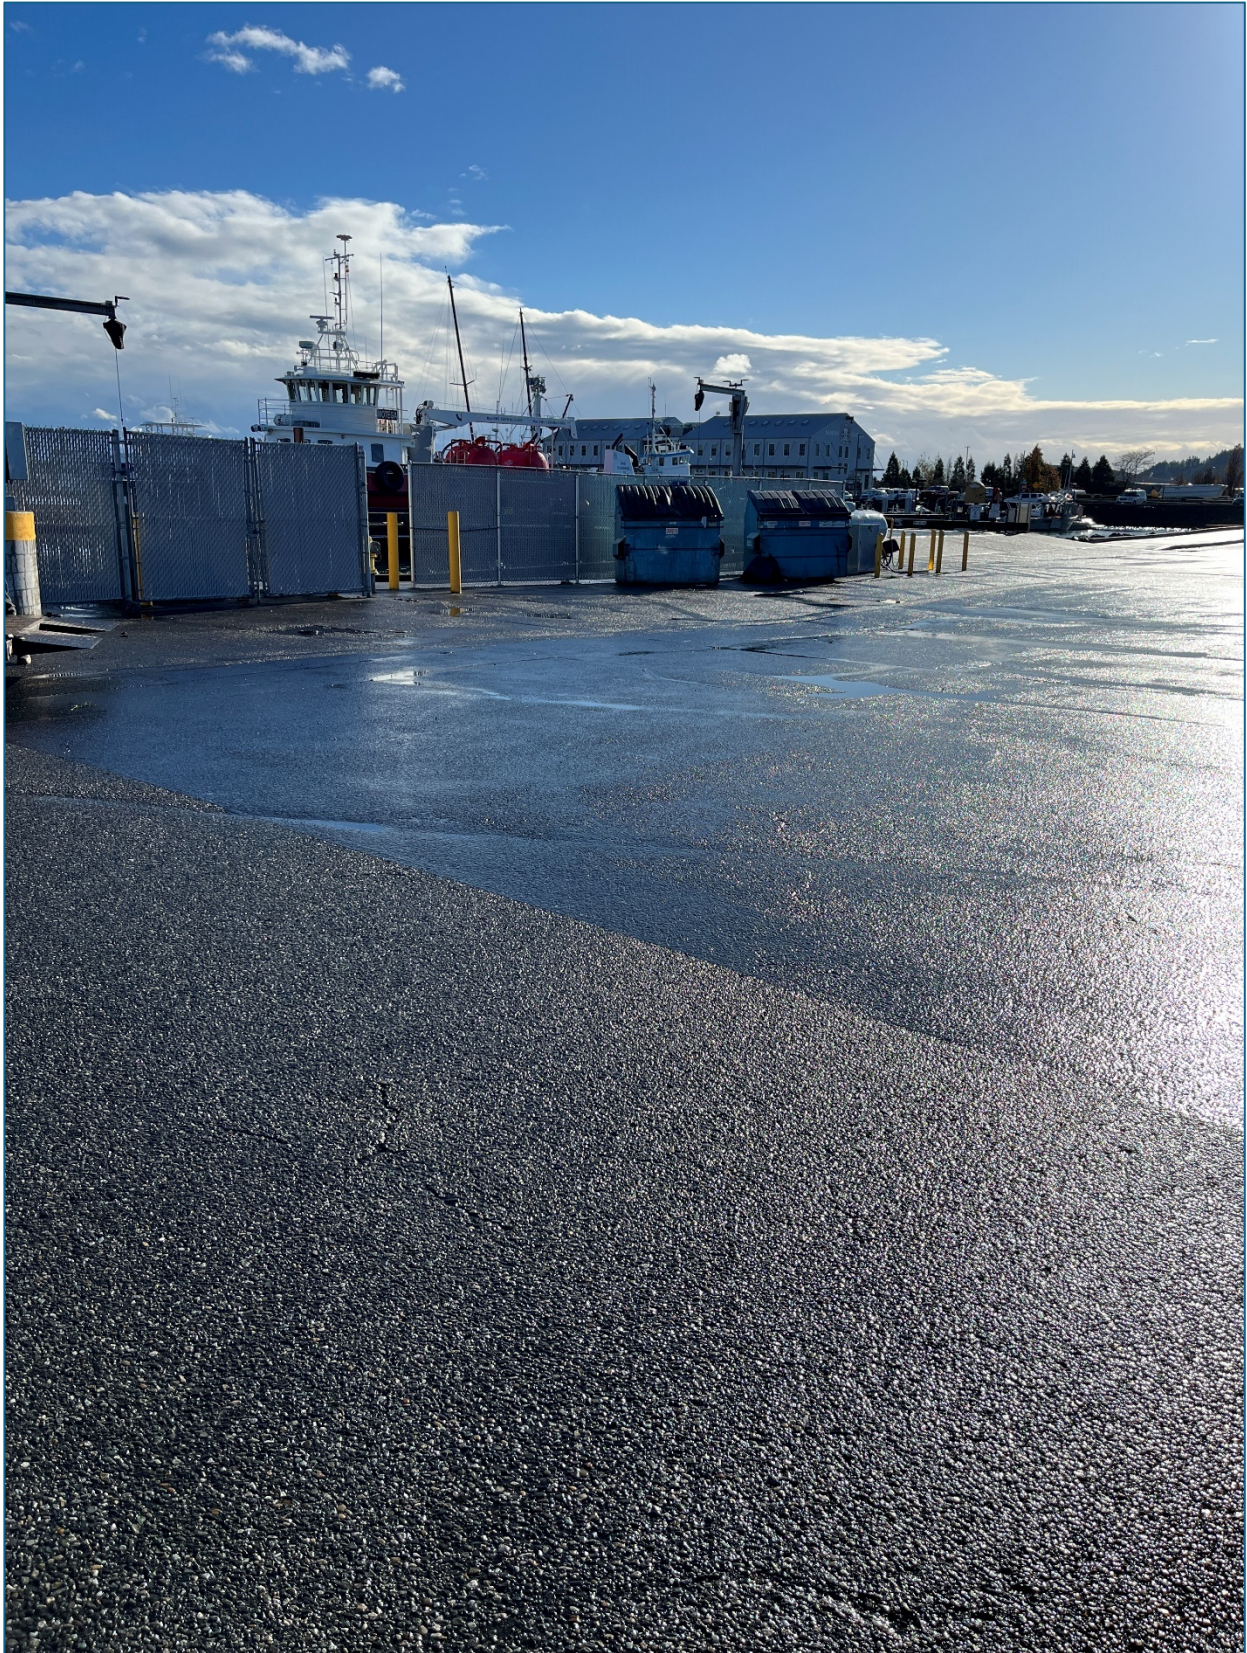
Figure 2: Photo monitoring point A1 looking SE towards T-Dock

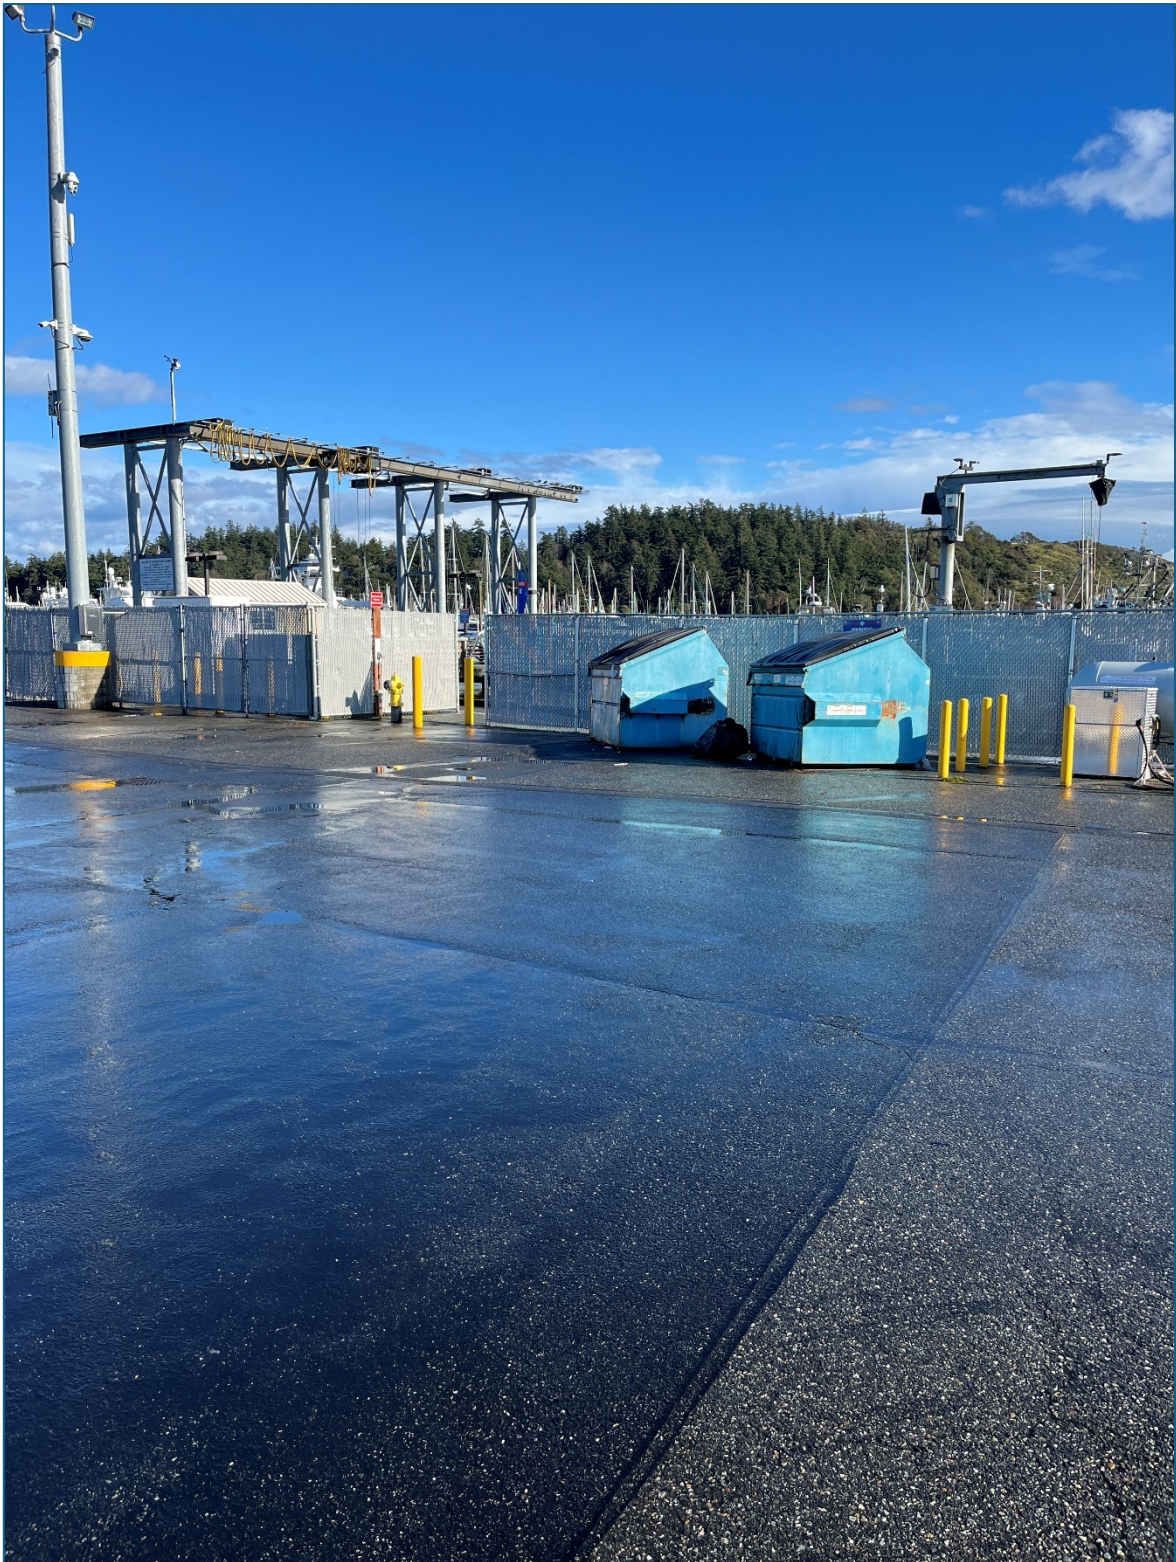
Figure 3: Photo monitoring point A2 looking NE towards B-dock/T-Dock

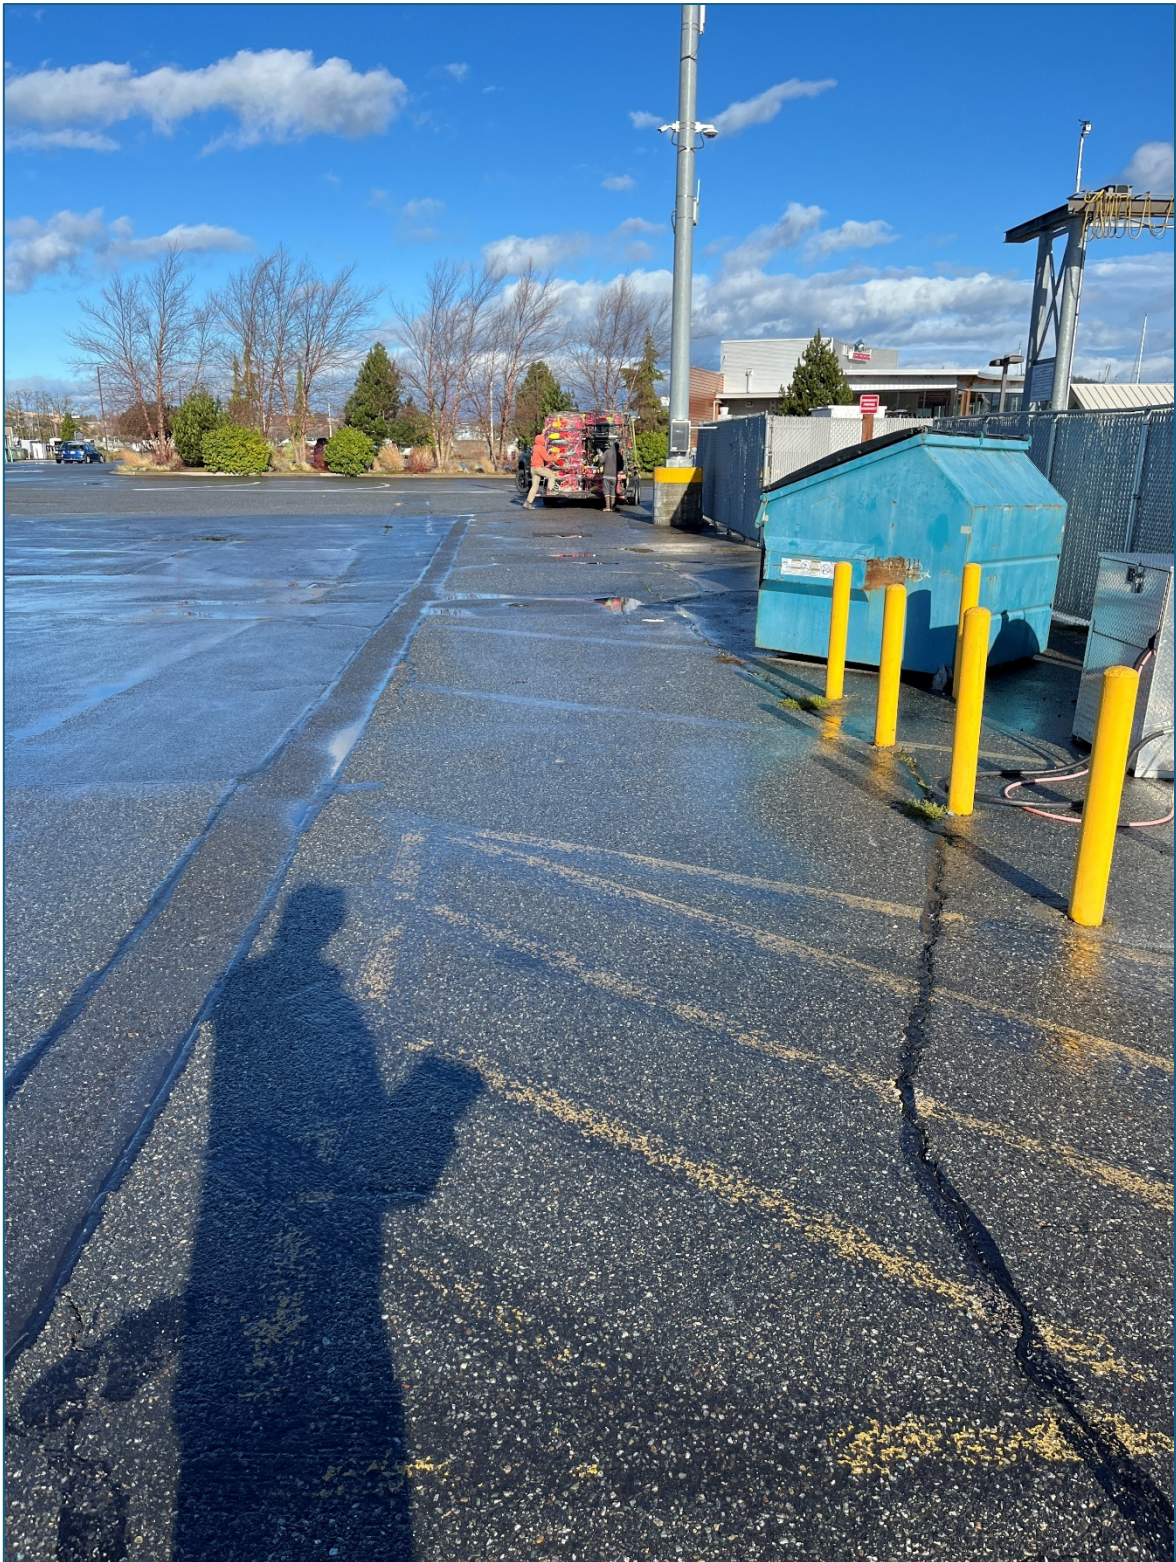
Figure 4: Photo monitoring point A3 looking N towards Anthony's Trailer Boat Launch

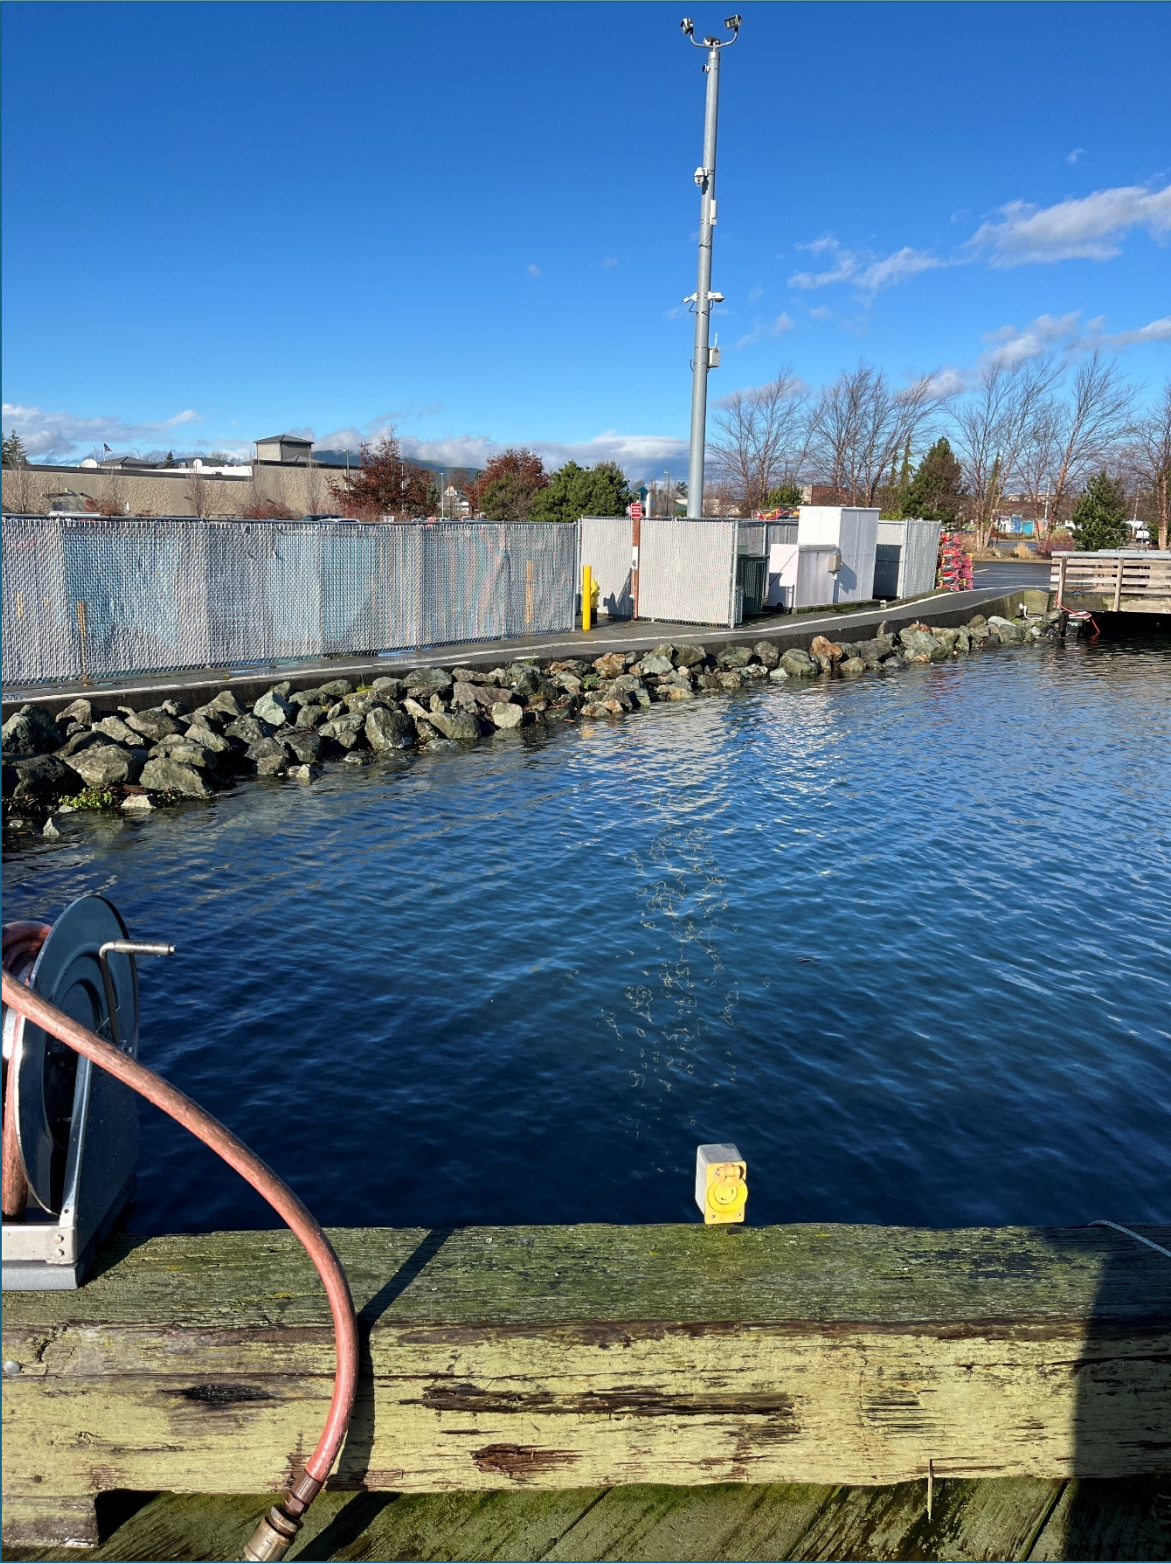
Figure 5: Photo monitoring point A4 looking NW towards Cap Sante Marina uplands, view occluded by trash enclosures and electrical infrastructure.

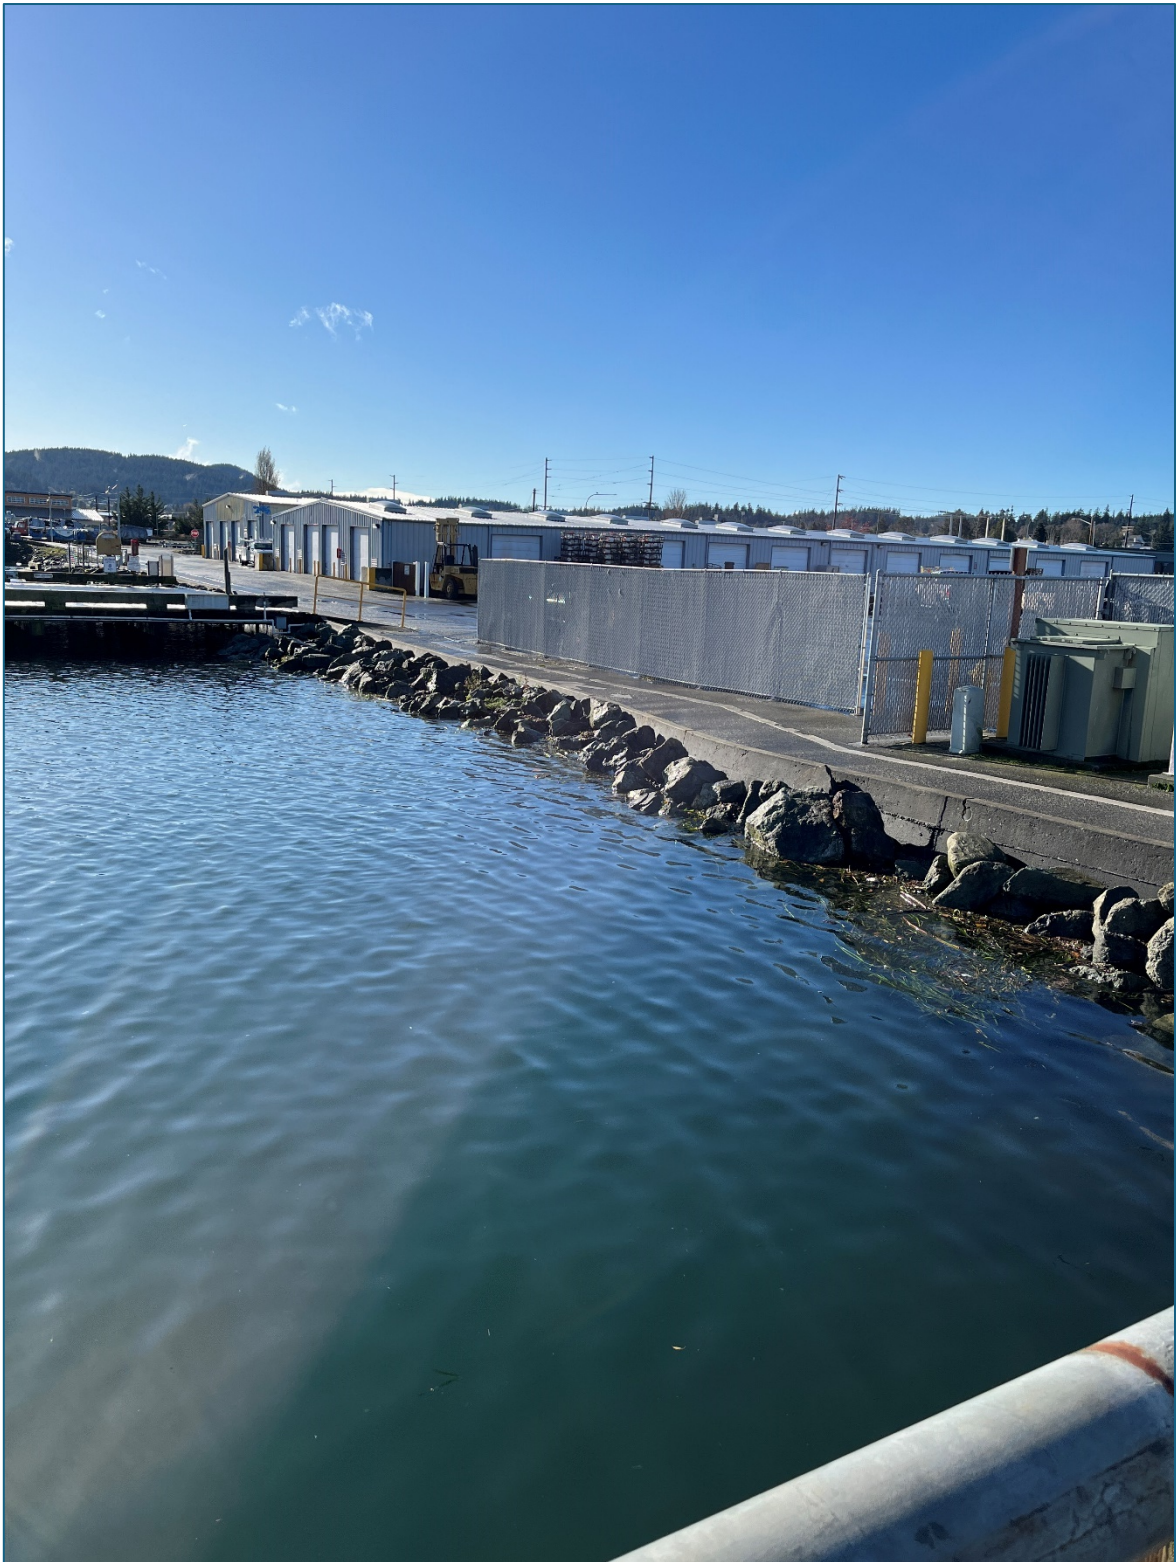
Figure 6: Photo monitoring point A5 looking SW towards Cap Sante Marina uplands

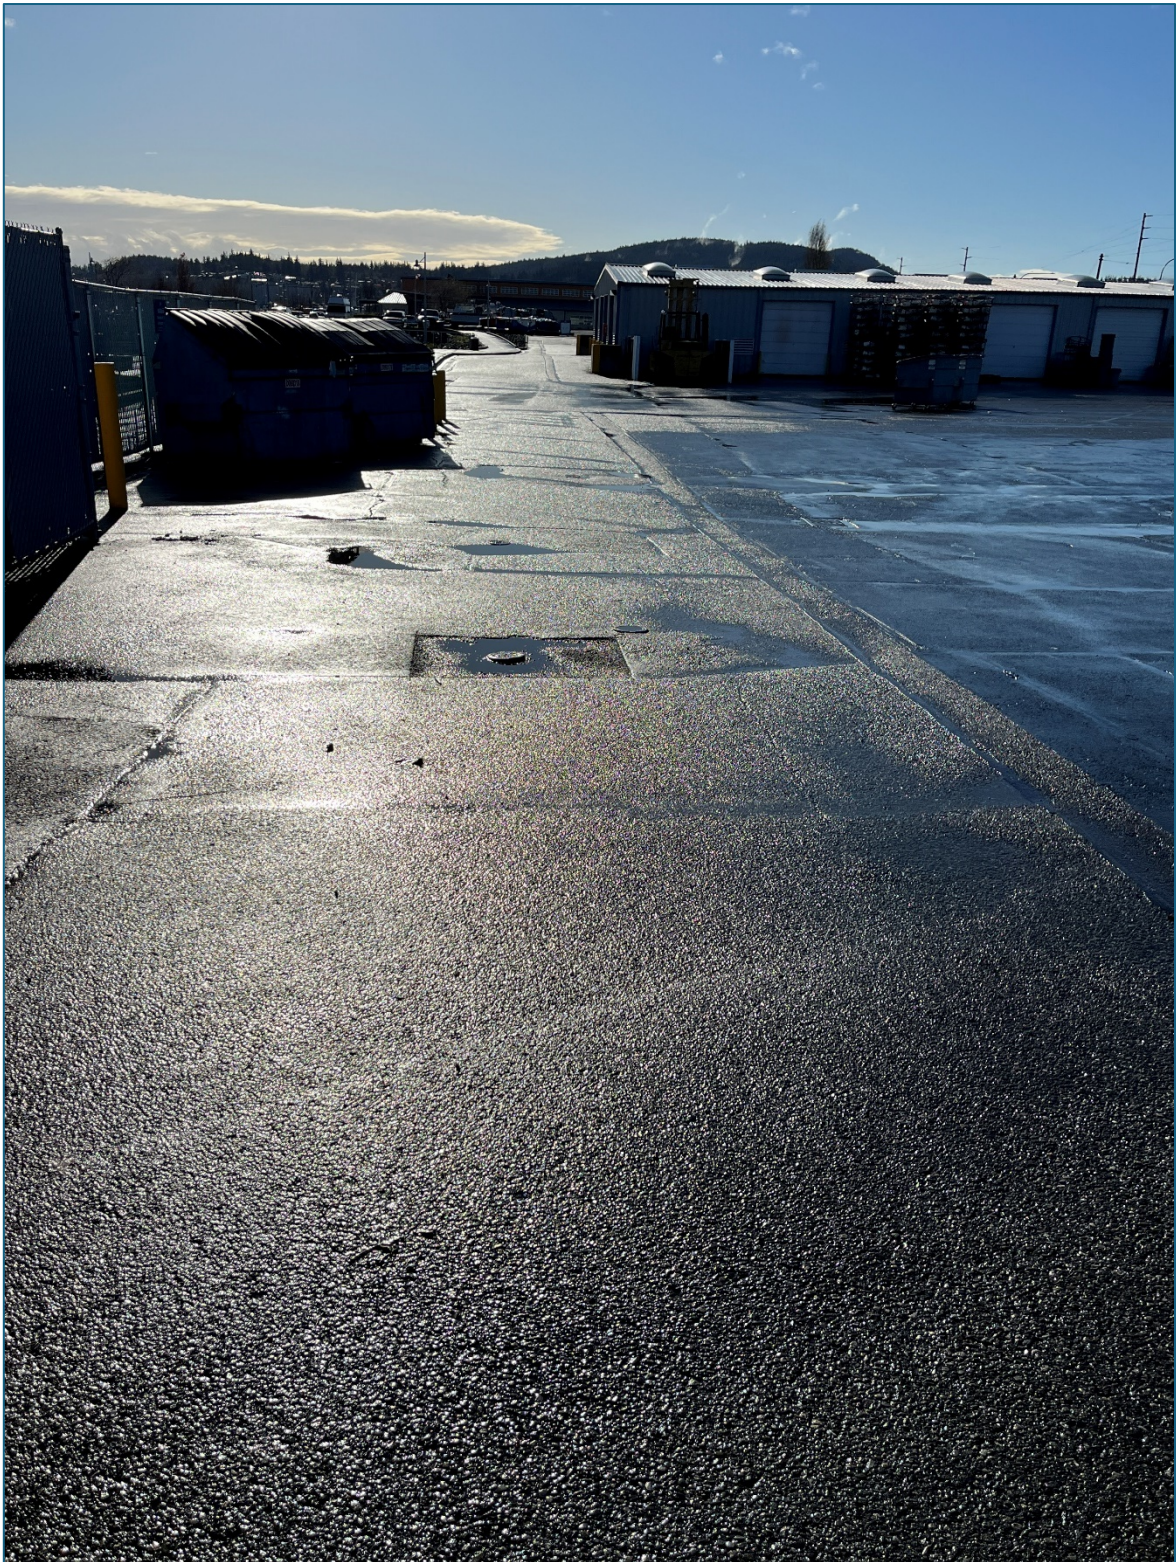
Figure 7: Photo monitoring point A6 looking south across Cap Sante Marina uplands

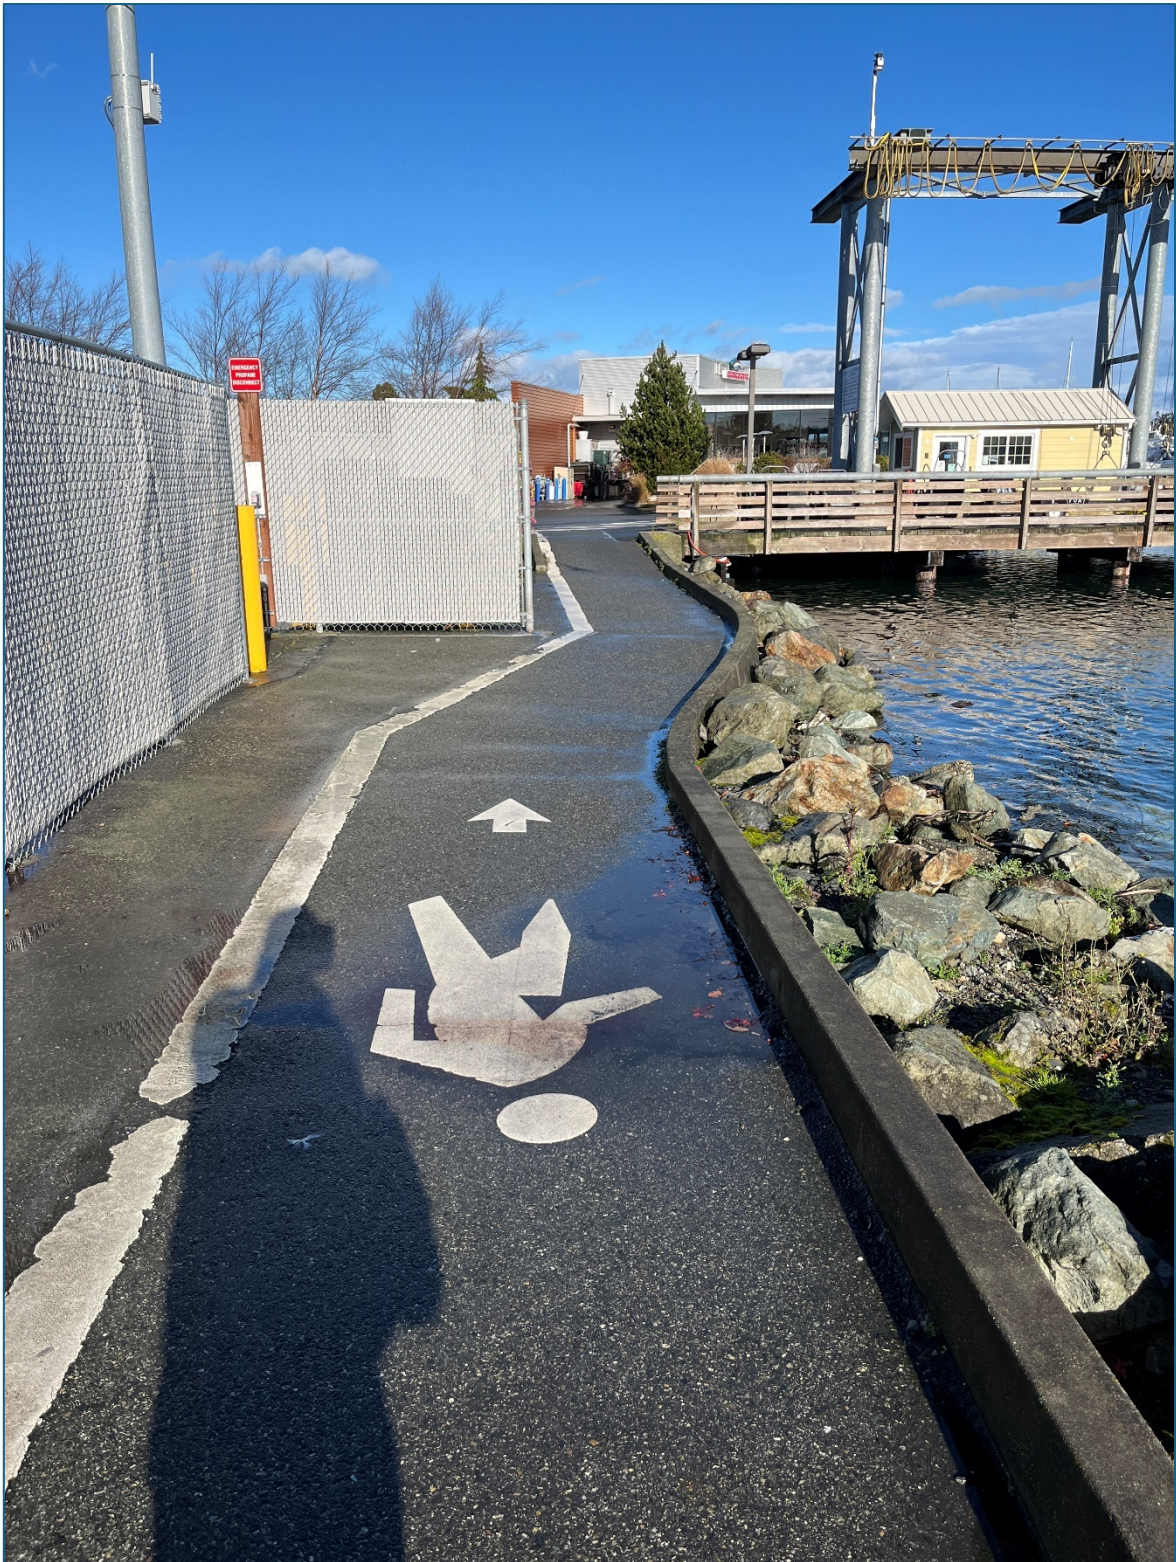
Figure 8: Photo monitoring point A7 looking north along esplanade

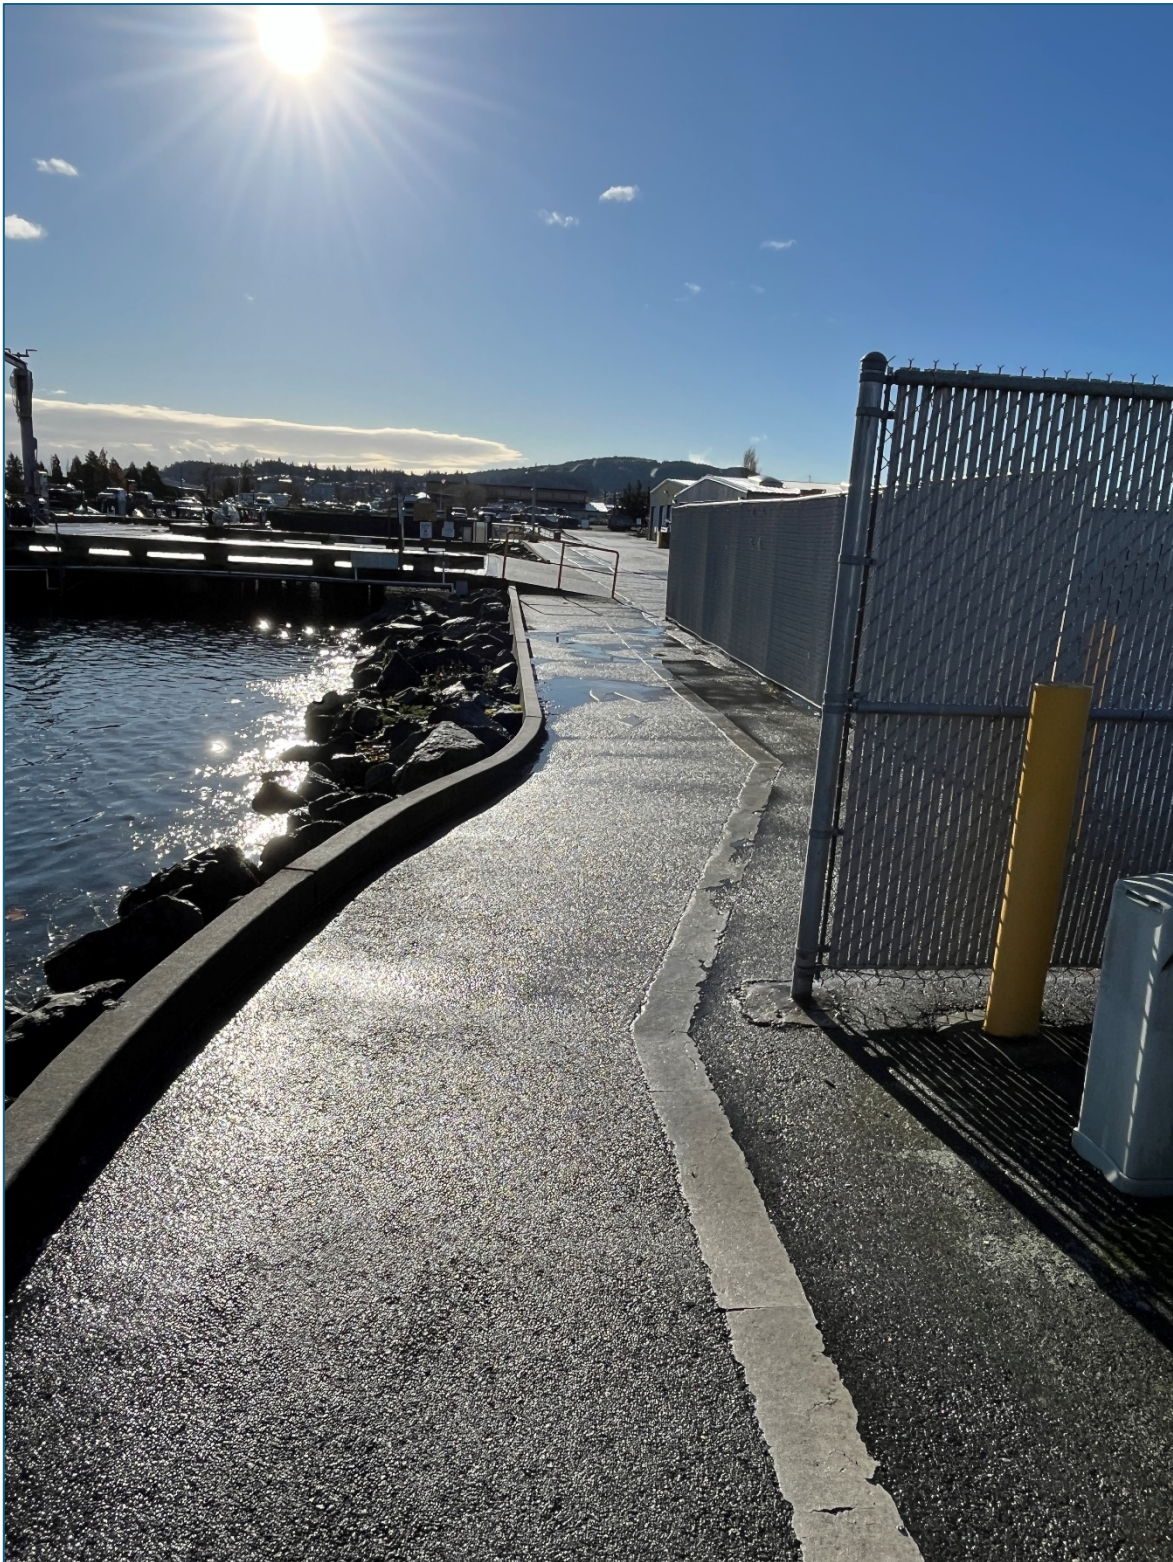
Figure 9: Photo monitoring point A8 looking south along esplanade

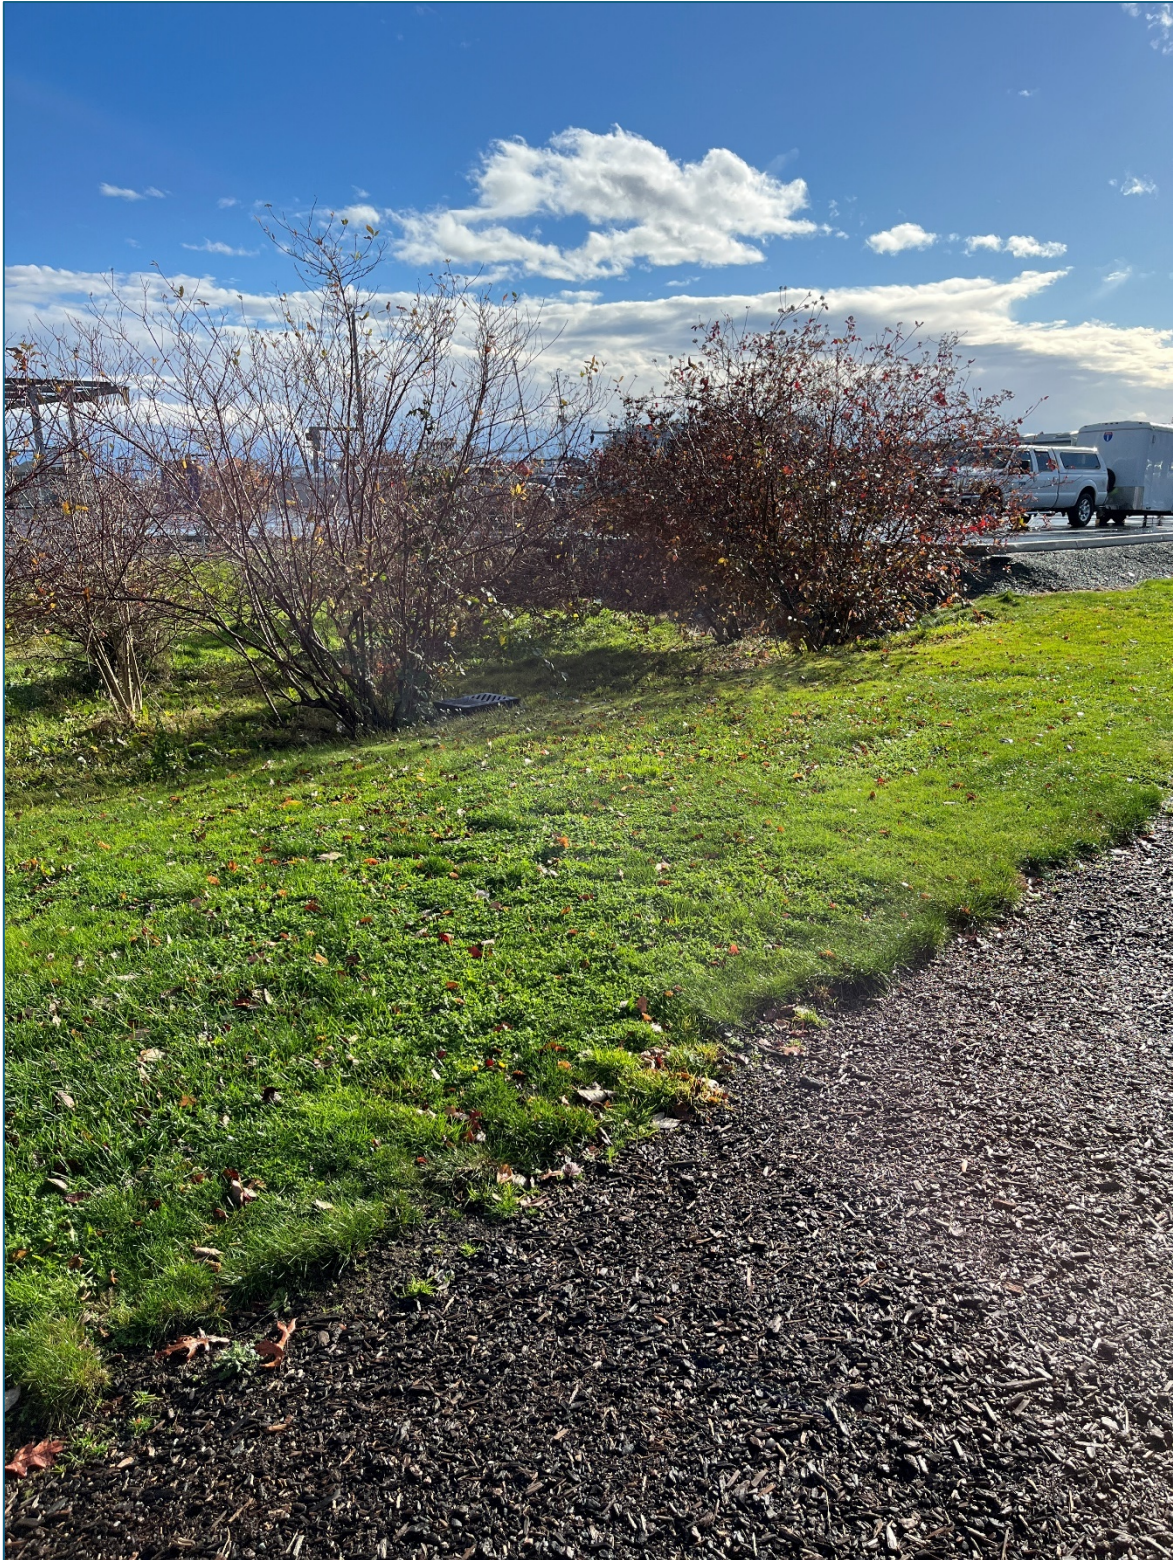
Figure 11: Photo monitoring point B1 looking to the SE

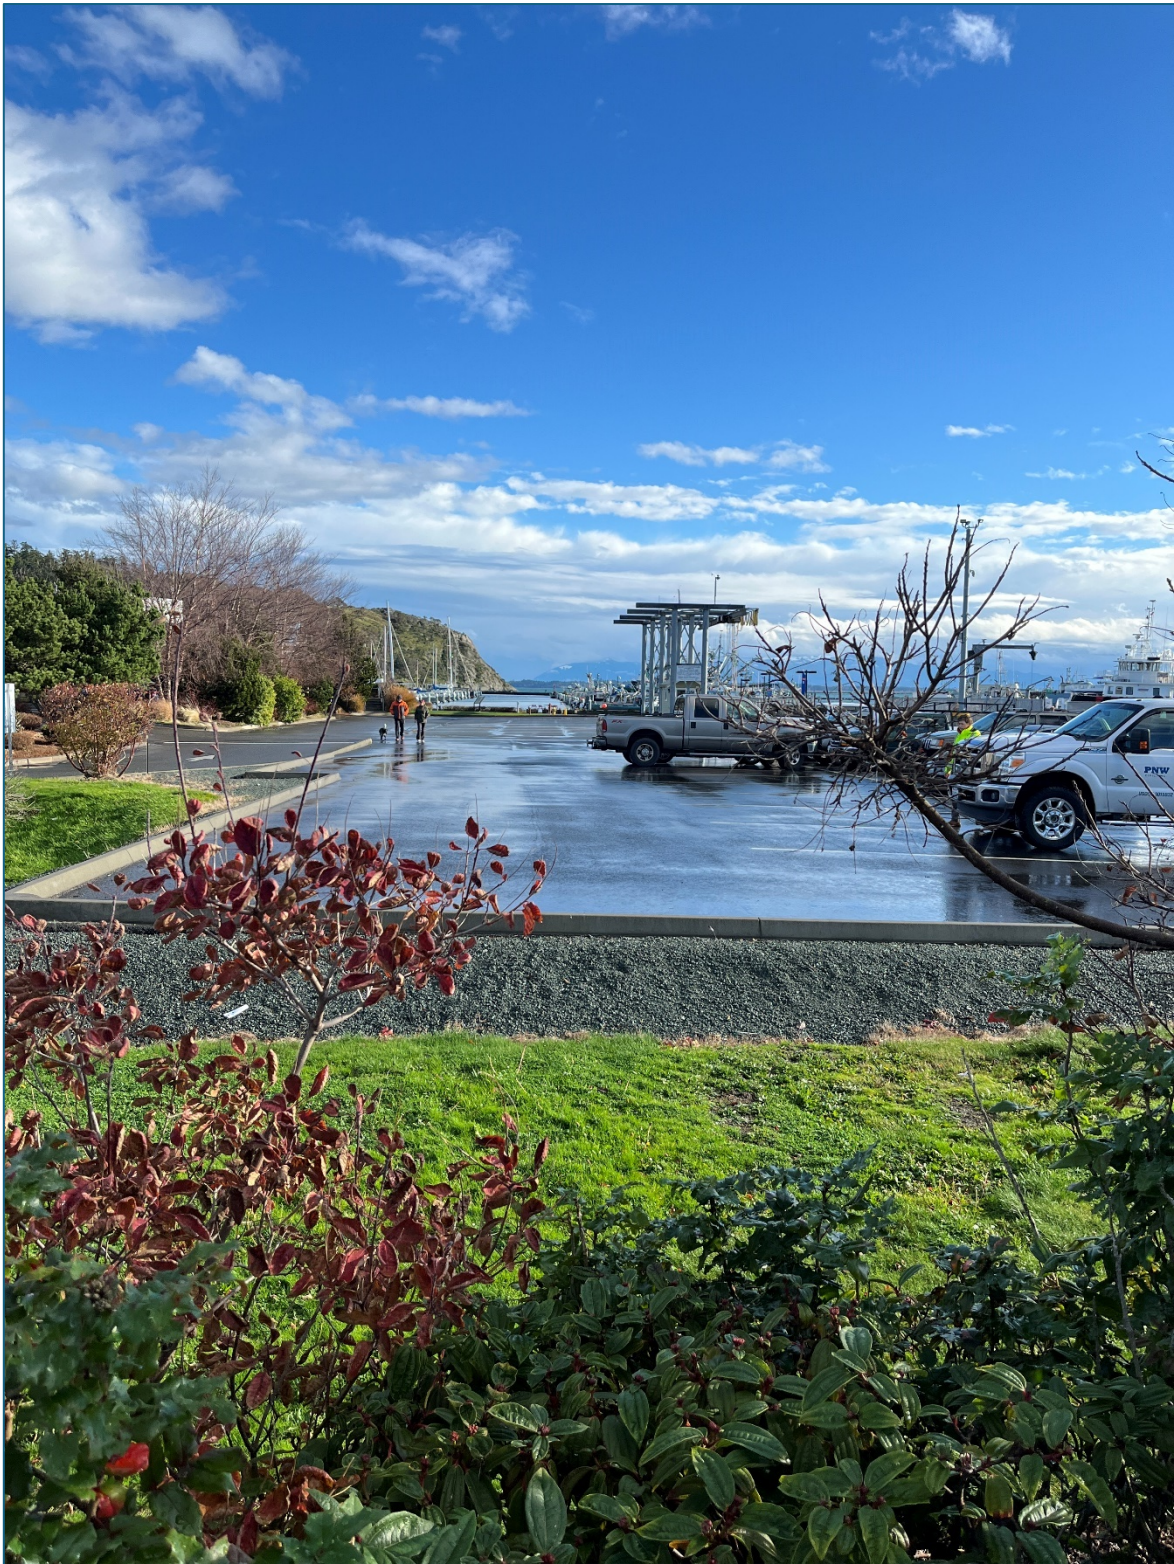
Figure 12: Photo point B2 looking east across Cap Sante marina uplands

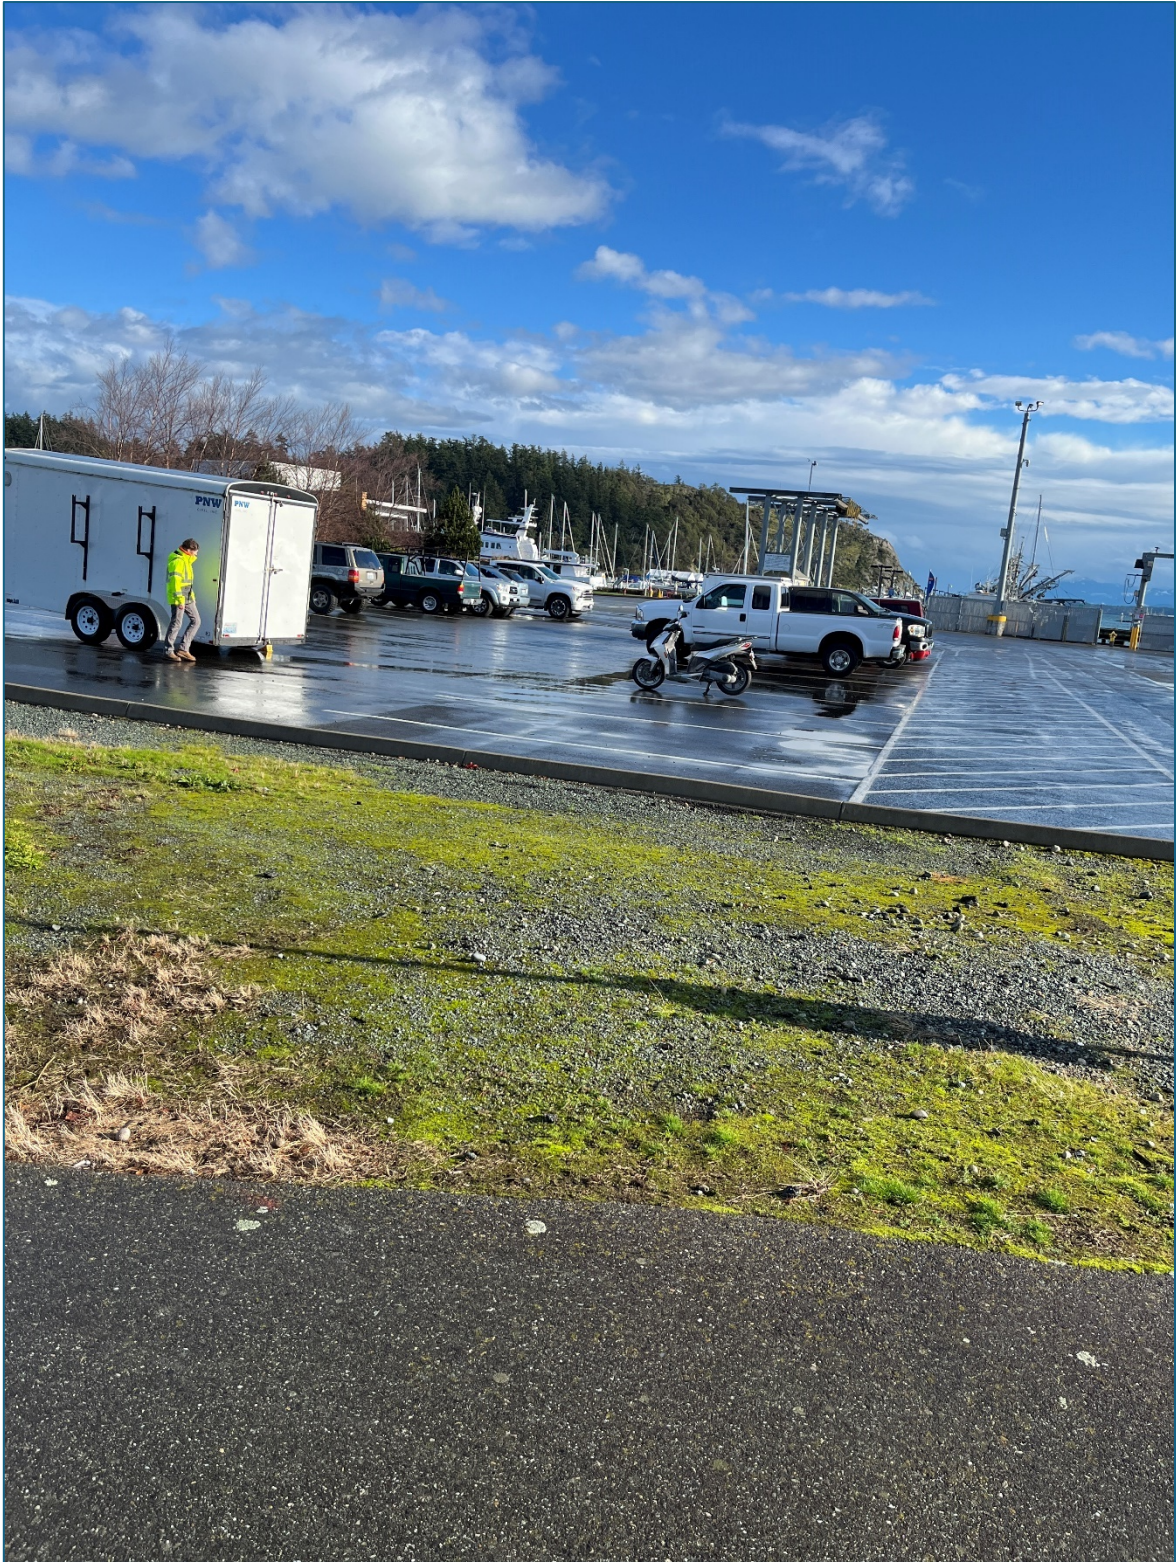
Figure 13: Photo point B3 looking NE across Cap Sante marina uplands

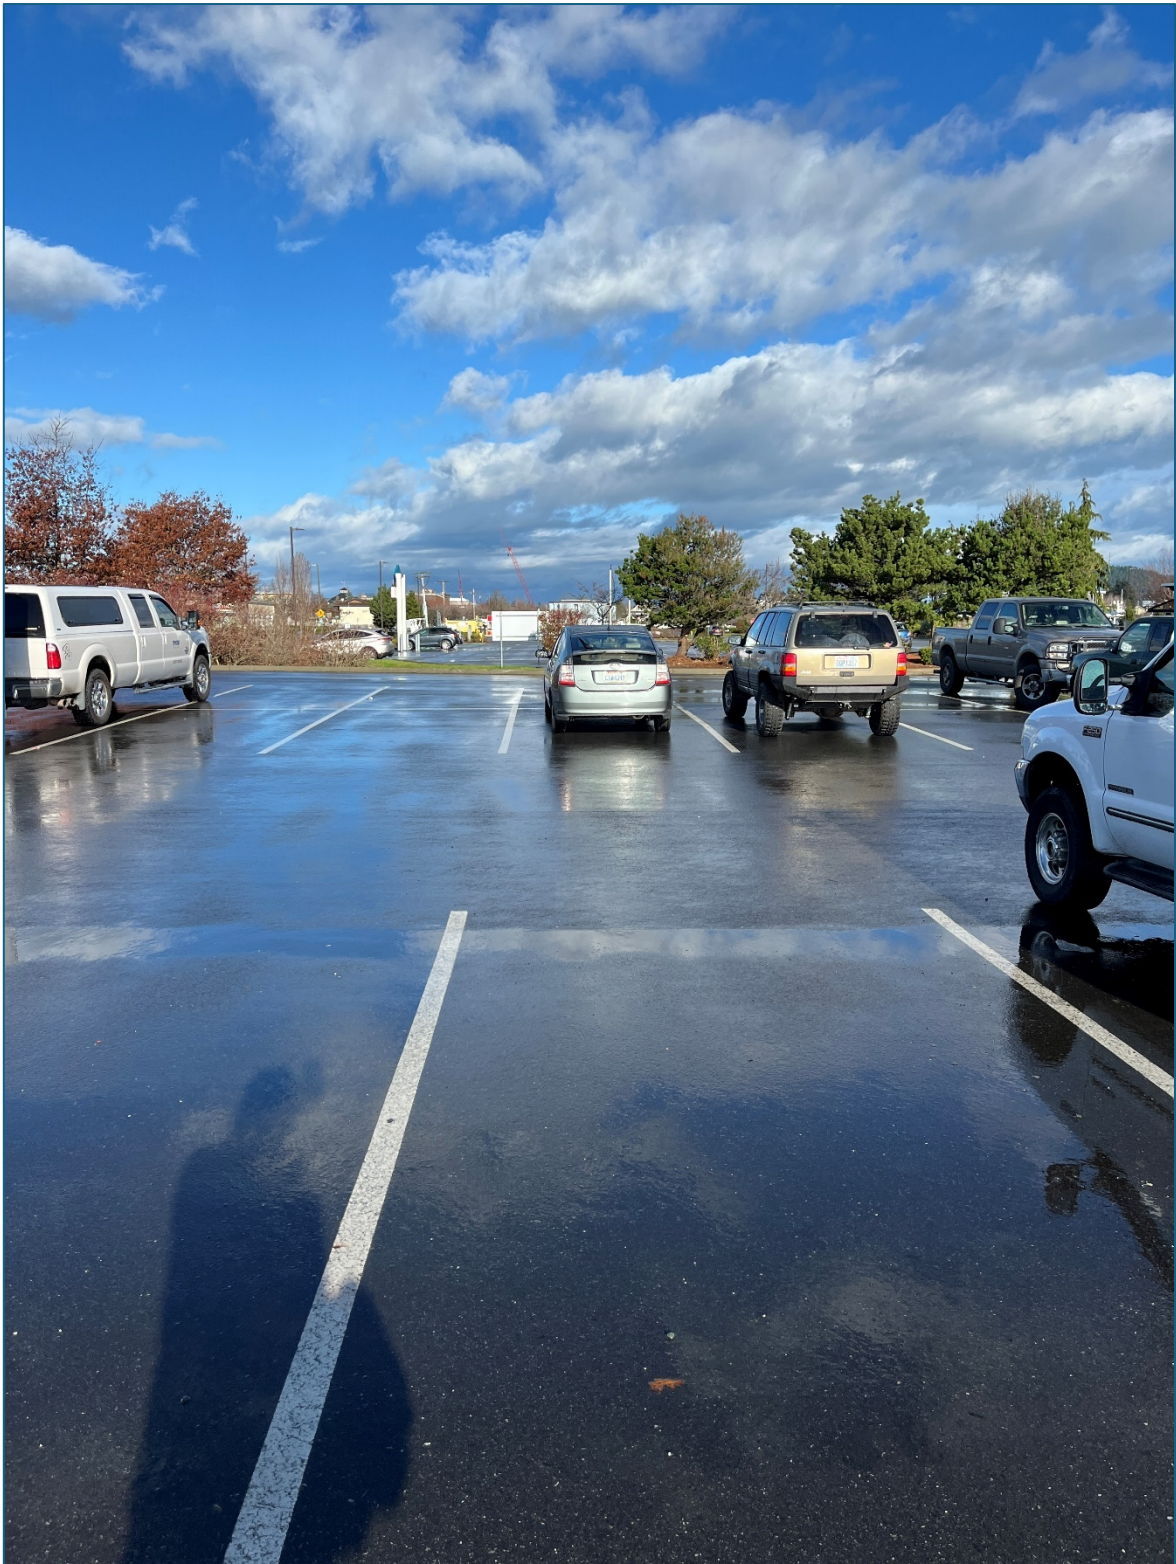
Figure 14: Photo point B4 looking north
