Port of Anacortes
Engineering and Institutional Controls Report
Year 10 -- 2024

Cap Sante Marine Site
Anacortes, WA
Ecology Consent Decree No. 9917

for
Washington State Department of Ecology
January 22nd, 2025

Subject: Engineering and Institutional Controls Monitoring Report – Year 10 – 2024
Cap Sante Marine Site
Anacortes, Washington
Ecology Consent Decree No. 9917

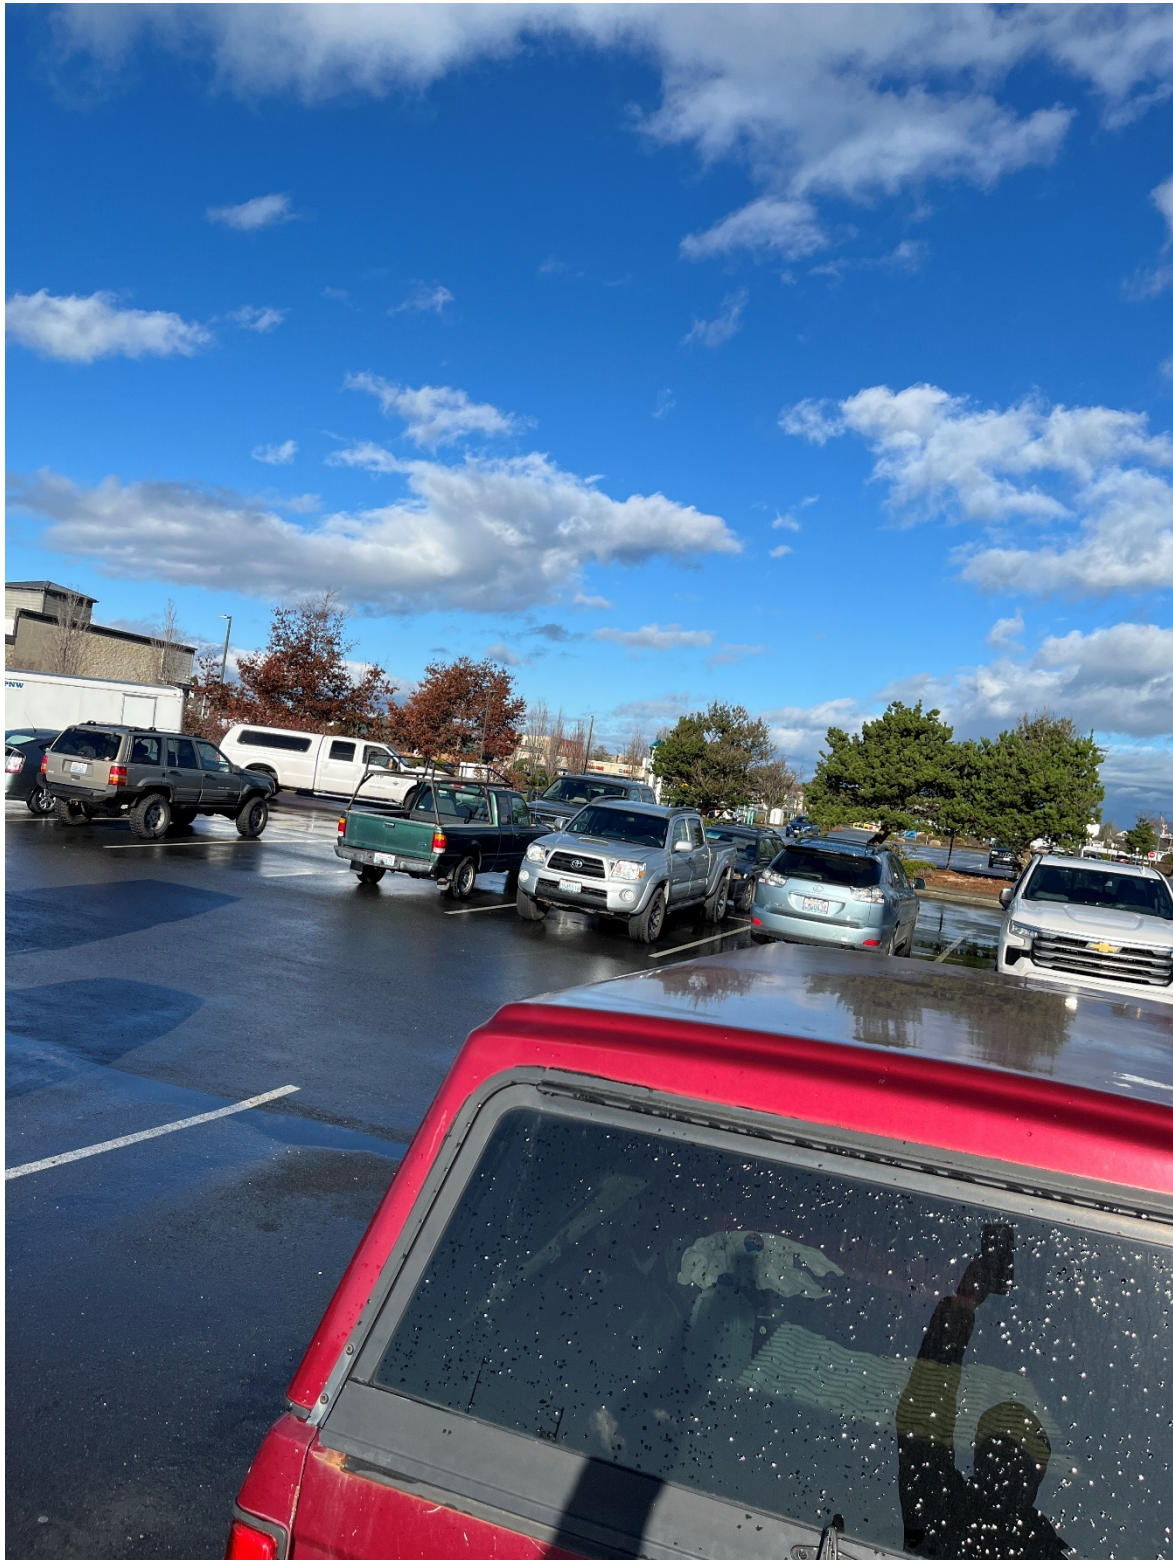
Figure 15: Photo point B5 looking NW

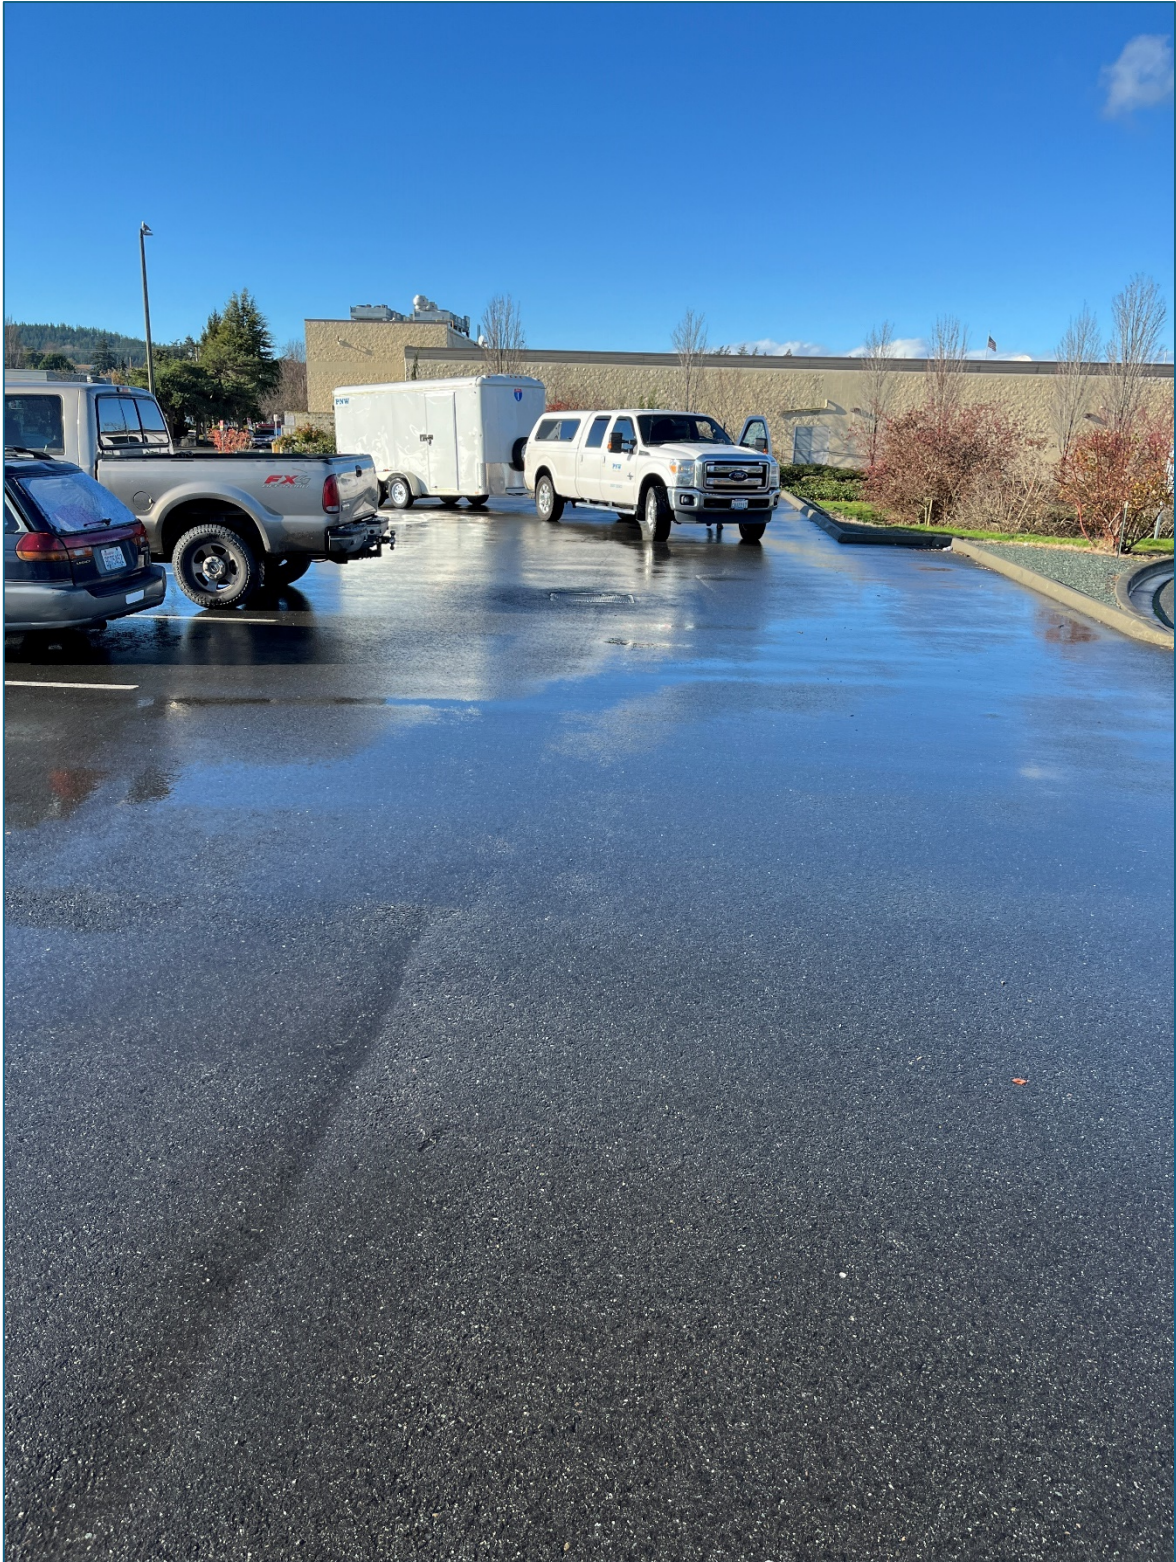
Figure 16: Photo point B6 looking west

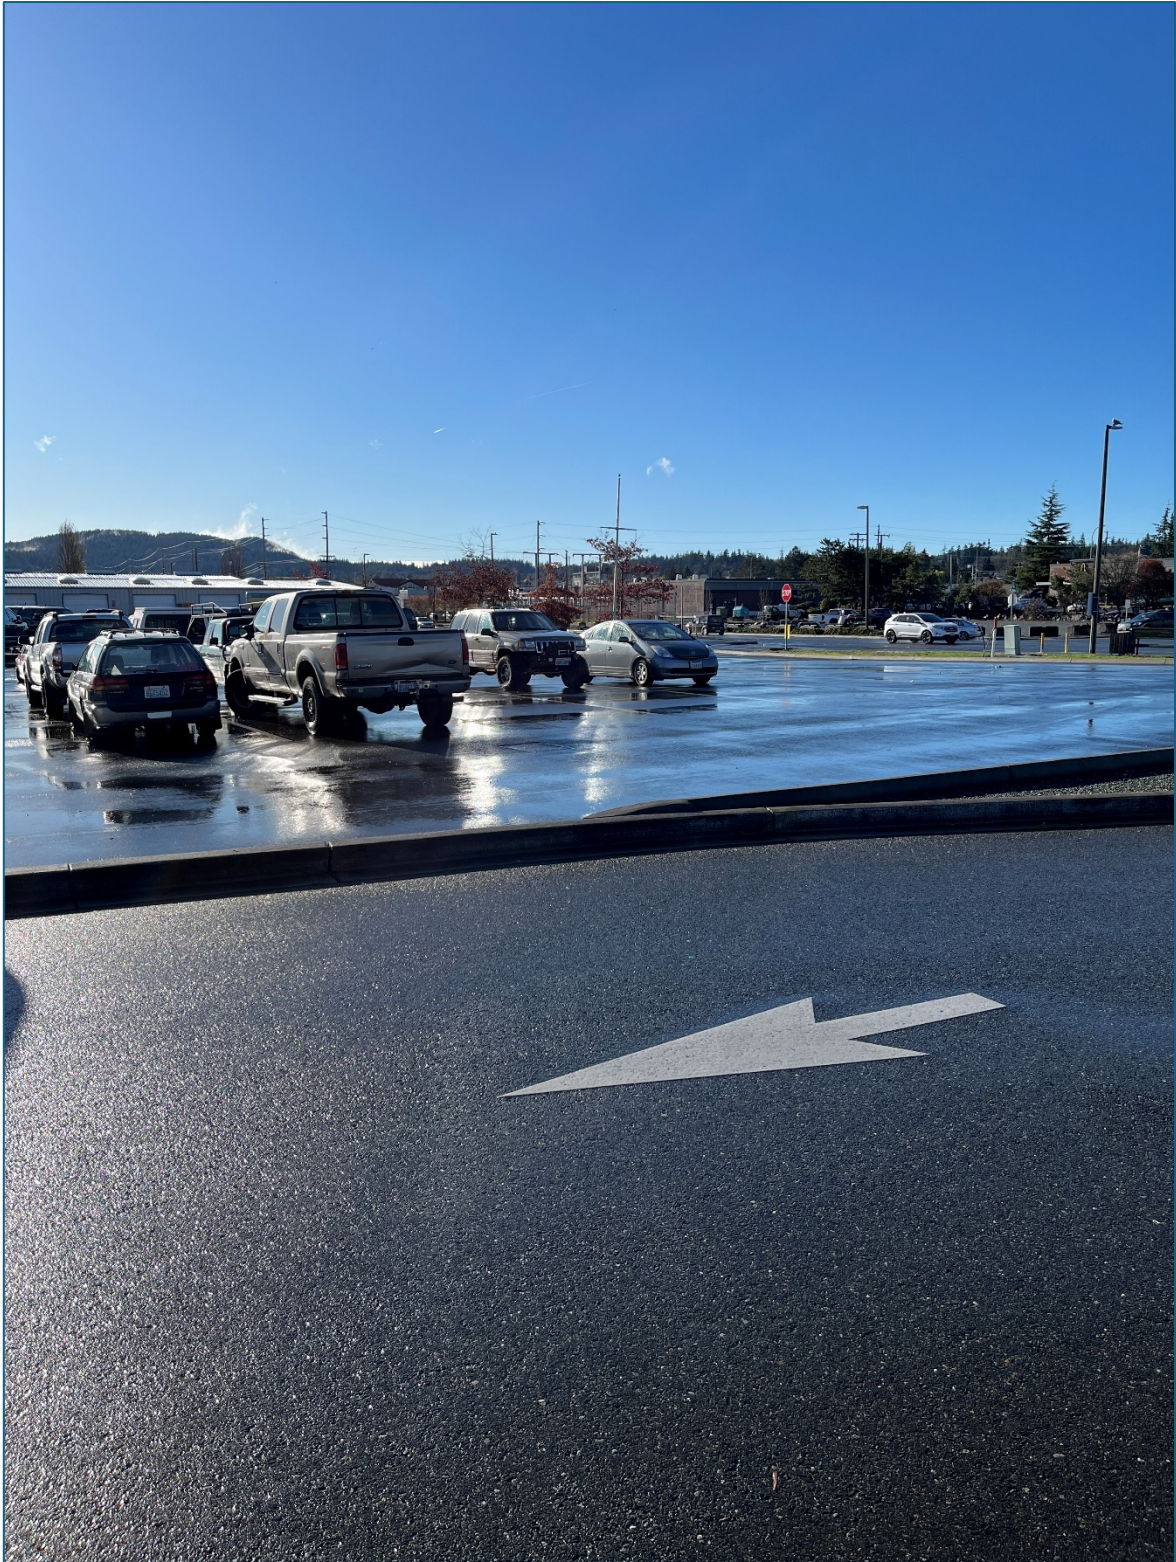
Figure 17: Photo point B7 looking SW

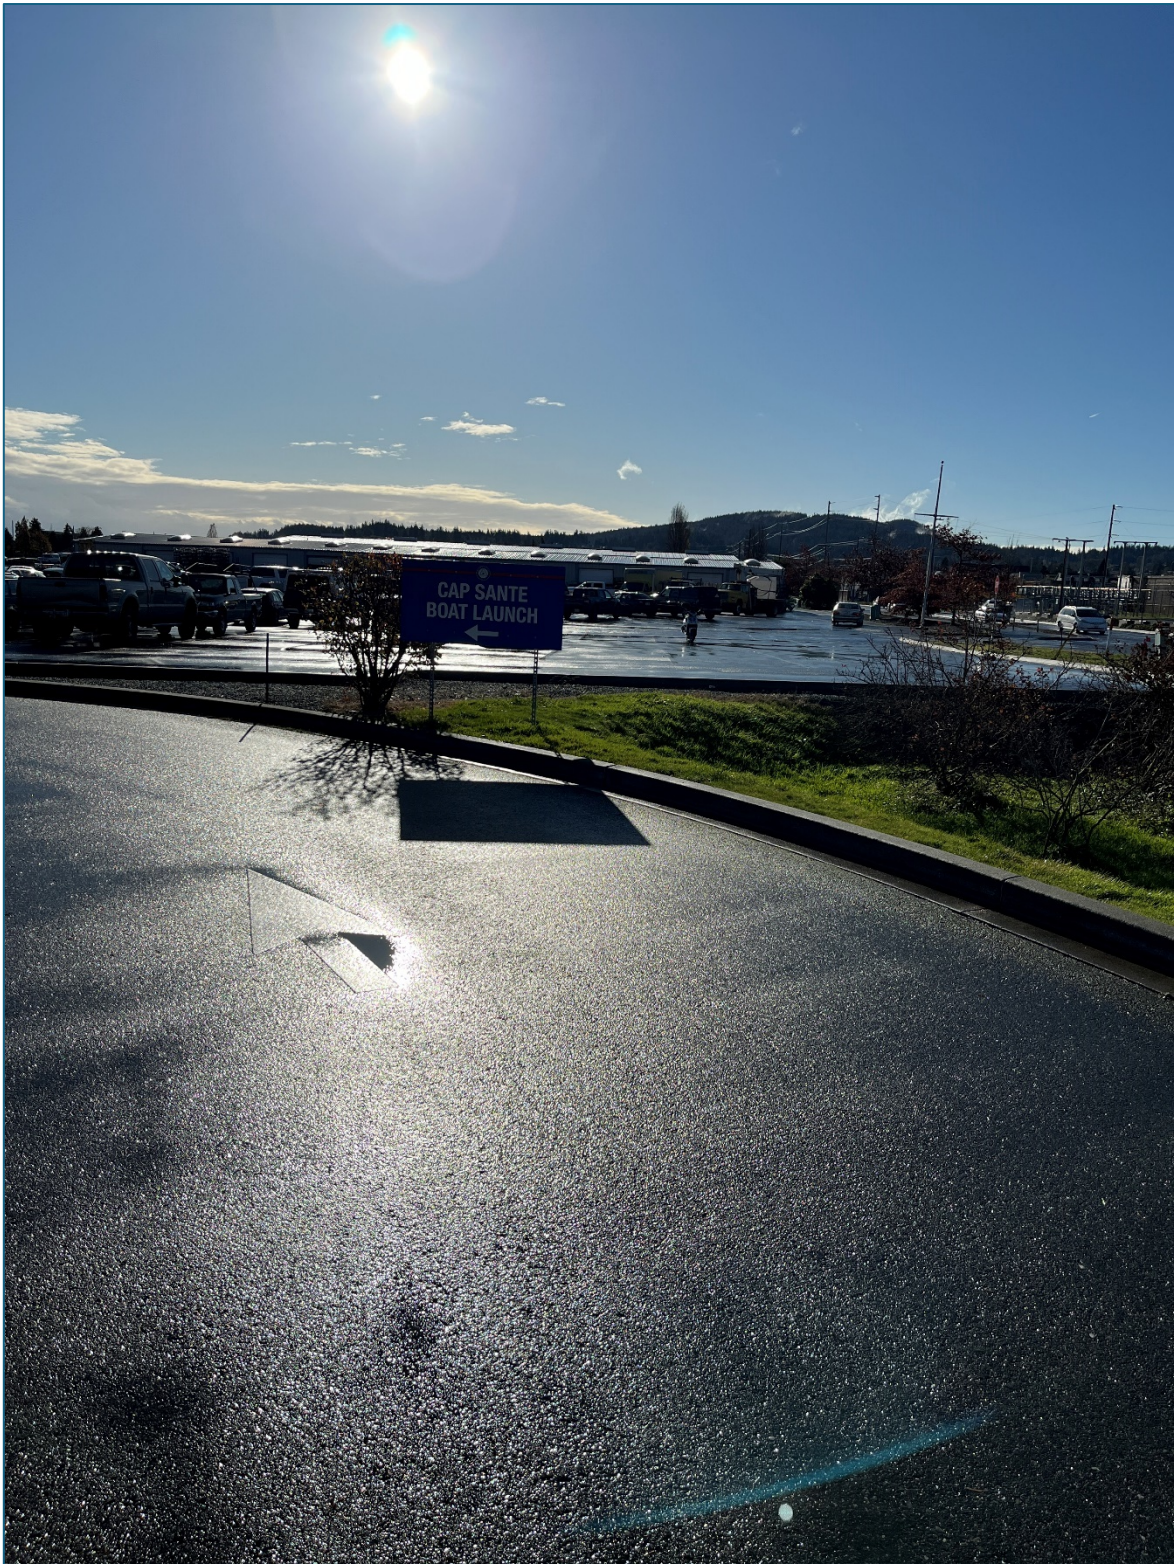
Figure 18: Photo point B8 looking south across swale and Cap Sante Marina uplands

b. Evidence of animal burrowing?		✓	
c. Evidence of erosion (wind or water)?		✓	
d. Change in vegetation cover?		✓	
e. Evidence of ponded water (excluding bioswale)?		✓	Bioswale has water in it
