## **FINAL Third Periodic Review Cascade Timber 3 POT**

**Thorne Rd & Maxwell, Tacoma, Pierce County, WA 98421  
Facility Site ID: 1206, Cleanup Site ID: 2693**

**Toxics Cleanup Program, Southwest Region**

April 2025

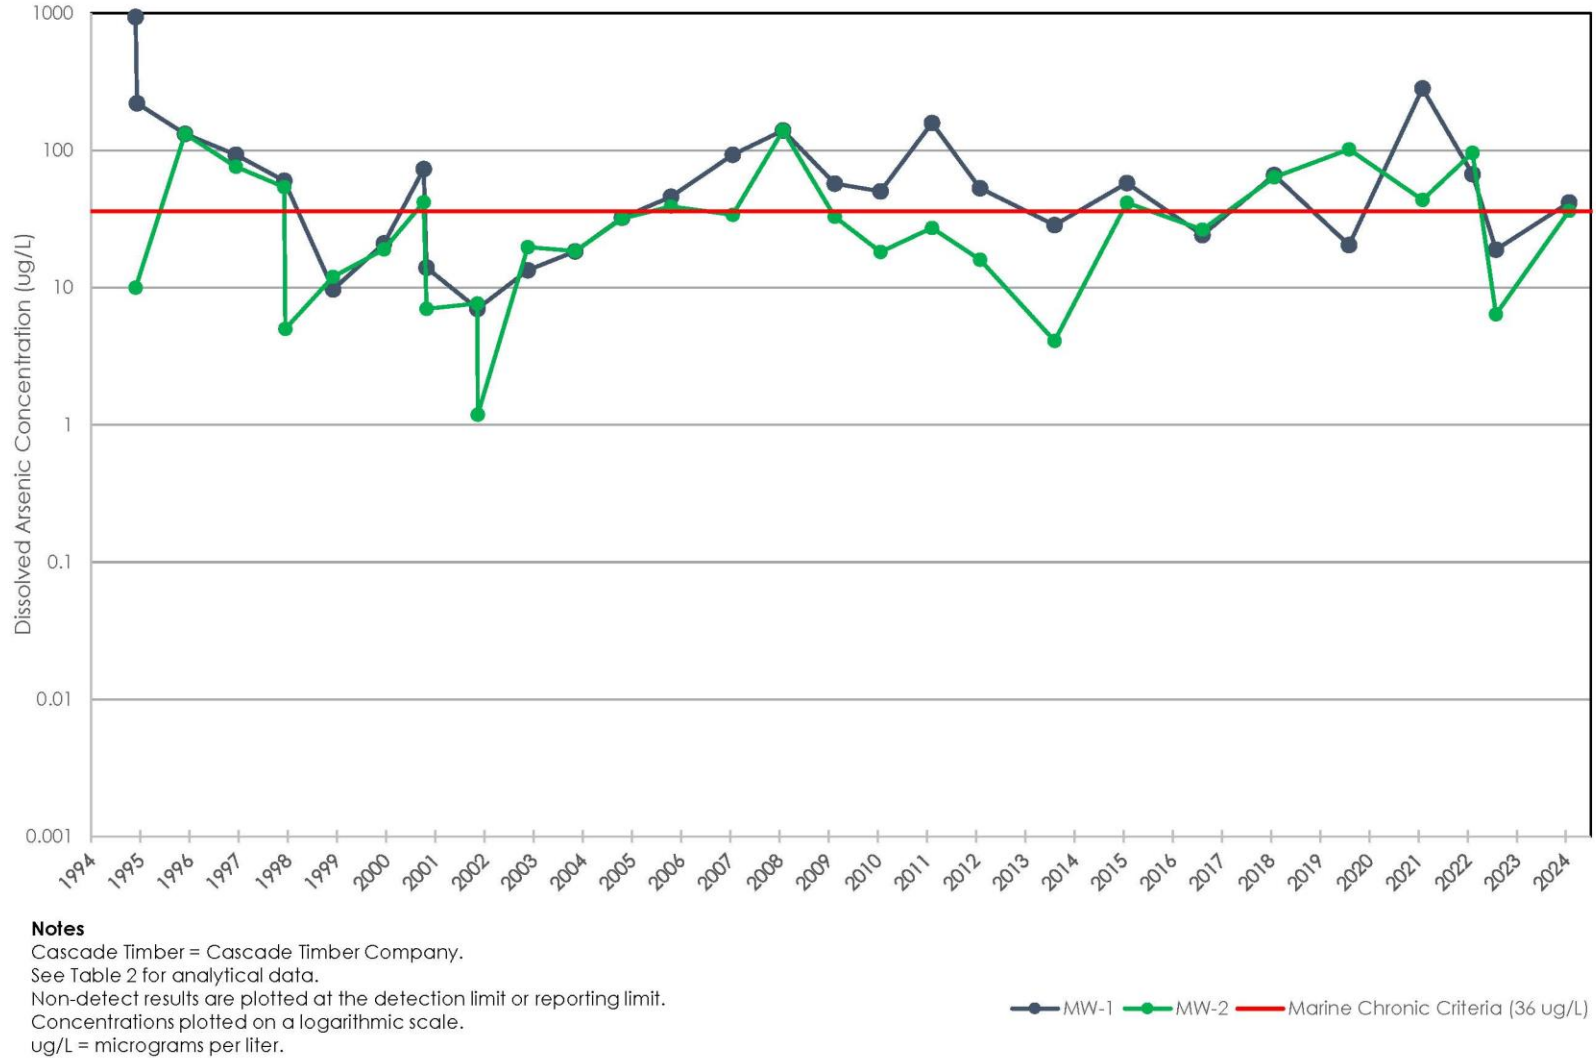
**Figure 1.** Dissolved Arsenic Trend Plot – 1994 to 2024 (MFA 2024a)

Analytical results for groundwater sampling conducted between 1994 and 2024 are presented in Tables 2 through 5. Trend plots depicting arsenic and copper concentrations over time are presented in Figures 1 and 2, respectively.

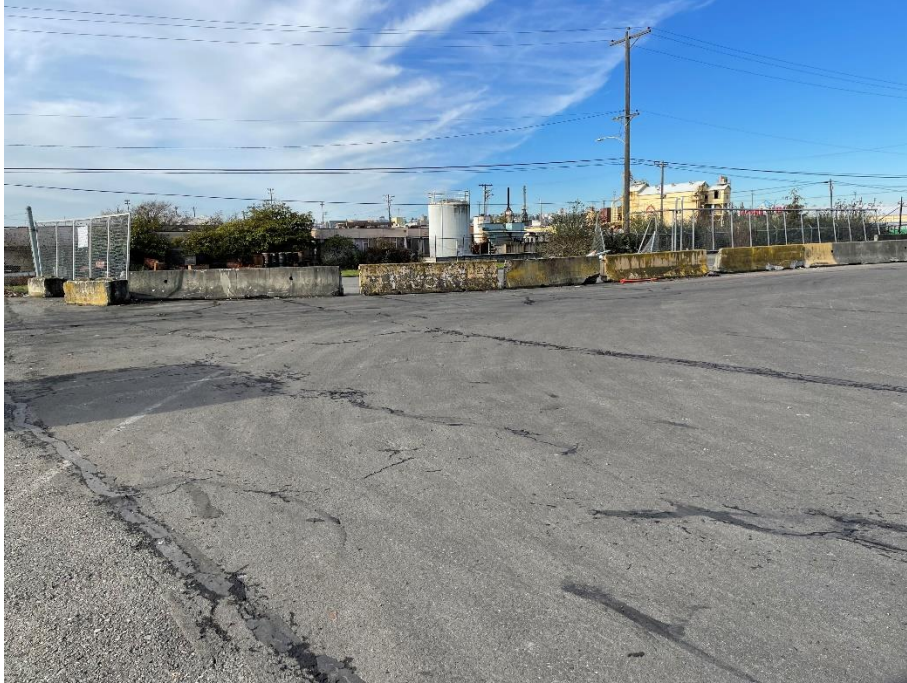
**Photo 1 (facing north): View of the capped area near the southwest entrance to the Site.**

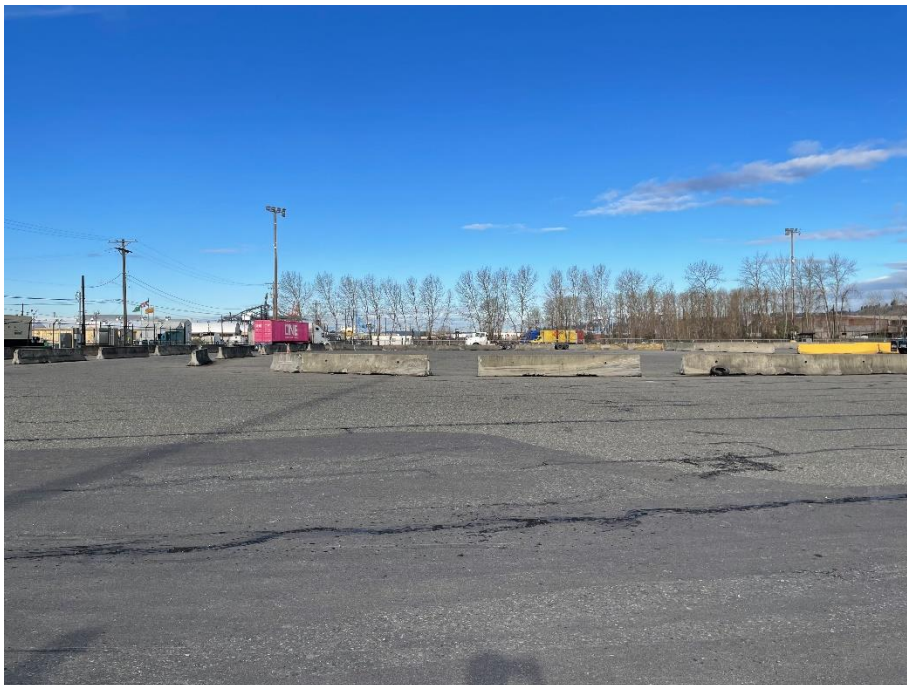
**Photo 2 (facing northwest): View of the southwest portion of the capped area from the eastern boundary of the Site.**

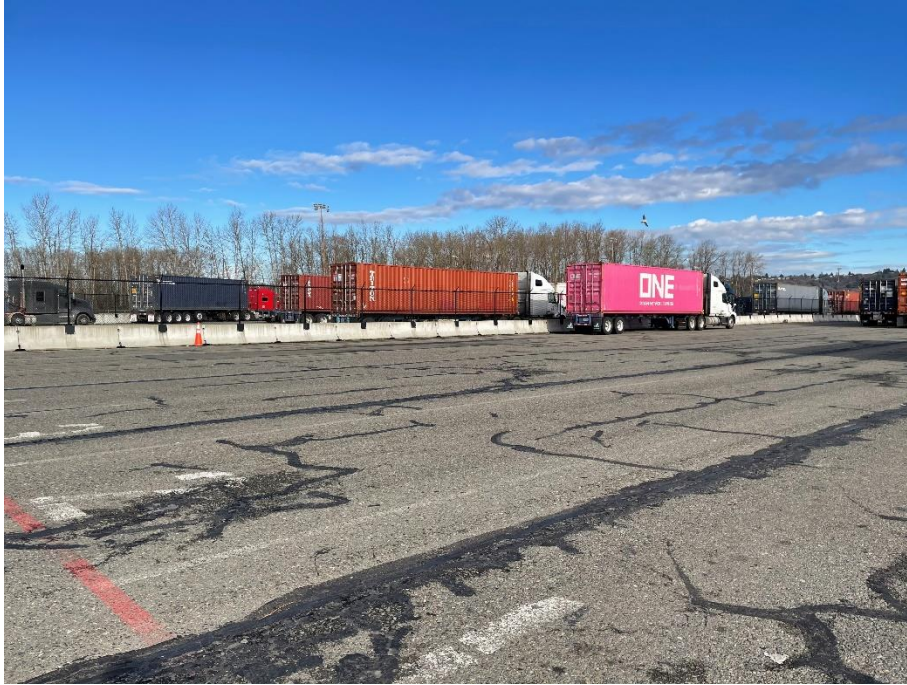
**Photo 3 (facing north): View of the south-central portion of the capped area from the eastern boundary of the Site.**

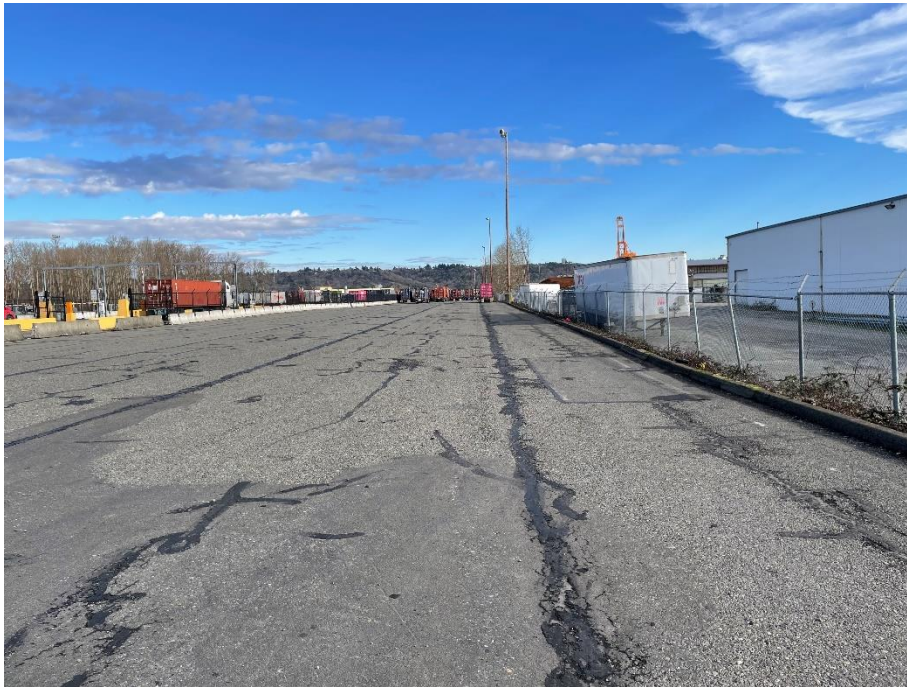
**Photo 4 (facing northeast): View along the eastern boundary of the capped area.**

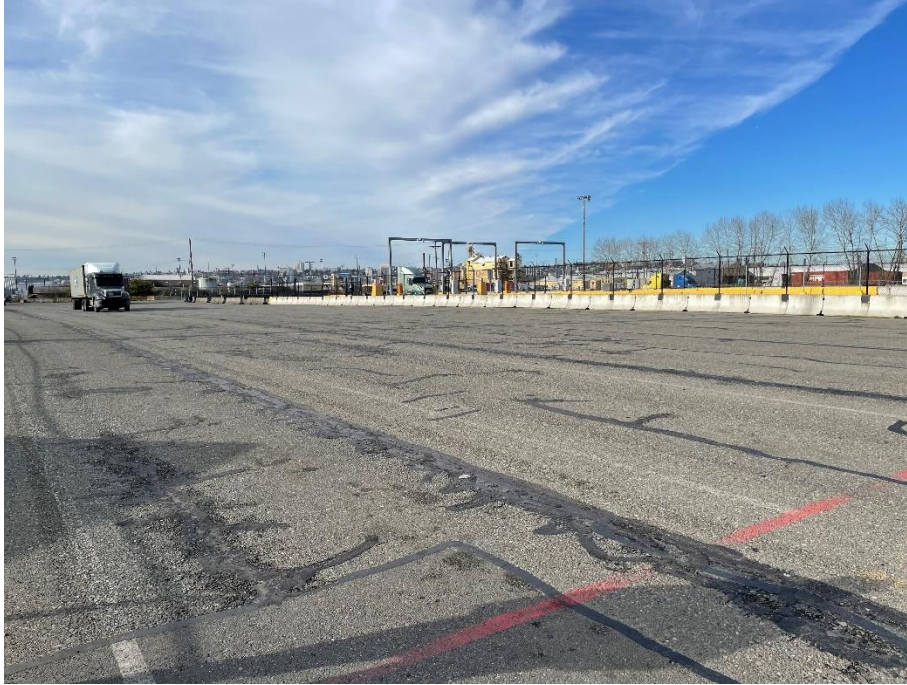
**Photo 5 (facing southwest): View of the south-central portion of the capped area from the eastern boundary of the Site.**

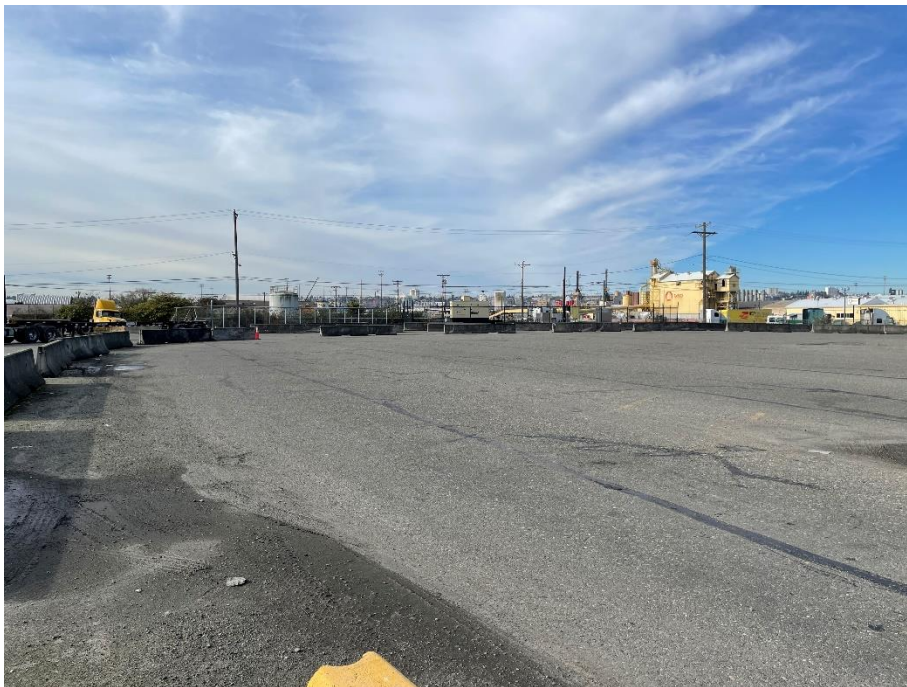
**Photo 6 (facing southwest): View of the southwest portion of the capped area.**

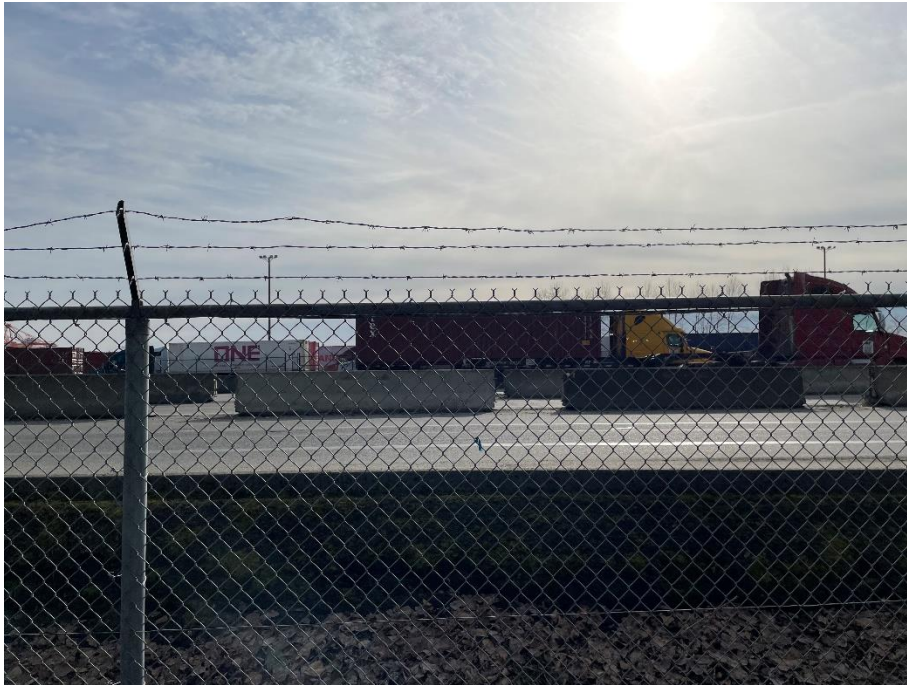
**Photo 7 (facing southeast): View of the northern portion of the capped area from the western boundary of the Site.**

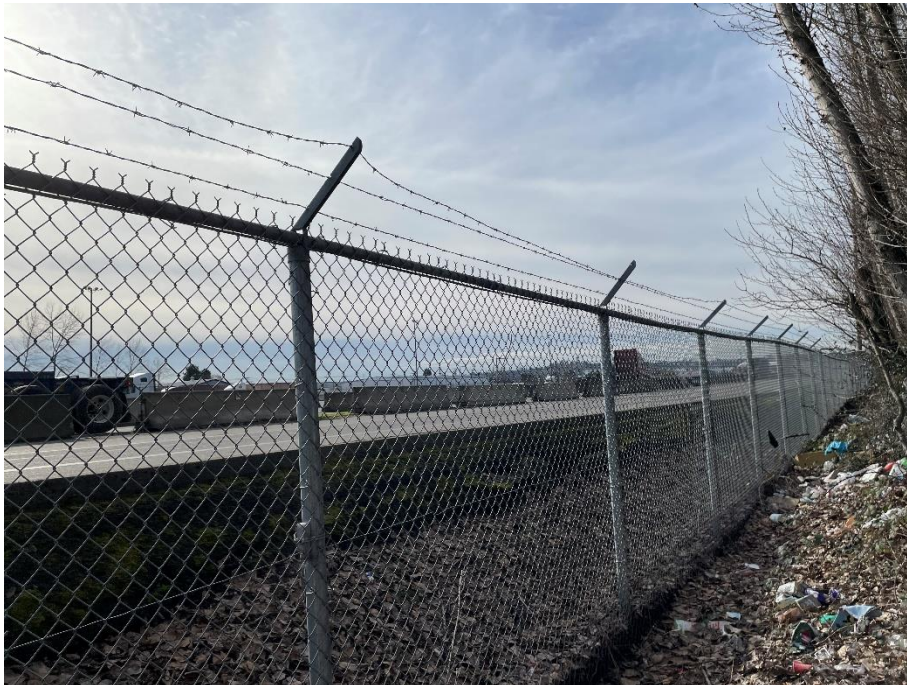
**Photo 8 (facing south): View along the western boundary of the capped area.**

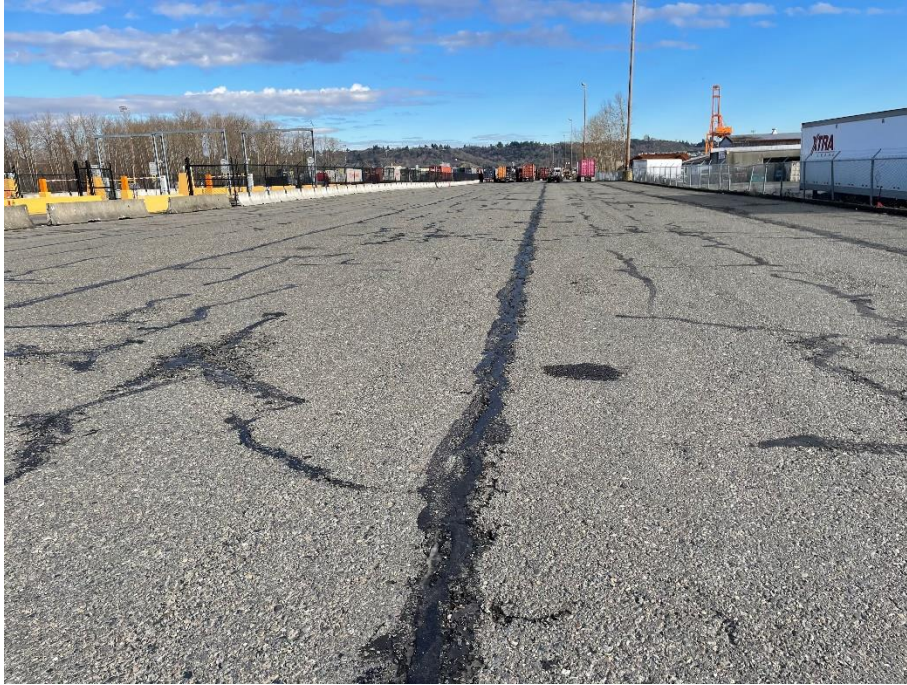
The cleanup actions were intended to eliminate exposure to contaminated soil and groundwater at the Site. Exposure pathways to contaminated soils by ingestion and direct contact were reduced by installation of a cap over the entire Site. The cap appears to be in satisfactory condition and no repair, maintenance, or contingency actions are required at this time. Evidence of previous repairs were observed during the Site visit.

**Photo 9 (facing northeast): View of previous cap repairs along the eastern portion of the capped area.**

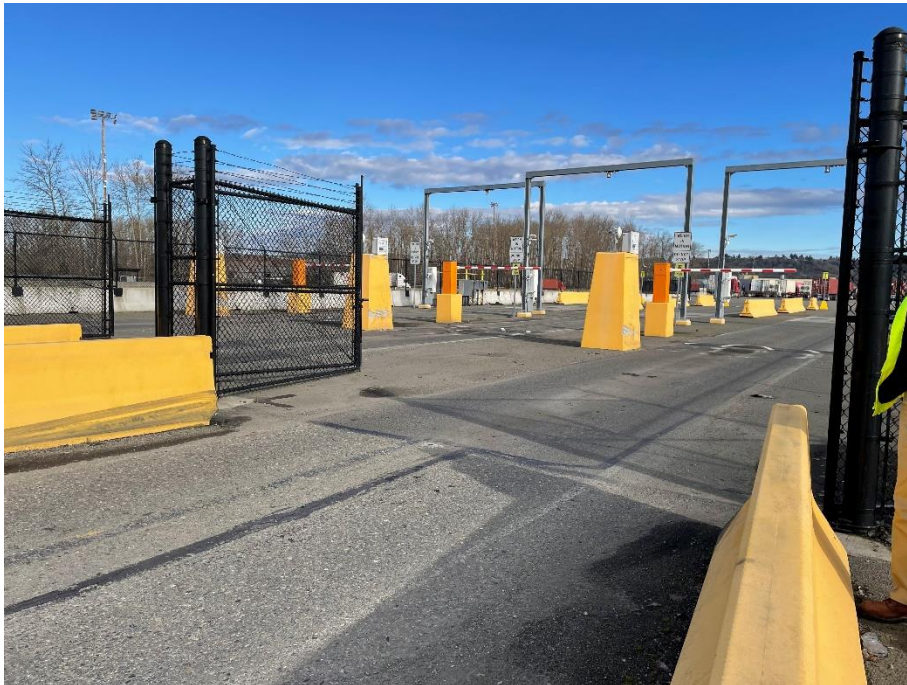
**Photo 10 (facing north): View of weigh stations within the south-central portion of the Site.**

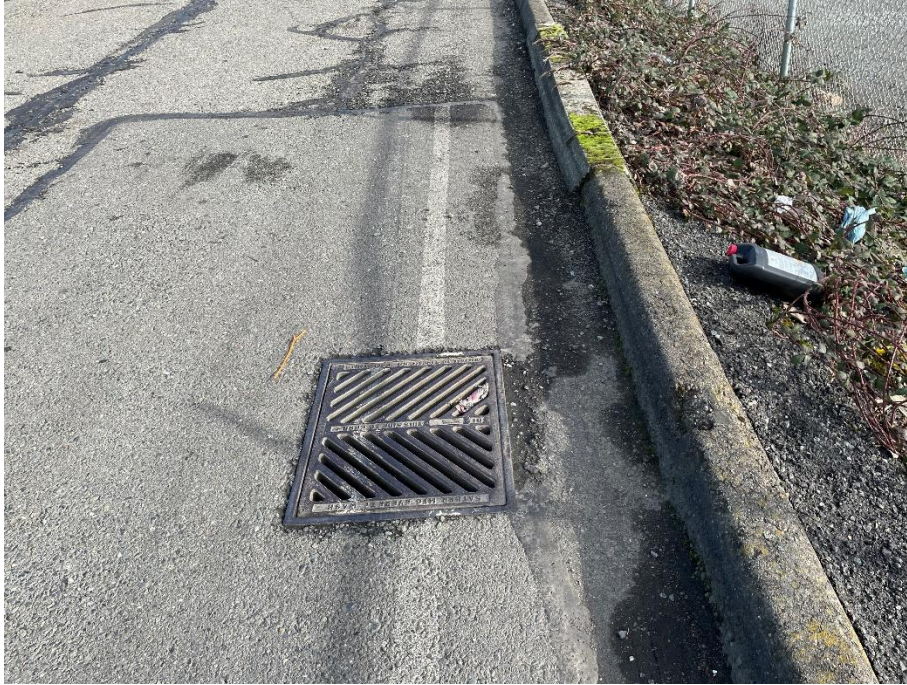
The stormwater drainage system at the Site consists of six catch basins, one spill containment vessel, one oil/water separator, and one maintenance hole. The drainage system was inspected in 2024 for general appearance, sediment and debris accumulation (as visible), and structural and functional condition. In general, catch basins observed appeared to be structurally sound and functioning normally. At the time of the inspection, sediment accumulation and debris were observed in all catch basin inserts.

**Photo 11 (facing not applicable [NA]): View of a catch basin on the southeastern portion of the Site.**

- Consider replacing filter inserts and removing debris in all catch basins on a more frequent basis.
- Evaluate means to prevent stormwater runoff from bypassing catch basin 5 and reseal the area around the grate.

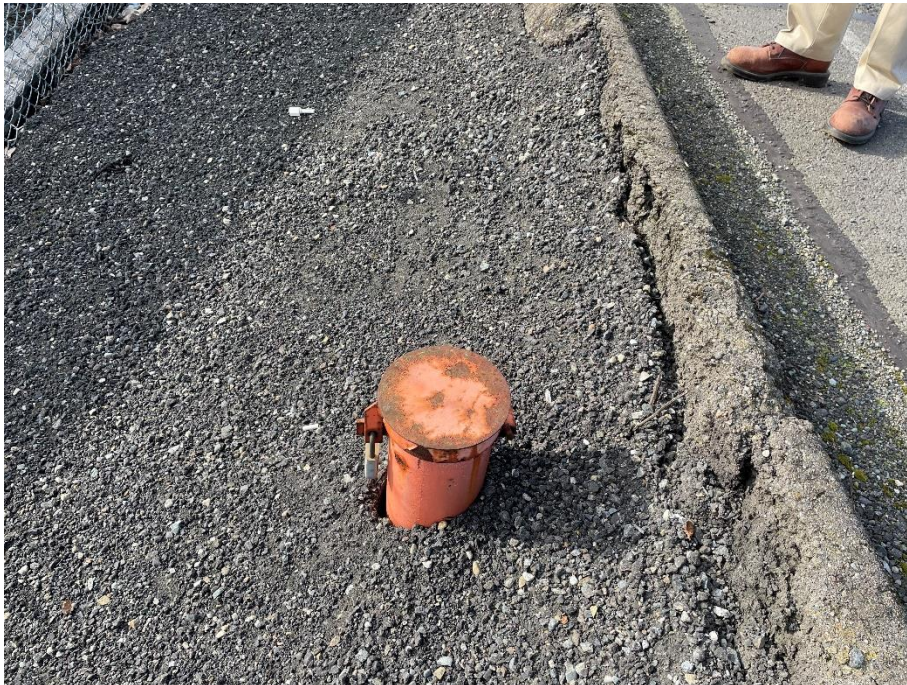
**Photo 12 (facing NA): View of monitoring well MW-1 along the eastern boundary of the Site.**

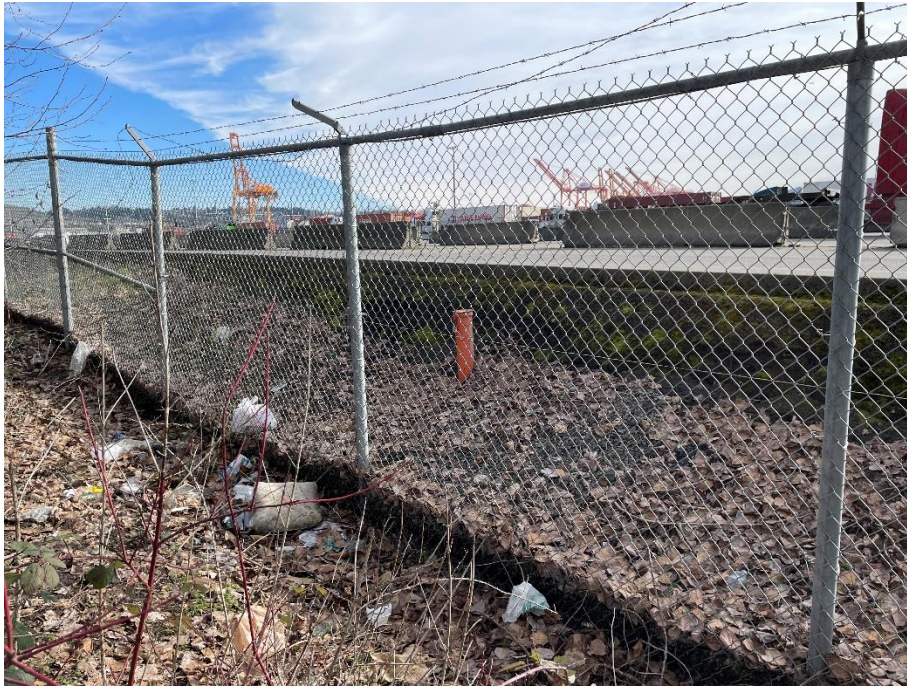
**Photo 13 (facing northeast): View of monitoring well MW-2 along the western boundary of the Site.**
