CONSTRUCTION SUMMARY REPORT

LOWER DISPOSAL AREA COVER UPGRADE

**RESERVE SILICA SITE
RAVENSDALE, WASHINGTON**

July 25, 2008

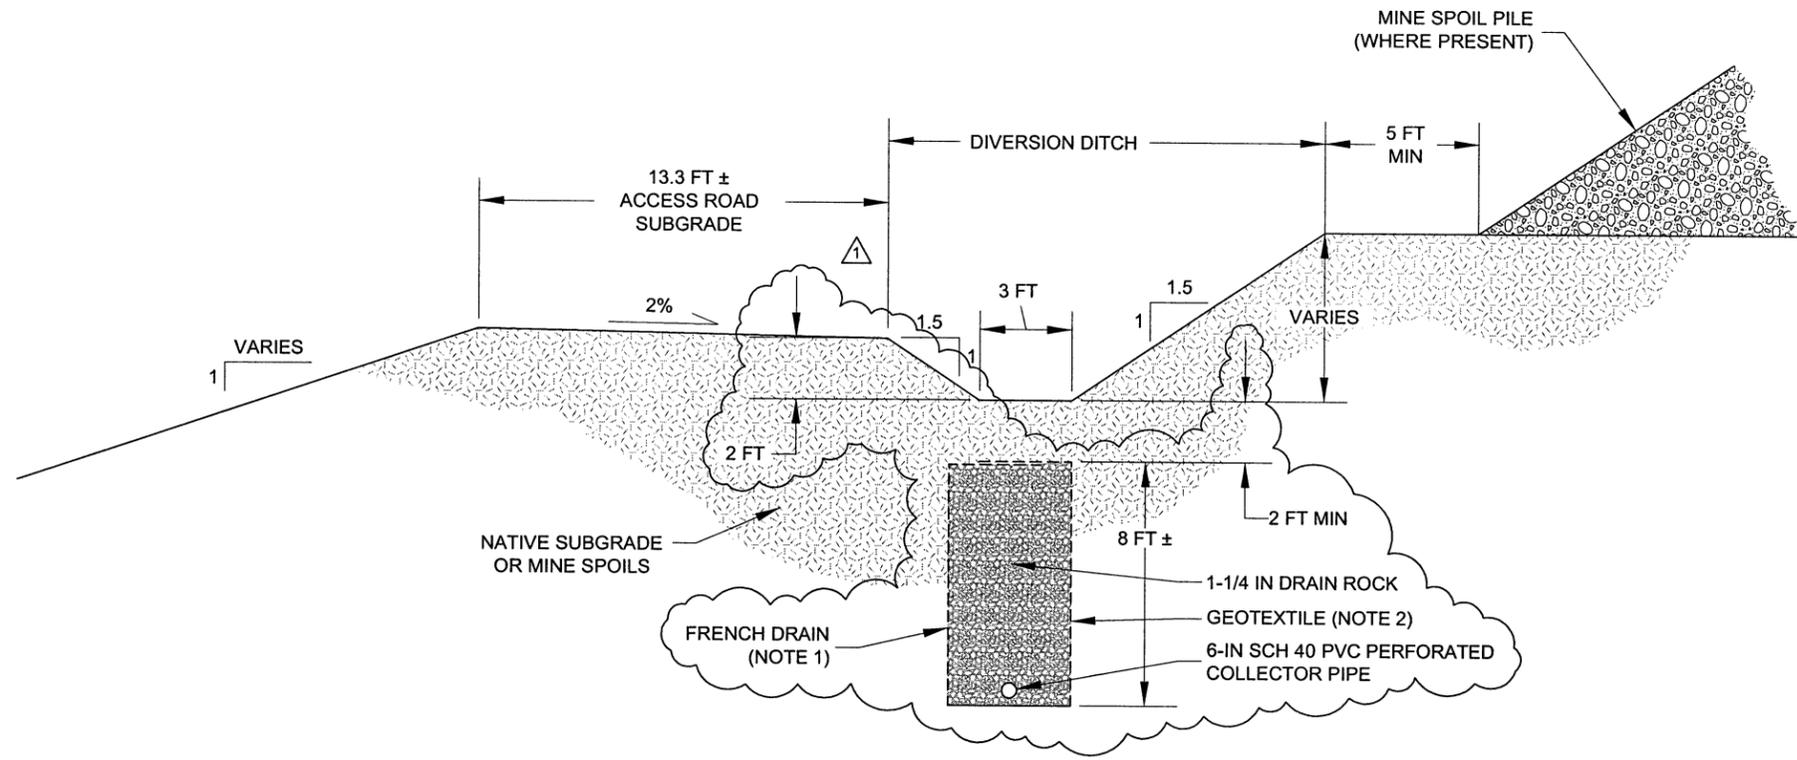
TYPICAL DIVERSION DITCH AND ACCESS ROAD SECTION - REGRADE SURFACE

- SEE SHEET 060 FOR PLAN LOCATION OF FRENCH DRAIN. LATERAL POSITION WITH RESPECT TO DIVERSION DITCH CENTERLINE VARIES APPROXIMATELY 5 FT DOWNSLOPE FROM THAT SHOWN.
- GEOTEXTILE CONSISTS OF 12 OZ/SY NON-WOVEN POLYPROPYLENE, INSTALLED ON SIDES OF TRENCH AND OVERLAPPED ON TOP OF DRAIN ROCK.
