## **First Periodic Review**

### **Crownhill Elementary School Bremerton SD**

**1500 Rocky Point Rd NW, Bremerton, 98312, Kitsap  
County, Washington**

**Toxics Cleanup Program, Northwest Region**  
Washington State Department of Ecology  
February 2025

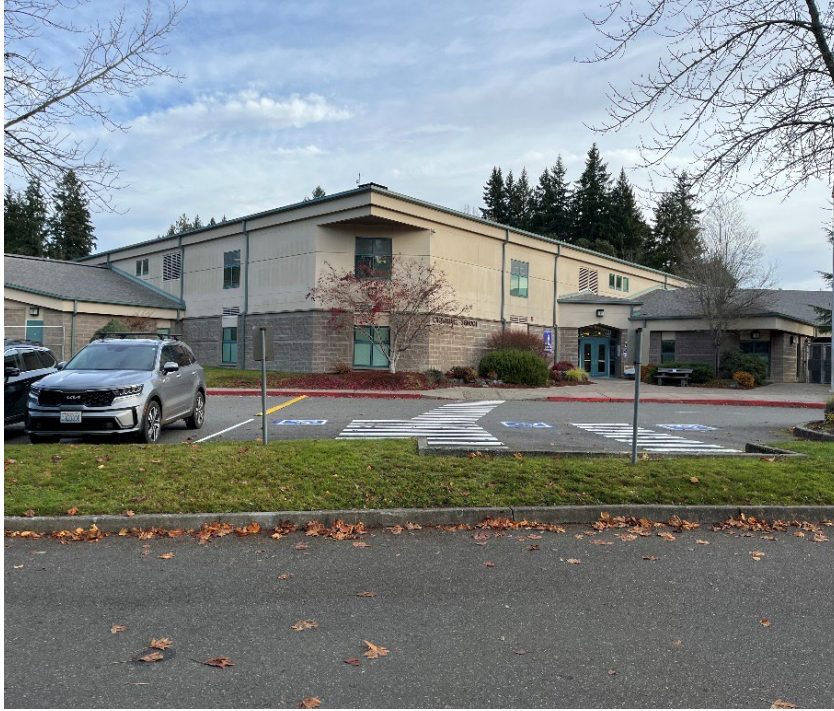
Photo 1: Main School Building, photo from west

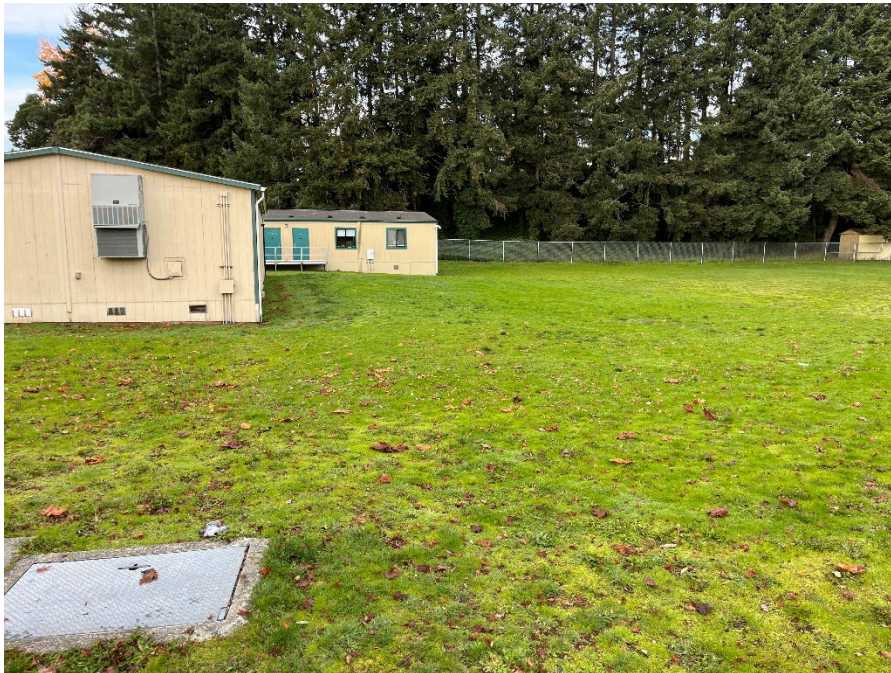
Photo 2: Portable Classrooms and landscaped cover, photo to north

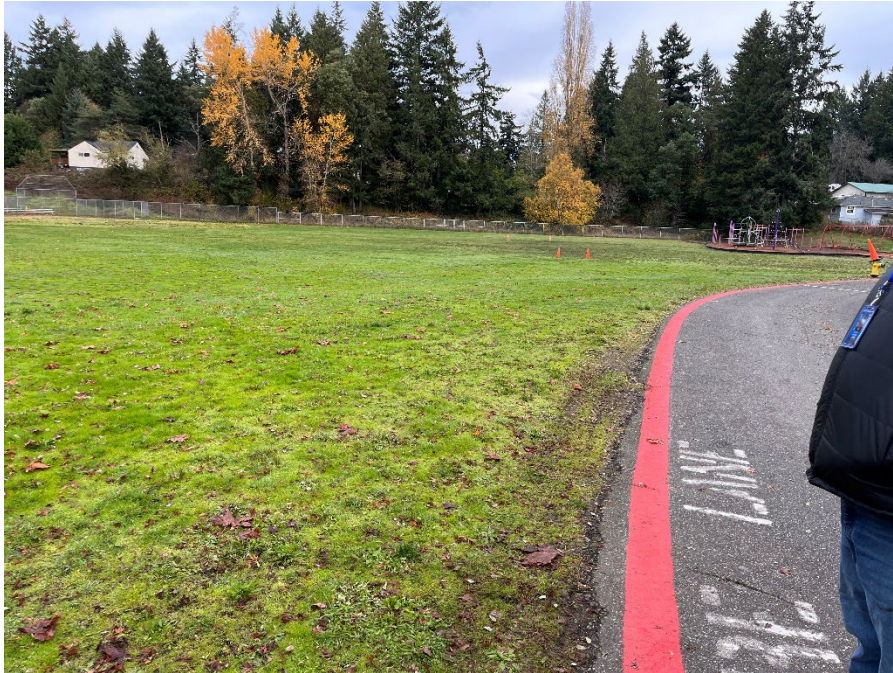
**Photo 3: Landscaped cover, play area, photo to northeast**

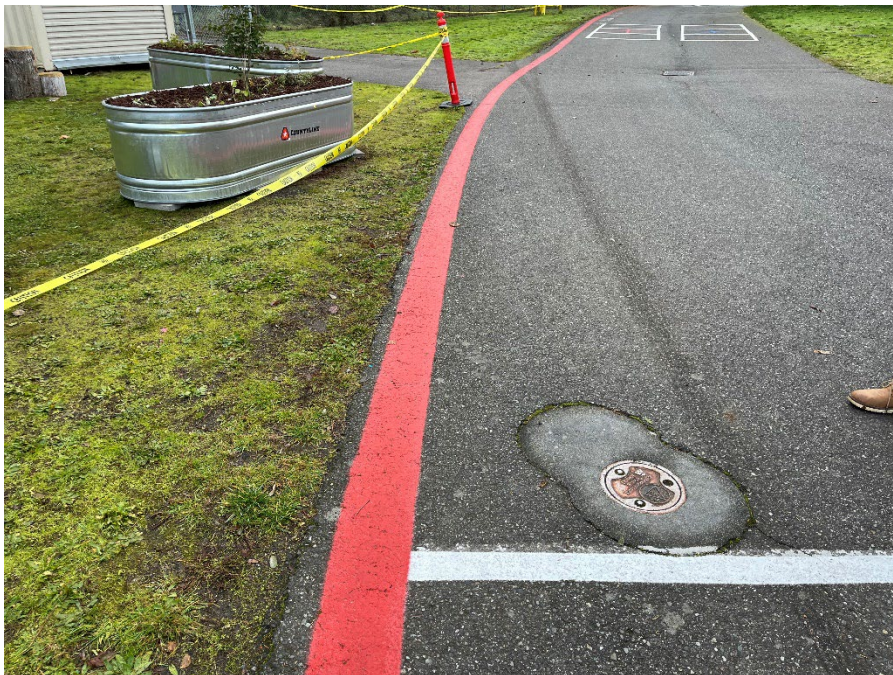
One unauthorized soil disturbance was reported to Ecology in October 2021, when a volunteer installed fence posts at a garden area at the Site. The fence post holes did not penetrate the protective soil cap, however, they were installed in violation of the Environmental Covenant. The installation was reported to Ecology, and the fence posts removed and area restored. Other elements of the garden area did not contradict the Environmental Covenant, as they consisted of above-ground planters and work tables set on a bed of wood chips.

**Photo 4: Above-ground planting containers and monitoring well (typical), photo to south**

- The PLP has been diligent in inspection and maintenance of the Site soil cap and associated institutional controls. However, to improve communication with school district staff and volunteers, posting of informational signs warning against soil disturbance is recommended to avoid other inadvertent soil cap damage.

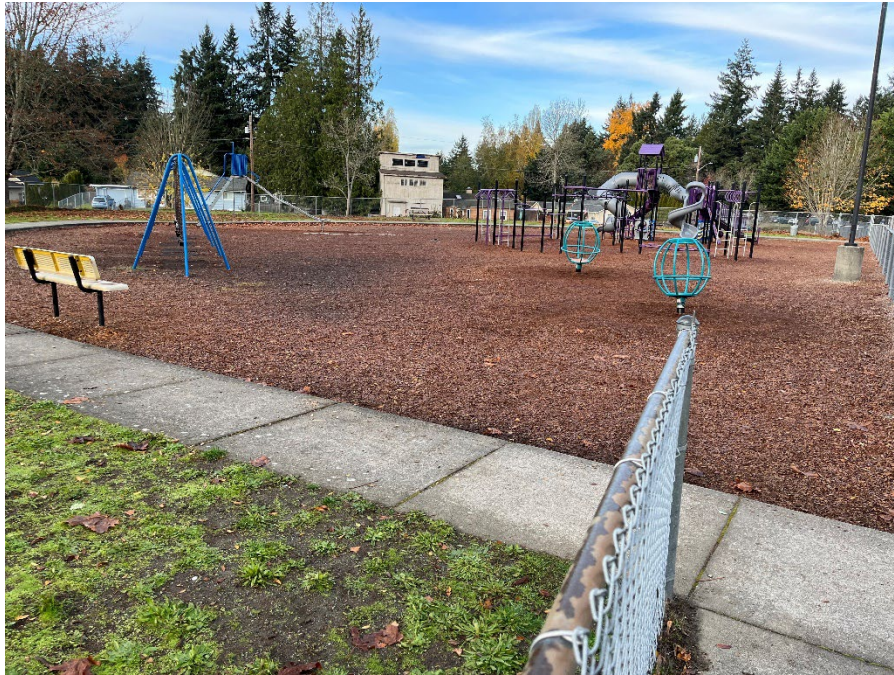
Photo 5: Play area with ground cover, photo to west

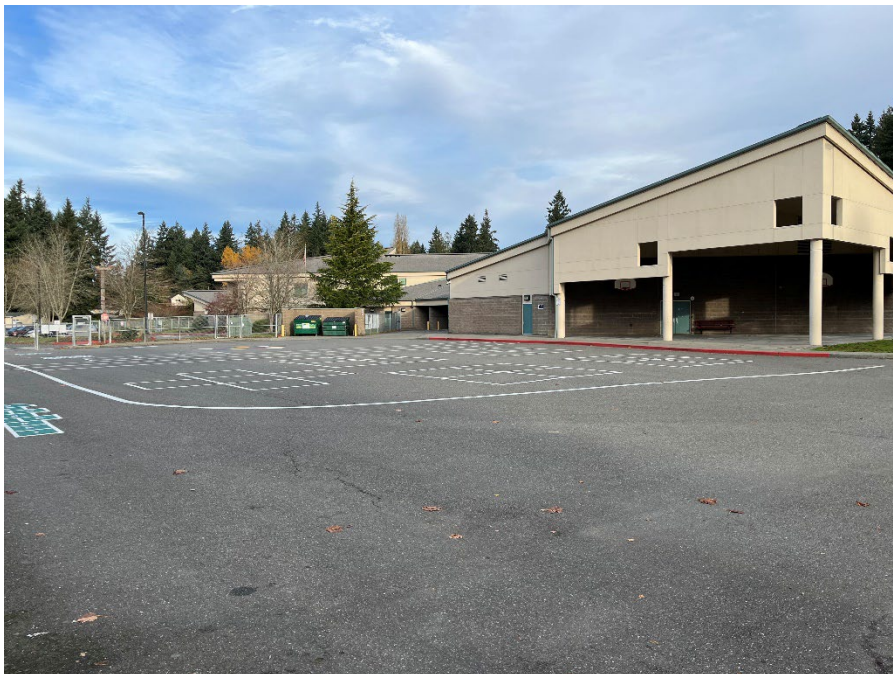
Photo 6: Main school building and asphalt play area, photo to north

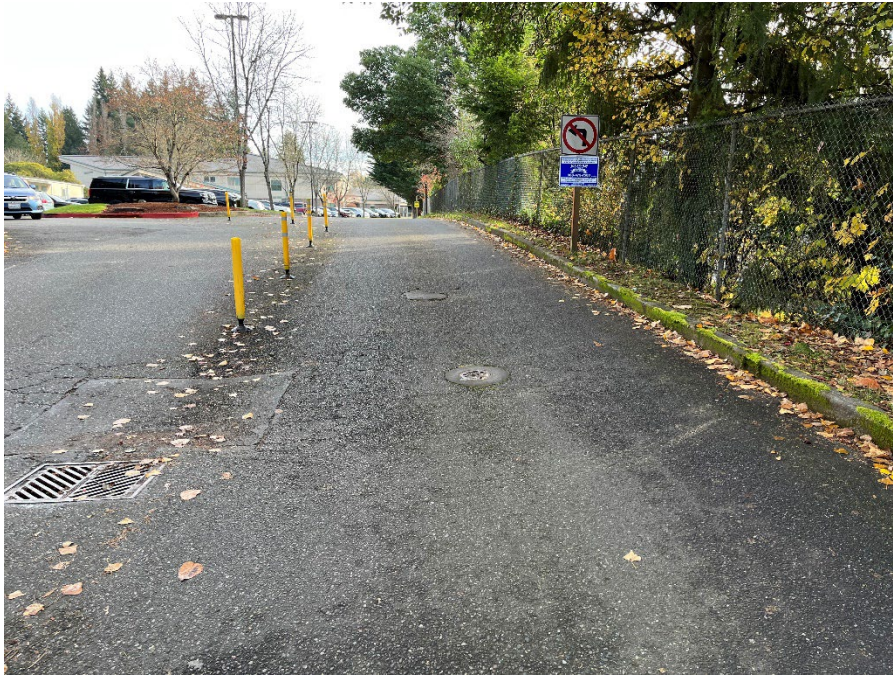
- Groundwater compliance monitoring at the Site indicates that diesel- and oil-range TPH, TCE, and arsenic are present above MTCA cleanup levels, and LNAPL is present in Site monitoring wells. However, these contaminants of concern do not exceed cleanup levels at well MW-10 at the conditional point of compliance.

**Photo 7: School Driveway, monitoring well MW-10 in foreground, photo to east**

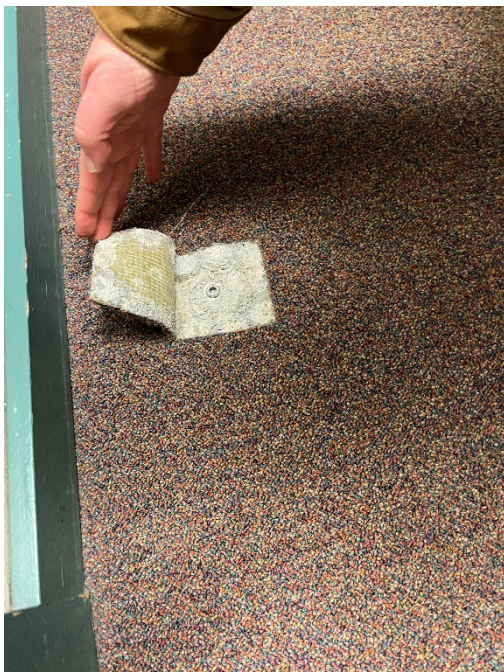
Six soil vapor sampling points are located inside the main school building. One sampling point located in a public access way was located and inspected as part of the Site visit. It was found to be in good condition. The remaining sampling points are located within classrooms and were not accessible at the time of the Site visit.

**Photo 8: Soil gas monitoring point, school building interior**

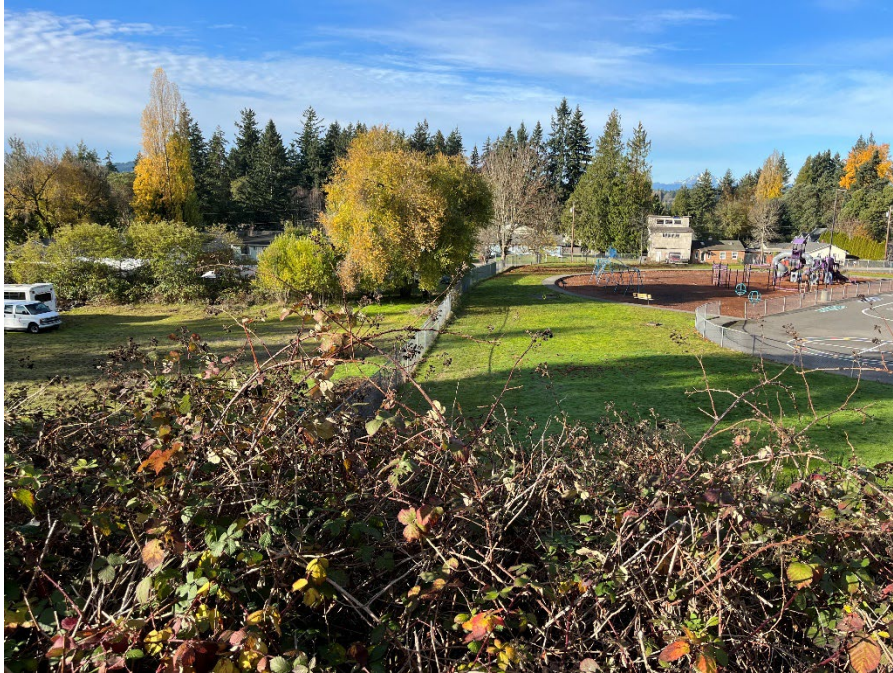
**Photo 9: South edge of School parcel and north edge of BUMC parcel, view to west**

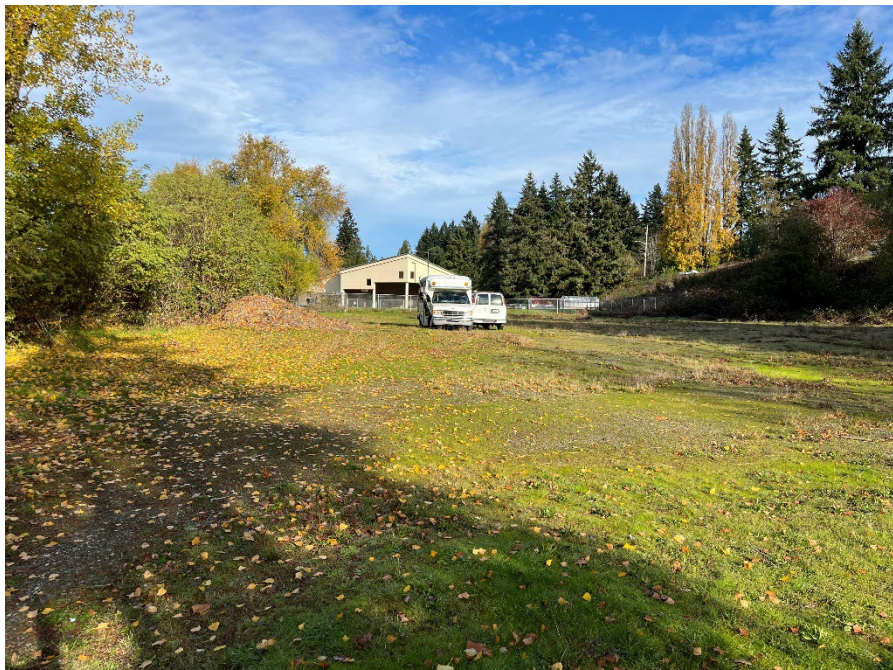
**Photo 10: Portion of BUMC parcel within Site, photo to north**
