REGULATED BUILDING MATERIAL INSPECTION

PORT OF FRIDAY HARBOR JENSEN BOATYARD SELECT BUILDINGS 1293 TURN POINT ROAD FRIDAY HARBOR, WASHINGTON

Prepared by EMB Consulting, LLC May 15, 2023

EMB Consulting Project #: 1730

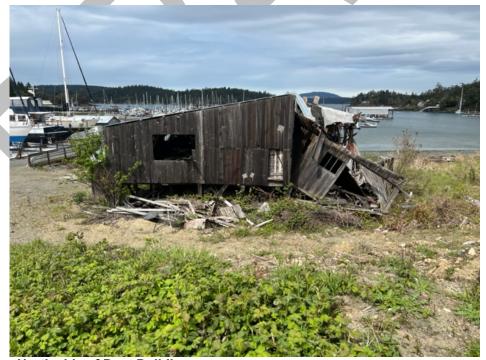
The east portion of the building collapsed in 2022, so at the time of this inspection there was a sprawling debris pile of wood, roofing, and windows extending onto the ground to the east. The building could not be entered during this inspection, as it is no longer structurally sound.

North side of Boat Building

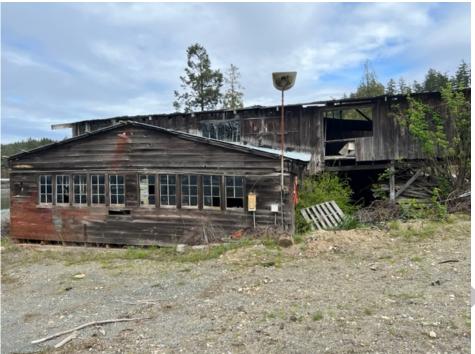
West side of Boat Building

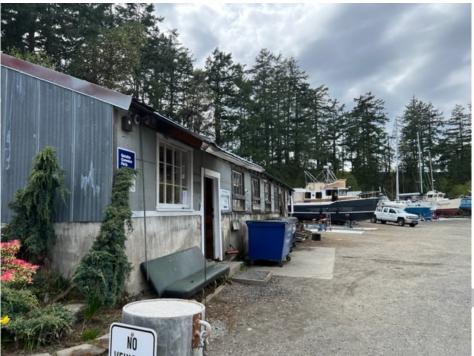
North Exterior of Office Building

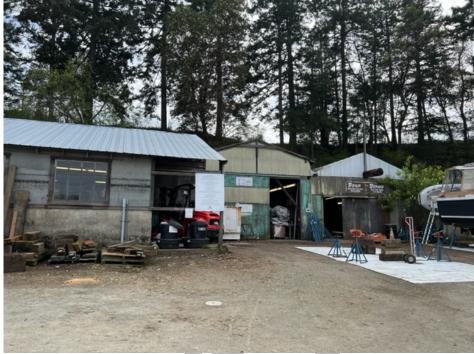
South side of Office Building and Bays 1 and 2

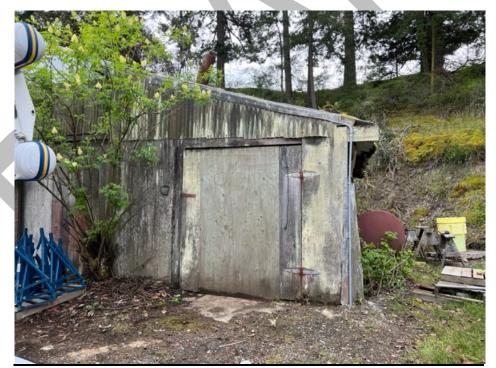
South side of Bay 3

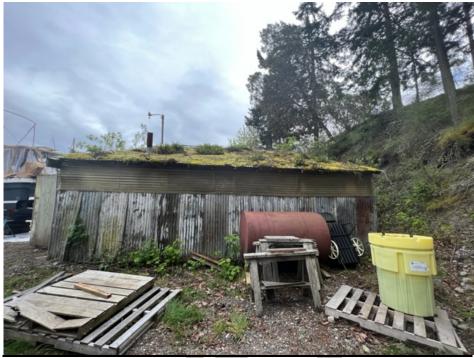
West side of Bay 3
