**RE: 2024 ANNUAL OPERATIONS AND MAINTENANCE SITE INSPECTION FOR THE HAMILTON STREET BRIDGE SITE**

**RE:** 2024 Annual Operation and Maintenance Site Inspection  
Hamilton Street Bridge Site  
Spokane, Washington  
Project No. 0236042.150

## Site Inspection Photographs

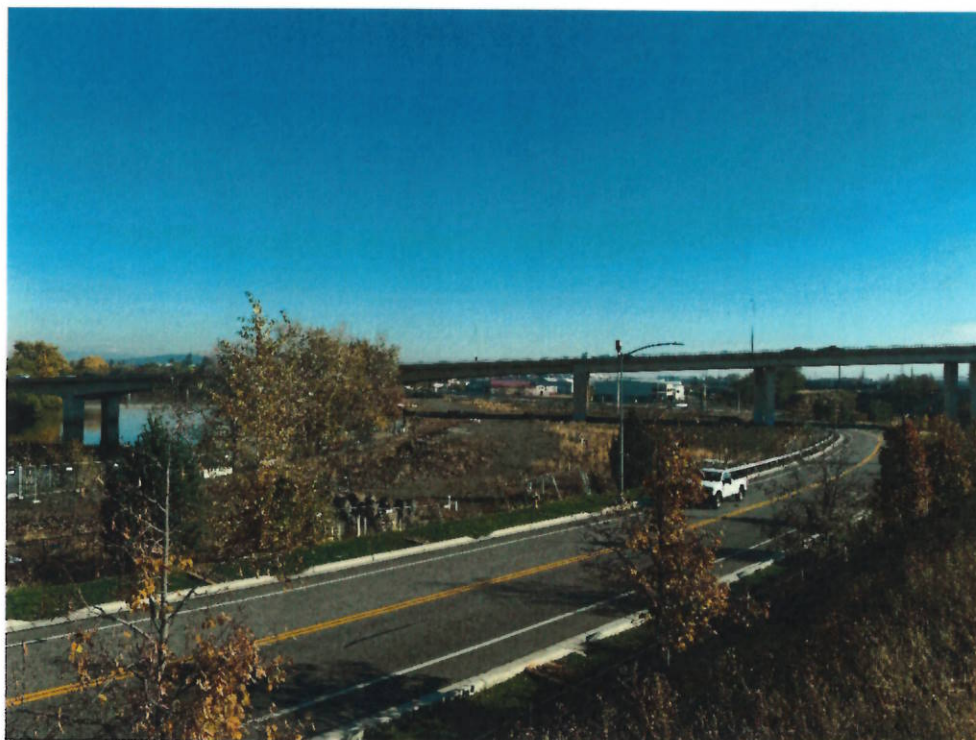
1. View of former SGP portion of the site (looking northeast).

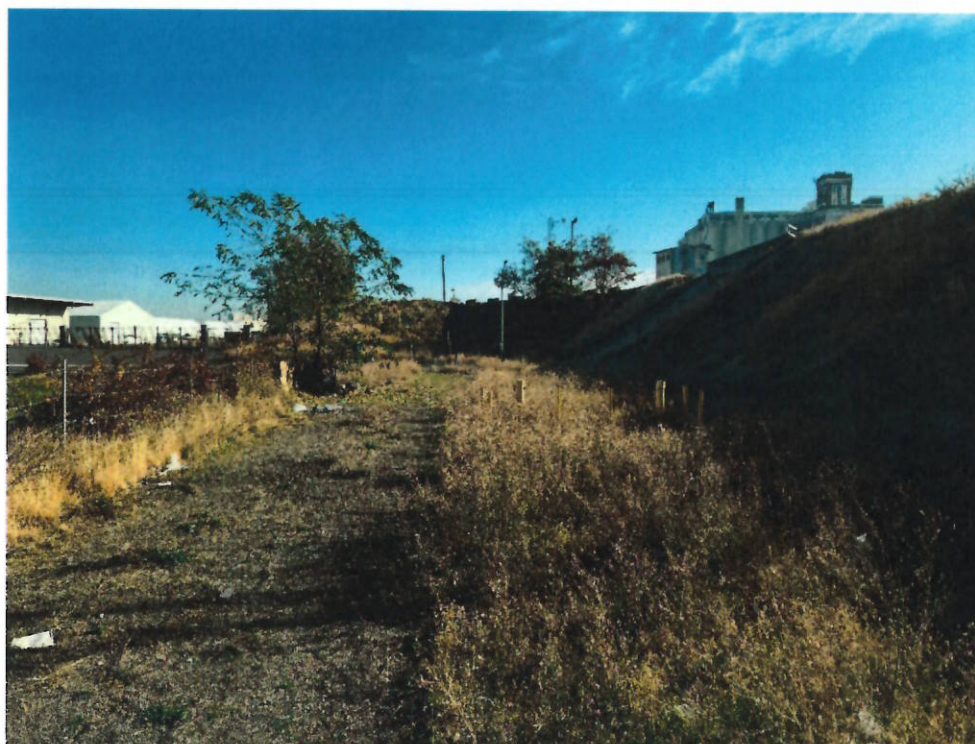
2. View of ATC portion of the site and ATC monitoring wells (looking east).

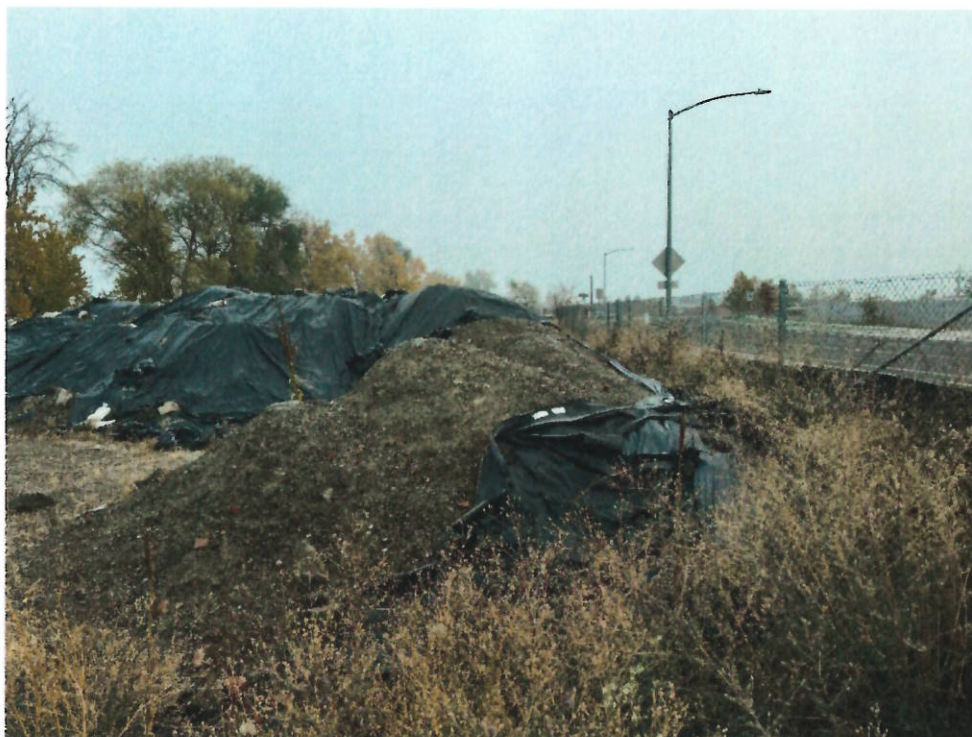
- **Stockpiles.** Stockpiles were observed at various locations throughout the Site. The stockpile at the southwest end of the north detention basin was partially covered by plastic at the time of Landau's O&M Site inspection. The following uncovered stockpiles were observed at the Site.

1. View of the partially covered stockpile adjacent to the north detention pond containing Site debris (bricks) on the former SGP property (looking east).

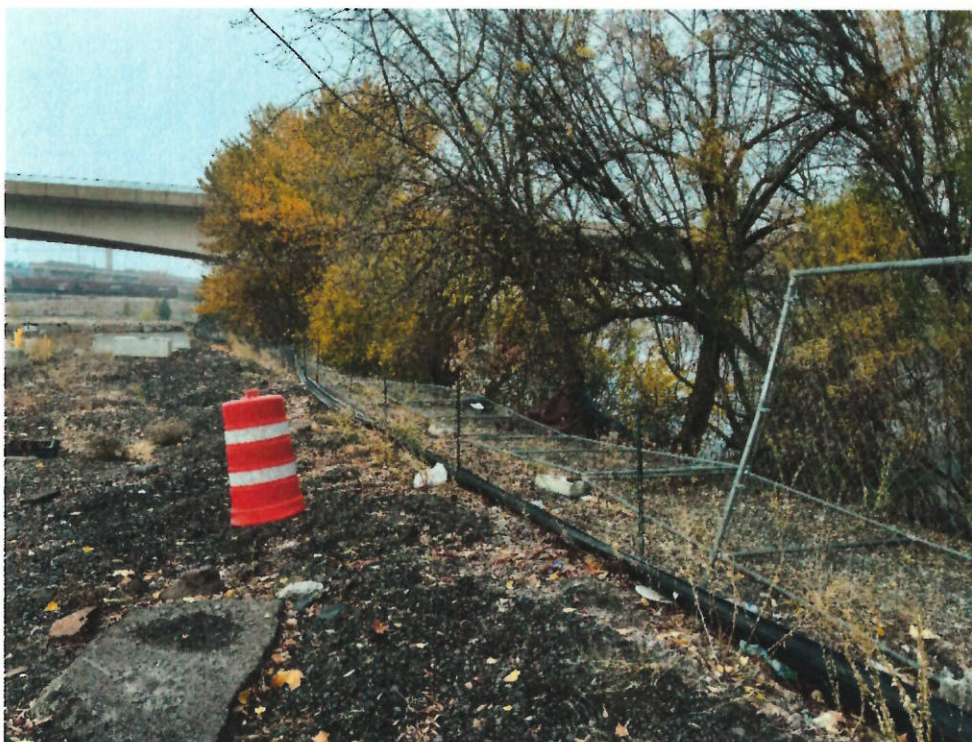
2. View of laid down fence along the top of the riverbank east of the James E. Keefe Bridge on the former SGP property (looking west).

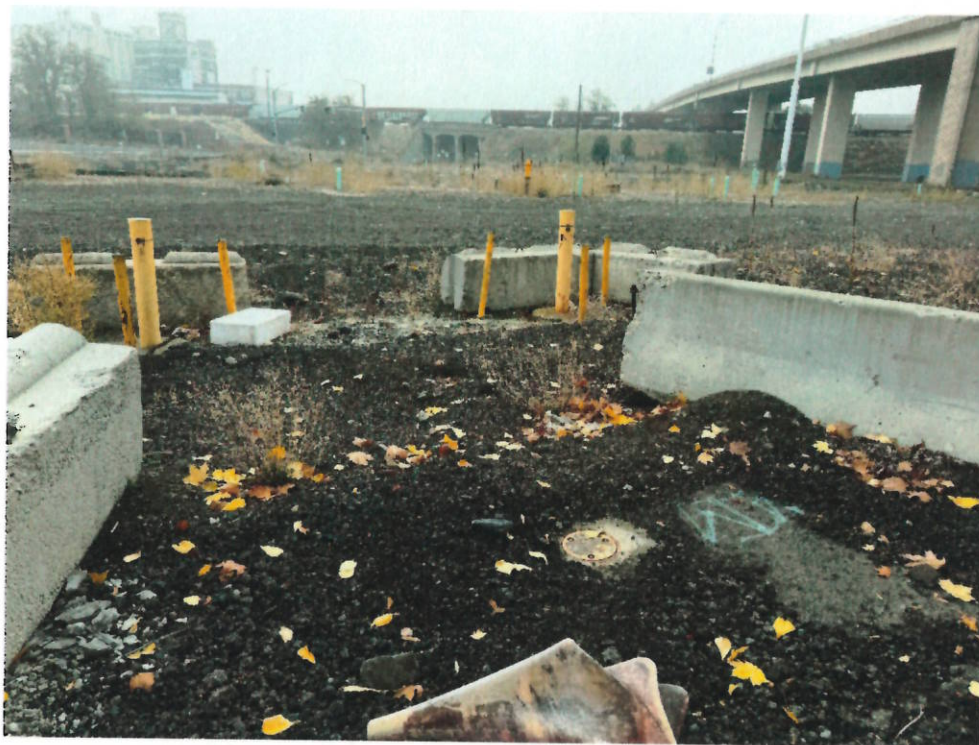
1. View of the MW4 monitoring well cluster on the former SGP property (looking south).

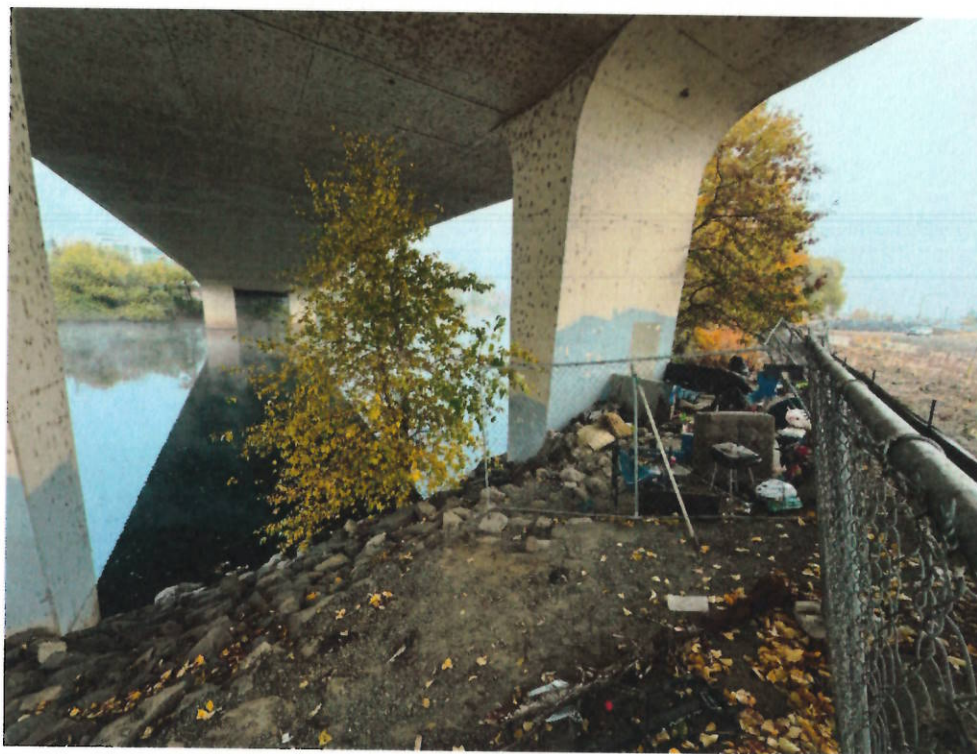
- **Cleanup Action Shoreline Armoring and Bioengineering.** Erosion was observed in the upper portion of the shoreline riprap face and transition zone beneath the James E. Keefe Bridge along the Spokane River. The observed erosion appeared to be related to a transient camping area underneath the James E. Keefe Bridge at the top of the riverbank. No ponding or loose boulders were observed and no Site debris (i.e. bricks) was observed; however, the top of the slope had been significantly eroded by foot traffic, and it appeared that riprap had been moved to a small area on the uphill side of the east bridge pier to create a level platform for a camping area. No additional trees were observed to have been cut in the area surrounding the James E. Keefe Bridge since Landau's November 3, 2023 O&M Site Inspection. The majority of the remaining mature trees growing from the bank appear stable and healthy, with the exception of a few dead trees approximately 225 ft east of the James E. Keefe Bridge.

- a. Cleanup Action Shoreline Armoring and Bioengineering. Significant erosion was observed in the upper portion of the shoreline riprap face and transition zone beneath the James E. Keefe Bridge. The observed erosion appeared to be related to a transient camping area underneath the James E. Keefe Bridge at the top of the riverbank. The majority of the mature trees growing from the bank, aside from those observed to be cut down at the time of the 2023 O&M Site Inspection, appear stable and healthy, with the exception of a few dead trees approximately 225 ft east of the James E. Keefe Bridge.

2. View of transient camp and shoreline armoring erosion underneath the James E. Keefe Bridge on the former SGP property (looking east).

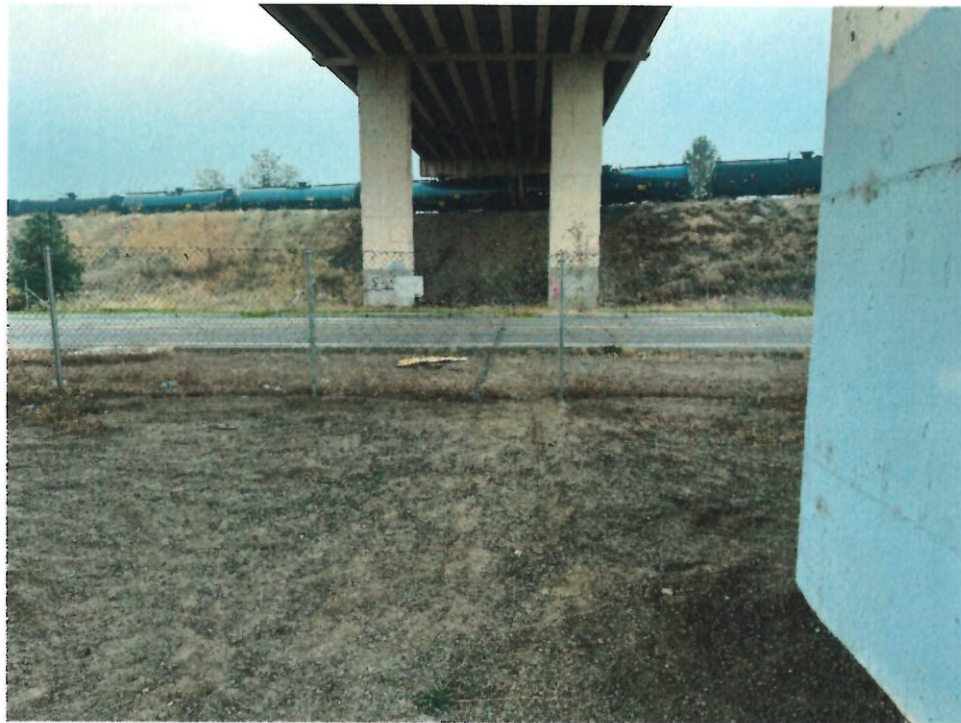
- Additional holes in the fencing around the former SGP portion of the Site were observed to the northeast and northwest of the north detention basin and at the south end of the Site underneath the James E. Keefe bridge.

1. View of compromised perimeter fence at the south end of the former SGP property (looking south).

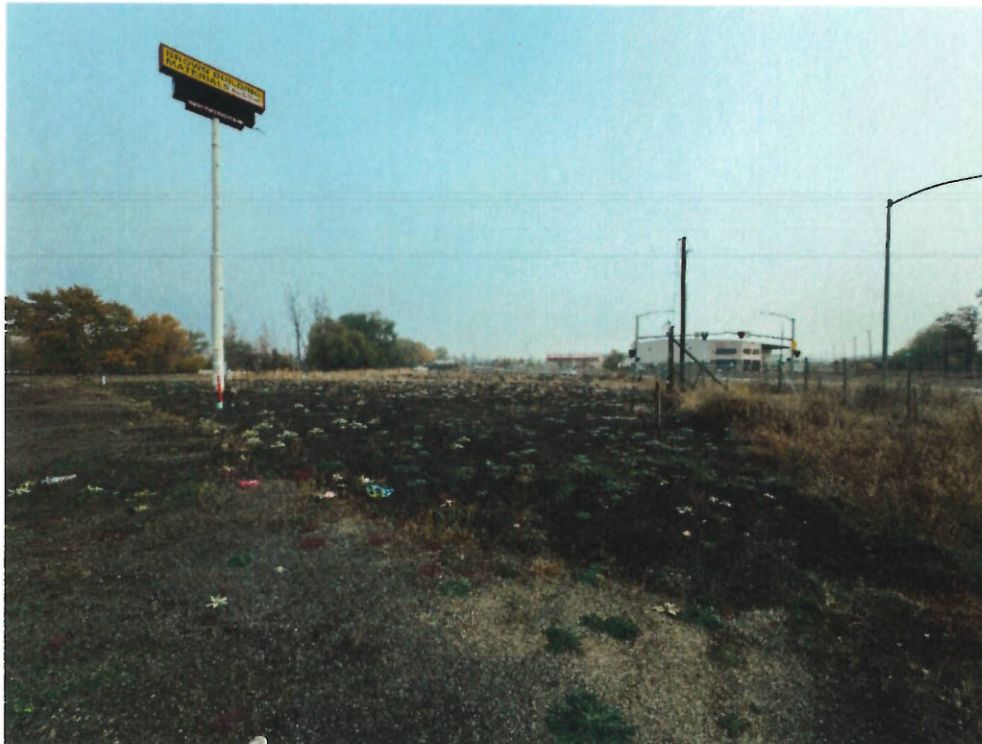
- **Grading.** Grading at the footprints of buildings 2A and 2B was observed to be generally sloped away from the cPAH-impacted soil boundary, and a sumped stormwater collection basin was observed near the northeast corner of the building 2A footprint. An elevated area of soil, approximately 2.5 ft above the surrounding grade, was observed in the western portion of the Site between the building 2B footprint, the riverbank, and the west infiltration gallery.

2. View of regraded area in the footprint of Building 2A on the former SGP property (looking northeast).

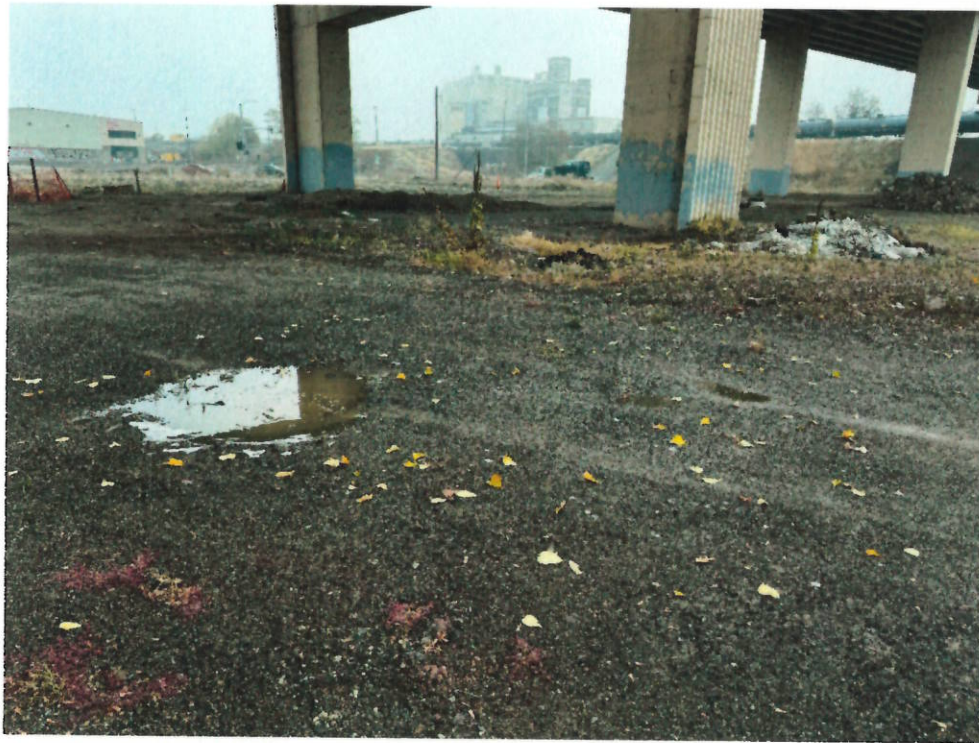
1. View of ponding within the cPAH-impacted soil boundary on the former SGP property (looking southeast).

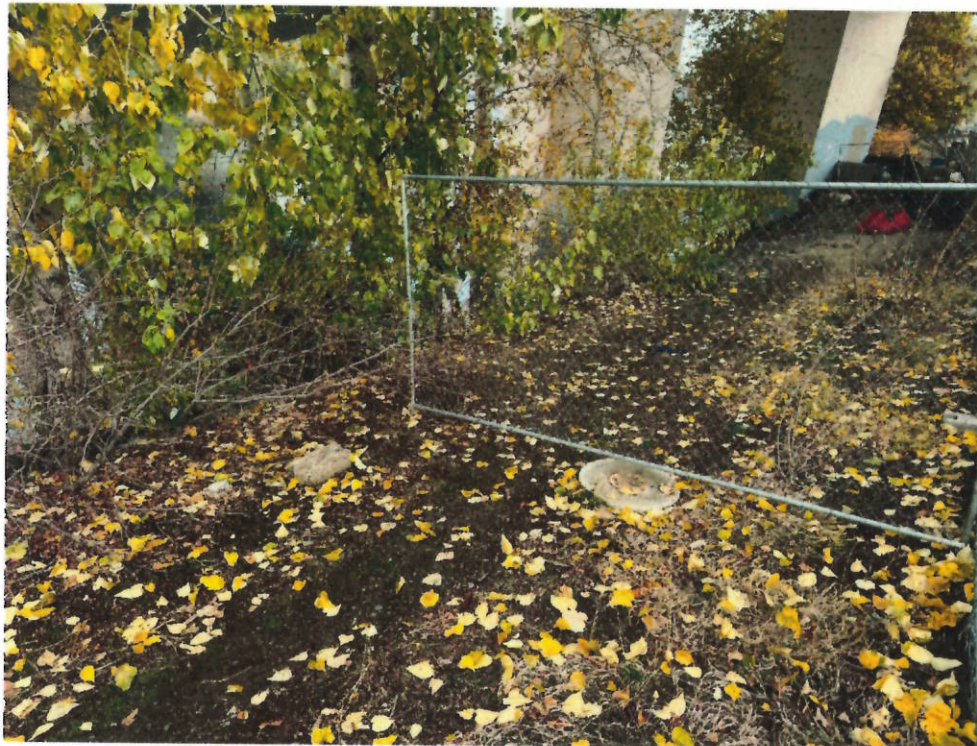
2. View of MW7-90 on the former SGP property (looking northeast).

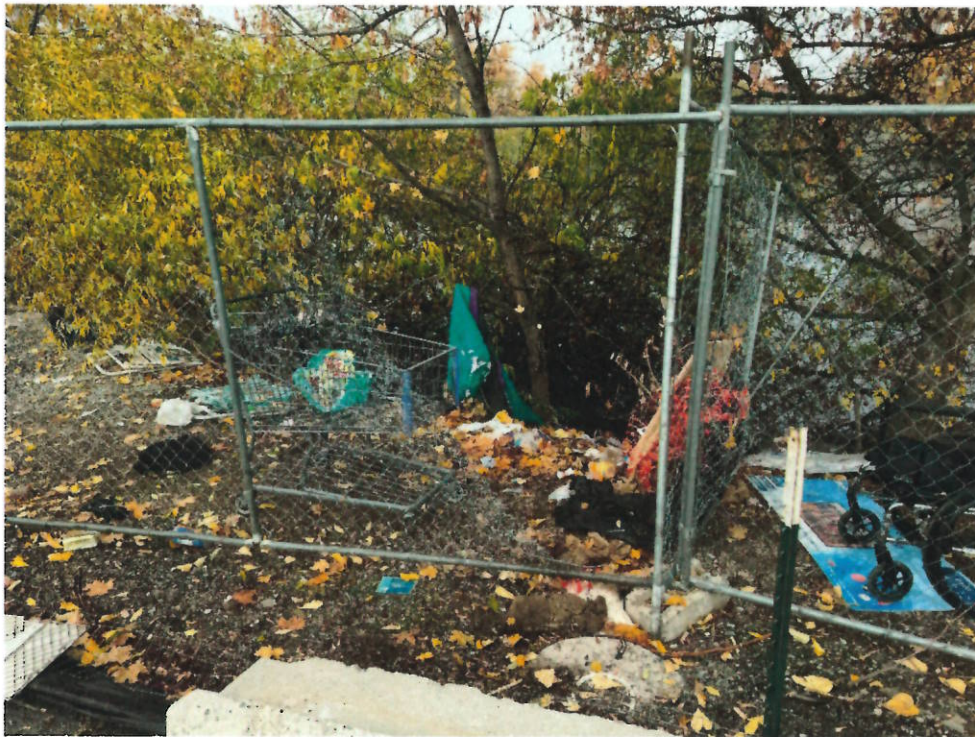
- **Compliance Monitoring Wells**. All Site compliance monitoring wells were secure and observed to be in good condition, MW02-20 and MW02-40 being covered by refuse and debris likely related to transient camps.

1. View of transient refuse and compromised perimeter fence at the location of monitoring well MW2-40 on the former SGP property (looking north).

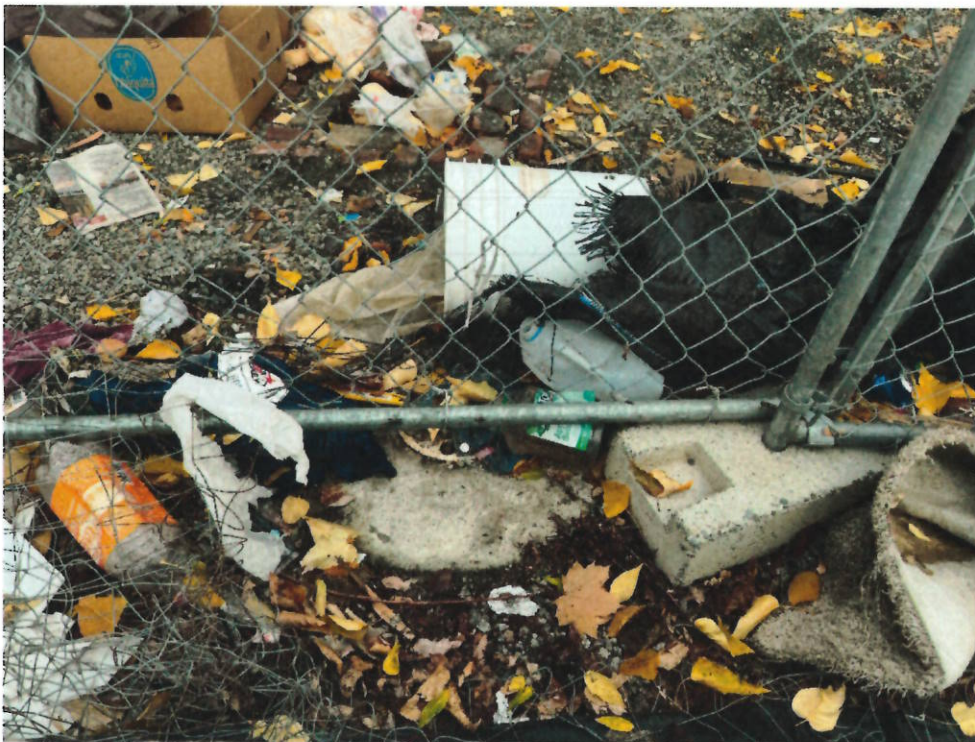
2. View of monitoring well MW2-20 on the former SGP property (looking north).

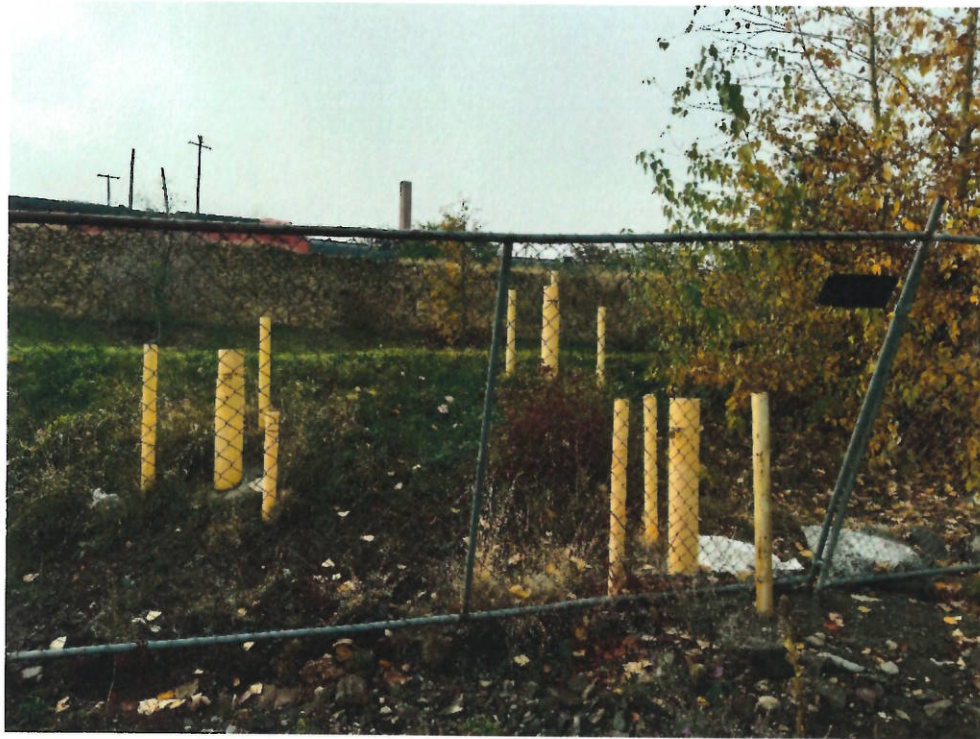
1. View of MW8 monitoring well cluster on the former SGP property (looking southwest).

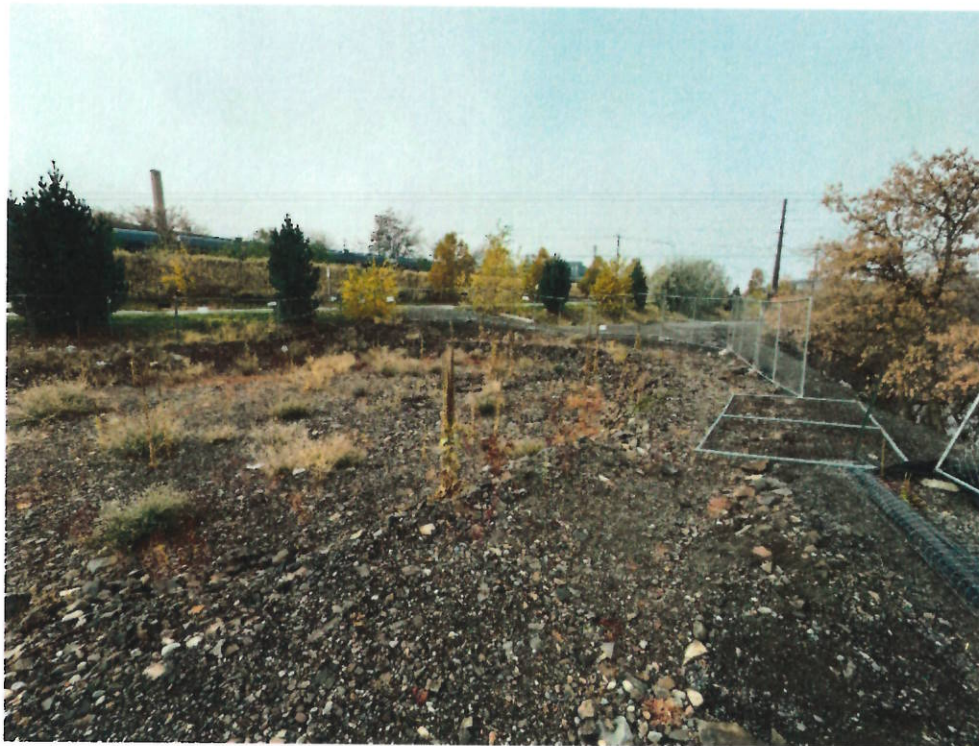
- **West Infiltration Gallery.** The west detention basin was removed as part of Sagamore's redevelopment activities. The west infiltration gallery, located approximately 130 ft west of the former west detention basin, was excavated by Sagamore in 2022 and contains two drywells. It is Landau's understanding that the removal of the west detention basin and excavation of the west infiltration gallery was conducted under CAP Amendment 1. According to Sagamore's Engineering Design Report (Aspect 2021), stormwater collected from buildings on the western portion of the former SGP portion of the Site will be transferred to drywells installed outside the extents of cPAH-impacted soil, replacing the west detention basin. Due to the grade on the SGP portion of the Site not being developed to direct surface water runoff toward the stormwater facilities, it did not appear that infrastructure was in place to transfer stormwater to the infiltration gallery/drywells at the time of the O&M Site inspection.

2. View of the new west infiltration gallery and compromised perimeter fencing on the former SGP property (looking west).

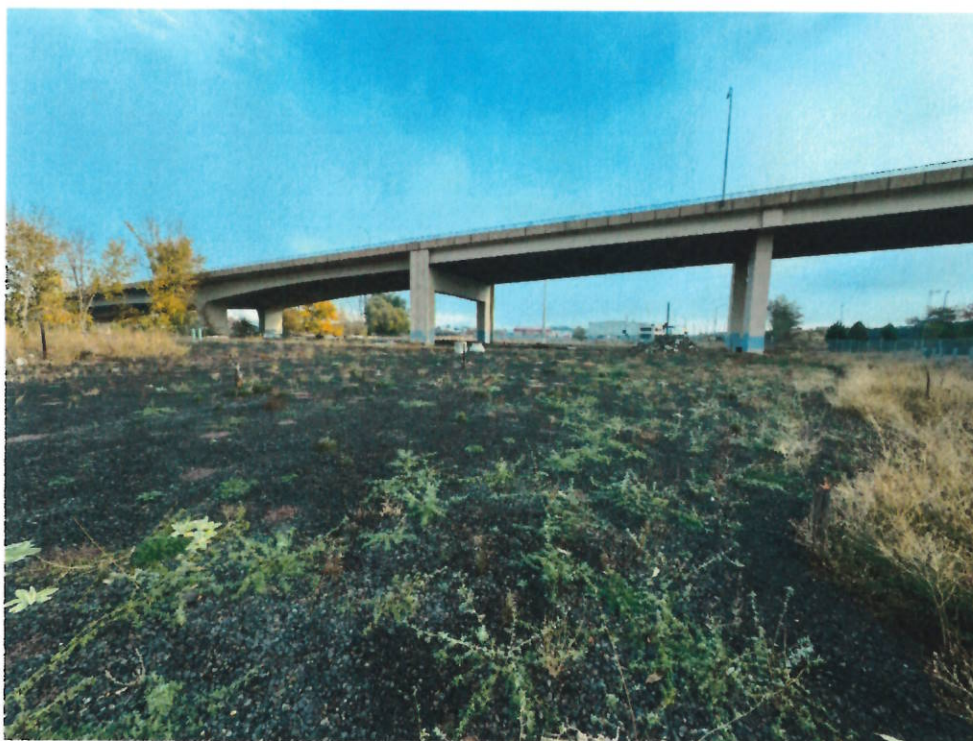
1. View of regraded area in the footprint of Building 2B on the SGP portion of the site (looking east).

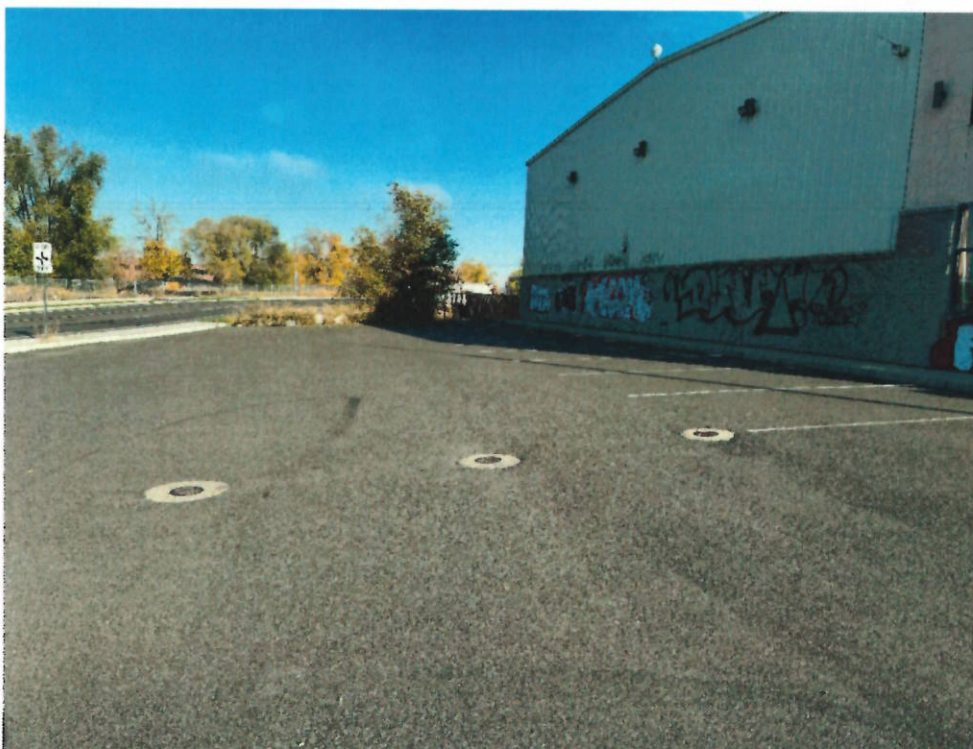
2. View of the MW9 monitoring well cluster in the parking lot east of North Erie Street (looking east).

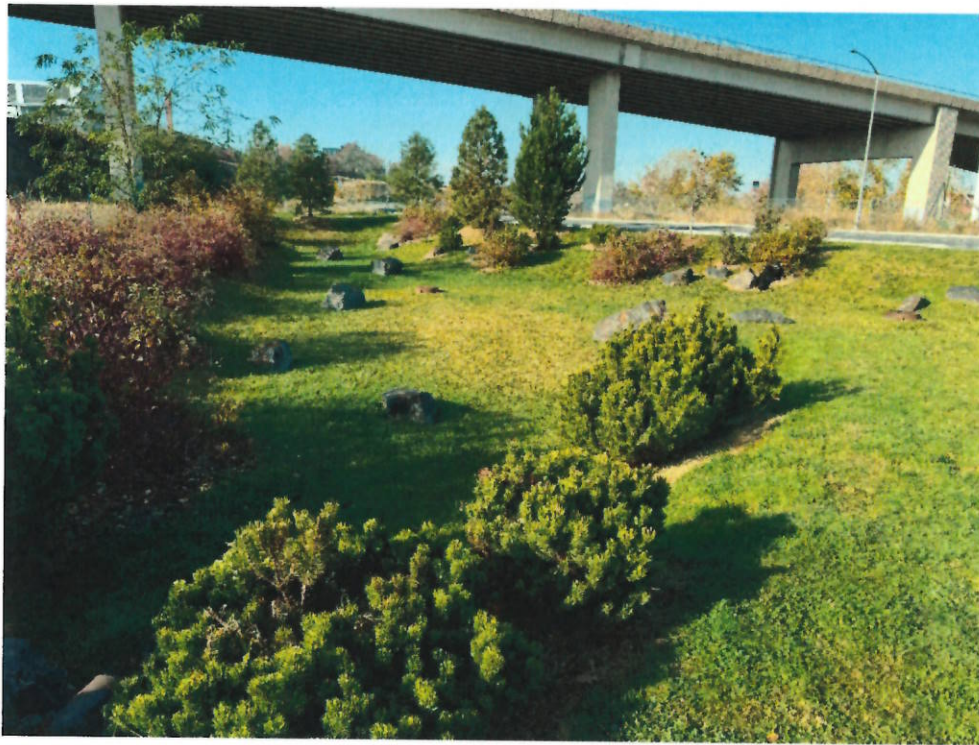
- **Evaporation Pond.** The City's lined evaporation pond contained healthy growing vegetation and appeared to be in good condition. Overall, the City right-of-way, which includes the lined evaporation pond, was observed to be in good condition.

1. View of lined evaporation pond on the former ATC property (looking west).

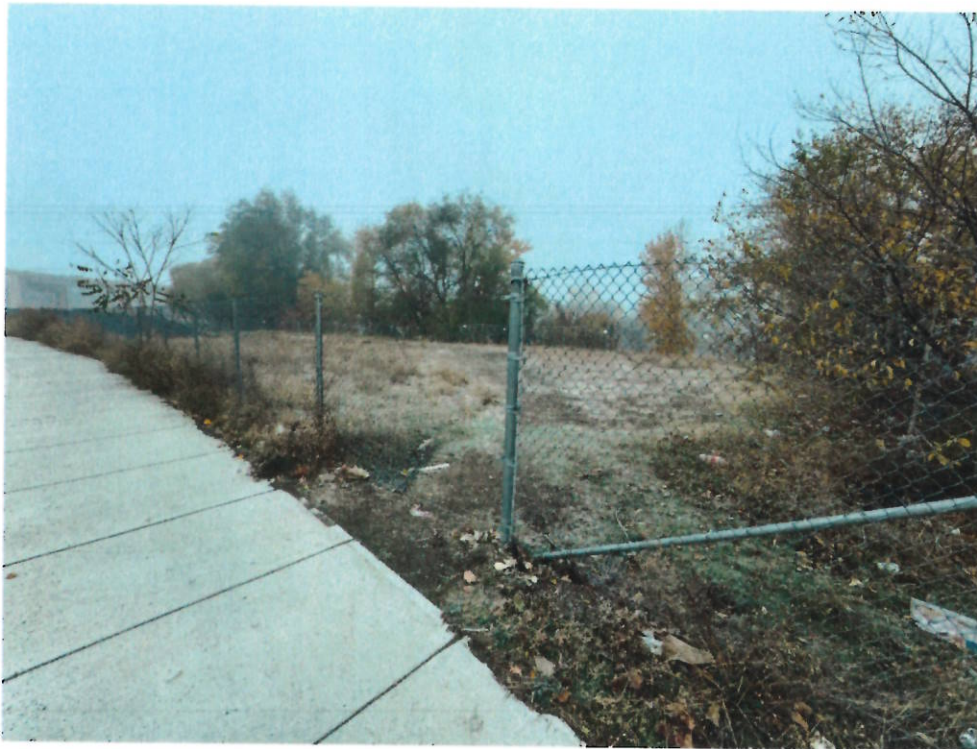
2. View of compromised perimeter fence at the northeast end of the former SGP property (looking west).

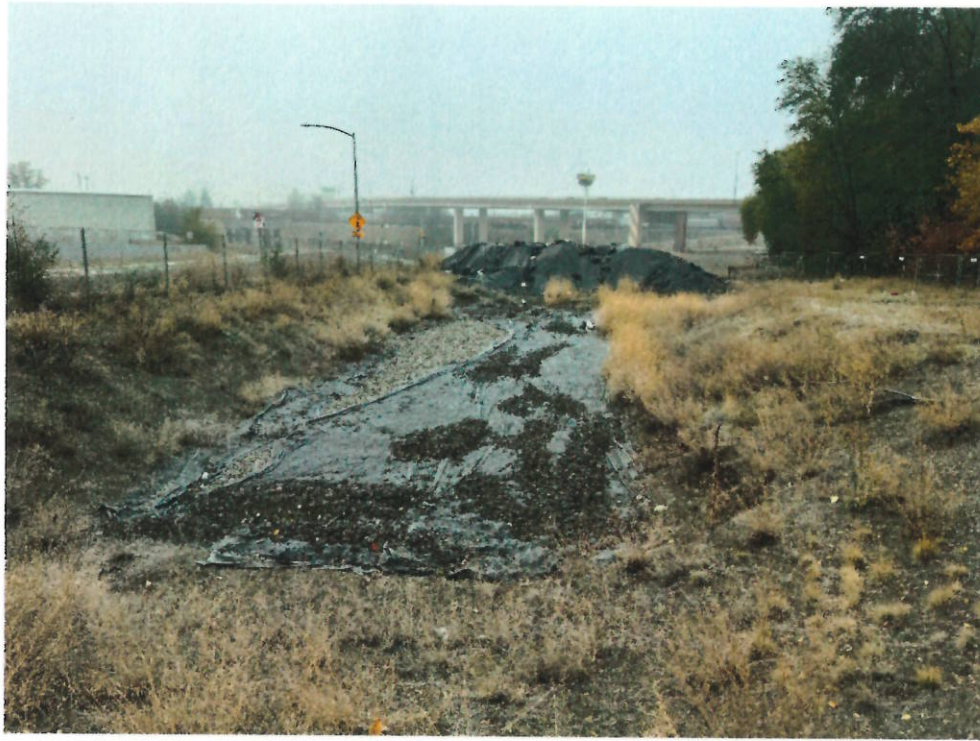
1. View of north detention pond on the former SGP property (looking west).

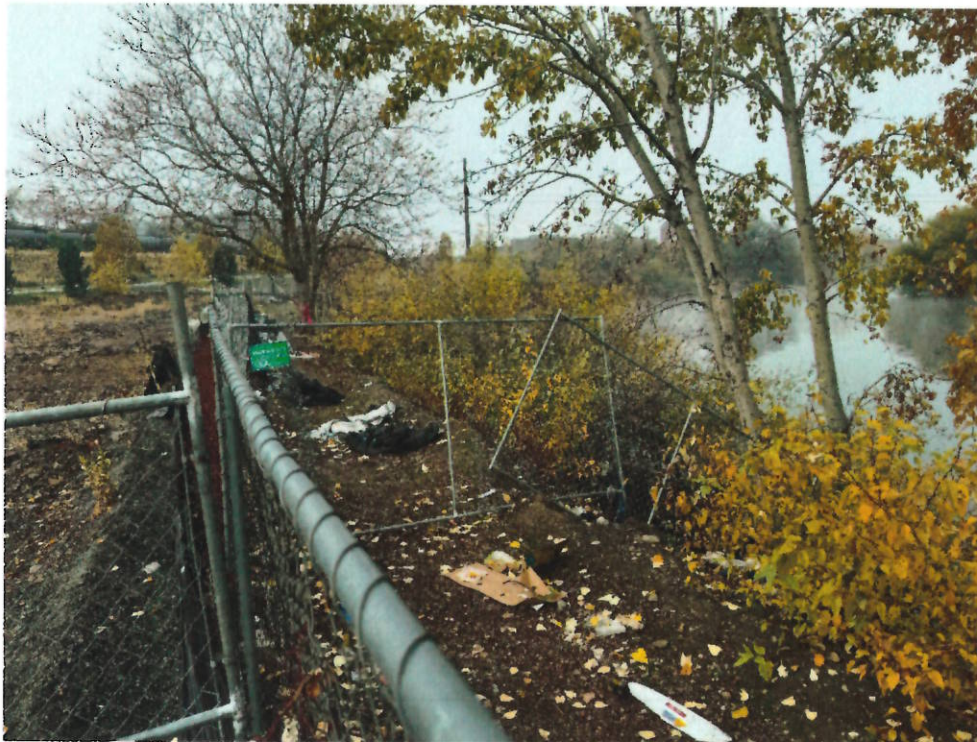
- The fencing installed by Sagamore on the former SGP property near the Spokane River is generally located at the top of the bank, and sections of fencing leading from the top of the bank to the river are present at the eastern and western extents of the fence line. Both sections of fence leading from the top of the bank to the river were observed to allow access to the Site and the riverbank as a result of holes having been cut into the fence or portions of the fence removed. At the western end of the SGP portion of the Site, the fencing was observed to be taken down, allowing access along the riverbank and into the main area of the SGP portion of the Site. At the eastern end of the SGP portion of the Site, the fencing extending down to the riverbank has a large hole cut in it, allowing pedestrian access to the riverbank. A large portion of fence, approximately 210 ft long, east of the James E. Keefe bridge had been laid down and partially disconnected from the adjacent fencing at the time of Landau's O&M Site inspection, allowing for access to the riverbank and the Site. Additionally, fencing extending down to the riverbank has been removed along the boundary with the adjacent property to the northeast, allowing access to the SGP portion of the Site.

2. View of compromised riverbank fencing and abundant debris on the former SGP property (looking west).
