January 13, 2025

RE: Annual Soil Cap Inspection Report - 2024
8701 Greenwood Ave N, Seattle, Washington
Former Texaco 211544 Facility
VCP Project # SW1351

PHOTOGRAPHIC LOG

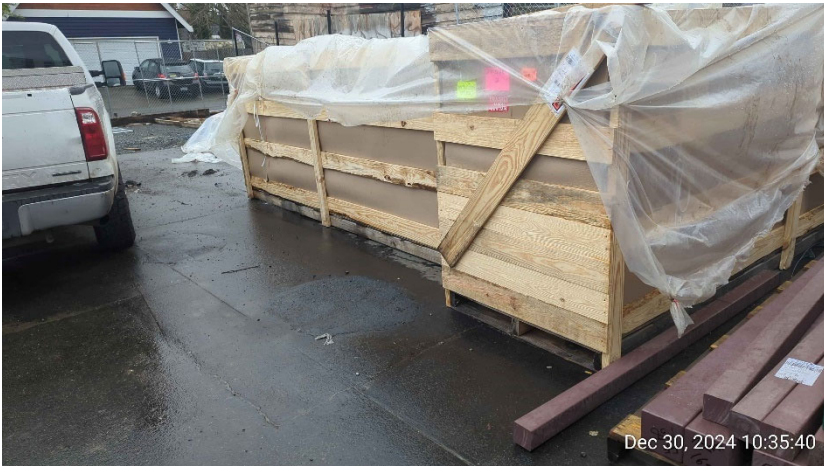
The asphalt condition in the northern parking lot appeared to be in good condition with no through-going cracks observed.

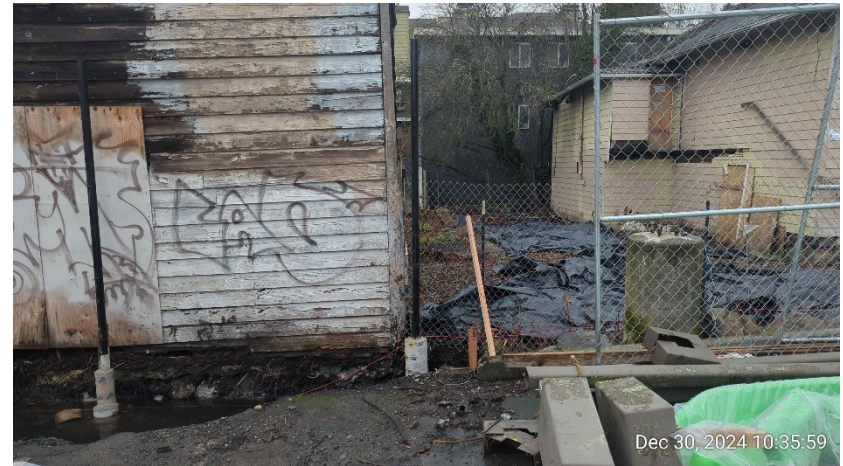
View of the NW corner of the site where posts were being installed for a new fence along the northern property boundary. The fence was designed to span the designated restricted area with no penetrations in this area.

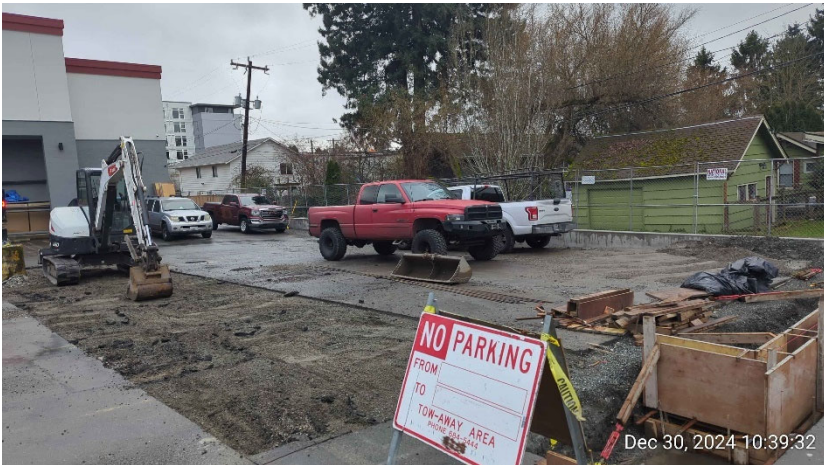
During the inspection, site improvements were being conducted elsewhere on the property, outside of the designated restricted area.
