# Environmental Cap and Drainage System Inspection Report

Former Murray Pacific No. 2 Log Sort Yard  
(Ecology Facility ID #1211)

February 28, 2025

Project No. M0615.18.004

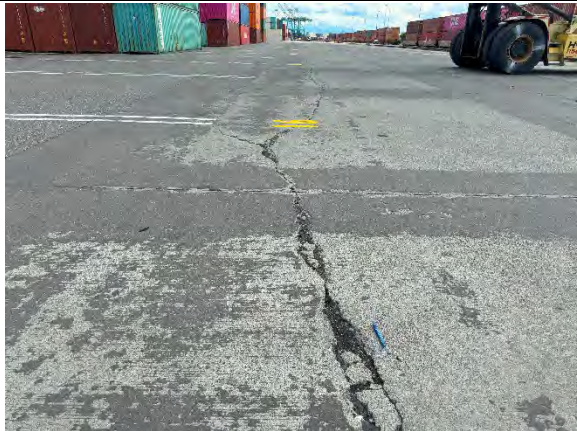
P1B	Pavement	Cracking in concrete filled with mastic and slurry sealed in September 2024 <sup>2</sup> , wider than 2 inches in places, varying depths extends several hundred feet along drive lane; associated with damage documented in P16	Monitor and reevaluate during next inspection cycle

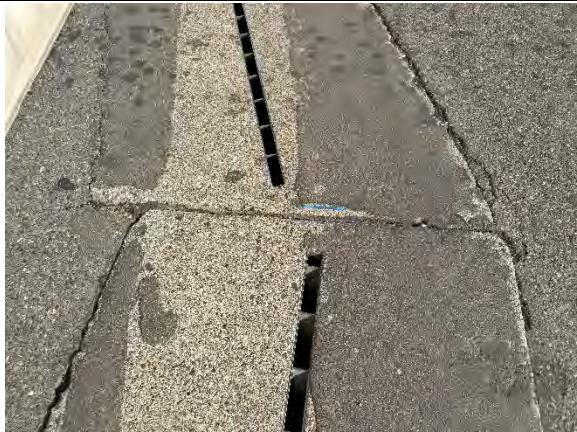
ID <sup>1</sup>	Type of Structure	Observation	Recommended Actions	Photograph
P4	Pavement	Partially unsealed slot drain joint	Reseal joints around slot drain. Feature repaired following cap inspection <sup>2</sup>

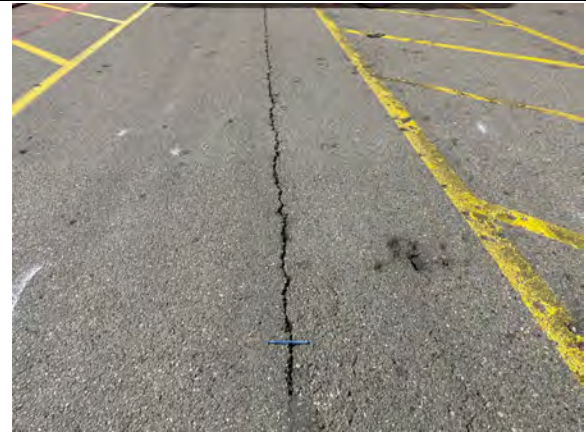
ID <sup>1</sup>	Type of Structure	Observation	Recommended Actions	Photograph
P13/P37	Pavement	Linear crack in asphalt adjacent to rail track, several hundred feet	Seal cracks in asphalt

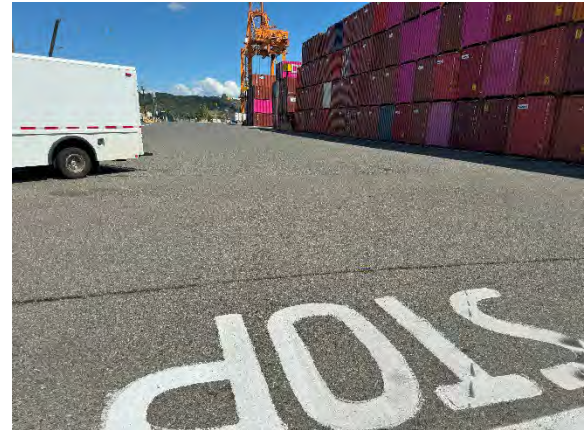
P15	Pavement	Previous asphalt repair with wear; approximately 50 lf parallel cracks; up to 1/2 inch wide	Seal cracks in asphalt

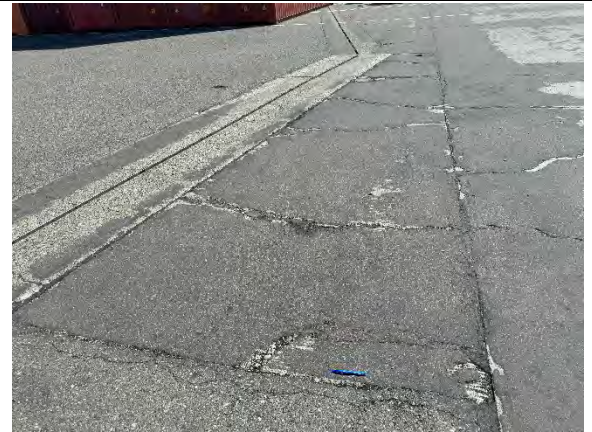
ID <sup>1</sup>	Type of Structure	Observation	Recommended Actions	Photograph
P16	Pavement	Concrete area approximately 70 feet wide that runs the length of the cap; numerous cracks wider than 1/8 inch; all cracks shallower than 2 inches; most cracks appear to have been previously sealed, but sealant has failed	Seal/reseal cracks; consider alternate sealant that holds up to heavy machinery/tire wear. Feature repaired following cap inspection <sup>2</sup>

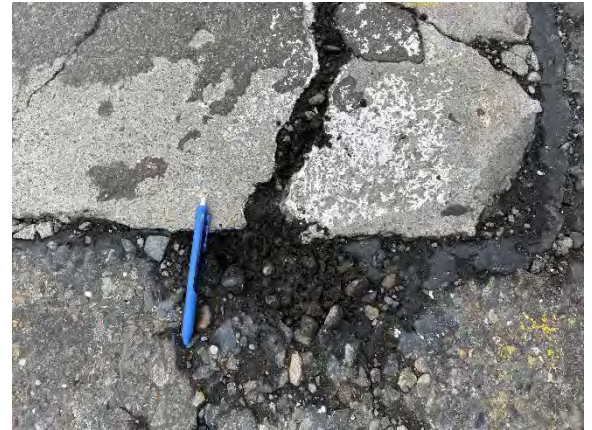
P17	Pavement	Sealant in joints around concrete pad running the length of cap is failing in places; separation as wide as 2 inches and as deep as 1.5 inches; concrete appears to have been previously sealed	Seal/reseal joints/cracks. Feature repaired following cap inspection <sup>2</sup>

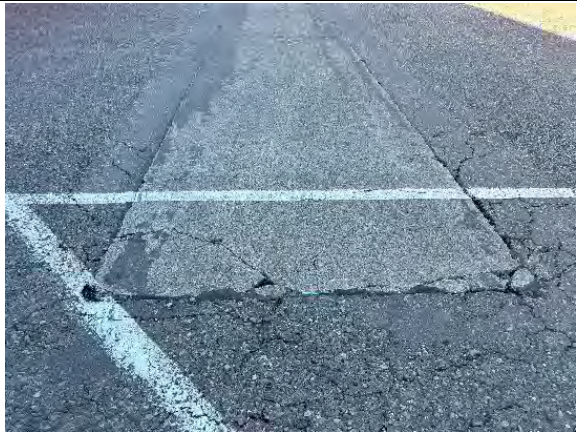
ID <sup>1</sup>	Type of Structure	Observation	Recommended Actions	Photograph
P18	Pavement	Cracks wider than 1/8 inch and shallower than 1/2 inch observed in concrete and adjacent asphalt	seal/reseal cracks

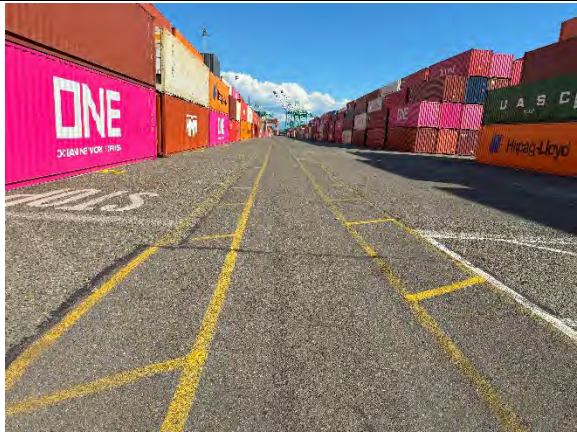
ID <sup>1</sup>	Type of Structure	Observation	Recommended Actions	Photograph
P20	Pavement	Tire ruts in previous asphalt repair; extends length of drive lane	Monitor and reevaluate during next inspection cycle

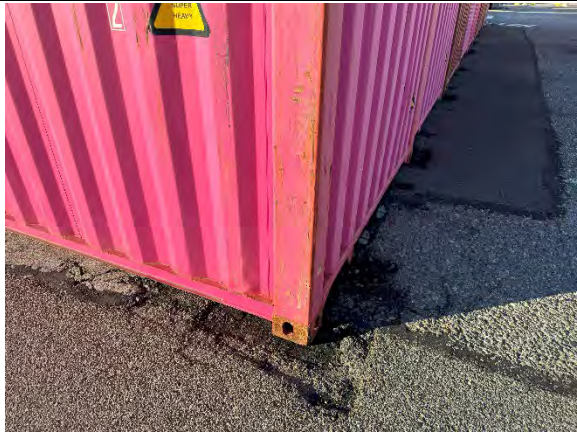
ID <sup>1</sup>	Type of Structure	Observation	Recommended Actions	Photograph
P23	Pavement	Asphalt and concrete deterioration adjacent to two asphalt repairs	Monitor and reevaluate during next inspection cycle

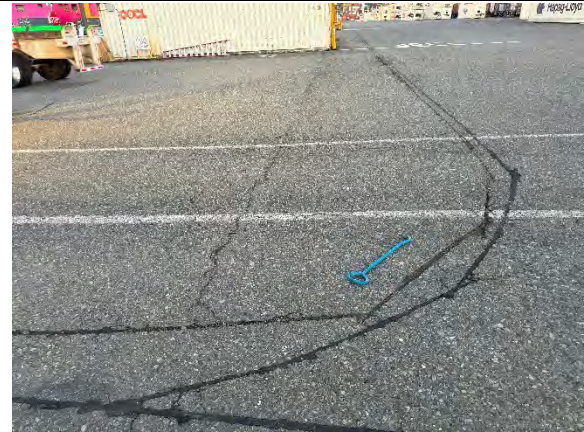
ID <sup>1</sup>	Type of Structure	Observation	Recommended Actions	Photograph
P31	Pavement	Approximately 3-inch deep sawcut for fiber optic line; impervious membrane intact; extends approximately 250 lf	Monitor and reevaluate during next inspection cycle

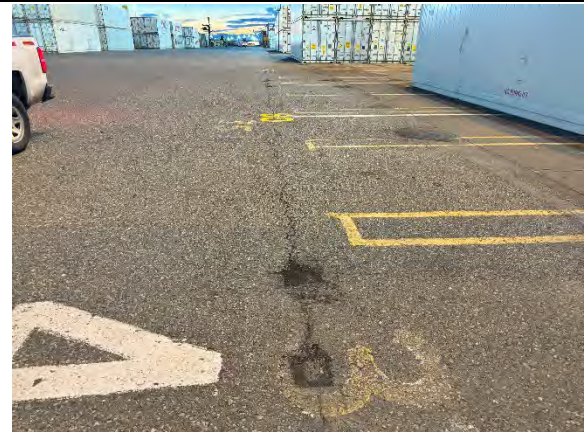
P32	Pavement	Crack as wide as 2 inches and as deep as 1 inch; crack starts at point and extends several hundred feet northwest along the drive aisle; divots as wide as 1 foot along crack in several locations	Seal crack/repair asphalt

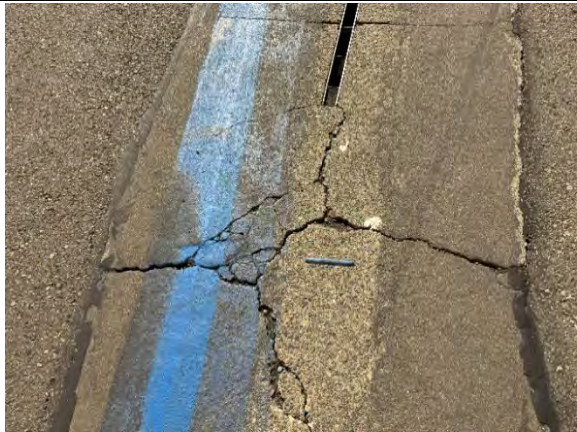
ID <sup>1</sup>	Type of Structure	Observation	Recommended Actions	Photograph
P40	Pavement	Cracking in concrete at slot drain joint wider than 1/8 inch; approximately 2 to 3 feet wide	Repair concrete and seal joint with asphalt. Feature repaired following cap inspection <sup>2</sup>

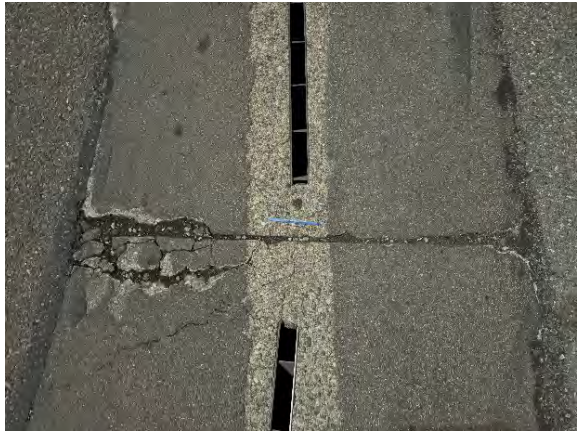
P41	Pavement	Cracking in concrete at slot drain joint wider than 1/8 inch; approximately 2-3 feet wide	Repair concrete and seal joint with asphalt. Feature repaired following cap inspection <sup>2</sup>

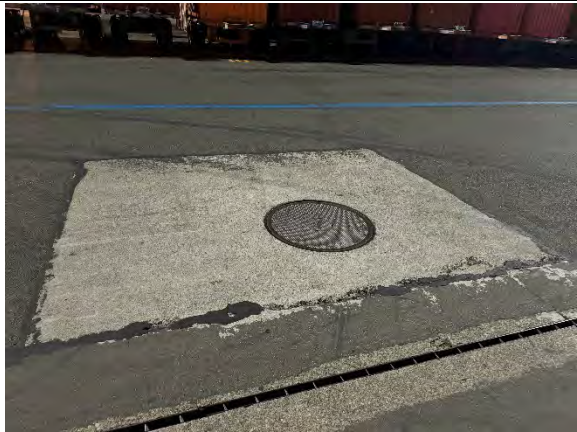
ID <sup>1</sup>	Type of Structure	Observation	Recommended Actions	Photograph
P43	Pavement	Previously repaired concrete around maintenance hole; wear of seal between concrete and asphalt	Reseal joint between concrete and asphalt. Feature repaired following cap inspection <sup>2</sup>

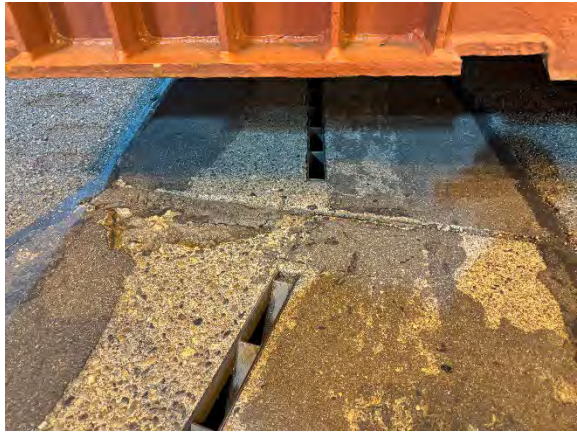
P48	Pavement	Concrete missing from slot drain joint; approximately 1 foot by 6 inches	Repair concrete. Feature repaired following cap inspection <sup>2</sup>

- Repair curb along the southeastern portion of the asphalt cap (C1)
- Repair concrete (some as wide as 2 inches) in several locations (P48 and P67)
- Reseal cracks between concrete structures and asphalt cap (P19, P28, P34, P35, P49, and P52)
- Seal cracks (some as wide as 3 in wide) in asphalt throughout the Site
- Repair divots in asphalt (P36, P66, P69, P80, and P88)
- Remove vegetation and reseal cracks around settlements (P39 and P52) in tack

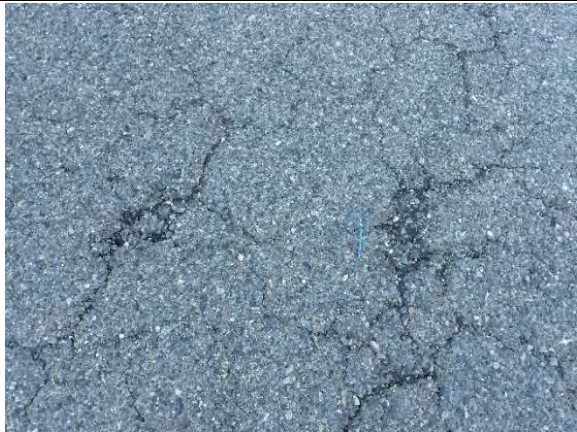
ID <sup>1</sup>	Type of Structure	Observation	Recommended Actions	Photograph
P56	Pavement	alligator cracking wider than 1/8 inch and as deep as 0.5 inches; approximately 5 foot by 5 foot area	Seal cracks in asphalt

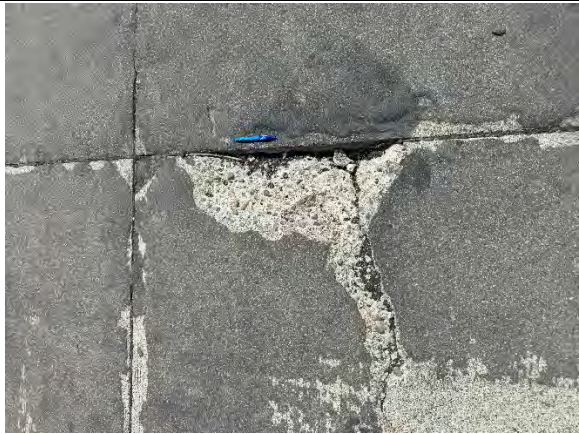
ID <sup>1</sup>	Type of Structure	Observation	Recommended Actions	Photograph
P60	Pavement	Former asphalt patch missing; Divot approximately 2 feet long and 1 foot wide	Repair patch/divot. Feature repaired following cap inspection <sup>2</sup>

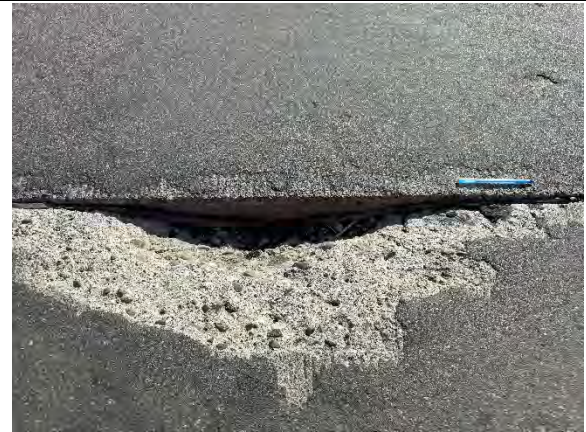
ID <sup>1</sup>	Type of Structure	Observation	Recommended Actions	Photograph
P63	Pavement	Unsealed joint between concrete and asphalt with gouge as deep as 2 inches and approximately 3 feet long; associated with impacts documented in P16	Repair concrete and reseal joint. Feature repaired following cap inspection <sup>2</sup>

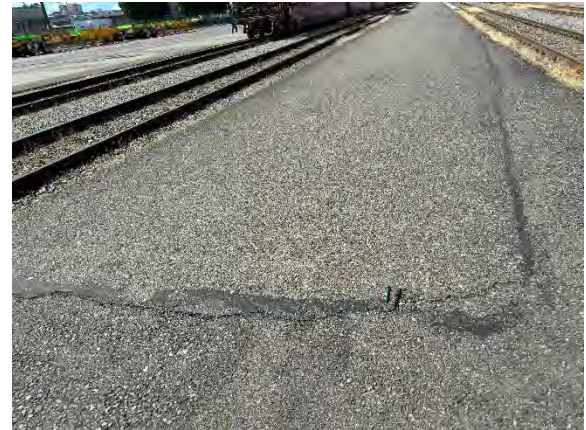
P65	Pavement	Crack wider than 1/8 inch; approximately 20 feet long	Seal crack. Feature repaired following cap inspection <sup>2</sup>

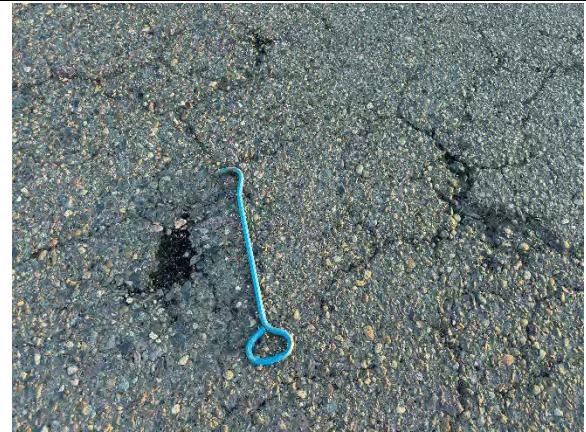
ID <sup>1</sup>	Type of Structure	Observation	Recommended Actions	Photograph
P68	Pavement	Alligator cracking wider than 1/8 inch and as deep as 1 inch in places; approximately 6 feet by 4 feet area	Seal cracks

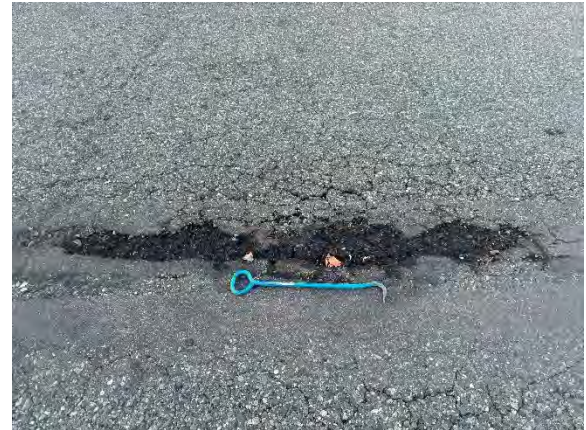
P69	Pavement	Previous asphalt patch with wear and a divot approximately 4 feet in length and less than 1 inch deep	Reseal asphalt and repair divot

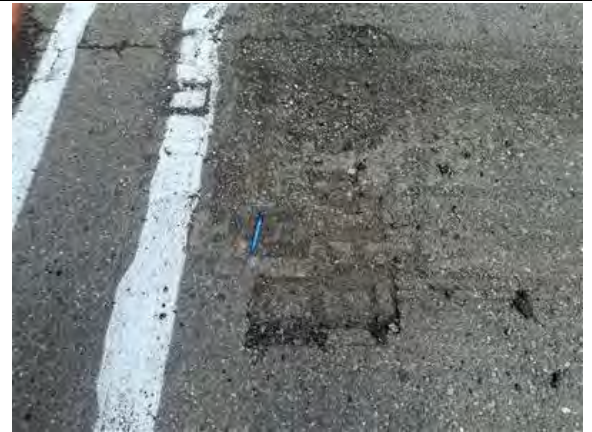
ID <sup>1</sup>	Type of Structure	Observation	Recommended Actions	Photograph
P70	Pavement	Asphalt depressions and gouges from containers; up to 2 inches deep	Monitor and reevaluate during next inspection cycle

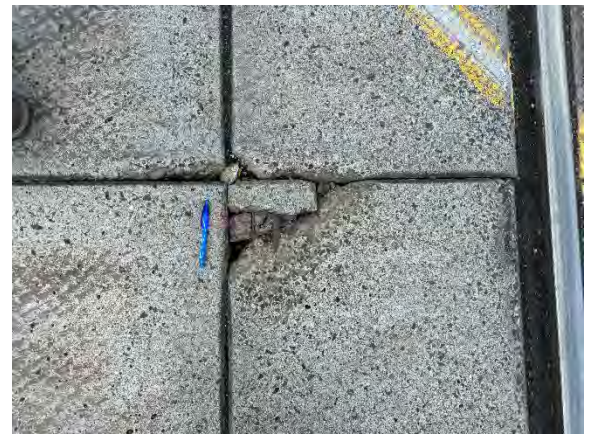
P71	Pavement	Concrete degradation at rail crossing; rebar exposed; approximately 1 inch by 6 inches and up to 4 inches deep; cap extends below rail components	Monitor and reevaluate during next inspection cycle

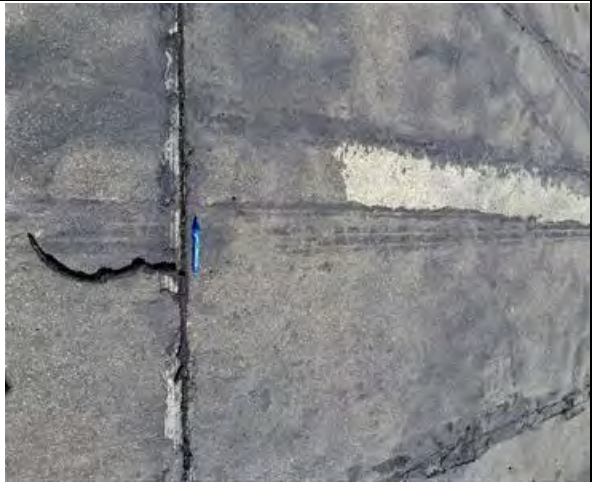
ID <sup>1</sup>	Type of Structure	Observation	Recommended Actions	Photograph
P72	Pavement	Sealed cracks with sealant missing in places	Reseal areas of missing sealant. Feature repaired following cap inspection <sup>2</sup>

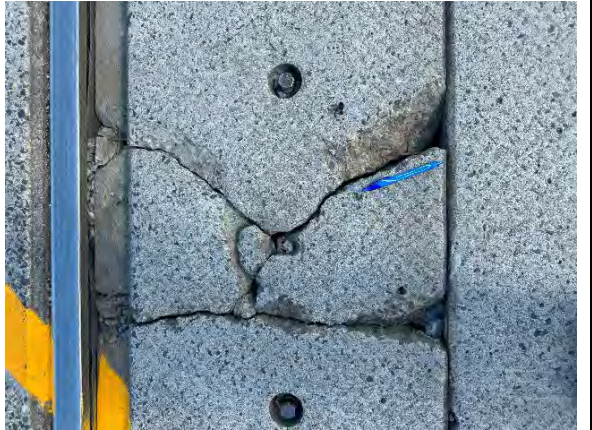
P73	Pavement	Concrete degradation at rail crossing; approximately 2 feet long and up to 3 inches deep; cap extends below rail components	Monitor and reevaluate during next inspection cycle

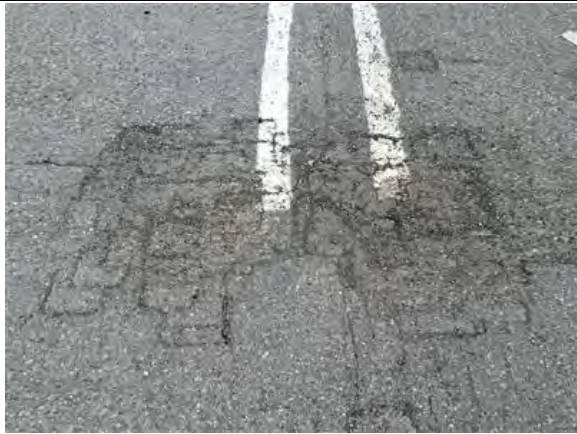
ID <sup>1</sup>	Type of Structure	Observation	Recommended Actions	Photograph
P74	Pavement	Depressions and gauges from containers; approximately 80 feet by 100 feet area; full extent not visible	Monitor and reevaluate during next inspection cycle

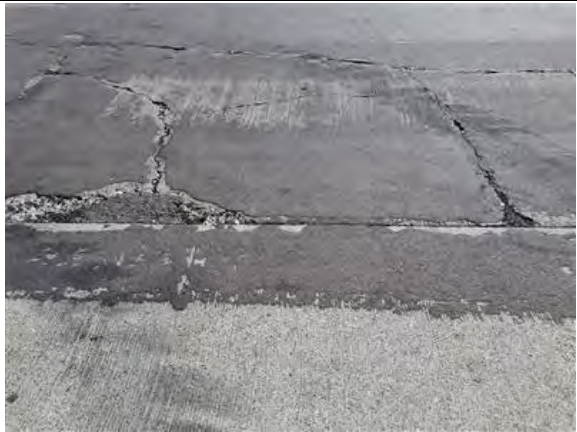
P75	Pavement	Existing asphalt repair with deterioration; approximately 4 feet by 1 foot	Reseal cracks in asphalt. Feature repaired following cap inspection <sup>2</sup>

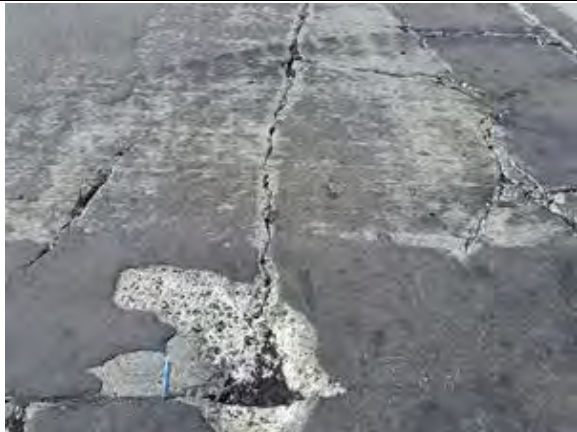
ID <sup>1</sup>	Type of Structure	Observation	Recommended Actions	Photograph
P76	Pavement	Several cracks and asphalt patch deterioration; approximately 10 lf and as wide as 1 foot	Seal cracks in asphalt. Feature repaired following cap inspection <sup>2</sup>

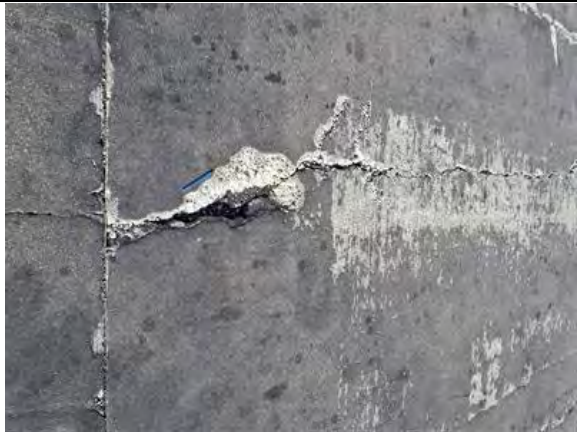
P77	Pavement	Cracks and asphalt patch deterioration; up to 2 inches deep	Seal cracks in asphalt. Feature repaired following cap inspection <sup>2</sup>

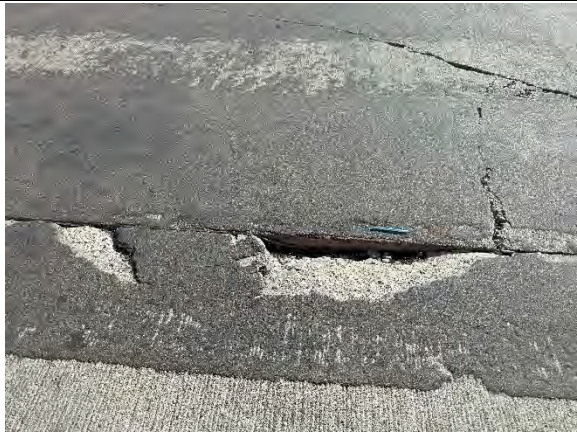
ID <sup>1</sup>	Type of Structure	Observation	Recommended Actions	Photograph
P78	Pavement	Unsealed joint between concrete and asphalt with gouge as deep as 2 inches and approximately 3 feet long; associated with impacts documented in P16	Repair concrete and reseal joint. Feature repaired following cap inspection <sup>2</sup>

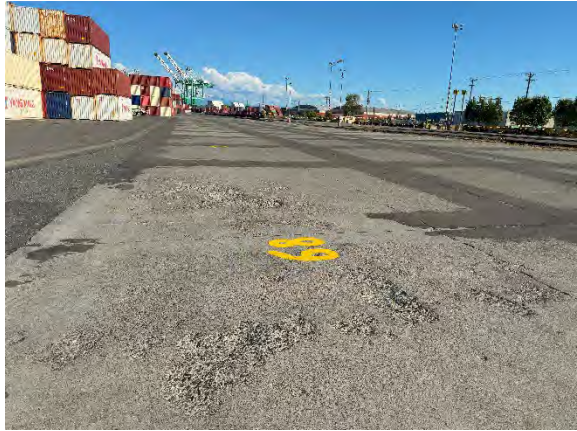
P79	Pavement	Concrete degradation; approximately 15 foot by 20 foot area; up to 1 inch deep	Monitor and reevaluate during next inspection cycle. Feature repaired following cap inspection <sup>2</sup>

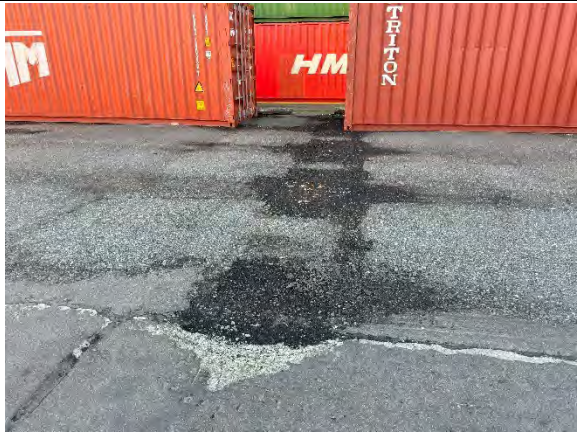
ID <sup>1</sup>	Type of Structure	Observation	Recommended Actions	Photograph
P82	Pavement	Asphalt depressions from shipping containers; extend along extent of cap	Monitor and reevaluate during next inspection cycle

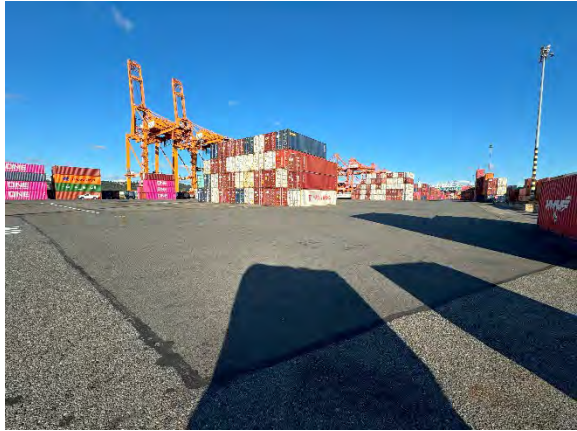
P30	Pavement	Alligator cracking repaired as part of larger asphalt repair (included in the asphalt repair described in P27)	None

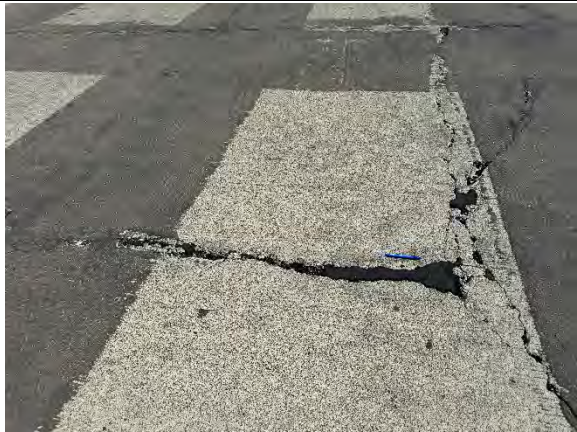
ID <sup>1</sup>	Type of Structure	Observation	Recommended Actions	Photograph
P64	Pavement	Resealed cracks	Monitor and reevaluate during next inspection cycle

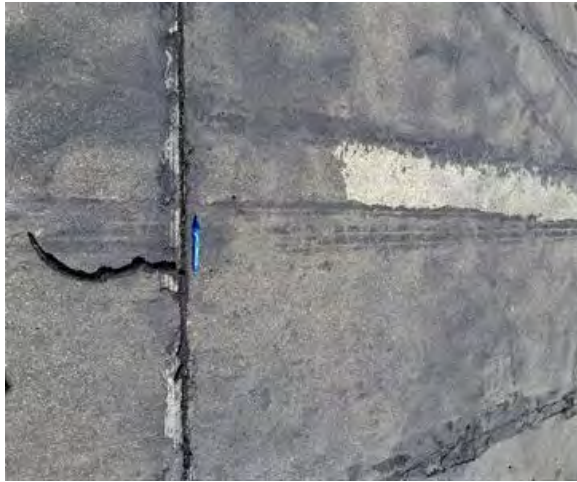
P72	Pavement	Sealed cracks with sealant missing in places	Reseal areas of missing sealant

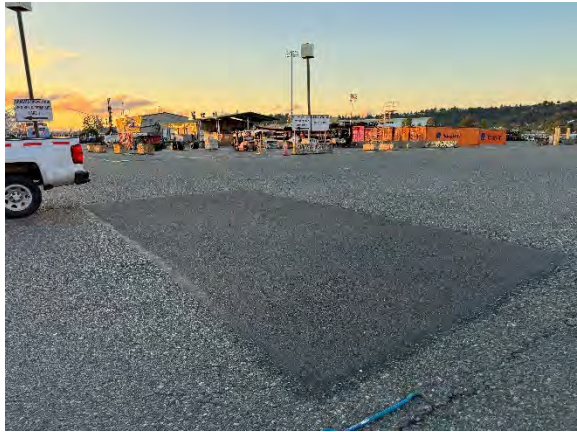
P87	Pavement	Asphalt repair; approximately 10 feet by 25 feet	None

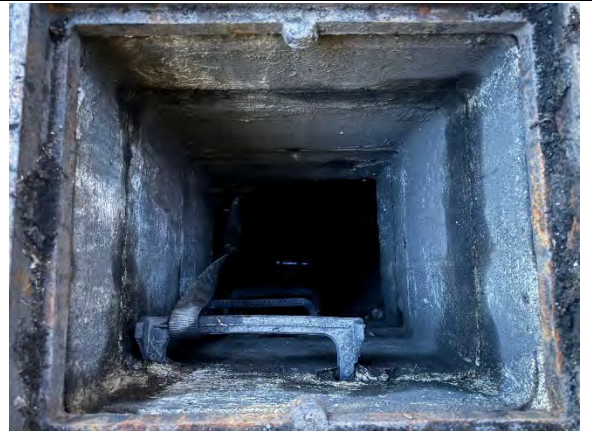
CB6	Catch basin	Structure in good condition; functioning normally	Sediment accumulation in insert; water in structure and too deep to measure	Trace floatables on water surface	Replace insert in accordance with stormwater maintenance requirements

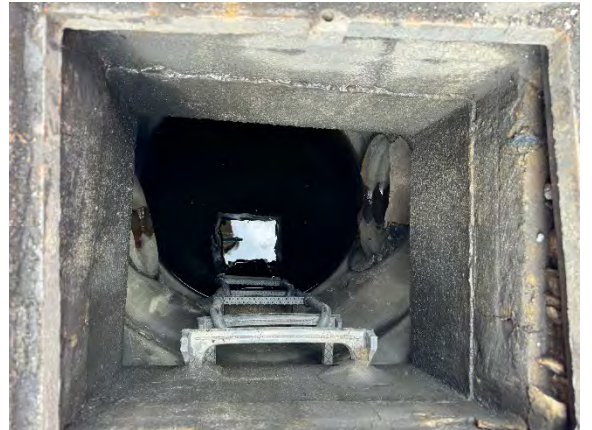
CB16	Catch basin	Minor cracking in riser; functioning normally	Sediment accumulation in insert; water in structure and too deep to measure	Trace floatables on water surface	Remove and floatables; replace insert in accordance with stormwater maintenance requirements

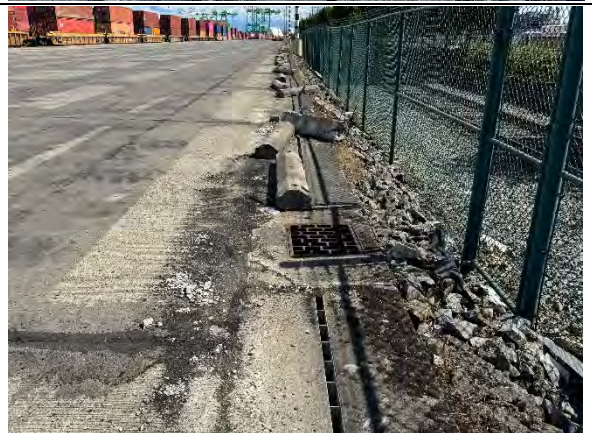
CB18	Catch basin	Structure in good condition; functioning normally	nm	None	None

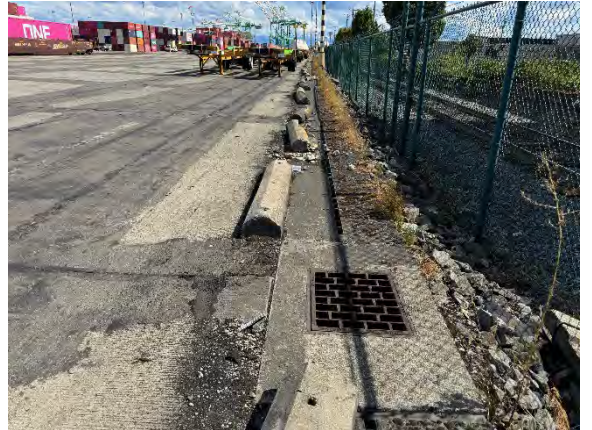
CB20	Catch basin	Structure in good condition; functioning normally	nm	None	None

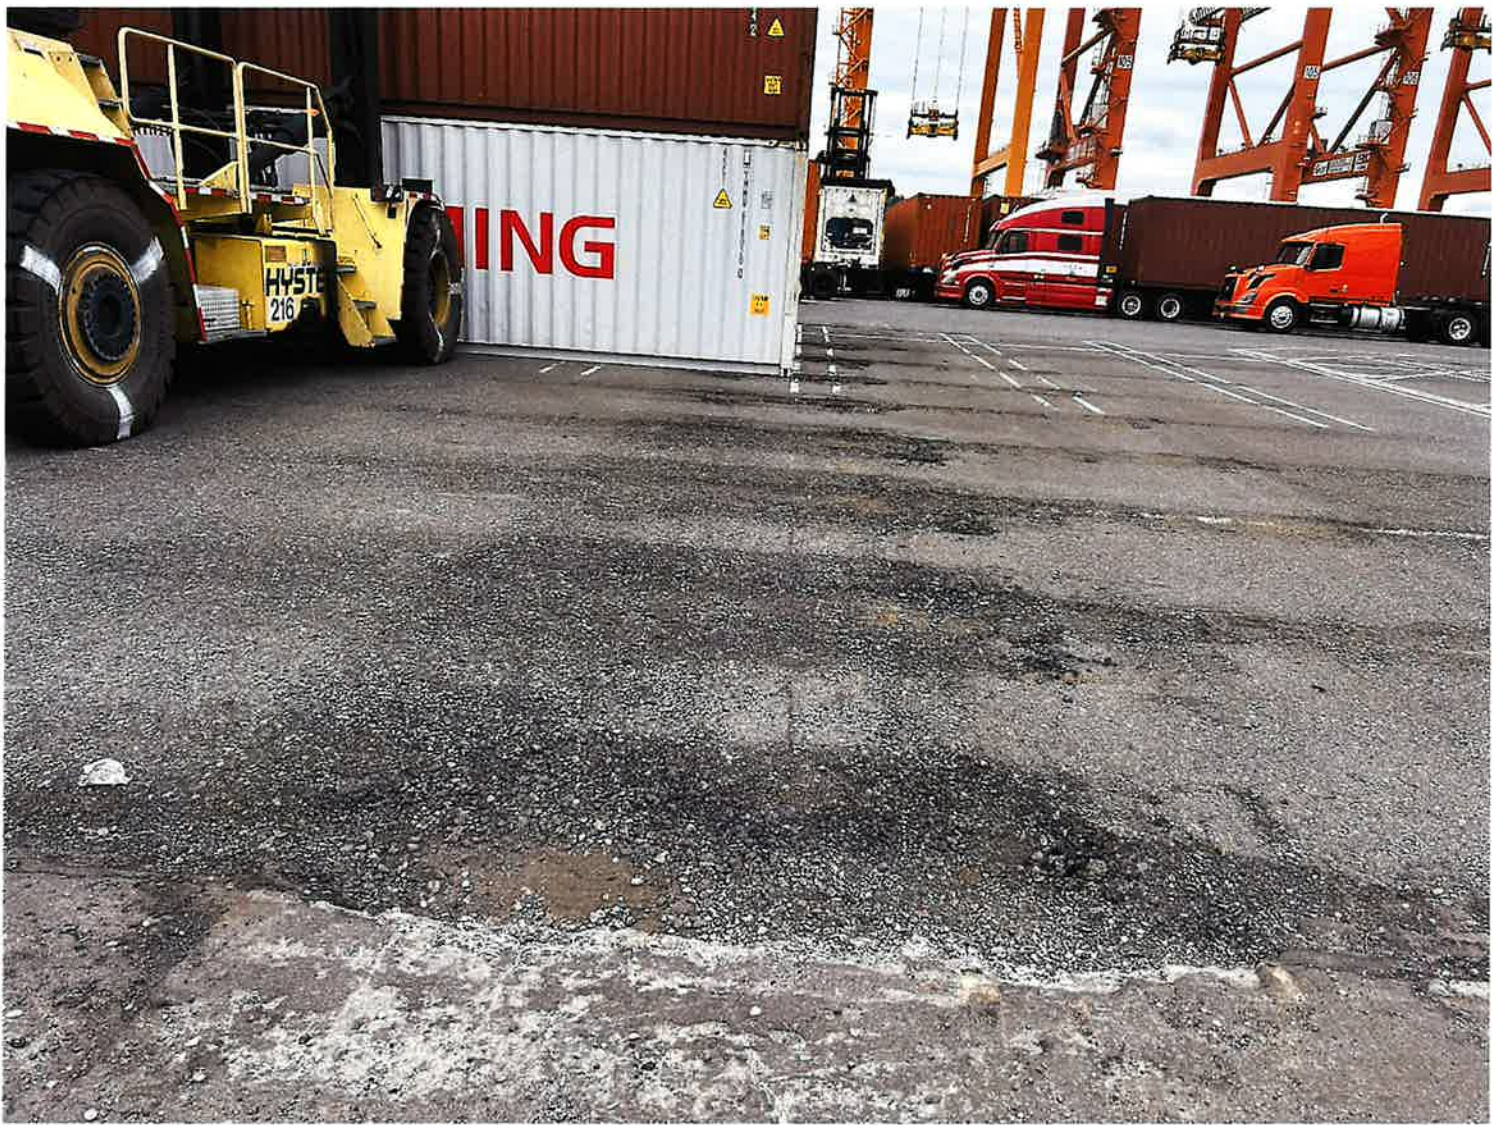
Typical damage to asphalt surface created by years of wear from container pockets. In the area completed in 2024 many of the areas of damage were thru the wearing course (upper 2 ½”) of asphalt. These areas were milled to a depth of 3” to ensure that repairs were below any damaged wearing course.

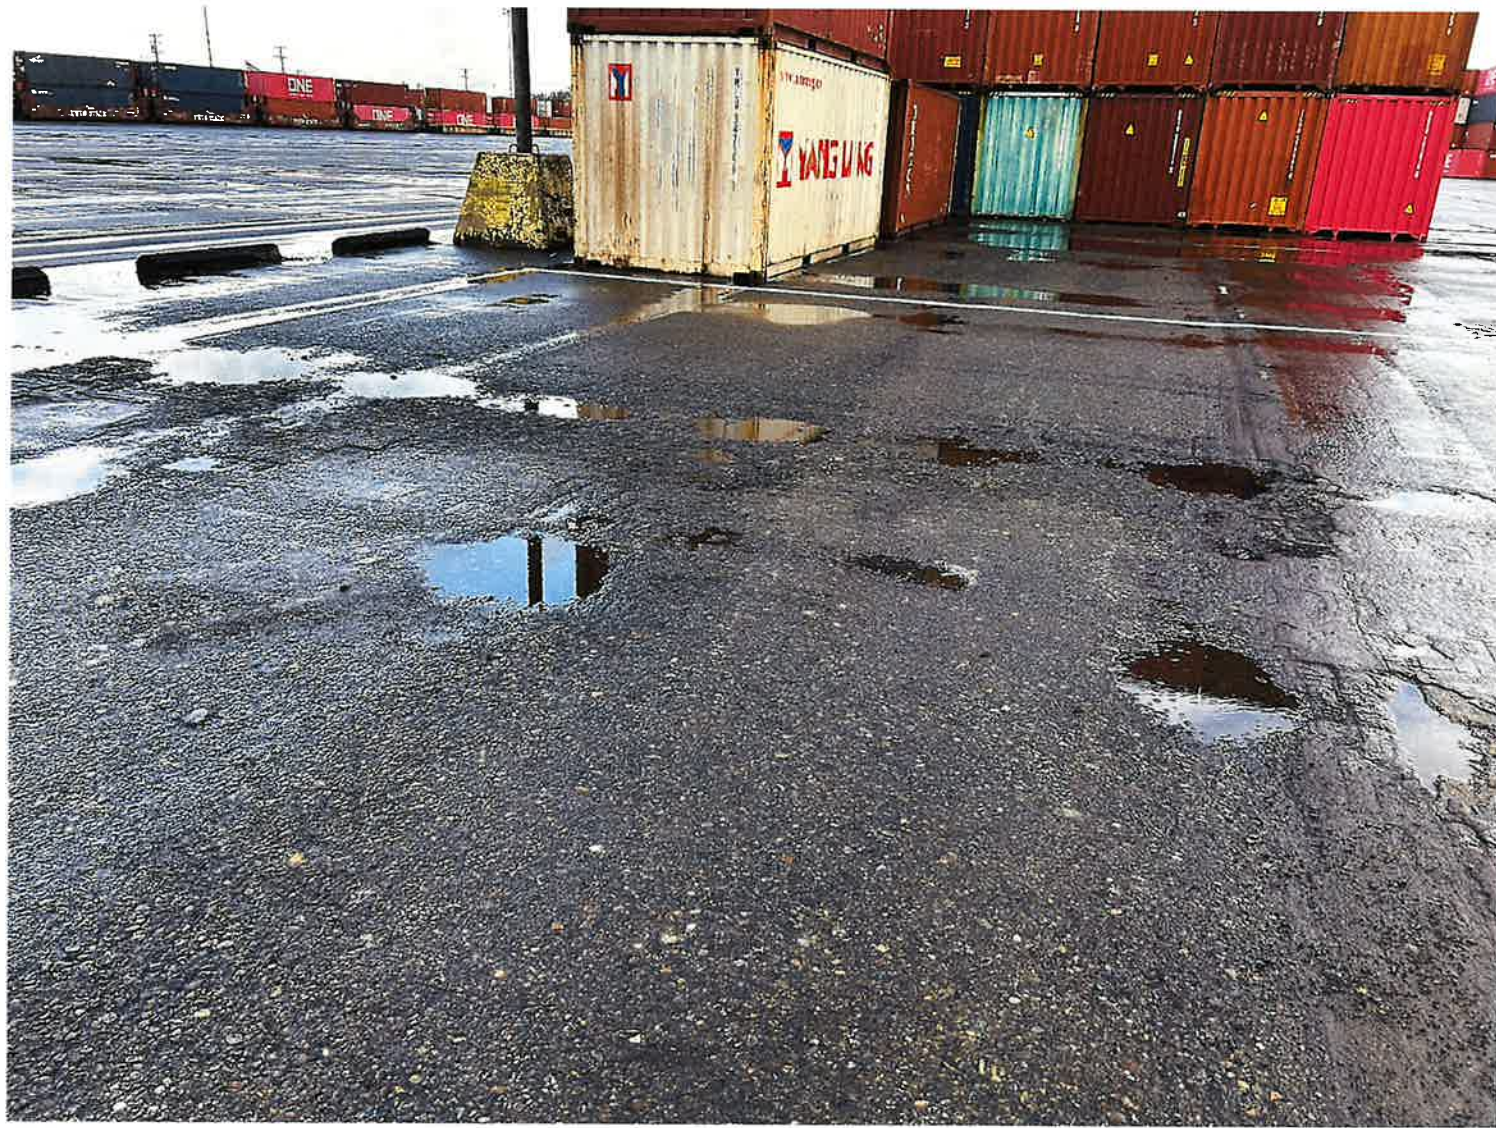
Adjacent area to repair seen after a recent rain. Damage from container pockets creates a field of puddles.

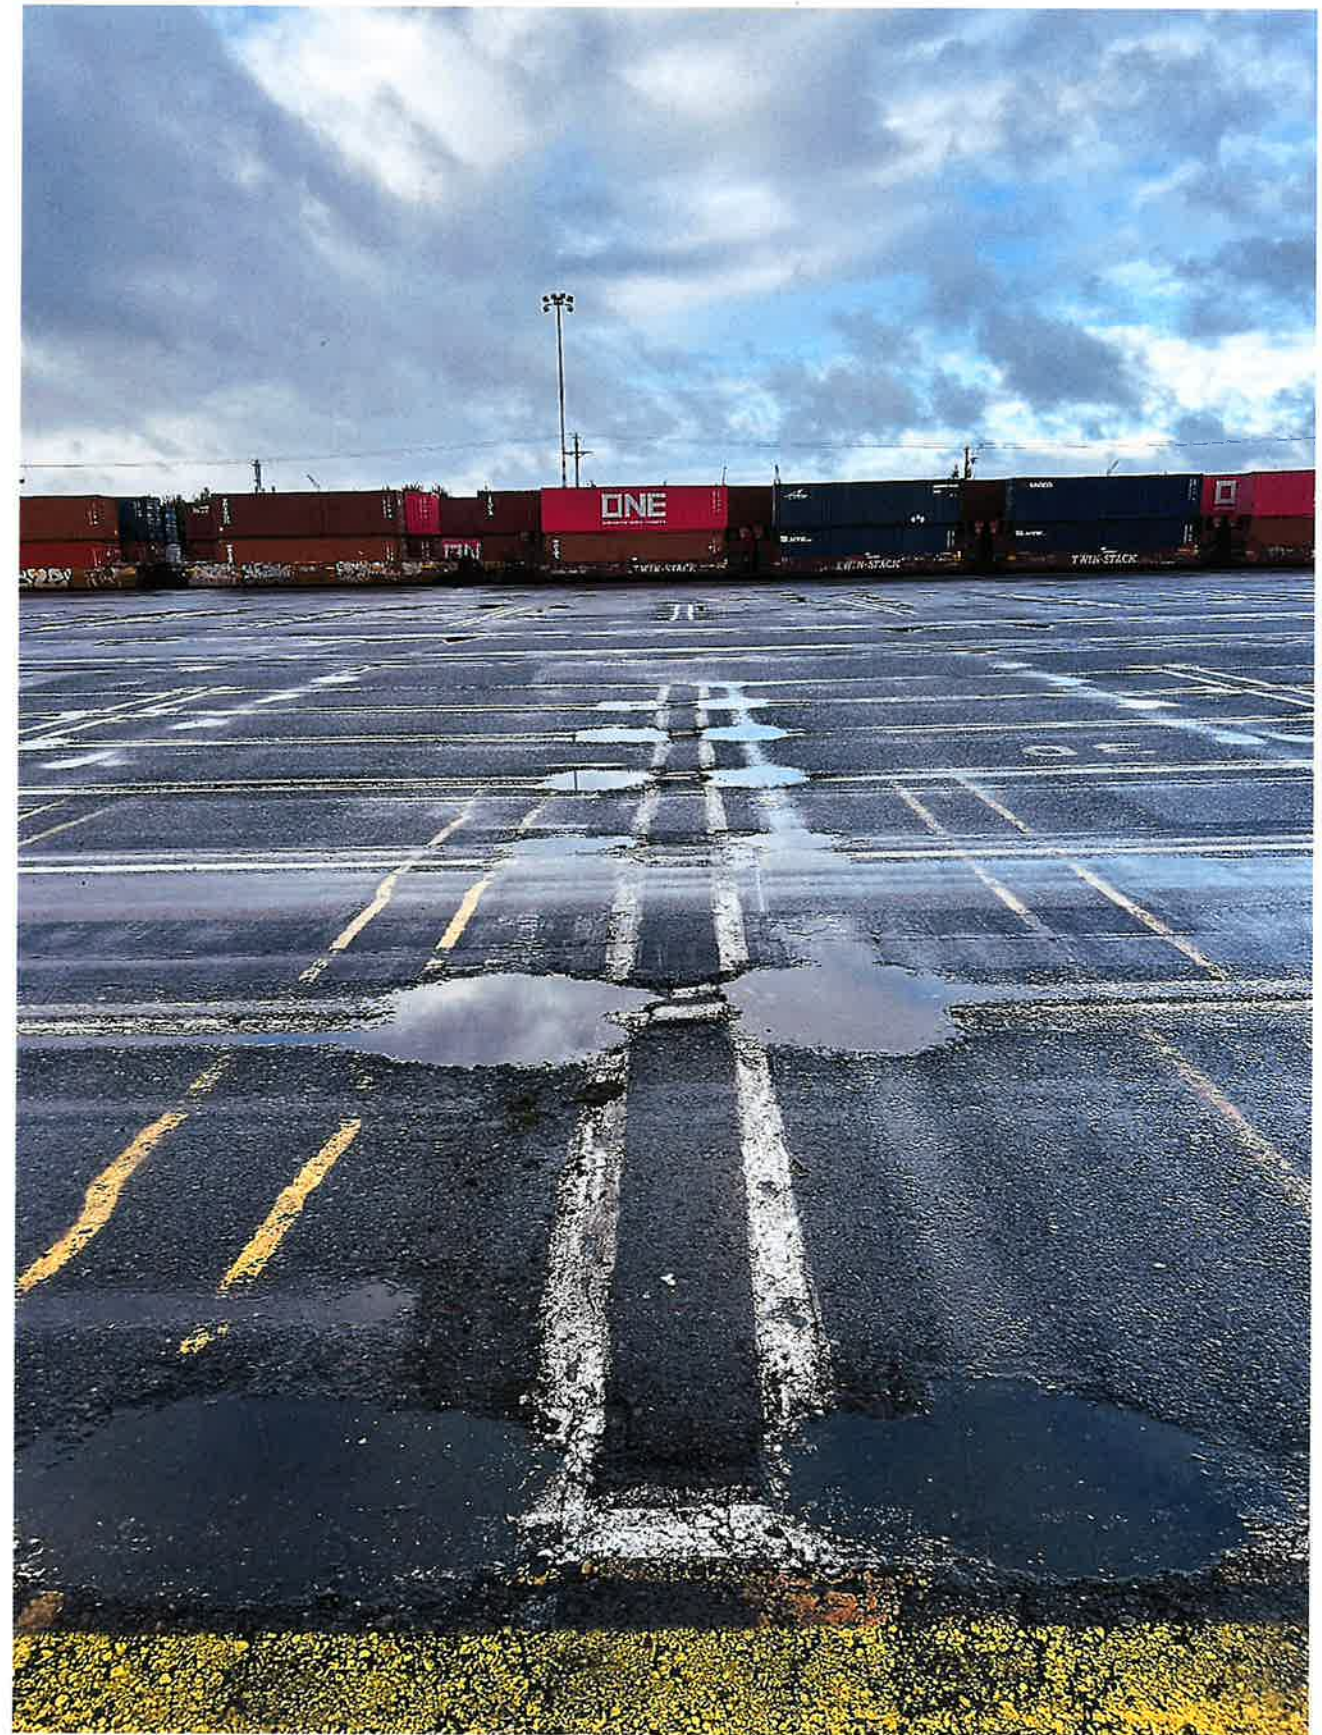
Another view of an adjacent area. Container pockets create depressions in the wearing (surface) course that typically extends approximately 2" deep into the asphalt.

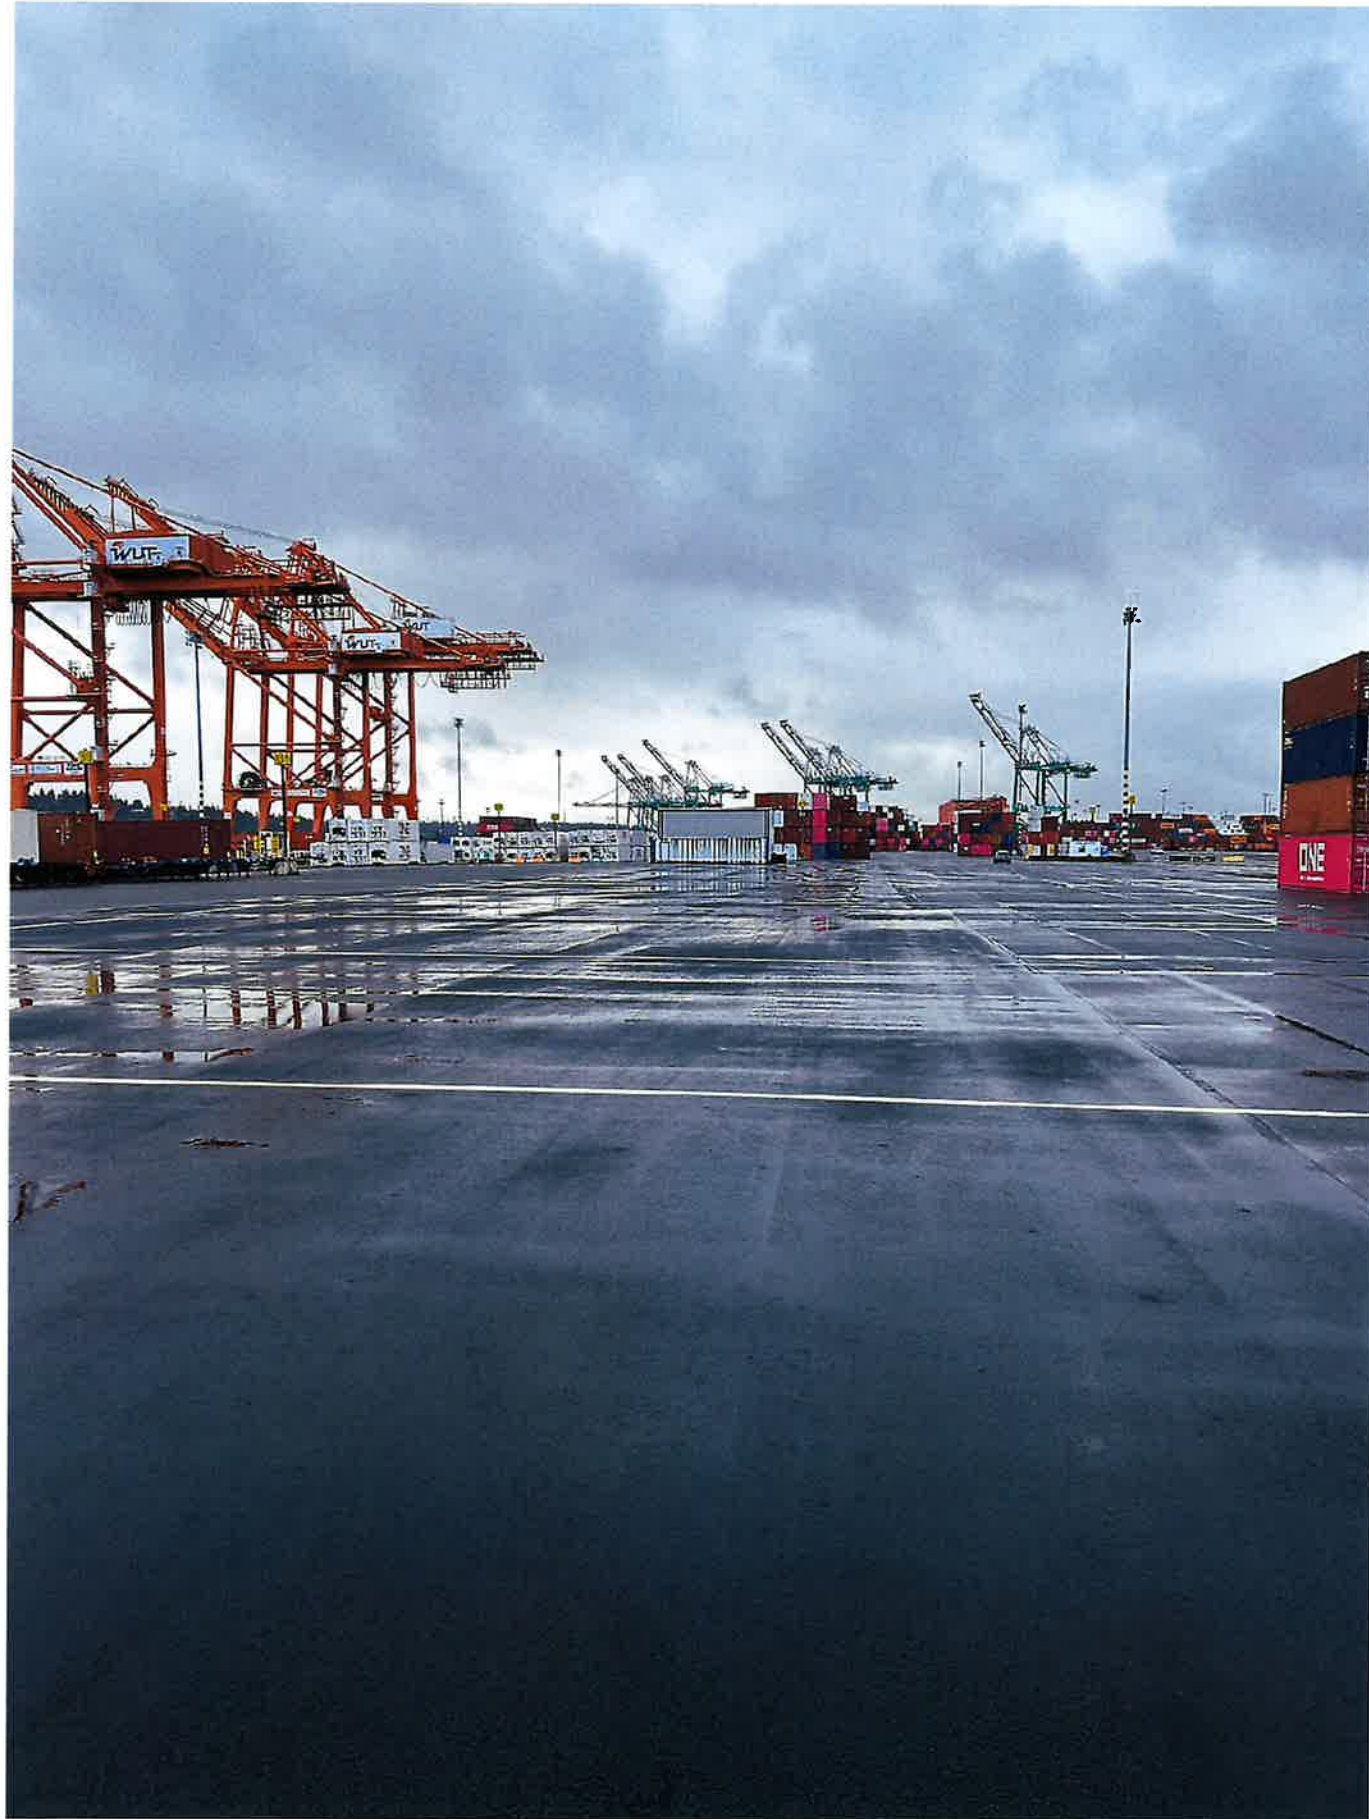
2024 repair area seen after paving. Work was completed on Thursday May 2<sup>nd</sup>. Approximately 1000 tons of asphalt was removed and replaced. Surface water that is visible in areas is less than 1/8" deep. Pavement surface is solid and tight.

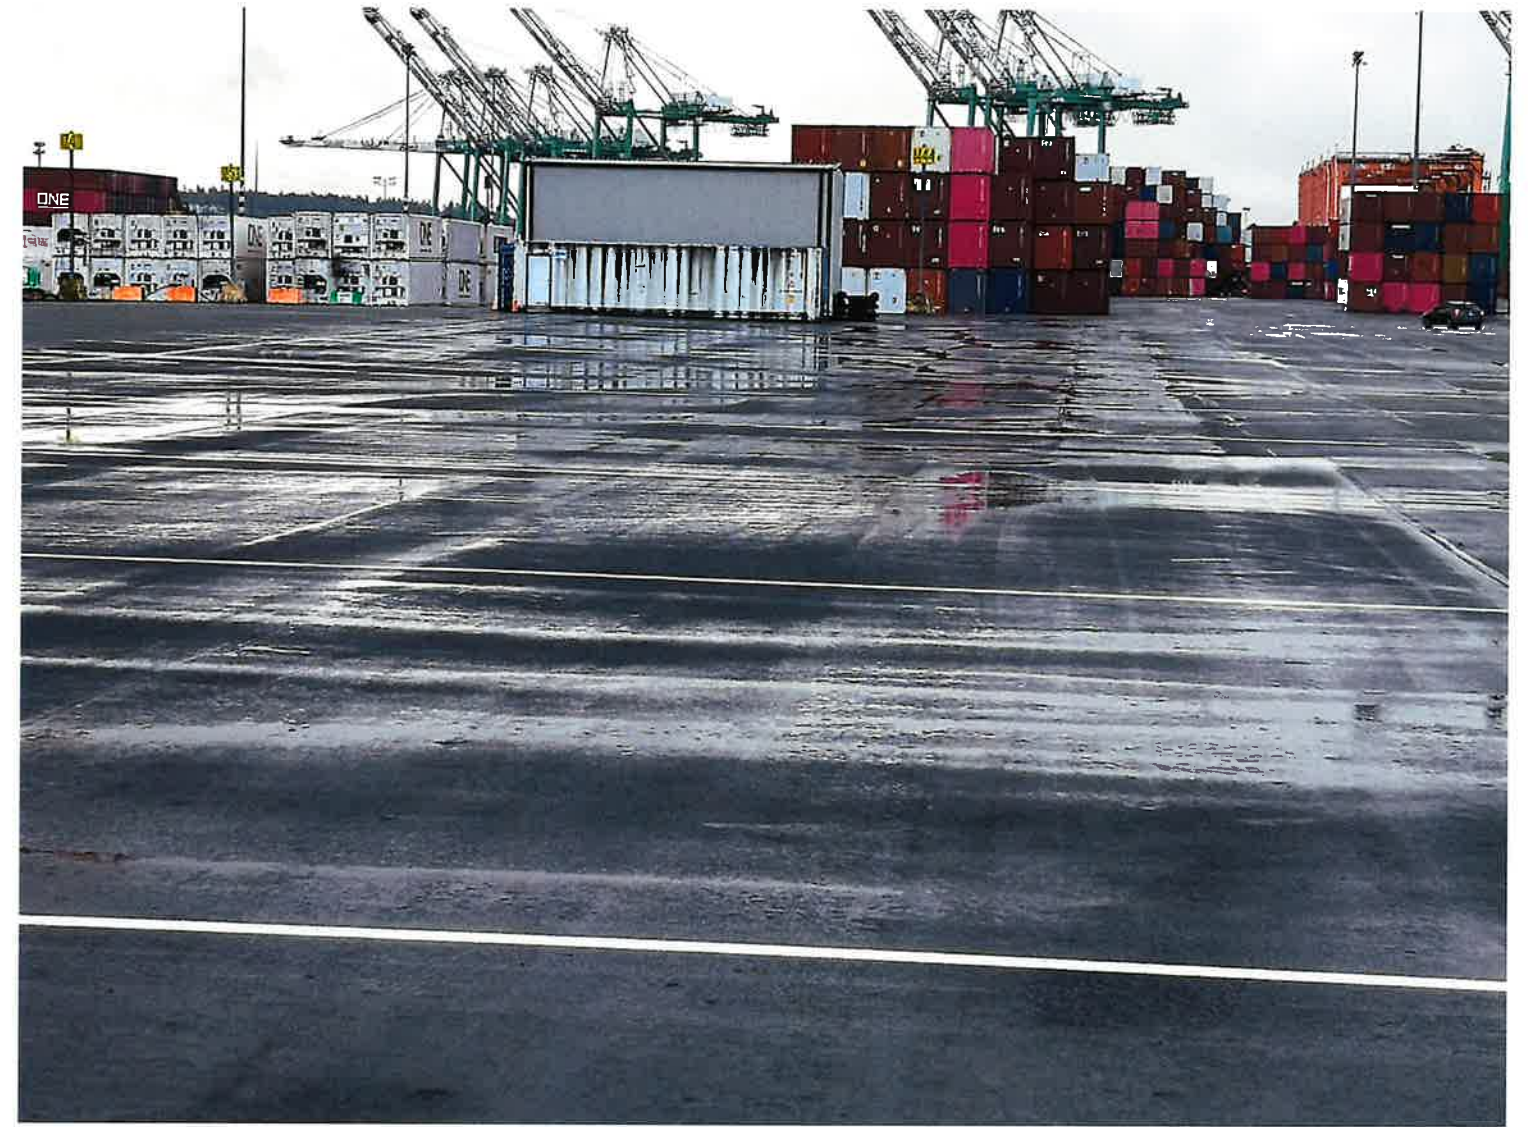
Another view of the larger repair area. Monitoring well is located on the opposite side of the building seen in this image.
