# Environmental Cap and Drainage System Inspection Report

Former Murray Pacific No. 2 Log Sort Yard  
(Ecology Facility ID #1211)

February 28, 2025

Project No. M0615.18.004

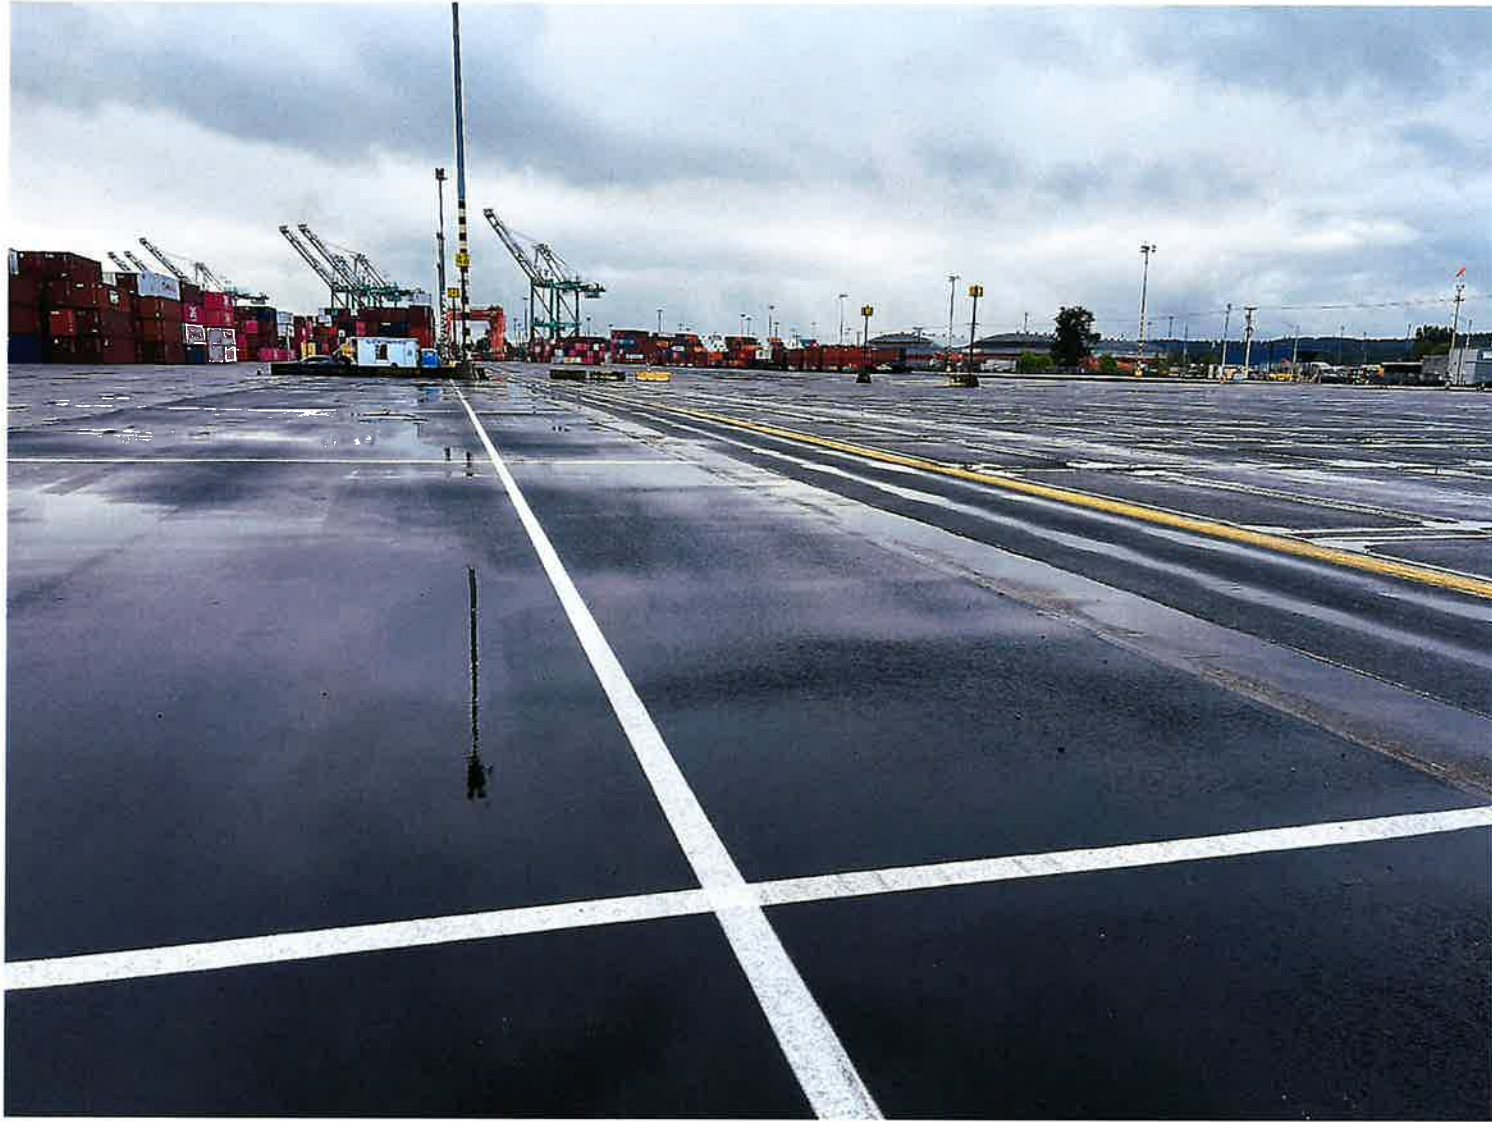
Image of the smaller repair area on the west side of the aisleway. Note that the parking stops have been removed along with the pin anchors. Anchors holes are filled with asphaltic sealer prior to paving. Edges of new paving to existing are also sealer with AR 7000 Rubberized Mastic.

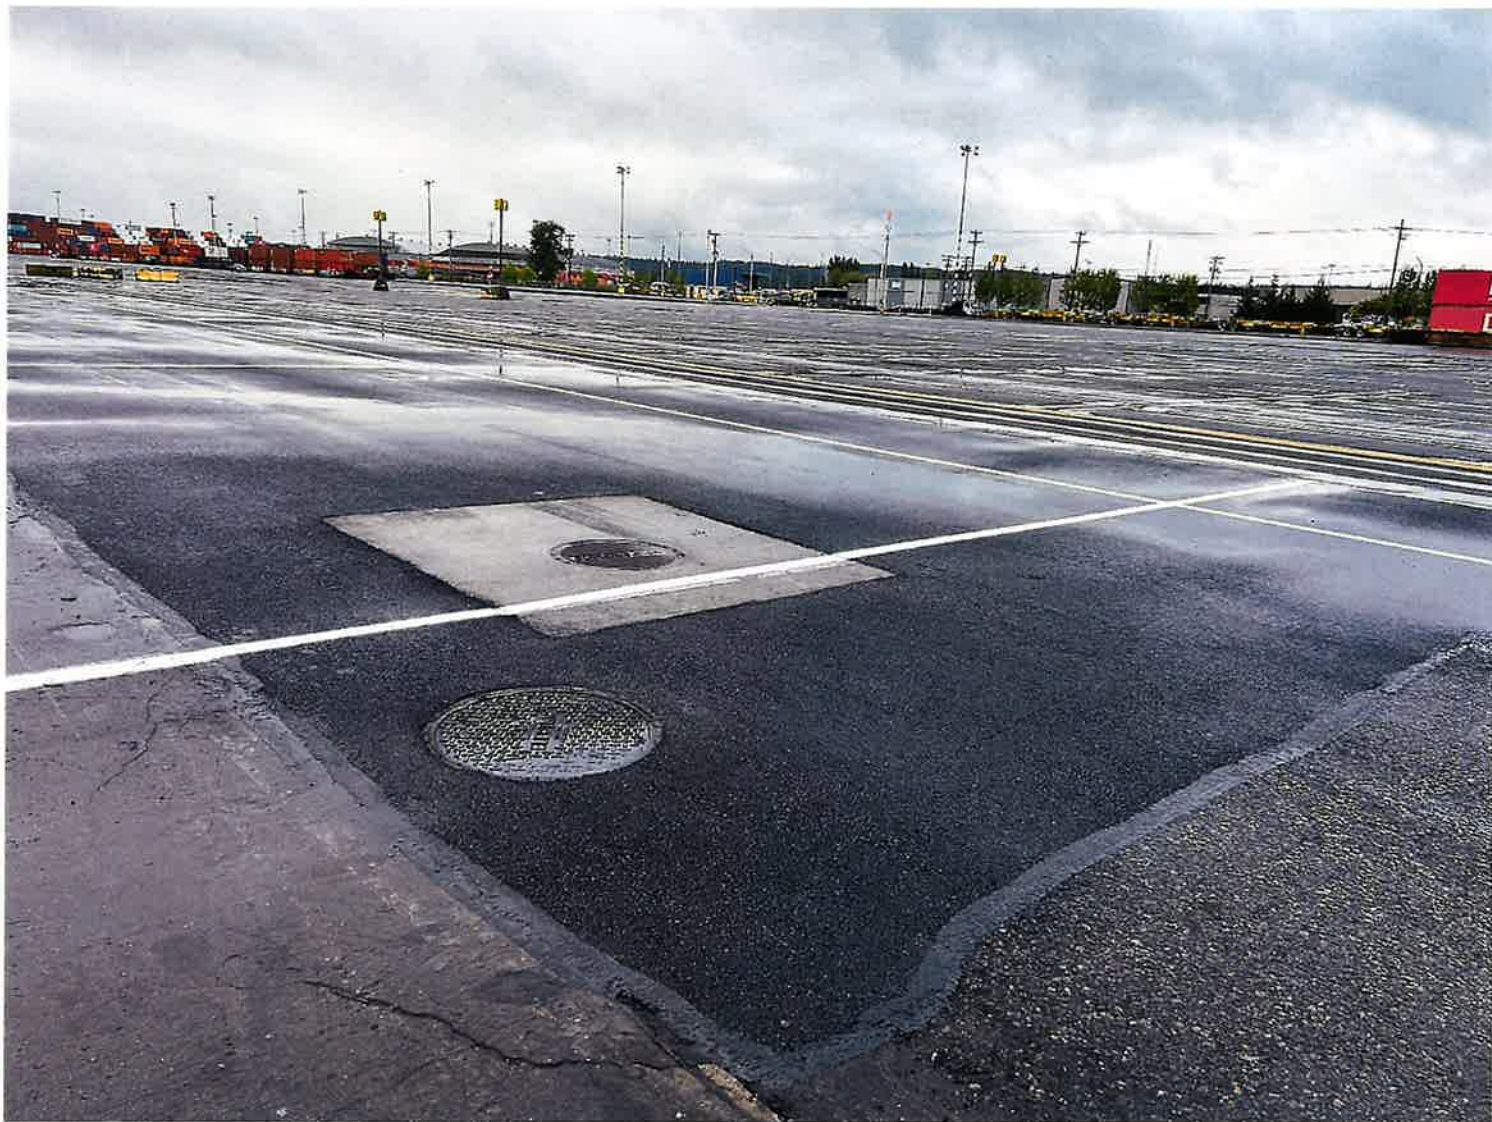
Another image of the repairs made to the west of the aisleway.

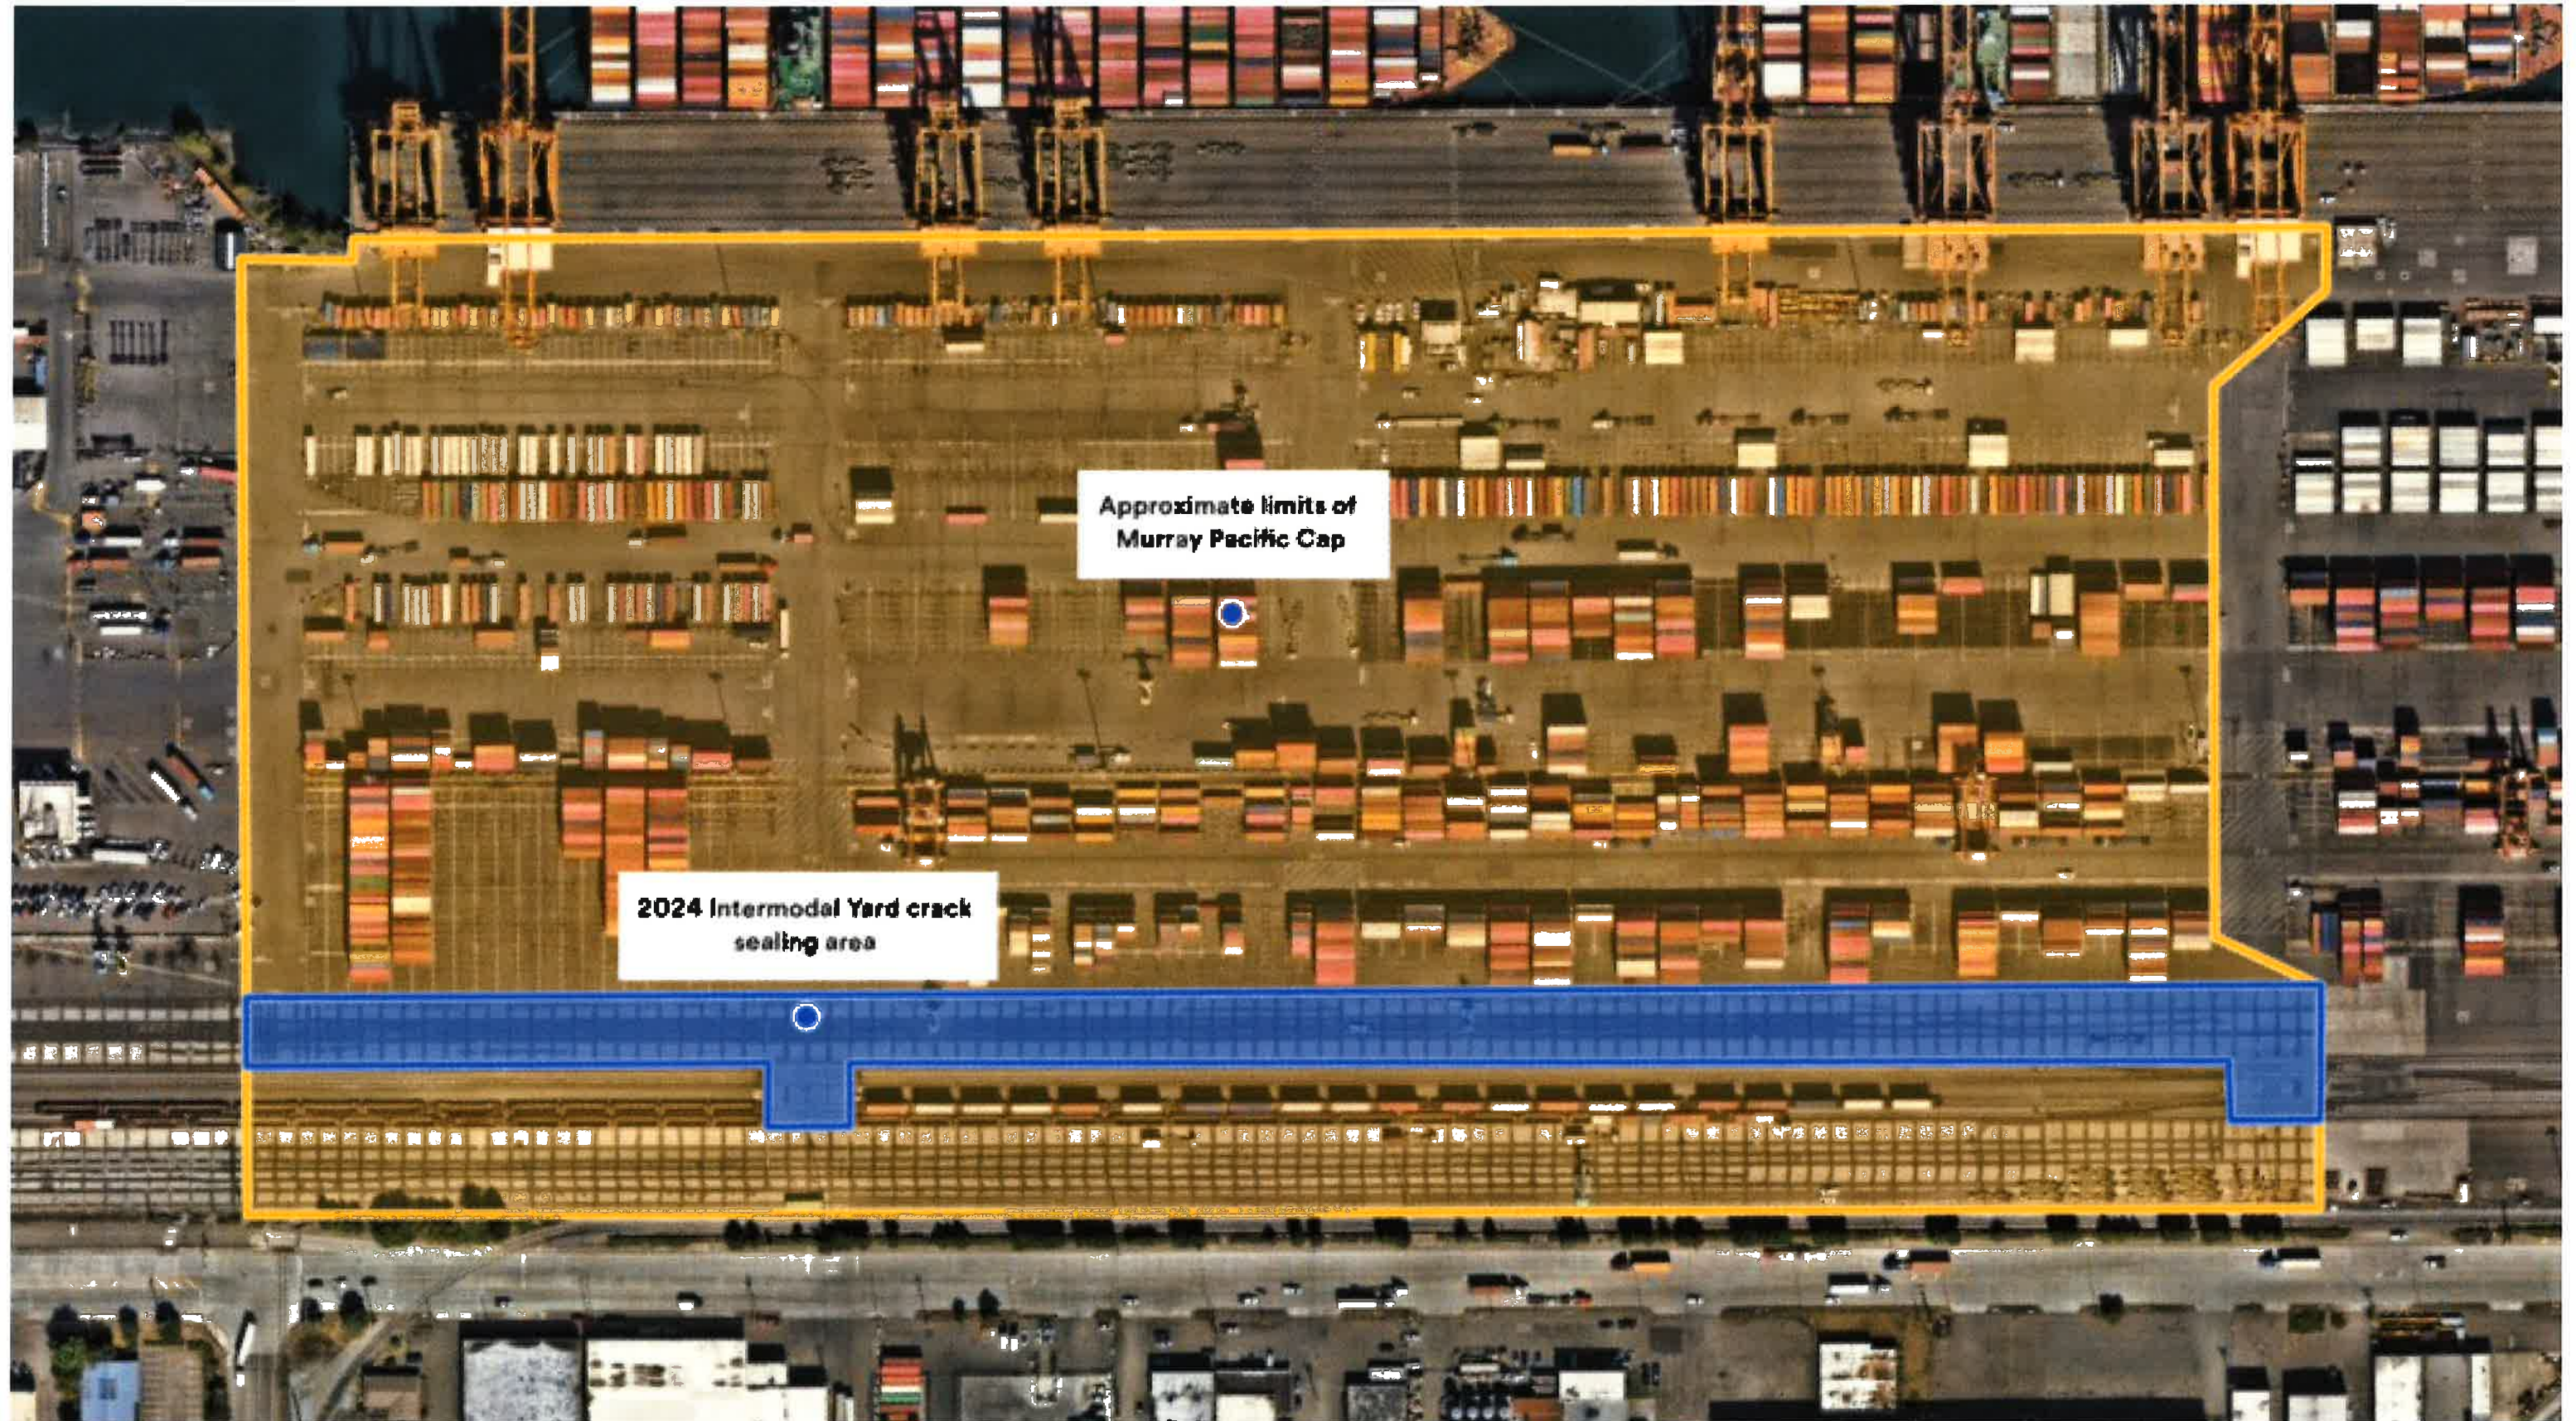
In early September 2024 Puget Paving completed a crack sealing effort in the area depicted in blue above. This area is constructed of 12" concrete. The cracks and joints in the concrete panels were blown out to remove debris. Cracks were sealed with AR7000 Rubberized Mastic. In areas of larger concrete spalling the impacted concrete was removed and the area filled with asphalt paving.

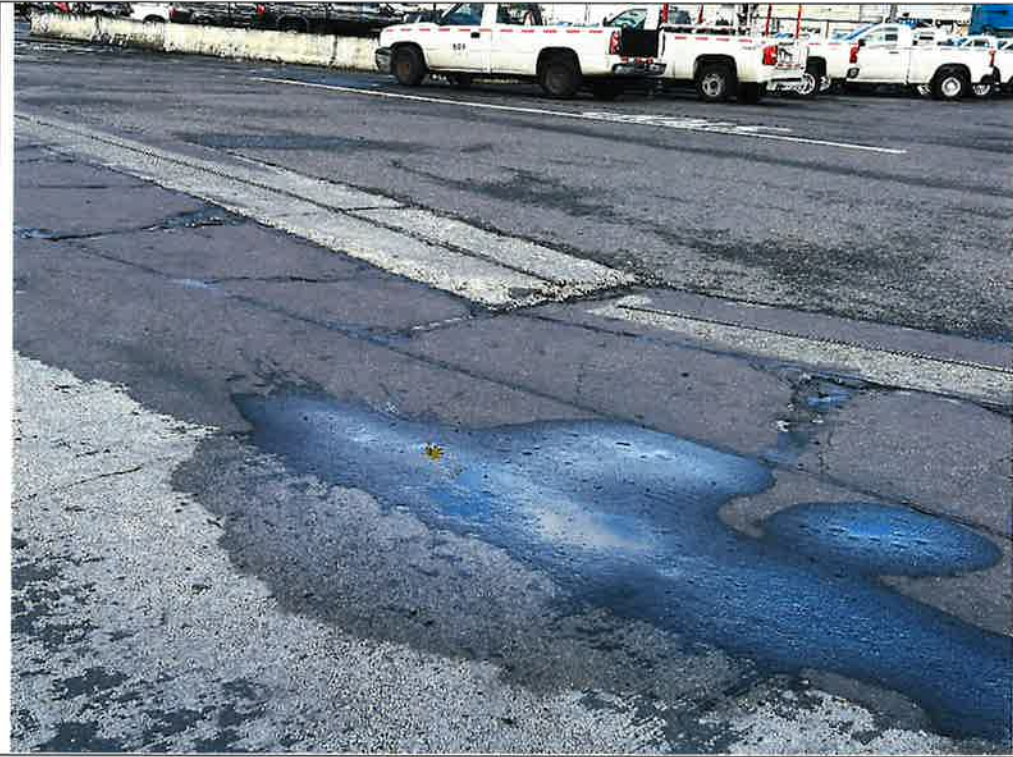
Cracks sealed at northeast end of work area around strip drain

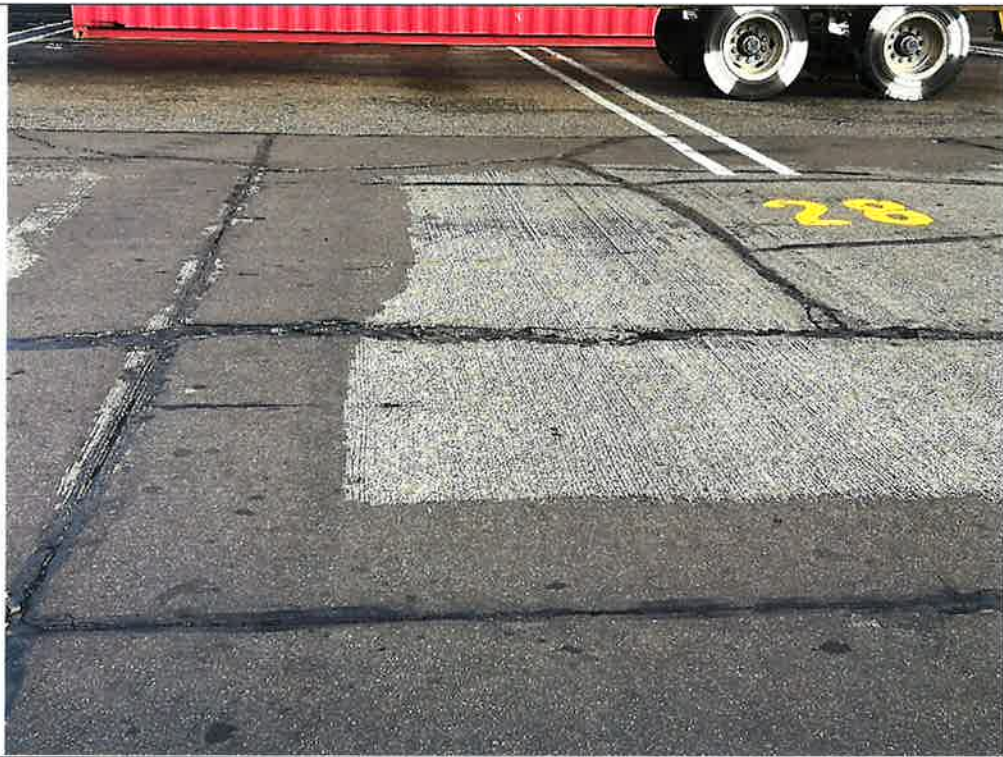
Typical joint and crack sealing in the intermodal yard

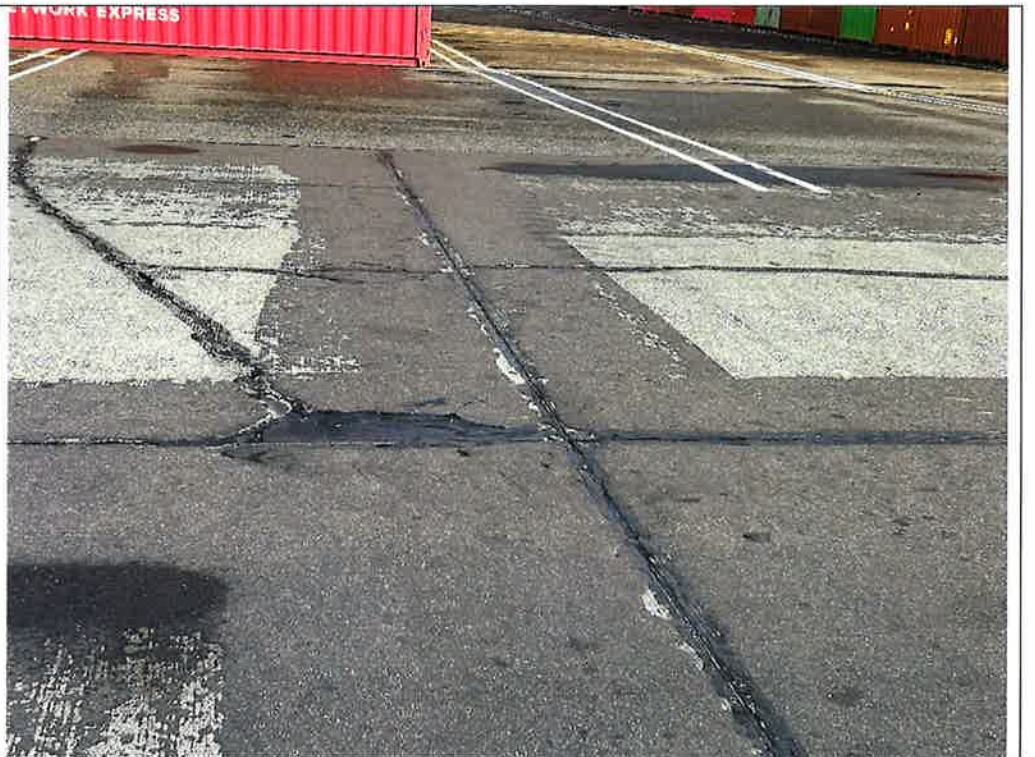
Area of larger spall filled with asphalt paving and adjacent cracks and joints sealed with AR 7000 Rubberized Mastic

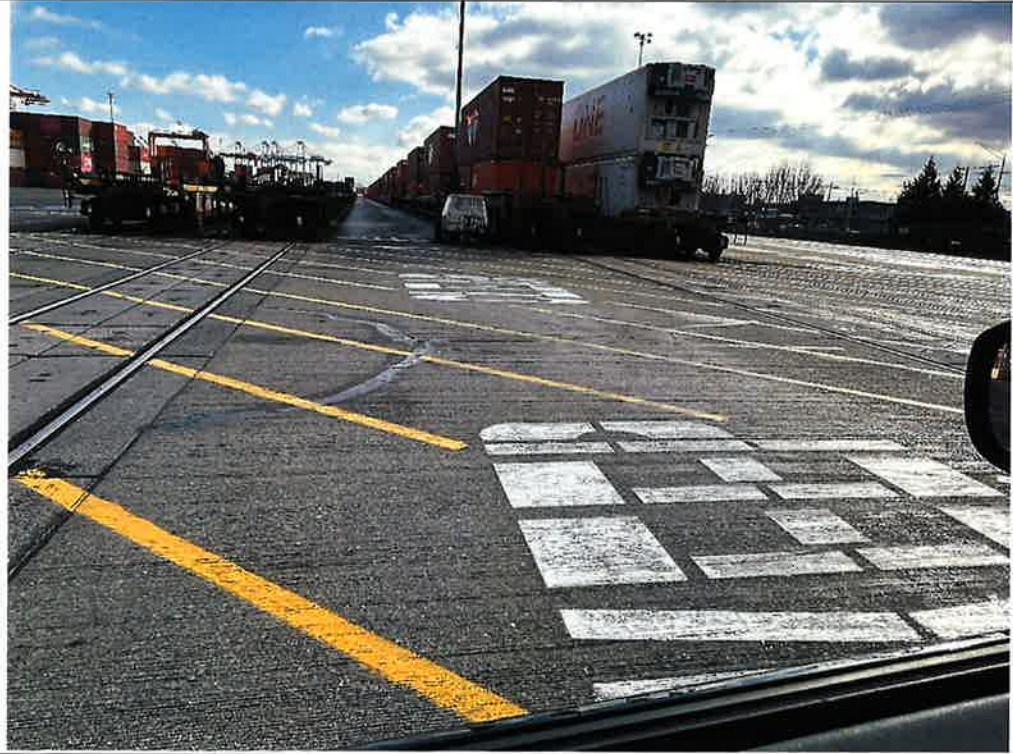
Within the crossing the tubs on the rail lines are not included in this maintenance effort. Only the crossing panel cracks are sealed.

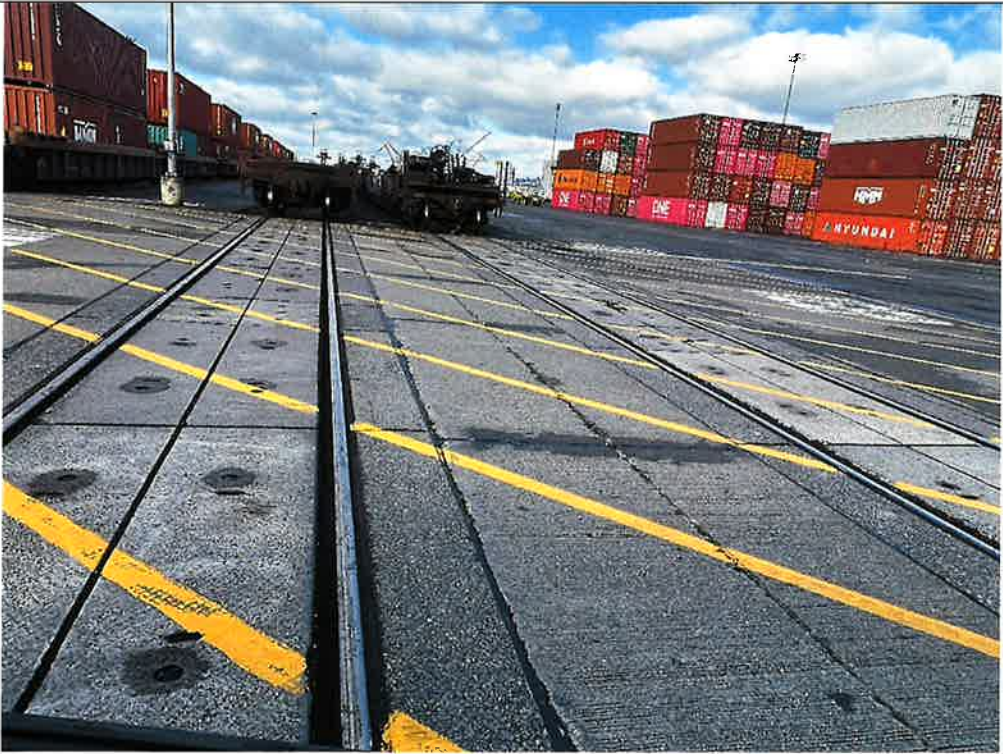
Area within the rail lines is protected by a cap beneath the ballast as shown on the attached section

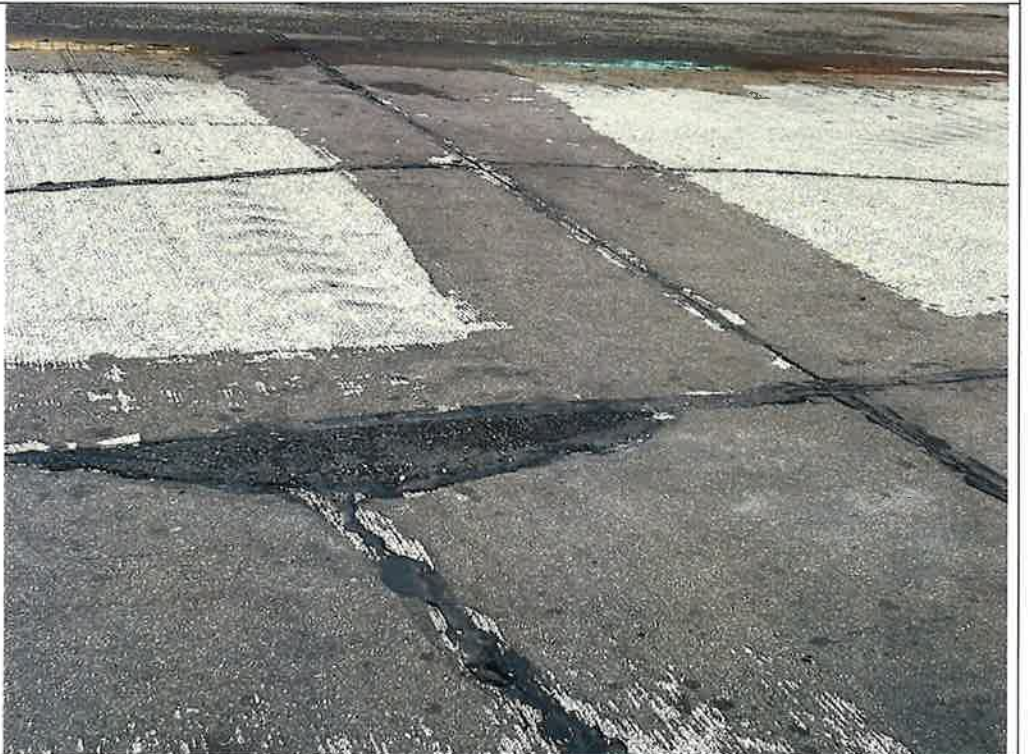
Area of larger spall repaired with asphalt

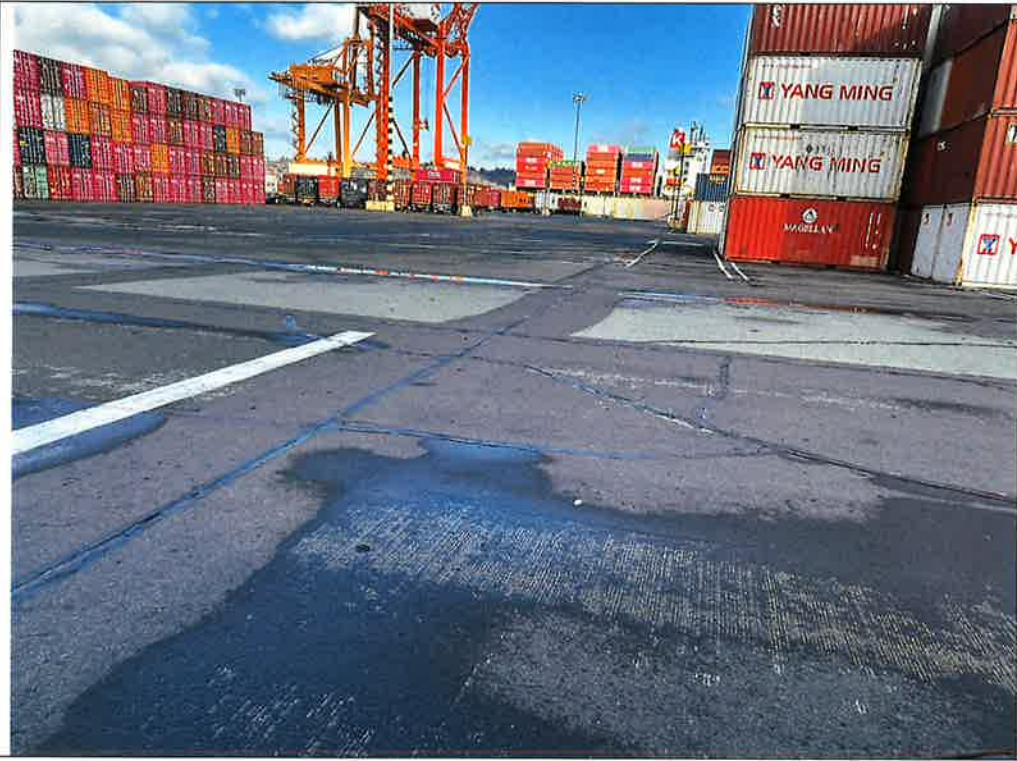
Typical area of crack and joint sealing

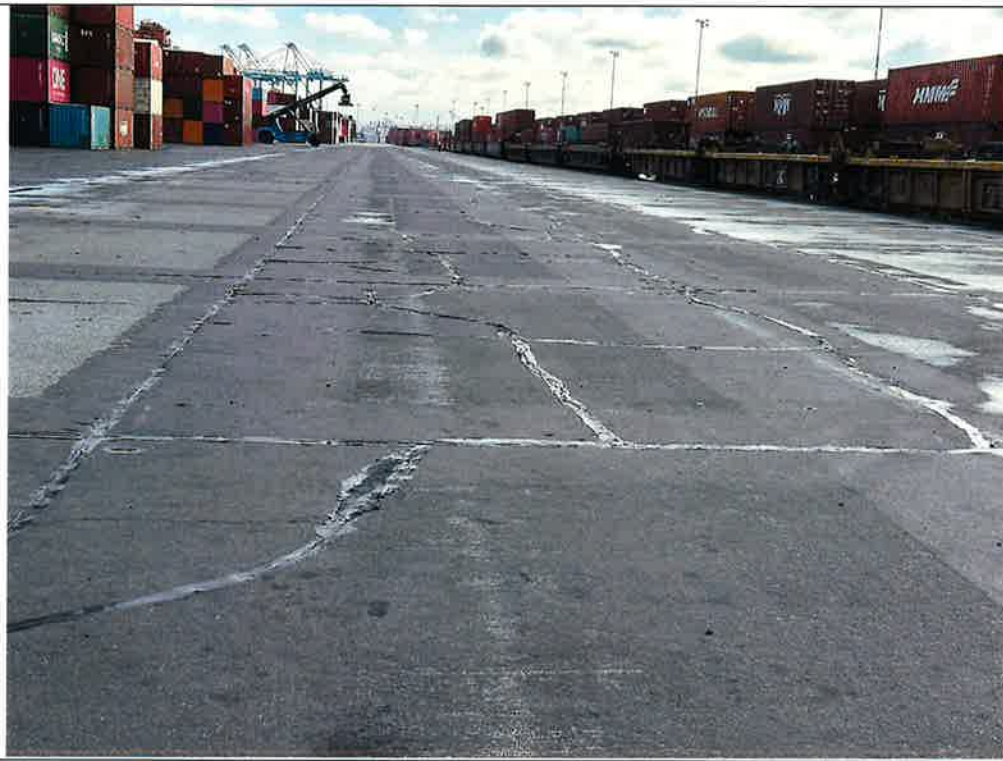
Typical joint and crack sealing.  
In 2010 the Port did an extensive repair of the concrete portion of the cap that included removal of all loose and spalled concrete. Rubberized mastic was placed back in the joints. In larger joints and pockets the mastic was extended with pea gravel to ensure better adhesion. The areas of work were then coated with an asphaltic slurry that included stone chips. This material is still present as seen in the area of black on the concrete. While surface cracking is occurring, the rubberized mastic installed previously is still in tack and providing protection from water intrusion. This effort provides a layer of surface protection for the previous repairs.

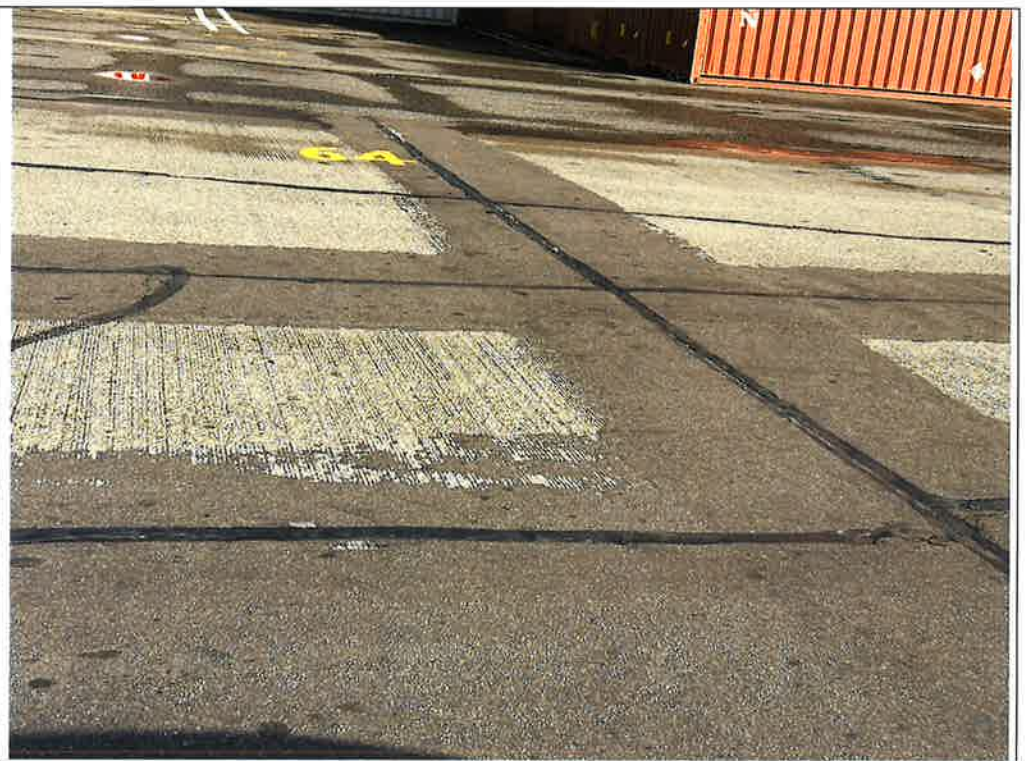
Typical joint and crack sealing.
