Subject:
Stimson Lumber Company, Former Josephine Mill No. 1, Pend Oreille County,
Washington, 2012 Annual Monitoring Maintenance and Repairs Report.

Photo Log - Former Josephine Mill No. 1

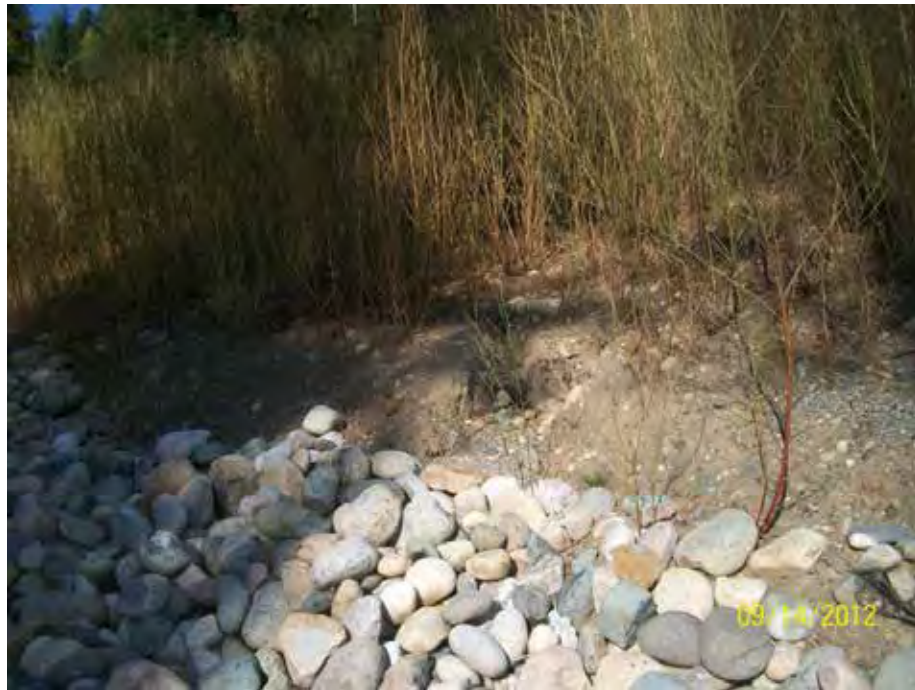
Erosion Rill #1

Erosion rill along the toe of the slope, approximately 4" deep

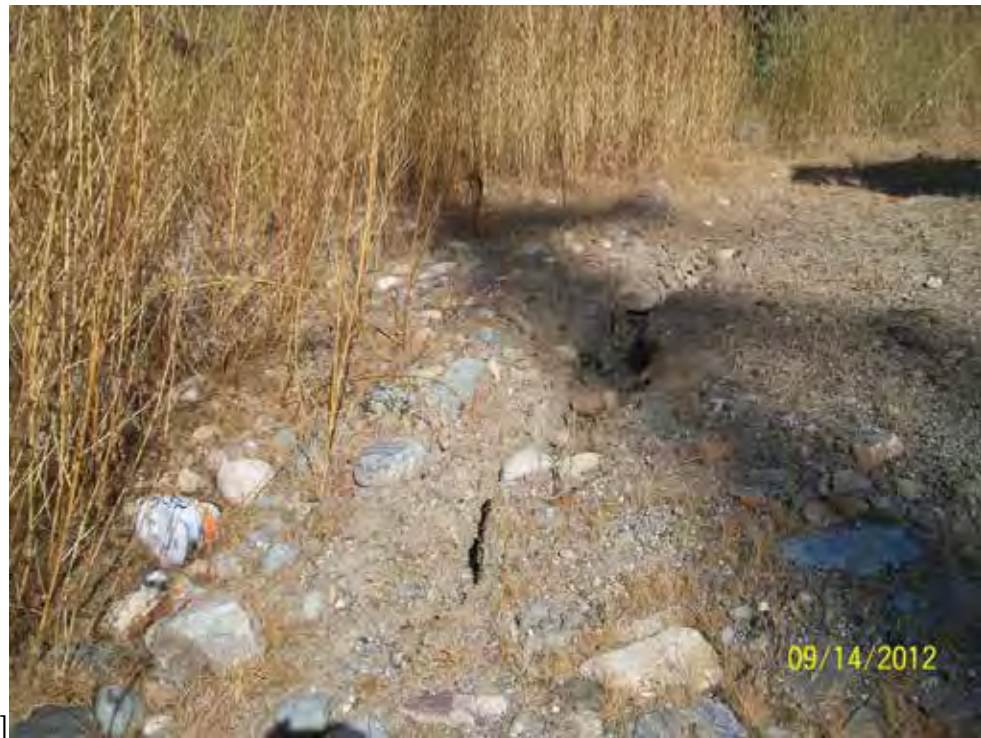
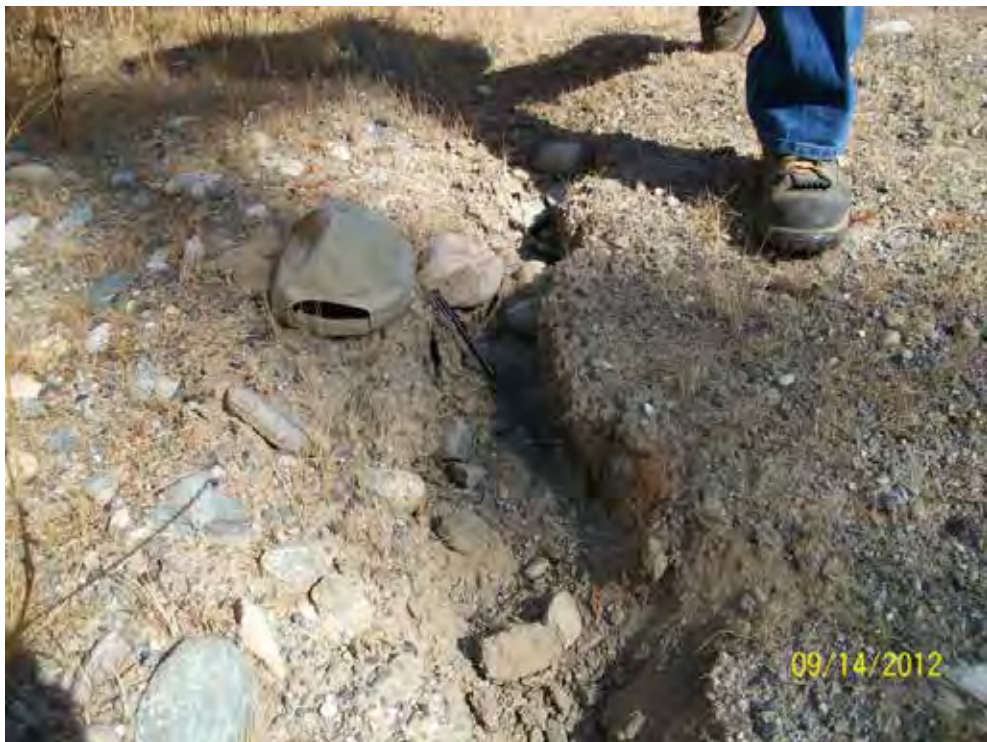
Erosion Rill #2

Erosion rill along western edge of cap, penetrating to the underlying liner material

Same erosion rill as pictured above

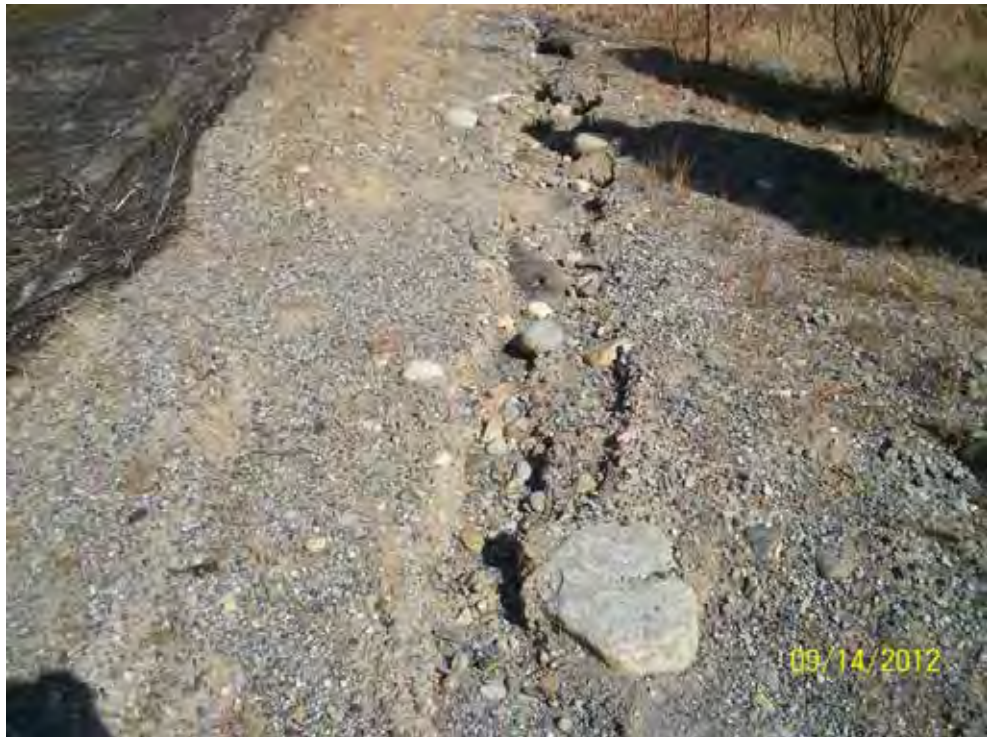
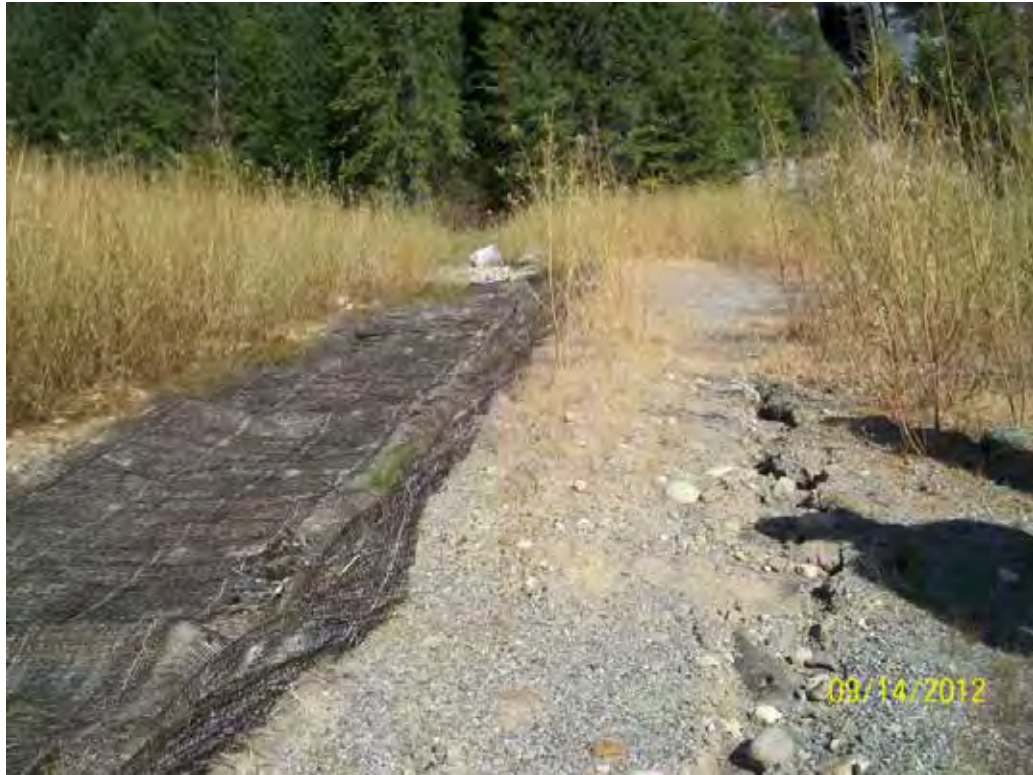
Erosion Rill #3

Erosion rill and cover material loss along the top of the termination trench and stormwater swale on the eastern side of the repository

Same erosion rill as pictured above

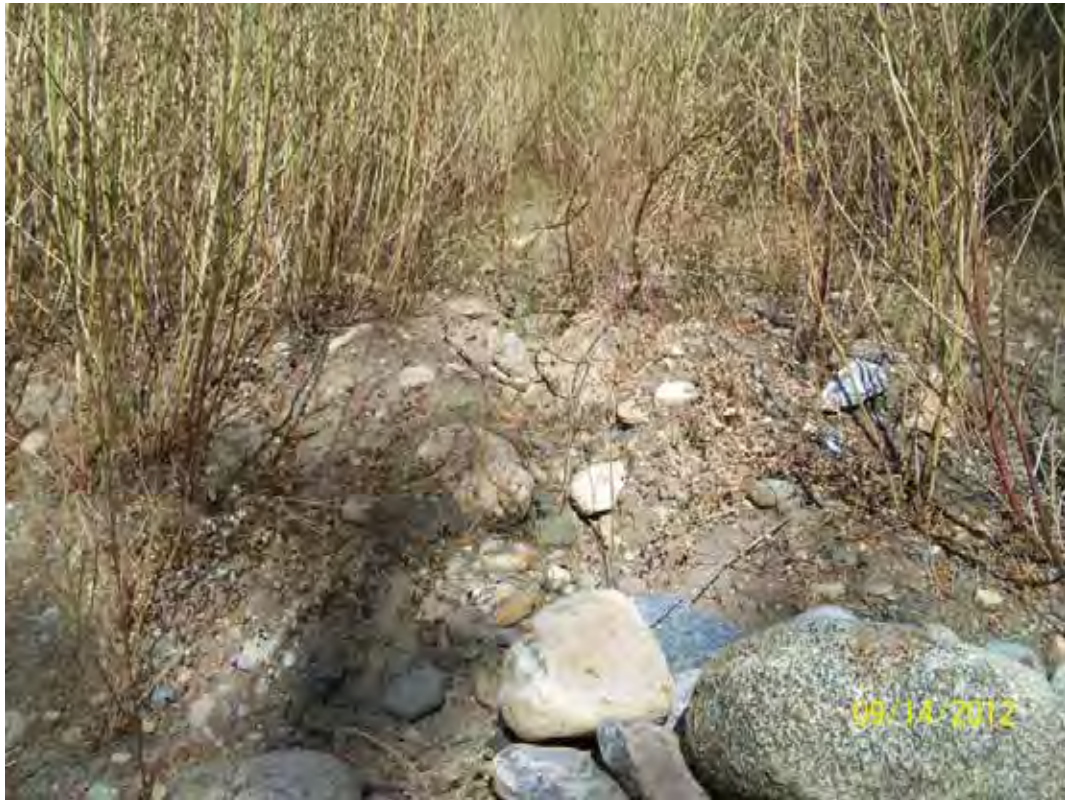
Erosion Rill #4

Erosion rill along the toe of slope, rill was approximately 4" deep and 5' long

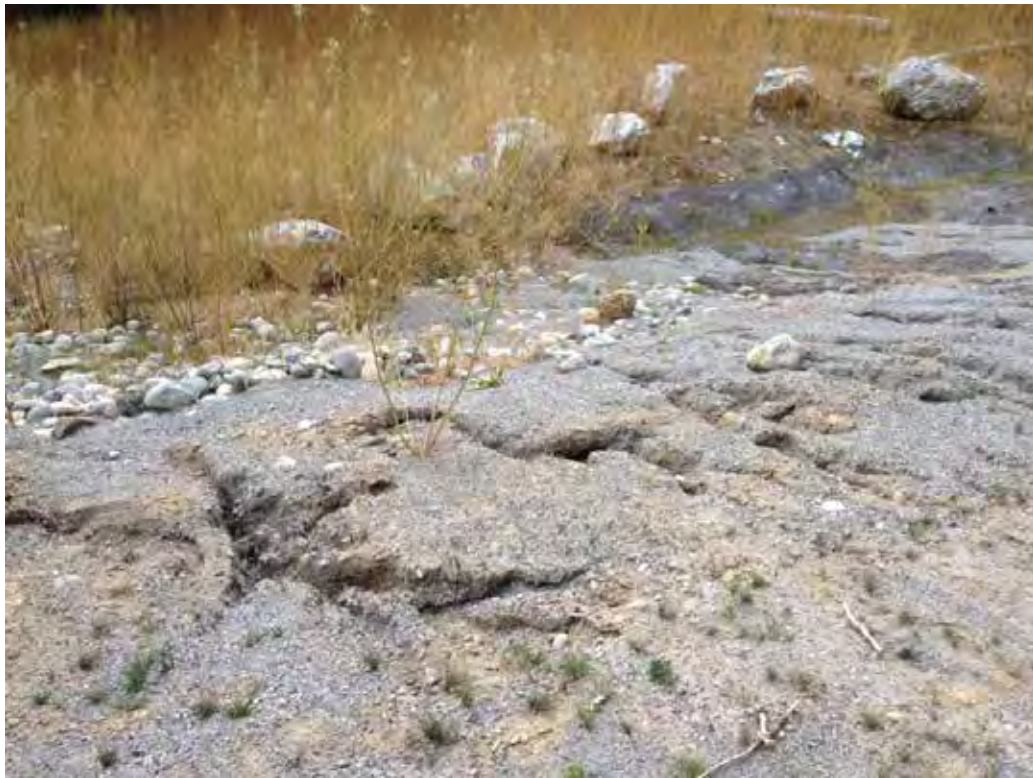
Erosion Rill #5

Erosion rills along the Access Road on the northeastern corner of the repository
