STIMSON LUMBER COMPANY

May 9, 2014

Subj: 2014 Annual MMR Report: Former Josephine Mill No. 1

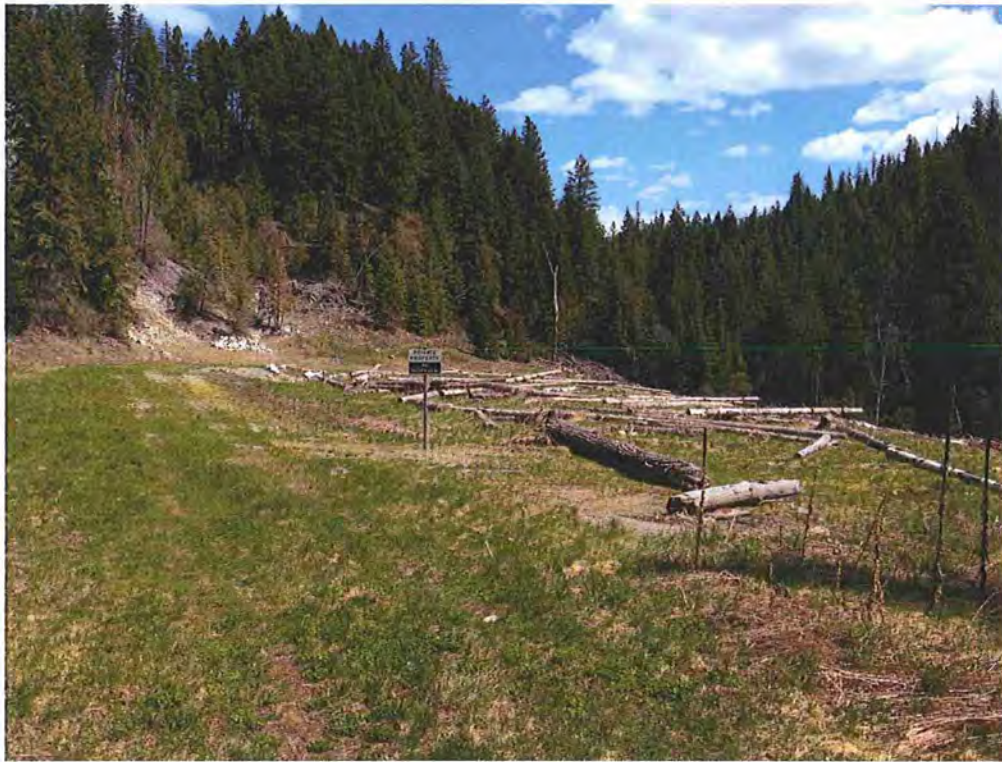
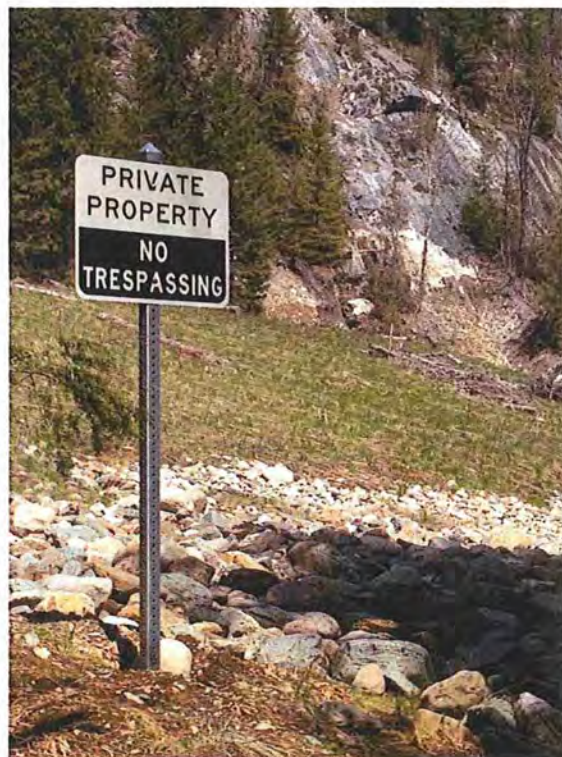
Confirm presence and condition of warning signage

- *All 3 warning signs remain upright and in place, were undamaged, and are readily visible.*

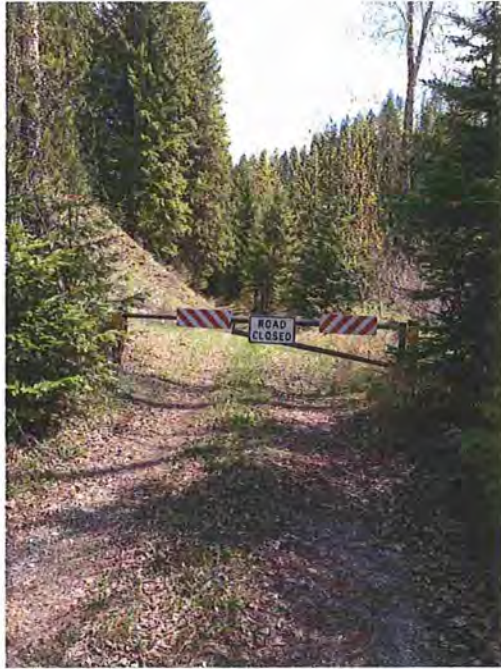
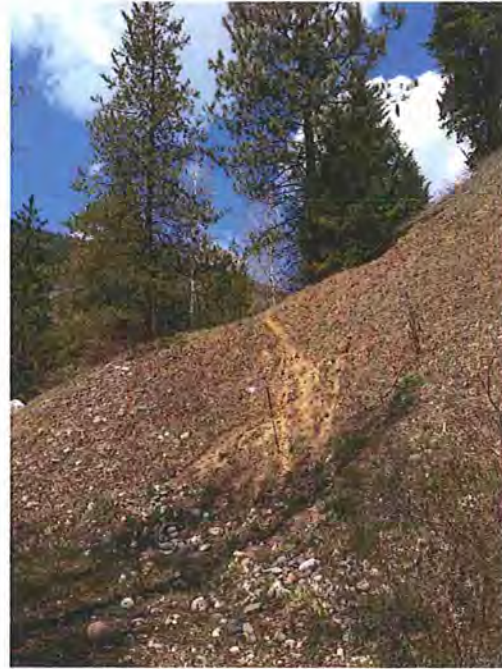
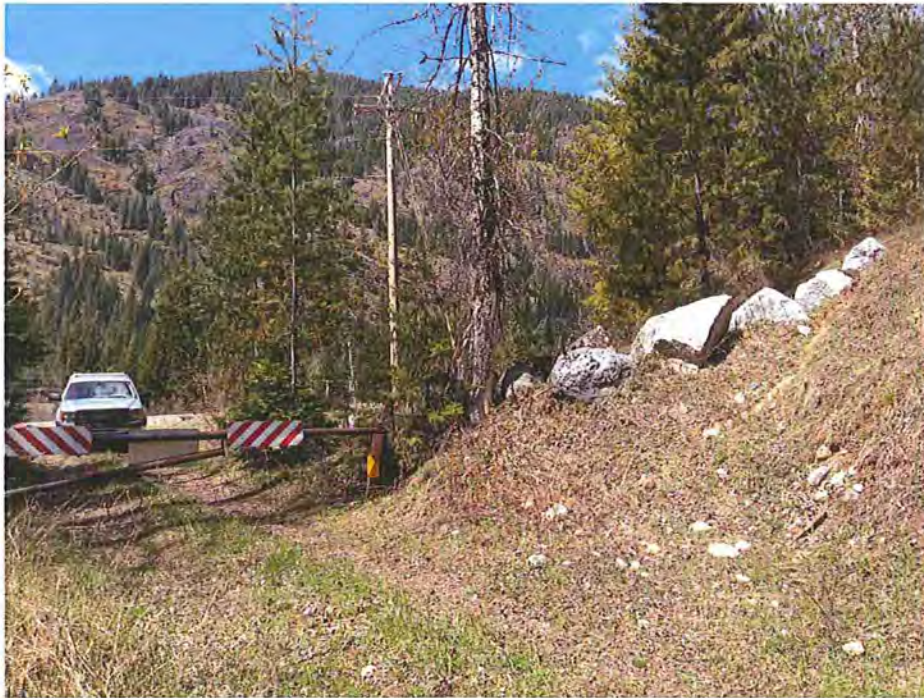
Confirm presence and operation of site controls including access gates

- *The gate was locked and in good working order. Boulders and other structures designed to restrict vehicular entry remain in place and were undamaged. There was evidence of some minor breaching by a motorcycle which gained access by climbing up a steep hill and going around the boulders, but occurrence appears to be sporadic and travel is confined to the access road as no signs of entry onto the repository cap were seen.*

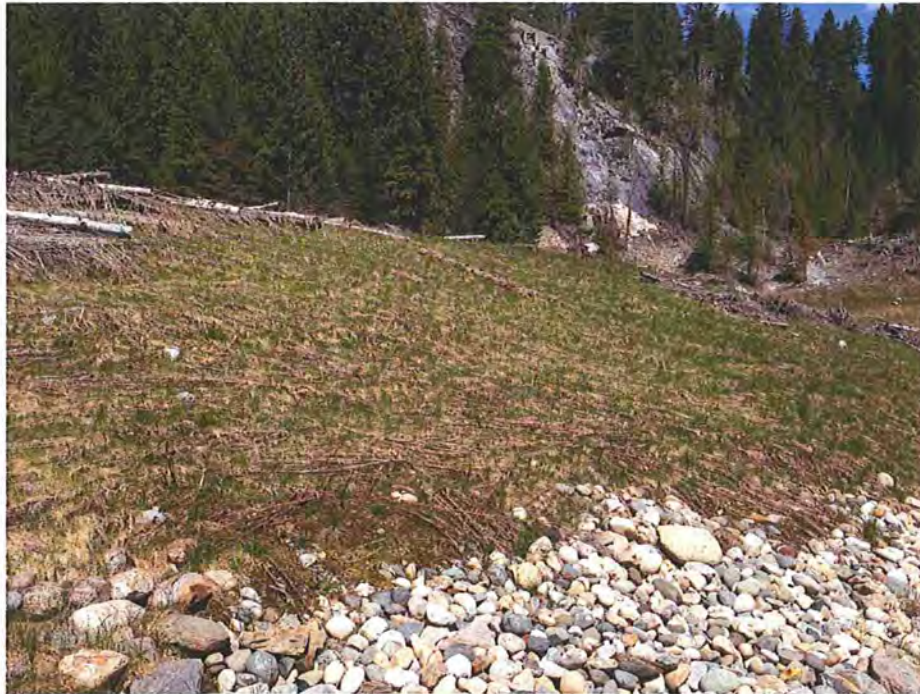
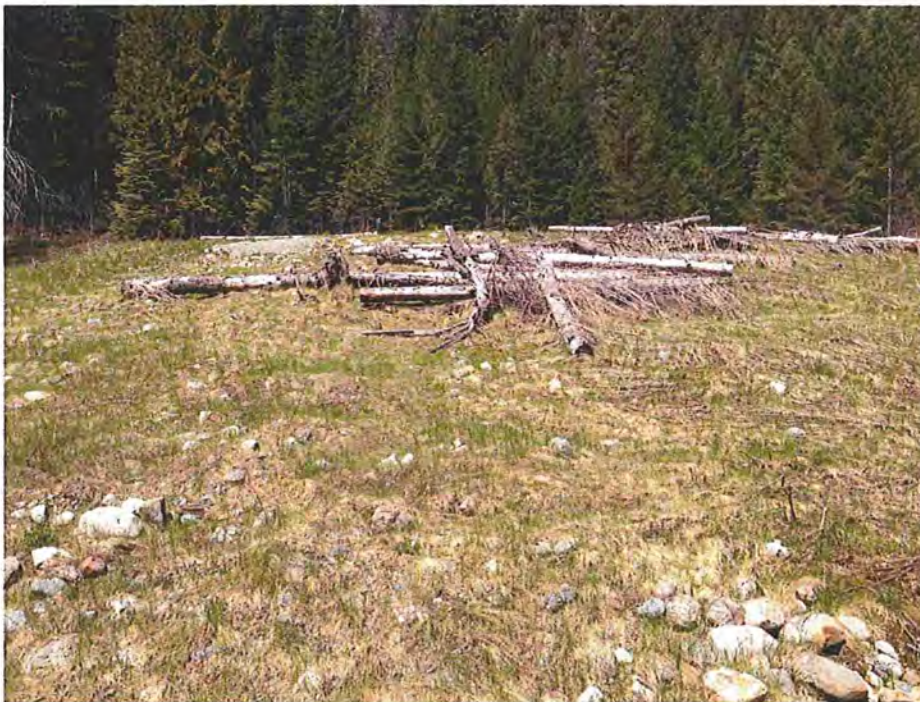
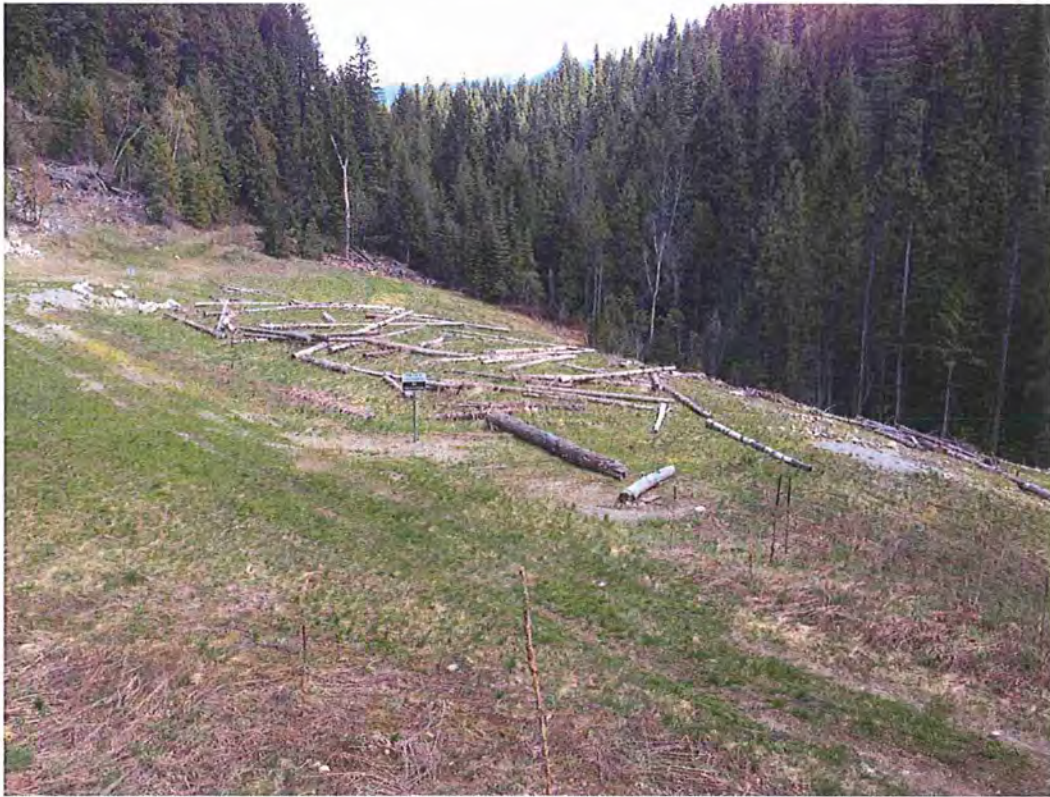
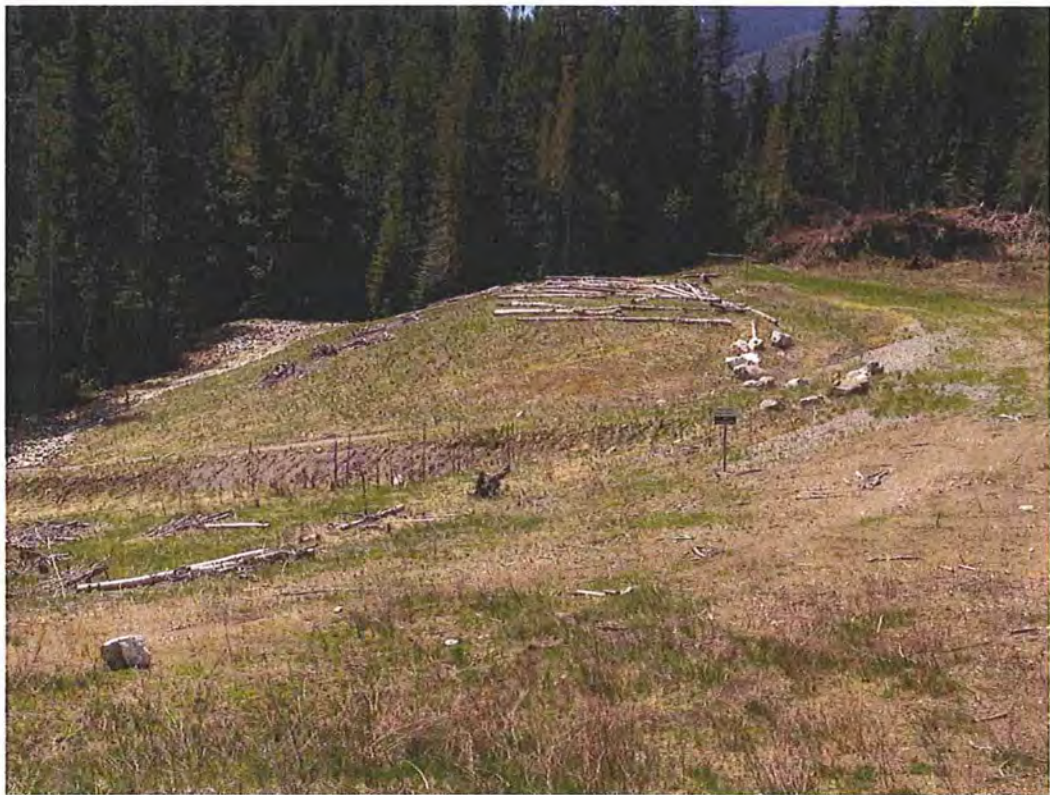
Observe the condition of the repository cover and identifying areas of movement, erosion or exposed liner

- *The repository cap appears stable and has a good vegetative cover of grass and sweet clover. The logs distributed on the cap to discourage entry are in good physical condition. No erosion or areas with exposed liner were visible, and there was no evidence of mass movement.*

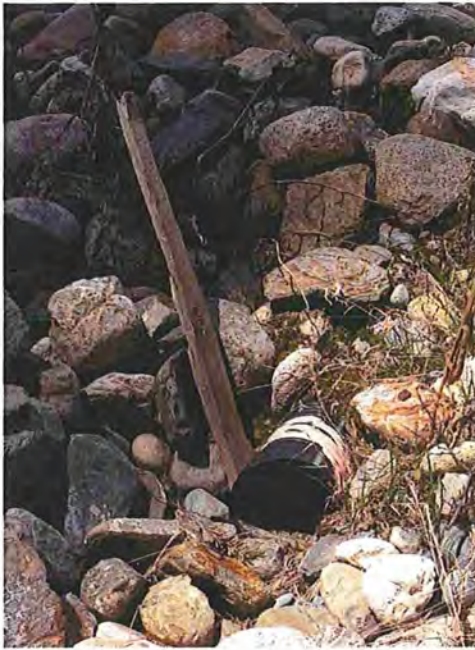
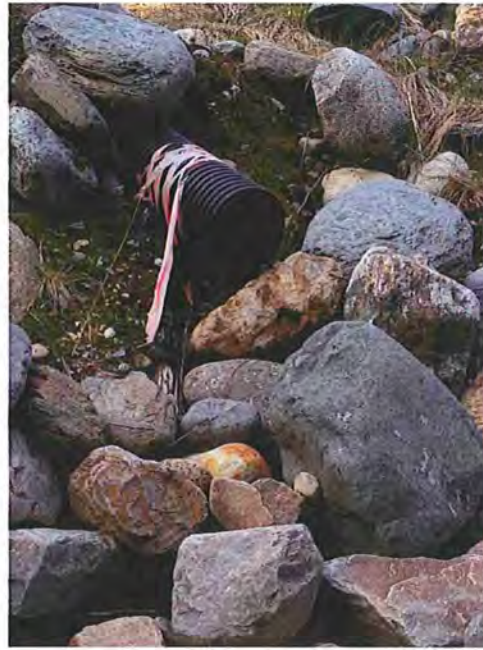
Observe operation of the underdrain system and cleanout as necessary

- *The underdrain system appeared to be functioning as engineered, and all cleanouts were clear of debris.*

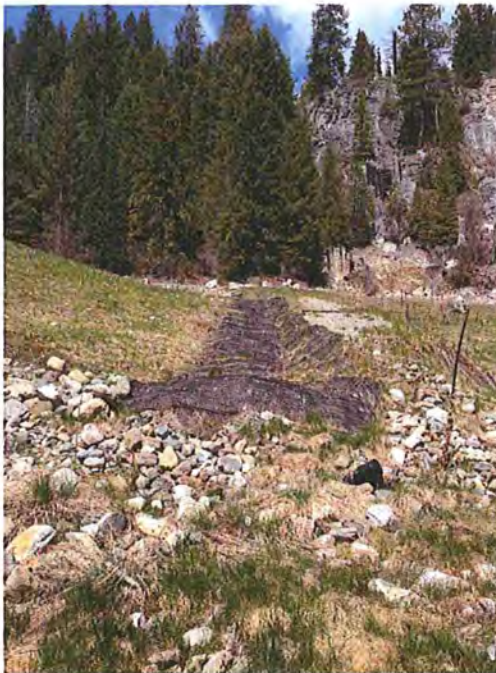
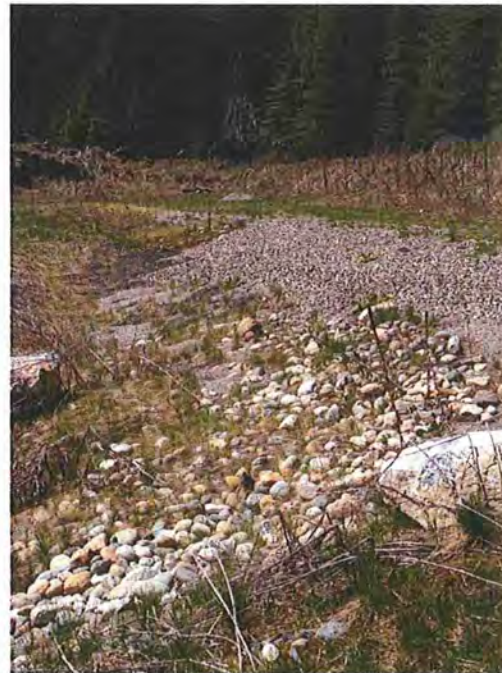
Observe the condition of stormwater management structures

- *No visual damage to the system was evident.*
