Subj: 2015 Annual MMR Report: Former Josephine Mill No. 1

Stimson employees Steven Petrin (Corporate Environmental Manager) and Ted Carlson (Area Woodlands Manager) completed an annual spring site inspection on June 18, 2015 pursuant to the Post Removal Site Control Plan (PRSCP) found in Appendix E to the Final Removal Action Report (RAR) dated February 10, 2012. The PRSCP outlines the long-term maintenance and monitoring obligations to ensure the continuous protection, integrity and stability of the mine waste repository constructed at the former Josephine Mill No. 1 in Pend Oreille County, Washington. This letter serves as the 2015 annual spring Monitoring Maintenance and Repairs (MMR) report.

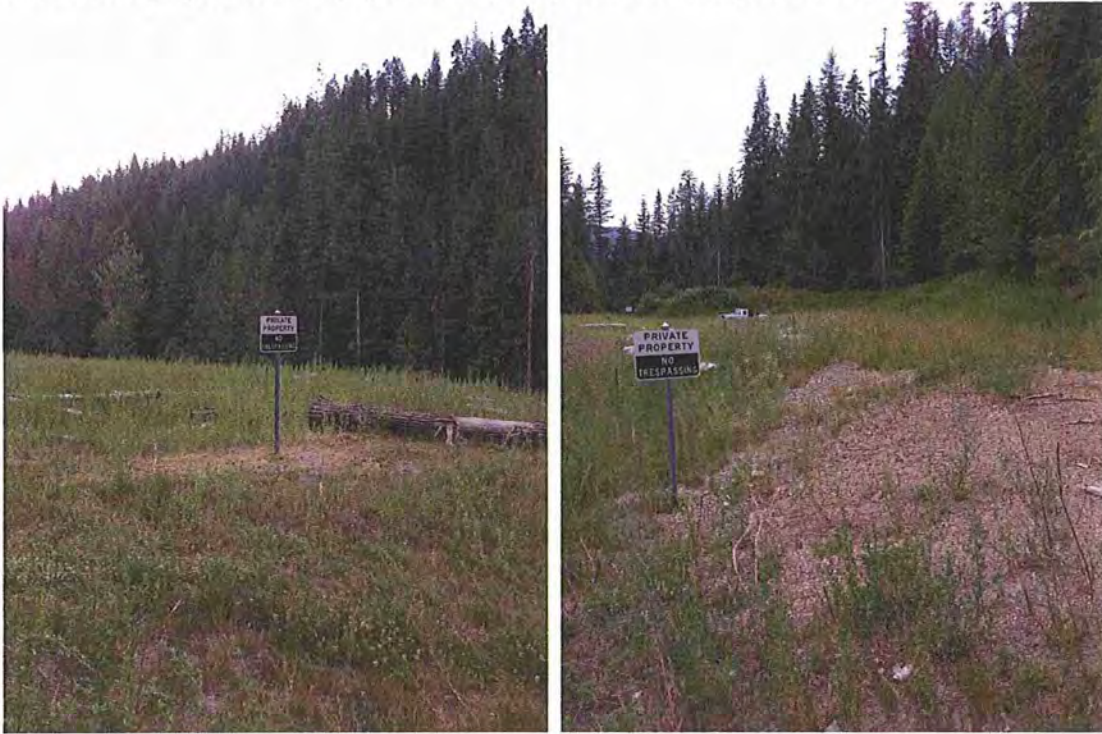
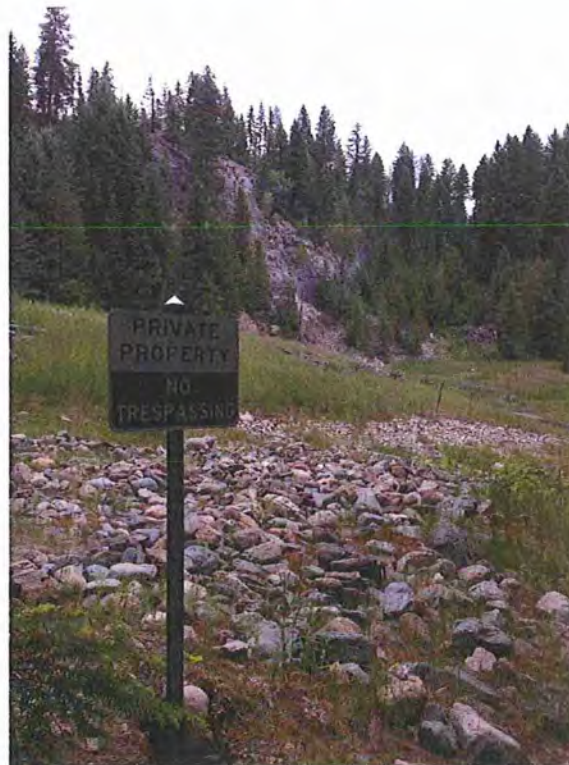
**Confirm presence and condition of warning signage**

- All 3 warning signs remain upright and in place, were undamaged, and are readily visible.

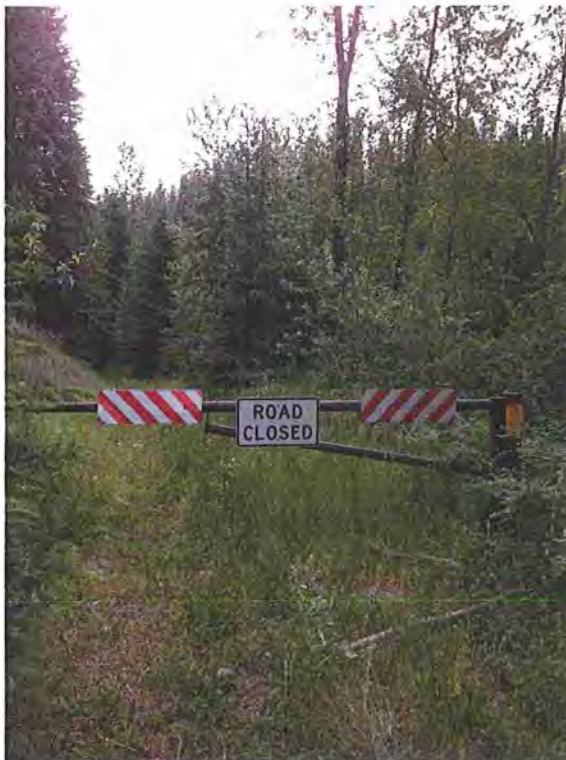
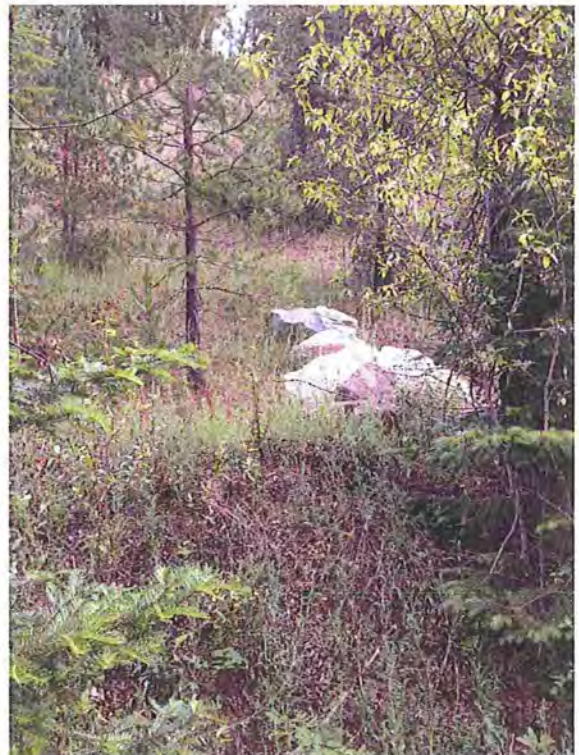
**Confirm presence and operation of site controls including access gates**

- *The gate was locked and in good working order. Boulders and other structures designed to restrict vehicular entry remain in place and were undamaged. There was evidence of some minor breaching by a motorcycle which gained access by going under the gate, but occurrence appears to be sporadic and travel is confined to the access road as no signs of entry onto the repository cap were seen.*

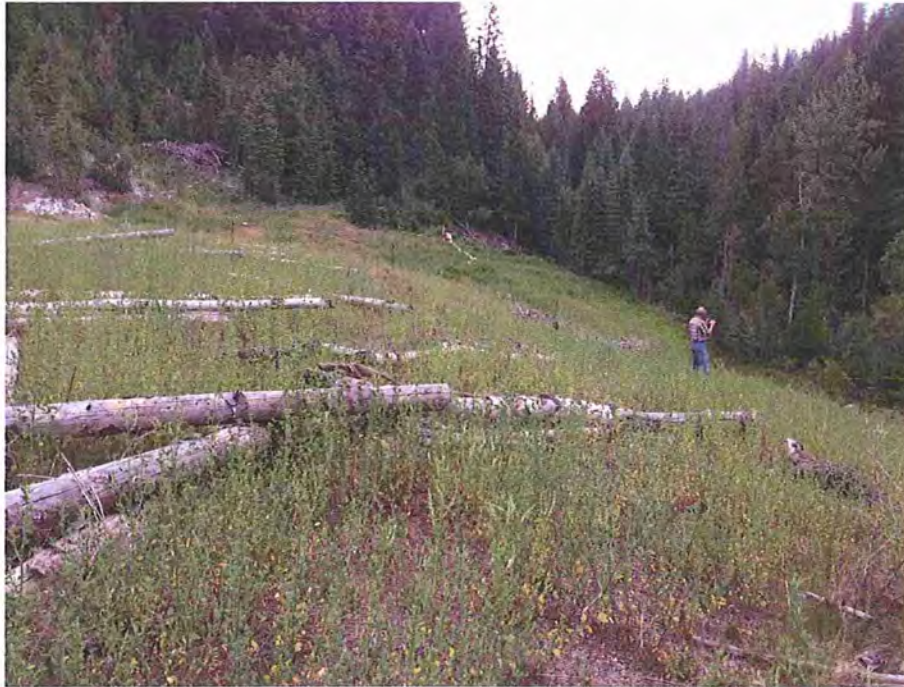
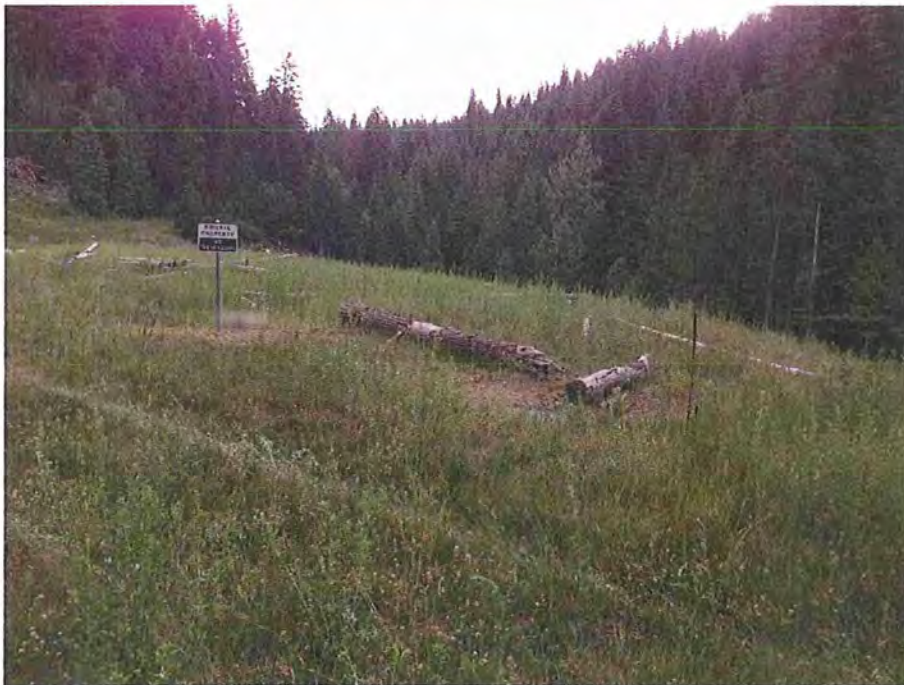
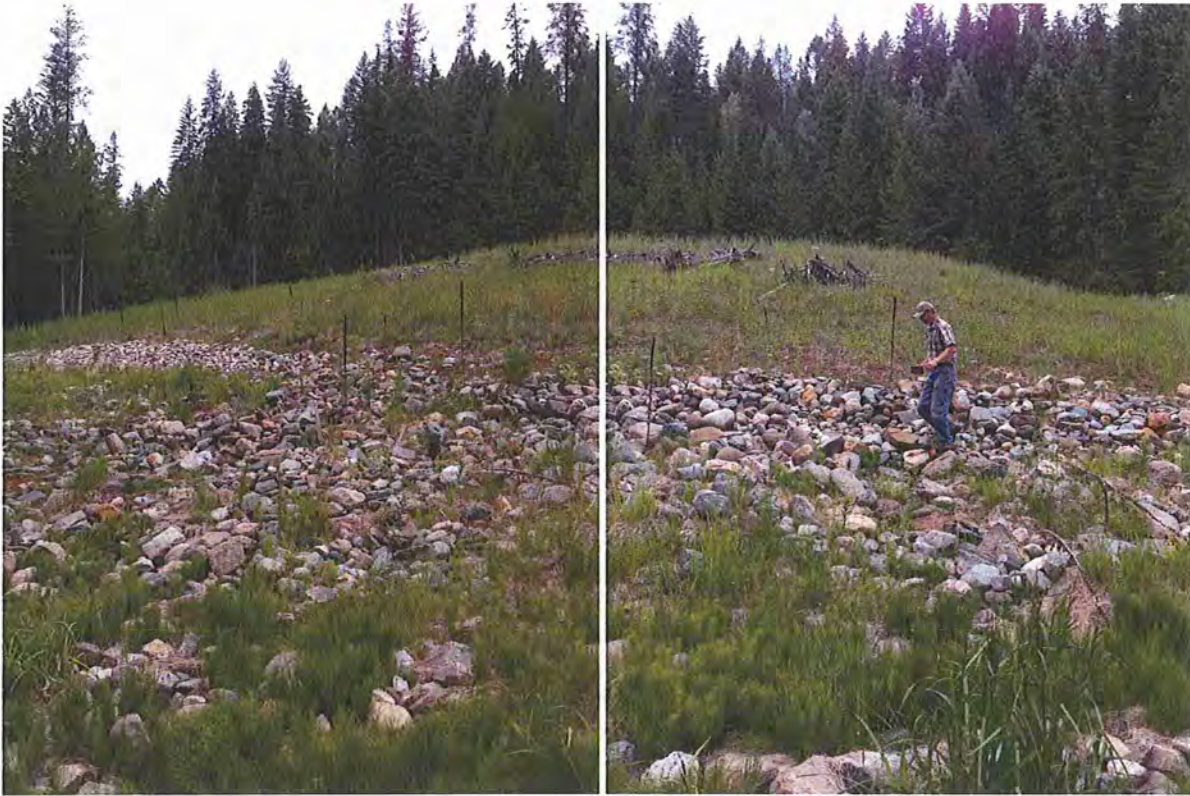
**Observe the condition of the repository cover and identifying areas of movement, erosion or exposed liner**

- *The repository cap appears stable and has a good vegetative cover of grass and sweet clover. The logs distributed on the cap to discourage entry are in good physical condition. No erosion or areas with exposed liner were visible, and there was no evidence of mass movement.*

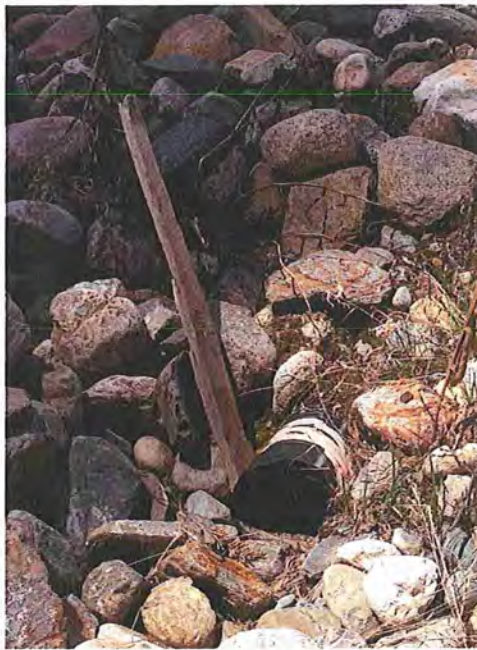
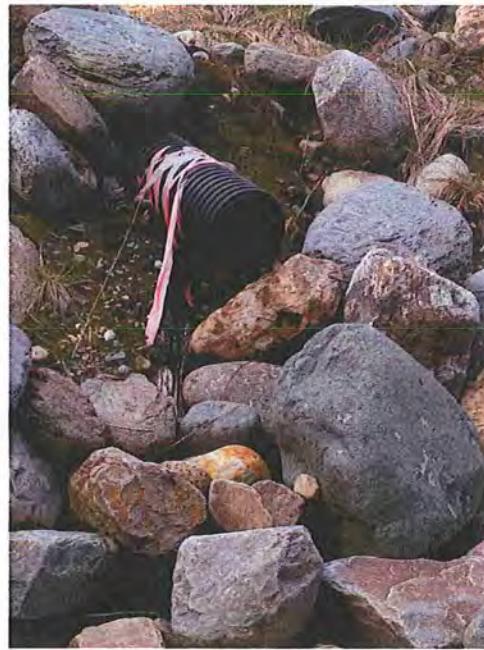
**Observe operation of the underdrain system and cleanout as necessary**

- *The underdrain system appeared to be functioning as engineered, and all cleanouts were clear of debris.*

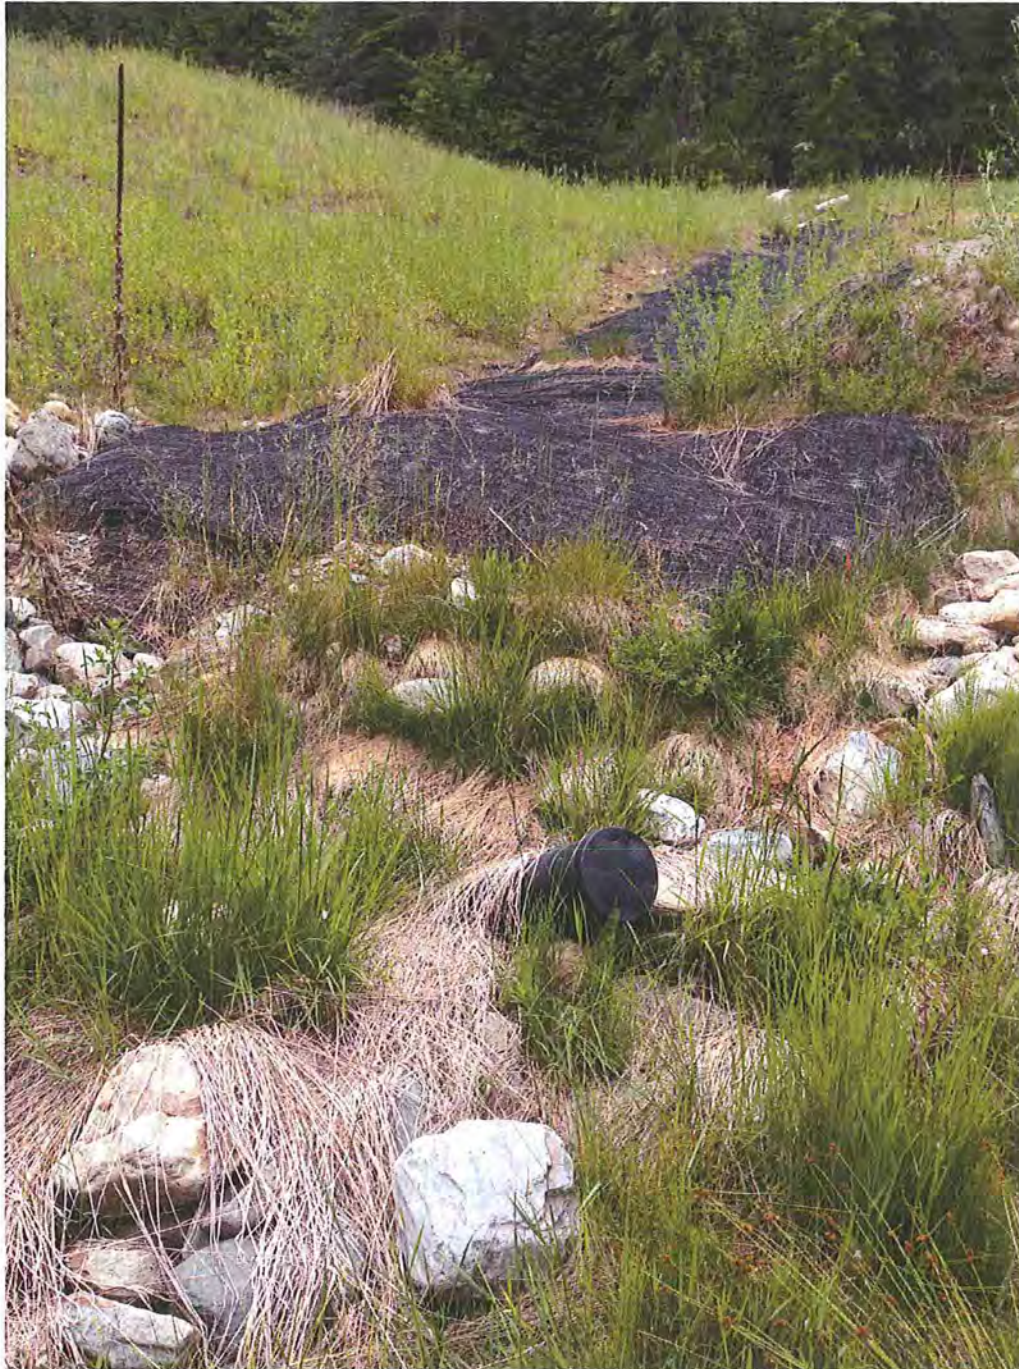
**Observe the condition of stormwater management structures**

- *No visual damage to the system was evident.*

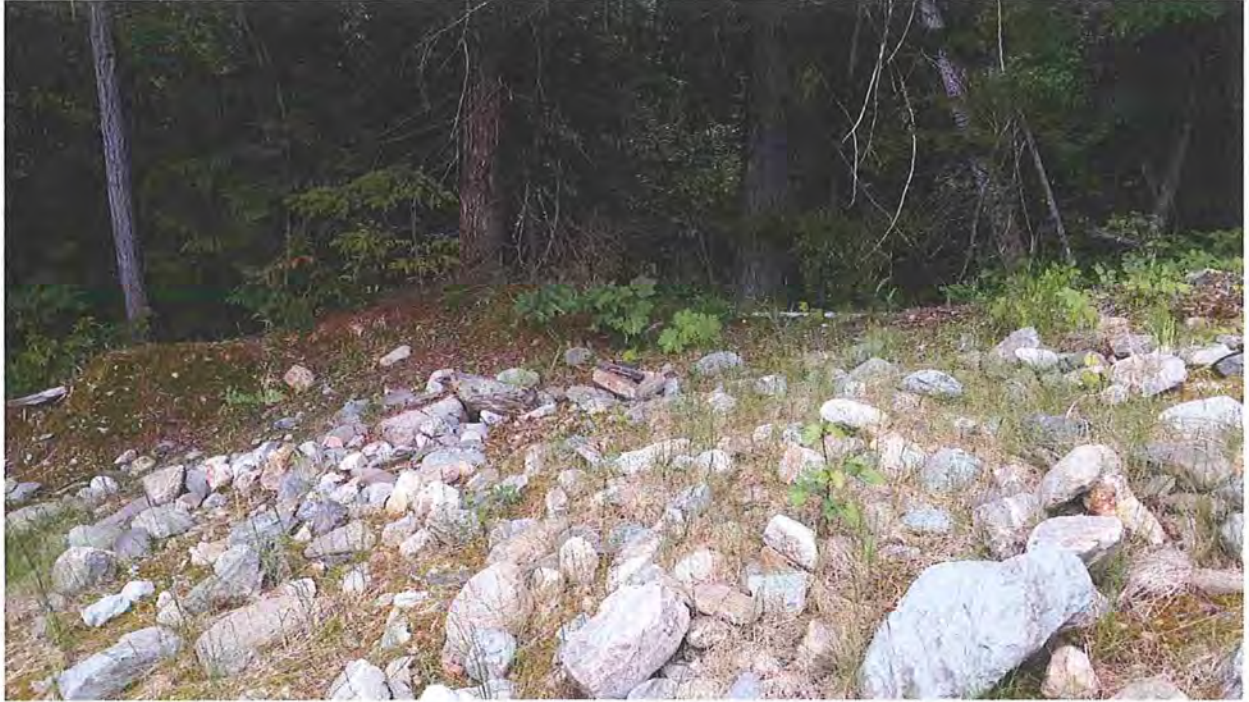
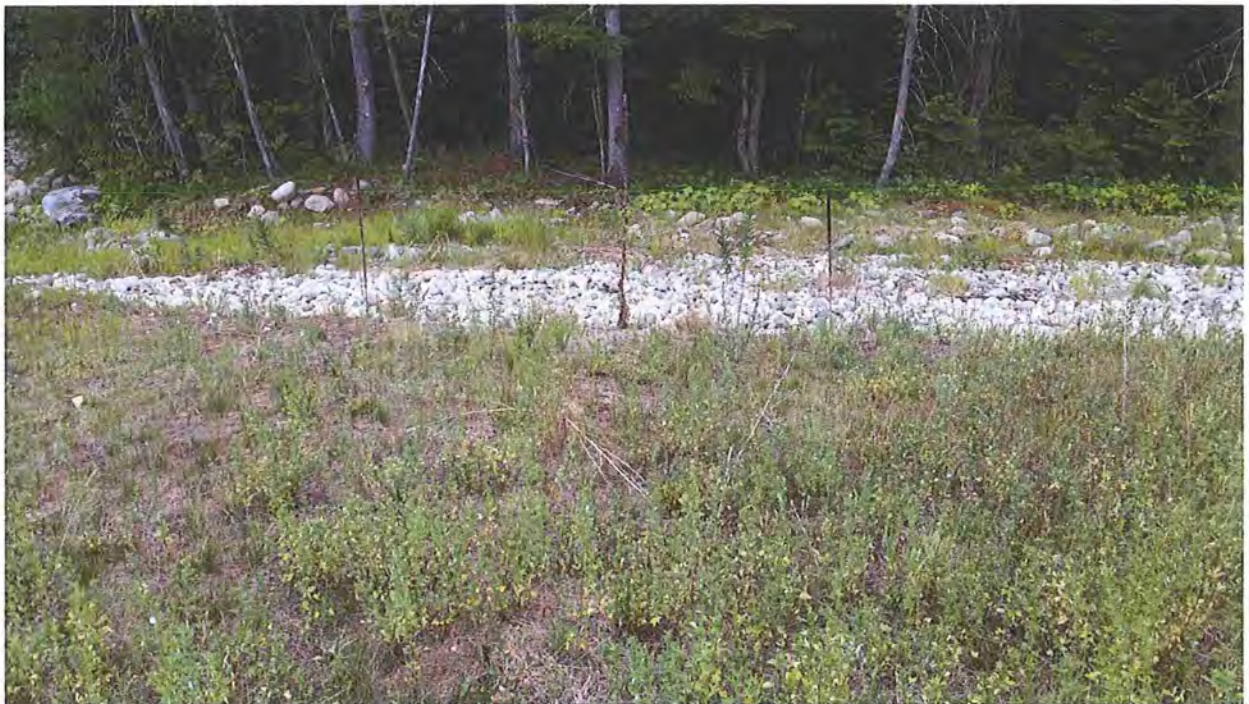
**Visual evidence or indications of mine waste release**

- *No evidence or indications of mine waste or potential for release was observed.*
