DEPARTMENT OF
ECOLOGY
State of Washington

<u>Site Name (Name over the door):</u> BNSF Longview Switching Yard Site Contact, Title, Business: Jeff Hankins, BNSF Railway, Manager, Hazardous Materials Field Operations and Emergency Response	<u>Site Address (including City, State, and Zip):</u> 115 Industrial Way, Longview, WA 98632-1003 <u>Site Contact Address (including City, State, and Zip):</u> 1624 1st St. NW, Albuquerque, NM 87102	<u>Phone</u> Click to enter text. <u>Email</u> Click to enter text. <u>Phone</u> O: 505.767.6847 C: 505.218.3582 <u>Email</u> Jeffrey.Hankins2@BNSF.com
Site Owner, Title Business: BNSF Railway Company	<u>Site Owner Address (including City, State, and Zip):</u> PO Box 961089 Fort Worth, TX 76161-0089	<u>Phone</u> Click to enter text. <u>Email</u> Click to enter text.
<u>Site Owner Contact, Title, Business:</u> Click to enter text.	<u>Site Owner Contact Address (Including City, State, and Zip):</u> Click to enter text.	<u>Phone</u> Click to enter text. <u>Email</u> Click to enter text.

COMPLAINT (Brief Summary of ERTS Complaint):

Diesel release of approximately 30 gallons during fueling activity.
--

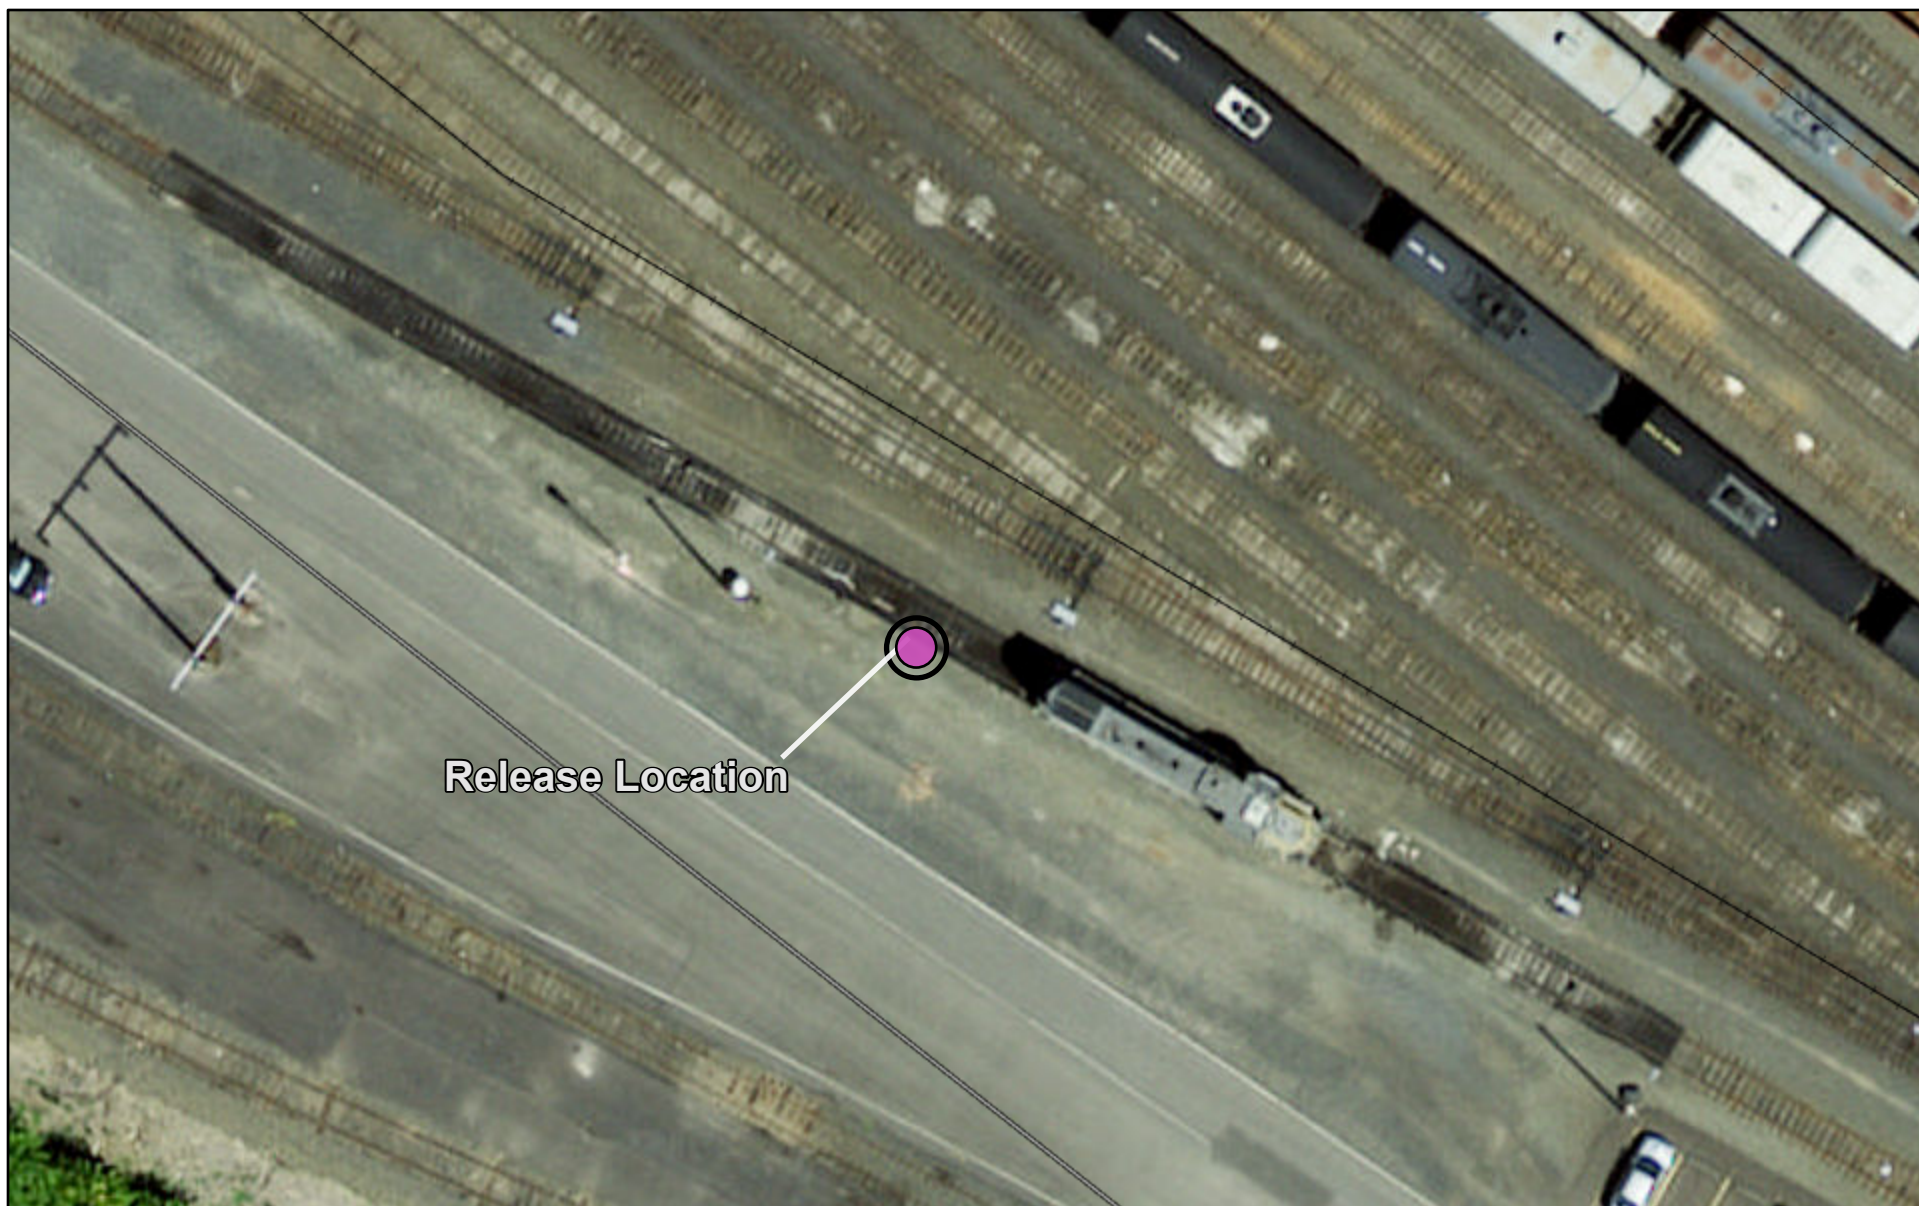
Ecology Figure 2: Release Location Detail

The release occurred on railway ballast rock.

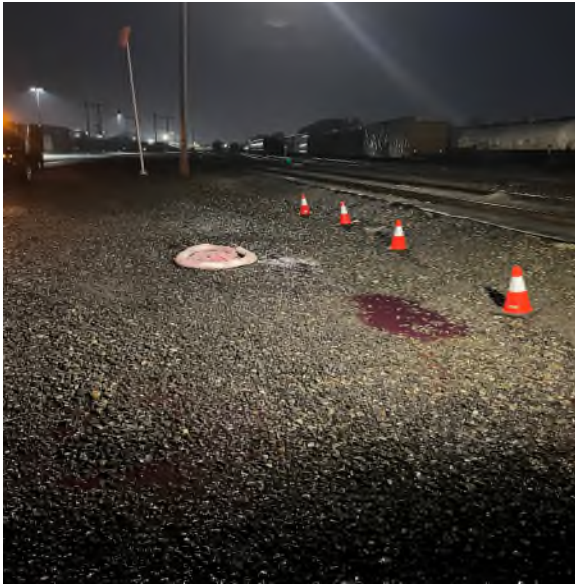
Photo 1

Impacts upon arrival.

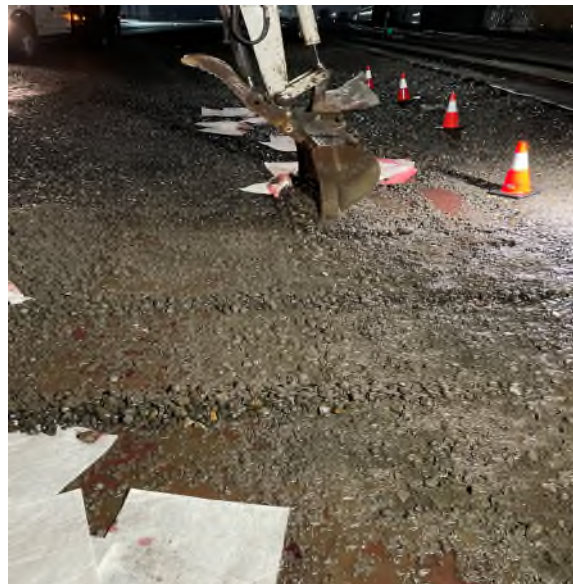
Photo 2

Impacts being removed.

RS personnel utilized an excavator and hand tools to remove the diesel impacted ballast rock and debris. This material was placed into four (4) cubic yard boxes. Field screening operations were conducted during the excavation to determine that the extent of the impacts had been removed. The site was then backfilled with ballast material provided by BNSF.

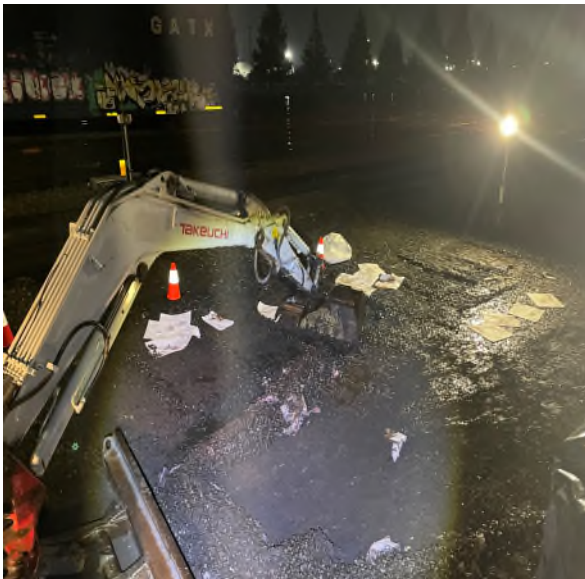
Photo 3

Impacts being removed.

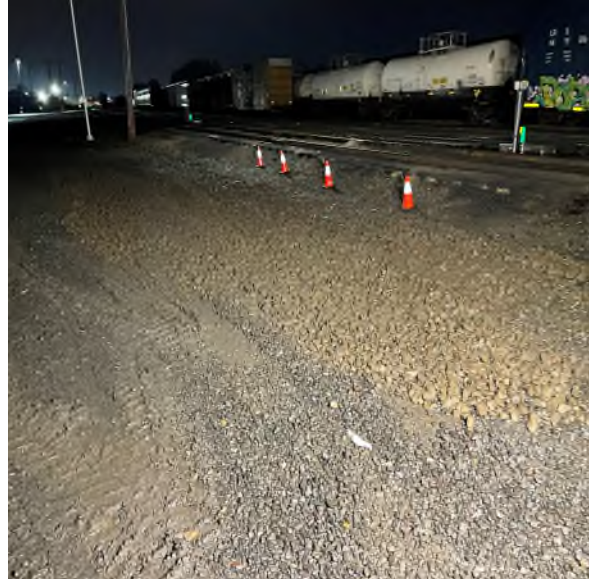
Photo 4

Site upon completion.
